Field Monitoring Report -- Pebble Copper/Gold Exploration Project --

Personnel: Kerwin Krause & Jim Renkert (DNR/DMLW) & Jeff Norberg (Manager, Site Compliance & Reclamation, PLP)	Inspection Date: August 21, 2012
	Site Contact: Jeff Norberg & Tom Jordan
	APMA #s: A126118 (GH 12-3333 and DDH 12551), A122788 (DDH 12550) & A113111 (DDH 12552)
<ul style="list-style-type: none"> ■ Inspection Type: 	<ul style="list-style-type: none"> ■ Wildlife Observed:
<ul style="list-style-type: none"> ○ Complete: X (GH 12-3333 & DDH 12551) 	<ul style="list-style-type: none"> ○ Bear: X (Several Brown)
<ul style="list-style-type: none"> ○ Partial: X (DDH 12550 and DDH 12552) 	<ul style="list-style-type: none"> ○ Caribou:
<ul style="list-style-type: none"> ○ Follow-up: 	<ul style="list-style-type: none"> ○ Moose: X (Several)
<ul style="list-style-type: none"> ○ Response to Public Complaint: 	<ul style="list-style-type: none"> ○ Waterfowl: X (Swans)
	<ul style="list-style-type: none"> ○ Fish: X

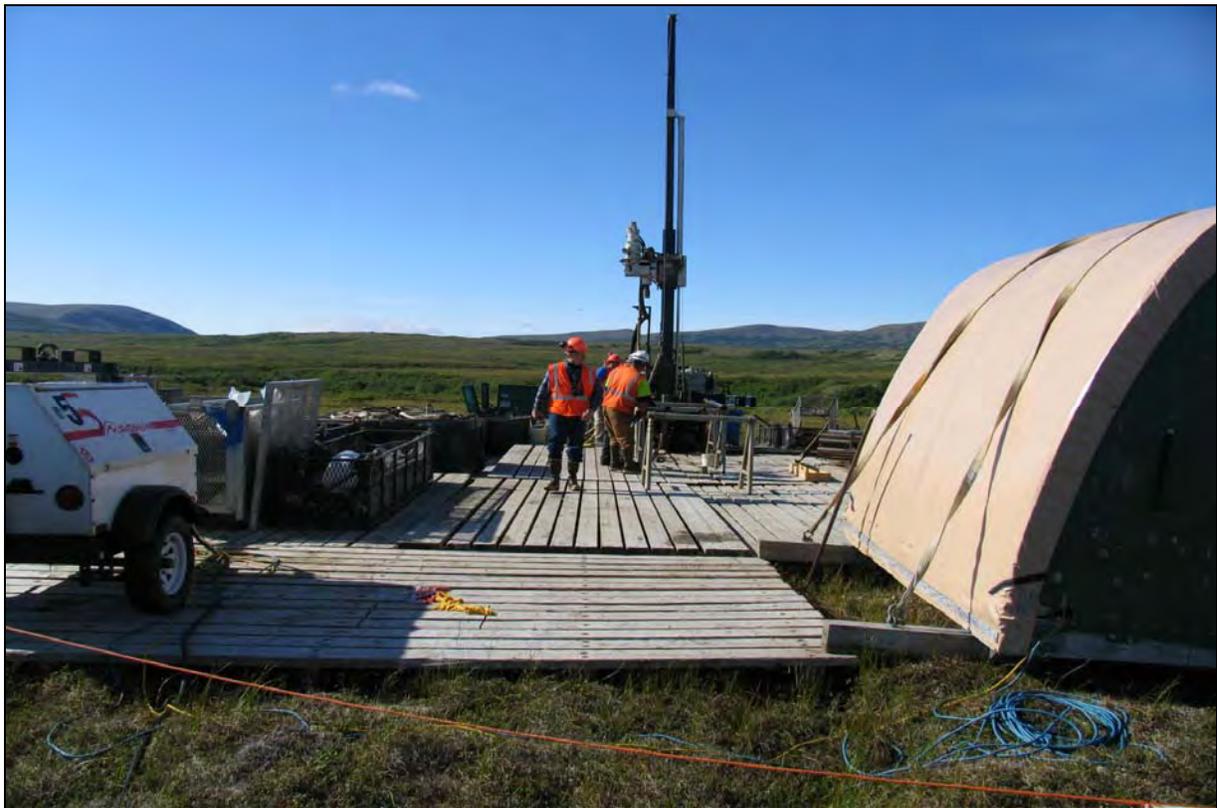
GH 12-333 Looking South

Drill Hole/Site No.: GH 12-333	Date: August 21, 2012
Rig No.: 4	Time: 11:50 AM
Activity: Drilling Geo-Tech Mud Rotary Hole	
<ul style="list-style-type: none"> ■ Condition of Drilling Site: Orderly (Pictures 1&2) 	<ul style="list-style-type: none"> ■ Sump Pit (continued): Water from sump pit pumped up slope and away from any surface water and discharged on tundra.
<ul style="list-style-type: none"> ○ Distance from waterbody: ~ 500 feet 	<ul style="list-style-type: none"> ○ Location and extent of discharged material: See above
<ul style="list-style-type: none"> ○ Location of fuel storage: Adjacent to pads 	<ul style="list-style-type: none"> ○ Topsoil, muck, tundra stockpiled: Yes
<ul style="list-style-type: none"> ○ Sorbent pads present: Yes, 1 barrel 	<ul style="list-style-type: none"> ○ Hose color: White
<ul style="list-style-type: none"> ○ Tundra mat: Yes, and all drill related equipment situated on pads.

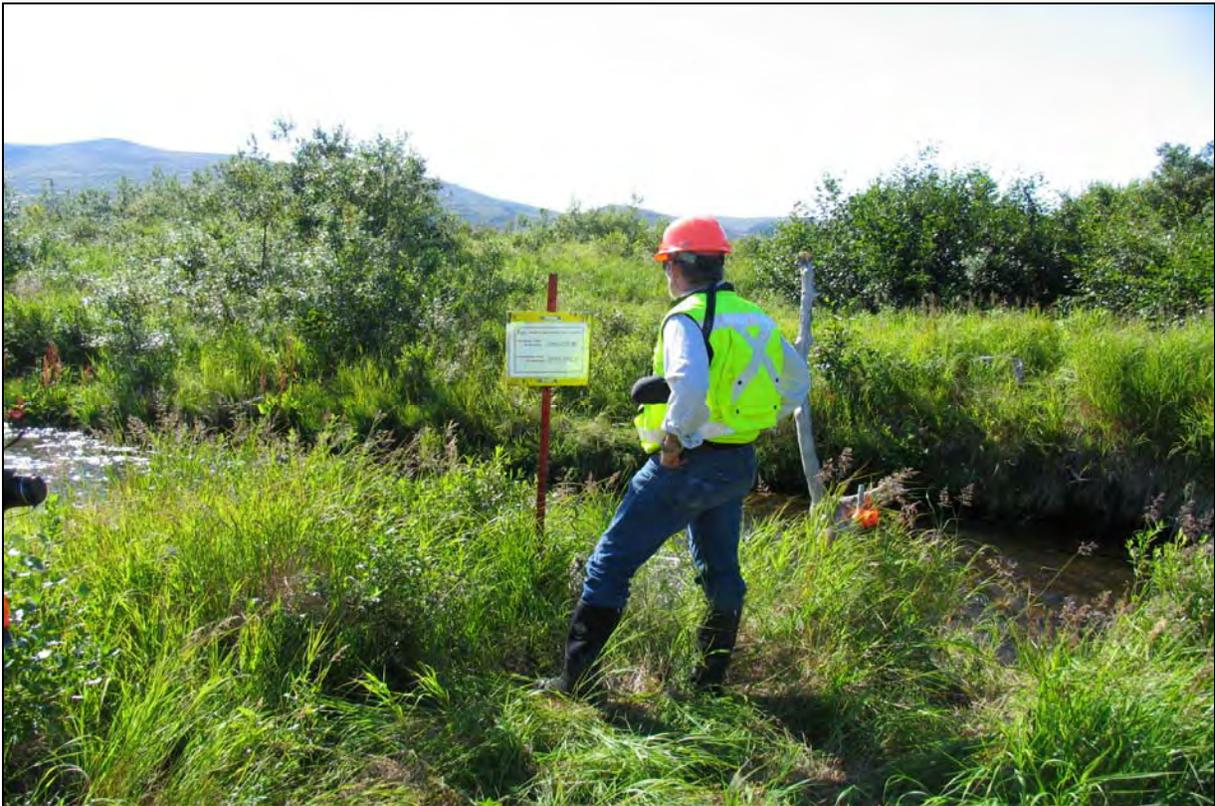
GH 12-333 Water Take Point

<ul style="list-style-type: none"> ○ Pipe off tundra: Yes 	<ul style="list-style-type: none"> ■ Drill Water Supply: Pictures 3 and 4.
<ul style="list-style-type: none"> ○ Litter: None 	<ul style="list-style-type: none"> ○ Stream, lake/pond: Headwaters of Upper Talarik Creek
<ul style="list-style-type: none"> ○ Trash containment: Yes 	<ul style="list-style-type: none"> ○ Location: (See Map)
<ul style="list-style-type: none"> ○ Sanitary facilities: Yes - privy 	<ul style="list-style-type: none"> ○ Adequate water flow and depth for fish passage in streams: Yes
<ul style="list-style-type: none"> ○ Any spills or staining: No 	<ul style="list-style-type: none"> ○ Evidence of significant impacts to riparian vegetation or stream banks: None
<ul style="list-style-type: none"> ○ General impression: Clean 	<ul style="list-style-type: none"> ○ General impression of water body (i.e. clear, turbid, tannic): Clear ○ Intake description: Screened electric submersible

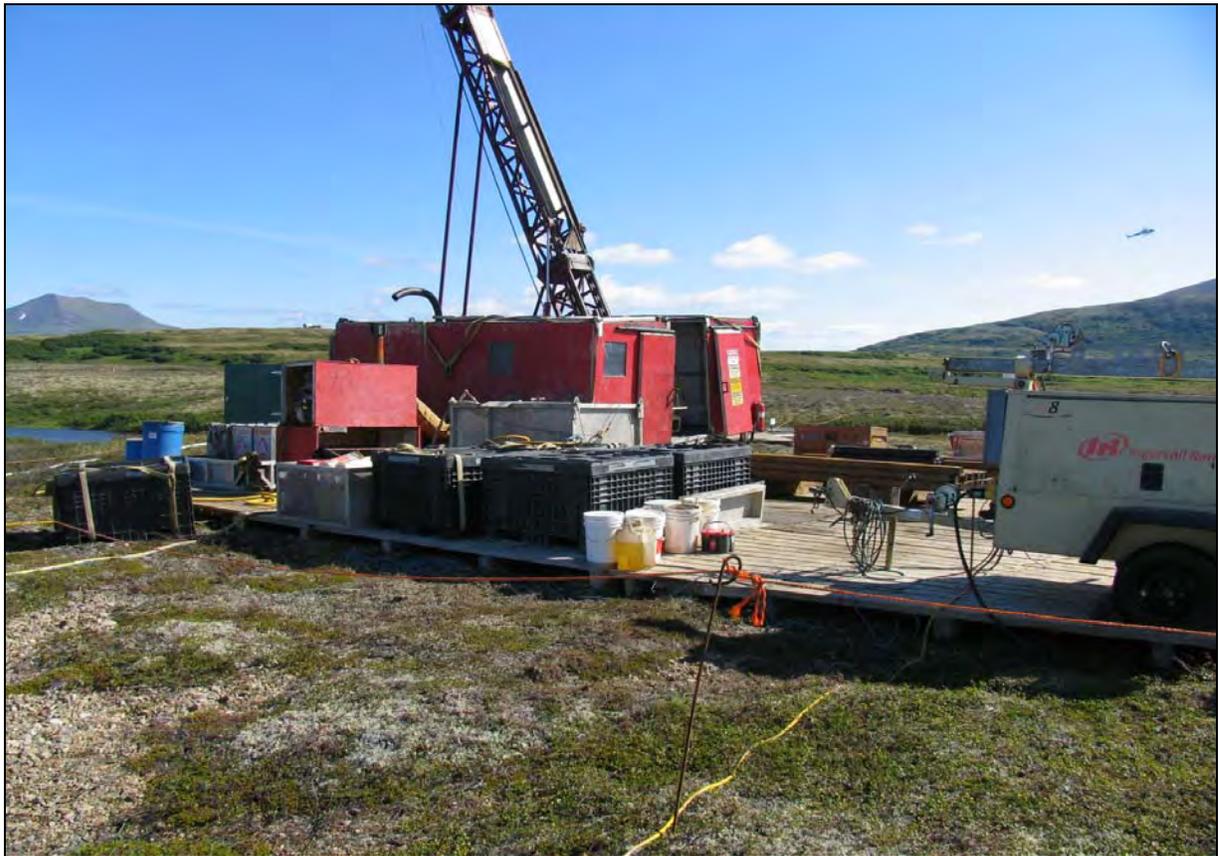
DDH 12551 Looking South

Drill Hole/Site No.: DDH 12551	Date: August 21, 2012
Rig No.: 3	Time: 12:40 PM
Activity: DDH	
<ul style="list-style-type: none"> ■ Condition of Drilling Site: Orderly (See Pictures Below) <ul style="list-style-type: none"> ○ Distance from waterbody: ~ 150 feet ○ Location of fuel storage: Next to Drill ○ Sorbent pads present: Yes, 1 barrel ○ Tundra mat: Yes, and all drill related equipment situated on pads. ○ Pipe off tundra: Yes ○ Litter: None ○ Trash containment: Yes ○ Sanitary facilities: Yes - privy ○ Any spills or staining: No ○ General impression: Clean 	<ul style="list-style-type: none"> ■ Sump Pit (continued): <ul style="list-style-type: none"> ○ Location and extent of discharged material: North of Drill Collar ○ Topsoil, muck, tundra stockpiled: Yes ○ Hose color: White ■ Drill Water Supply: Pond – See Pictures 3 and 4. <ul style="list-style-type: none"> ○ Stream, lake/pond: Pond ○ Location: South of Drill (See Map) ○ Adequate water flow and depth for fish passage in streams: N/A ○ Evidence of significant impacts to riparian vegetation or stream banks: None ○ General impression of water body (i.e. clear, turbid, tannic): Clear ○ Intake description: Screened electric submersible

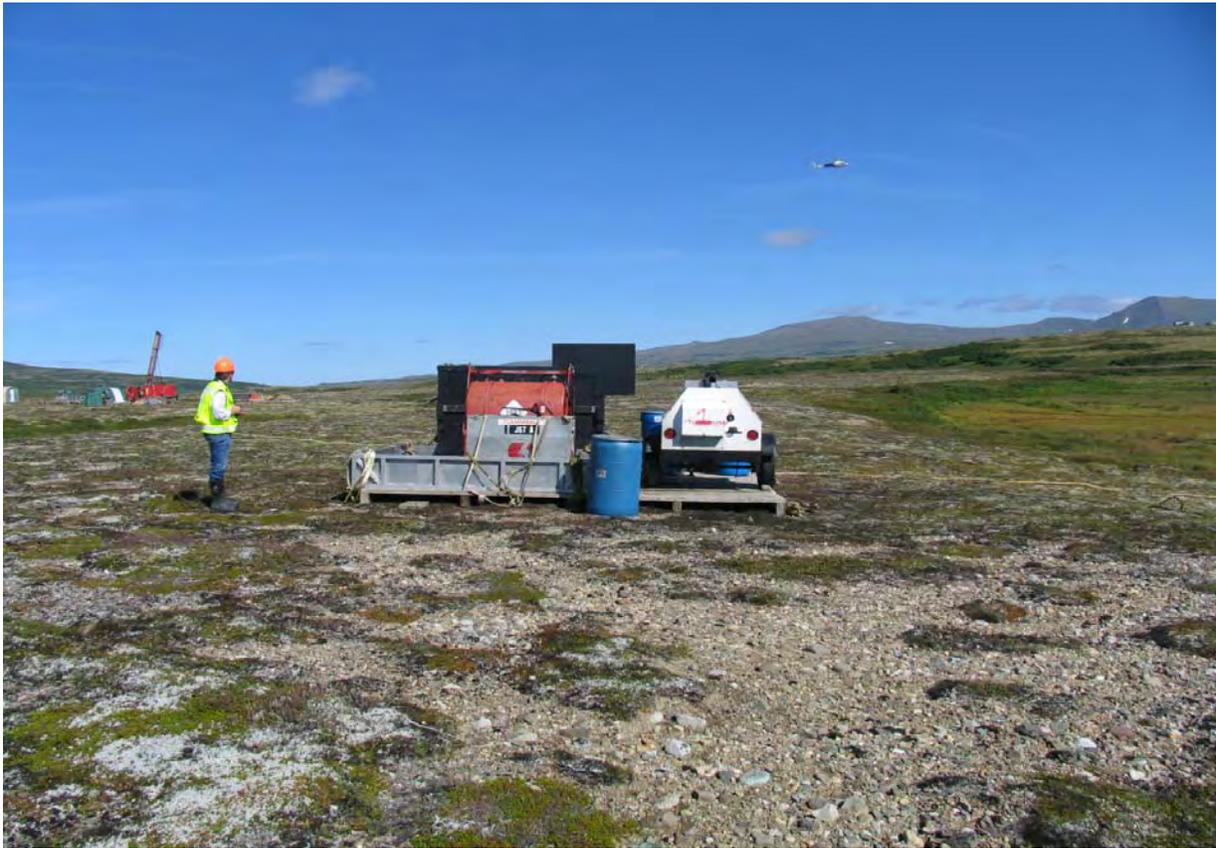
DDH 12551 Looking North from Generator Site for Water Pump.
Pump located 250' to the south.

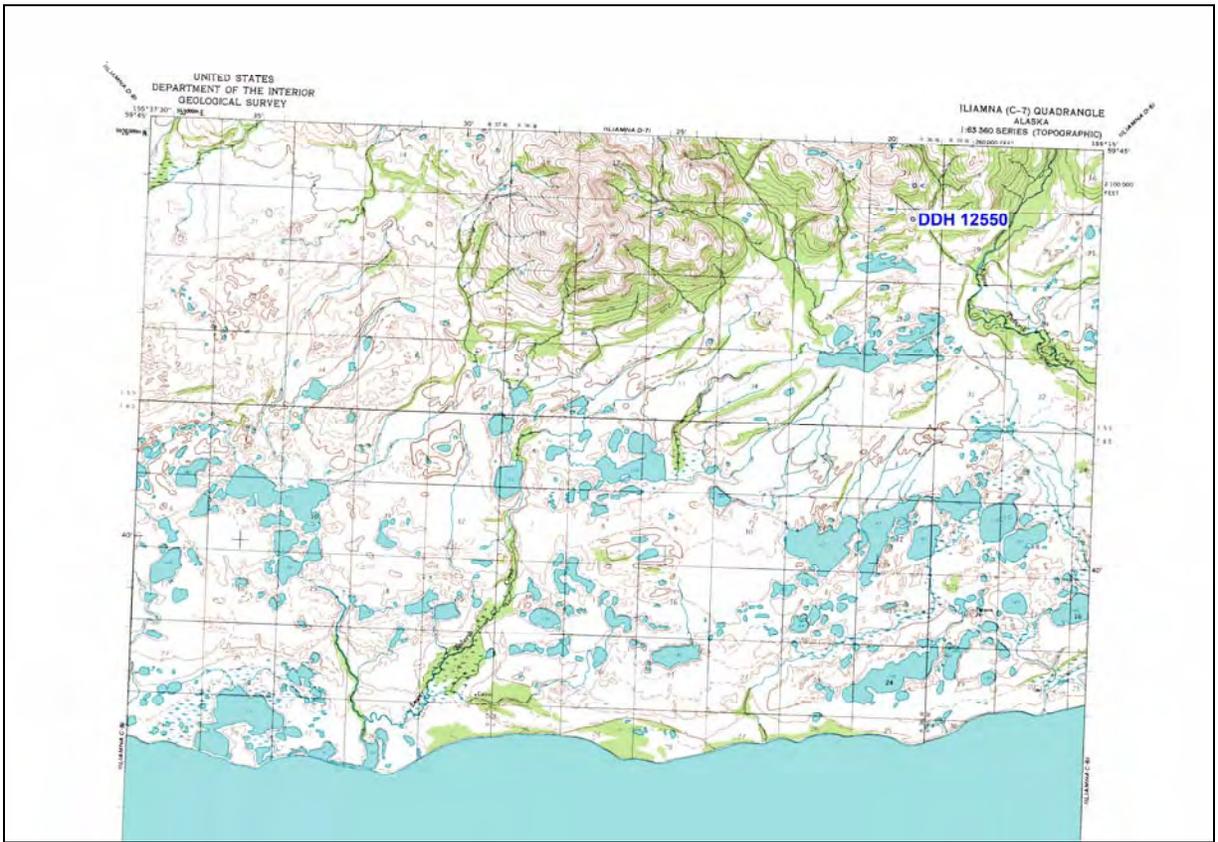
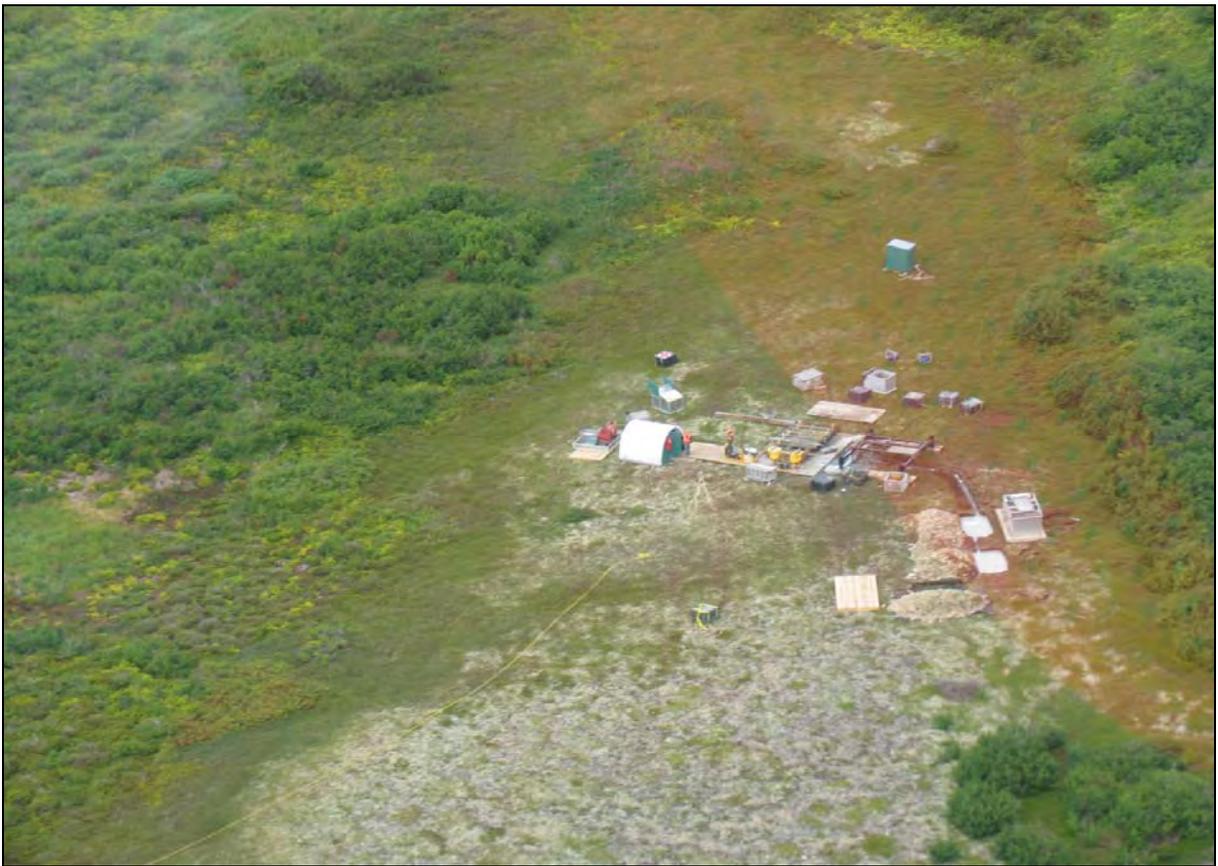
Drill Hole/Site No.: DDH 12550	Date: August 21, 2012
Rig No.: 5	Time: 2:00 PM
Activity: DDH being set up on FMM's Kaskanak claim block (Viewed from the air only).	
<ul style="list-style-type: none"> ■ Condition of Drilling Site: Orderly (See Pictures Below) <ul style="list-style-type: none"> ○ Distance from waterbody: ~ 600 feet ○ Location of fuel storage: Next to Drill ○ Sorbent pads present: Yes, 1 barrel ○ Tundra mat: Yes, and all drill related equipment situated on pads. ○ Pipe off tundra: Yes ○ Litter: None ○ Trash containment: Yes ○ Sanitary facilities: Yes - privy ○ Any spills or staining: No ○ General impression: Clean 	<ul style="list-style-type: none"> ■ Sump Pit (continued): <ul style="list-style-type: none"> ○ Location and extent of discharged material: North of Drill Collar ○ Topsoil, muck, tundra stockpiled: Yes ○ Hose color: White
	<ul style="list-style-type: none"> ■ Drill Water Supply: <ul style="list-style-type: none"> ○ Stream, lake/pond: Creek ○ Location: East of drill (See Map) ○ Adequate water flow and depth for fish passage in streams: ? ○ Evidence of significant impacts to riparian vegetation or stream banks: ? ○ General impression of water body (i.e. clear, turbid, tannic): ? ○ Intake description: Screened electric submersible

<ul style="list-style-type: none"> ■ Drilling Activity: Not started yet, getting ready. <ul style="list-style-type: none"> ○ Drill additives in use: Pure Vis only ○ Recirculation tank: Yes ○ Water discharged: Not yet ○ Artesian zone encountered: No 	<ul style="list-style-type: none"> ○ Structure clear of debris: ? ○ Mesh size: 1x12 mm slotted 0.1 CFS ○ Submerged: ? ○ Fuel/generator location to source: >100 feet west ○ Catch basin for fuel supply: Yes ○ Sorbent pads: Yes
<ul style="list-style-type: none"> ■ Sump Pit: Yes, 2 Pits <ul style="list-style-type: none"> ○ Location: East of drill site ○ Discharge trench: Yes ○ Dimensions of pit: 5 foot x 10 foot ○ In use: No 	<ul style="list-style-type: none"> ○ Hose color: Yellow ■ Other Comments: Site set up, no drilling yet

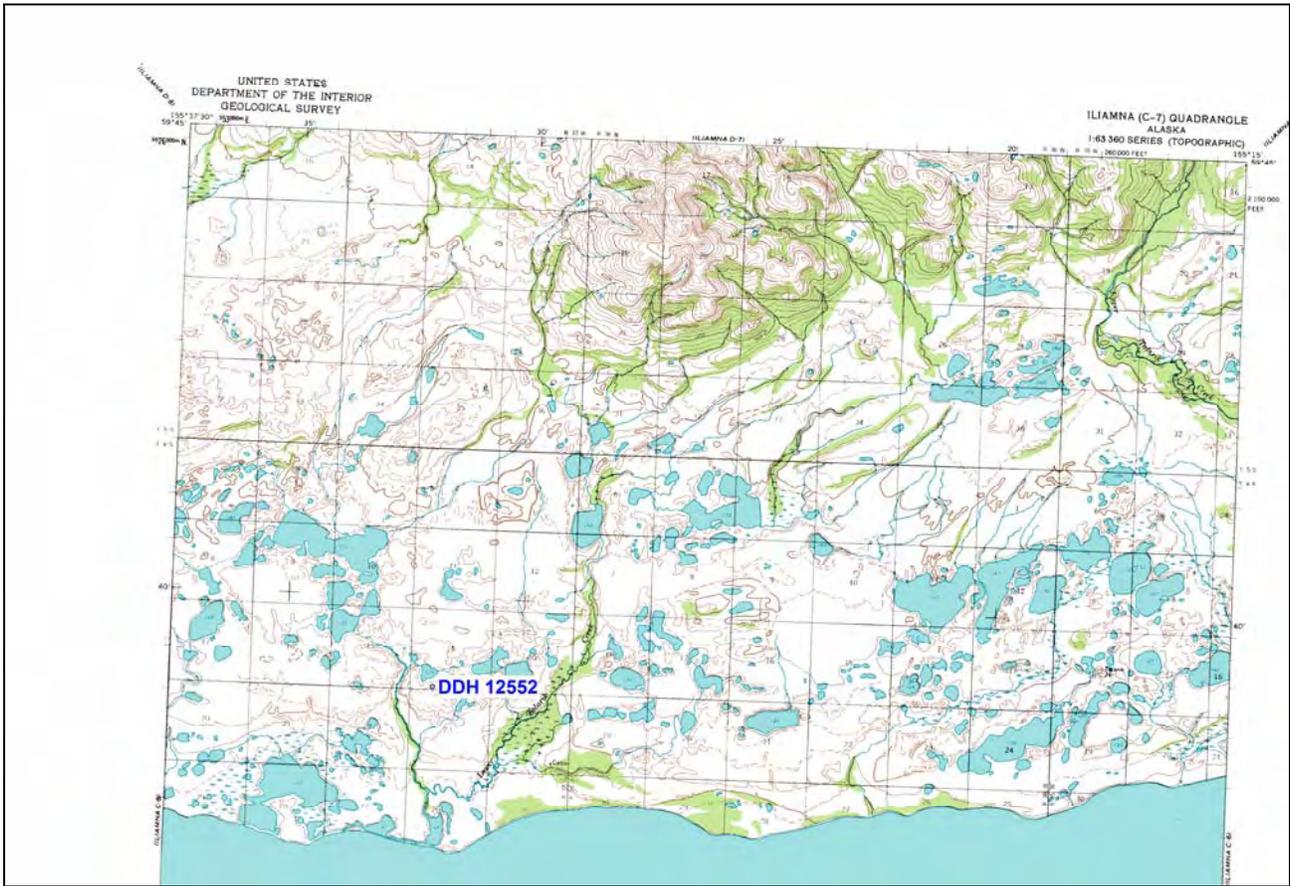
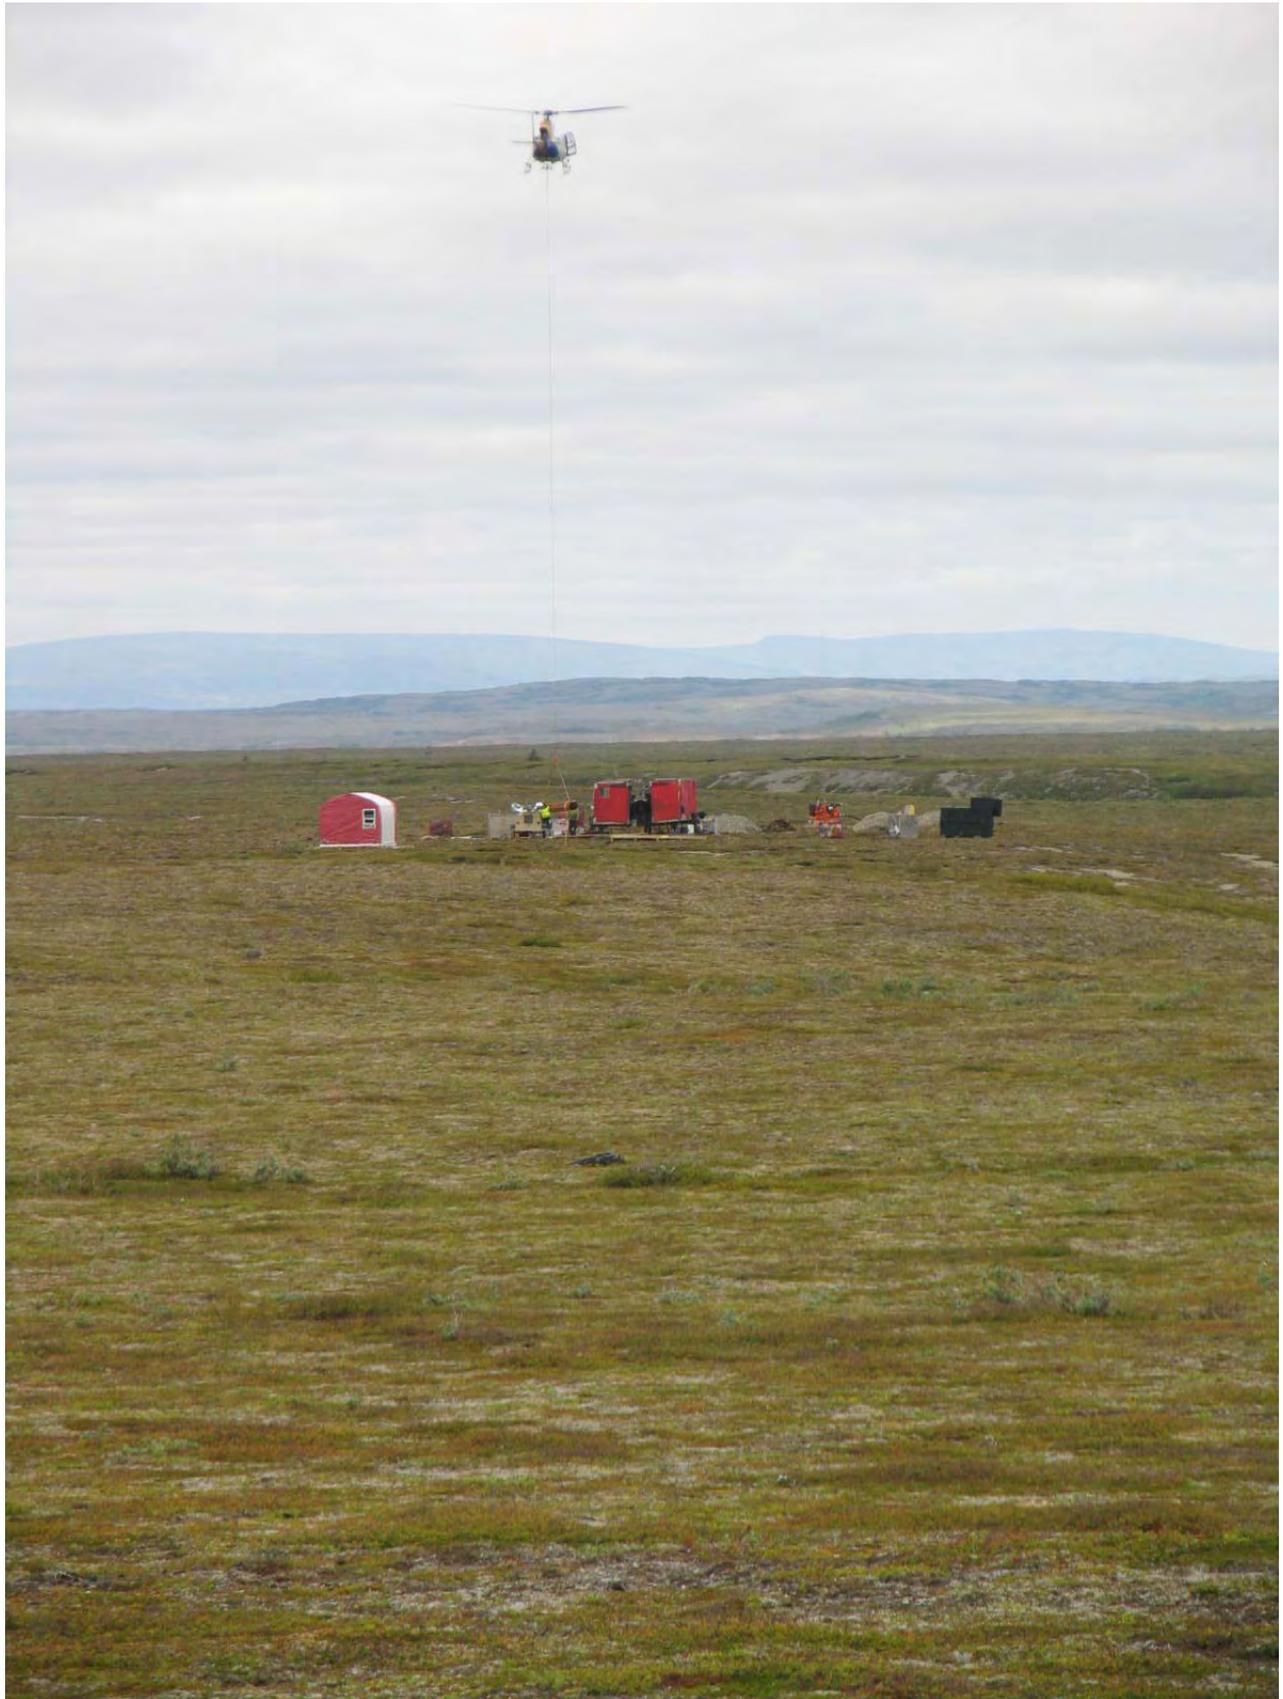
Drill Hole/Site No.: DDH 12552	Date: August 21, 2012
Rig No.: 5	Time: 3:00 PM
Activity: DDH being set up on PLP's KAS claim block (viewed from a distance only).	
<ul style="list-style-type: none"> ■ Condition of Drilling Site: Orderly (See Picture Below) <ul style="list-style-type: none"> ○ Distance from waterbody: ~ 2,000 feet ○ Location of fuel storage: ? ○ Sorbent pads present: ? ○ Tundra mat: Yes, and all drill related equipment is being situated on pads. ○ Pipe off tundra: ? ○ Litter: ? ○ Trash containment: ? ○ Sanitary facilities: Yes - privy ○ Any spills or staining: ? ○ General impression: ? 	<ul style="list-style-type: none"> ■ Sump Pit (continued): <ul style="list-style-type: none"> ○ Location and extent of discharged material: ? ○ Topsoil, muck, tundra stockpiled: ? ○ Hose color: ?
	<ul style="list-style-type: none"> ■ Drill Water Supply: <ul style="list-style-type: none"> ○ Stream, lake/pond: Creek ○ Location: West of drill (See Map) ○ Adequate water flow and depth for fish passage in streams: ? ○ Evidence of significant impacts to riparian vegetation or stream banks: ? ○ General impression of water body (i.e. clear, turbid, tannic): ? ○ Intake description: Screened electric submersible

<ul style="list-style-type: none"> ■ Drilling Activity: Not started yet, getting ready. <ul style="list-style-type: none"> ○ Drill additives in use: ? ○ Recirculation tank: ? ○ Water discharged: ? ○ Artesian zone encountered: 	<ul style="list-style-type: none"> ○ Structure clear of debris: ? ○ Mesh size: 1x12 mm slotted 0.1 CFS ○ Submerged: Yes ○ Fuel/generator location to source: ? ○ Catch basin for fuel supply: ? ○ Sorbent pads: ?
<ul style="list-style-type: none"> ■ Sump Pit: ? <ul style="list-style-type: none"> ○ Location: ? ○ Discharge trench: ? ○ Dimensions of pit: ? ○ In use: No 	<ul style="list-style-type: none"> ○ Hose color: ? ■ Other Comments: Site set up, no drilling yet
