FIELD REPORT --PEBBLE COPPER/GOLD PROJECT--

Date: 22 August 2007

Objectives: Site visit to Pebble Project, inspect temporary water use for exploratory drilling.

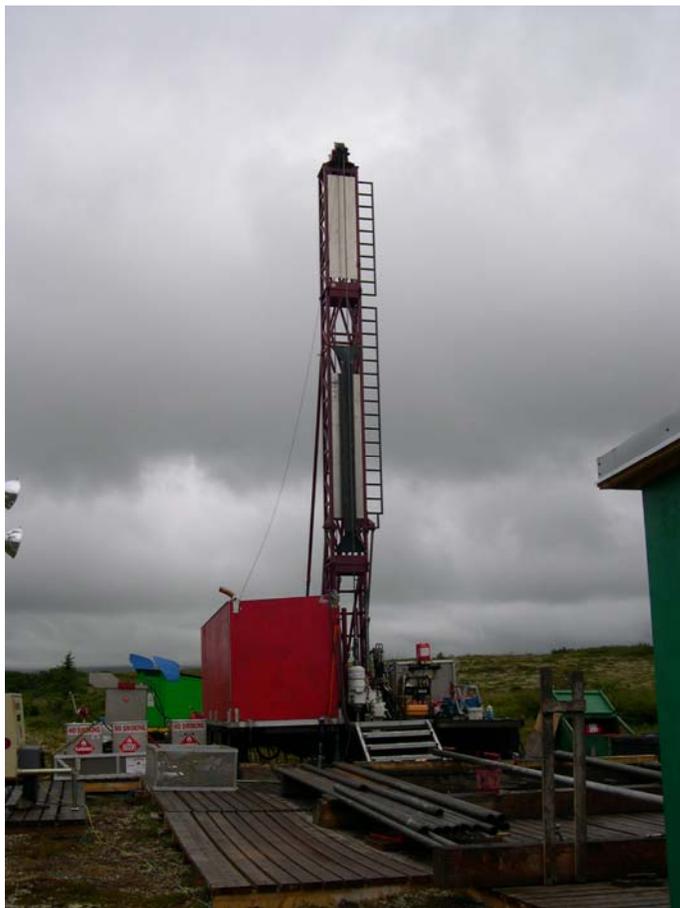
The site visit to the proposed mine area was carried out by helicopter. The first landing site was a drilling rig located due east of Koktuli Ridge on a saddle north of Frying Pan Lake (Figure 1). The drill site was clean and orderly (Figure 2). To minimize impacts to the tundra, drilling structures were placed on mobile wooden platforms constructed of timbers and decking. We observed an area where a drilling platform had been previously, and the impact appeared minimal (Figure 3). One objective of this trip was to inspect water withdrawal approved under Fish Habitat permits 07-II-010, 07-II-011, 07-II-0012, 07-II-013, and 07-II-014. These permits authorize water to be withdrawn from Upper Talarik Creek and designated tributaries for use in drilling operations. Upon arriving in Iliamna, Northern Dynasty staff informed OHMP staff that water was not being withdrawn from the permitted creeks, rather it was being withdrawn from non-fish bearing kettle lakes in the area. Also, water was recycled between drilling rigs to minimize water withdrawal. At each drilling rig, settling sumps (Figure 4) are dug to allow rock flour to settle from the drilling water. There was a centralized settling pond (Figure 5) that received and provided water to several other drilling rigs in the area via a network of pumps and hoses. The kettle pond that served as the primary water source for the visited drilling rig and others in the area exhibited considerable drawdown (Figure 6). To the best of OHMPs knowledge no fish

Figure 2. Visited drilling rig and pad.

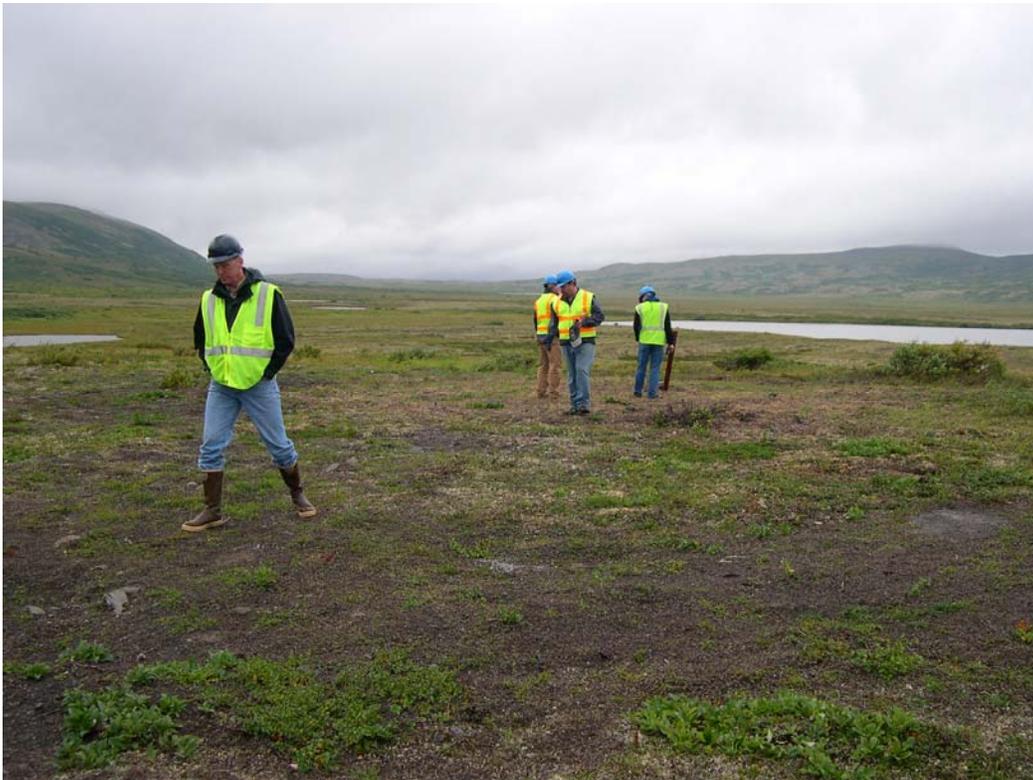
Figure 3. Location of previous drilling site.

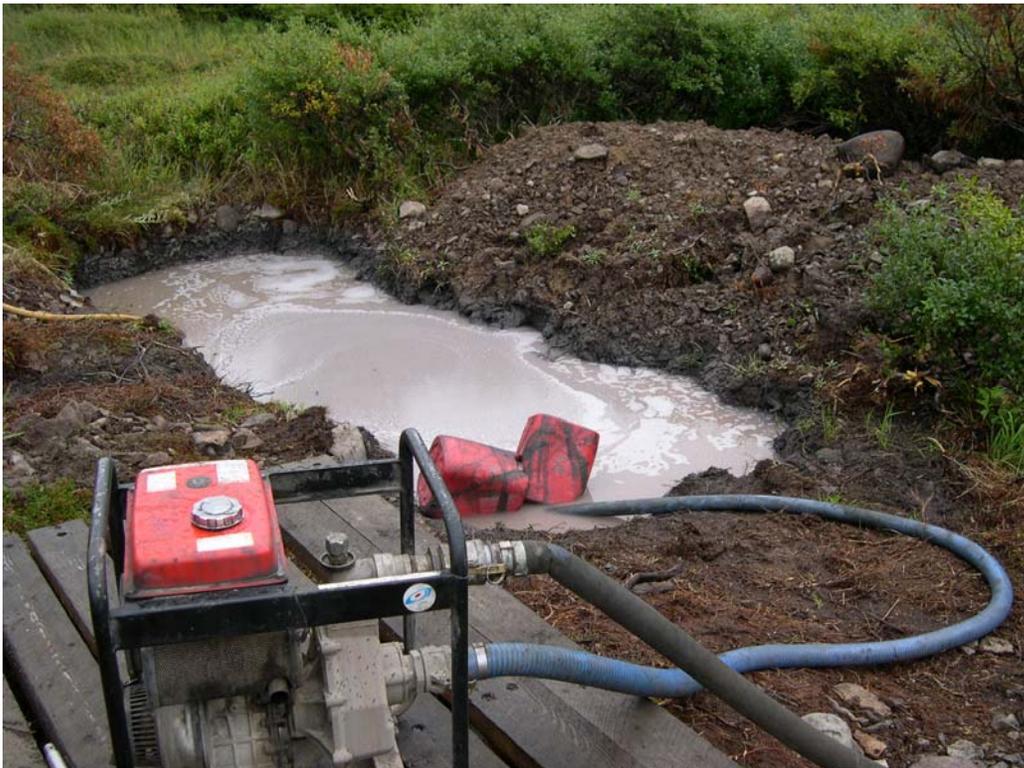
Figure 4. Settling pond at drill site.

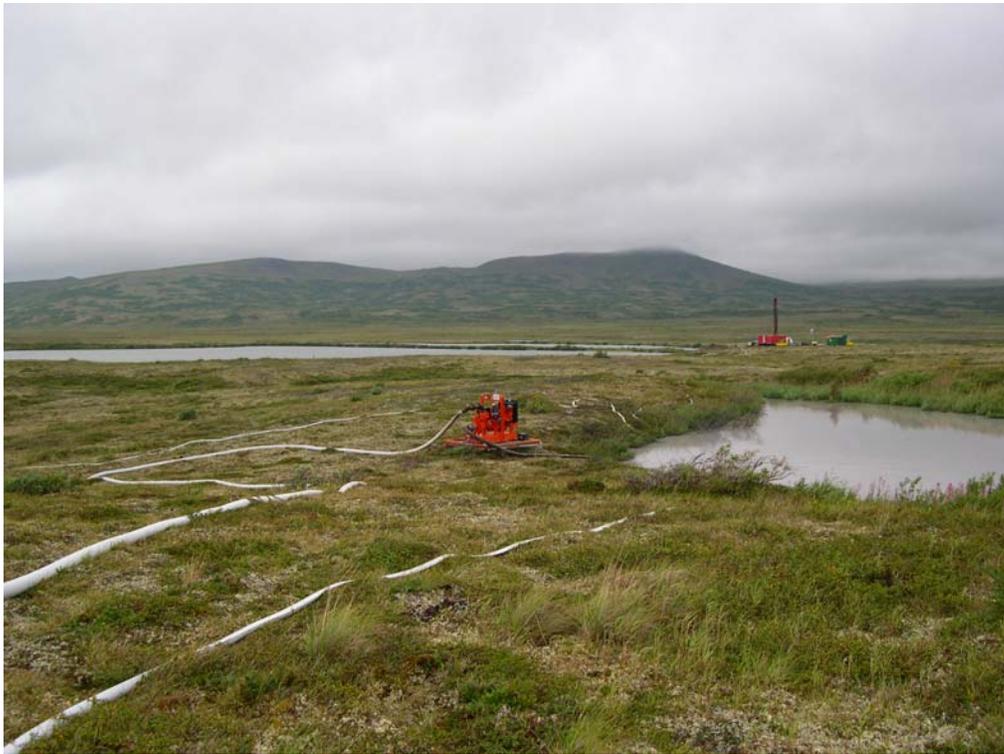
Figure 5. Centralized settling pond.

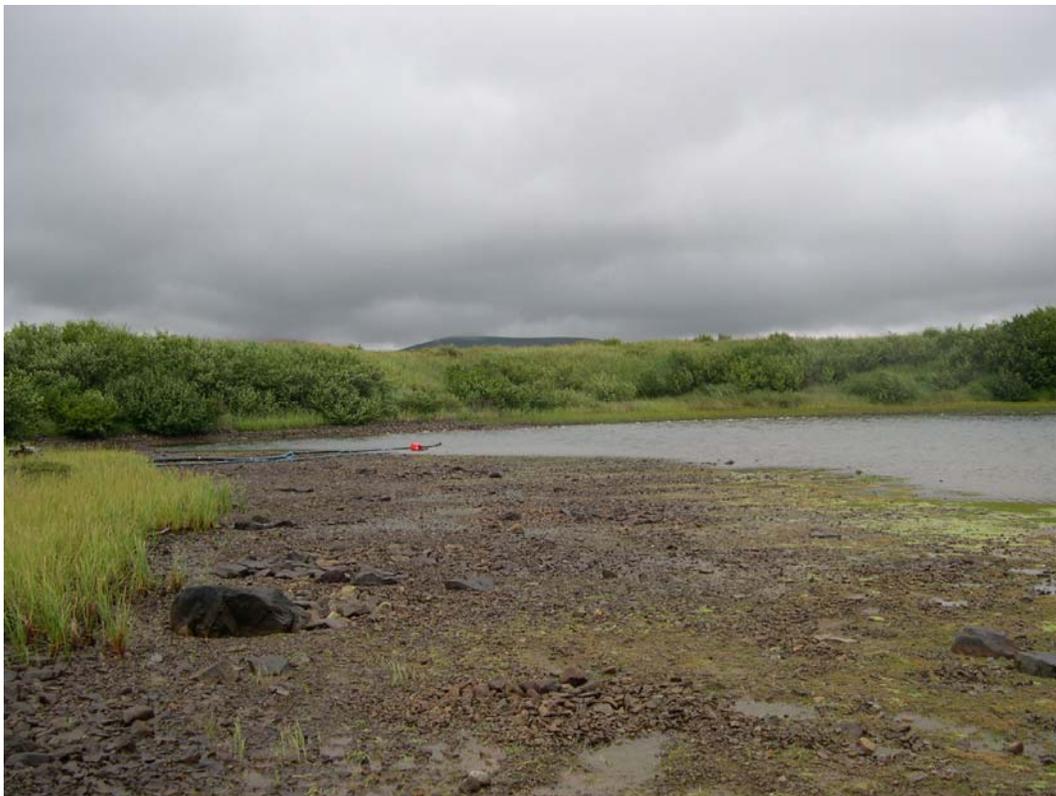
sampling has been conducted in the local kettle lakes and it is assumed they are non-fish bearing. A water intake structure design to prevent fish entrapment and impingement during withdrawal was not visible at this site because the intake hose was submerged. However, we were informed that a structure was in place. I observed another kettle lake that water had previously been withdrawn from, and an intake structure was present. Also noted was extensive helicopter activity (e.g. 3-4 helicopters airborne simultaneously) in the area during the visit. Most of their activity was associated with sling loading equipment.

Figure 6. Primary water source and observed drawdown.

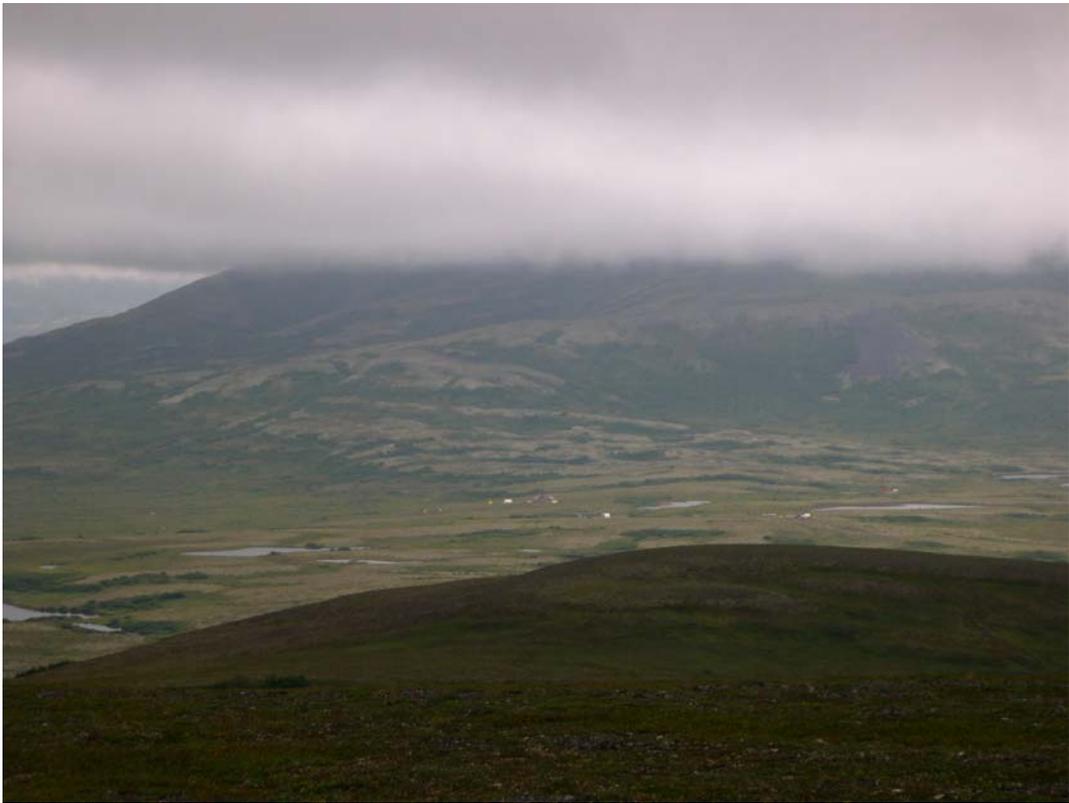
The second landing site was on the eastern side of Koktuli Peak (Figure 1). From this location drill rigs were visible working within the project area and the location provided a good overview of the current exploratory drilling area (Figure 7). The flight back to Iliamna proceeded over the north and south forks of Koktuli River, Big Wiggly Lake, Upper Talarik Creek, and the tentative road access route. I observed several kettle lakes unaffected by drilling operations with low water level were observed throughout the area (Figure 8). A brief tour of the core shack concluded the site visit.

Figure 7. View of drilling area, looking east from Koktuli Ridge.

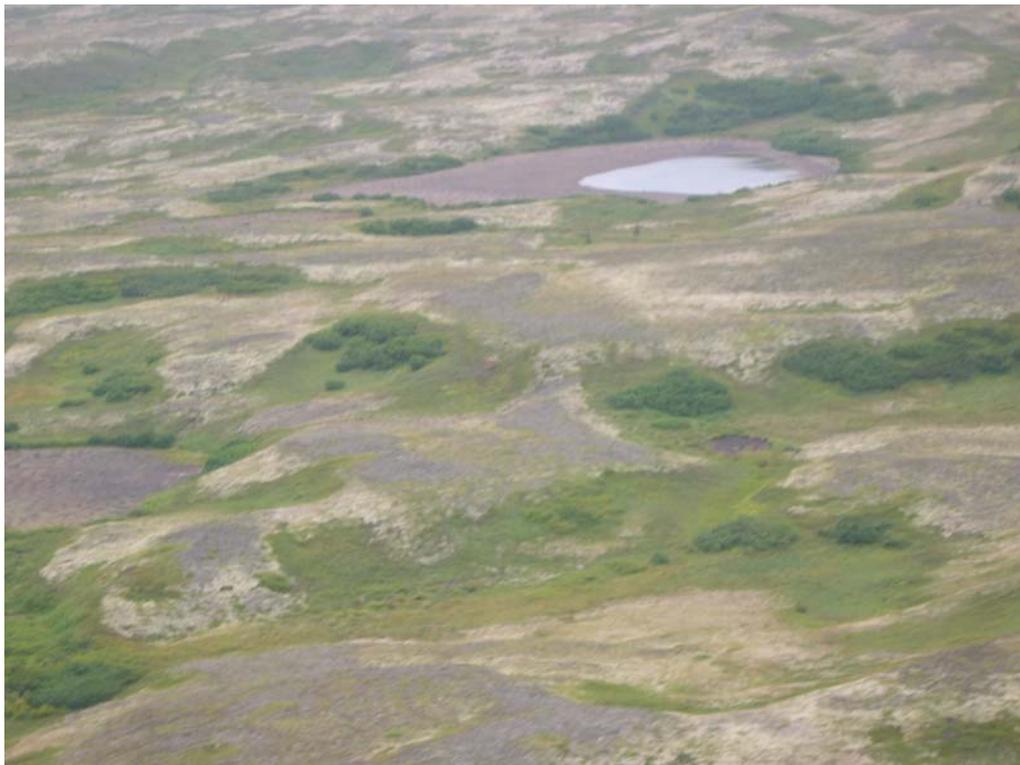
Figure 8. Typical observed kettle lake unaffected by exploratory drilling showing low water level.
