Field Monitoring Report -- Pebble Copper/Gold Exploration Project --

| Personnel: Rick Fredericksen (DNR/MLW) | Inspection Date: August 25, 2011 |
| Brent Goodrum (DNR/MLW) | APMA #: A116118 |

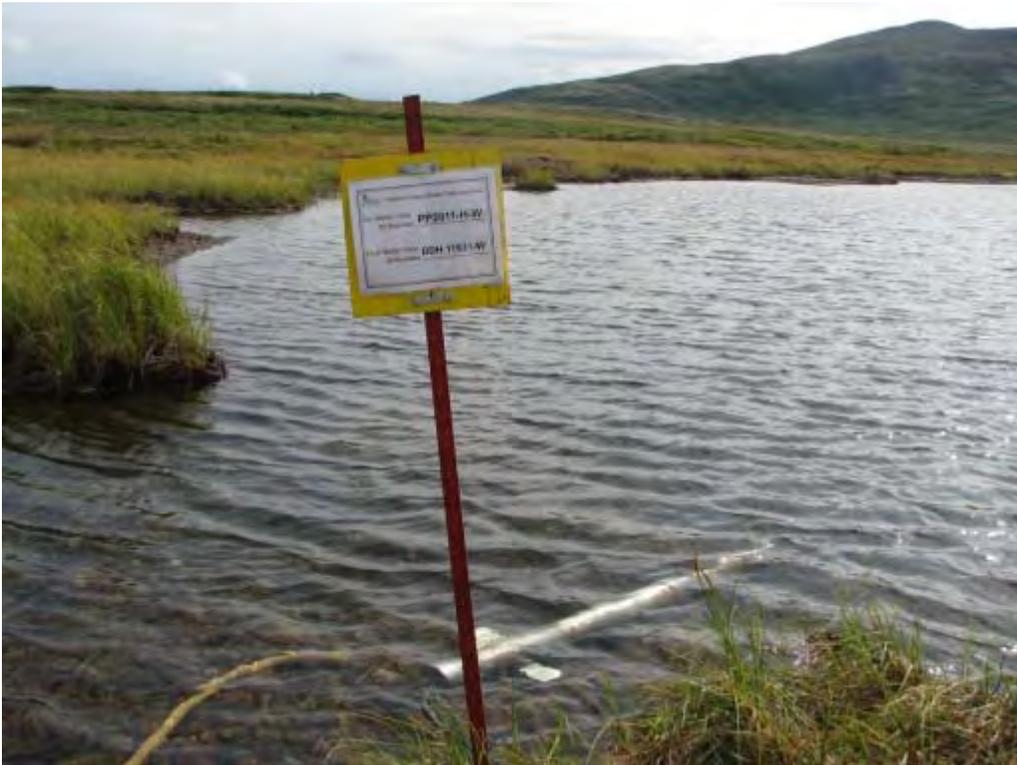
Water supply for DDH-11531; note use of Johnson well screen

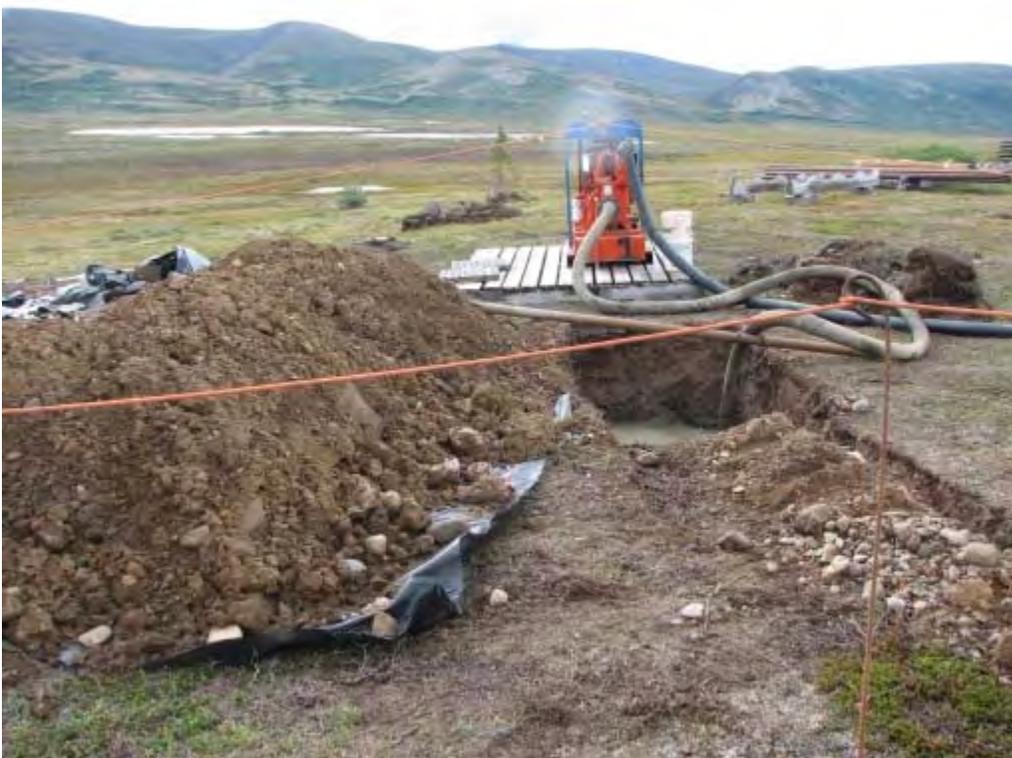
Sump and stockpiled soils and tundra at site DDH-11531

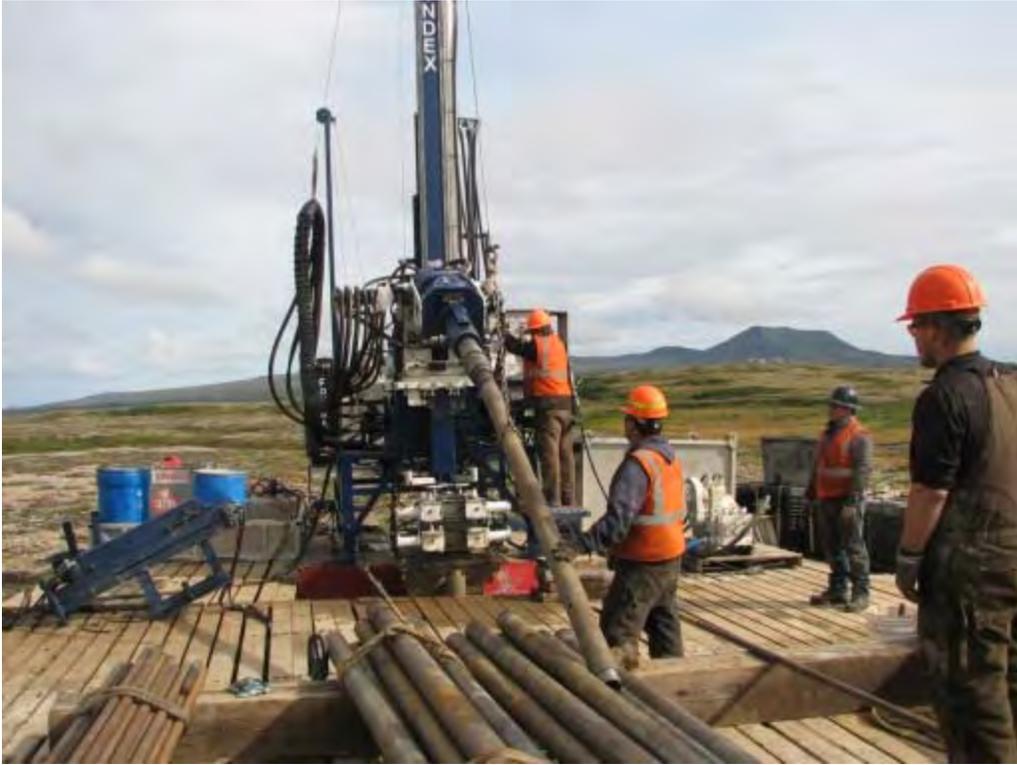
Foundex Sonic Drill at site GH 11-260 S

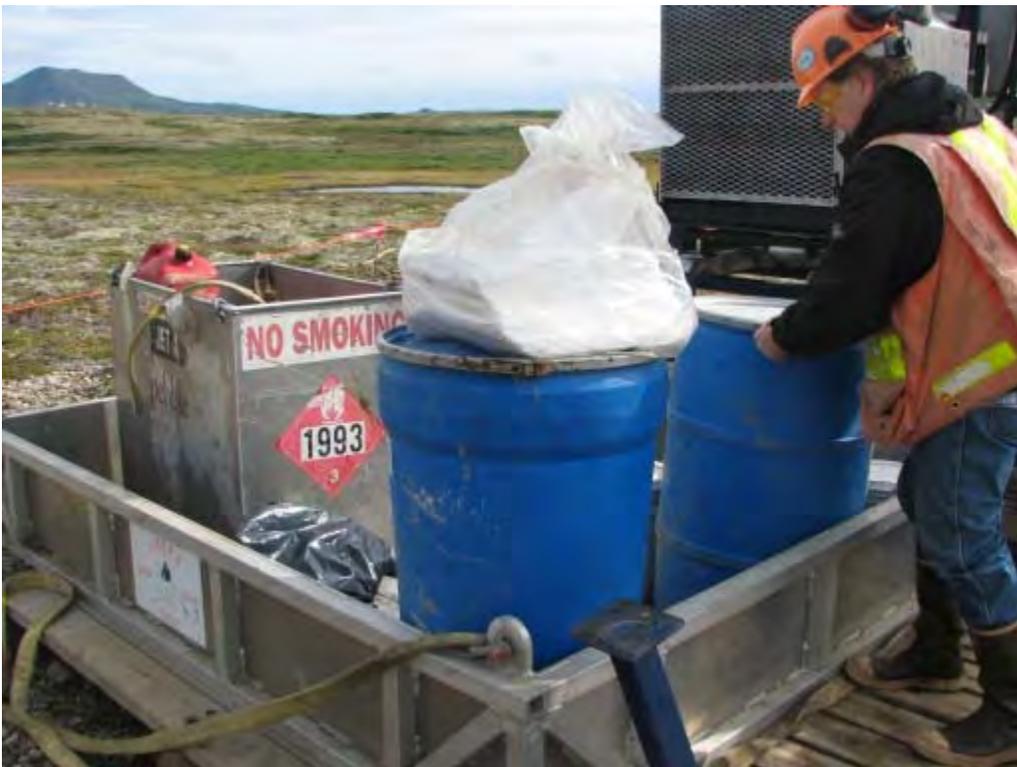
Fuel supply, fuel containment, and spill packages at site GH 11-260 S

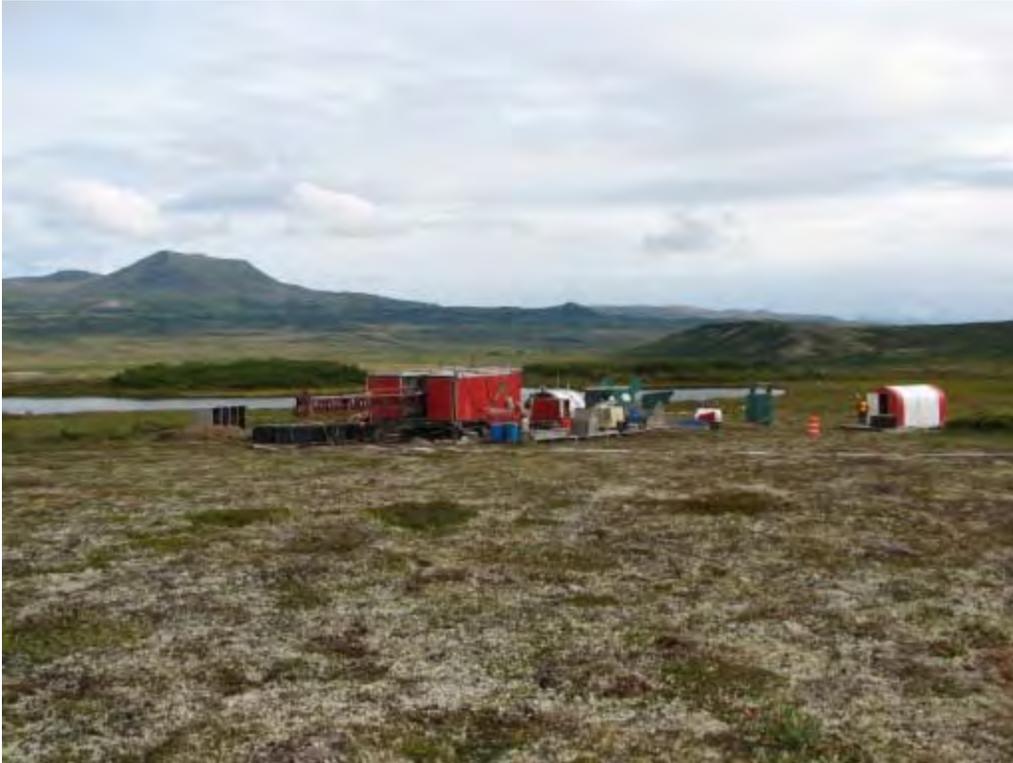
| ○ General impression: site shows use from 2 months of occupation | ○ General impression of water body (i.e. clear, turbid, tannic): Clear |

Site DDH 11-533. Note medical tent, portable sanitary facility; site being readied for rig move.

| <ul style="list-style-type: none"> ■ Recommendations: Site 11-533 will require extra attention during reclamation as the site was occupied for a considerable period of time and some vegetation was trampled | |

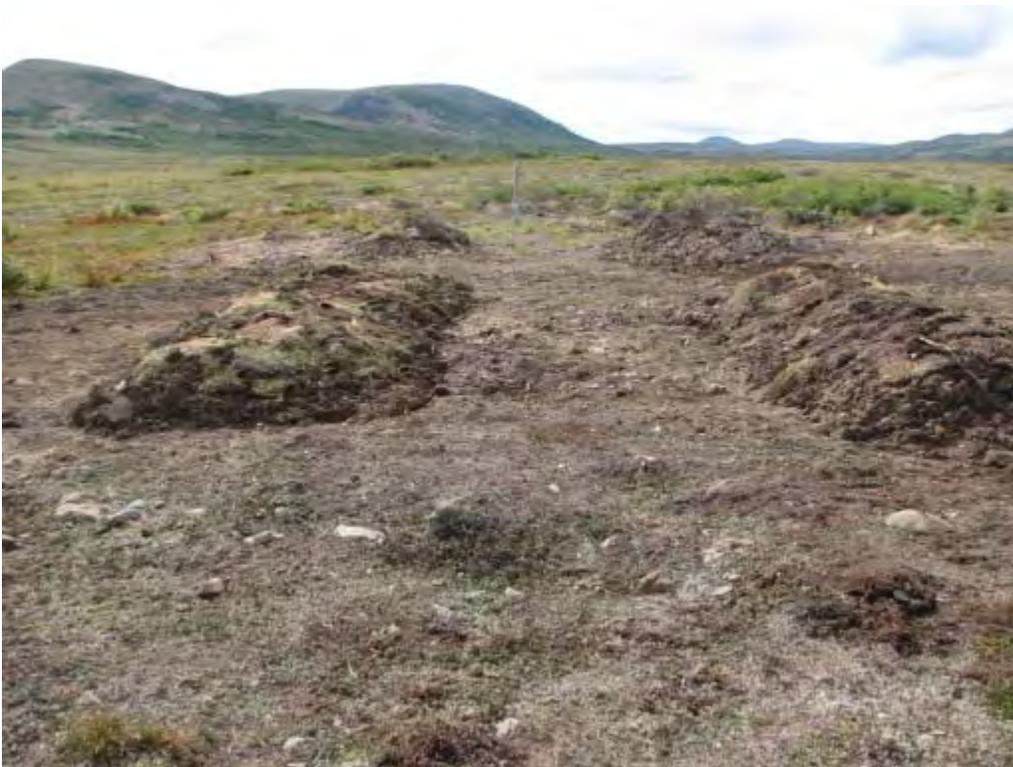
| ○ Discharge trench: series of 5 trenches | ■ Other Comments: 4 sumps added uphill |
| ○ Dimensions of pit: ea. 10 ft x 5 ft x 4 ft deep | with material transported in totes. Sediment |

Site DDH 11-533. Uphill addition of additional sludge pits; undergoing reclamation. Mounding of fill is to allow for settling of the pits. Reclamation is not complete.

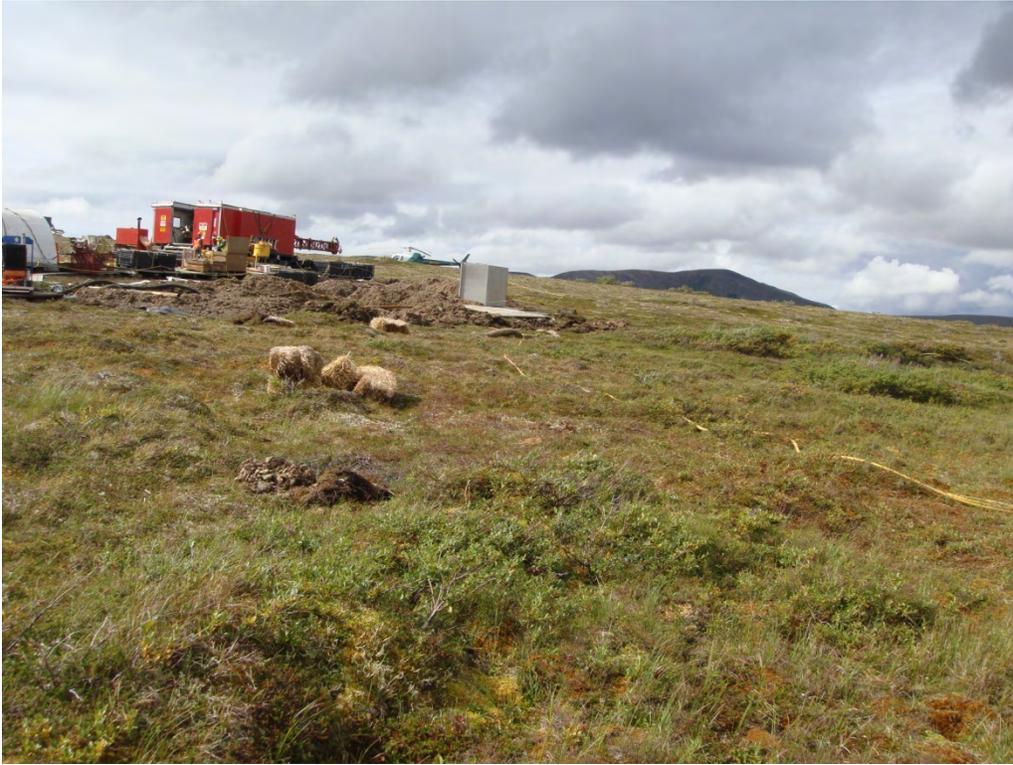
| ○ In use: Yes | BMP measures (straw bales) placed by water as a precaution. |

Site DDH 11-533. Straw bales placed and staged around 5 sumps for precaution.

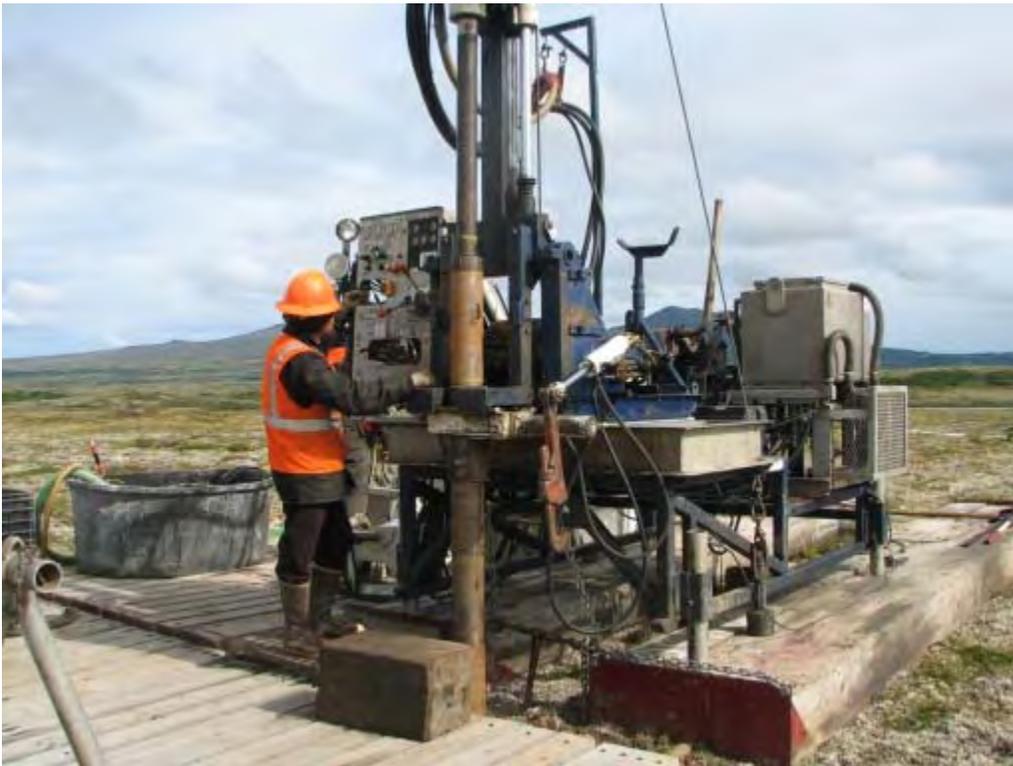
Foundex Mud Rotary drilling operation to drill the pre-collar at site SH-AU

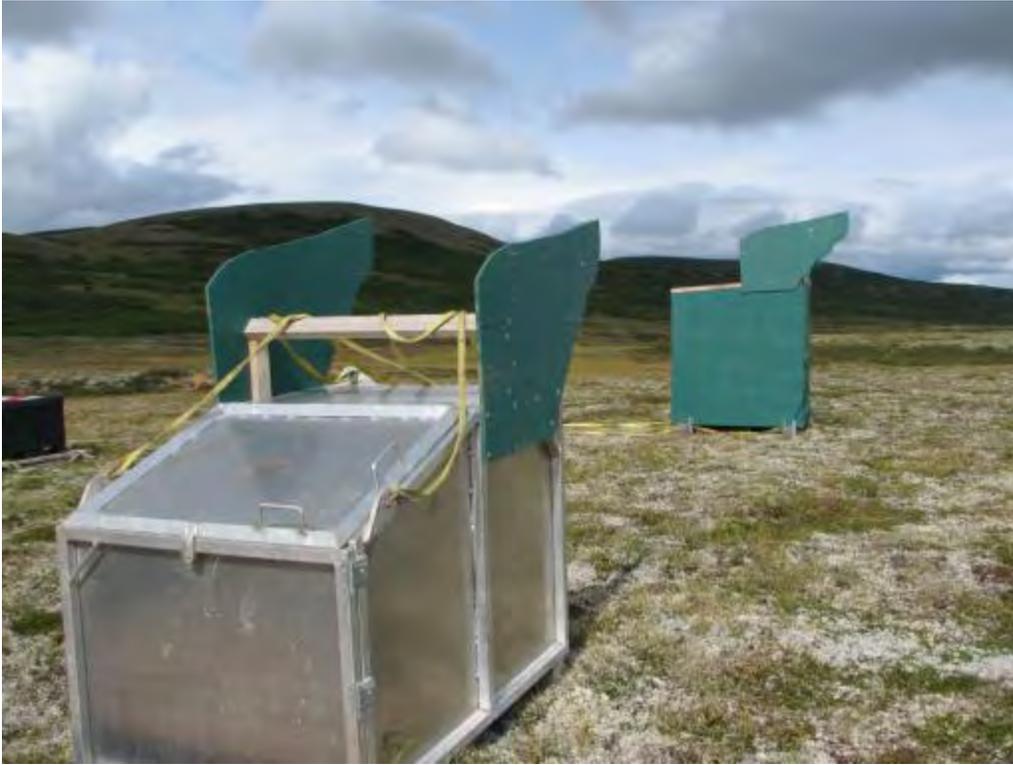
Site SH- AU. Portable trash containment and privy. Wings are for stabilization when being slung by helicopter.

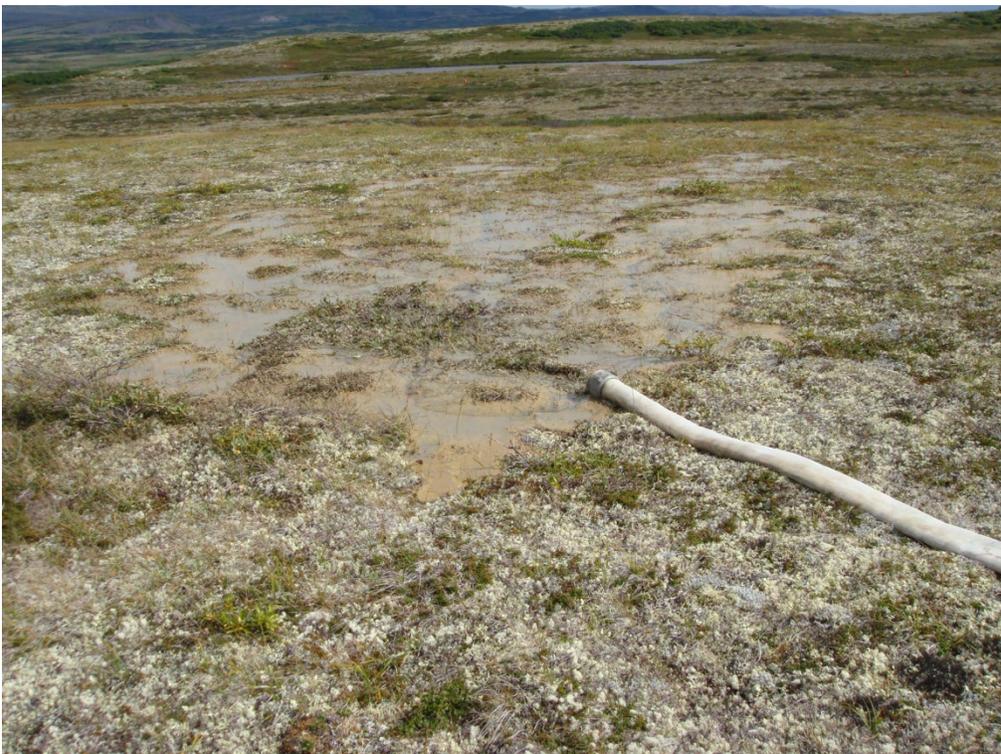
| ○ Discharge trench: 20 ft x 8 in x 10 in | ■ Other Comments: Incidental discharge to |
| ○ Dimensions of pit: 6 ft x 4 ft x 4 ft deep | Tundra from sump. See Photo. |

Site SH-AU. Incidental Discharge.

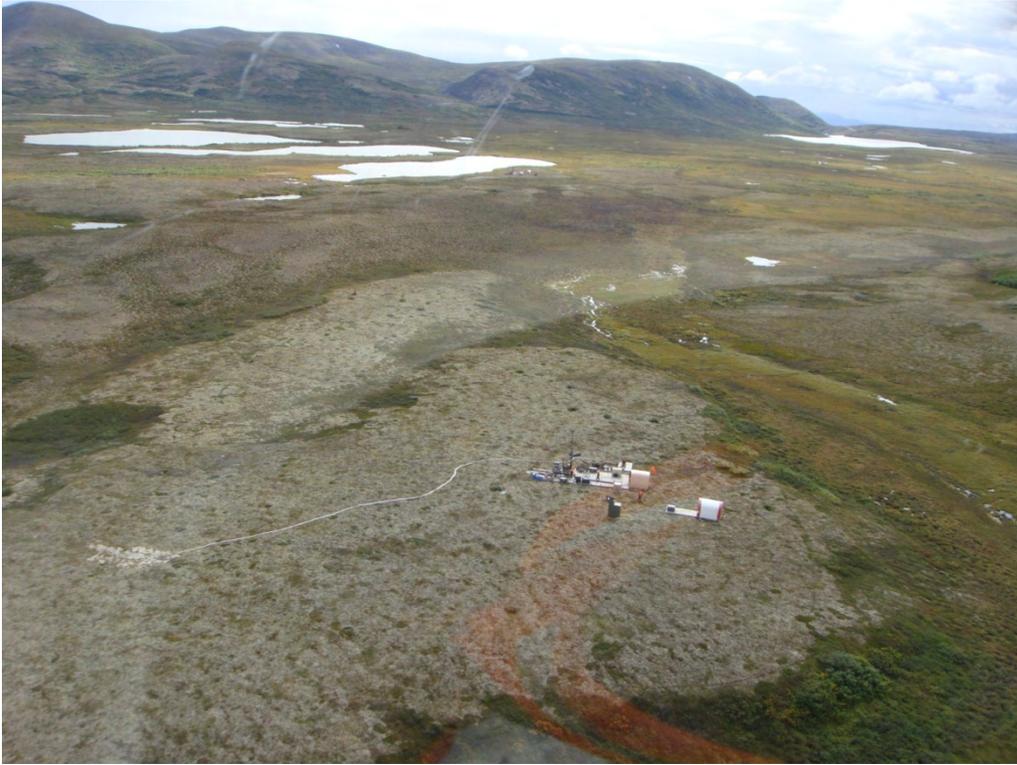
Site SH-AU. Aerial

| ○ Any spills or staining: None | ○ Evidence of significant impacts to riparian vegetation or stream banks: None from aerial view. |

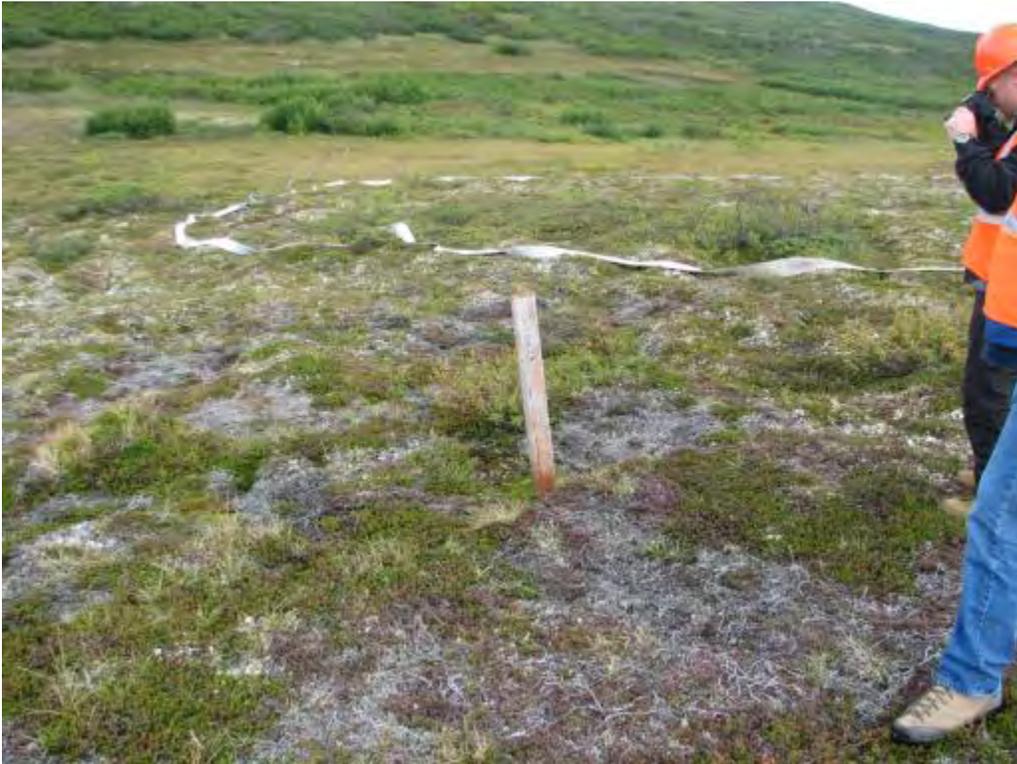
| ■ Comments/General impression: very successful reclamation/revegetation. Little evidence of the drilling activity is observable. Healthy blueberry patches growing at site. | |

Abandoned and reclaimed drill site DDH-4191.

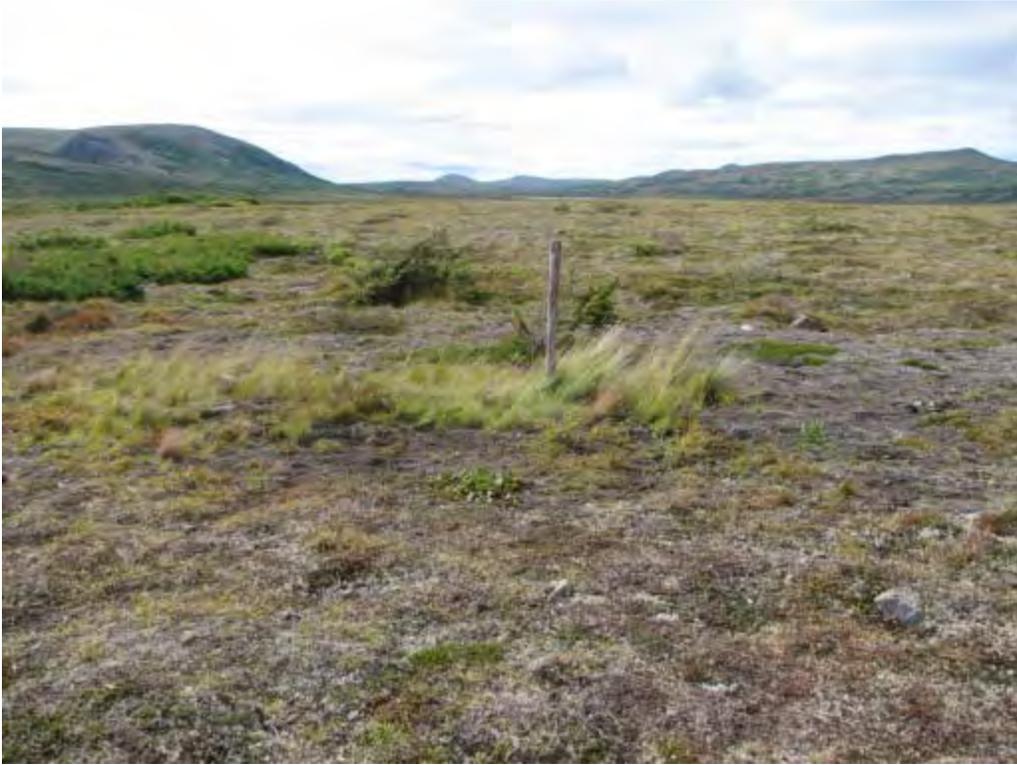
| ■ Comments/General impression: Some grasses from original revegetation still growing in proximity to the collar location. Native grasses and mosses growing over approximately 25% of the original pad location; not yet fully recovered as these plants grow slowly. | |

Abandoned and reclaimed drill site DDH-7384.

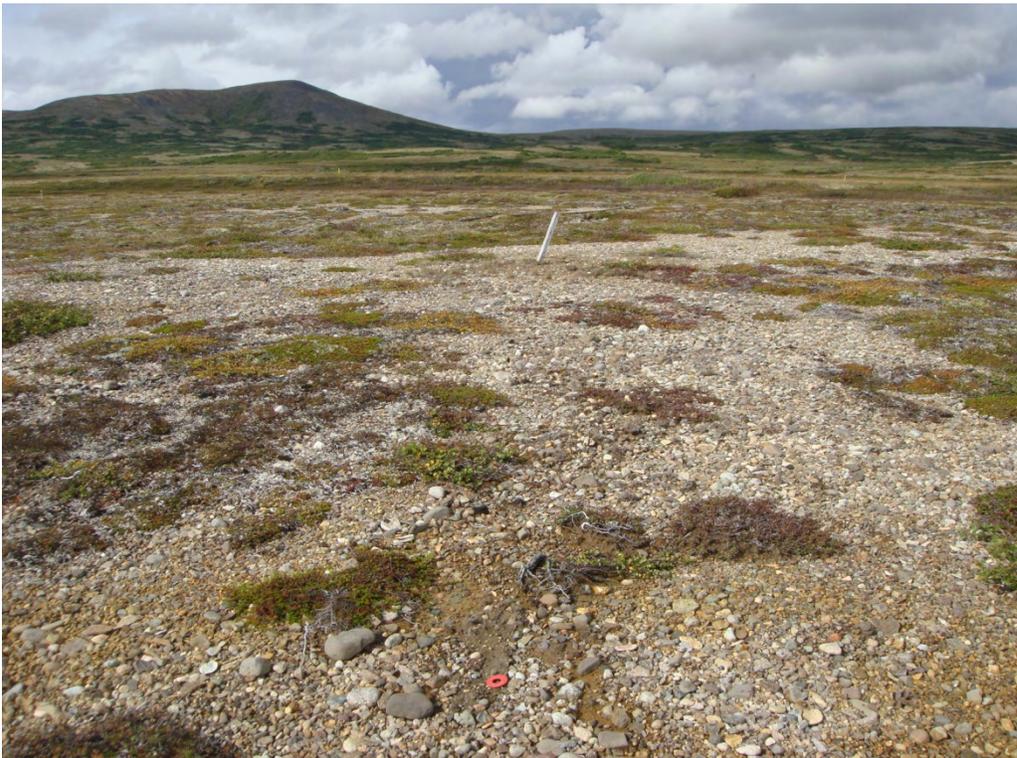
| <ul style="list-style-type: none"> ■ Plugged: not observable; no noticeable subsidence ■ Cemented: not observable ■ Standing pipe: None; only post ■ Sump pit filled in: Yes ■ Water discharge trench filled in: Yes ■ Site revegetated: Yes ■ Date revegetated/reclaimed: 2005 ■ Artesian water present: None ■ Any spills or staining: None ■ Comments/General impression: General natural landscape is approximately 50 % barren. Area around abandoned well 75 % barren. | |

Abandoned Site DDH-5328.
