## Field Report -Pebble Copper/Gold Exploration Project-

Site Visit Date: September 6, 2007

APMA No.: A076118

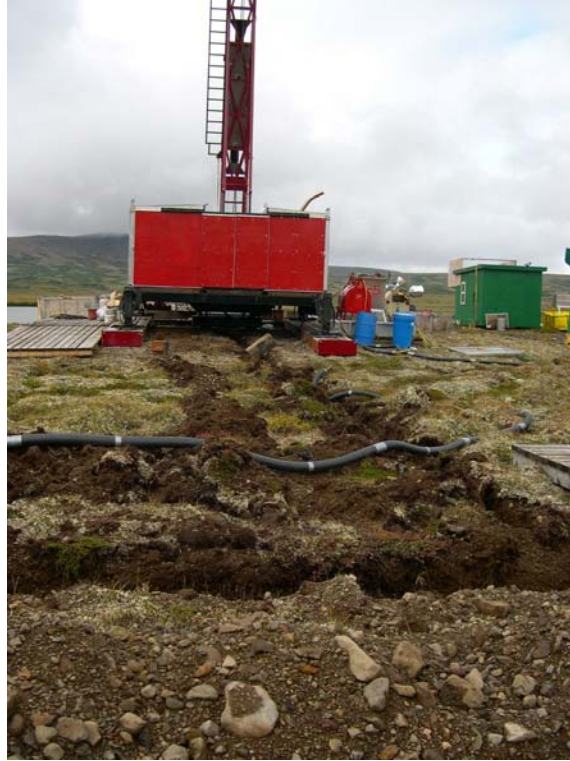
- Location: **Next to rig.**
- Discharge trench: **Yes. Approx 6 inches deep and 10 inches wide, measured 54 ft from platform to sump pit (Figure 1).**
- Dimension pit: **Max 6 feet in depth, 2 to 5 feet in width.**
- In use: **No.**

Figure 1. Rig no. 5 on new site. Trench leads from rig to sump pit.

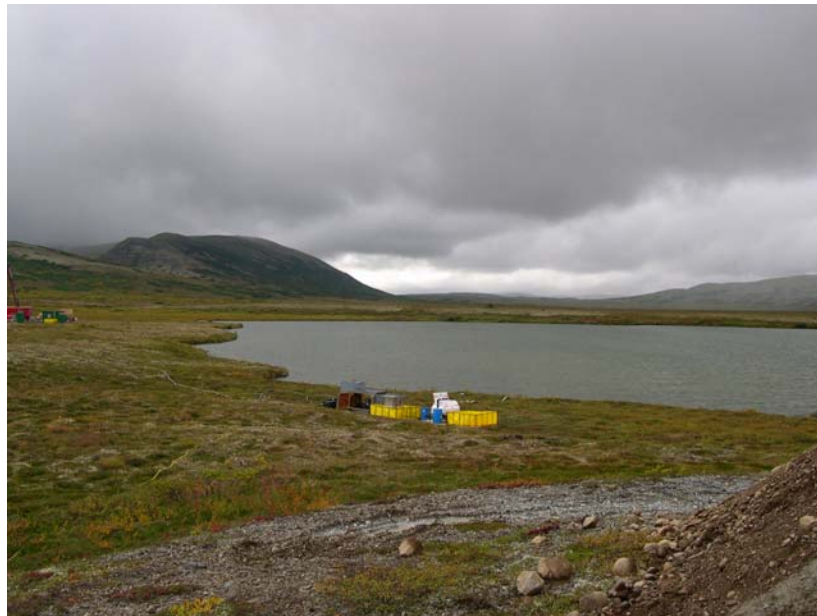
- Adequate water flow and depth for fish passage in streams? **NA**
- Evidence of significant impacts to riparian vegetation or stream banks? **There was no sign of drawdown from water use from this lake. No impact to stream bank observed.**

- Relative water level? **High.**
- General impression of water body, i.e. clear, turbid, tannic colored, etc.? **Good. Clear waters in shallow portions of lake. No indication of pollution or sedimentation.**

Figure 2. Water source for drill site no. 7374 and for rig no. 5 new drill site.  
Note pumping station for the water in the foreground. Rig no. 5 visible in the left background.

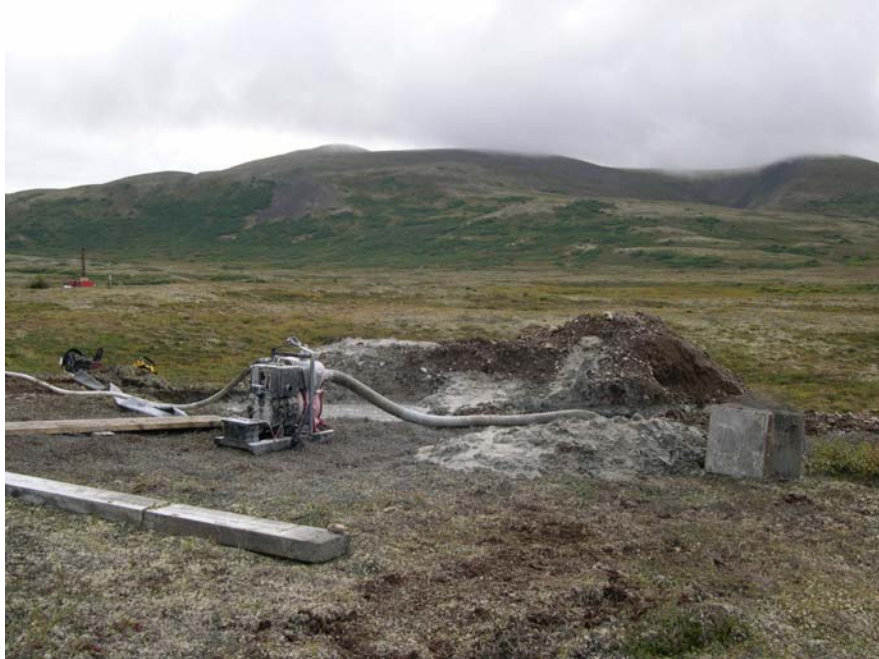
- In use: **Yes.**
  - Location and extent of discharged material?
- Sump Pit Cont'd**
  - Evidence that the settling sump pit had overflowed (Figure 3).**

Figure 3. Signs of sump overflow on drill site no. 7374.

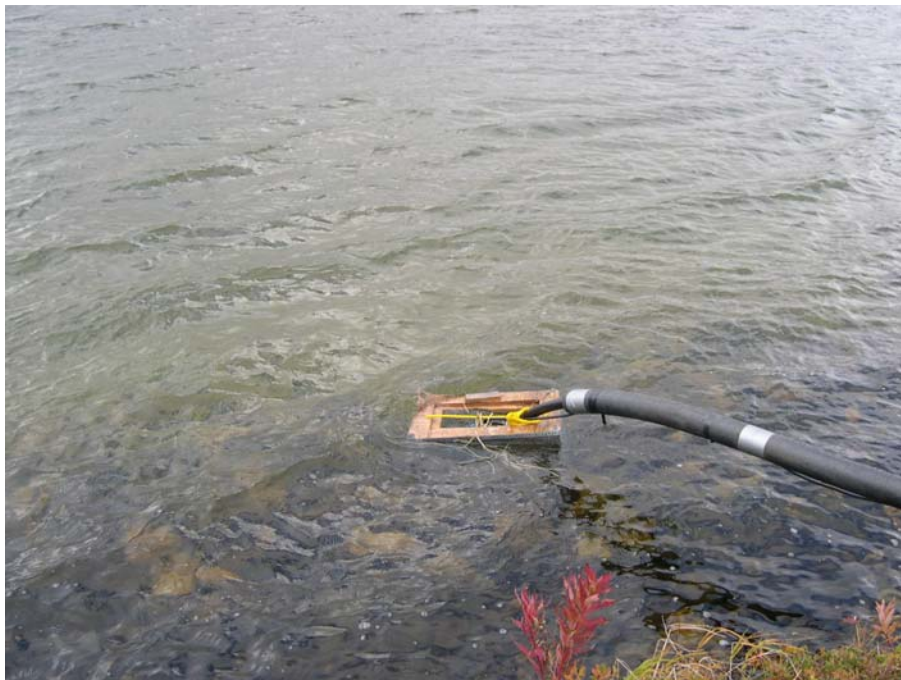
- Intake structure: **In use. Intake cover box missing, (Figure 4). However, it was quickly covered when staff was made privy of it.**
  - Structure clear of debris: **Yes.**

Figure 4. Water intake structure for drill site no. 7374 and for rig no. 5 new drill site.  
Note cover missing on intake box.

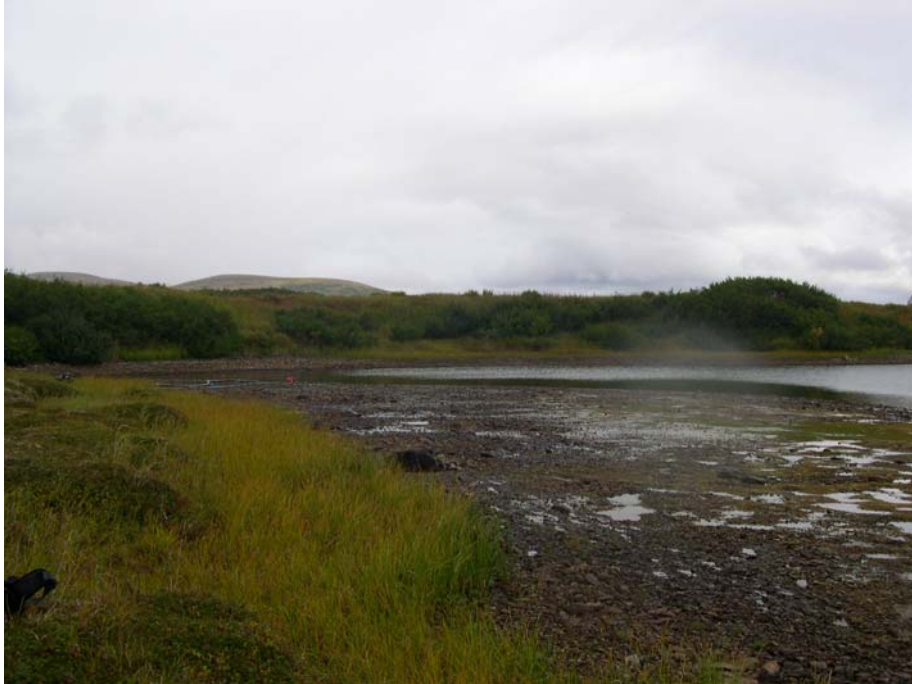
- Distance from water body: **approx 230 ft.**
- Location of fuel storage: **On pad.**
- Sorbent Pads Present or Not: **Yes**
- Tundra Mat: **Yes**
- Pipe off Tundra: **Discarded pipes on tundra.**
- Litter: **Present**
- Spill Indications: **None**
- Trash Containment: **Yes**
- Sanitary Facilities: **Yes**
- Any spills or staining, or 'none' for that matter: **None.**
- General impression of site: **No disturbance to tundra other than sump pit and trench. Water source significantly drawn down.**

Figure 5. Water source for drill site no. 7376, note the low water level.

- Establish a permanent benchmark elevation for monitoring recharge of unnamed pond located within NE $\frac{1}{4}$ NE $\frac{1}{4}$  Section 27, Township 3 South, Range 35 West, Seward Meridian. Pond was water source for several rigs including rig no. 6, (see location map and figure 3).

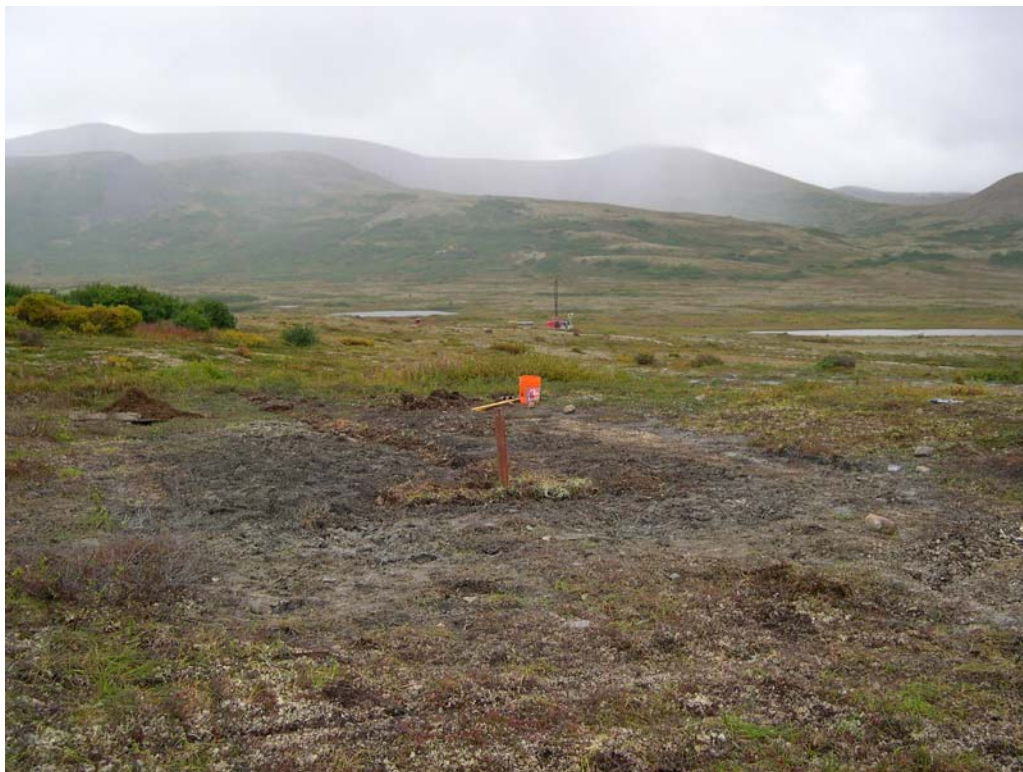
Figure 6. Reclamation site 7368.

- Plugged: **Yes.**
- Cemented: **Unknown.**
- Standing pipe: **No. Wooden stake marked the location.**
- Sump pit filled in: **Not used. Drilling water discharge was on tundra (prior to change in operation that required sump pit use).**
- Water discharge trench filled in: **Yes.**
- Site re-vegetated: **No.**
- Artesian water present: **No.**
- Any spills or staining, or 'none': **None observed.**
- Comments: **Reclaimed site (RCS) 7368 had a more visible footprint with bare soil observed, (Figure 6). However, there was indication of reclamation work in progress.**

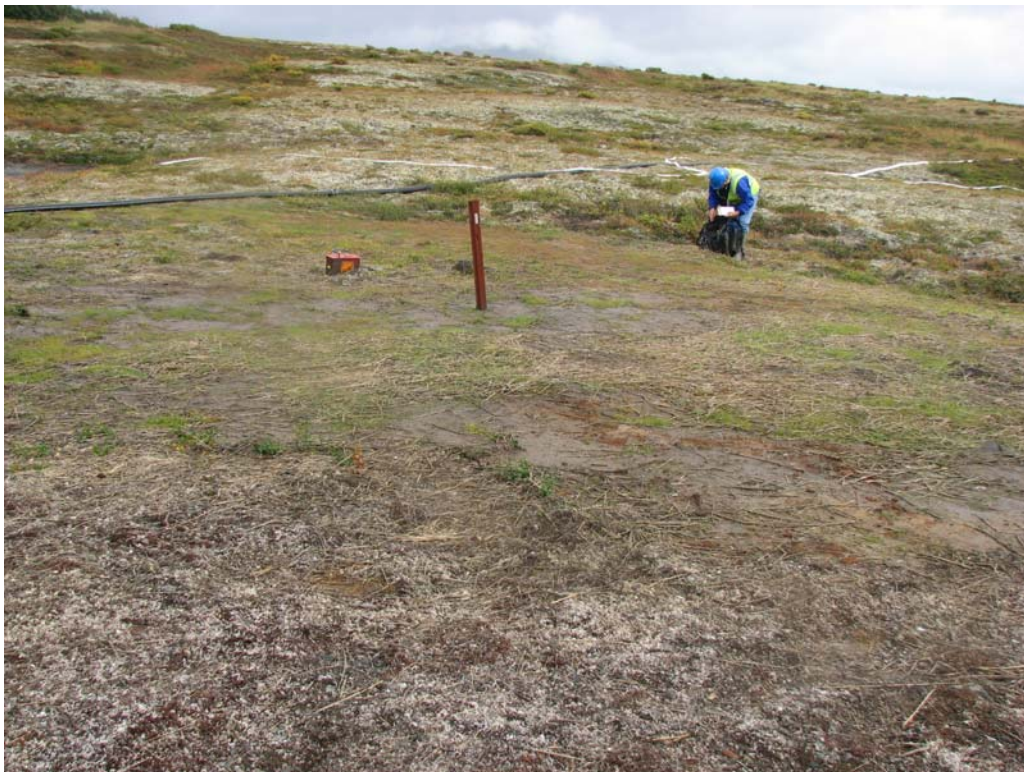
Figure 7. Reclamation Site no. 6355.

- Plugged: **Yes.**
- Cemented: **Unknown.**
- Standing pipe: **No, wooden stake marked location site.**
- Sump filled in: **Not used. Drilling water discharge was on tundra (prior to change in operation that required sump pit use).**
- Water discharge trench filled in: **Yes.**
- Site re-vegetated: **Yes.**
- Artesian water present: **No.**
- Any spills or staining, or 'none': **None observed.**
- Comments: **The site footprint was slightly visible (Figure 7) and re-vegetation was evident (Figure 8).**

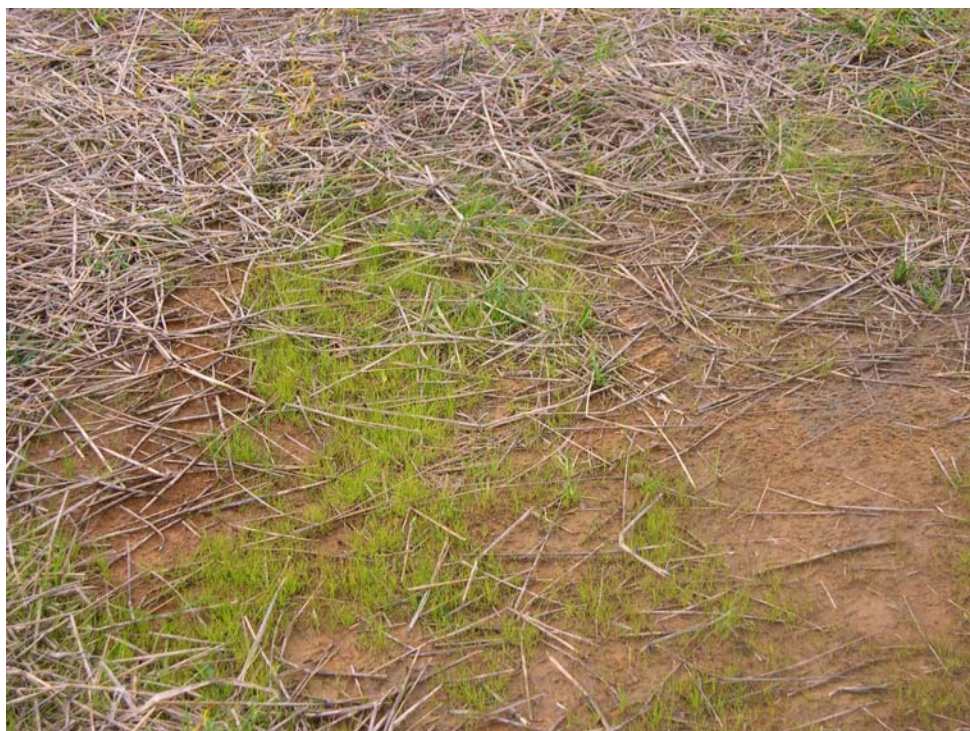
Figure 8. Reclamation site 6355 showing revegetation.
