## Field Monitoring Report -- Pebble Copper/Gold Exploration Project --

Personnel: Kerwin Krause & Scott Pexton (DNR/DMLW) & Jeff Norberg (Manager, Site Compliance & Reclamation, PLP)	Inspection Date: September 11, 2012
	Site Contact: Jeff Norberg & Tom Jordan
	APMA #s: A126118 (DDH 12551 & DDH 12553) & A122788 (DDH 12554)
<ul style="list-style-type: none"> <li>■ Inspection Type:</li> </ul>	<ul style="list-style-type: none"> <li>■ Wildlife Observed:</li> </ul>
<ul style="list-style-type: none"> <li>○ Complete: X (DDH 12553, 12551 &amp; 12554)</li> </ul>	<ul style="list-style-type: none"> <li>○ Bear:</li> </ul>
<ul style="list-style-type: none"> <li>○ Partial:</li> </ul>	<ul style="list-style-type: none"> <li>○ Caribou:</li> </ul>
<ul style="list-style-type: none"> <li>○ Follow-up:</li> </ul>	<ul style="list-style-type: none"> <li>○ Moose:</li> </ul>
<ul style="list-style-type: none"> <li>○ Response to Public Complaint:</li> </ul>	<ul style="list-style-type: none"> <li>○ Waterfowl:</li> </ul>

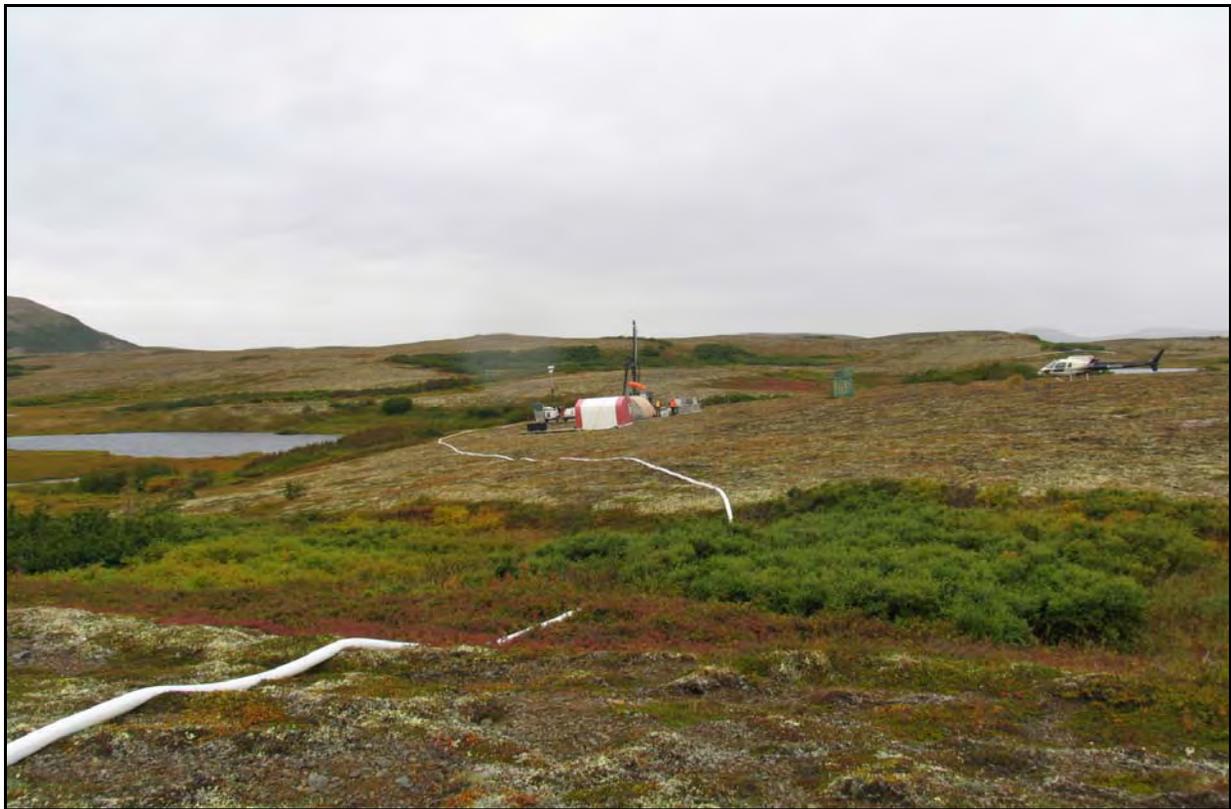
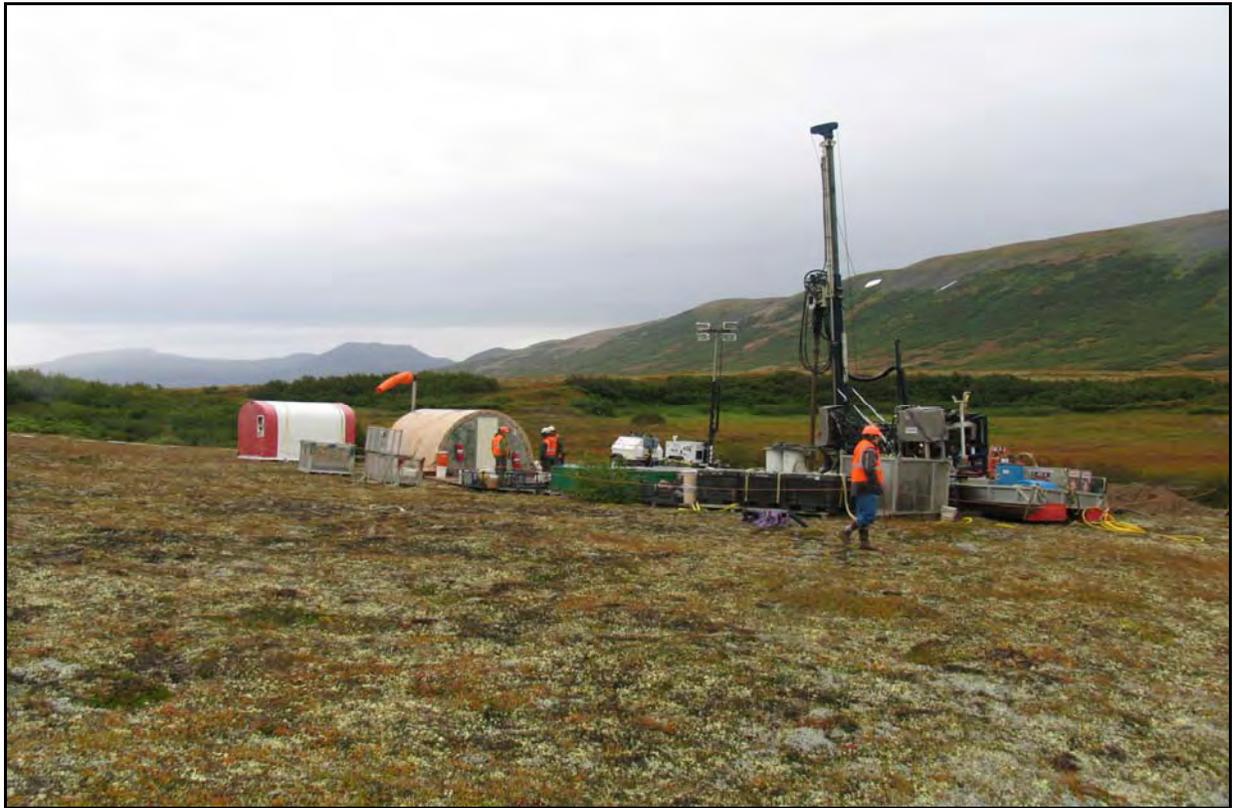
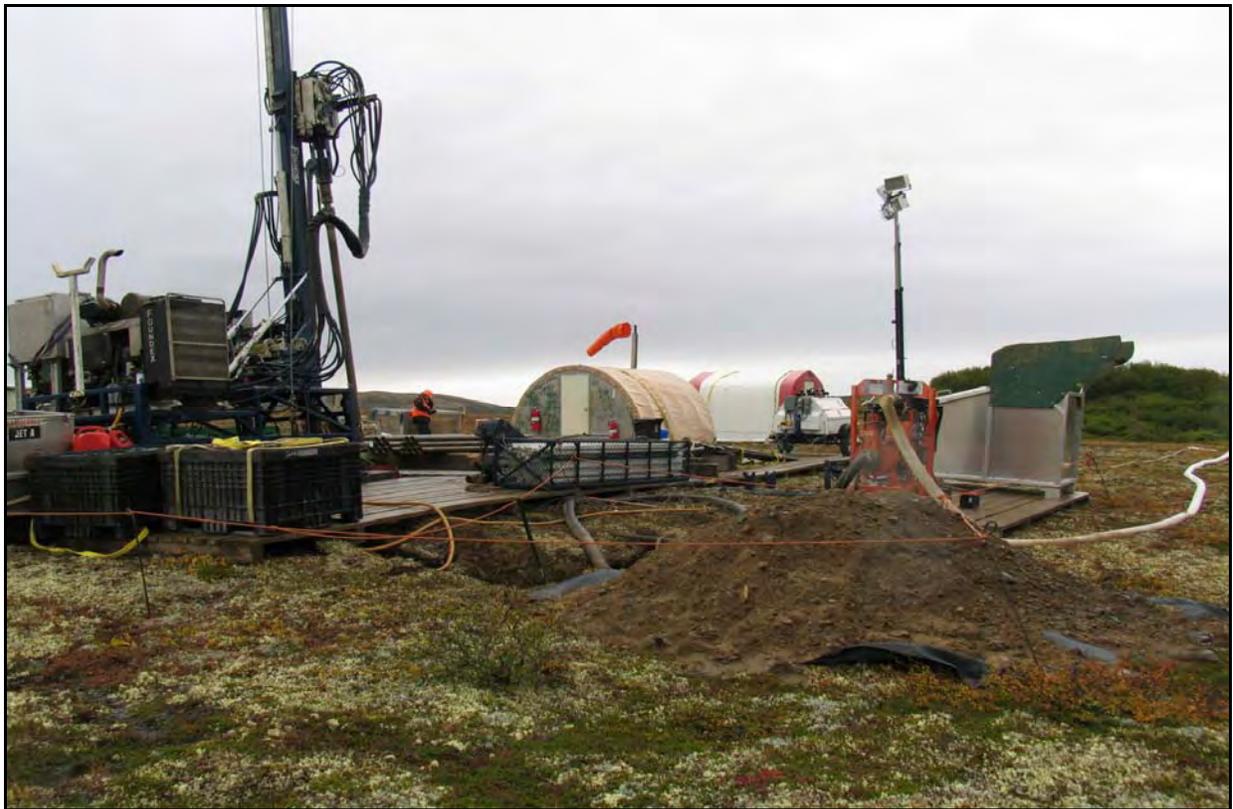
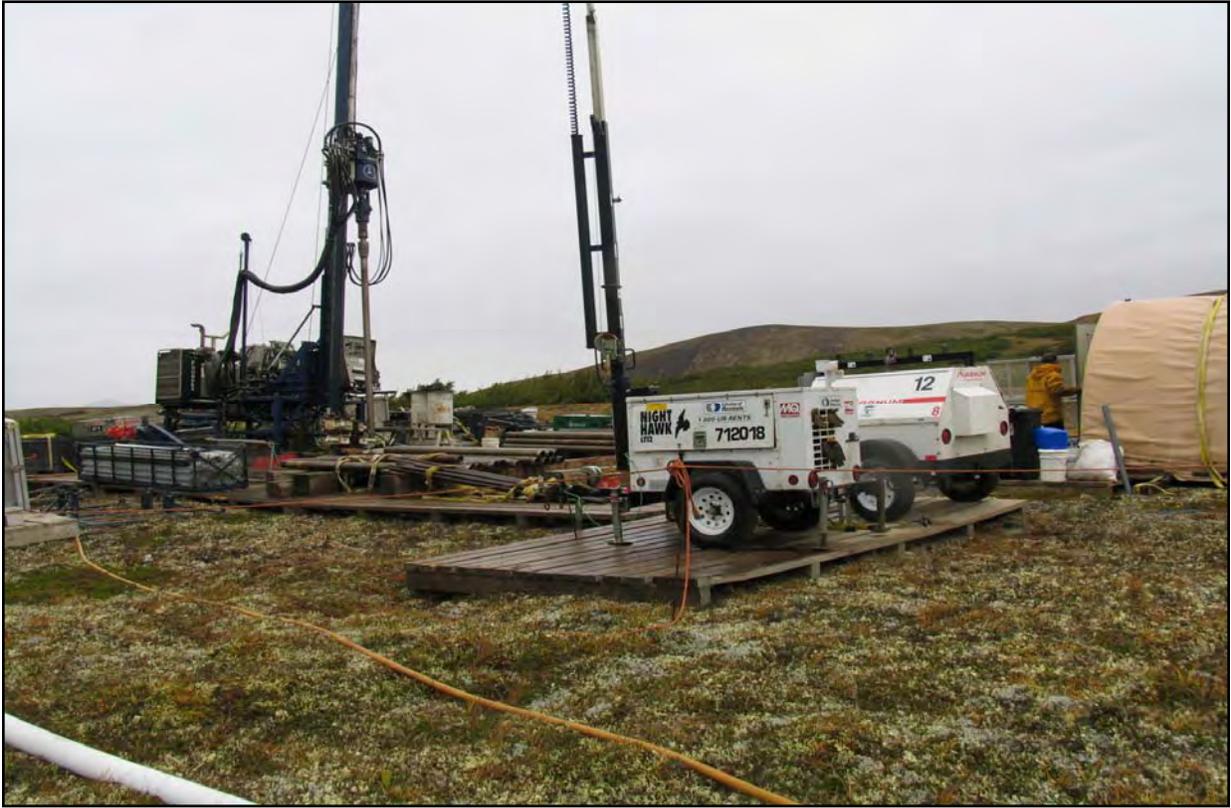
Picture of DDH 12553

Drill Hole/Site No.: DDH 12553	Date: September 11, 2012
Rig No.: 2	Time: 12:40 PM
Activity: DDH with planned depth of 1,600 feet.	
<ul style="list-style-type: none"> <li>■ Condition of Drilling Site: Orderly (see pictures below). Drilling depth 1,536 ft. so almost finished</li> </ul>	<ul style="list-style-type: none"> <li>■ Sump Pit (continued): Water from sump pit pumped up slope and away from any surface water and discharged on tundra</li> </ul>
<ul style="list-style-type: none"> <li>○ Distance from waterbody: &gt; 500 feet</li> </ul>	<ul style="list-style-type: none"> <li>○ Location and extent of discharged material: See above</li> </ul>
<ul style="list-style-type: none"> <li>○ Location of fuel storage: On tundra pads</li> </ul>	<ul style="list-style-type: none"> <li>○ Topsoil, muck, tundra stockpiled: Yes</li> </ul>
<ul style="list-style-type: none"> <li>○ Sorbent pads present: Yes, 1 barrel</li> </ul>	<ul style="list-style-type: none"> <li>○ Hose color: White</li> </ul>

<ul style="list-style-type: none"> <li>○ Tundra mat: Yes, and all drill related equipment situated on pads</li> </ul>	
<ul style="list-style-type: none"> <li>○ Pipe off tundra: Yes</li> </ul>	<ul style="list-style-type: none"> <li>■ Drill Water Supply:</li> </ul>
<ul style="list-style-type: none"> <li>○ Litter: None</li> </ul>	<ul style="list-style-type: none"> <li>○ Stream, lake/pond: Pond (see pictures)</li> </ul>
<ul style="list-style-type: none"> <li>○ Trash containment: Yes</li> </ul>	<ul style="list-style-type: none"> <li>○ Location: ~ 800 feet east</li> </ul>
<ul style="list-style-type: none"> <li>○ Sanitary facilities: Yes – privy and containment for removing sewage to Iliamna</li> </ul>	<ul style="list-style-type: none"> <li>○ Adequate water flow and depth for fish passage in streams: N/A</li> </ul>
<ul style="list-style-type: none"> <li>○ Any spills or staining: No</li> </ul>	<ul style="list-style-type: none"> <li>○ Evidence of significant impacts to riparian vegetation or stream banks: None</li> </ul>

<ul style="list-style-type: none"> <li>○ General impression: Clean</li> </ul>	<ul style="list-style-type: none"> <li>○ General impression of water body (i.e. clear, turbid, tannic): Clear</li> </ul>
	<ul style="list-style-type: none"> <li>○ Intake description: Screened electric submersible</li> </ul>
<ul style="list-style-type: none"> <li>■ Drilling Activity: DDH</li> </ul>	<ul style="list-style-type: none"> <li>○ Structure clear of debris: Yes</li> </ul>
<ul style="list-style-type: none"> <li>○ Drill additives in use: Extreme One</li> </ul>	<ul style="list-style-type: none"> <li>○ Mesh size: 1x12 mm slotted 0.1 CFS</li> </ul>
<ul style="list-style-type: none"> <li>○ Recirculation tank: Yes and in use</li> </ul>	<ul style="list-style-type: none"> <li>○ Submerged: Yes</li> </ul>
<ul style="list-style-type: none"> <li>○ Water discharged: Yes</li> </ul>	<ul style="list-style-type: none"> <li>○ Fuel/generator location to source: 100 feet south</li> </ul>

<ul style="list-style-type: none"> <li>○ Artesian zone encountered: No</li> </ul>	<ul style="list-style-type: none"> <li>○ Catch basin for fuel supply: Yes</li> </ul>
	<ul style="list-style-type: none"> <li>○ Sorbent pads: Yes</li> </ul>
<ul style="list-style-type: none"> <li>■ Sump Pit: Yes, 3 pits in use.</li> </ul>	<ul style="list-style-type: none"> <li>○ Hose color: Yellow</li> </ul>
<ul style="list-style-type: none"> <li>○ Location: 30 feet from drill collar</li> </ul>	
<ul style="list-style-type: none"> <li>○ Discharge trench: Yes</li> </ul>	<ul style="list-style-type: none"> <li>■ Other Comments: Orderly and clean</li> </ul>
<ul style="list-style-type: none"> <li>○ Dimensions of pit: 4 foot x 6 foot</li> </ul>	
<ul style="list-style-type: none"> <li>○ In use: Yes</li> </ul>

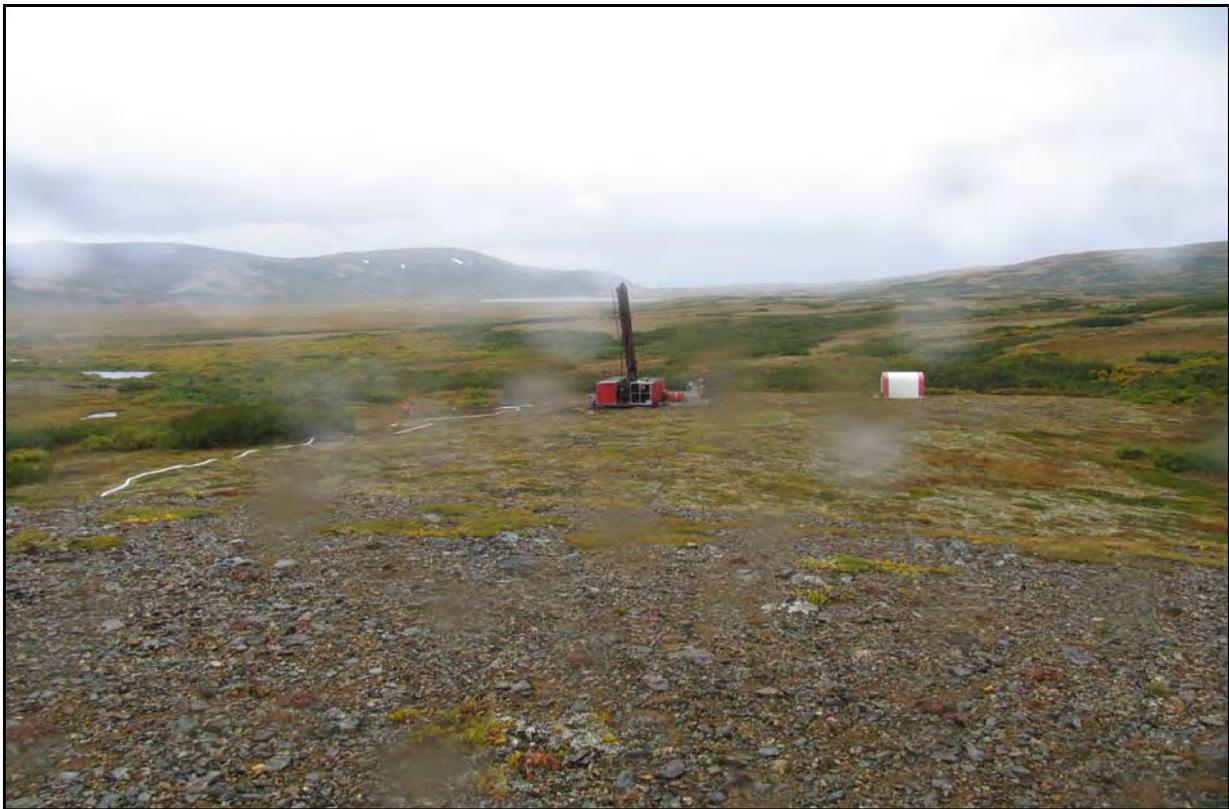
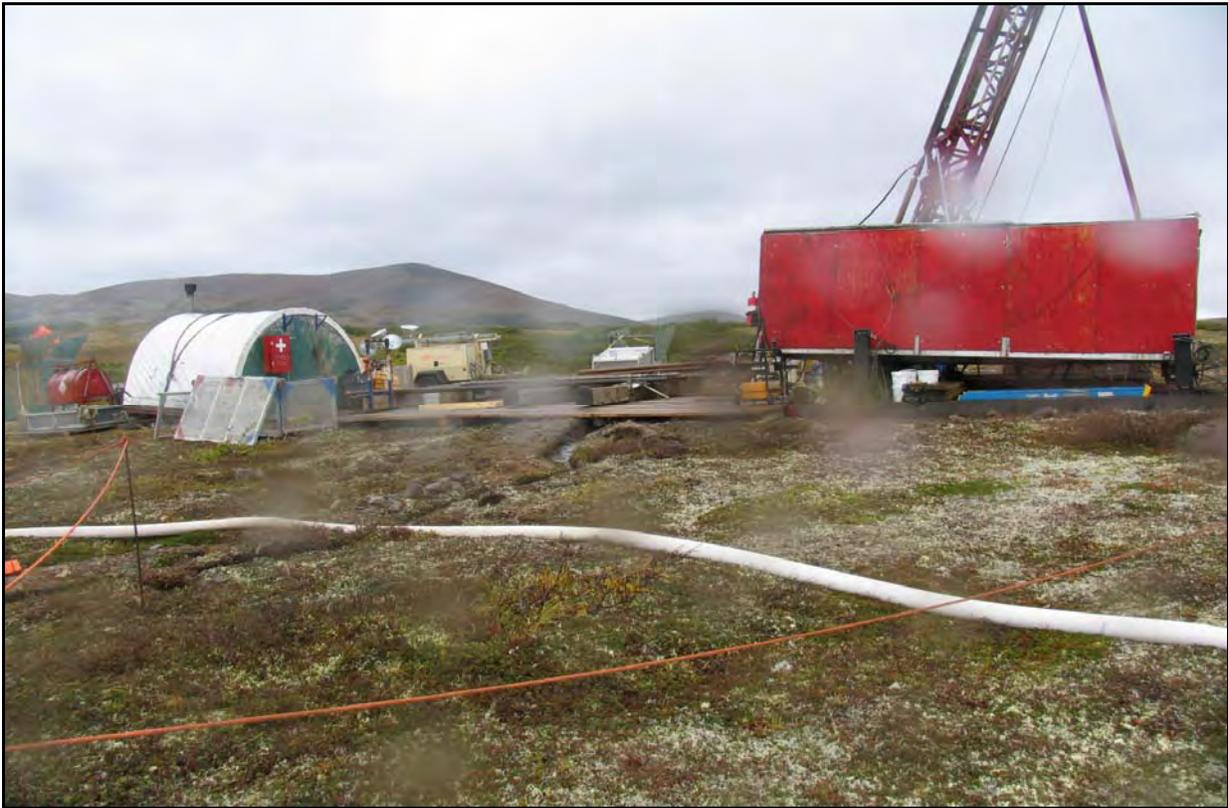
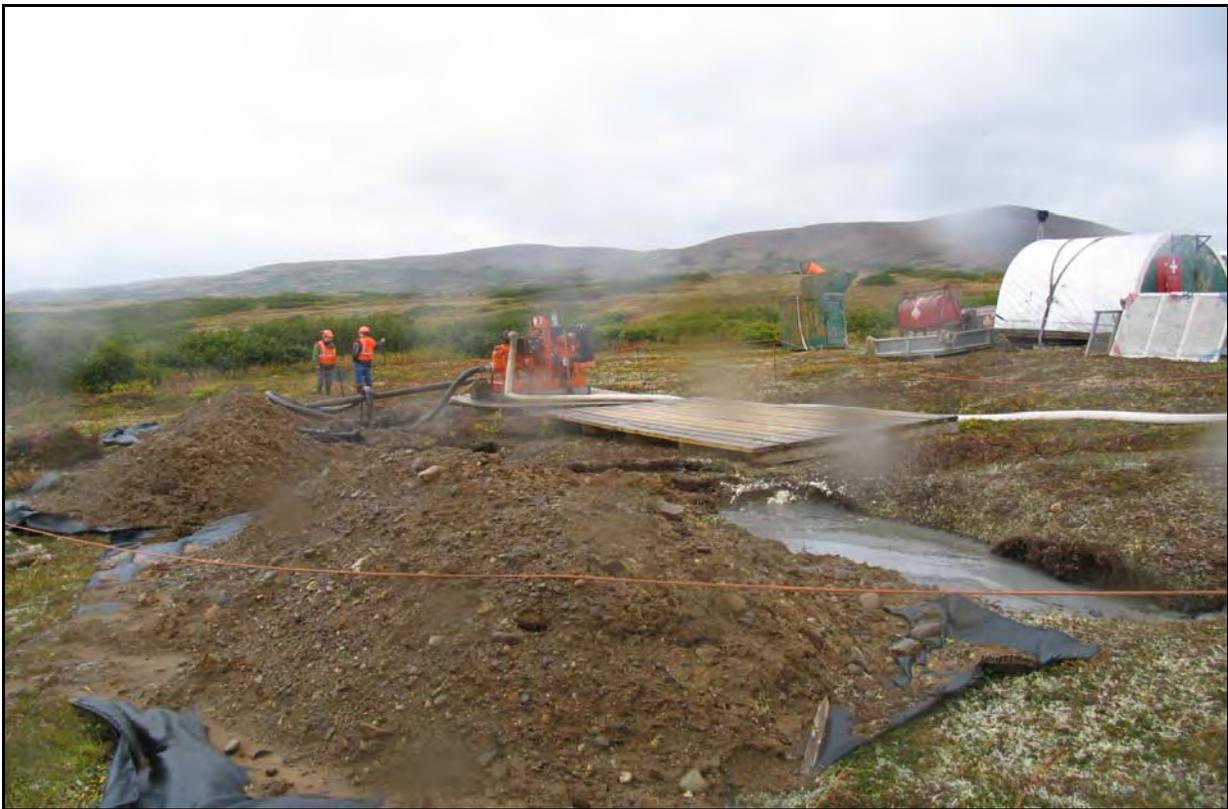
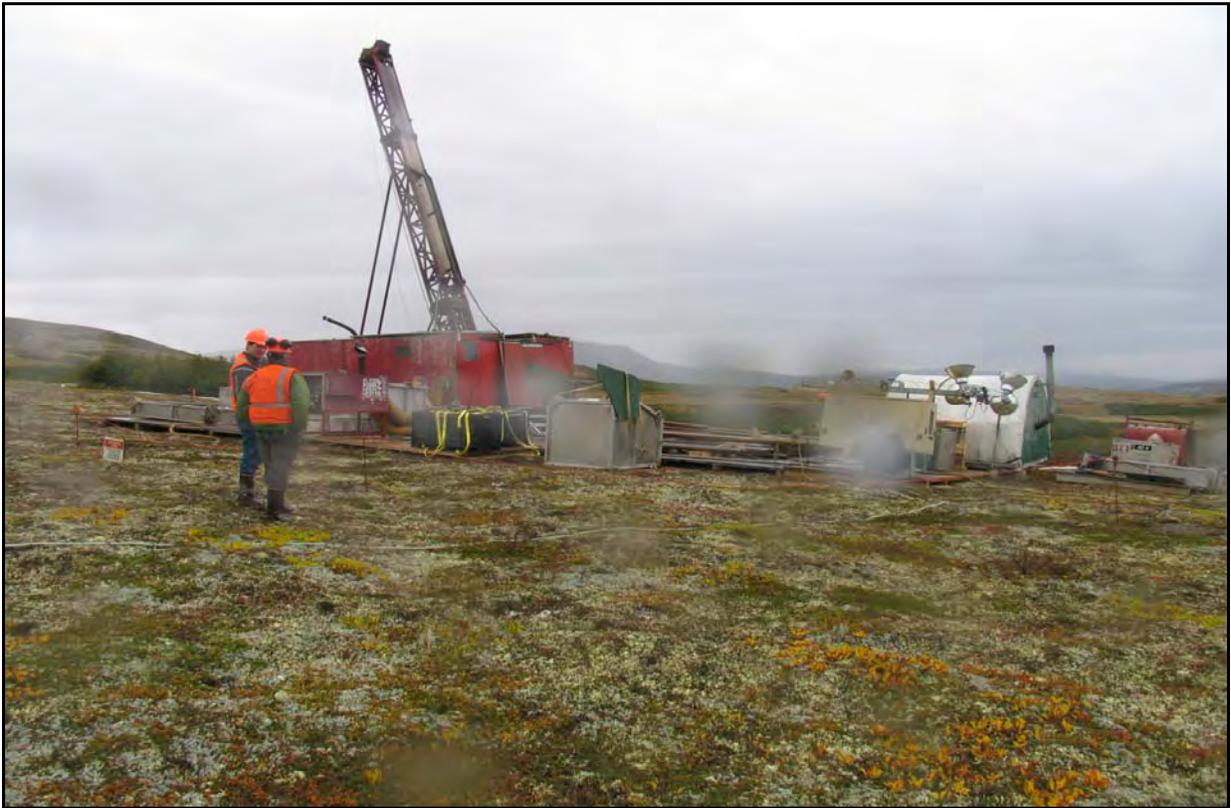
Picture of DDH 12551

Drill Hole/Site No.: DDH 12551	Date: September 11, 2012
Rig No.: 3	Time: 1:10 PM
Activity: DDH with a proposed depth of 3,300 ft. and a current depth of 1,205 ft. See comments pg. 1	
<ul style="list-style-type: none"> <li>■ Condition of Drilling Site: Orderly (See Pictures Below) <ul style="list-style-type: none"> <li>○ Distance from waterbody: ~ 500 feet (TWUP and water source moved from last month)</li> <li>○ Location of fuel storage: Next to Drill</li> <li>○ Sorbent pads present: Yes, 1 barrel</li> <li>○ Tundra mat: Yes, and all drill related equipment situated on pads</li> <li>○ Pipe off tundra: Yes</li> <li>○ Litter: None</li> <li>○ Trash containment: Yes</li> <li>○ Sanitary facilities: Yes – privy &amp; containment for removing sewage to Iliamna</li> <li>○ Any spills or staining: No</li> <li>○ General impression: Clean</li> </ul> </li> </ul>	<ul style="list-style-type: none"> <li>■ Sump Pit (continued): <ul style="list-style-type: none"> <li>○ Location and extent of discharged material: North of Drill Collar</li> <li>○ Topsoil, muck, tundra stockpiled: Yes</li> <li>○ Hose color: White</li> </ul> </li> </ul>

<ul style="list-style-type: none"> <li>■ Drilling Activity: Pump well. (Targeted depth ~ 3,300' / Currently at 1,205' depth) <ul style="list-style-type: none"> <li>○ Drill additives in use: Quick Troll &amp; Extreme One</li> <li>○ Recirculation tank: Yes and in use</li> <li>○ Water discharged: Yes – up slope</li> <li>○ Artesian zone encountered: No</li> </ul> </li> </ul>	<ul style="list-style-type: none"> <li>■ Drill Water Supply: <ul style="list-style-type: none"> <li>○ Stream, lake/pond: Pond</li> <li>○ Location: ~ 600 feet southeast of drill site (See Map)</li> <li>○ Adequate water flow and depth for fish passage in streams: N/A</li> <li>○ Evidence of significant impacts to riparian vegetation or stream banks: None</li> <li>○ General impression of water body (i.e. clear, turbid, tannic): Clear</li> <li>○ Intake description: Screened electric submersible</li> <li>○ Structure clear of debris: Yes</li> <li>○ Mesh size: 1x12 mm slotted 0.1 CFS</li> <li>○ Submerged: Yes</li> <li>○ Fuel/generator location to source: ~200 feet south</li> <li>○ Catch basin for fuel supply: Yes</li> <li>○ Sorbent pads: Yes</li> <li>○ Hose color: Yellow</li> </ul> </li> </ul>

<ul style="list-style-type: none"> <li>■ Sump Pit: Yes, 3 Pits <ul style="list-style-type: none"> <li>○ Location: North of drill collar</li> <li>○ Discharge trench: Yes</li> <li>○ Dimensions of pit: 5 foot x 10 foot</li> <li>○ In use: Yes</li> </ul> </li> </ul>	<ul style="list-style-type: none"> <li>■ Other Comments: Hole will be used as a pump well</li> </ul>

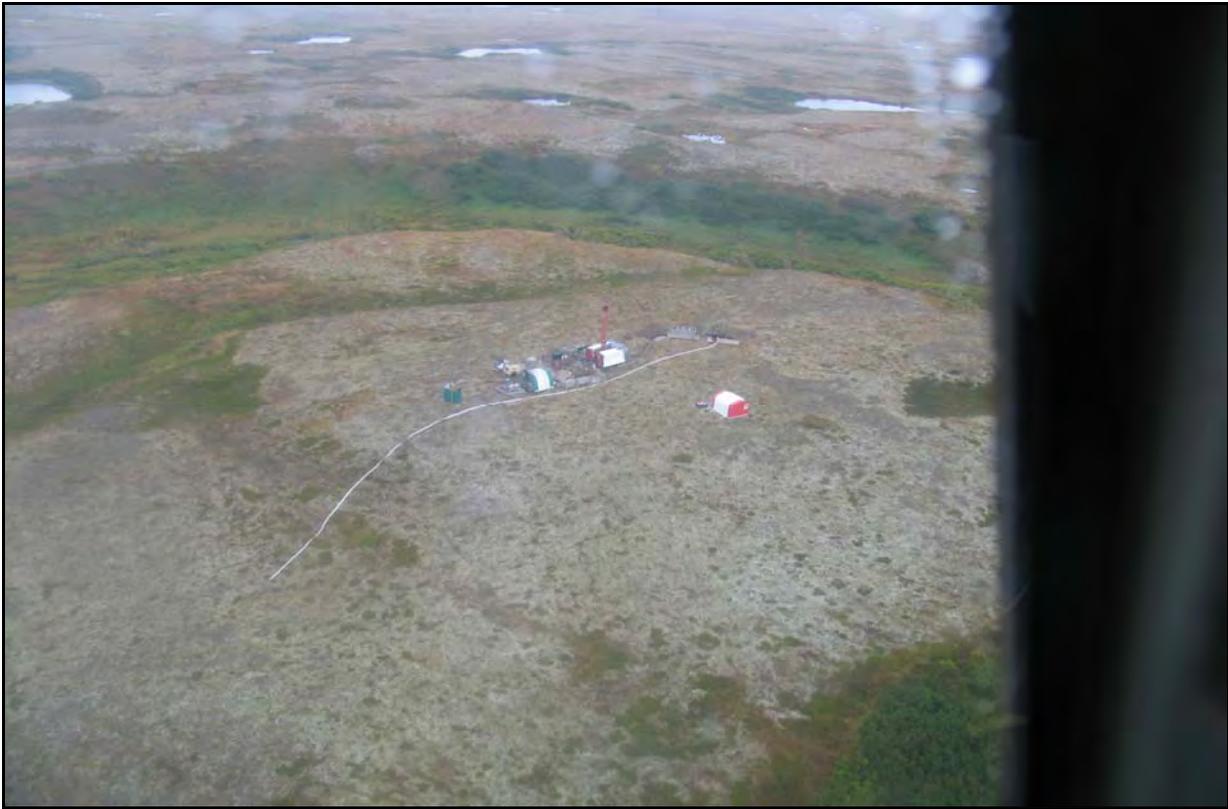
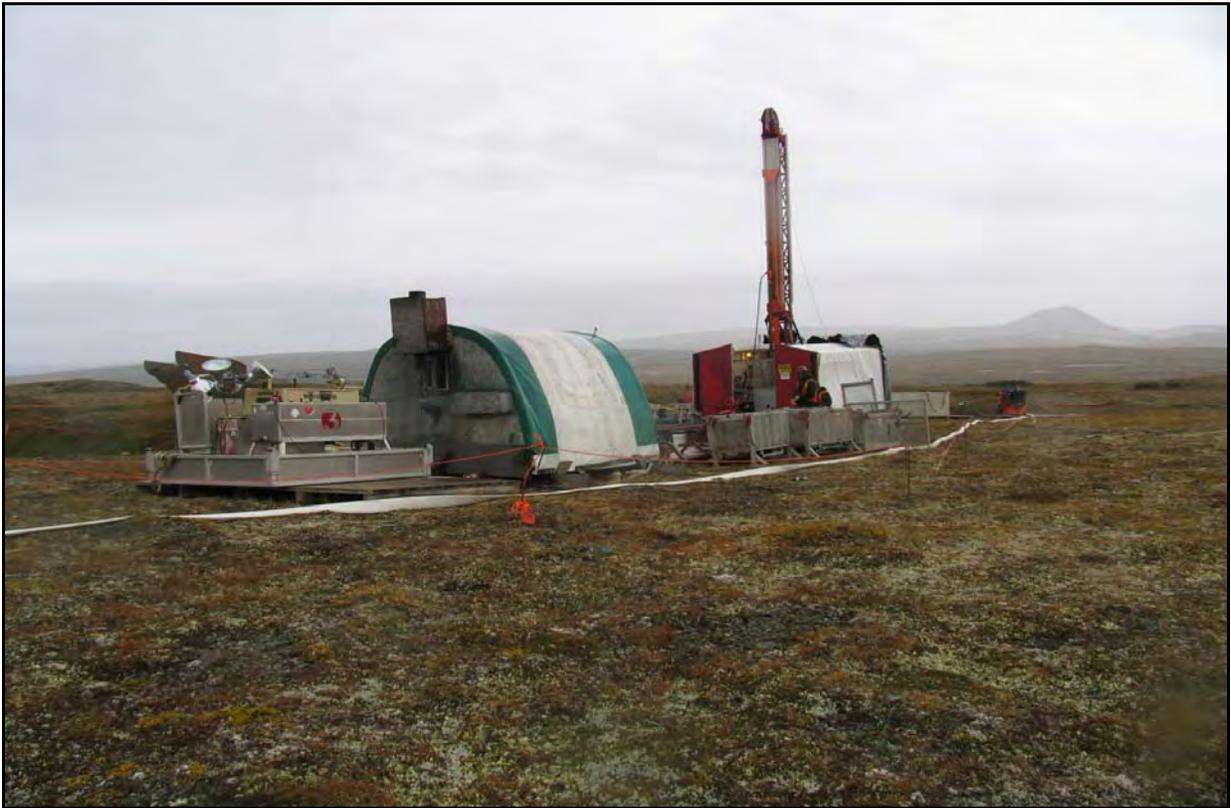
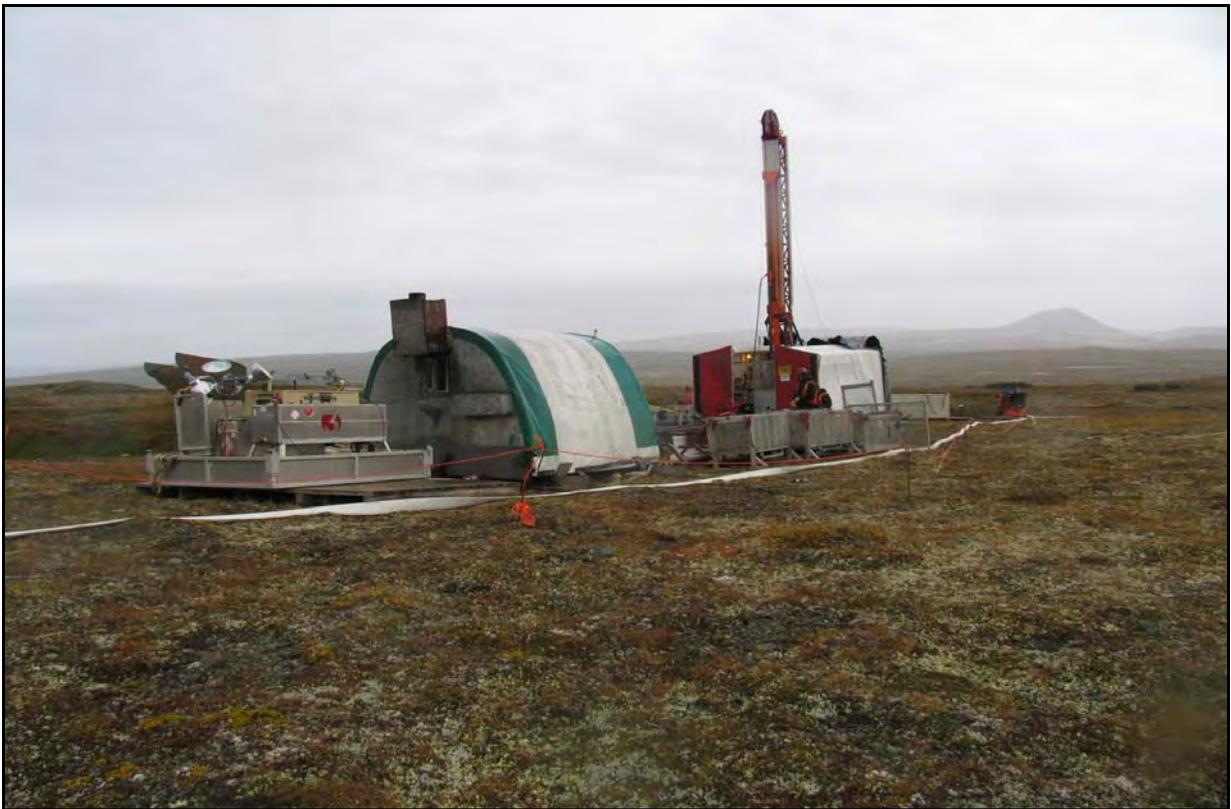
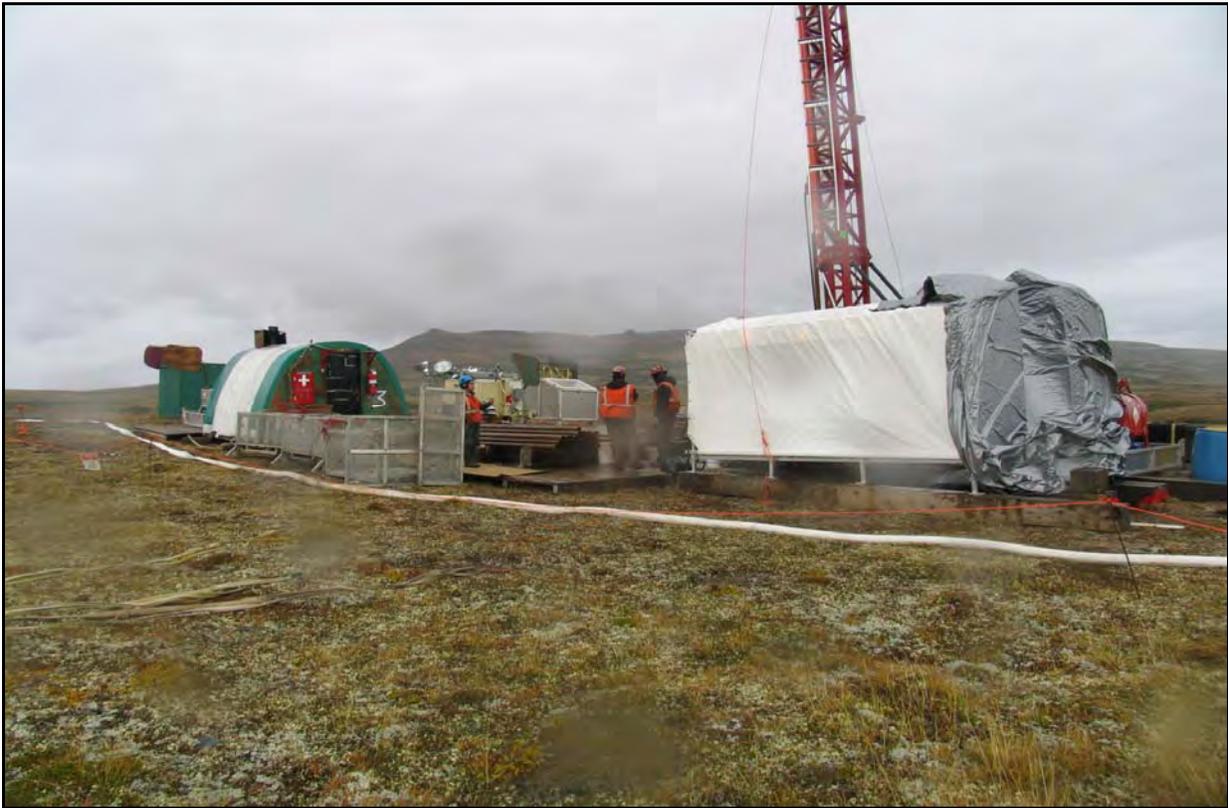
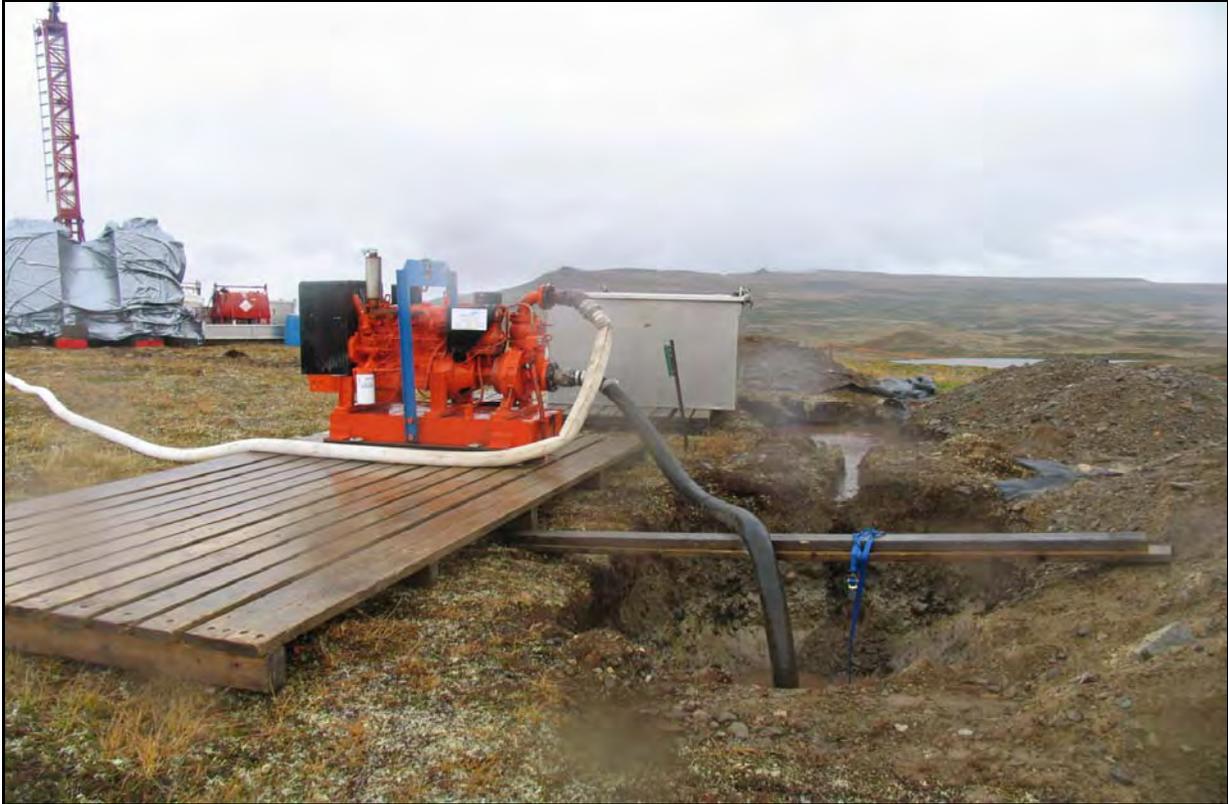
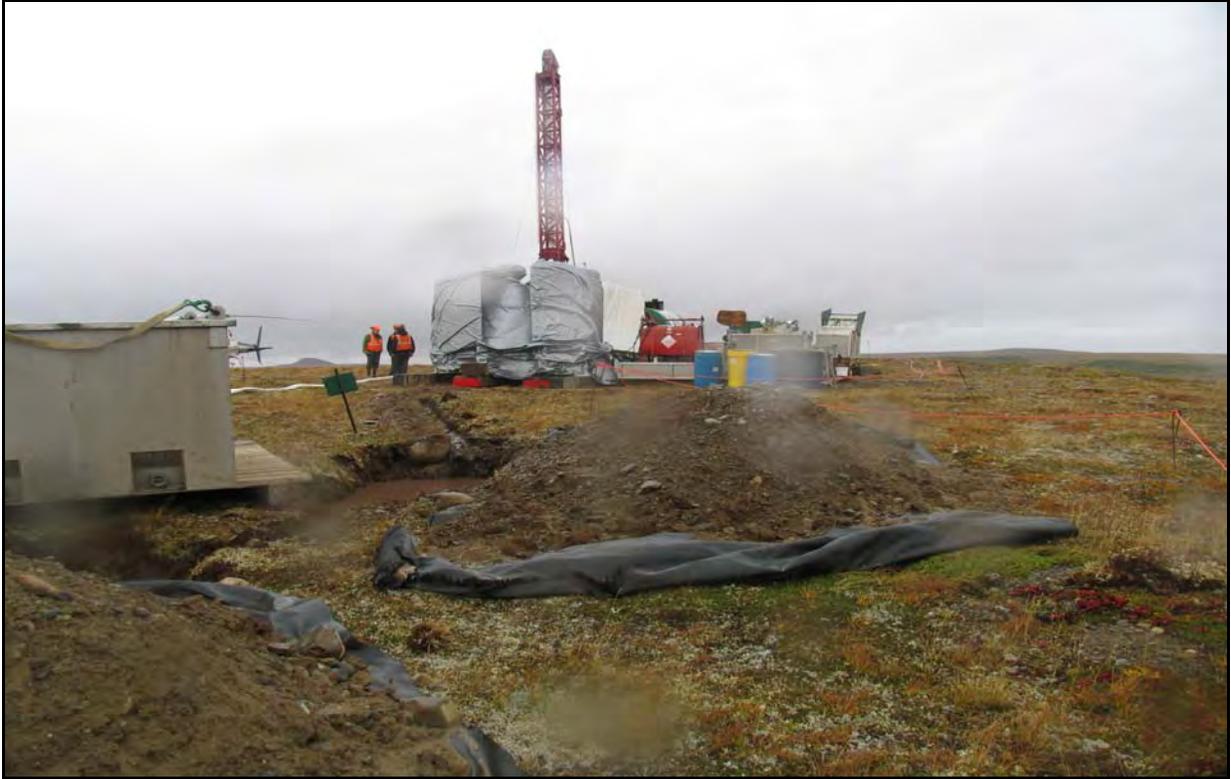
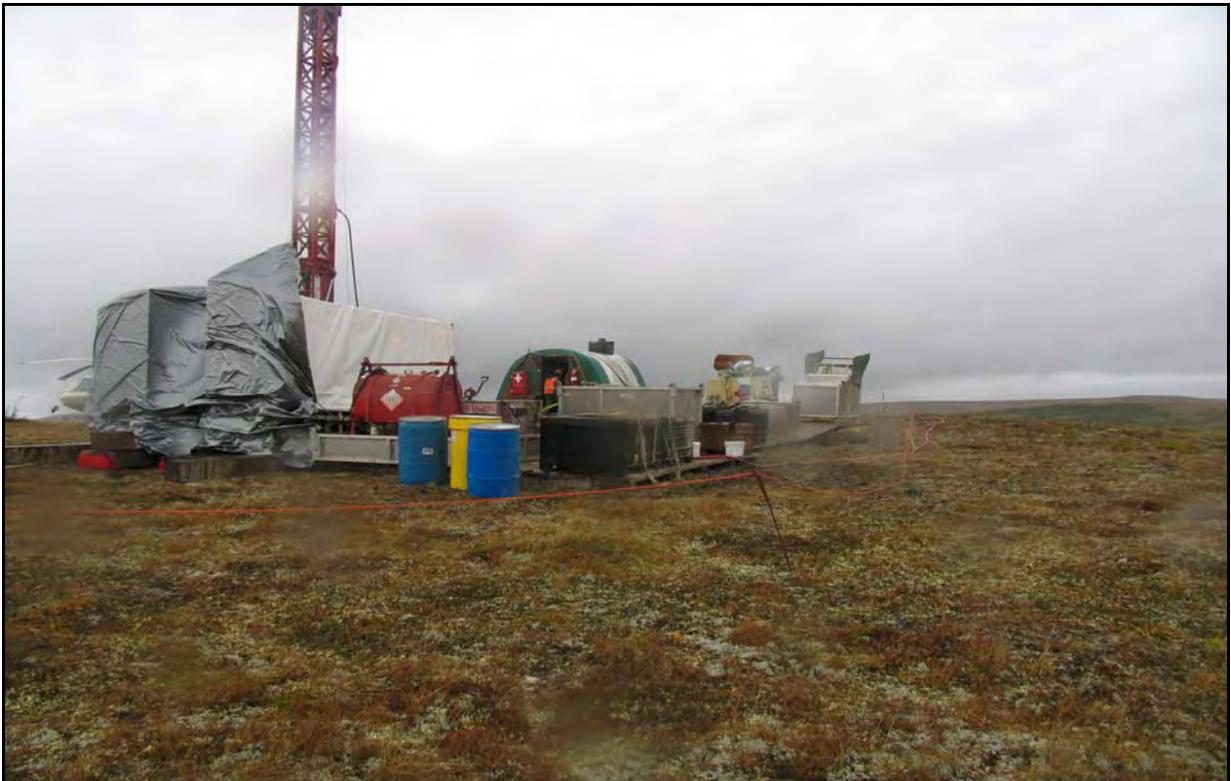
Picture of DDH 12554

Drill Hole/Site No.: DDH 12554	Date: August 21, 2012
Rig No.: 6	Time: 2:00 PM
Activity: DDH with proposed depth of 1,300 feet. Current depth is 116 feet. DDH located in the upper reaches of the lower Koktuli River (A122788).	
<ul style="list-style-type: none"> <li>■ Condition of Drilling Site: Orderly (See Pictures Below) <ul style="list-style-type: none"> <li>○ Distance from waterbody: ~ 400 feet</li> <li>○ Location of fuel storage: Next to Drill</li> <li>○ Sorbent pads present: Yes, 1 barrel</li> <li>○ Tundra mat: Yes, and all drill related equipment situated on pads.</li> <li>○ Pipe off tundra: Yes</li> <li>○ Litter: None</li> <li>○ Trash containment: Yes</li> <li>○ Sanitary facilities: Yes – privy and containment for removing sewage to Iliamna</li> <li>○ Any spills or staining: No</li> <li>○ General impression: Clean</li> </ul> </li> </ul>	<ul style="list-style-type: none"> <li>■ Sump Pit (continued): <ul style="list-style-type: none"> <li>○ Location and extent of discharged material: 100 feet north of drill collar</li> <li>○ Topsoil, muck, tundra stockpiled: Yes</li> <li>○ Hose color: White</li> </ul> </li> </ul>

<ul style="list-style-type: none"> <li>■ Drilling Activity: Current depth is 126 feet <ul style="list-style-type: none"> <li>○ Drill additives in use: Extreme One</li> <li>○ Recirculation tank: Yes</li> <li>○ Water discharged: Not yet</li> <li>○ Artesian zone encountered: No</li> </ul> </li> </ul>	<ul style="list-style-type: none"> <li>■ Drill Water Supply: The TWUP site for this DDH that was used for drill water was unusually far away (12,000+ feet). <ul style="list-style-type: none"> <li>○ Stream, lake/pond: Creek</li> <li>○ Location: East of drill about 12,000 feet (See Map)</li> <li>○ Adequate water flow and depth for fish passage in streams: Yes</li> <li>○ Evidence of significant impacts to riparian vegetation or stream banks: No ?</li> <li>○ General impression of water body (i.e. clear, turbid, tannic): Clear</li> <li>○ Intake description: Screened electric submersible</li> <li>○ Structure clear of debris: Yes</li> <li>○ Mesh size: 1x12 mm slotted 0.1 CFS</li> <li>○ Submerged: Yes</li> <li>○ Fuel/generator location to source: &gt;100 feet west</li> <li>○ Catch basin for fuel supply: Yes</li> <li>○ Sorbent pads: Yes</li> <li>○ Hose color: Yellow</li> </ul> </li> </ul>

<ul style="list-style-type: none"> <li>■ Sump Pit: Yes, 3 Pits <ul style="list-style-type: none"> <li>○ Location: 30 feet east of drill site</li> <li>○ Discharge trench: Yes</li> <li>○ Dimensions of pit: 5 foot x 10 foot</li> <li>○ In use: Yes</li> </ul> </li> </ul>	<ul style="list-style-type: none"> <li>■ Other Comments:</li> </ul>
