DIVISION OF MINING, LAND AND WATER

Pebble Project Inspection

Date: September 26-27, 2007

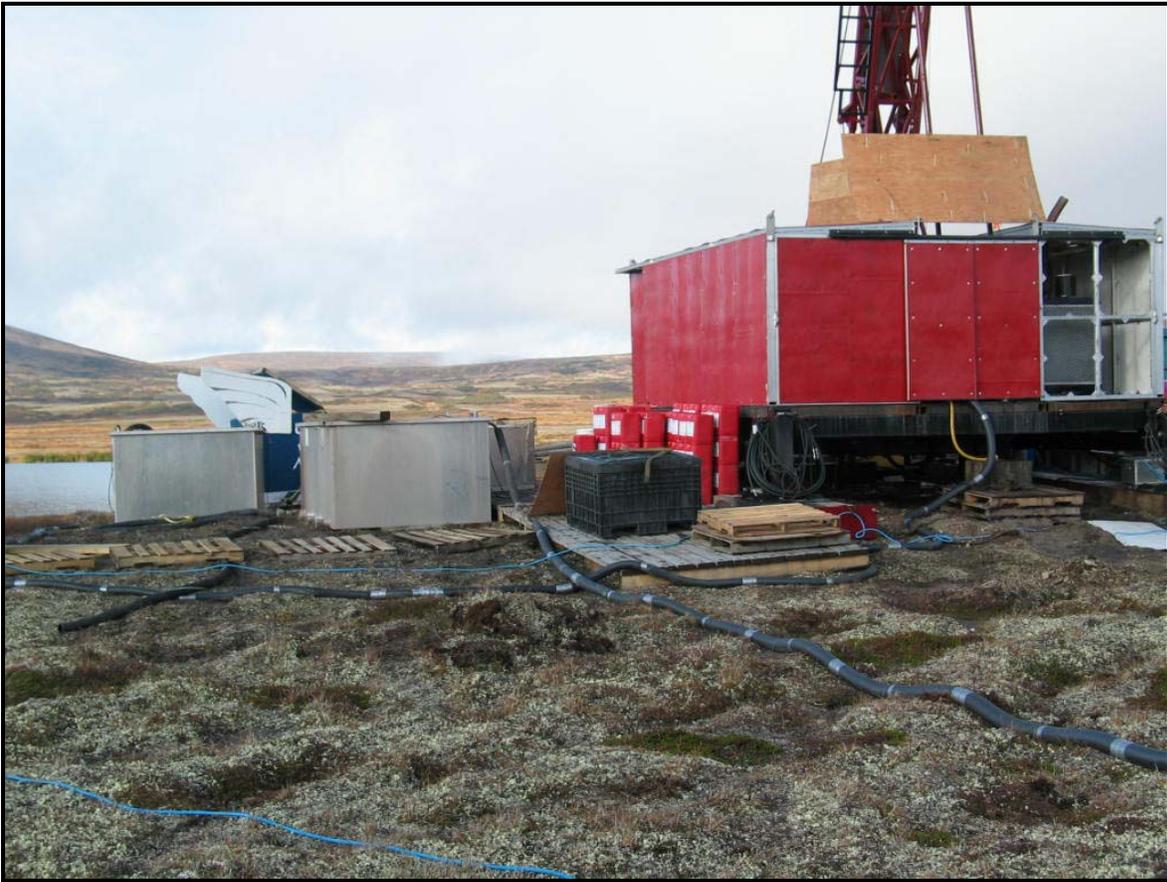
A few drills are recirculating their return fluids. (See photos #11 and 12.) Recirculation requires a larger sump, and one or two large tanks for mixing the mud. Recirculating the returns saves a considerable amount of discharge, but not all, because most wells make some amount of down hole water. The excess water must be disposed of. (See Drill Inspections, above.)

Photo #11. Extra tanks required for recirculating drilling fluids at drill #1.

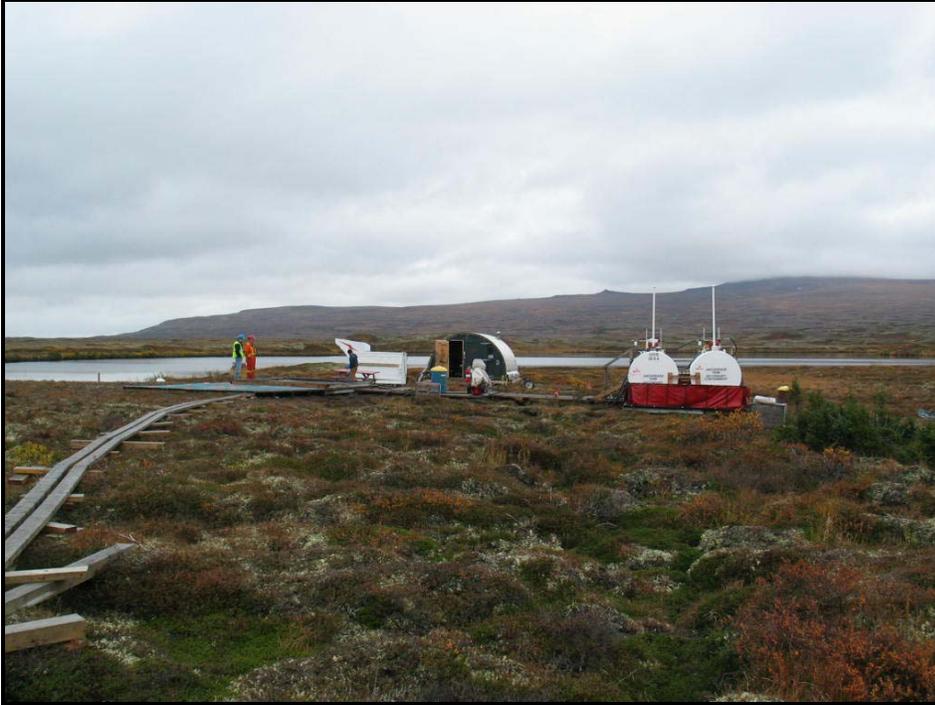
On the afternoon of the 26th we inspected the main fuel storage at Big Wiggley Lake, in section 5, T3S, R35E SM. Everything was in good order. (See July 26-27, 2007 report for more details on the facilities at Big Wiggley. See photos #13 and 14.) We noted that there are now three spill containment float booms, and there is an electric motor on the dock to pump fuel from the Beaver to the main tanks. This eliminates the need for fuel and an engine along the lake shore. (See photo #15.)

Photo #13. Big Wiggley fuel storage facility – 2,000 gallon storage containment. Boardwalk is for tundra protection.

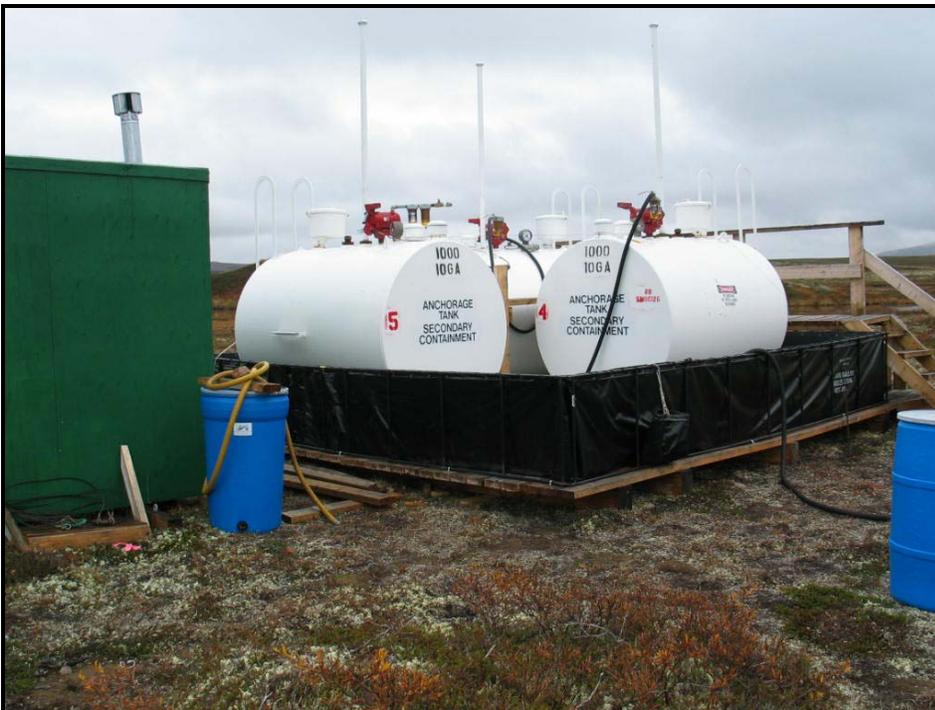
Photo #14. Larger, 3,000 gallon fuel containment at Big Wiggley. Each containment has a large fire extinguisher, spill kit, and scrubber barrel. The facility also has a large container of spill materials.
