## Field Monitoring Report -- Pebble Copper/Gold Exploration Project --

Personnel:	Inspection Date: October 5, 2012
Sharmon Stambaugh (DNR)	Site Contact: Jeff Norberg (Manager, Site Compliance & Reclamation. PLP)
Marty Brewer (DEC)	APMA #: A126118
Chris Foley (DEC)	
■ Inspection Type:	■ Wildlife Observed:
○ Complete:	○ Bear:
○ Partial: <b>X</b> (DDH12551, DDH12557, GH12-347S , DDH12558)	○ Caribou:
○ Follow-up: EXF-12D (12556) assessment of long hose to water source	○ Moose:
○ Response to Public Complaint:	○ Waterfowl: Swans
	○ Fish:
■ Weather Conditions:	○ Other: Ptarmigan, fox
○ Temperature: mid 40s	
○ Wind: moderate	
○ Precipitation: misting	
○ Visibility: good	
○ Sky Conditions: overcast	
○ Ground Conditions: wet	
<p>■ Comments: 4 drill sites were inspected (DDH12551, DDH12557, GH12-347S, DDH12558). As a follow-up from last inspection, EXF-12D (12556) was also assessed for potential impacts of the long water intake hose used at the site.</p>	
<p>■ Recommendations:  Numerous cigarette butts on tundra were noted at DDH 12551.  Various other materials (wood debris, buckets, etc.) were stored in secondary containment box at DDH 12551.</p> <p>Water discharge sump and trench system a

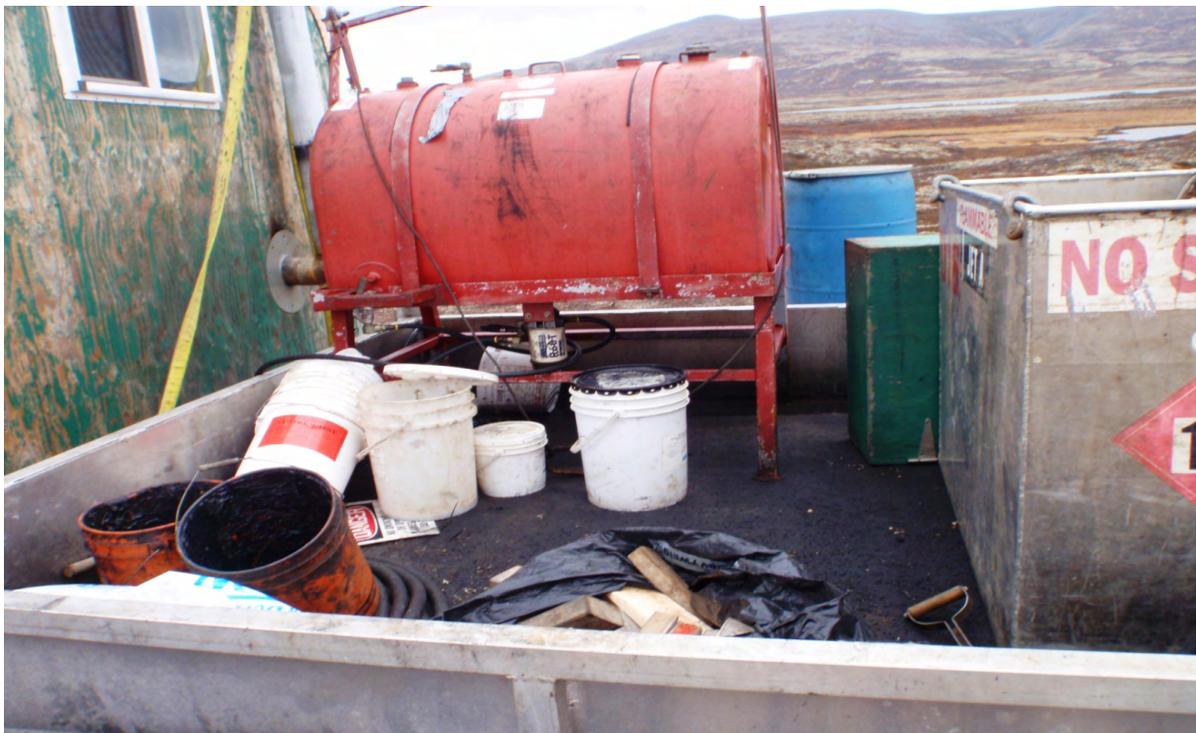
Secondary containment at DDH12551 with various debris stored within.

Improve site housekeeping pertaining to the secondary containment boxes.

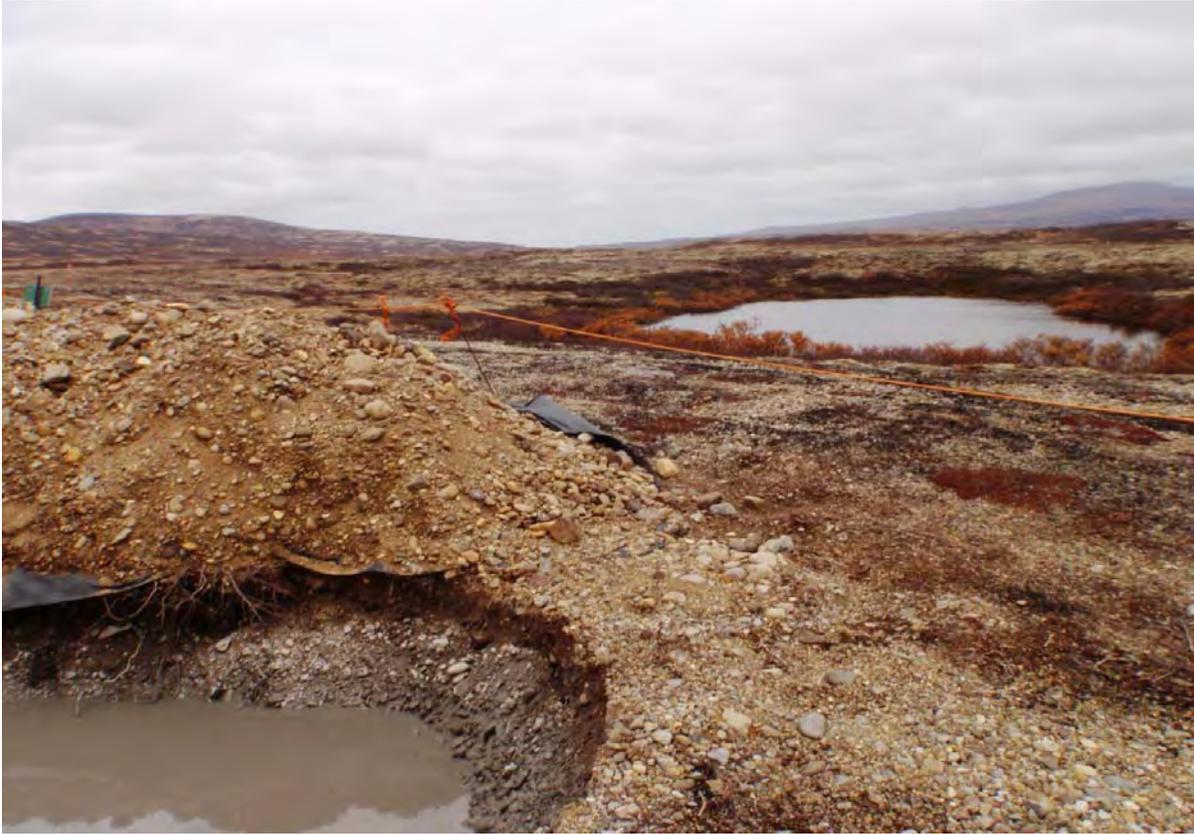
Proximity of third sump at DDH12551 to nearest surface water body.

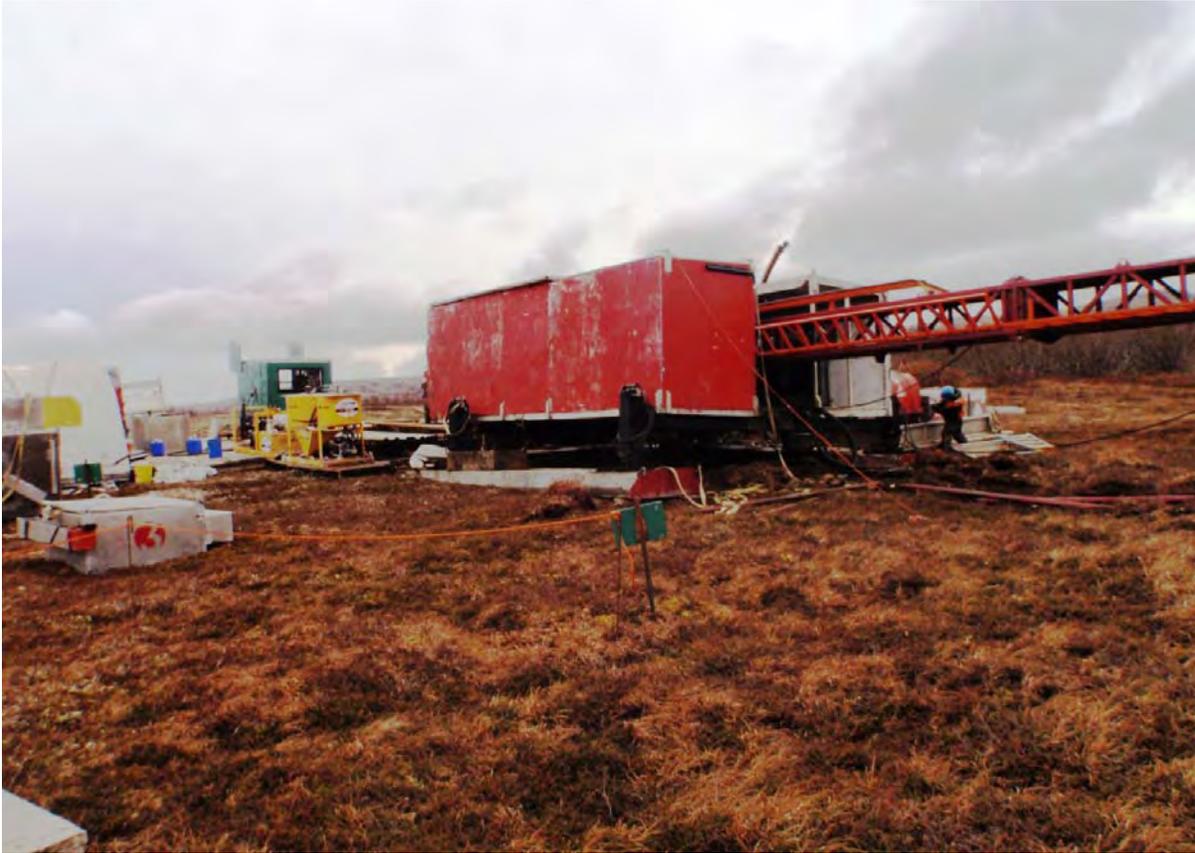
Rig 2 at DDH12557 being taken down.

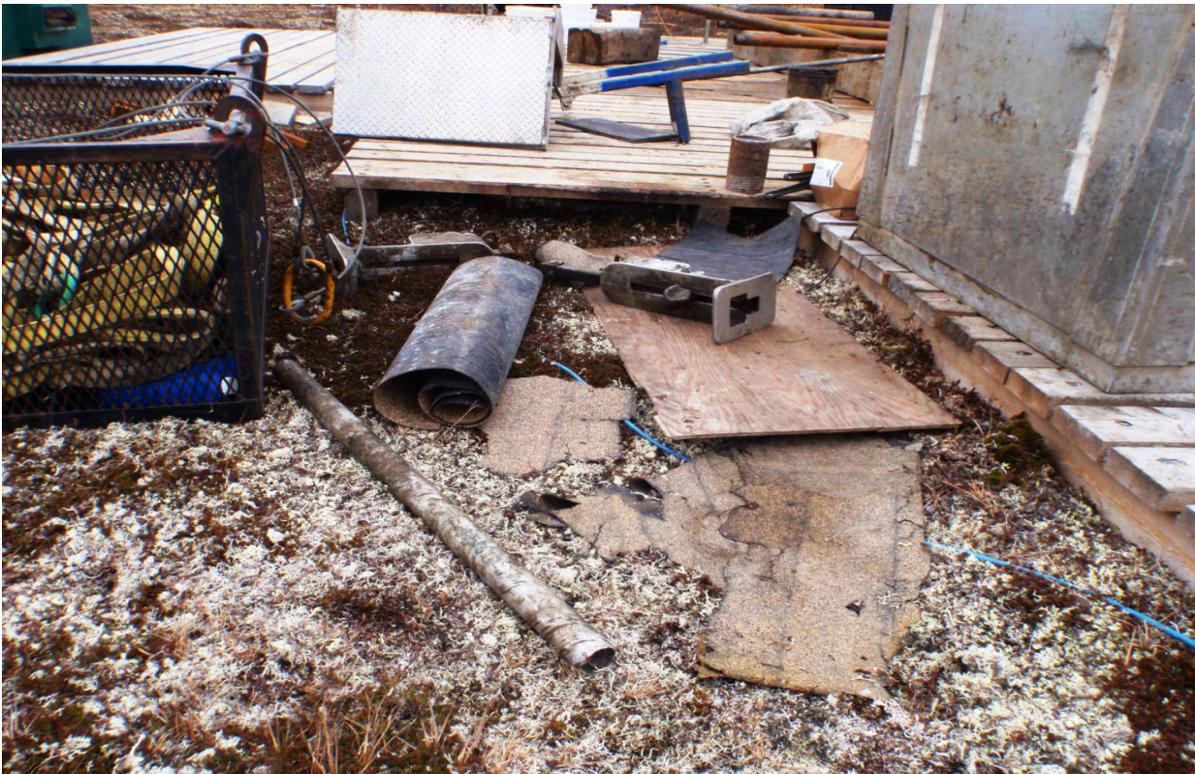
Rig 2 at DDH 12557 was in the process of being taken down when inspected. Some pipe and debris were found on the tundra.

Debris and pipe off the pad at site DDH12557 during Rig 2 breakdown process.

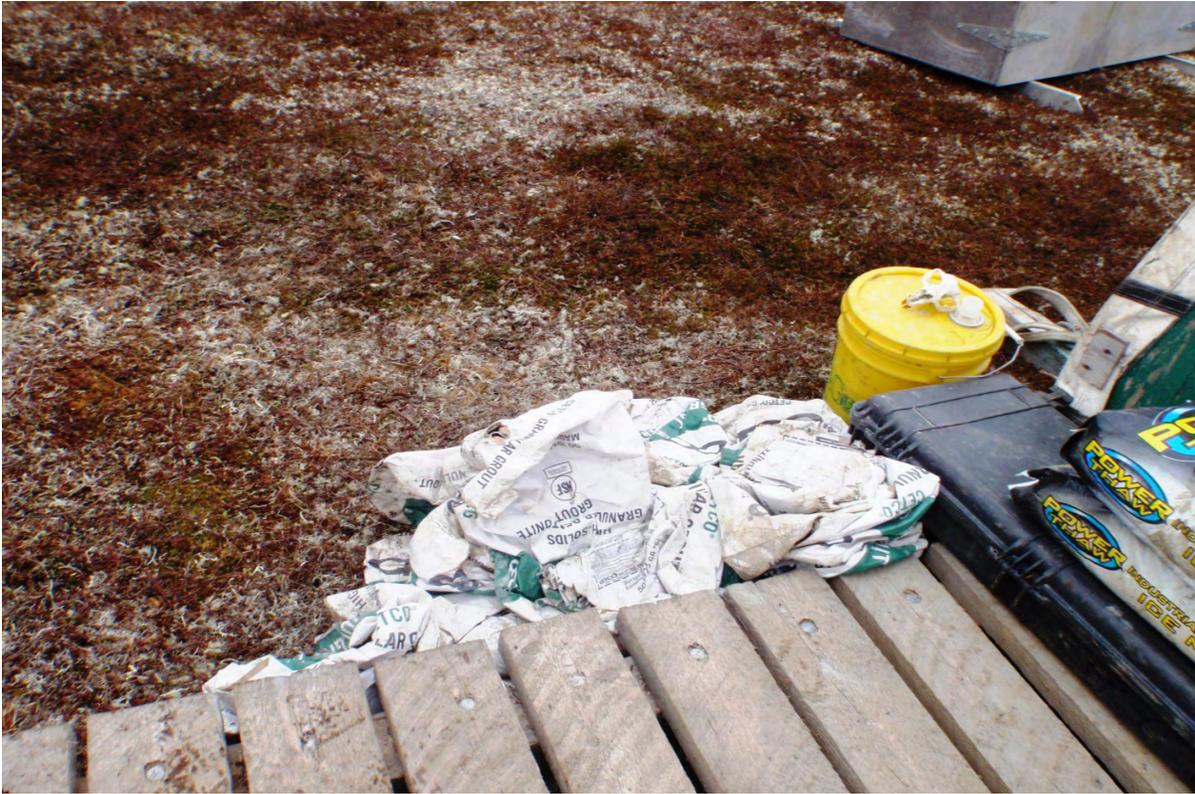
Grout bags and other debris off the pad at DDH12557 during Rig 2 breakdown process.

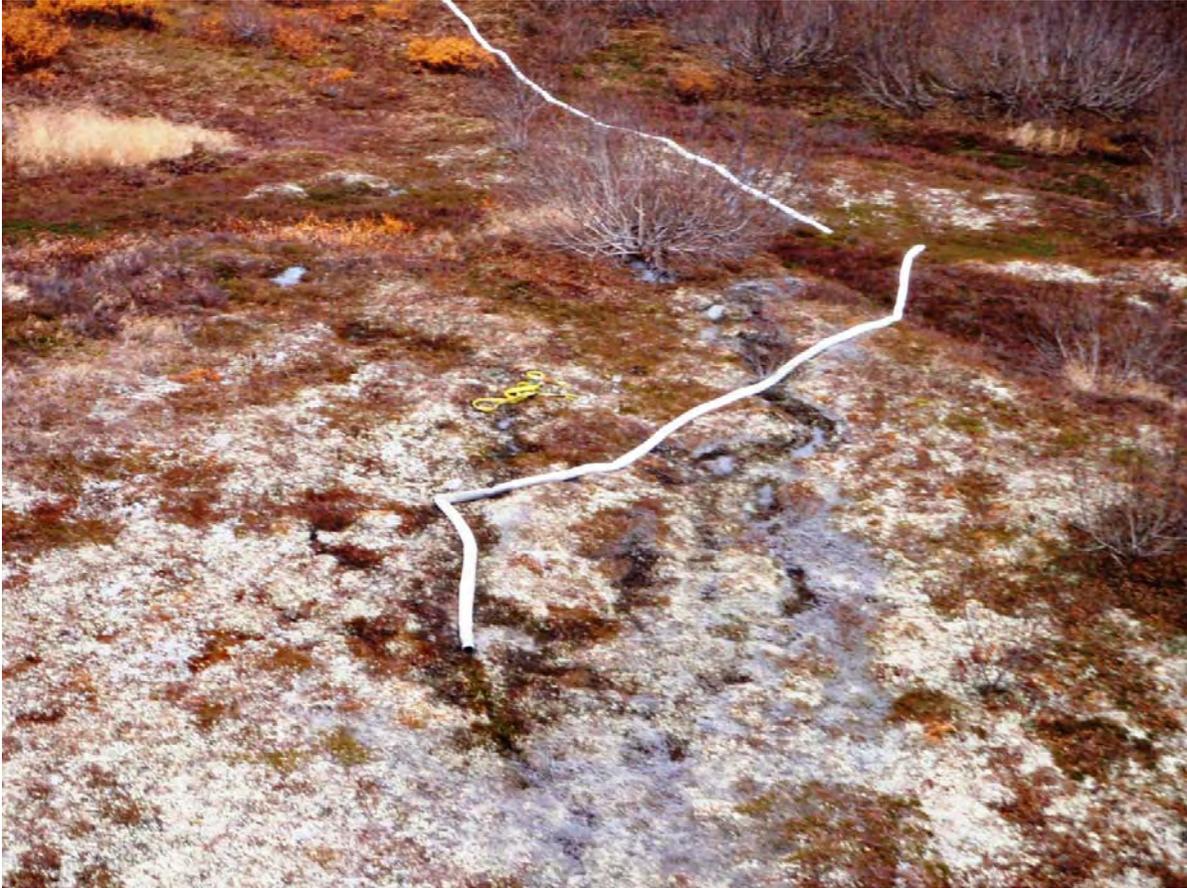
DDH 12557 discharge onto tundra

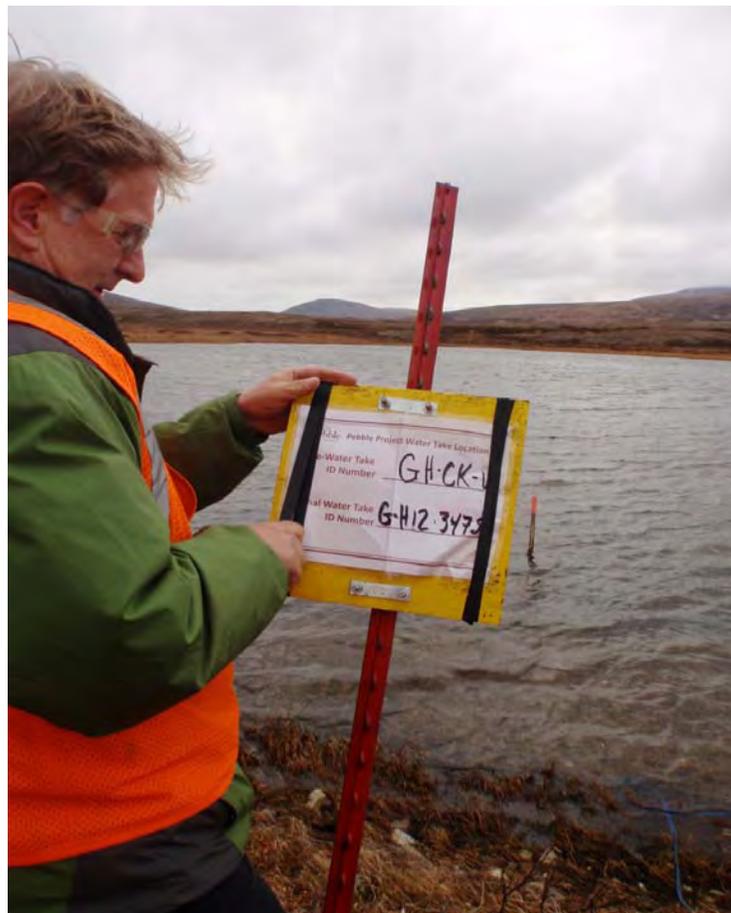
Sonic site (Rig 5) yellow sign denoting temporary water supply permit did not have the permit number posted, but it was reposted while on site.

Temporary water take permit notification.

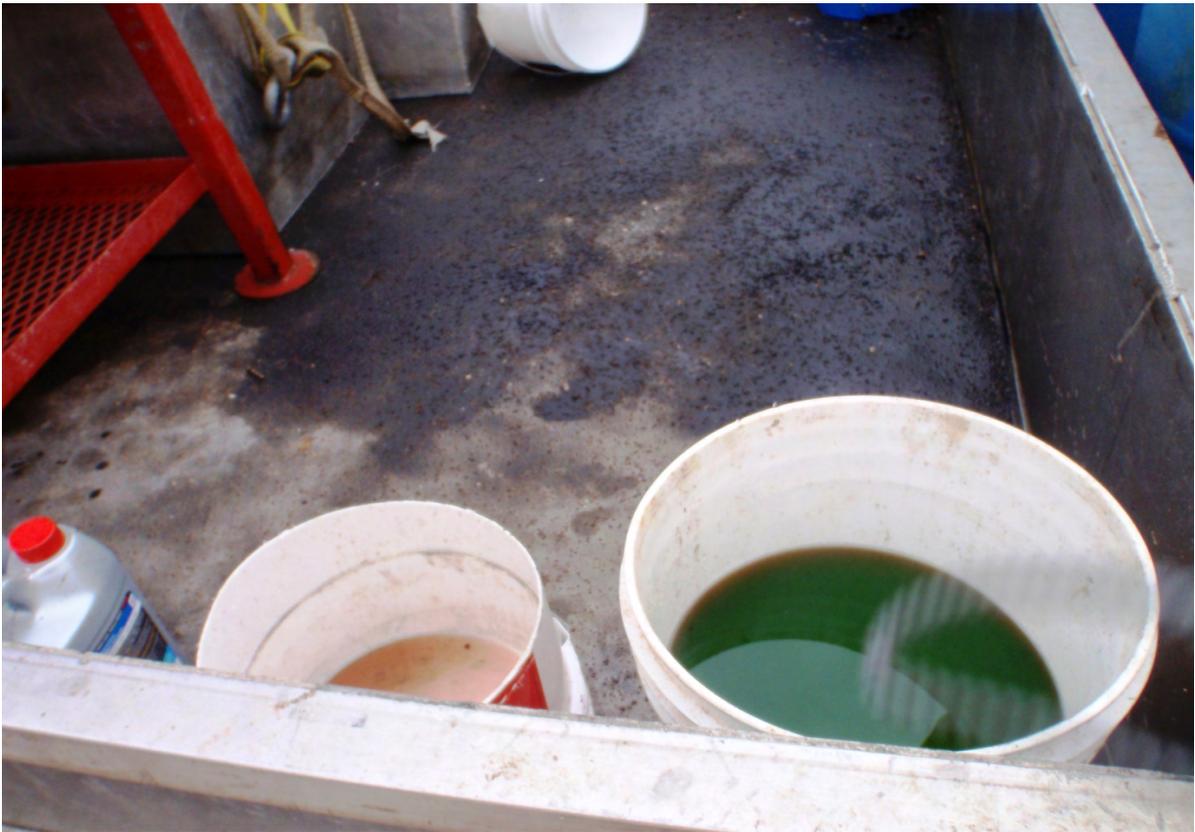
Unidentified liquids were found in the secondary containment box at DDH 12558. Upon consulting the rig operator, it was determined that the liquids were antifreeze recovered from a broken water pump. The field manager instructed the operator to cover the containers, label them, and dispose of them as hazardous waste accordingly.

Unlabeled waste liquids stored in secondary fuel containment box at DDH12558. Identified by rig operator as antifreeze leaked from water pump.

Educate field crews on the proper containment, storage, and disposal of any fluids that could be considered hazardous.

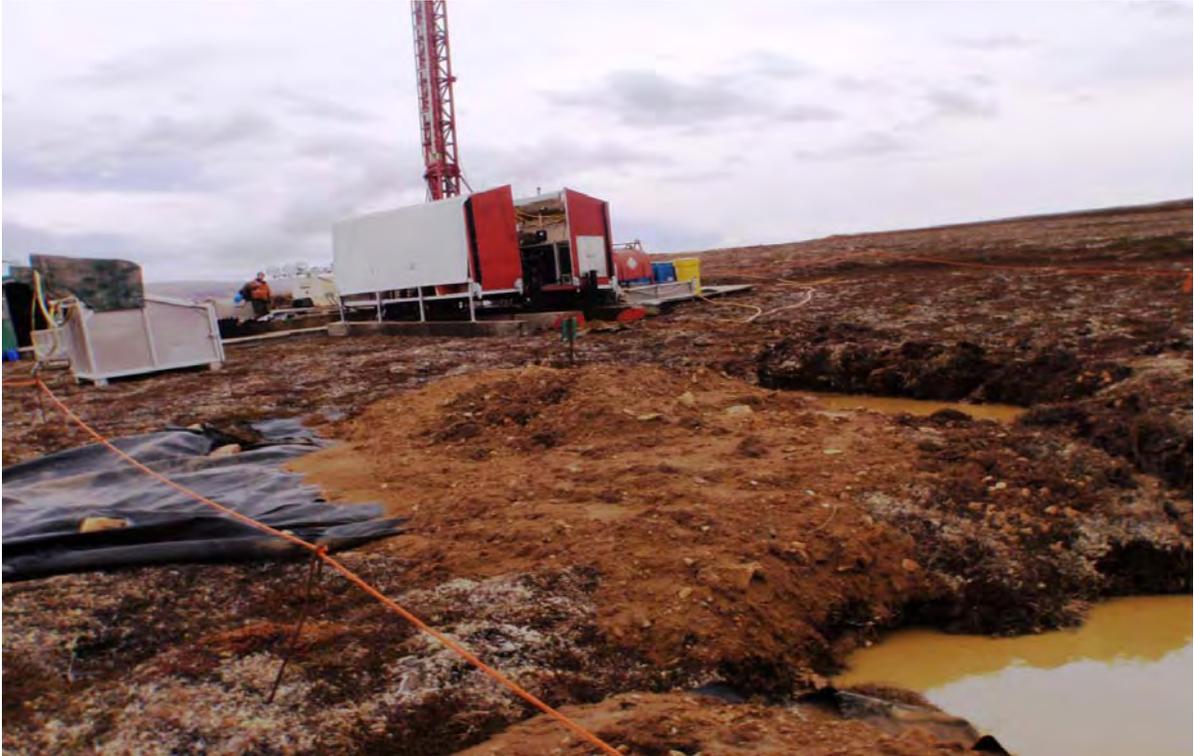
DDH12558 trench and sump system. Water notably murkier than other drill sites due to different geology.
