Inspection Report Pebble Copper Mine Site

Facility: Pebble Copper Mine by Northern Dynasty Minerals and Hunter Dickinson Group from Vancouver, BC <http://www.hdgold.com/hdi/Home.asp>

Date of Inspection: 6/14/2006

Purpose of Inspection: General site inspection

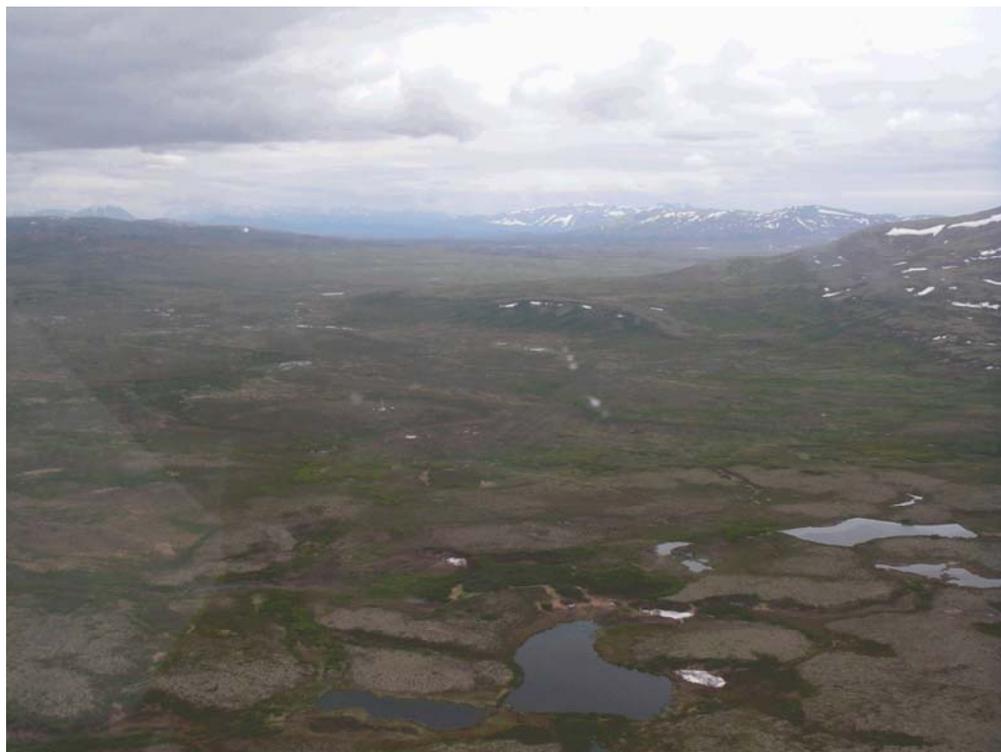
Figure 1. Aerial view of future Pebble Mine.

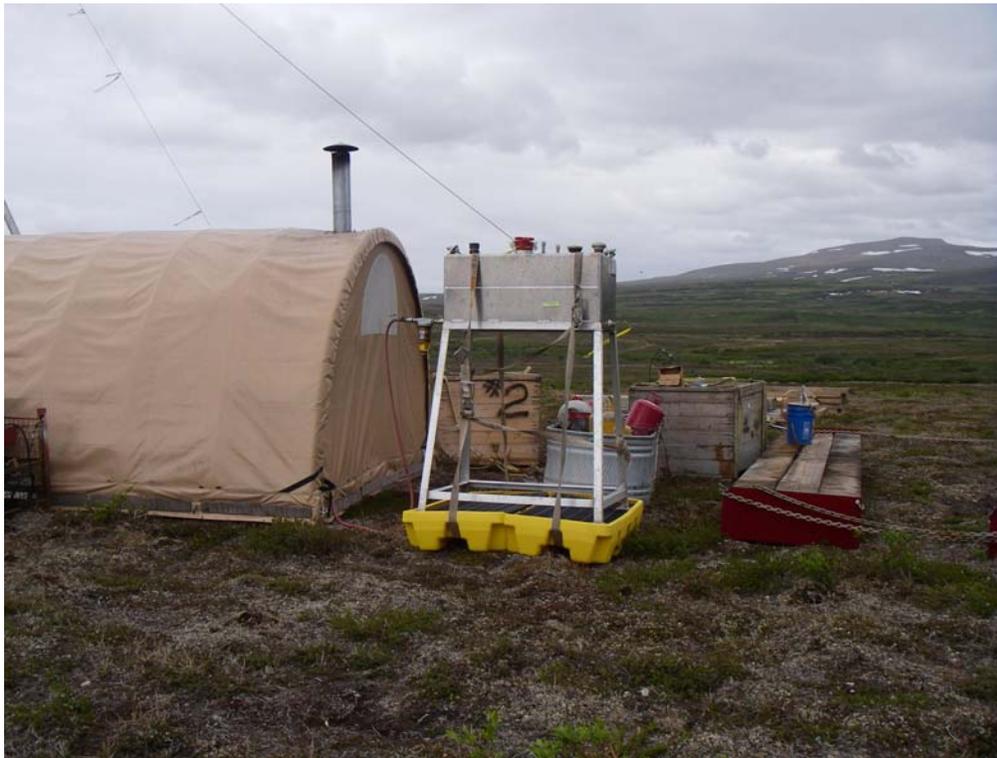
fresh water drained into one of the drainage ditches to the sump. Freshwater was mixed with bentonite in the black mixing tank which goes down the drill hole. When this mixture flows back out of the hole, it is captured in a separate tank for recycling back into the drilling operation. Overflow is captured in a third tank to settle fines before muddy water flows into a ditch to the sump. Overflow was captured with earthen berms. A large pump moved water uphill from the sump approximately 1000 feet to an upland pond. No seepage of sediment laden water was visible on the tundra. Fuel was stored appropriately.

Figure 2. Drill site 1, fuel storage.

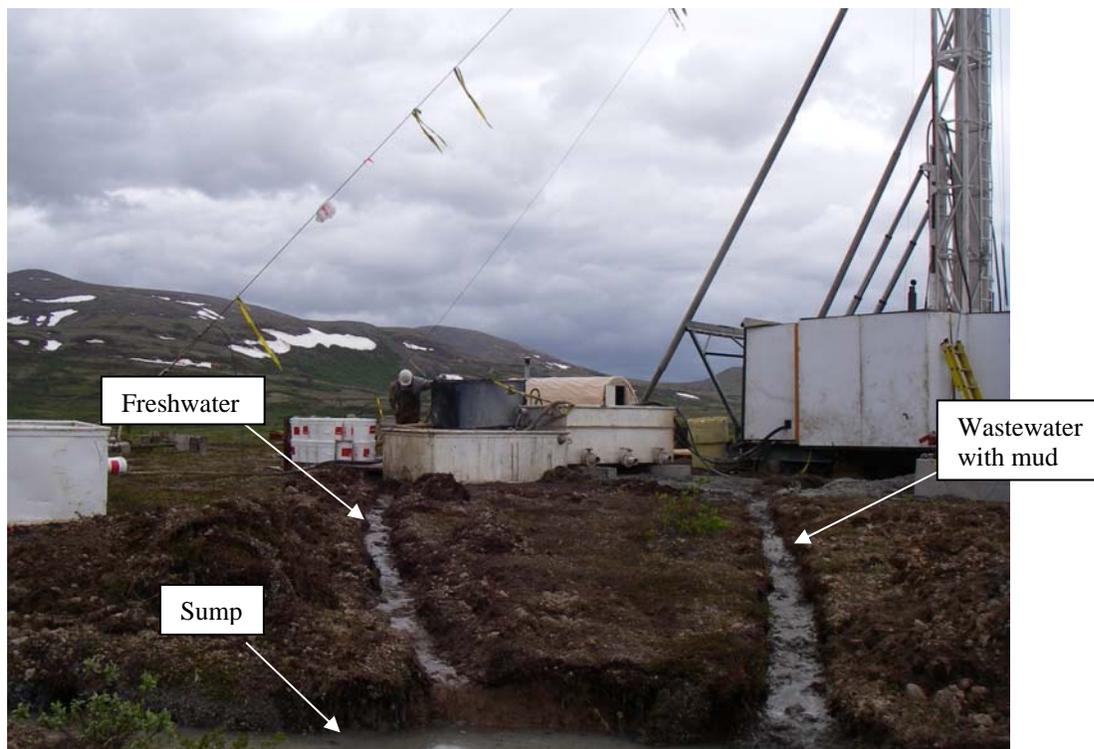
Figure 3. Drill site 1, water is recycled in a tank; wastewater and fresh water flow in ditches to a sump.

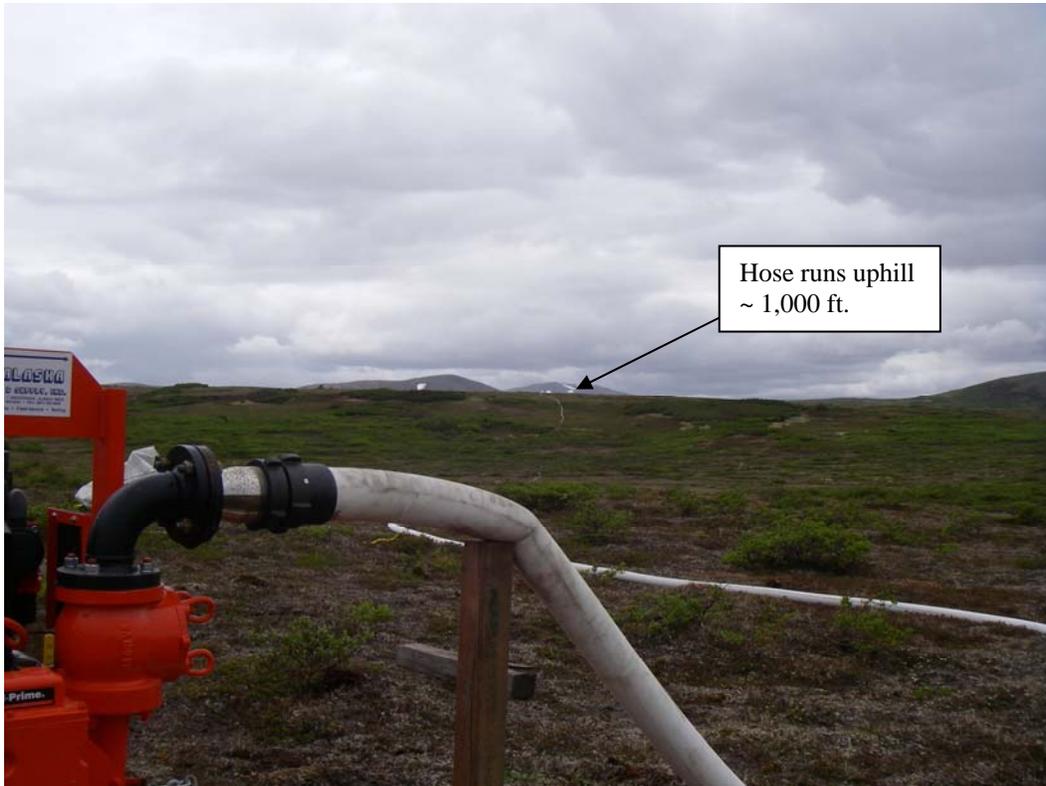
Figure 4. Drill site 1, wastewater is pumped uphill from the sump approximately 1000 feet to an uplands pond.

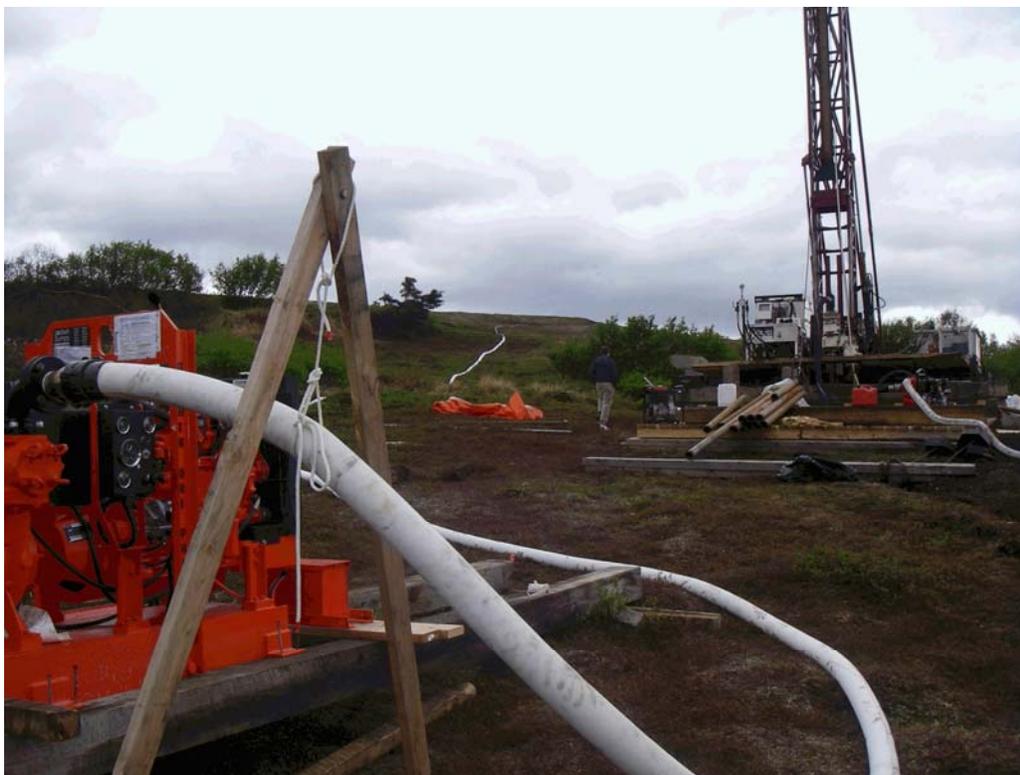
Drill three had become an artesian well when the drill hit pressurized underground water. Before we landed the drillers said water spurted 20 feet into the air. When we arrived water was flowing from the drill hole through a hose to a ditch flowing into a sump. The sump was overflowing onto the tundra. No erosion from this flow was visible. The company had two workers on site to collect foam and other debris before it flowed onto the tundra. At the same time, a large pump moved water from the sump to an upland pond. A trench near this pond diverted any water that may flow into surrounding tundra. The drillers received concrete to fill the drill hole at water level to stem the flow of water to the surface. Richard thought perhaps the water was flowing at a rate fast enough to cut around the drill and erode a larger void which will need to be filled. We left as the drillers mixed concrete to pour into the hole.

Figure 5. Drill site 3, water is pumped from the sump to a pond uphill.

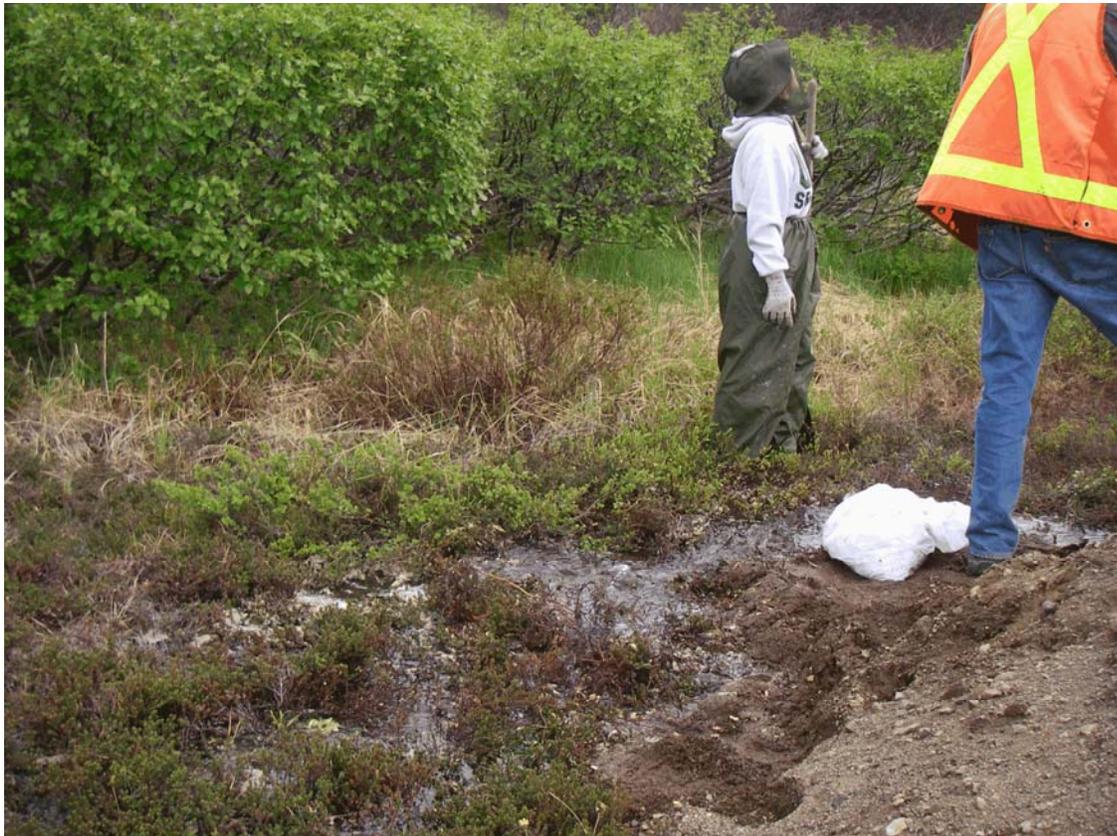
Figure 6. Drill site 3, workers remove foam and other debris from sump overflow.
