2013 Annual Reclamation Report

The Pebble Project

Iliamna, Alaska

Prepared by: JBN Consultants, Inc.
Eagle River, Alaska

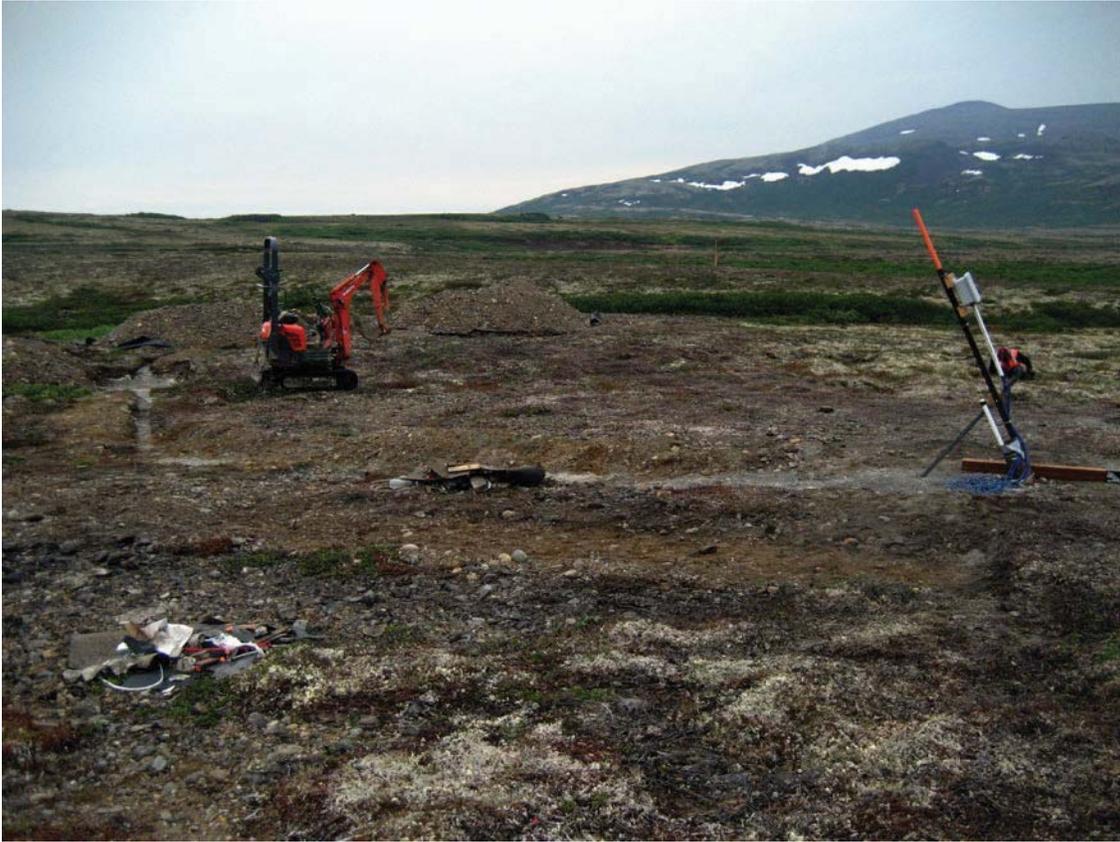
Photo 1: DDH 12551 – Drilled 2012 / Reclaimed 2013; Photo Taken Post Drilling on 24 June 2013; Looking East.

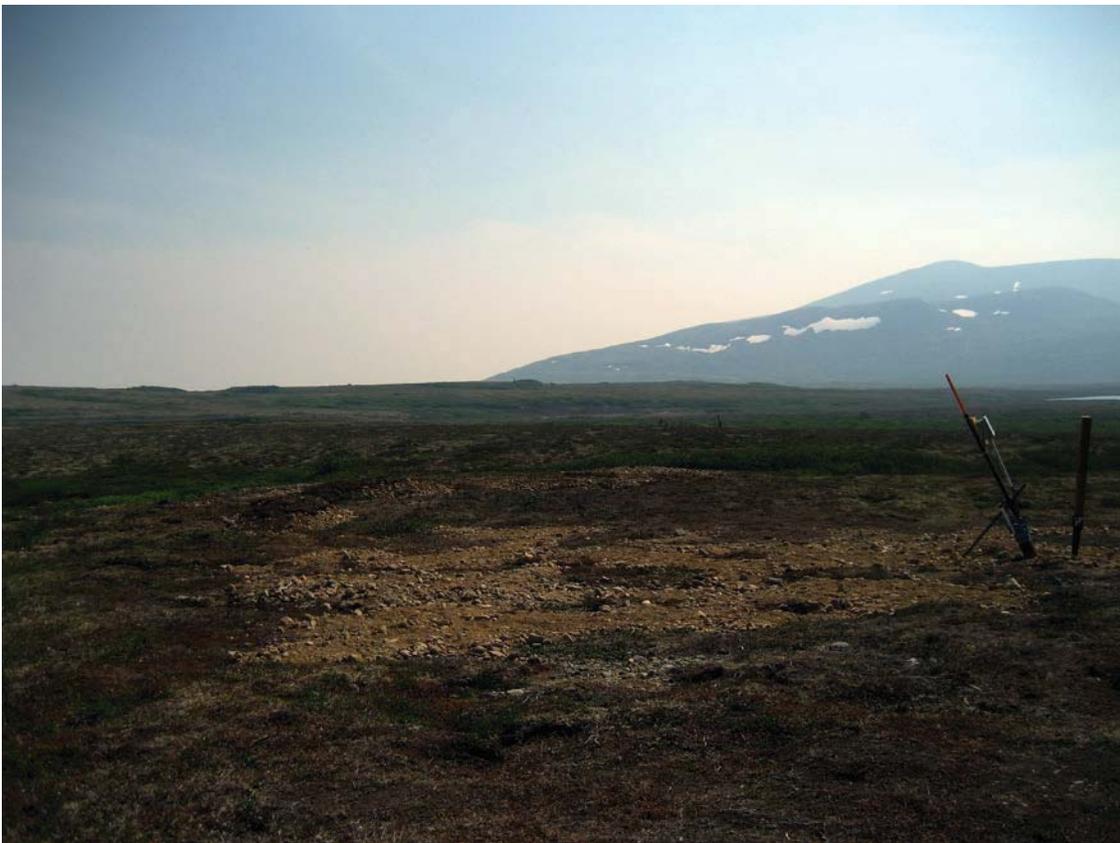
Photo 2: DDH 12551 – Photo Taken Post Reclamation on 25 June 2013; See Photo 1 for Reference; Looking East.

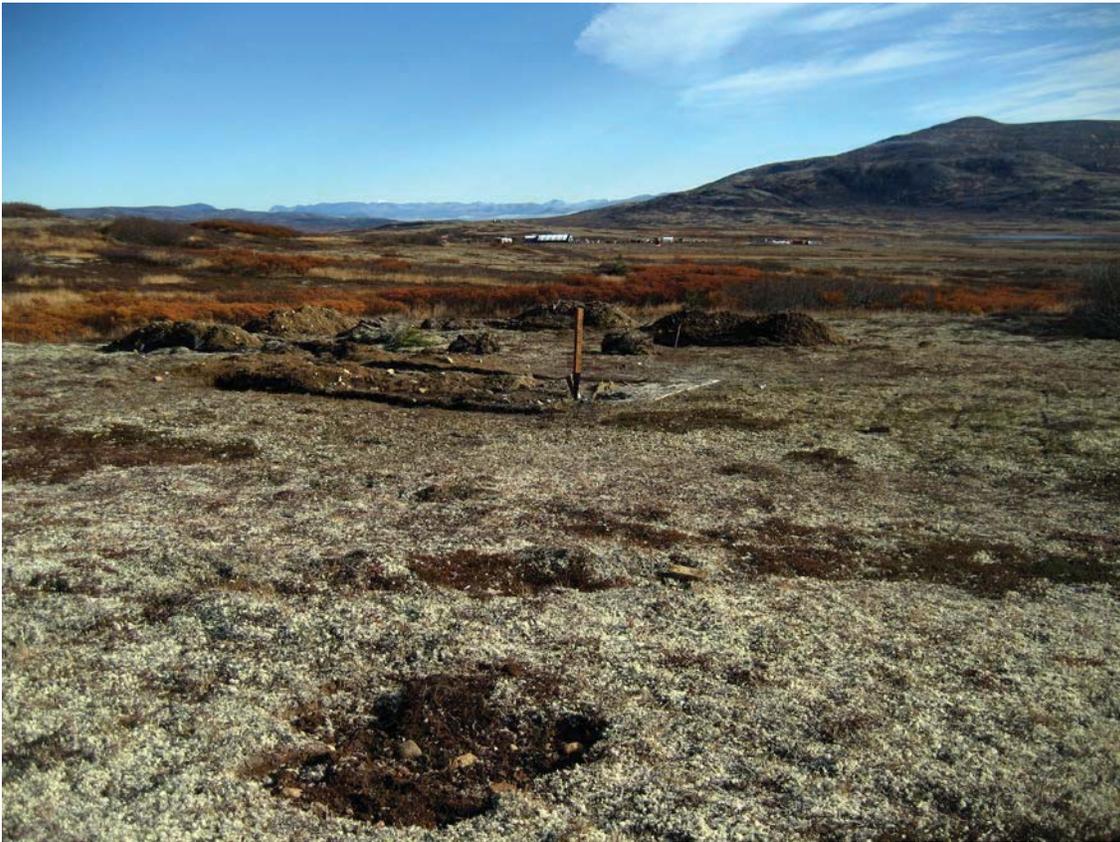
Photo 3: DDH 12555 – Drilled 2012 / Reclaimed 2013; Photo Taken Post Drilling on 10 October 2012; Looking East.

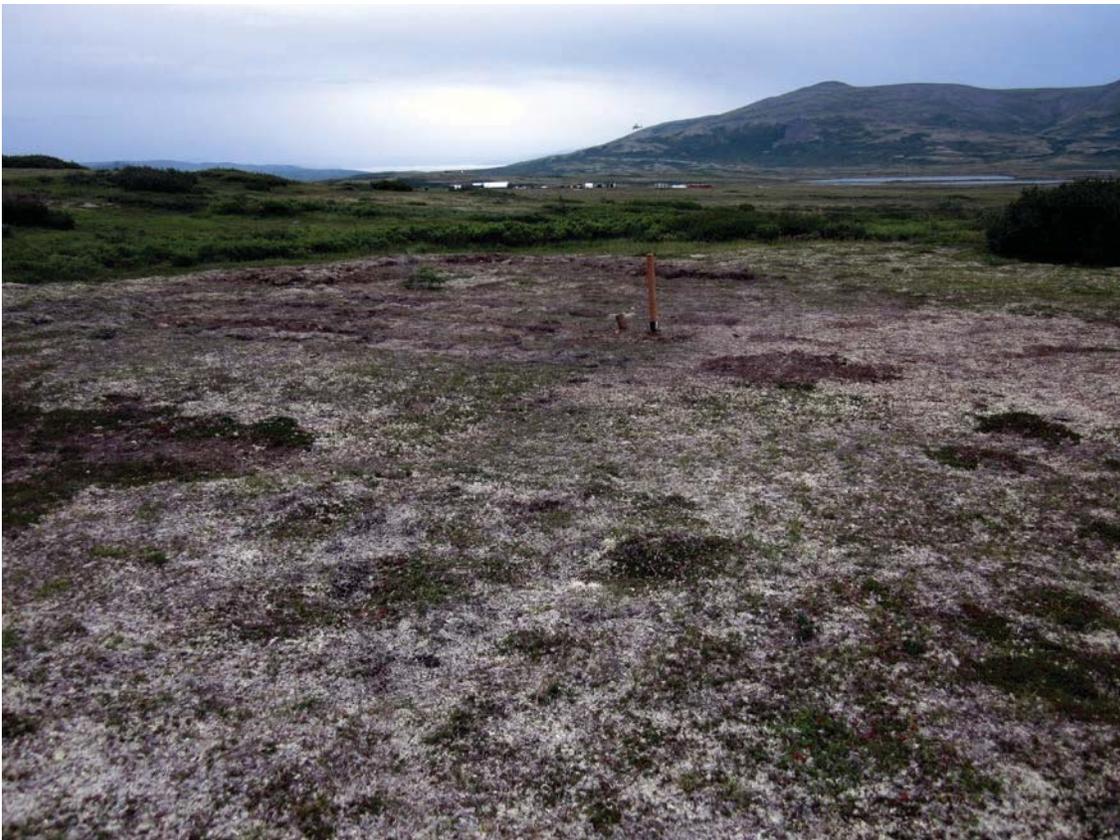
Photo 4: DDH 12555 – Photo Taken Post Reclamation on 12 August 2013; See Photo 3 for Reference; Looking East.

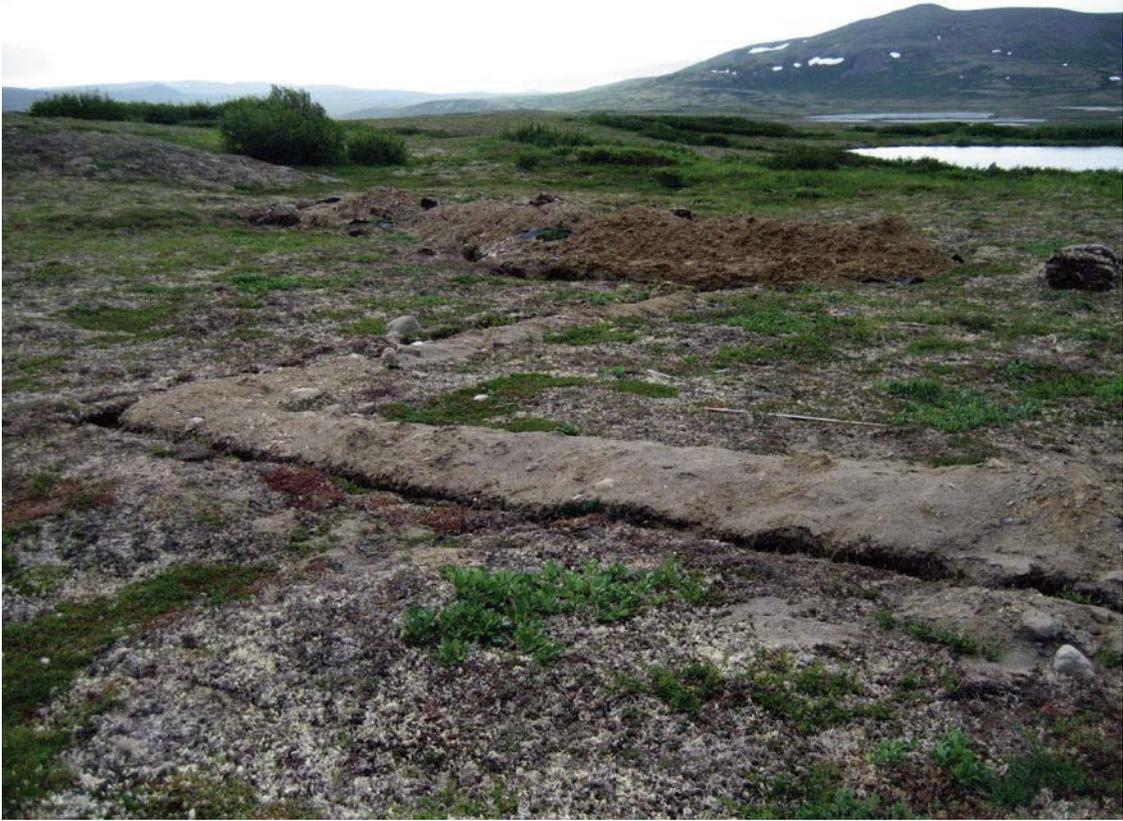
Photo 5: DDH 12559 – Drilled 2012 / Reclaimed 2013; Photo Taken Post Drilling on 30 June 2013; Looking Northeast.

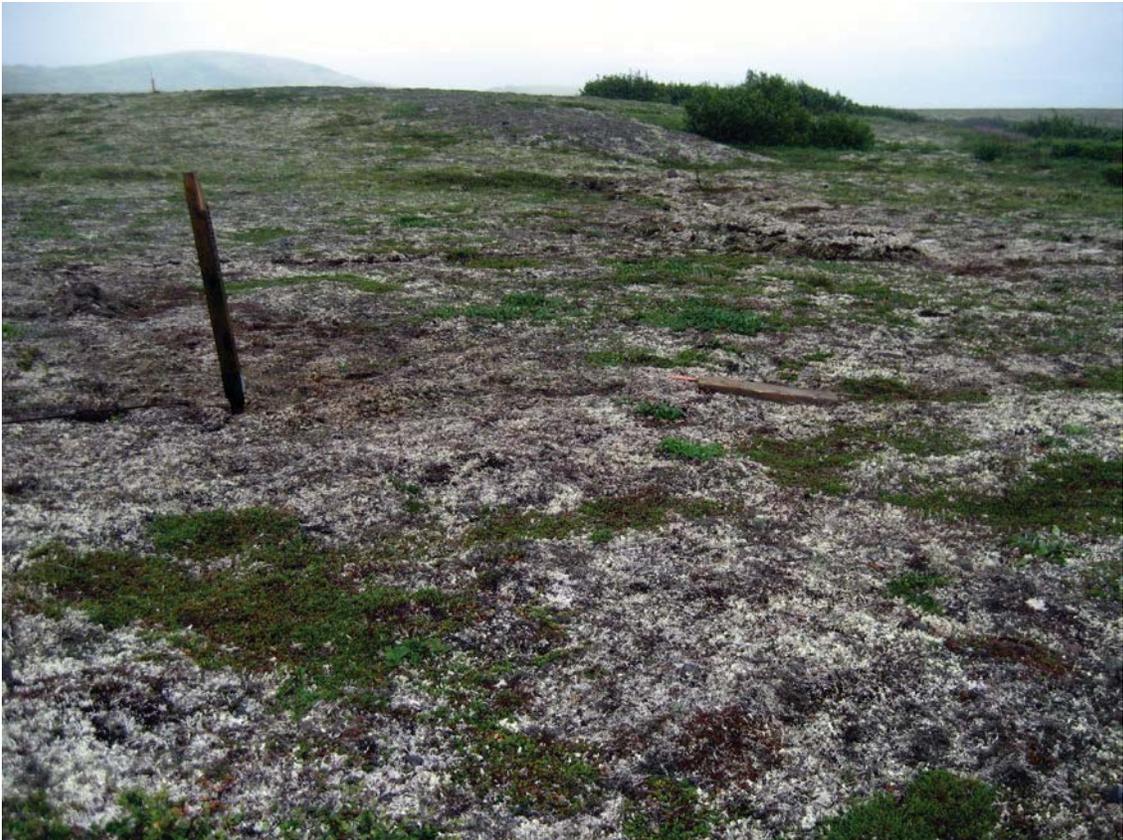
Photo 6: DDH 12559 – Photo Taken Post Reclamation on 18 July 2013; See Photo 7 for Reference; Looking North.

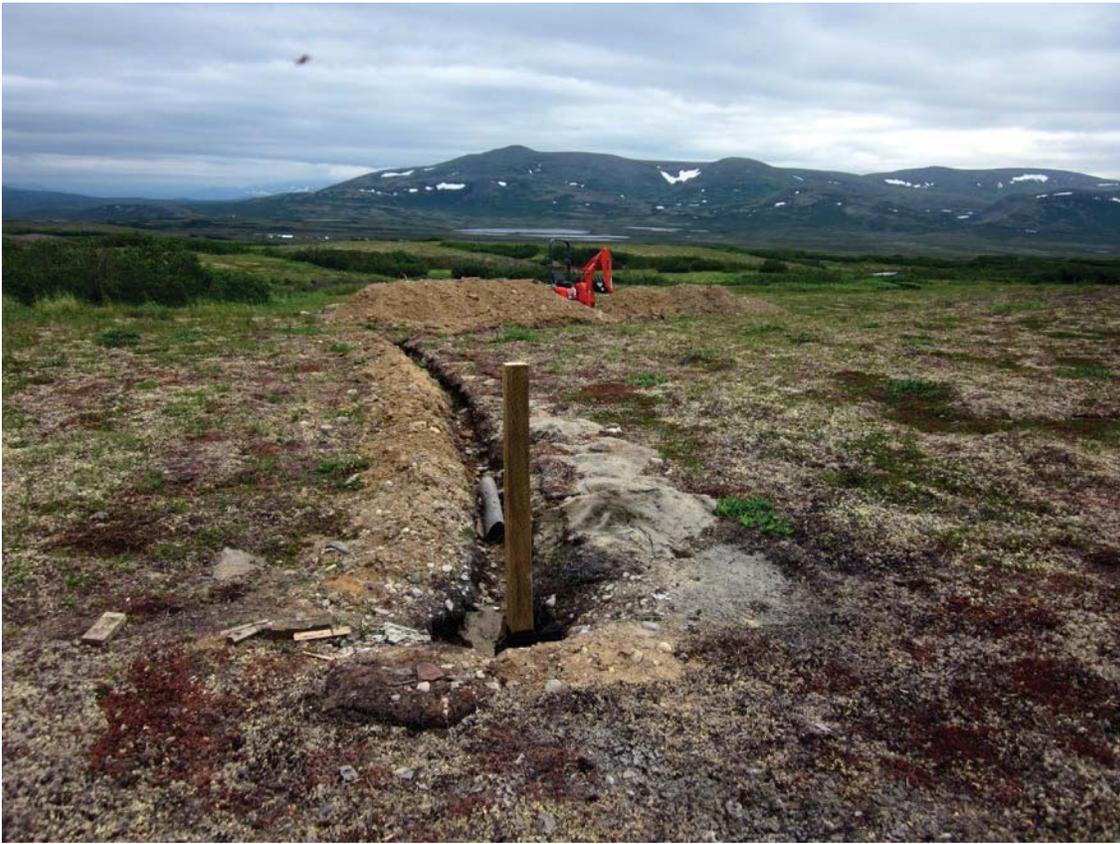
Photo 7: DDH 12561 – Drilled 2012 / Reclaimed 2013; Photo Taken Post Drilling on 28 June 2013; Looking East.

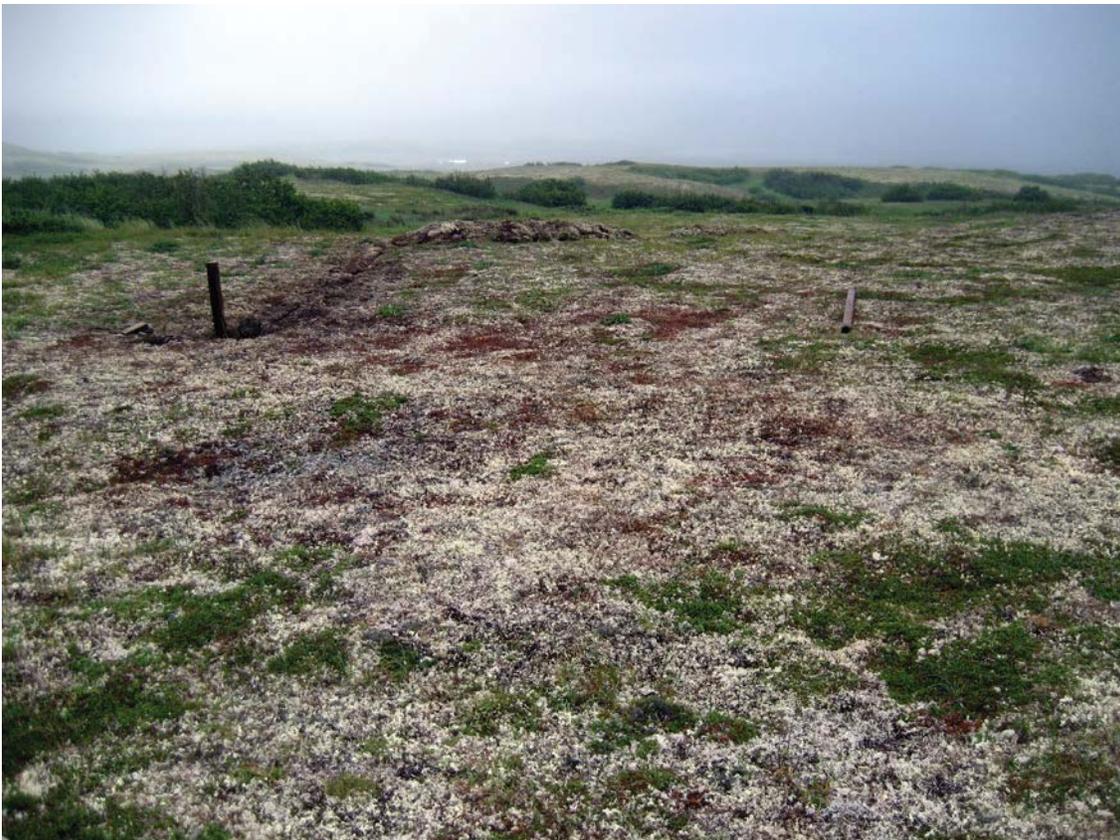
Photo 8: DDH 12561 – Photo Taken Post Reclamation on 18 July 2013; See Photo 7 for Reference; Looking East.

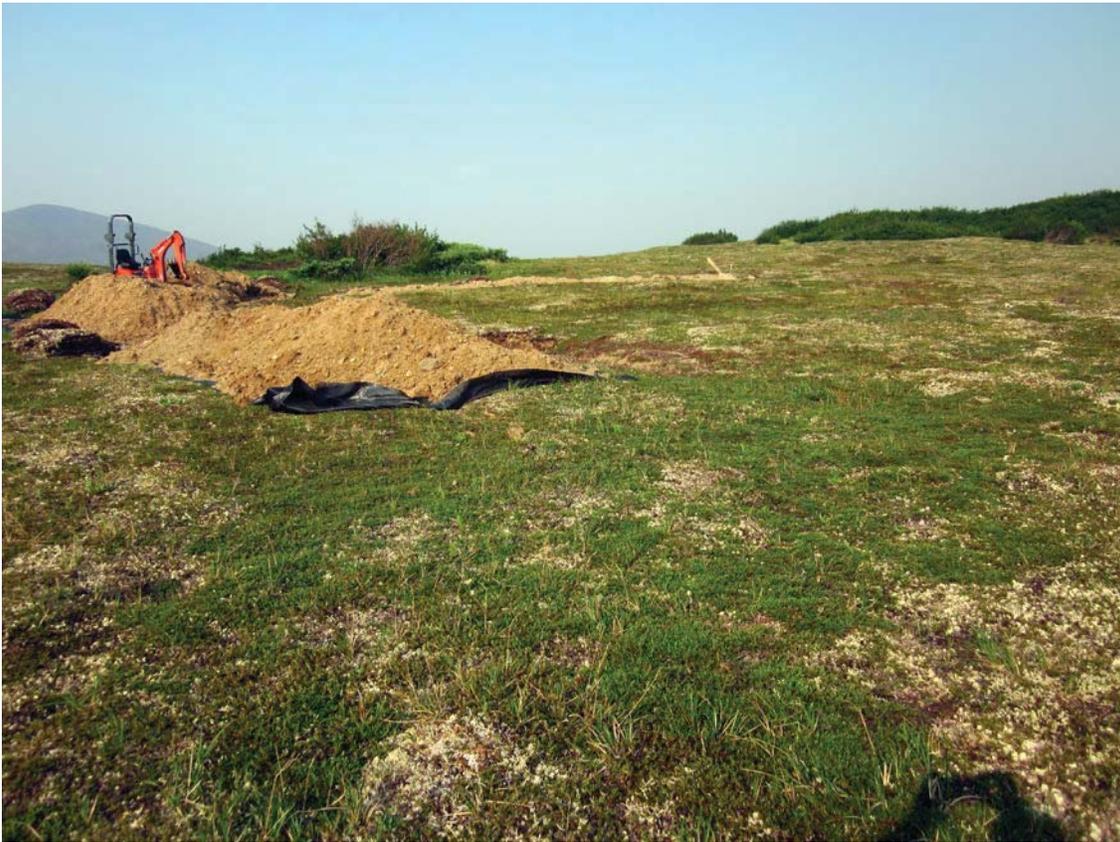
Photo 9: DDH 12562 – Drilled 2012 / Reclaimed 2013; Photo Taken Post Drilling on 26 June 2013; Looking West.

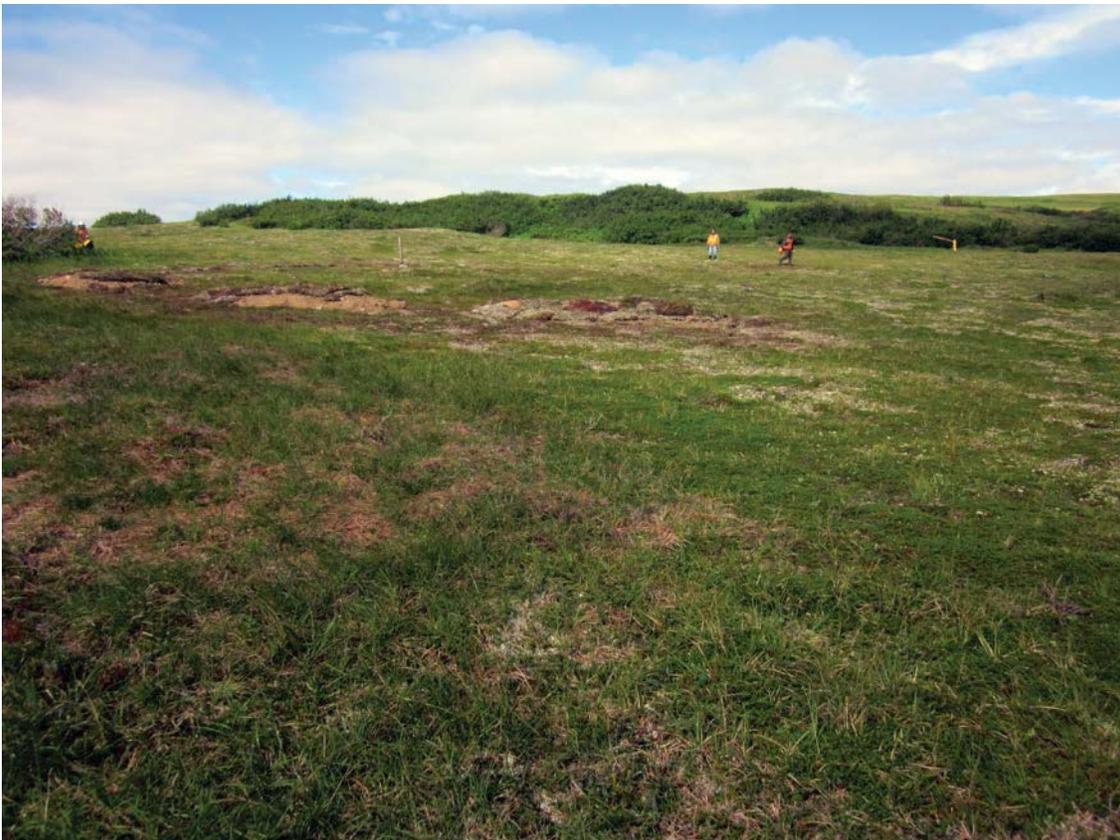
Photo 10: DDH 12562 – Photo Taken Post Reclamation on 21 July 2013; See Photo 9 for Reference; Looking West.

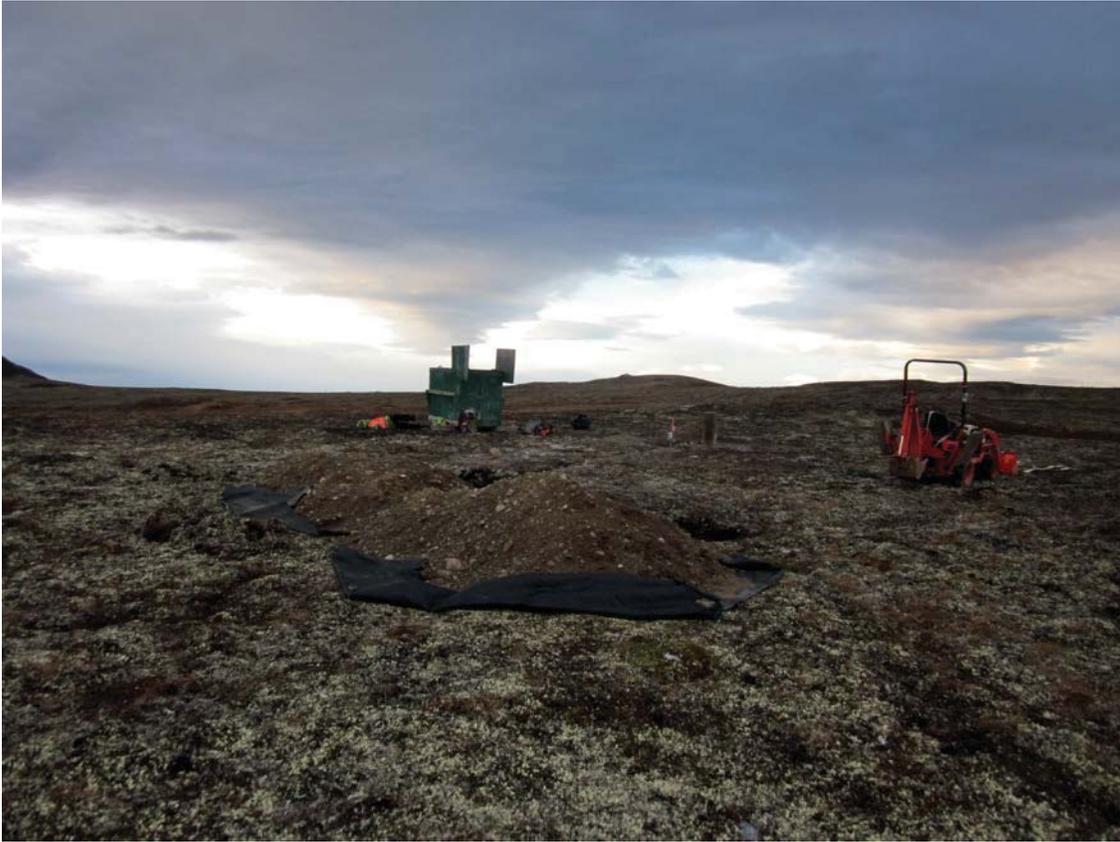
Photo 11: GH12-304S – Drilled 2012 / Reclaimed 2013; Photo Taken Post Drilling on 25 September 2012; Looking South.

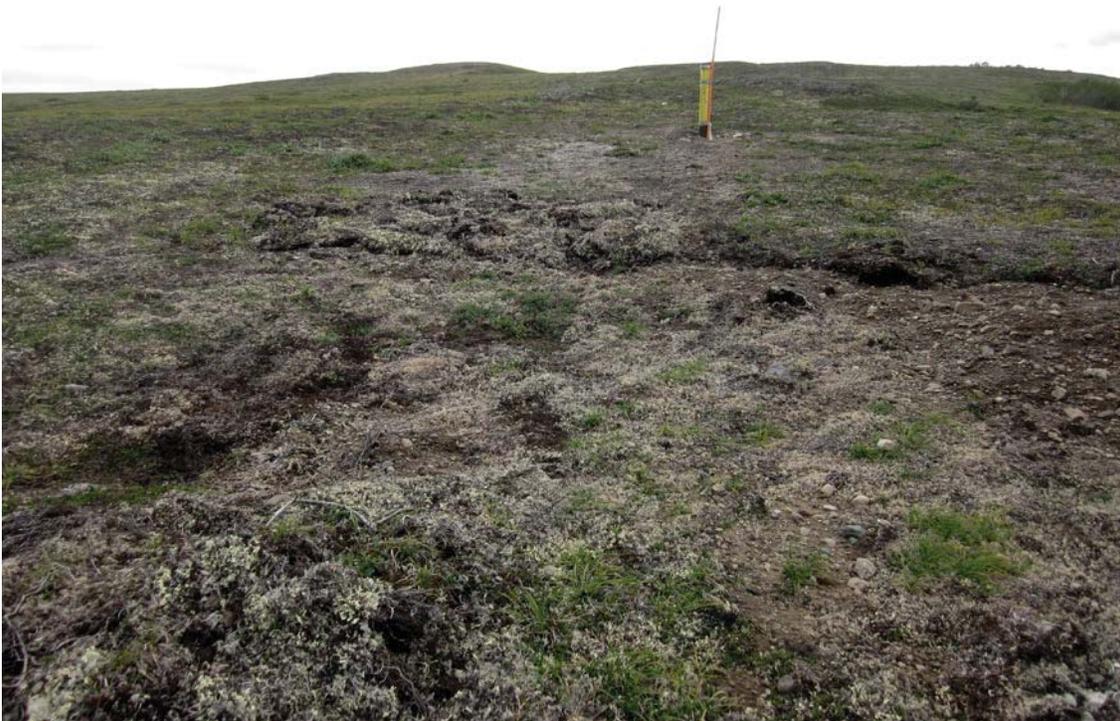
Photo 12: GH12-304S – Photo Taken Post Reclamation on 12 August 2013; See Photo 11 for Reference; Looking South.

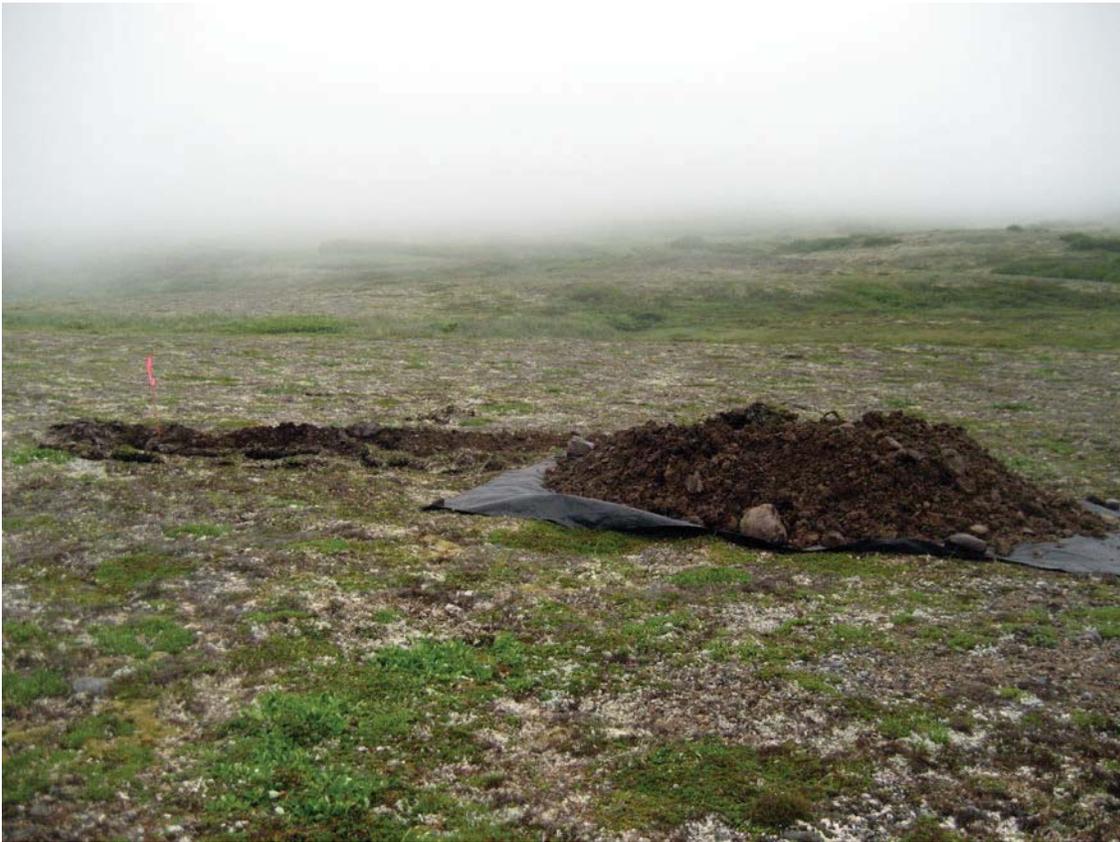
Photo 13: GH12-313S – Drilled 2012 / Reclaimed 2013; Photo Taken Post Drilling on 21 July 2013; Looking West.

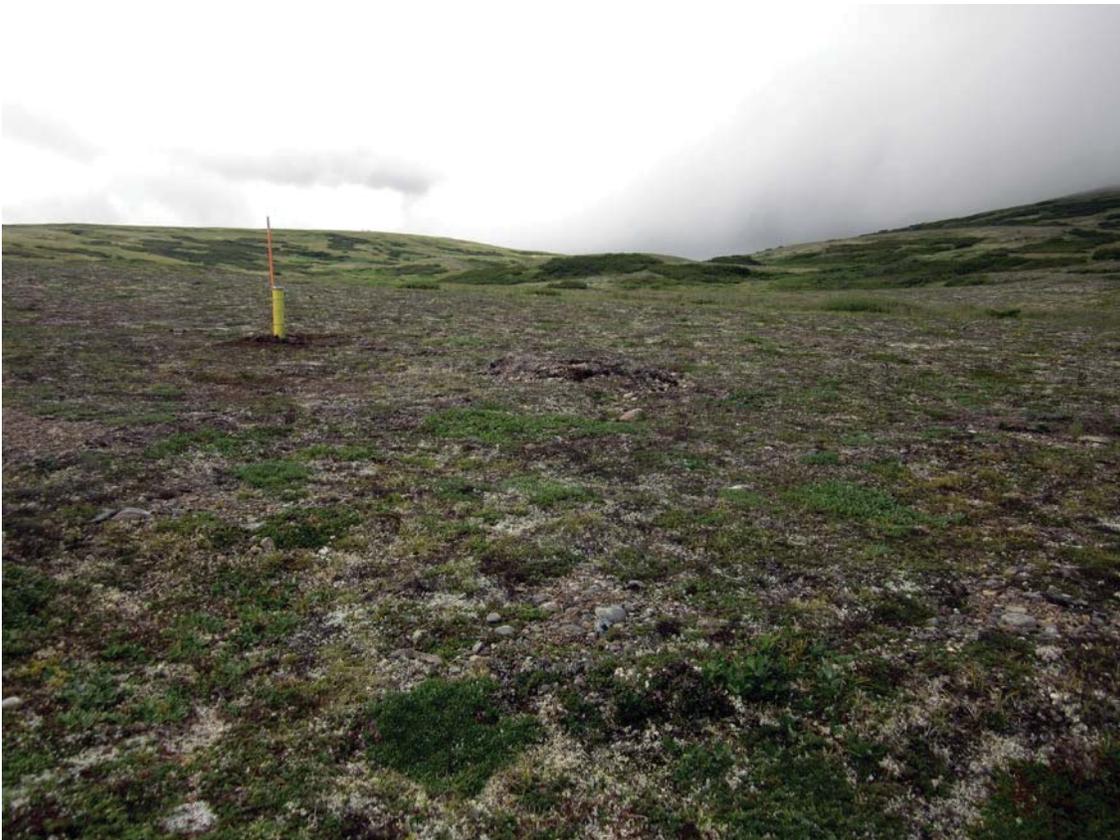
Photo 14: GH12-313S – Photo Taken Post Reclamation on 15 August 2013; See Photo 13 for Reference; Looking West.

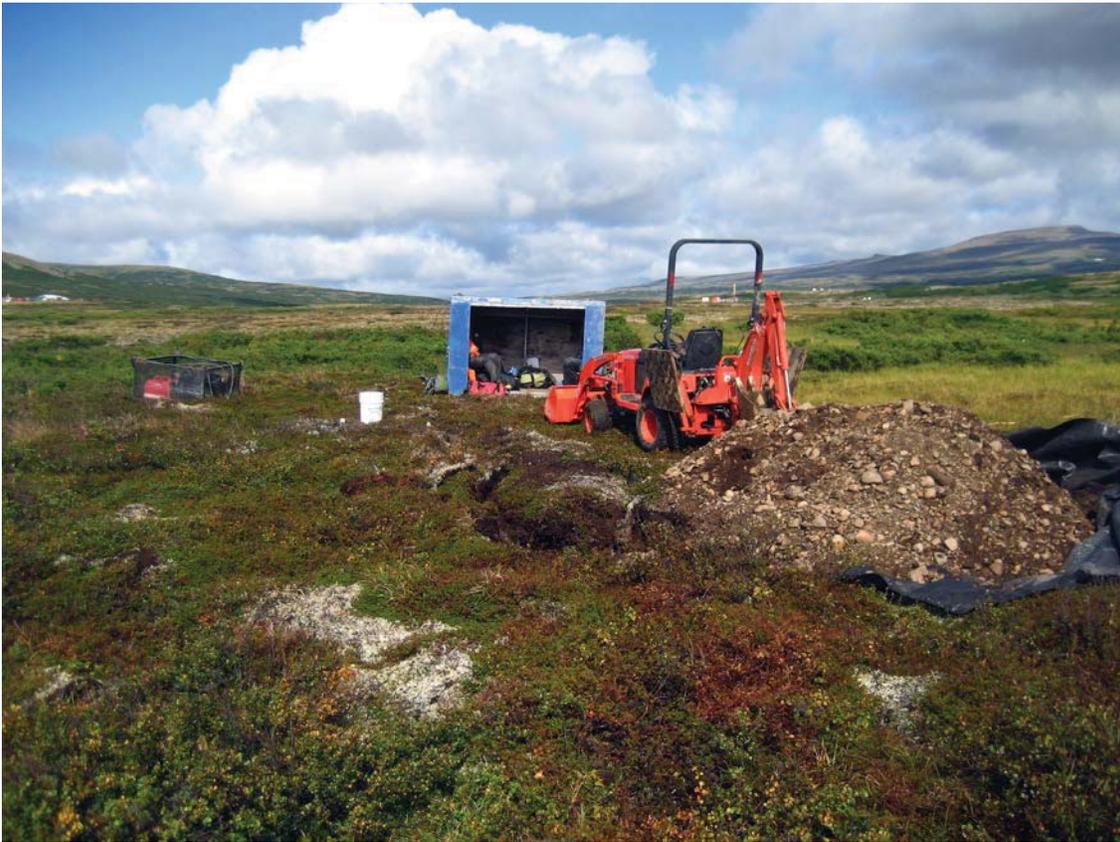
Photo 15: GH12-329S – Drilled 2012/ Reclaimed 2013; Photo Taken Post Drilling on 23 August 2012; Looking North.

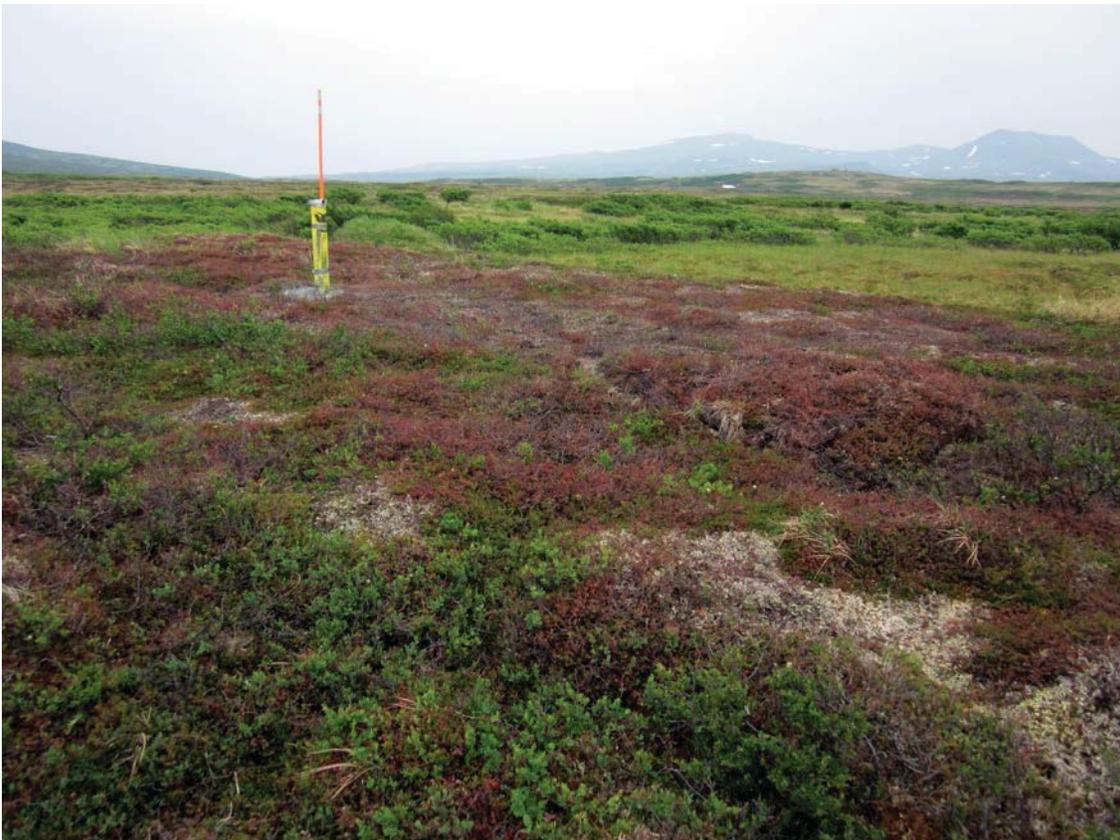
Photo 16: GH12-329S – Photo Taken Post Reclamation on 24 June 2013; See Photo 15 for Reference; Looking North.

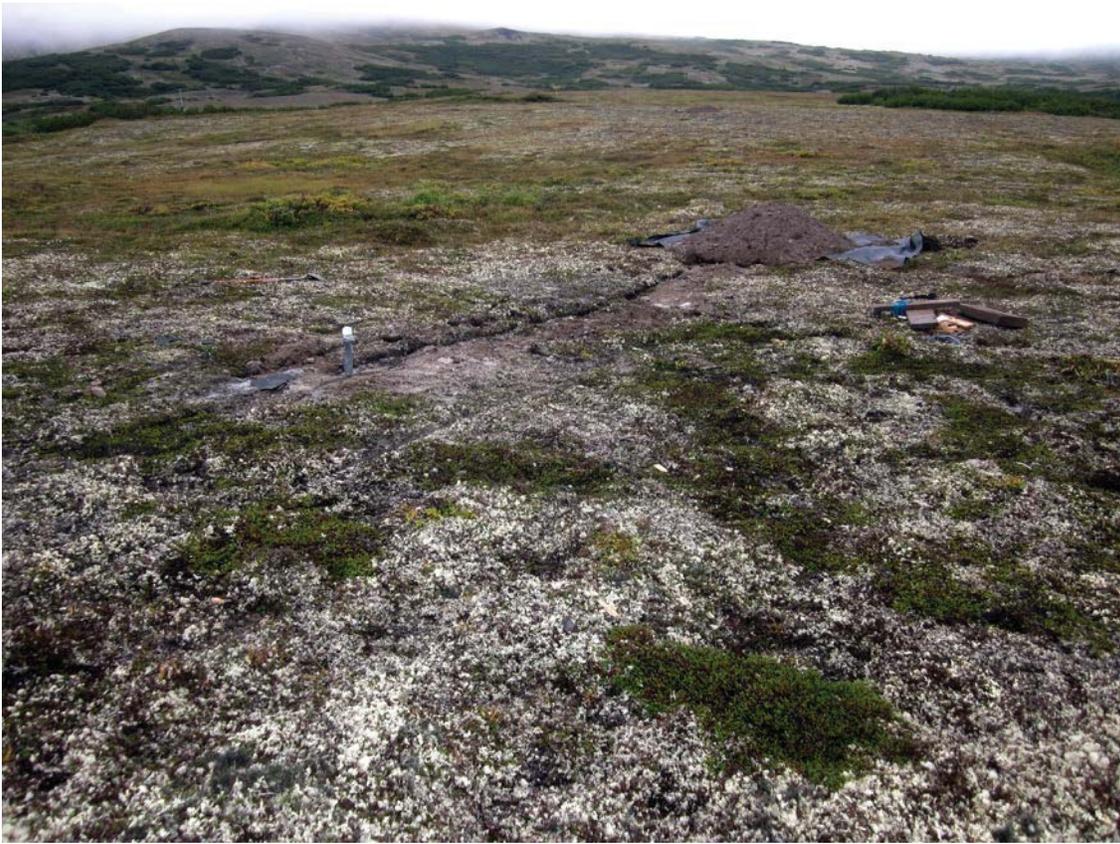
Photo 17: GH12-336S – Drilled 2012 / Reclaimed 2013; Photo Taken Post Drilling on 31 August 2012; Looking West.

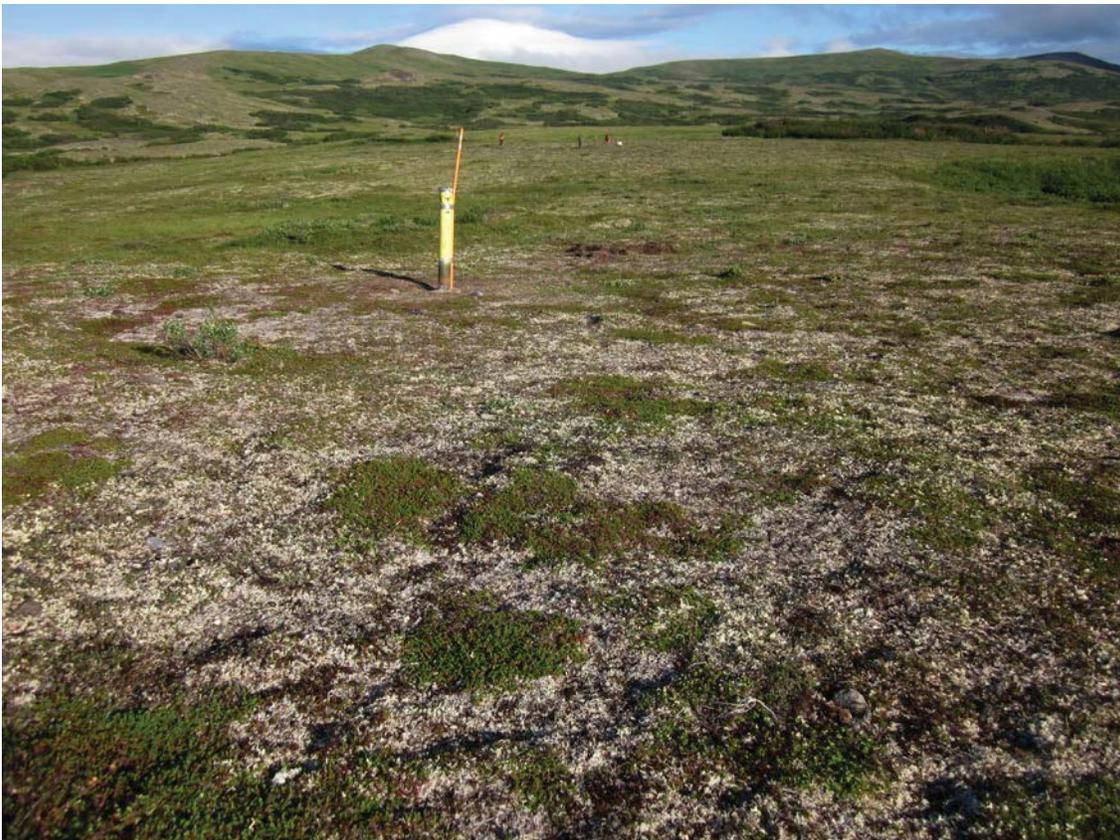
Photo 18: GH12-336S – Photo Taken Post Reclamation on 20 July 2013; See Photo 17 for Reference; Looking West.

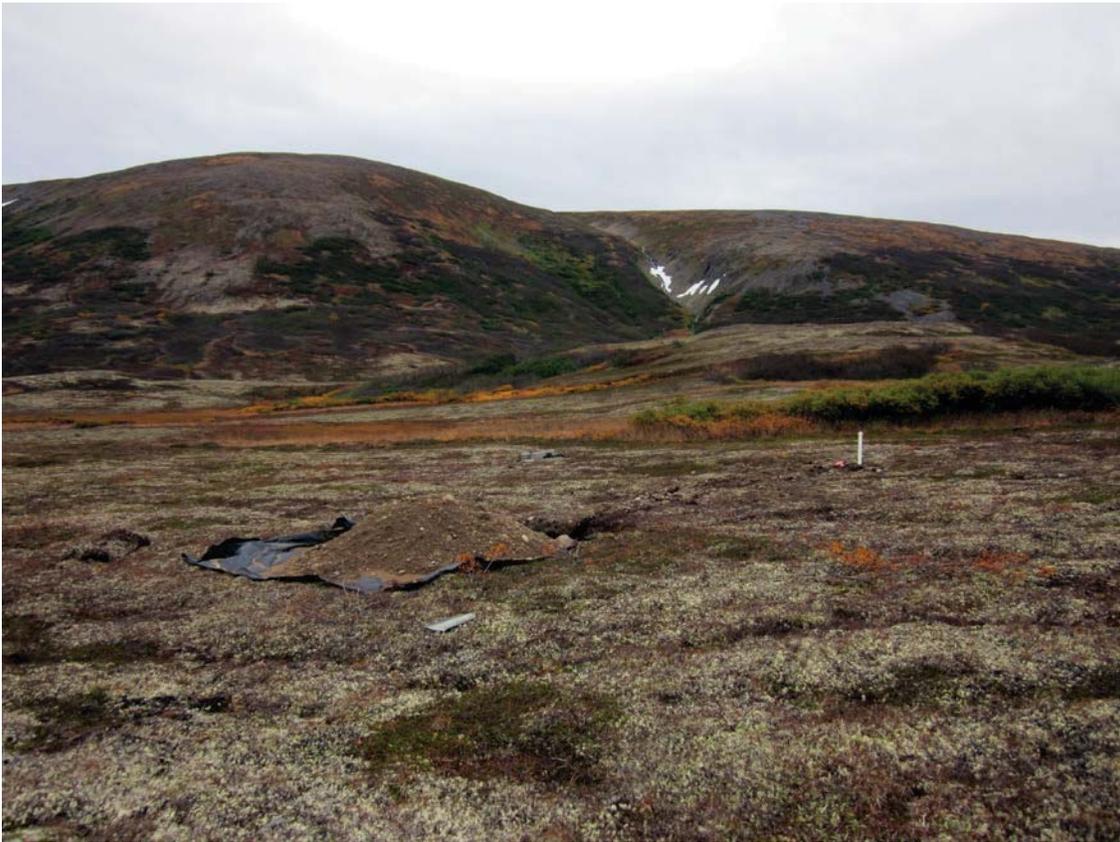
Photo 19: GH12-337S – Drilled 2012 / Reclaimed 2013; Photo Taken Post Drilling on 25 September 2012; Looking East.

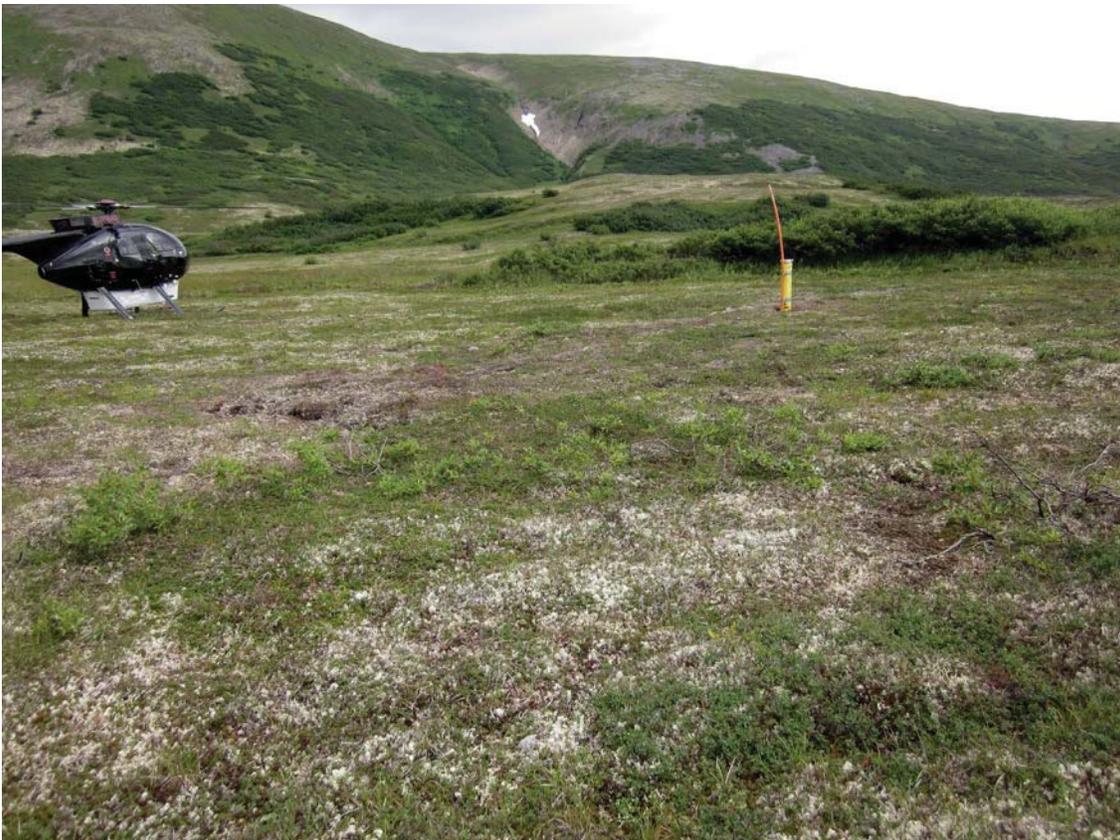
Photo 20: GH12-337S – Photo Taken Post Reclamation on 12 August 2013; See Photo 19 for Reference; Looking East.

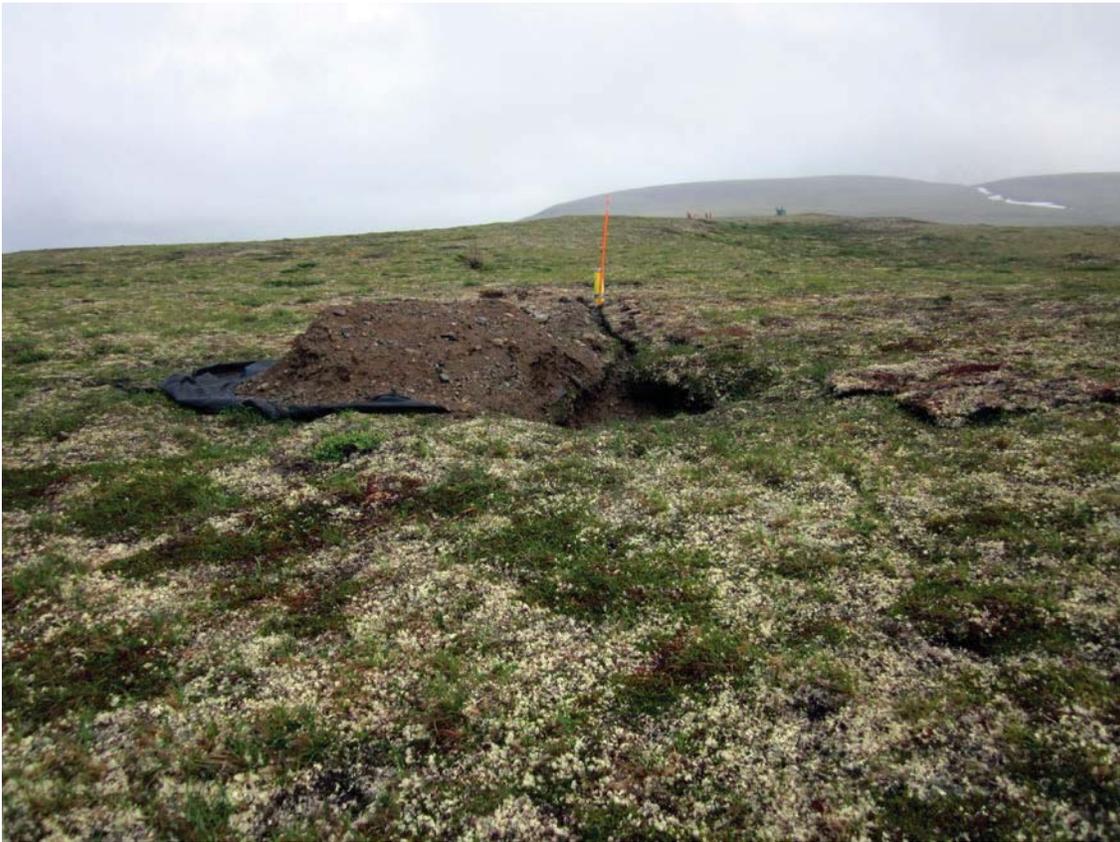
Photo 21: GH12-356S – Drilled 2012 / Reclaimed 2013; Photo Taken Post Drilling on 4 July 2013; Looking East.

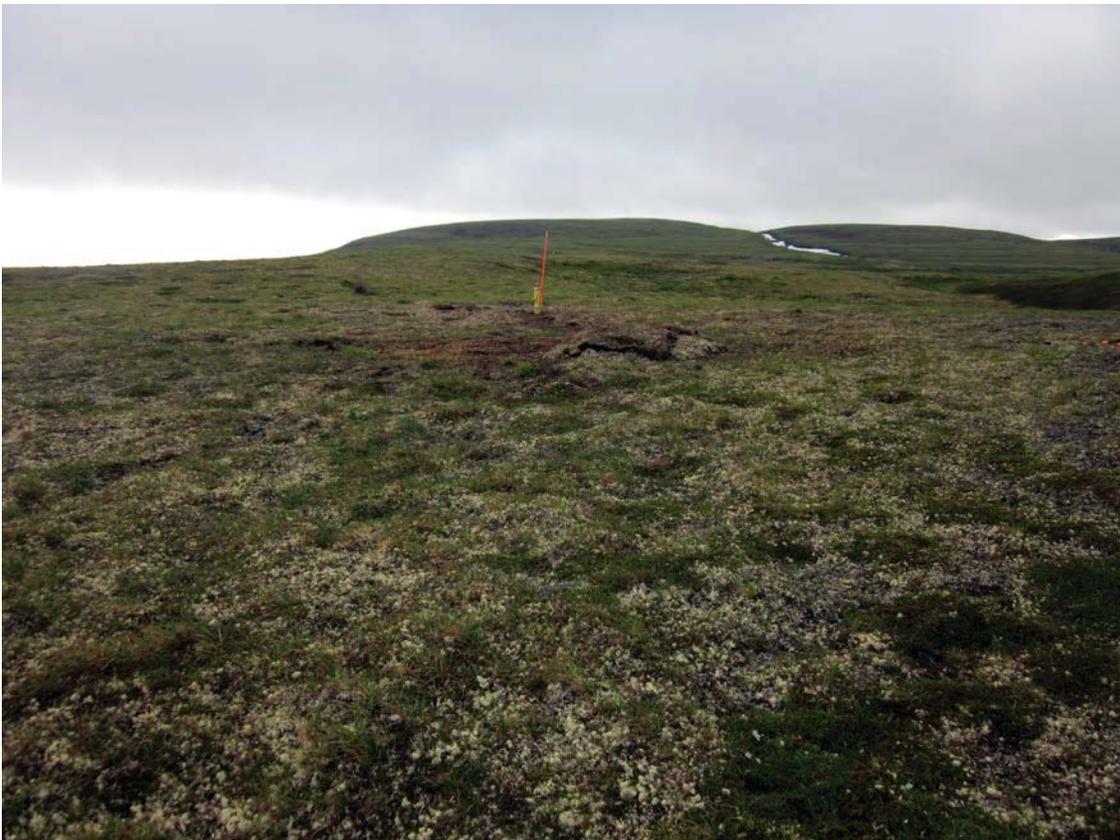
Photo 22: GH12-356S – Photo Taken Post Reclamation on 5 July 2013; See Photo 21 for Reference; Looking East.

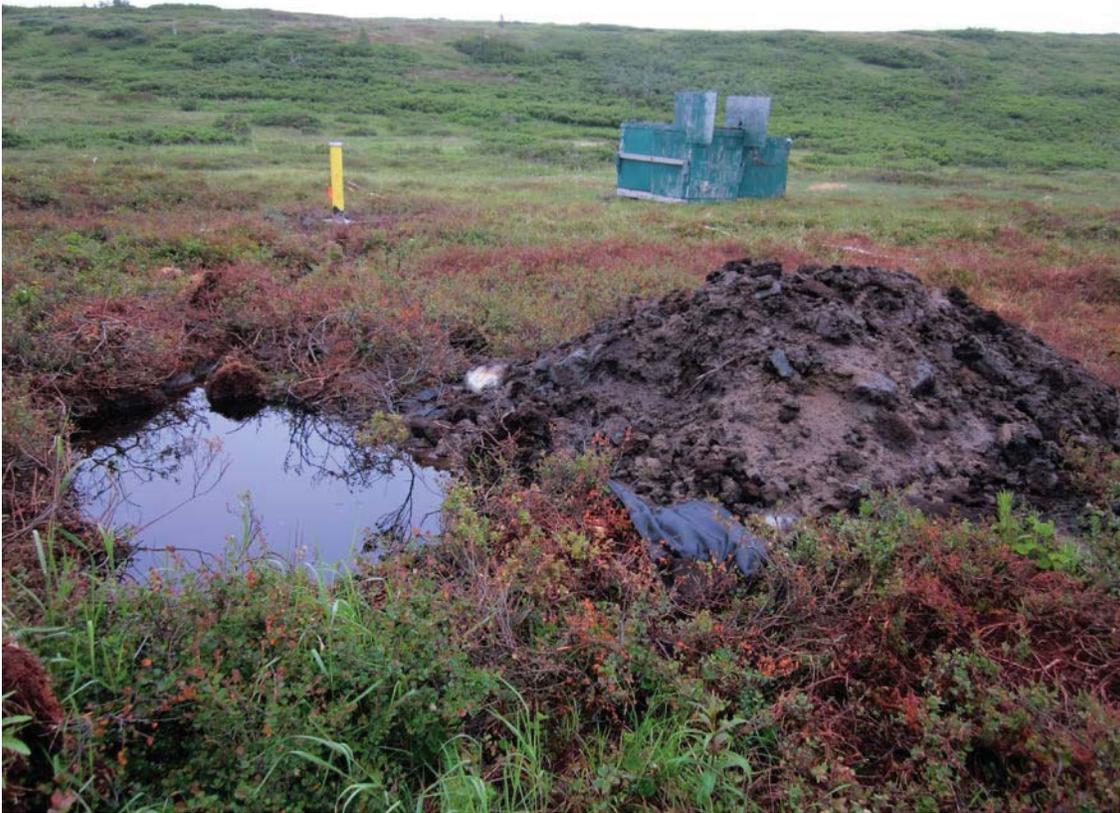
Photo 23: GH13-358 – Drilled / Reclaimed 2013; Photo Taken Post Drilling on 9 July 2013; Looking West.

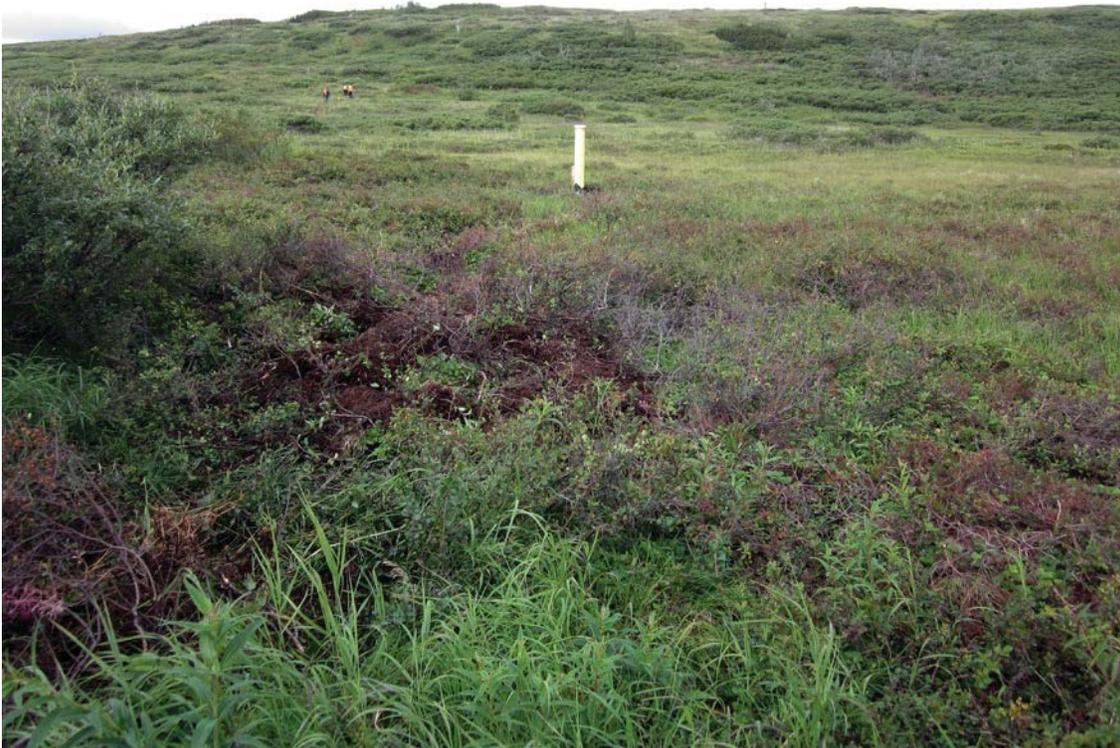
Photo 24: GH13-358 – Photo Taken Post Reclamation on 12 July 2013; See Photo 23 for Reference; Looking West.
