2013 Annual Reclamation Report

The Pebble Project

Iliamna, Alaska

Prepared by: JBN Consultants, Inc.
Eagle River, Alaska

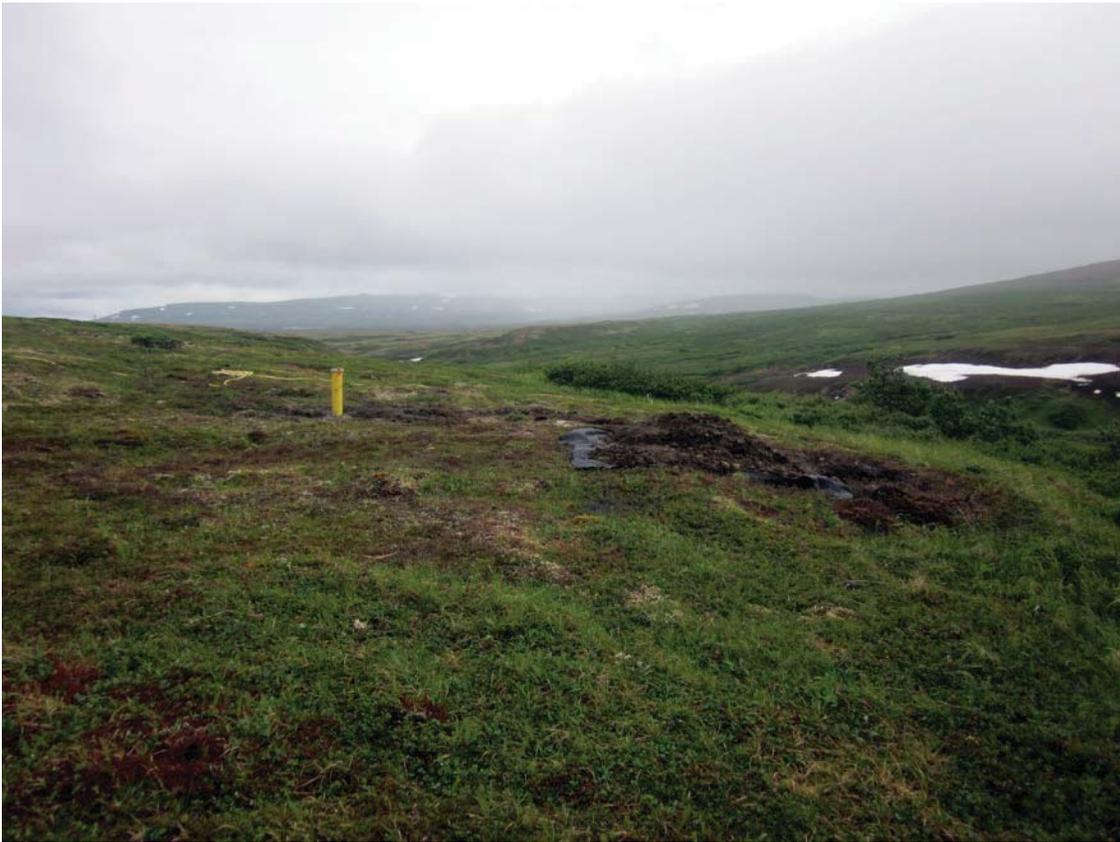
Photo 25: GH13-359 – Drilled / Reclaimed 2013; Photo Taken Post Drilling on 7 July 2013; Looking North.

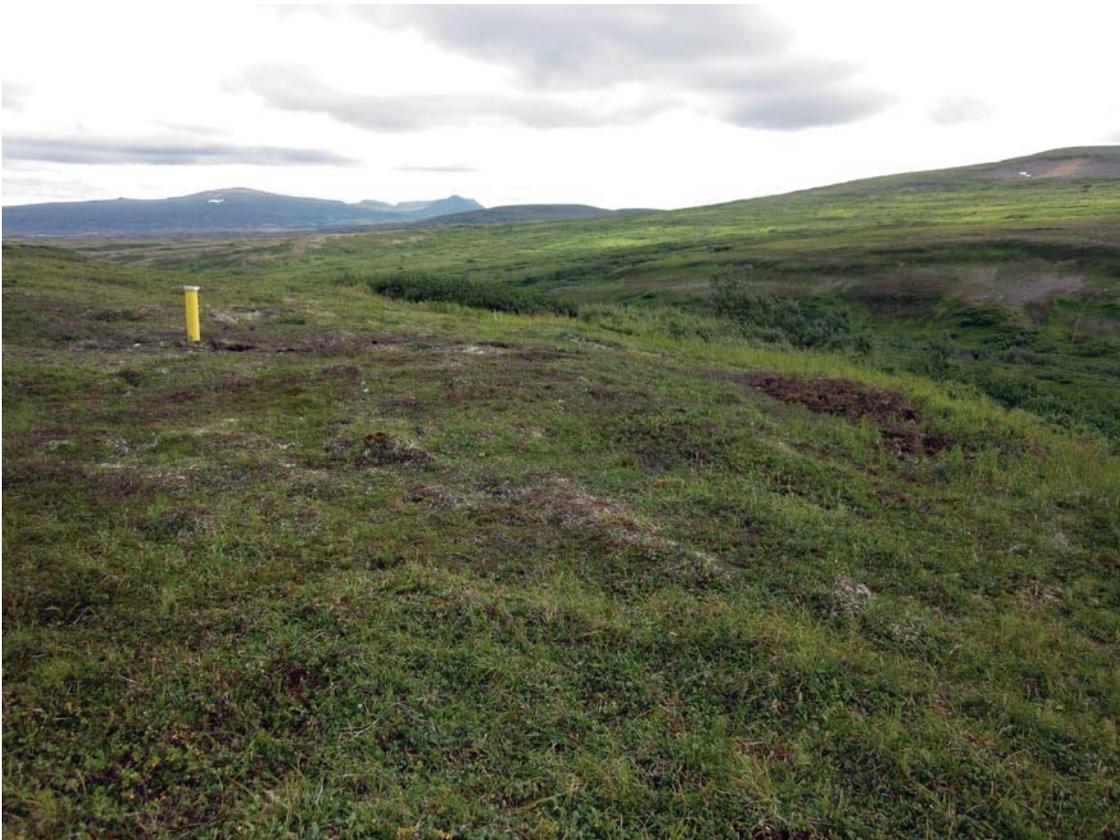
Photo 26: GH13-359 – Photo Taken Post Reclamation on 12 August 2013; See Photo 25 for Reference; Looking North.

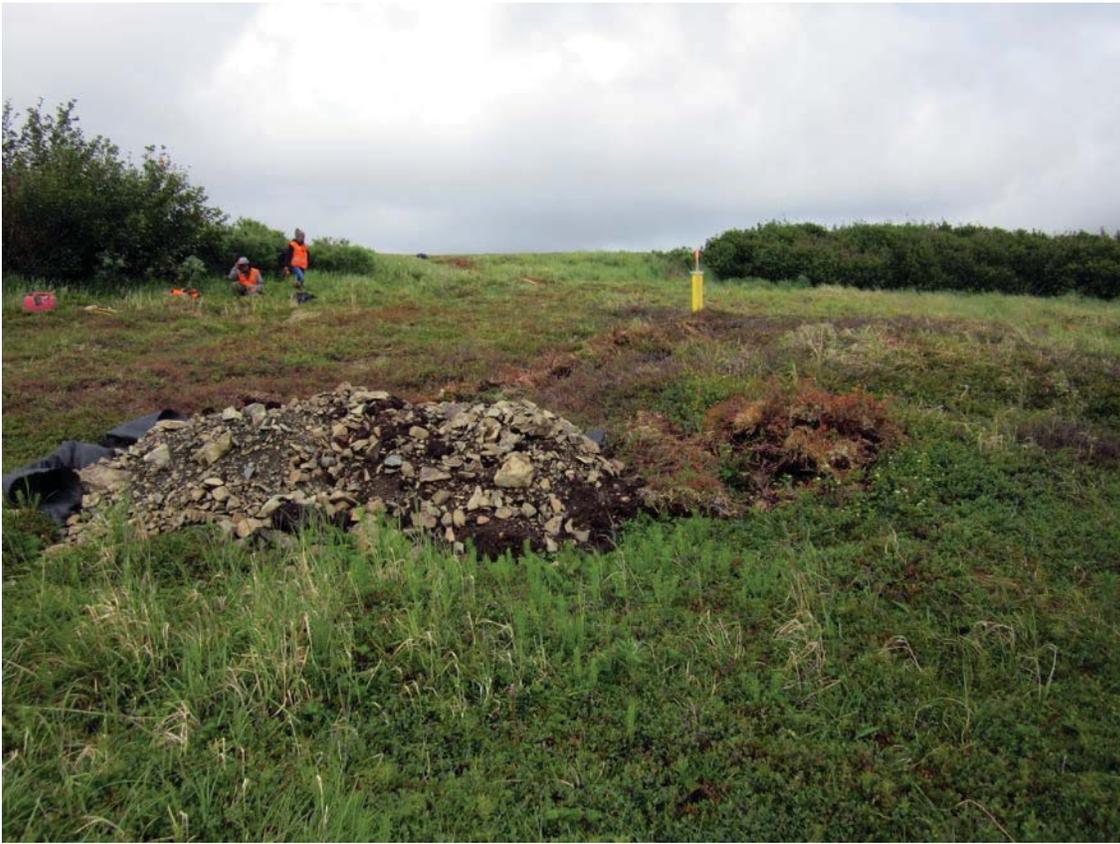
Photo 27: GH13-360 – Drilled / Reclaimed 2013; Photo Taken Post Drilling on 7 July 2013; Looking West.

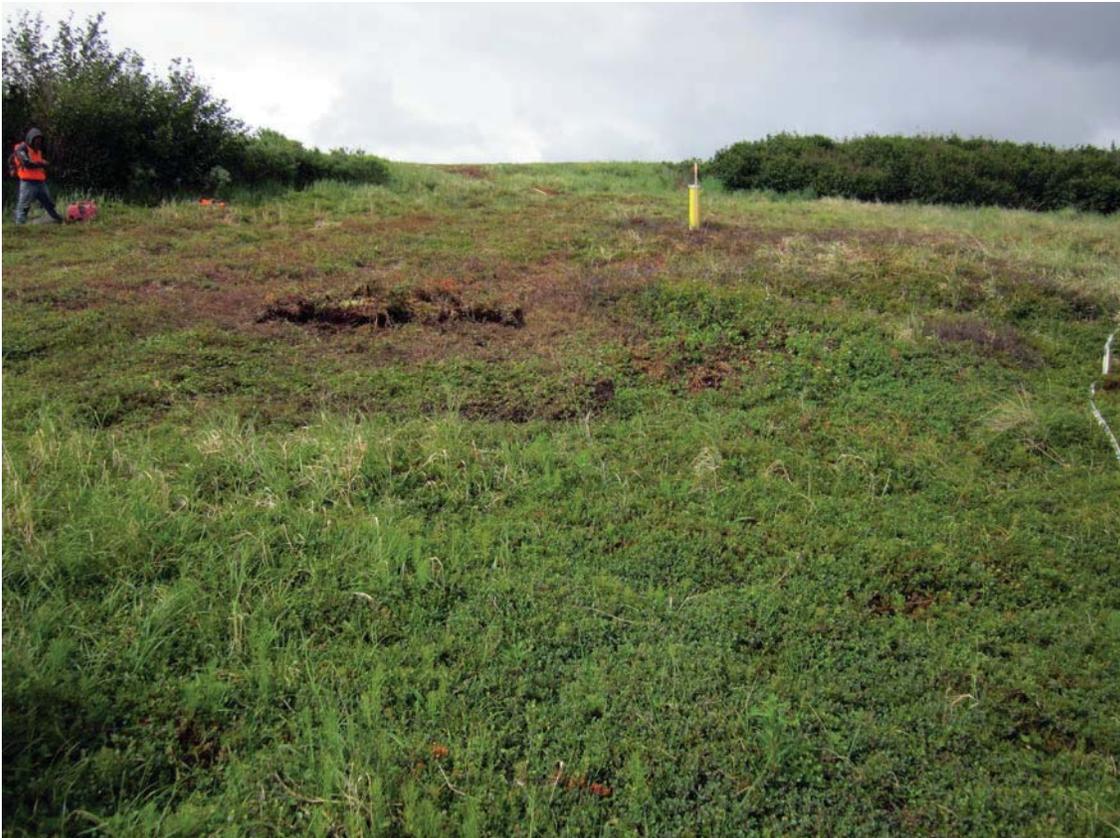
Photo 28: GH13-360 – Photo Taken Post Reclamation on 7 July 2013; See Photo 27 for Reference; Looking West.

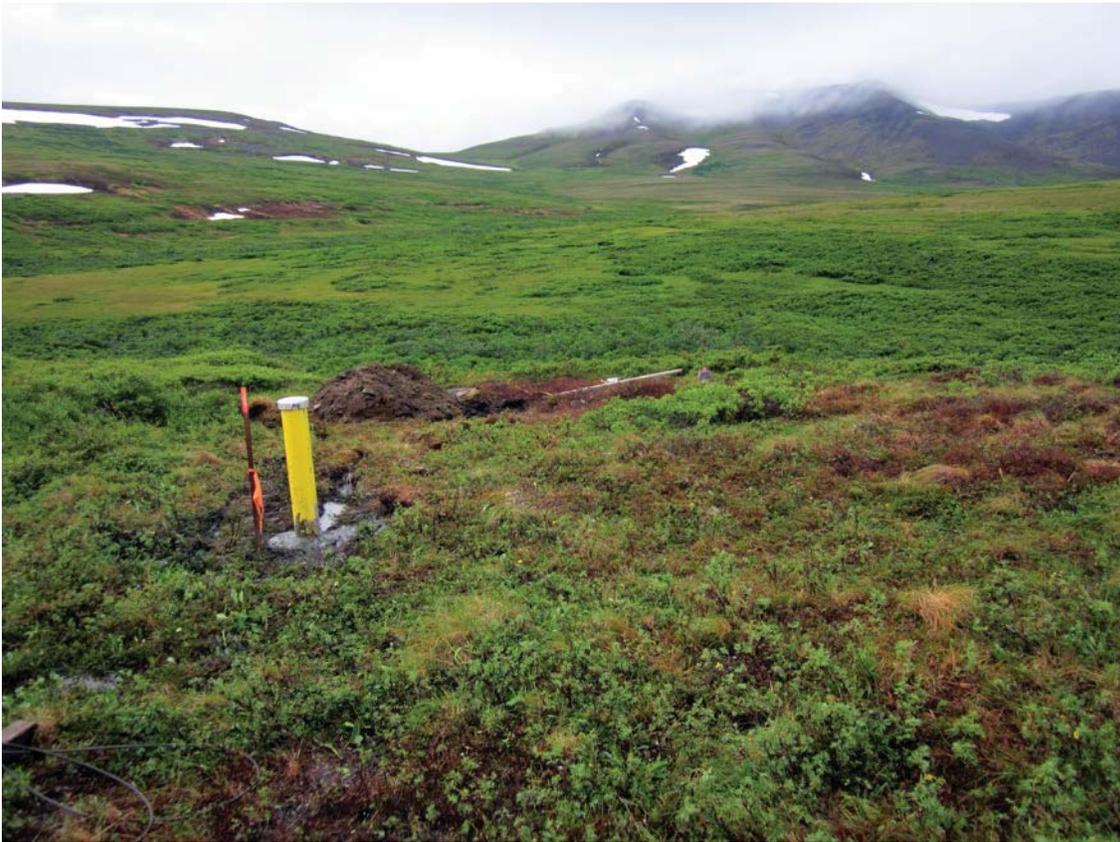
Photo 29: GH13-361 – Drilled / Reclaimed 2013; Photo Taken Post Drilling on 7 July 2013; Looking East.

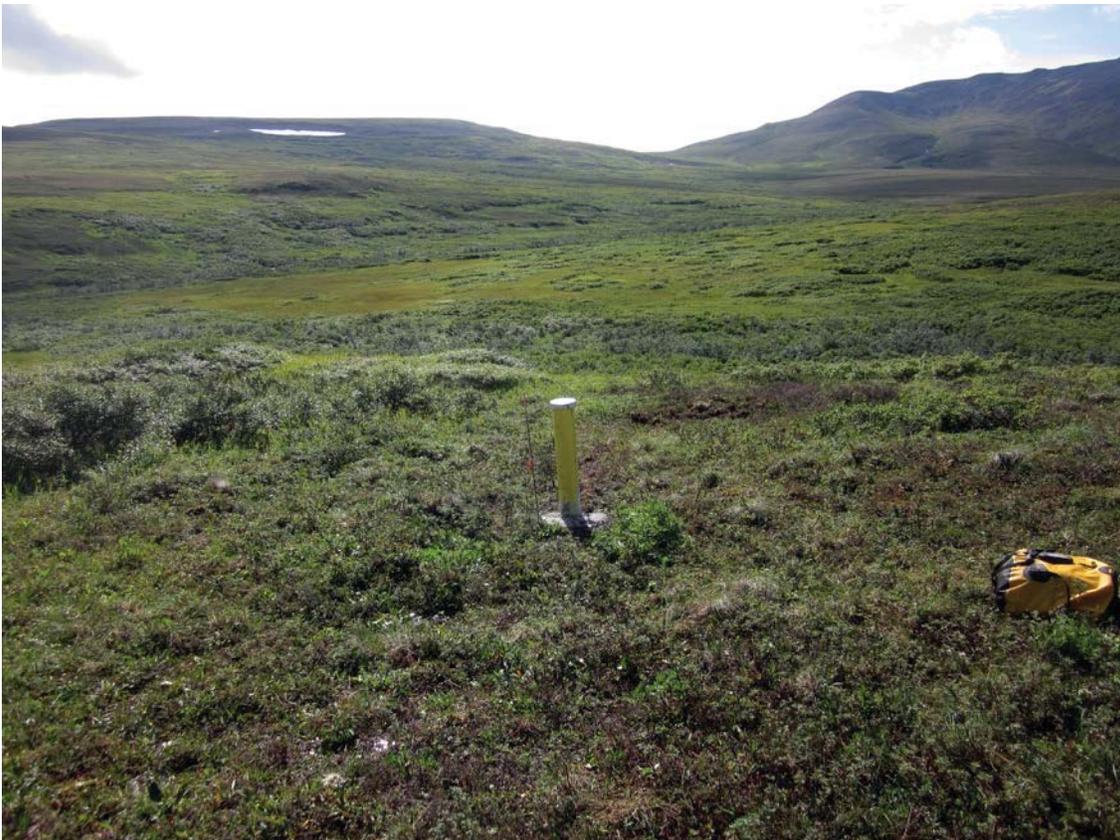
Photo 30: GH13-361 – Photo Taken Post Reclamation on 12 August 2013; See Photo 29 for Reference; Looking East.

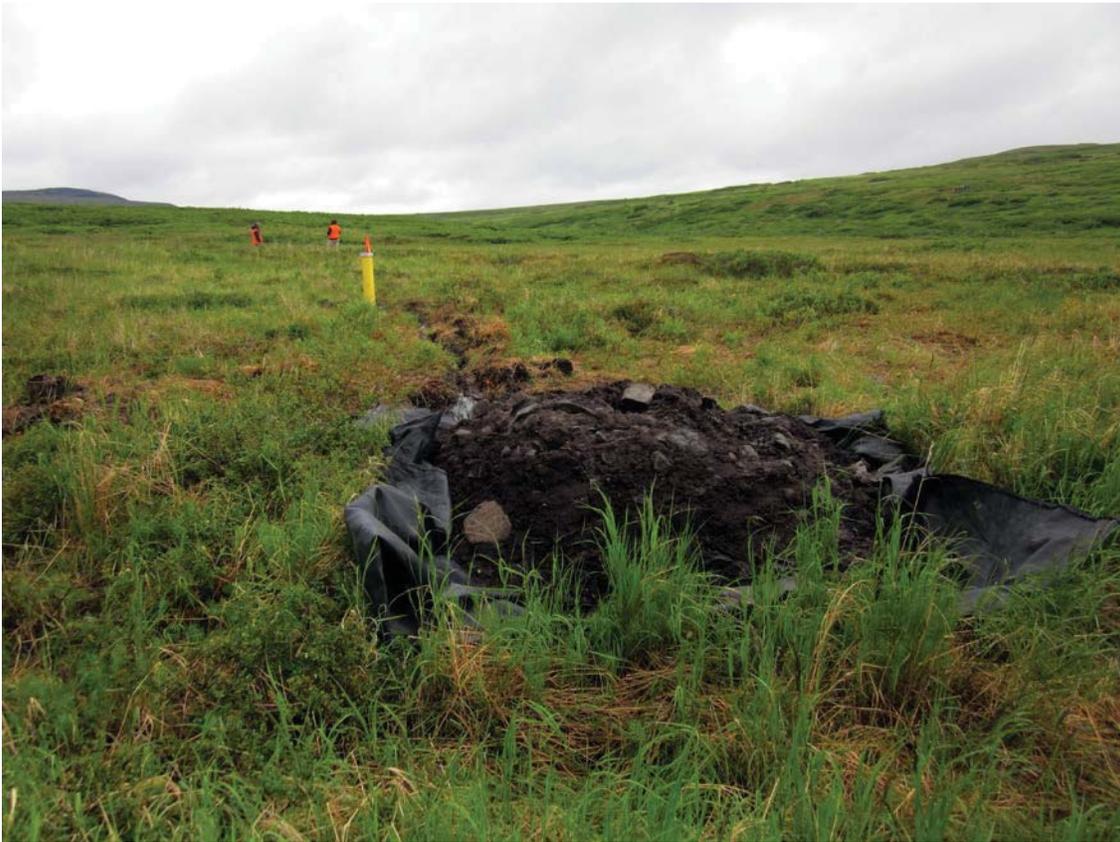
Photo 31: GH13-362 – Drilled / Reclaimed 2013; Photo Taken Post Drilling on 8 July 2013; Looking West.

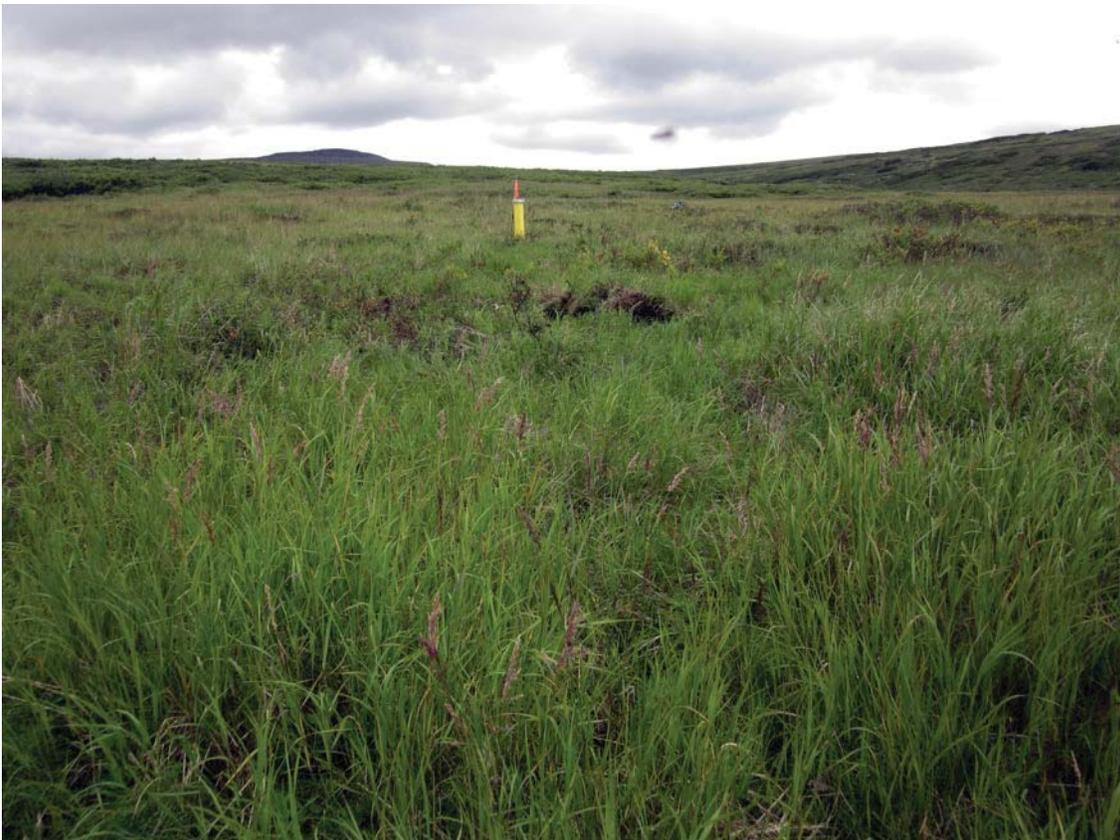
Photo 32: GH13-362 – Photo Taken Post Reclamation on 12 August 2013; See Photo 31 for Reference; Looking West.

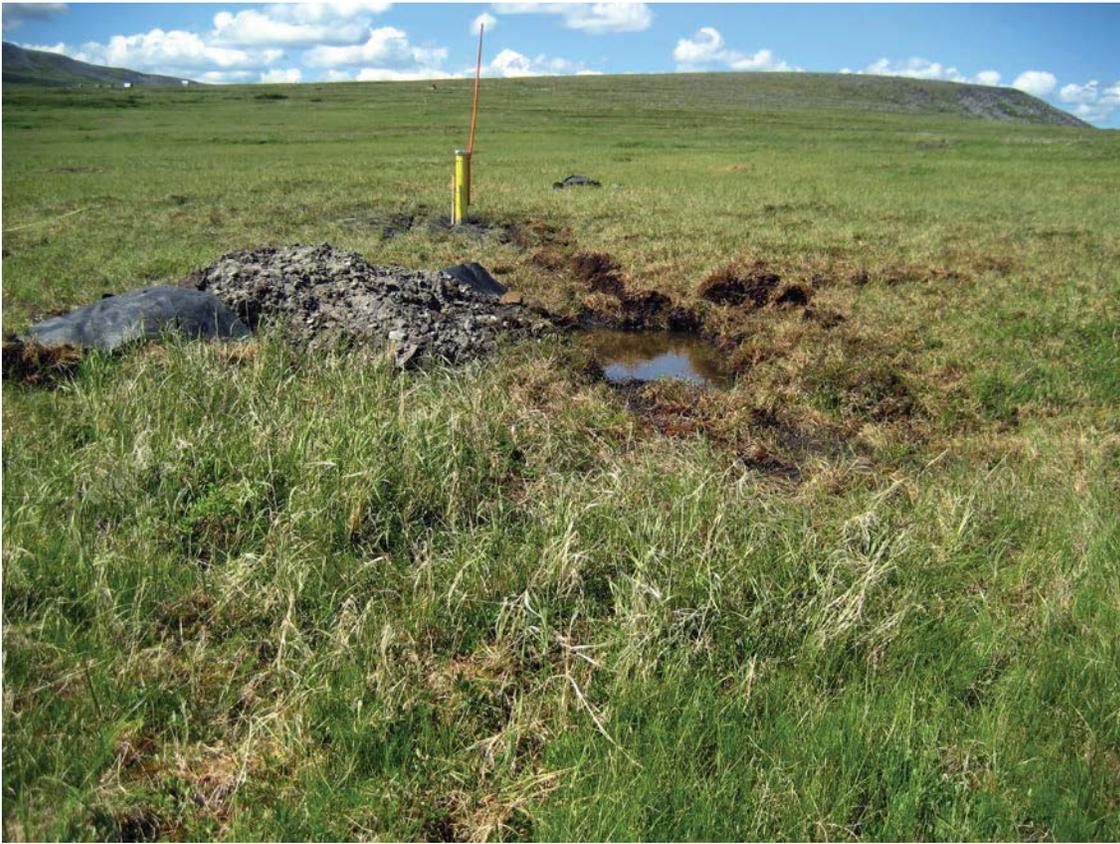
Photo 33: GH13-364 – Drilled / Reclaimed 2013; Photo Taken Post Drilling on 11 July 2013; Looking West.

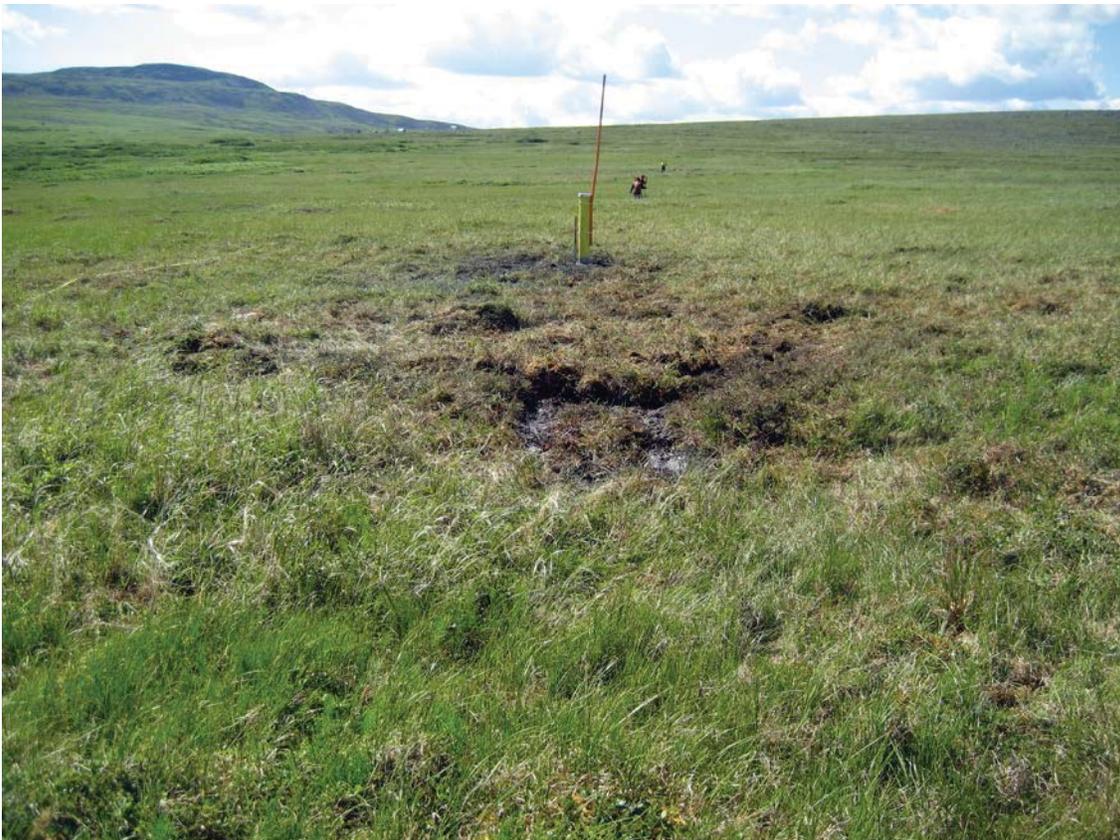
Photo 34: GH13-364 – Photo Taken Post Reclamation on 11 July 2013; See Photo 33 for Reference; Looking West.

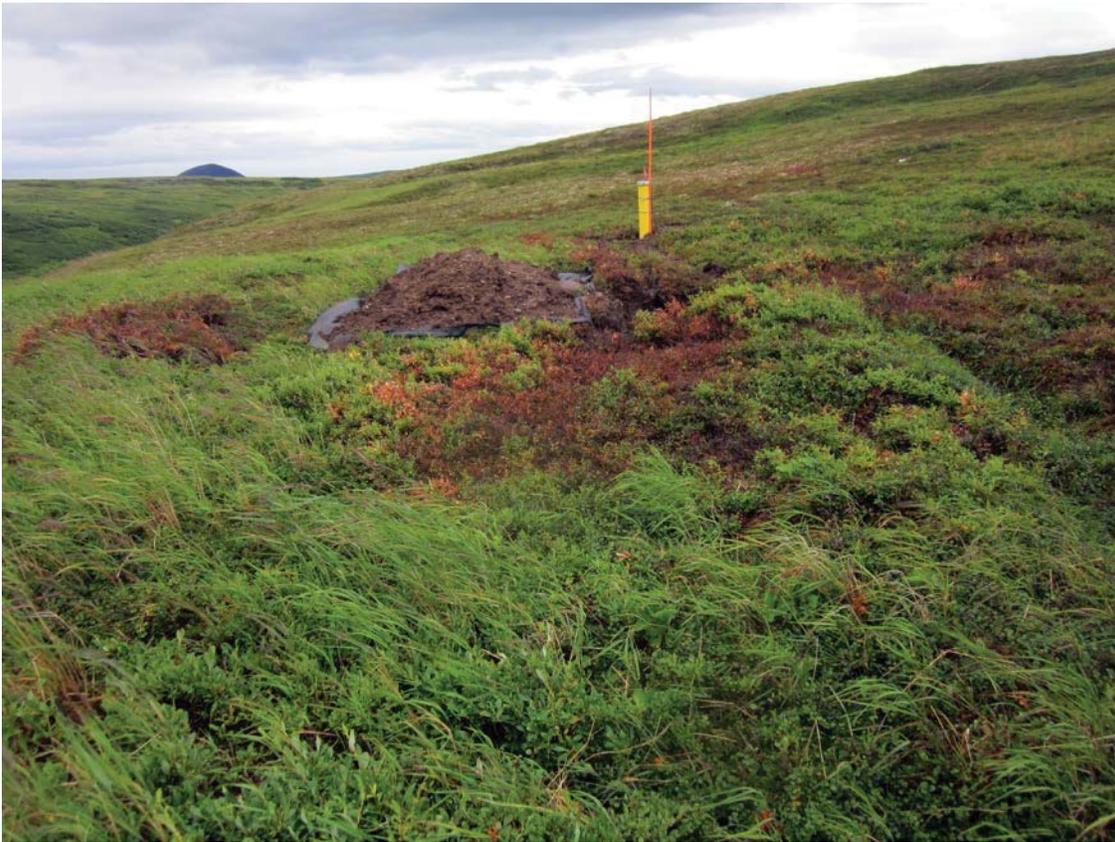
Photo 35: GH13-369 – Drilled / Reclaimed 2013; Photo Taken Post Drilling on 6 August 2013; Looking North.

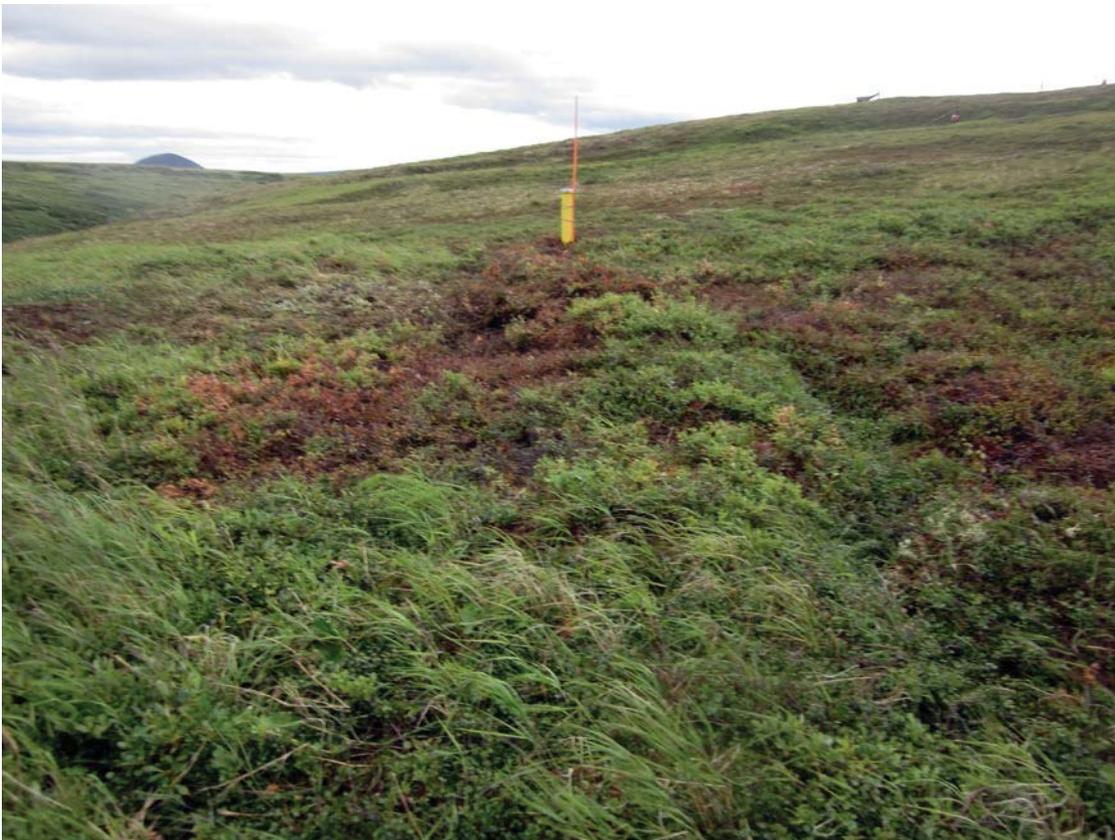
Photo 36: GH13-369 – Photo Taken Post Reclamation on 6 August 2013; See Photo 35 for Reference; Looking North.

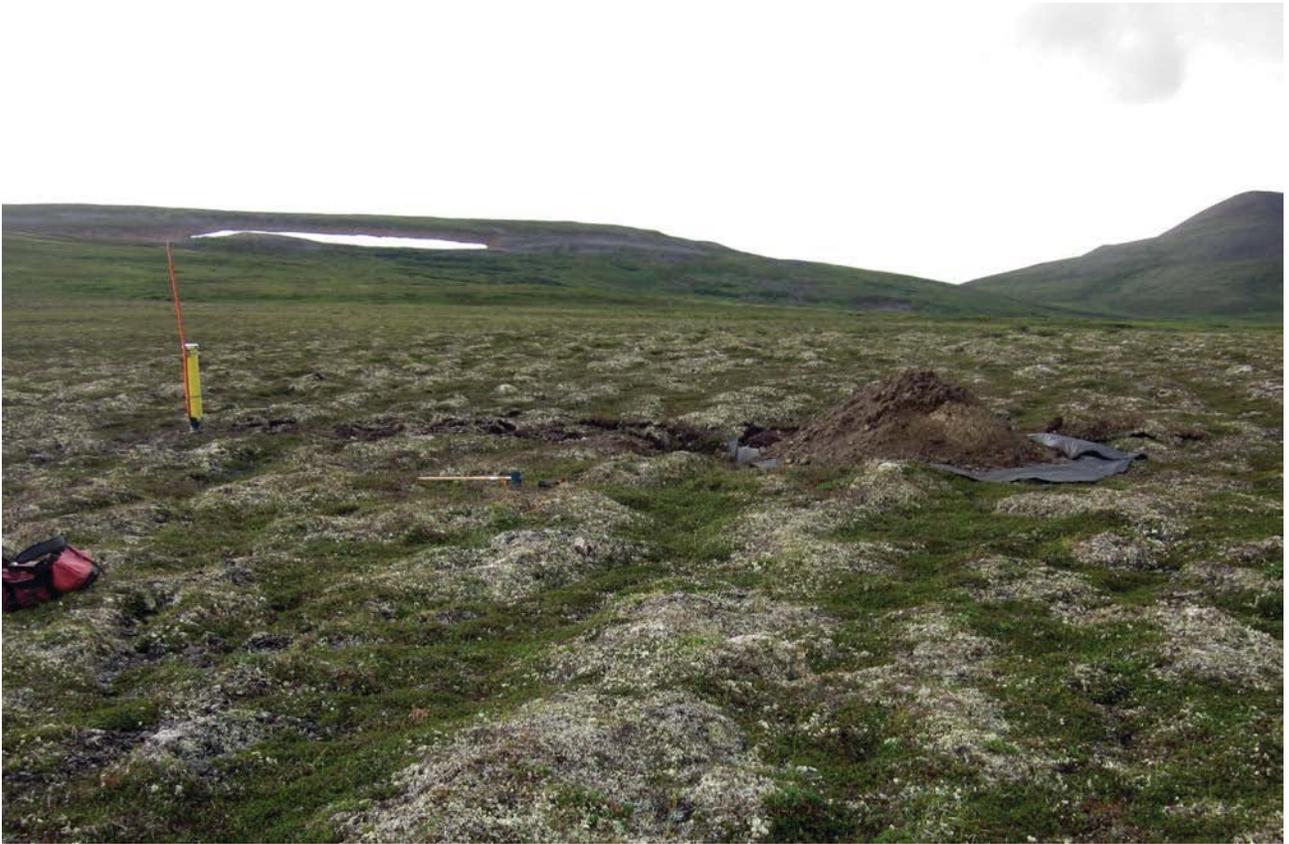
Photo 37: GH13-371 – Drilled / Reclaimed 2013; Photo Taken Post Drilling on 6 August 2013; Looking East.

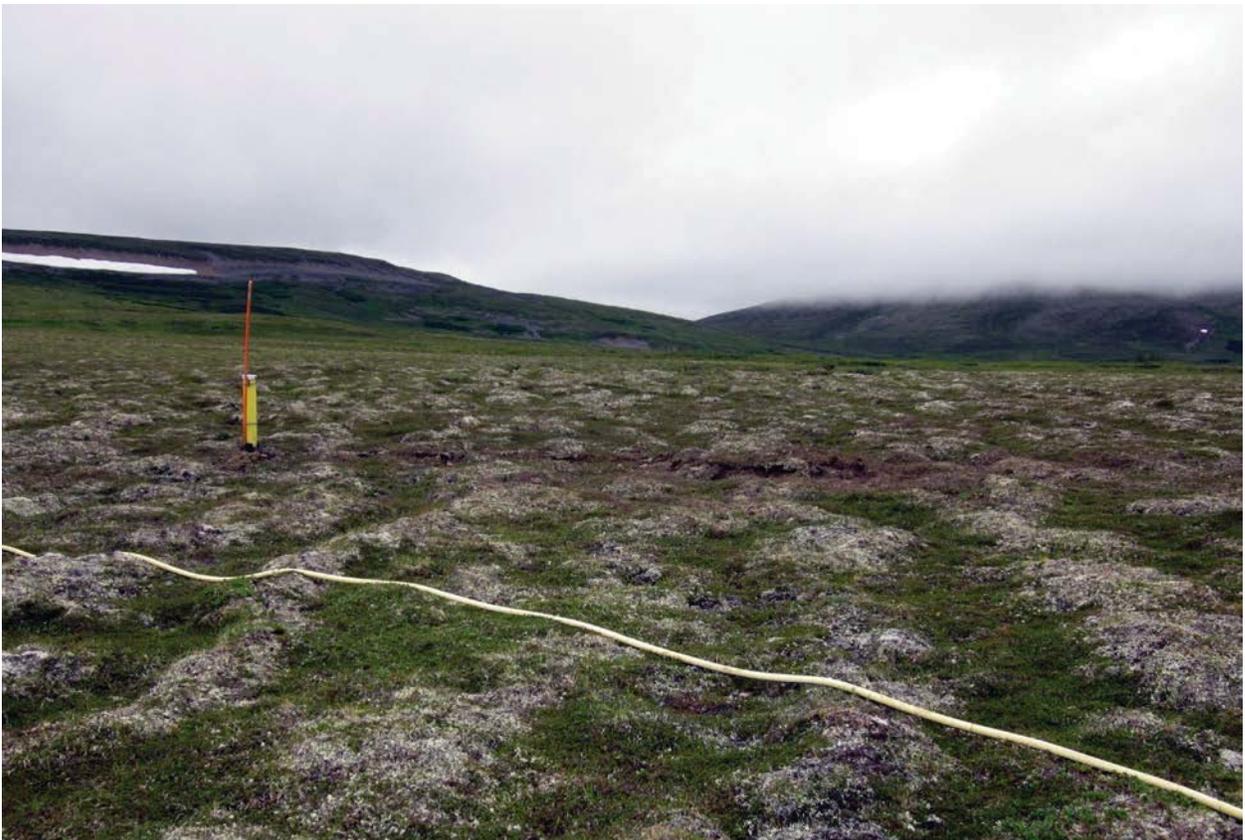
Photo 38: GH13-371 – Photo Taken Post Reclamation on 7 August 2013; See Photo 37 for Reference; Looking East.

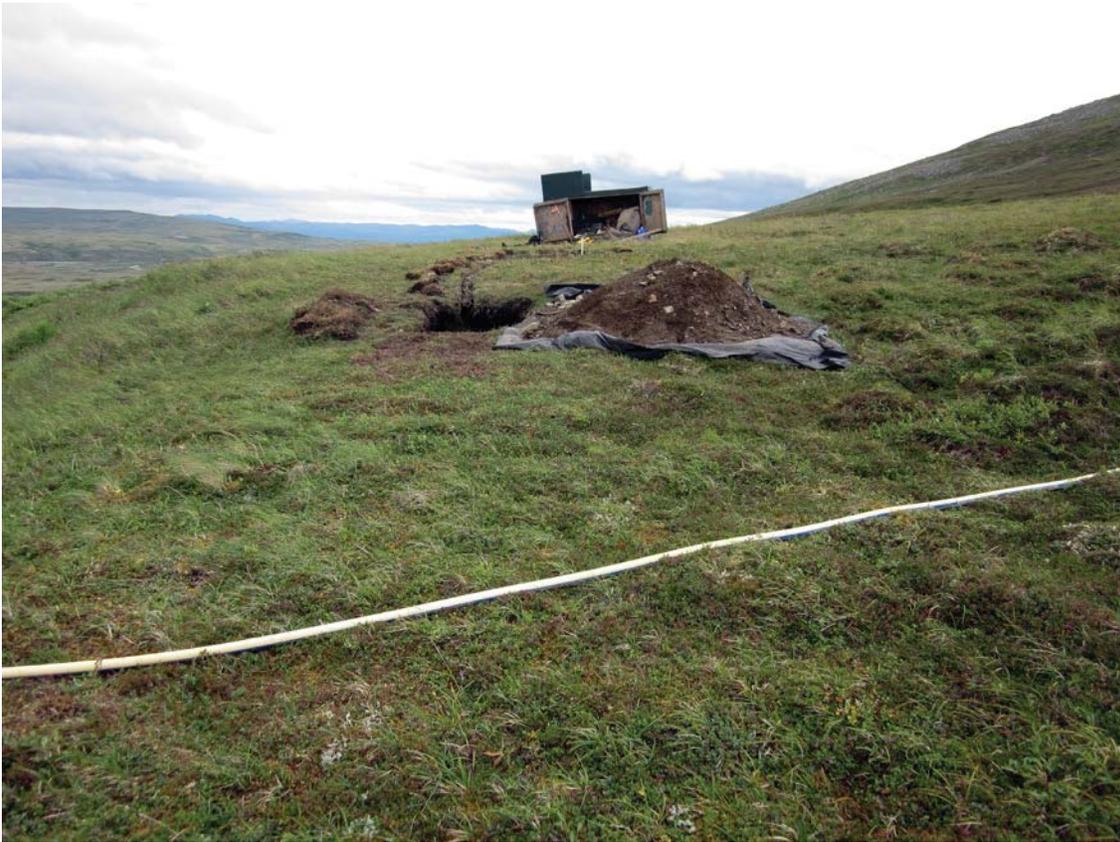
Photo 39: GH13-373 – Drilled / Reclaimed 2013; Photo Taken Post Drilling on 6 August 2013; Looking North.

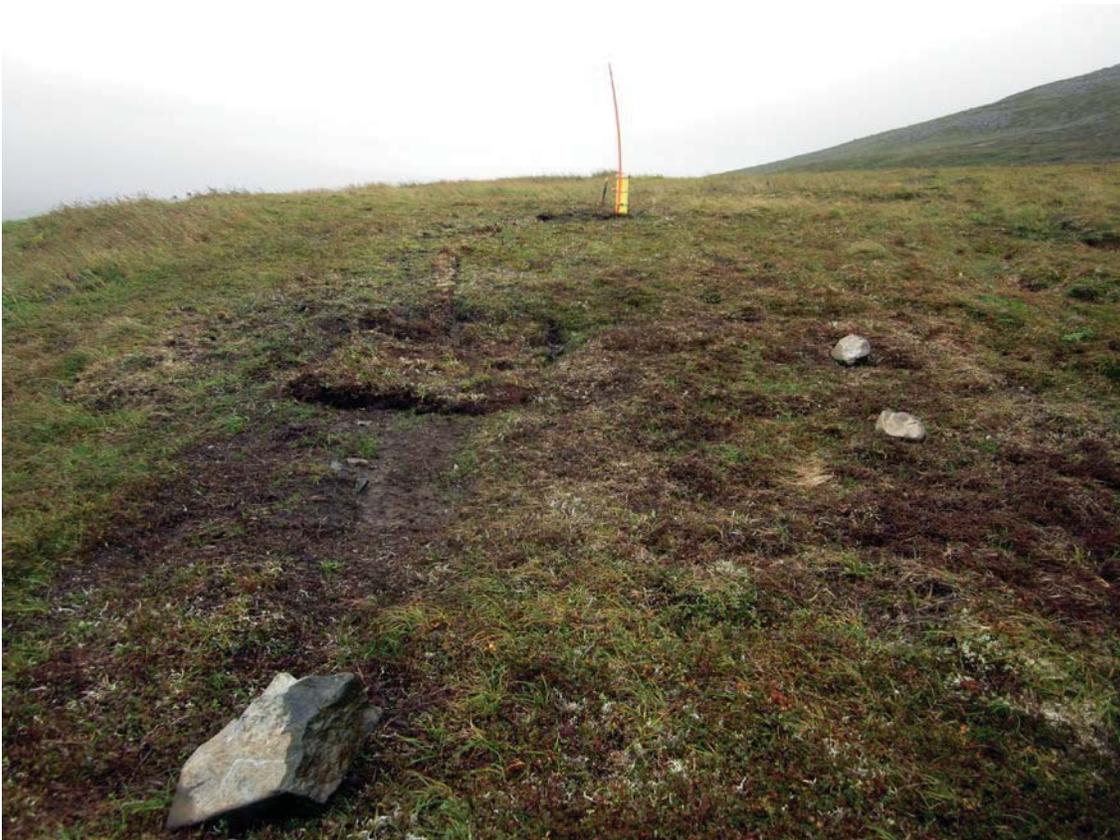
Photo 40: GH13-373 – Photo Taken Post Reclamation on 1 September 2013; See Photo 39 for Reference; Looking North.

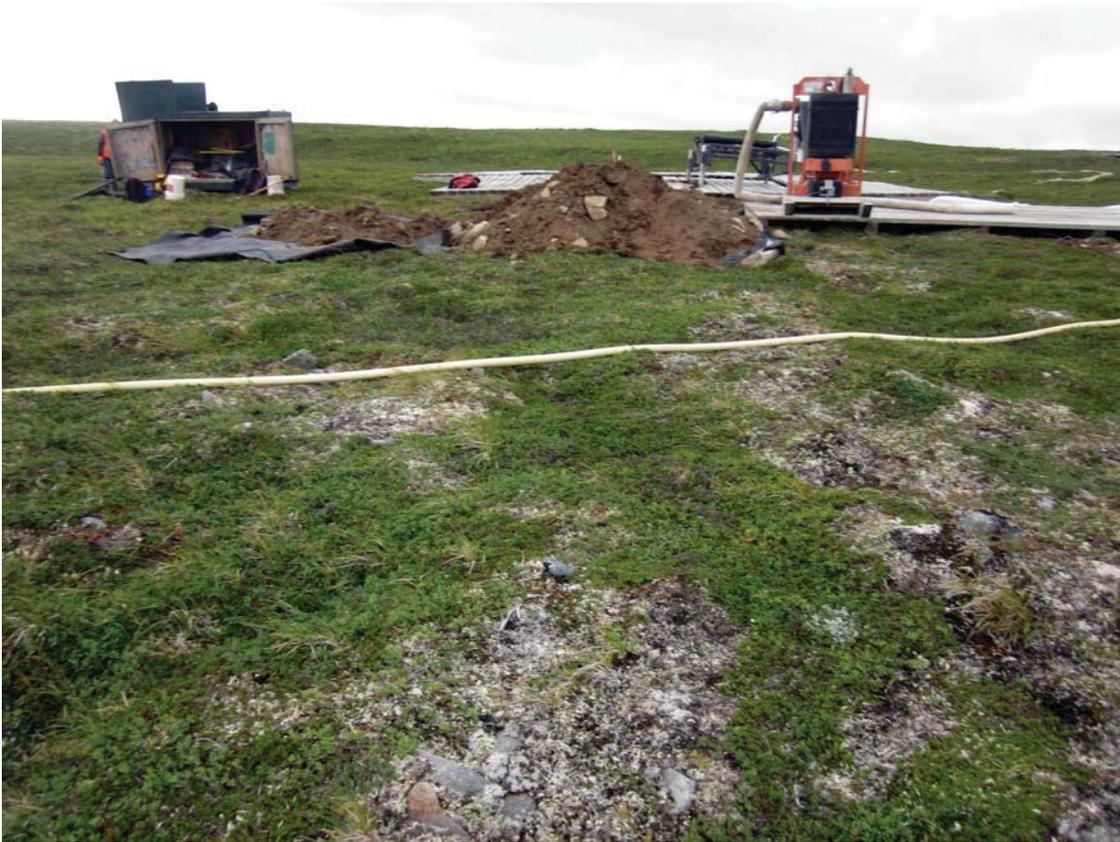
Photo 41: GH13-374 – Drilled / Reclaimed 2013; Photo Taken Post Drilling on 7 August 2013; Looking East.

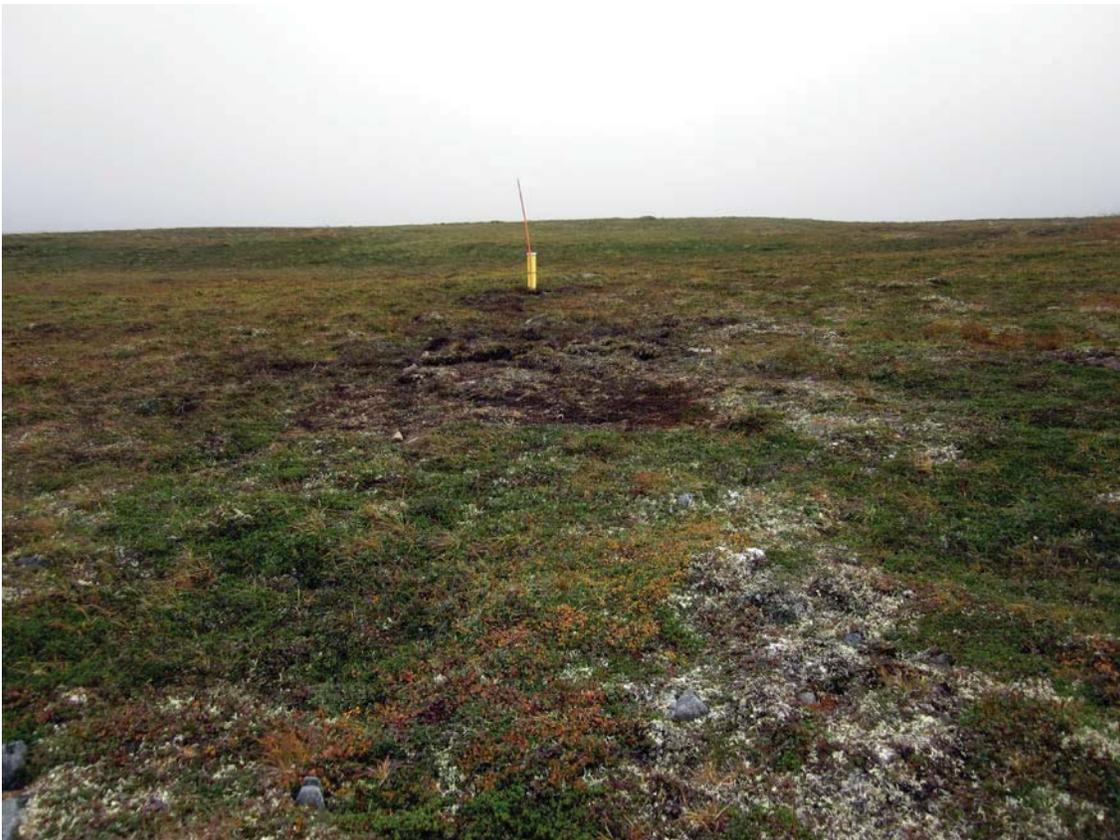
Photo 42: GH13-374 – Photo Taken Post Reclamation on 1 September 2013; See Photo 41 for Reference; Looking East.

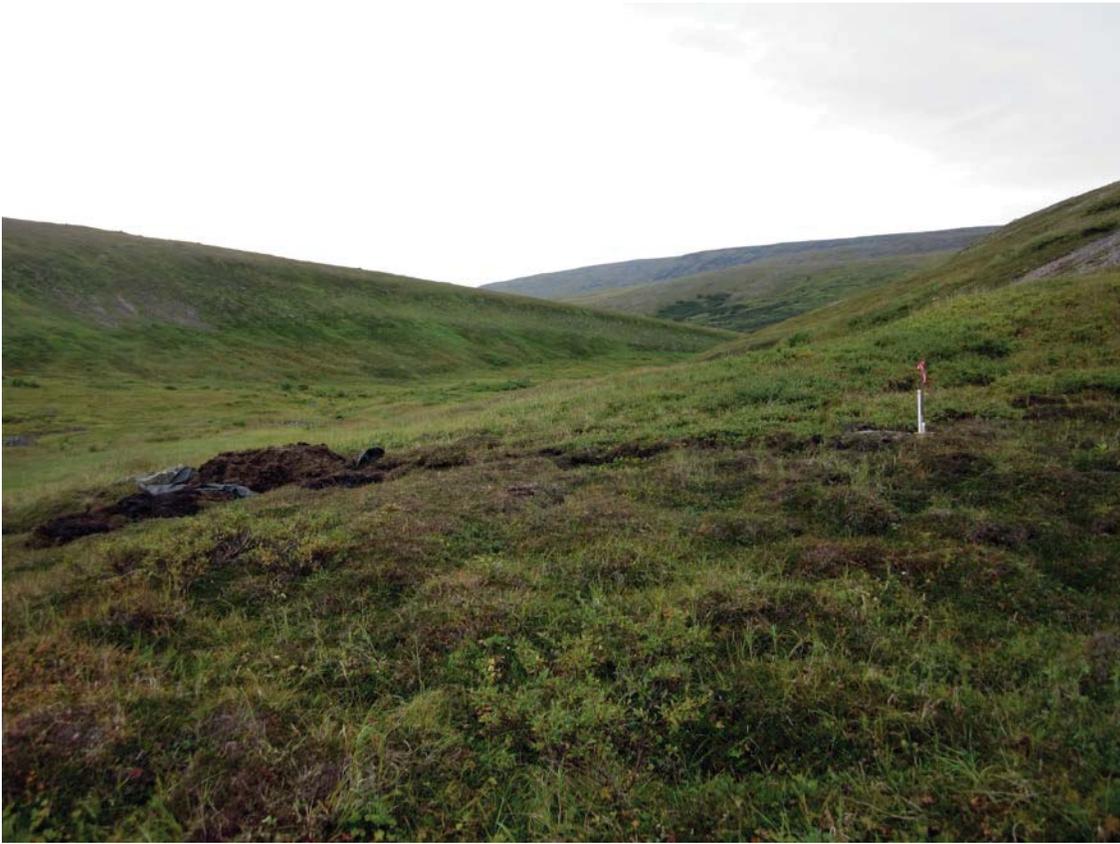
Photo 43: GH13-376 – Drilled / Reclaimed 2013; Photo Taken Post Drilling on 30 August 2013; Looking South.

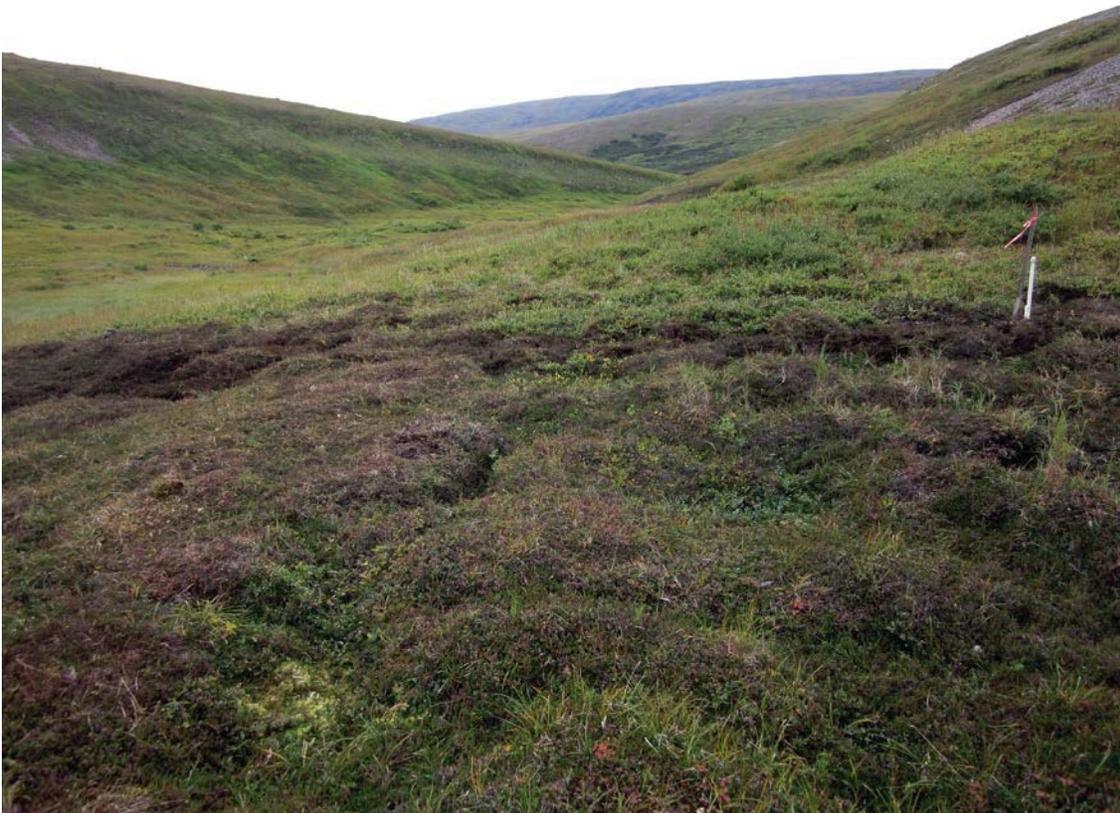
Photo 44: GH12-376 – Photo Taken Post Reclamation on 30 August 2013; See Photo 43 for Reference; Looking South.

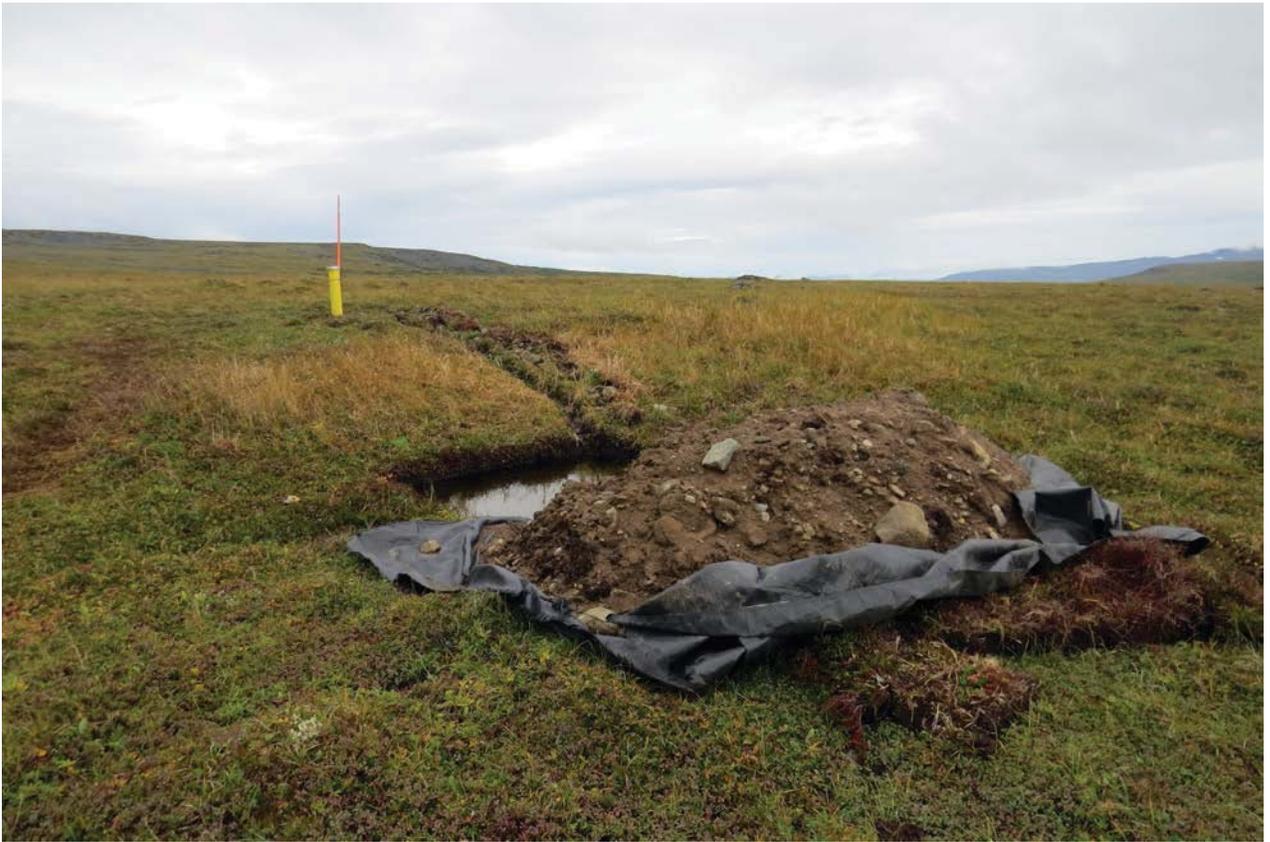
Photo 45: GH13-378 – Drilled / Reclaimed 2013; Photo Taken Post Drilling on 29 August 2013; Looking North.

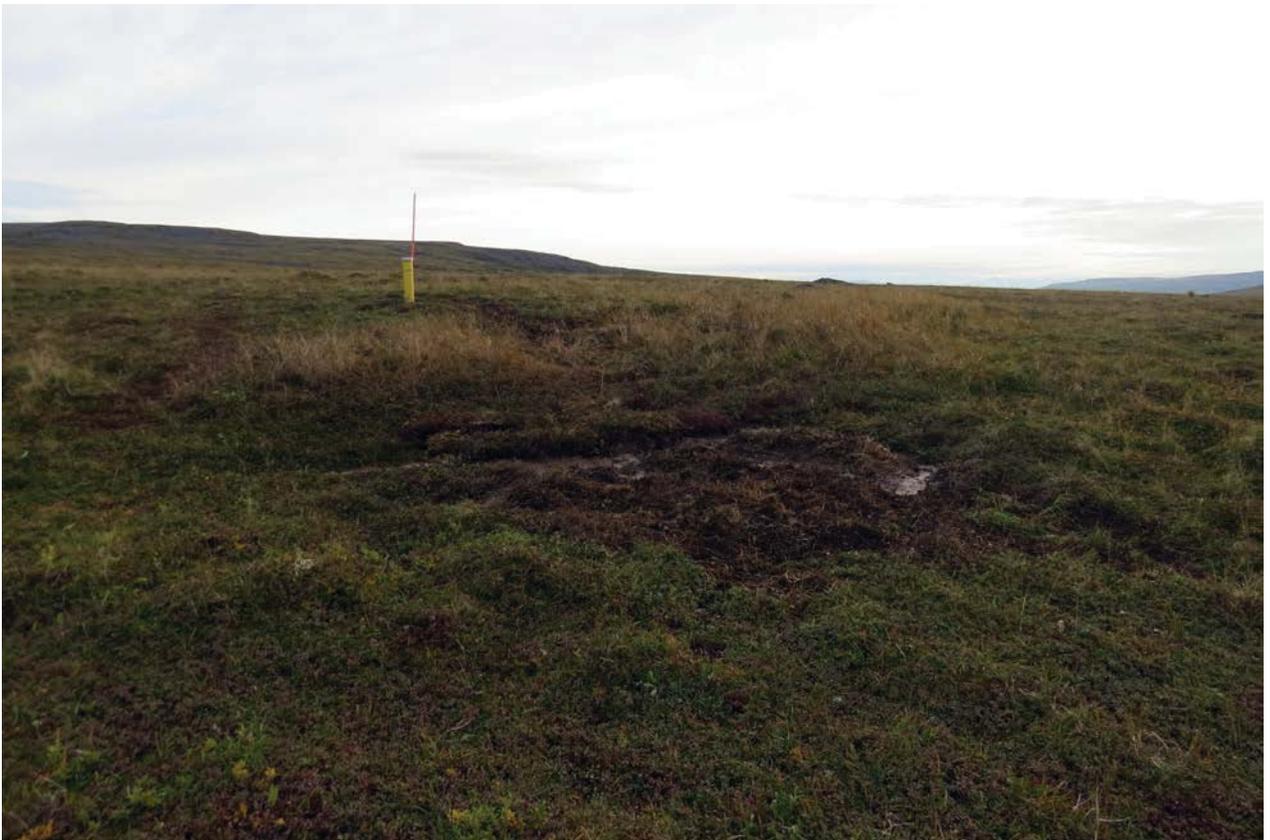
Photo 46: GH13-378 – Photo Taken Post Reclamation on 30 August 2013; See Photo 45 for Reference; Looking North.

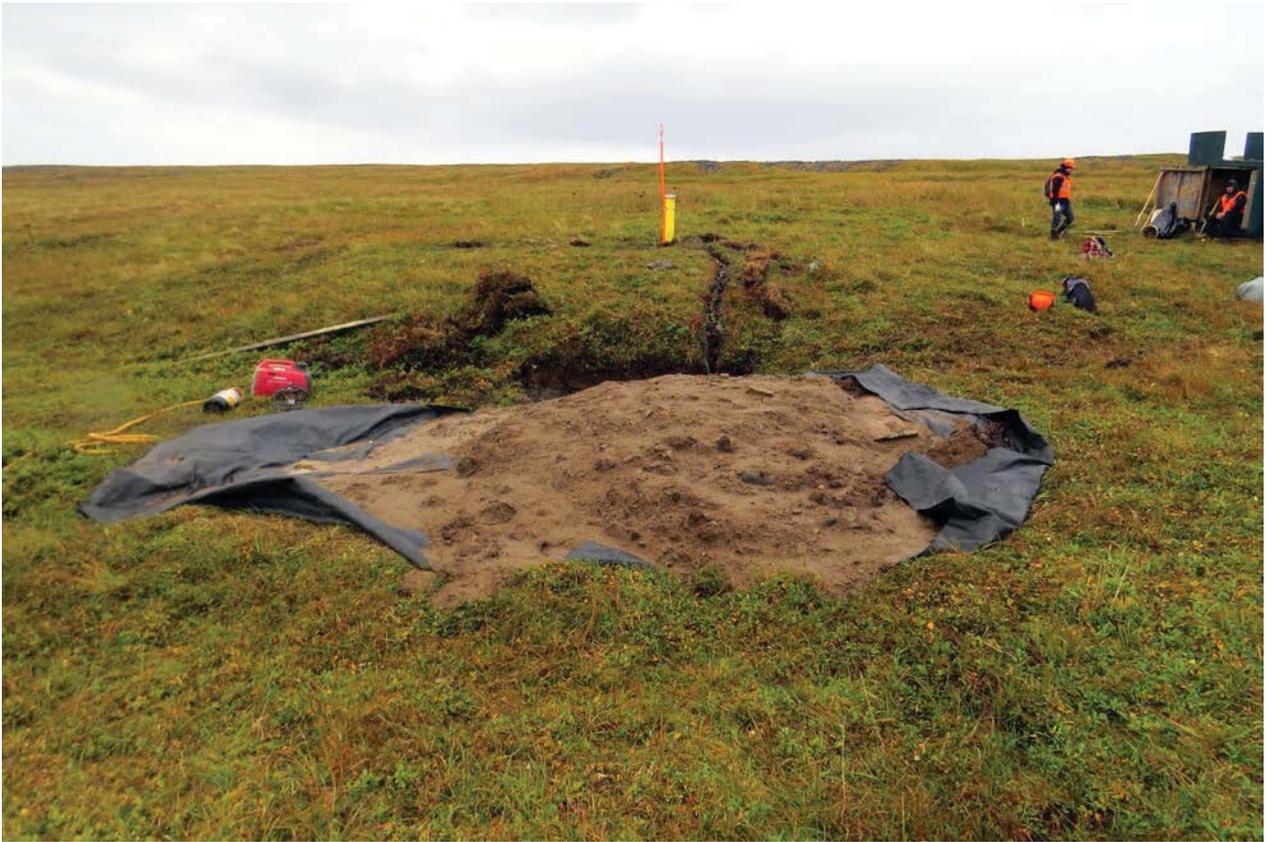
Photo 47: GH13-379 – Drilled / Reclaimed 2013; Photo Taken Post Drilling on 29 August 2013; Looking West.
