2013 Annual Reclamation Report

The Pebble Project

Iliamna, Alaska

Prepared by: JBN Consultants, Inc.
Eagle River, Alaska

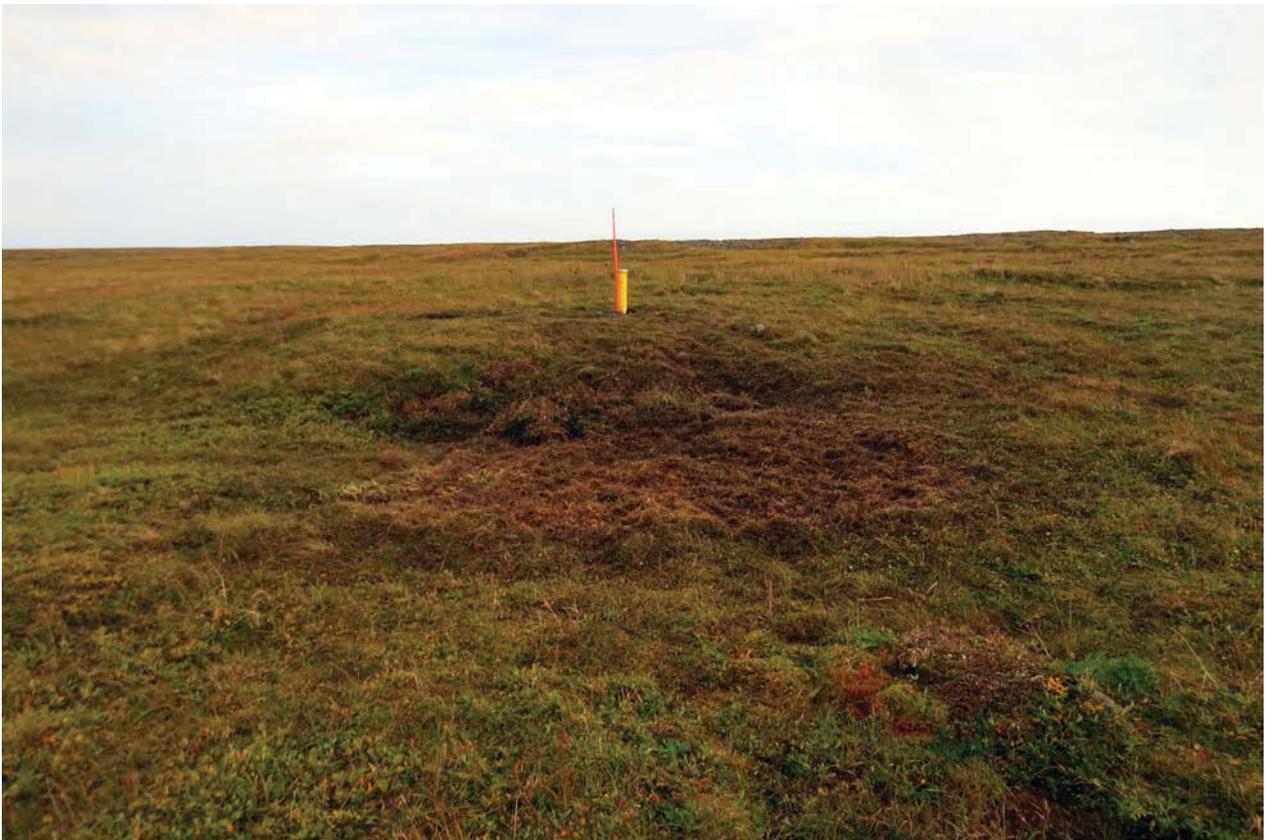
Photo 48: GH13-379 – Photo Taken Post Reclamation on 30 August 2013; See Photo 47 for Reference; Looking West.

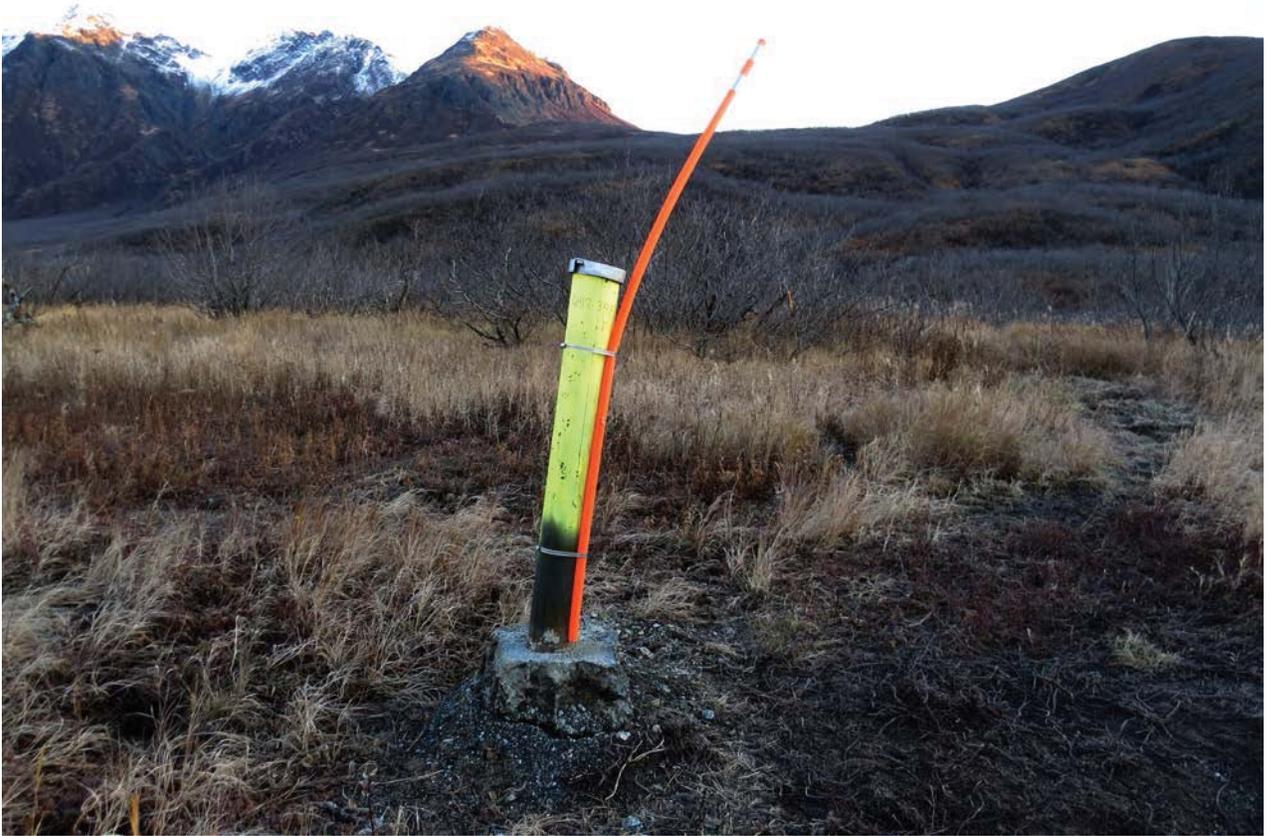
Photo 49: GH12-348 – Drilled and Monitoring Well Installed 2012 / Reclaimed 2013; Photo Taken Post Drilling on 23 October 2013; Looking East.

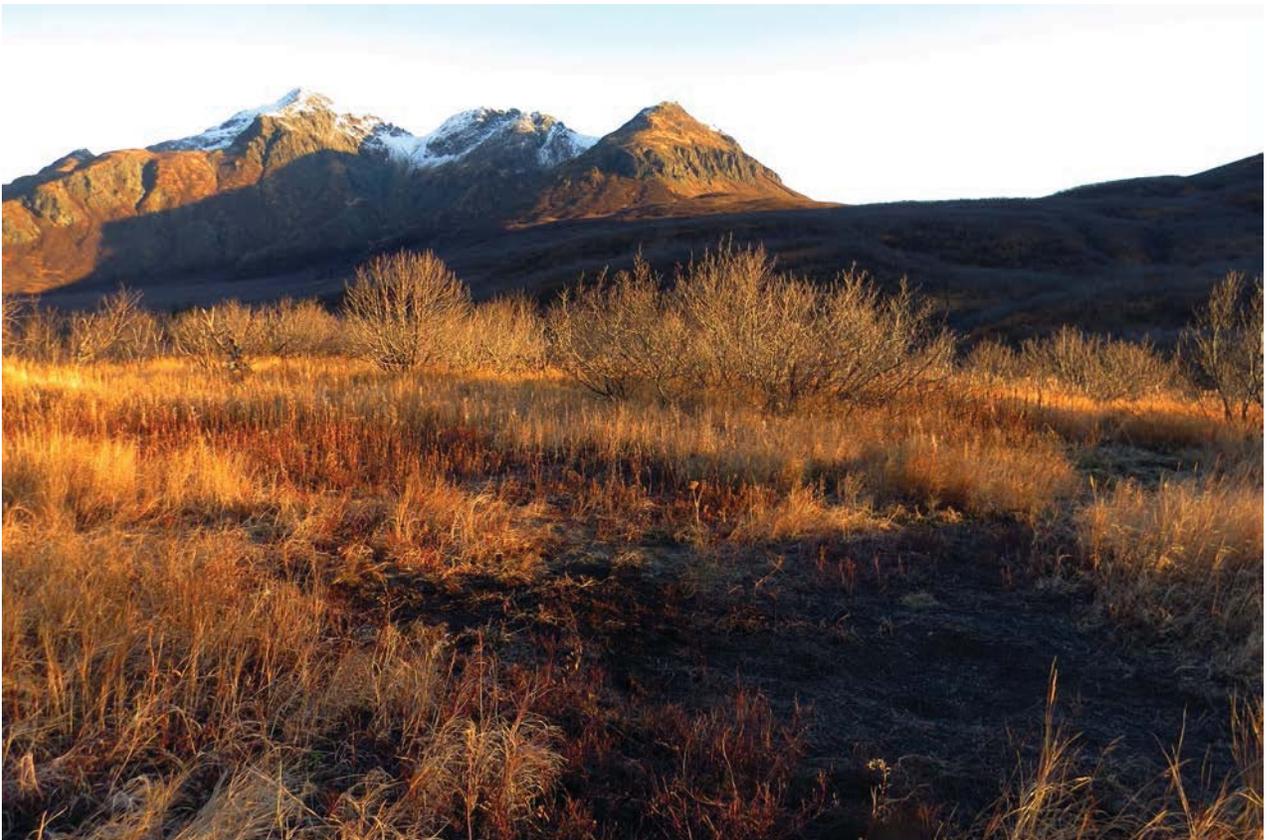
Photo 50: GH12-348 – Photo Taken Post Well Decommissioning and Reclamation on 23 October 2013; See Photo 49 for Reference; Looking East.
