Re: 2015 Annual Reclamation Report—Pebble Project MLUP No. 6118

PEBBLE PROJECT

2015 Reclamation Report

MLUP No. 6118

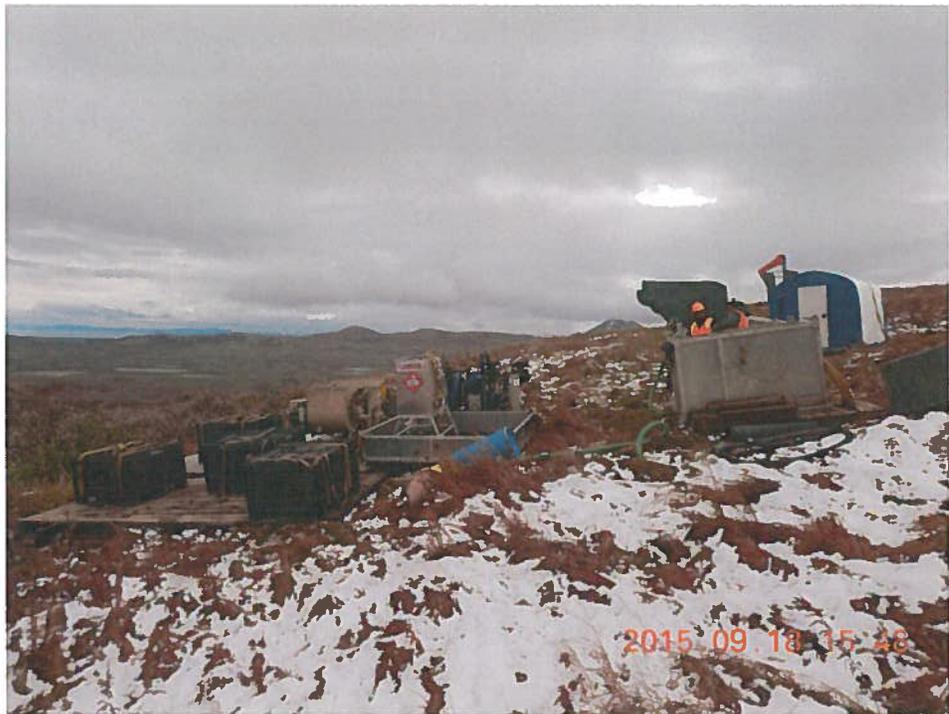
1. Borehole 9
9/18/2015

Mobilization and staging prior to drilling. Note use of tundra pads and fuel tank placed in leveled containment.

Repair work was initiated on 9/17. Reclamation was completed on 9/21. The original borehole was re-drilled to a depth of 12 feet at an angle of -45° . The hole was then pressure grouted from depth to surface using a mixture of sand, cement, and bentonite. All water flow was successfully cut off. No casing or surface structures were left in place.

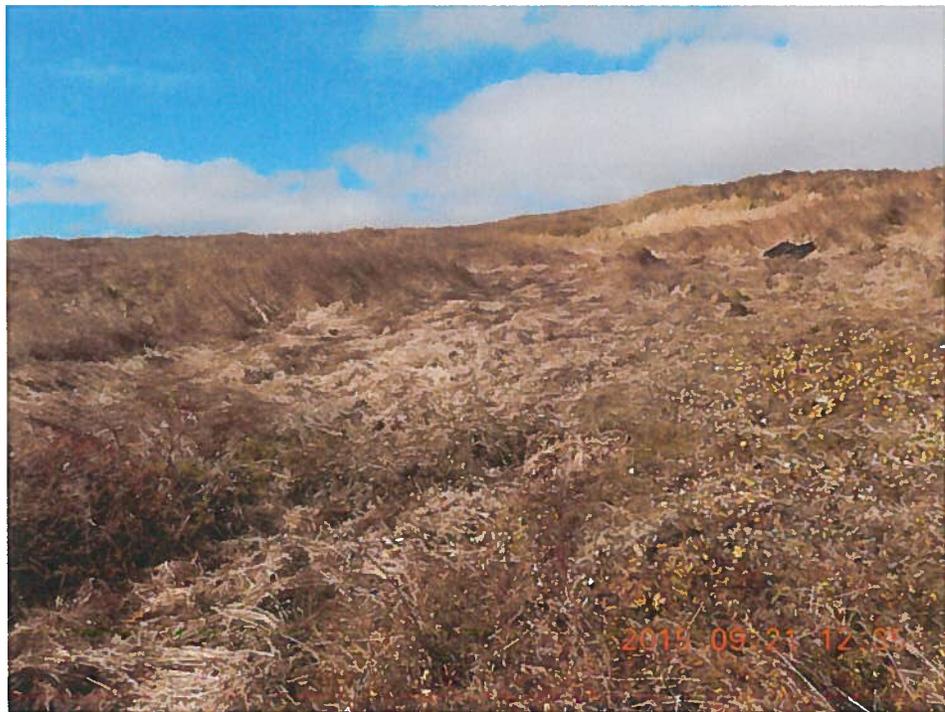
2. Borehole 9
9/21/2015

Post reclamation. Former borehole and outflow channel have been revegetated with native grasses.

All heavy equipment and materials were set on tundra pads. No sump was required for the activity. No vegetation was removed or destroyed as a result of repair work. Reclamation focused on the area immediately around the borehole and the outflow channel. Field crews overturned soil and smoothed channel banks to re-contour the area. Seeds from nearby native vegetation were collected and distributed over the reclaimed areas and covered with grasses.

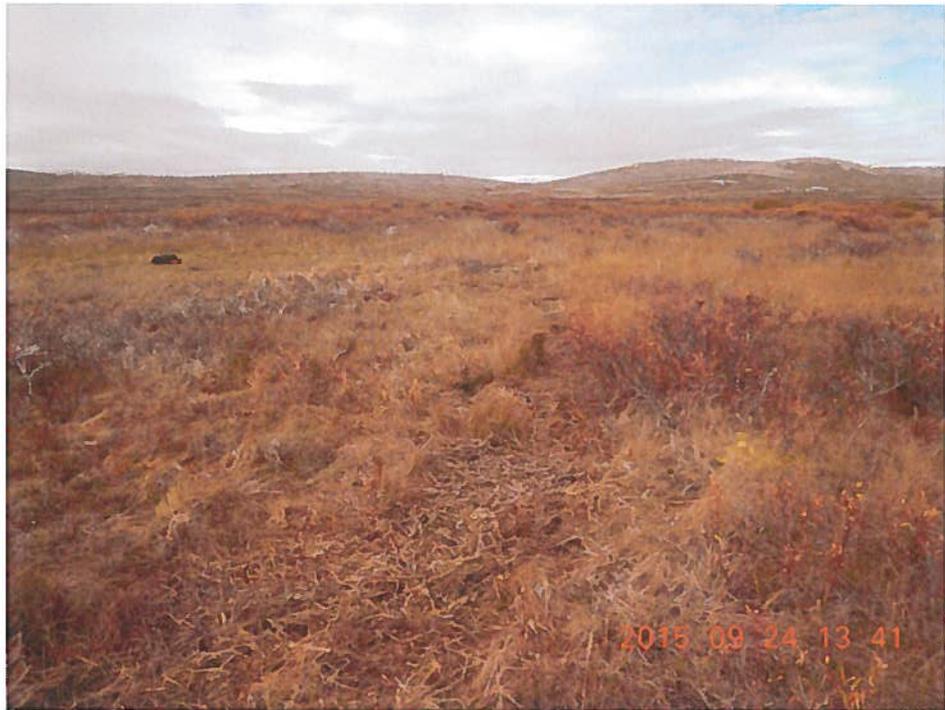
3. Borehole 40
9/18/2015

Post-reclamation. Outflow channel and borehole vicinity have been revegetated with native grasses.

Repair work was initiated on 9/16. Reclamation was completed on 9/24. The original borehole was re-drilled to a depth of 100 feet. The hole was then pressure grouted from depth to surface using a mixture of sand, gravel, cement, and bentonite. All water flow was successfully cut off. No casing or surface structures were left in place.

All heavy equipment and materials were set on tundra pads. No sump was required for the activity. Straw wattles and silt fences were placed in the outflow channel to control any sediment generated during grouting. No vegetation was removed or destroyed as a result of repair work. Reclamation focused on the area immediately around the borehole and the outflow channel. Field crews overturned compacted soil to raise the channel bed to the level of the surrounding tundra. Seeds from nearby native vegetation were collected and distributed over the reclaimed areas and covered with grasses.

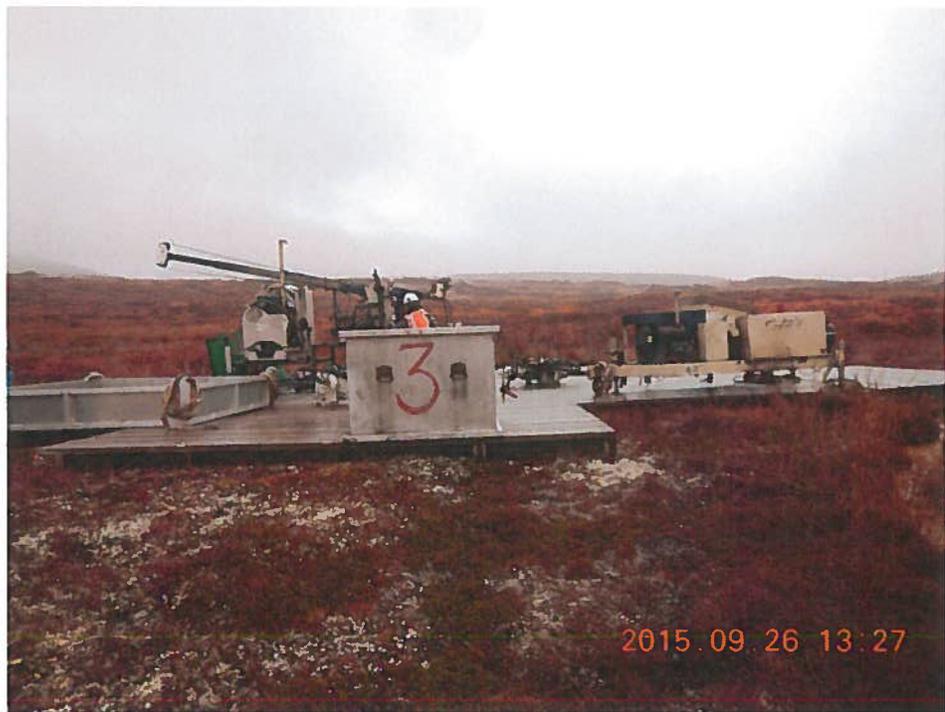
4. Borehole 3131
9/26/2015

Photo taken during repair work showing drill rig and use of tundra pads.

Repair work was initiated on 9/26. Reclamation was completed on 9/30. The original borehole was not re-drilled. Instead, the drill rig was set up approximately 20 feet from the original location. Using the azimuth strike (240°) and dip (-50°), crews drilled to a depth of 40 feet to intersect the original hole. The hole was then pressure grouted from depth to surface using a mixture of sand, gravel, cement, and bentonite. The original drill hole was excavated to a depth of 4 feet and cemented. Excavated material was backfilled.

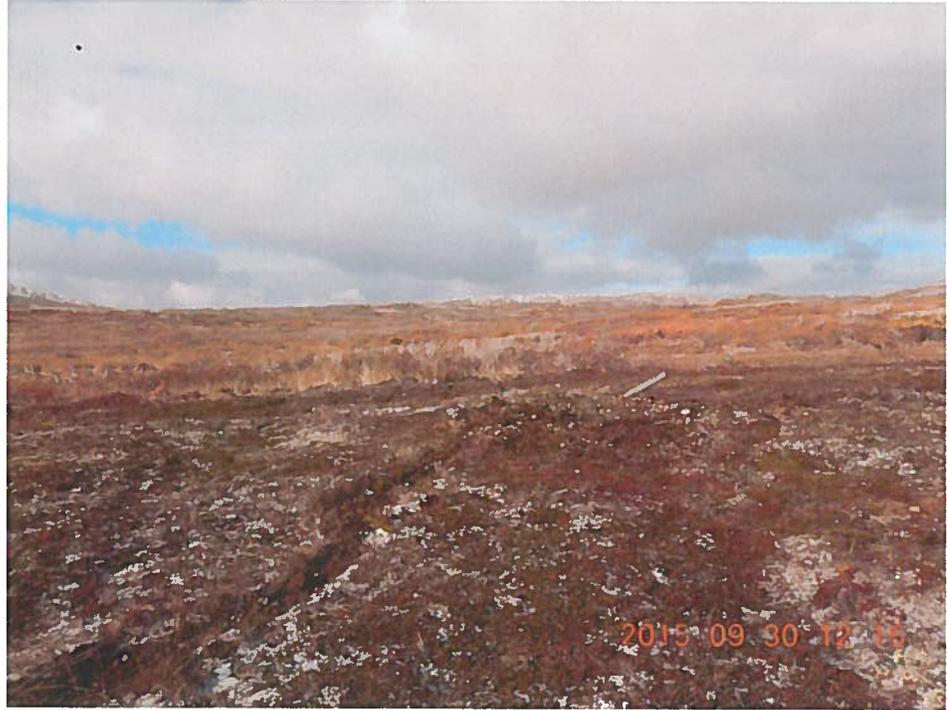
5. Borehole 3131
9/30/2015

Post-reclamation.

All heavy equipment and materials were set on tundra pads. No sump was required for the activity. A small area of approximately 48 square feet was excavated to complete repairs. The disturbed area was revegetated using seeds from nearby native grasses mixed with straw.

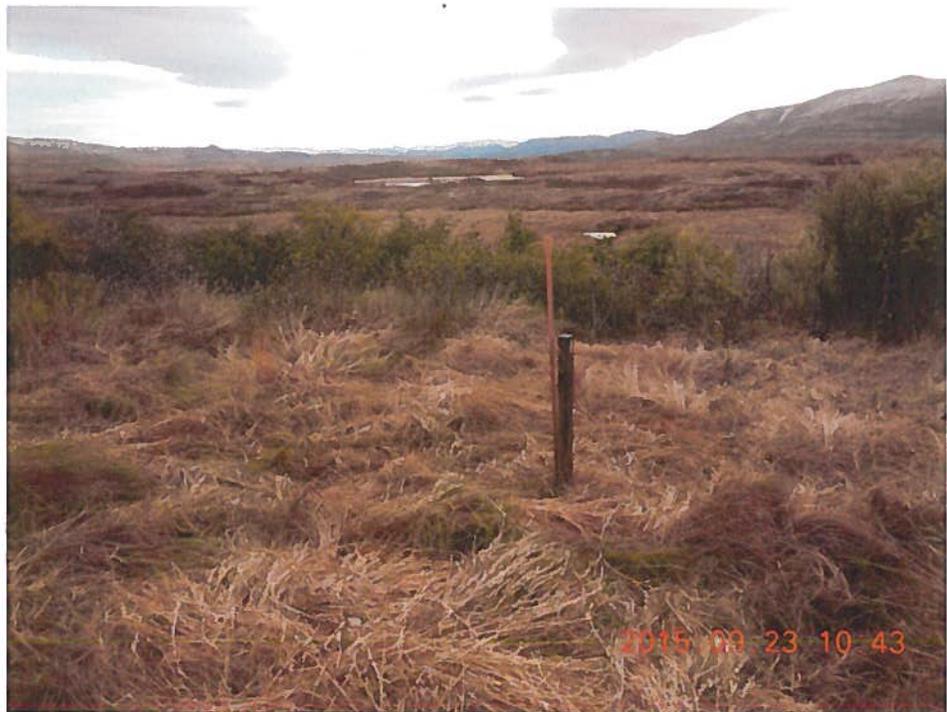
6. Borehole 4224
9/30/2015

Post-reclamation. Note that only minimal disturbance occurred during operations.

Repair work was initiated on 9/20. Reclamation was completed on 9/23. The original borehole was re-drilled to a depth of 35 feet. The hole was then pressure grouted from depth to surface using a mixture of sand, cement, and bentonite. All water flow was successfully cut off. No casing or surface structures were left in place.

All heavy equipment and materials were set on tundra pads. No sump was required for the activity. No vegetation was removed or destroyed as a result of repair work. Only minor reclamation was required in the small area around the drill hole.

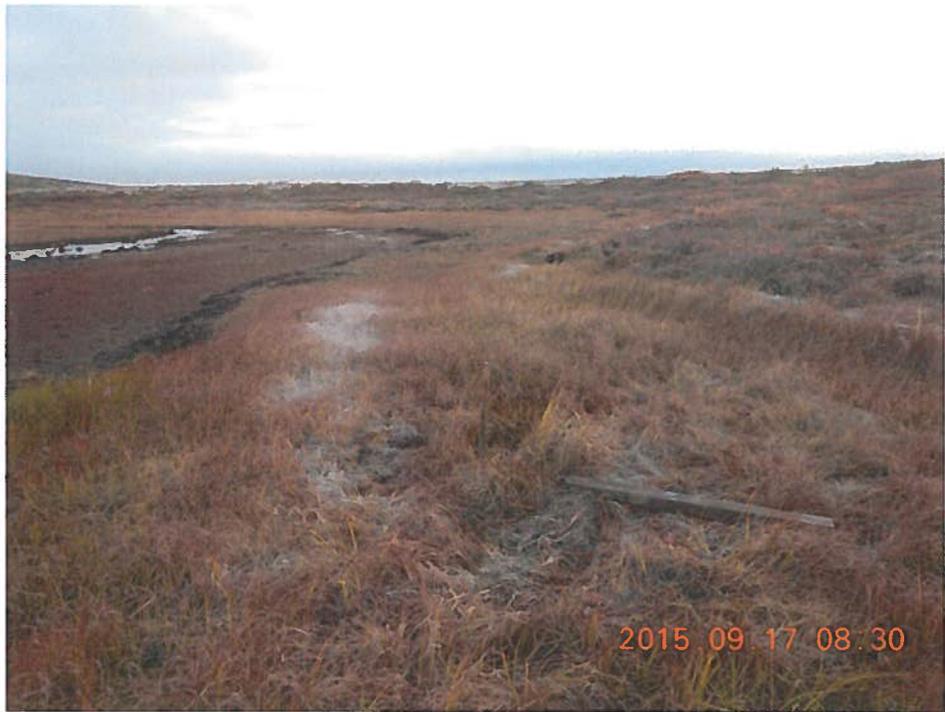
7. Borehole 4239
9/30/2015

Repairs were initiated and completed on 9/16. No reclamation was required. This site is located near a creek where the water table is high and ground is naturally saturated. Additional inspections revealed that the flowing water was the result of this shallow groundwater daylighting

Photo taken after repairs. No reclamation required. Note proximity to stream and topography, indicating the likelihood of shallow groundwater.

through the original drill hole. Repairs consisted of packing the hole with bentonite pellets to a depth of 4 feet and covering the hole with soil. All water flow was successfully cut off.

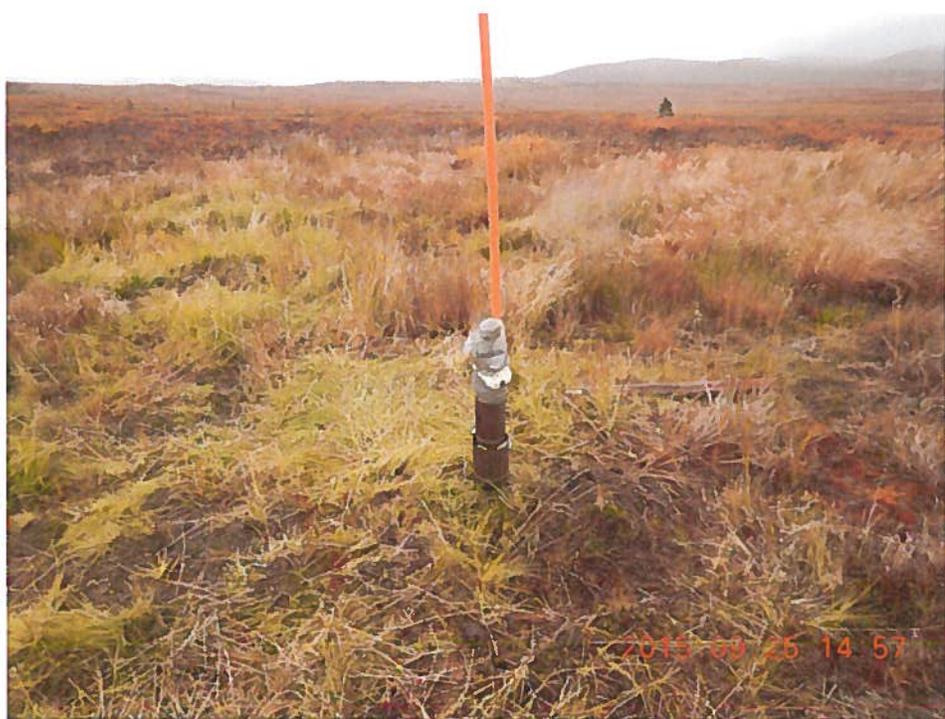
8. Borehole 6343
9/25/2015

Photo showing new Margo plug installed. Tape and plastic are applied to shield spray foam from rain and allow it to set properly. New snow pole installed. Area did not require reclamation.

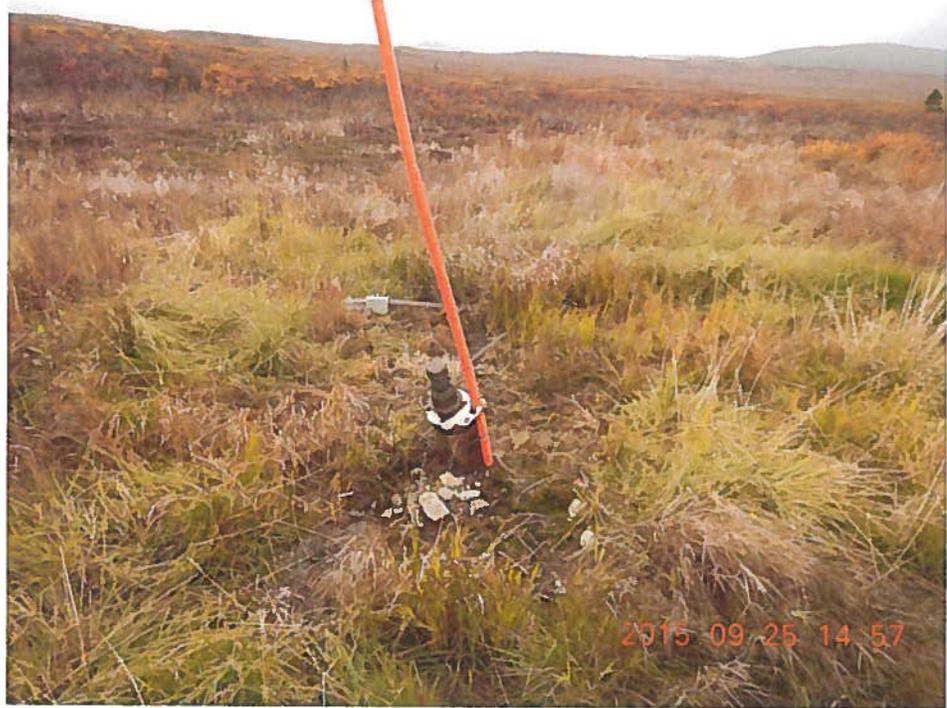
9. Borehole 8423
9/25/2015

Photo showing new Margo plug installed. New snow pole installed. Area did not require reclamation.

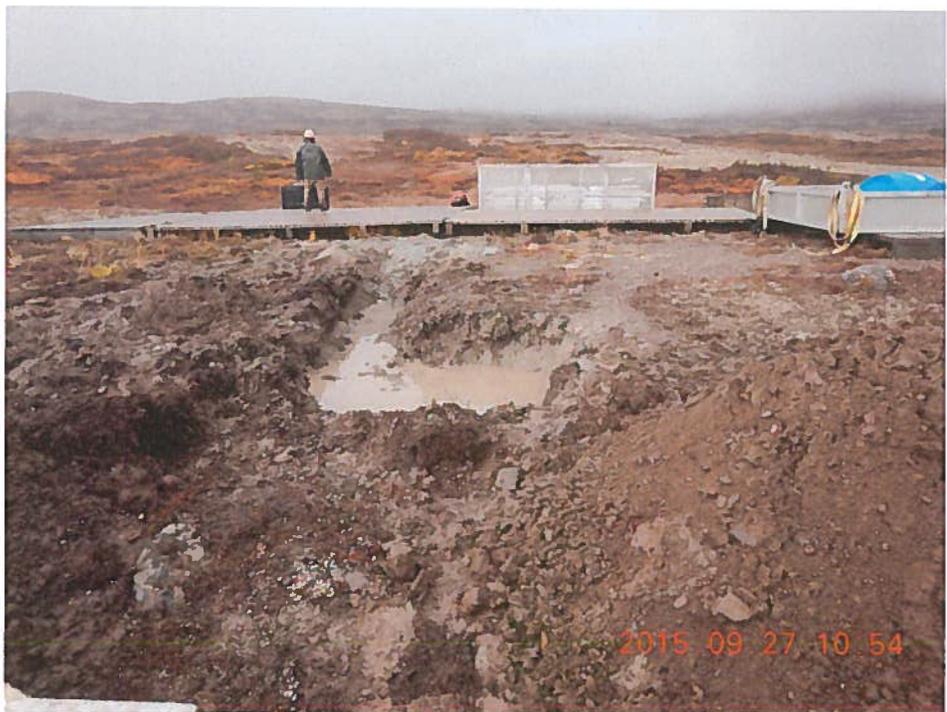
10. Borehole 9475
9/27/2015

Repair work was initiated on 9/22. Reclamation was completed on 9/28. Close inspection indicated water was upwelling outside of the casing. Initial repairs were attempted by drilling outside the casing to a depth of 40 feet and grouting with a mix of sand, cement and bentonite. With water still flowing, the rig was moved to drill from the opposite side to a depth of 80 feet. The hole was again grouted using the same mixture. All water flow was successfully cut off. The existing casing and monument were left in place at ground level for future use.

Photo taken after repairs, prior to reclamation. Sump and trench visible.

A single sump and connecting trench were excavated to collect and control water flowing from the borehole during repair operations. Excavated material was stockpiled for use as backfill. All water was confined to the sump and allowed to dissipate into the ground. The combined disturbed area for the sump (6 ft x 5 ft) and trench (9 ft x 3 ft) was 57 square feet.

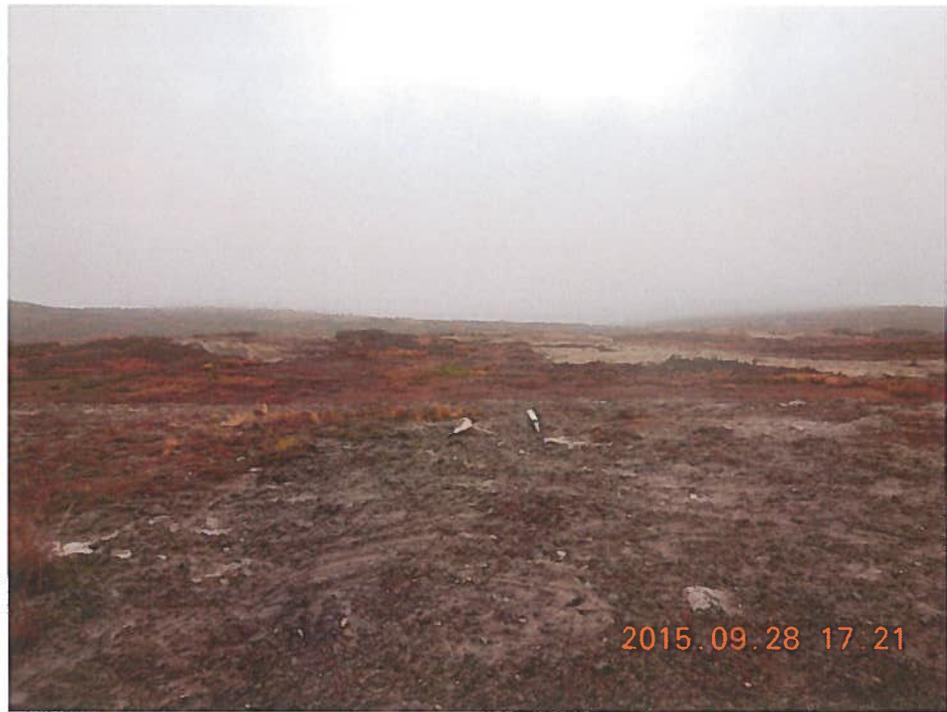
11. Borehole 9475
9/28/2015

Photo taken after reclamation in same direction. Sump and trench have been backfilled and reclaimed. Area will be inspected again in 2016.

Disturbed areas were backfilled and reclaimed using excavated material. The area is naturally rocky with thin patches of grass and other tundra plants. Nearby seeds were collected and scattered on the bare soil. Due to ground saturation from the repair effort, the area will be allowed to drain fully before determining if additional reclamation is needed. The area will be inspected in summer 2016.
