PIONEERS' HOME & TOTEM SQUARE

HISTORIC STRUCTURES REPORT

Alaska Department of Natural Resources
Office of History and Archaeology
2017

Summer Louthan, Architectural Historian

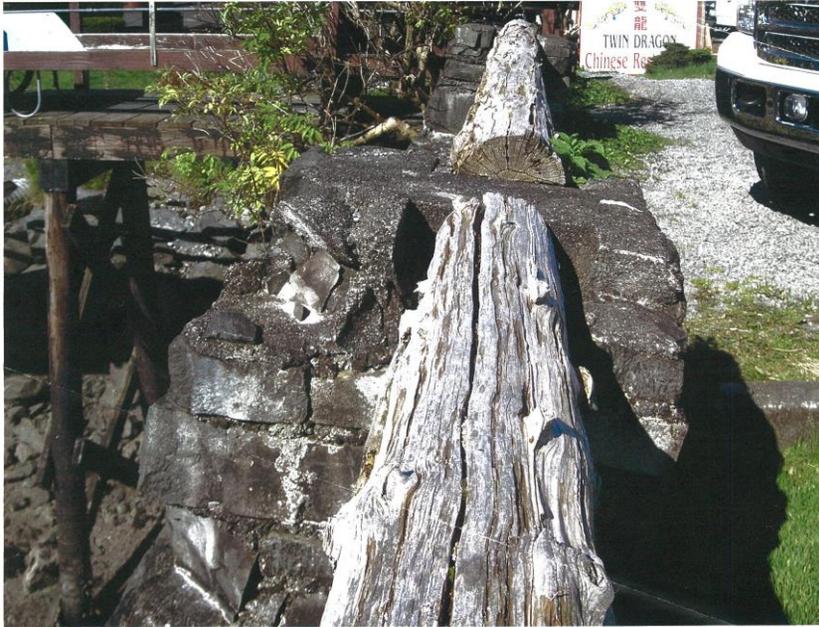
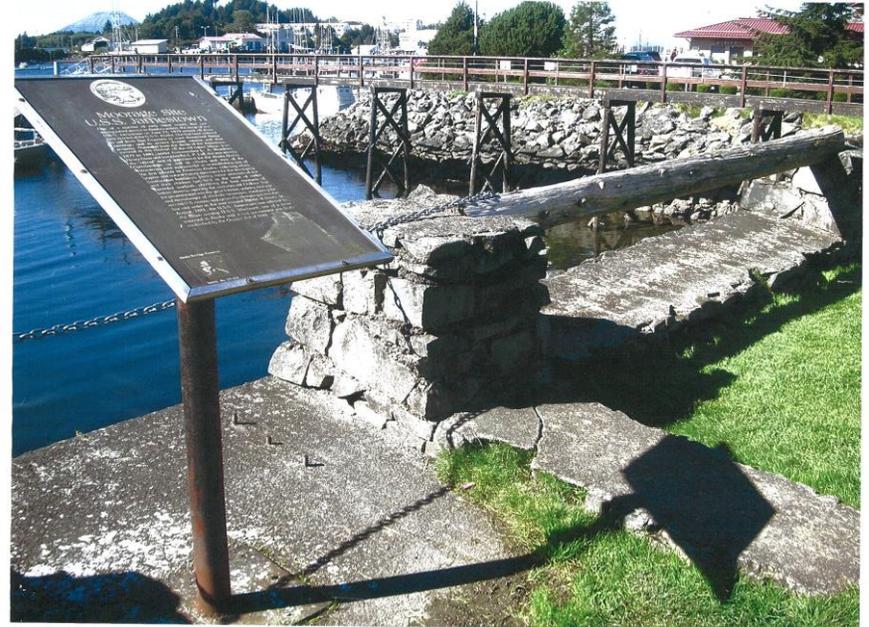
Figure 84 and 85. Seawall fence deterioration prior to renovation. Photos by Jennifer Klein, DHSS.

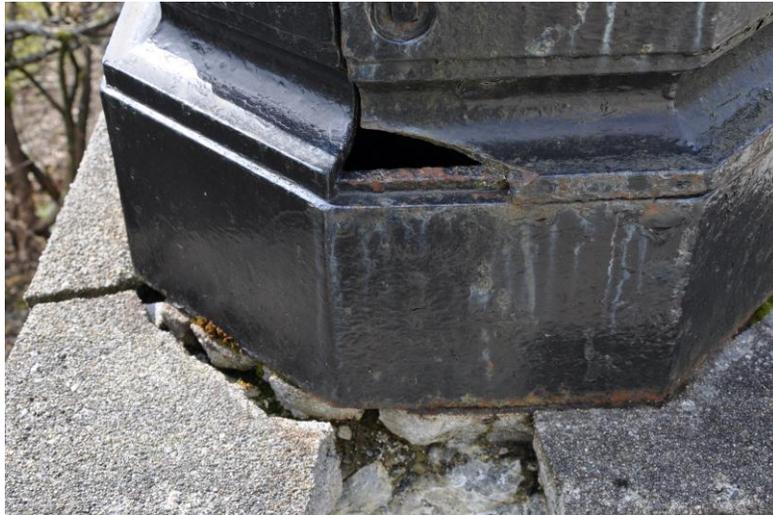
Figure 115. Detail of broken access panel of cast iron light standard, note damaged concrete base.

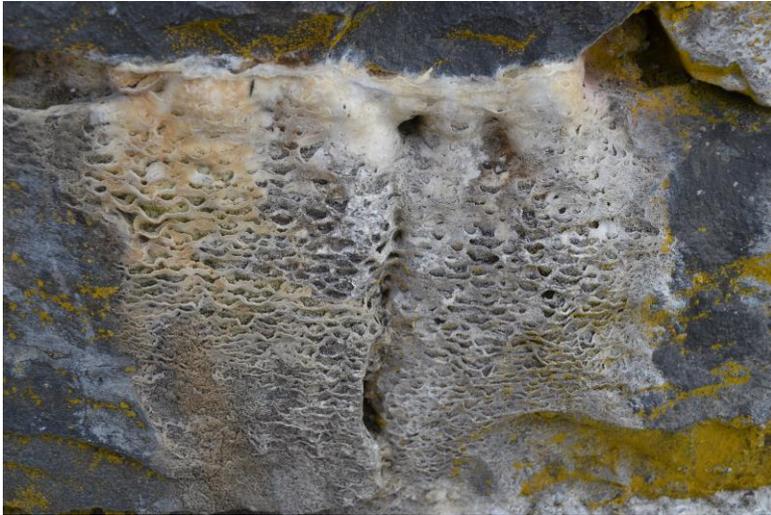
Figure 117. Heavy deposits of calcite along stone wall.

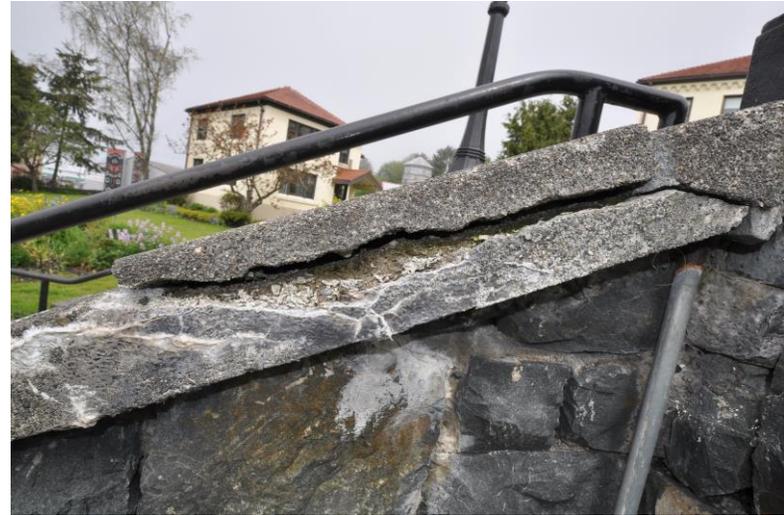
There is severe damage in a number of locations to the concrete cap of the wall from water infiltration which has caused the rebar to corrode and expand, cracking and in some places causing the concrete to shatter and spall (*figure 118-120*).

Figure 118. Spalling concrete cap of stone wall at stairway to upper lawn.

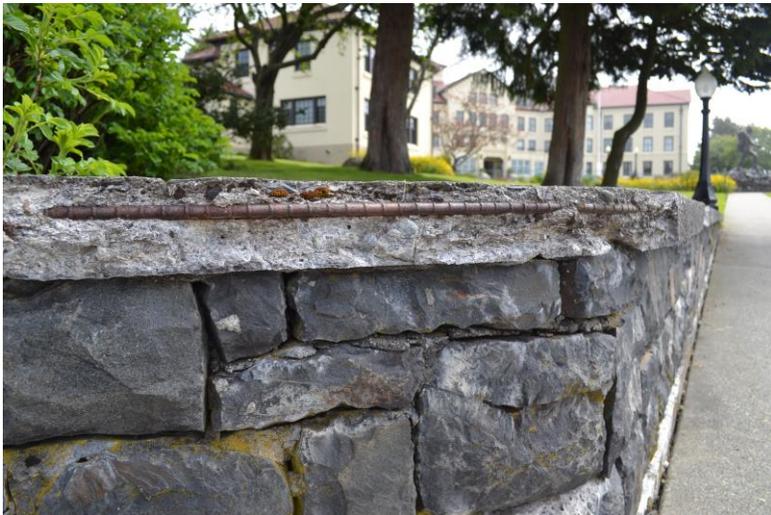
Figure 119. Damage to concrete cap of stone wall caused by corroded rebar.

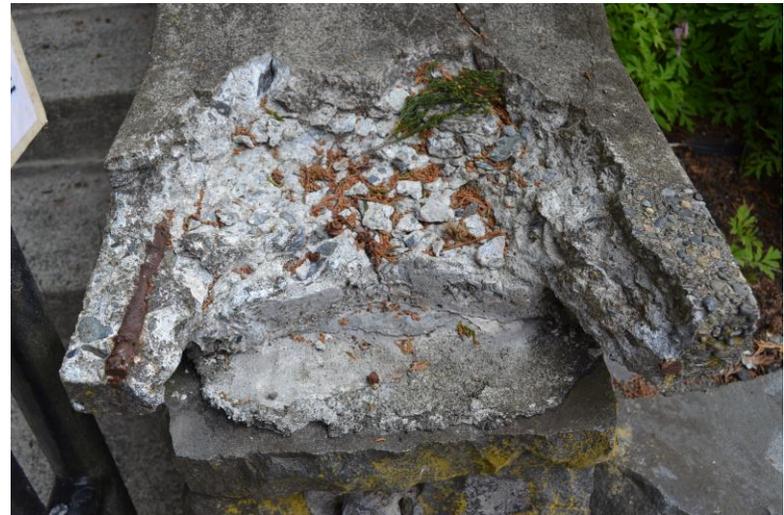
Figure 120. Detail of damaged concrete cap and exposed rebar at Lincoln Street side entry point.

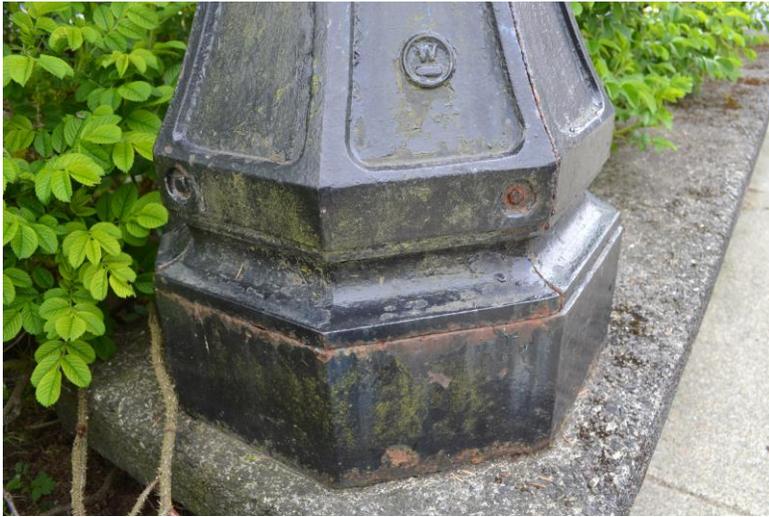
Figure 122. Detail of oxidation, or rusting, at base of cast iron light standard.

Hand scraping, chipping, and wire brushing is the least expensive method of removing paint and light rust from cast iron; however, this does not remove corrosion or paint as effectively as other methods.

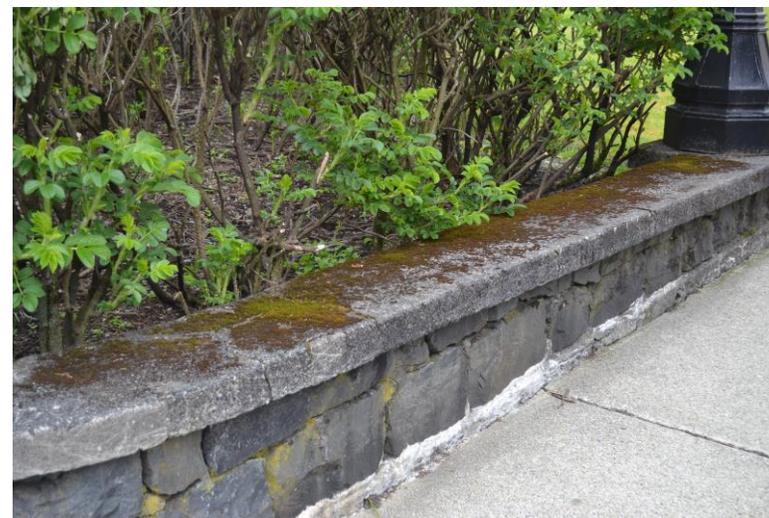
Figure 123. Detail of biological growth along concrete cap of stone wall.

Removal of the biological growth on the concrete caps should be through gentle cleaning to help stave off unwanted water penetration (*figure 123*). It is recommended that washing be undertaken with lower or medium pressure water. Start with a very low psi (100 or below) and progress as needed to a slightly higher pressure (generally no higher than 300-400 psi). You can gently scrub areas with a natural or synthetic bristle brush but never with metal. This should be done whenever needed.

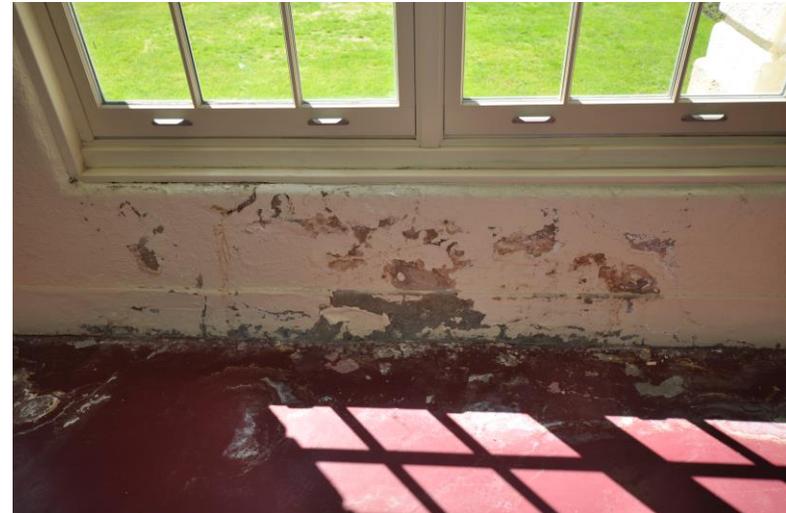
Figure 126. Detail of water damage to interior of sun porch wall.

*In the summer of 2016 work was completed to repair the front porch. See Section 2 page 124 for more detail on the porch work.

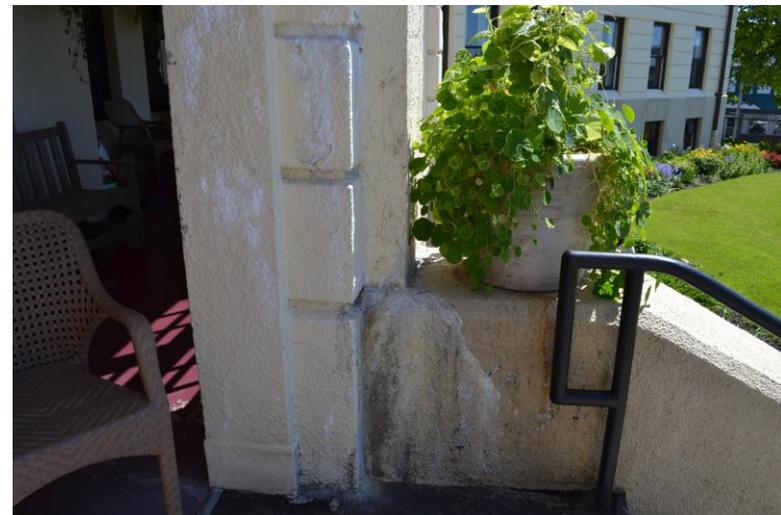
Figure 128. Efflorescence and crystalline calcite formation on wall of sun porch along with staining caused by water pooling around planter.

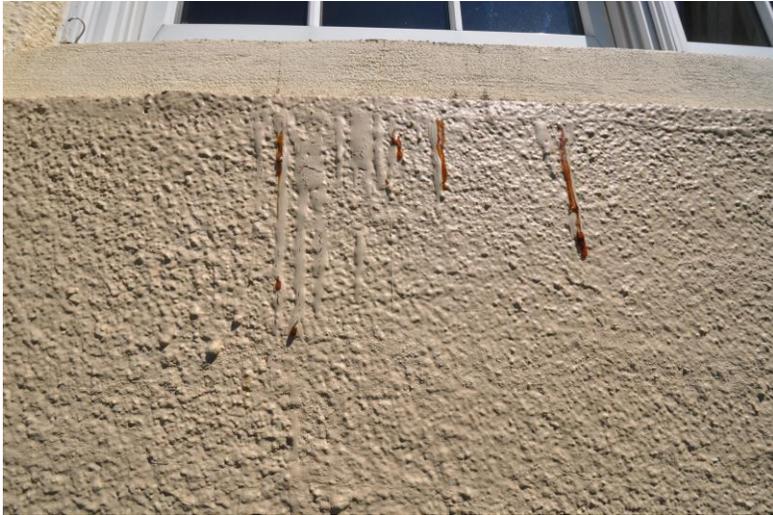
Figure 127. Detail of seepage from past epoxy patches under sun porch window.

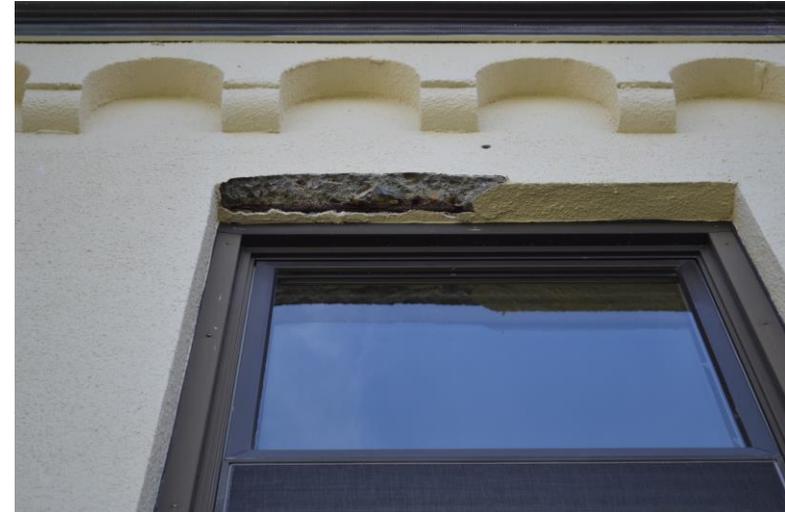
Figure 130. Detail of exposed rebar where concrete has spalled above third floor window.

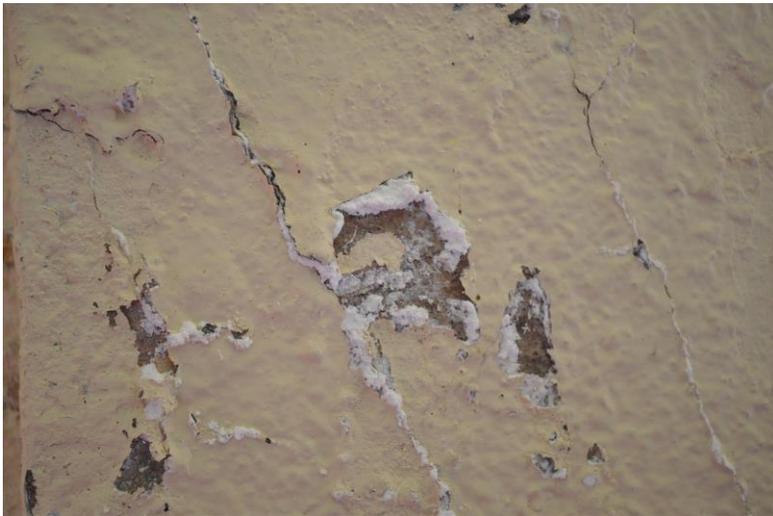
Figure 129. Detail of efflorescence causing damage to paint of interior wall of the sun porch.

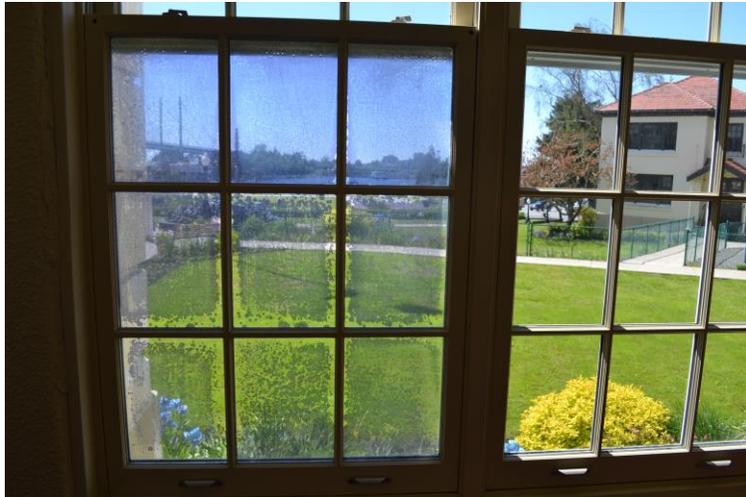
The majority of the windows at the Pioneers' Home are in good condition. Damage was observed on some of the windows of the sun porch including a number broken panes, and moisture between panes of glass (*figure 136*). One porch window sash is installed backwards. Window frames on the front porch are being damaged by the continued water infiltration issue noted earlier. As noted above the porch windows are currently being replaced as part of the larger porch restoration project.

Figure 136. Moisture damage between panes of glass on sun porch window.

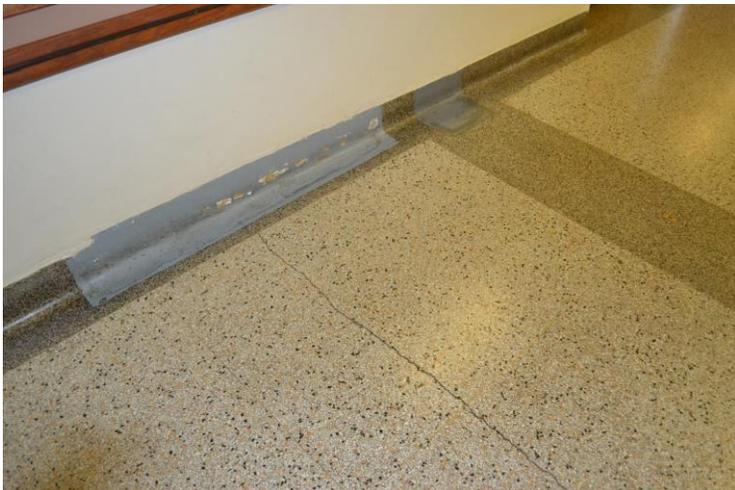
Figure 143. Detail of cracks and inappropriate patchwork of terrazzo flooring.

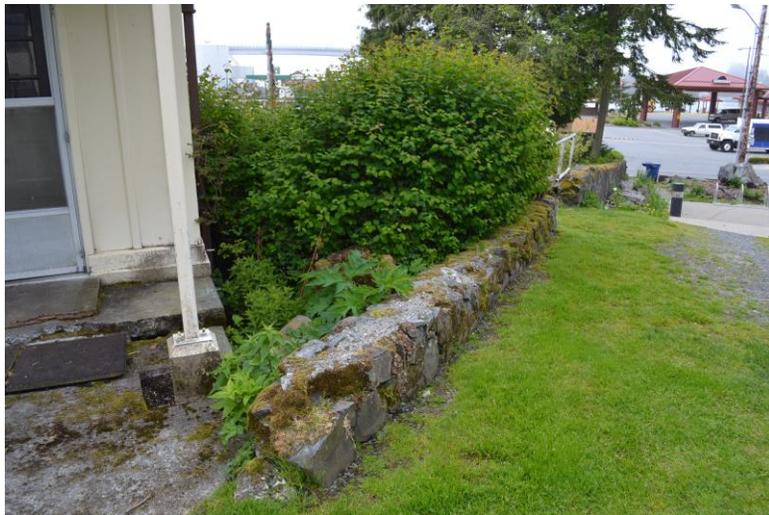
Figure 151. View of stone wall off rear of entry. The large shrubs are located too close to rear of building.

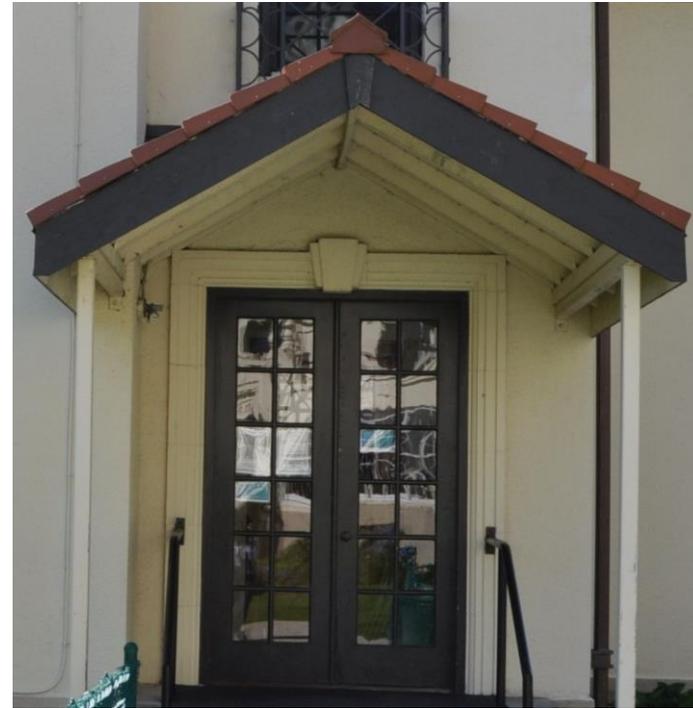
Figure 152. View of Superintendent's Home primary entry. Note the non-historic porch roof.

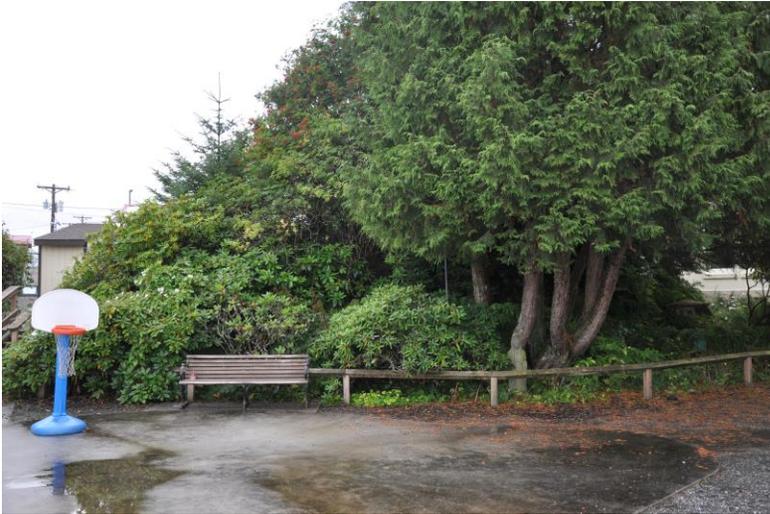
Figure 163. View of overgrown rock outcropping.

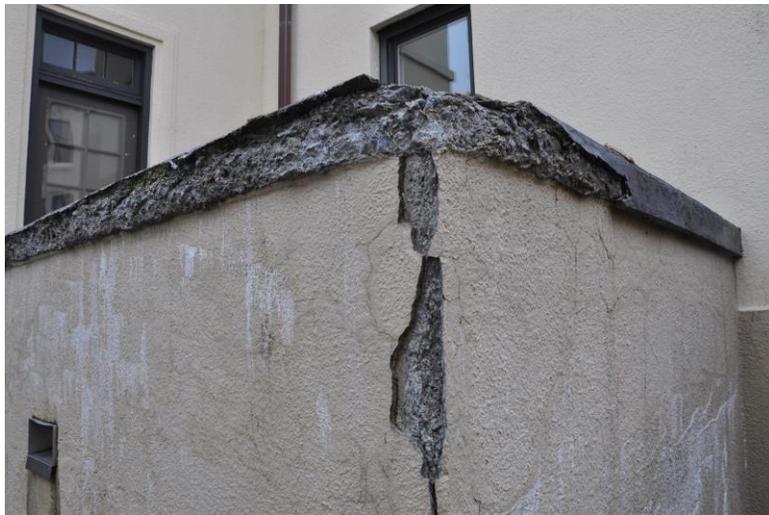
Figure 165. Detail of significant damage to concrete terrace wall.

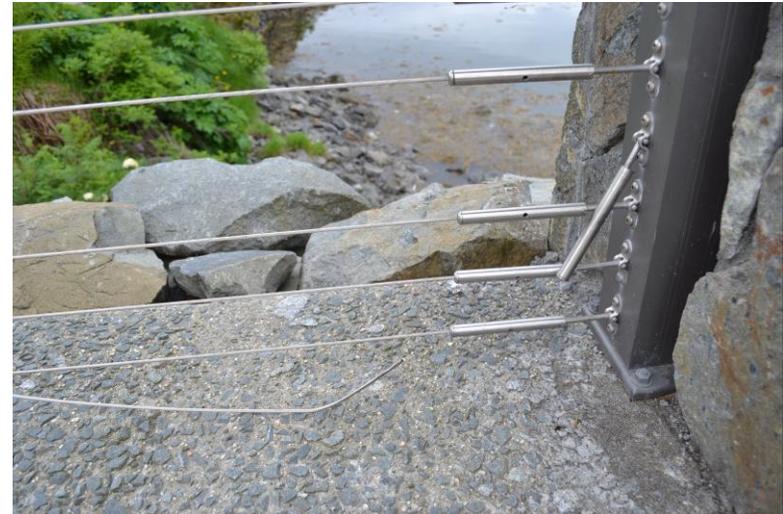
Figure 181. View of damaged cable along seawall.
