**Engineer's Inspection Report**  
**Re: 7210 Hollies Acres Dr. Salcha, AK**

Inspected by: Timothy Henry, P.E. and Dave Mowery  
Inspection date: August 21, 2020

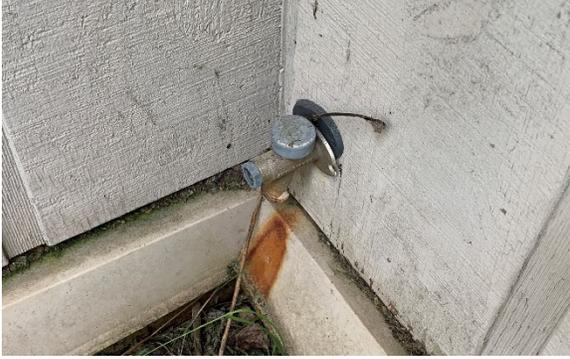
- 
- 
4. Replace the broken exterior hose bib with new.

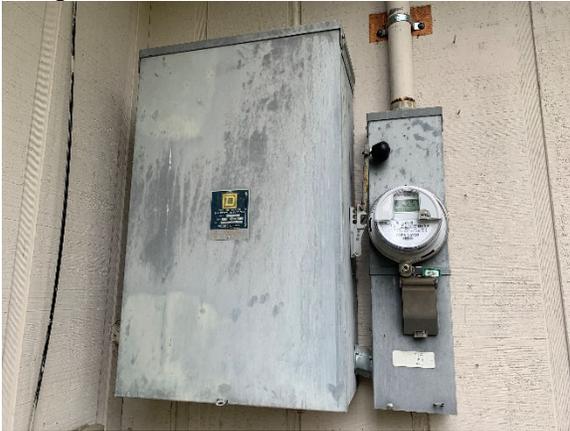
5. At the electric service panel, install a fastener or lock on the panel cover lid of the large “double throw” electric switch located to the left of the meter panel as to limit access to live components.

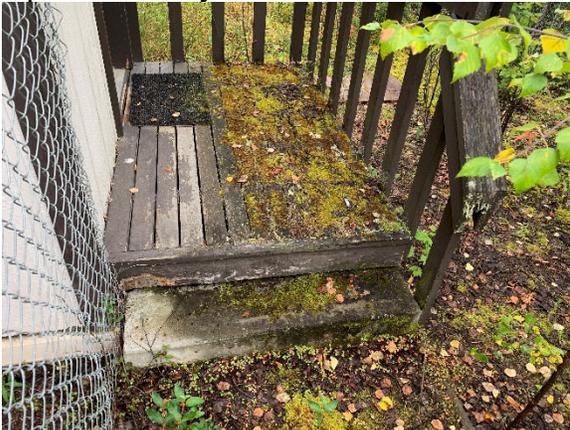
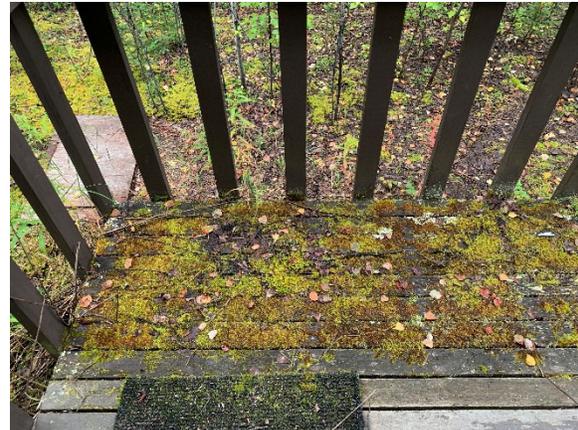
6. Clean all of the moss off of each of the entryway landings and reconstruct as needed to replace all decayed wood.

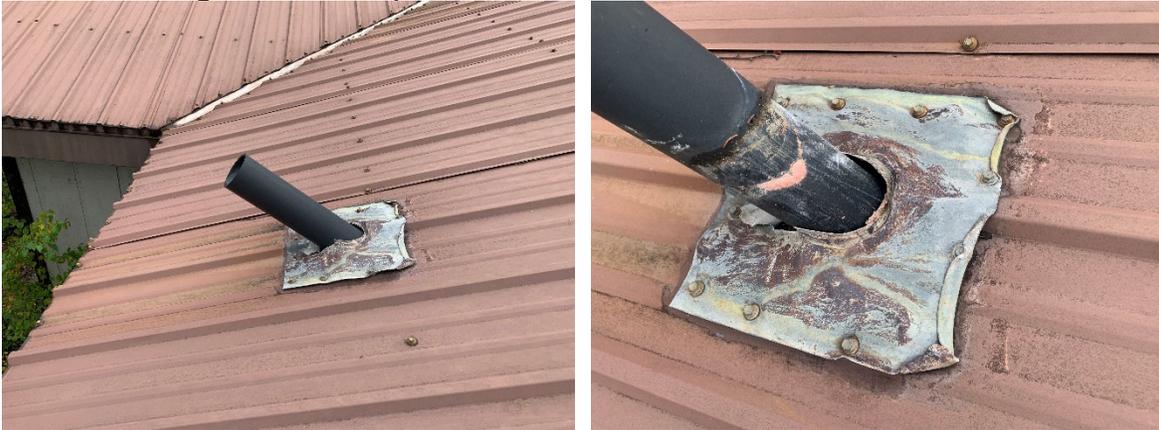
- 
- 
8. Repair the damaged sewer vents on the roof that have resulted from sliding snow. Replace the roof flashings with new as part of this work.

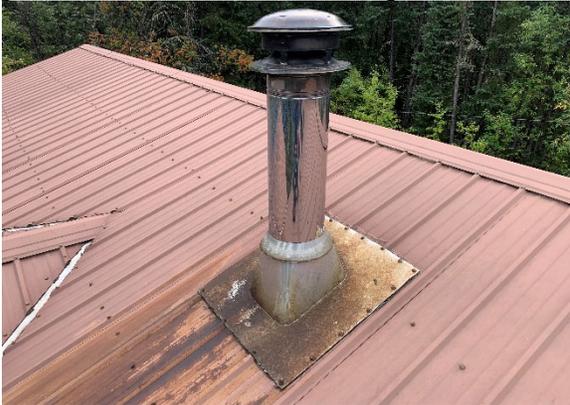
9. Refinish the heavily corroded metal roof panels adjacent to the furnace chimney as to help prevent further corrosion or replace this roofing panel with new.

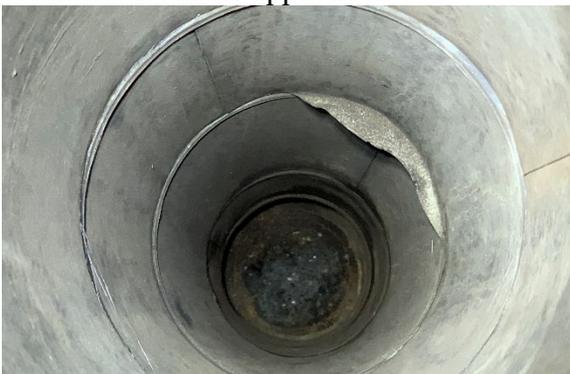
10. The furnace chimney is starting to buckle at the interior liner at one of the joints. This is typically the first stage of failure of the pipe. Have a professional chimney installer replace this furnace chimney with new factory built chimney suitable for use with solid fuels and conforming to UL-103HT. The chimney must extend above the roof at least three feet and two feet above any area of the roof within ten feet of the termination of the chimney. Installation should also include factory built and appropriate rain cap, storm collar, and roof flashing. The new chimney flue shall not be smaller in area than that of the area of the connector from the appliance.

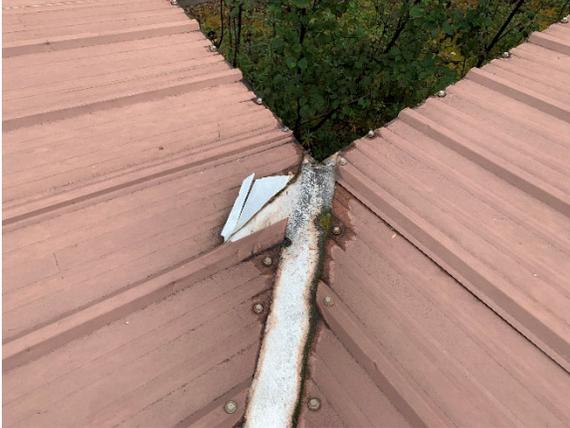
- 
- 
11. Repair the damaged metal roof at the valleys. Bend the sheet metal back into position and install additional screws to hold it in the future. Use a synthetic rubber caulking such as Lexel to patch and seal the torn area.

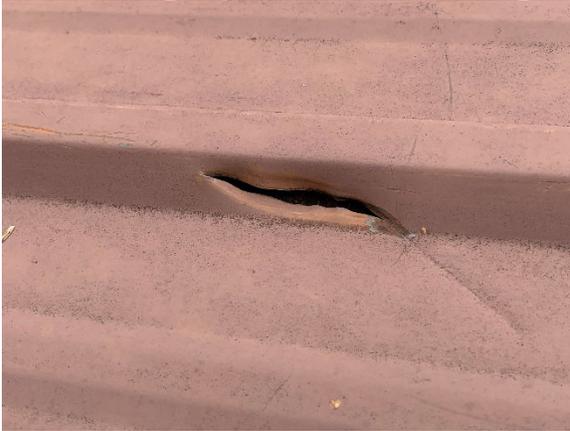
12. Patch and seal the damaged sections of metal roofing where there are tears. Seal from inside the roof using a synthetic rubber caulking such as Lexel.

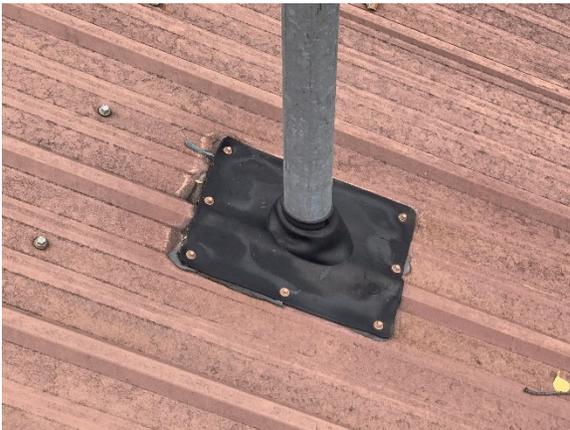
13. Re-seal around the electric power mast roof flashing using a synthetic rubber caulking such as Lexel.

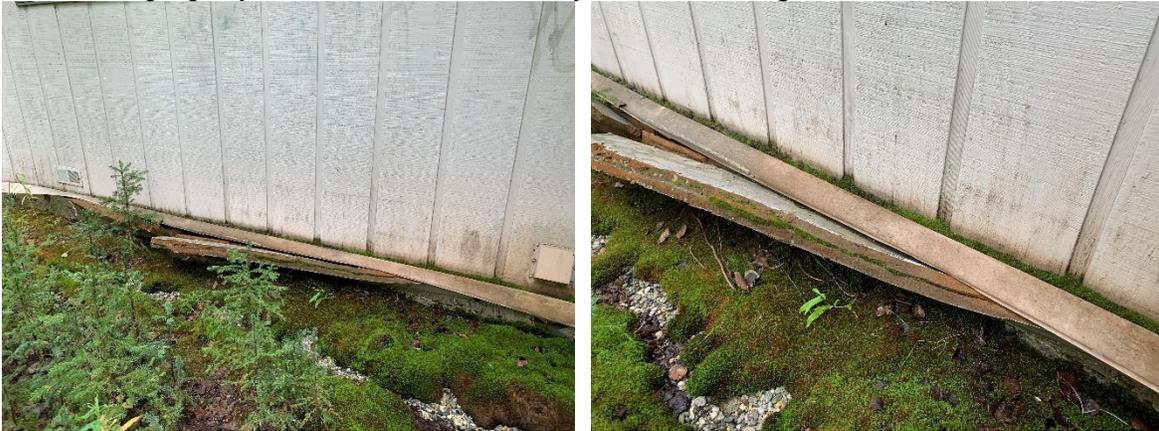
- 
- 
14. The foam insulation at the exterior of the foundation has frost heaved and is pushed the perimeter foundation flashing up. Excavate these areas adjacent to the foundation to reinstall the insulation and secure it to the foundation. Correct the perimeter metal flashing such that it is installed properly and drains moisture away from the siding.

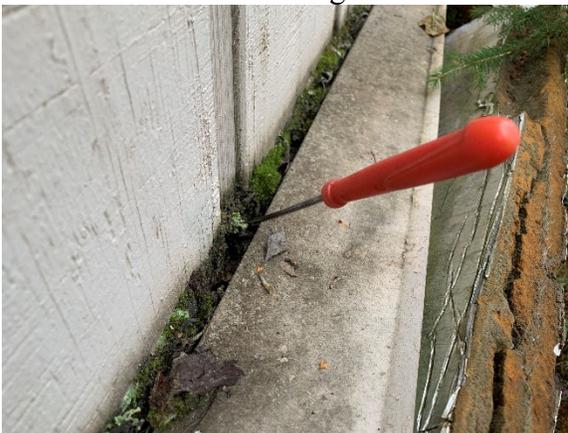
15. There is decay along the bottom of the T1-11 siding at locations where the metal flashing is frost heaved up and holds moisture. After the flashing is corrected, cut off and open up the areas of decayed siding. Evaluate the framing behind the siding for decay and make repairs as needed. Patch the siding.

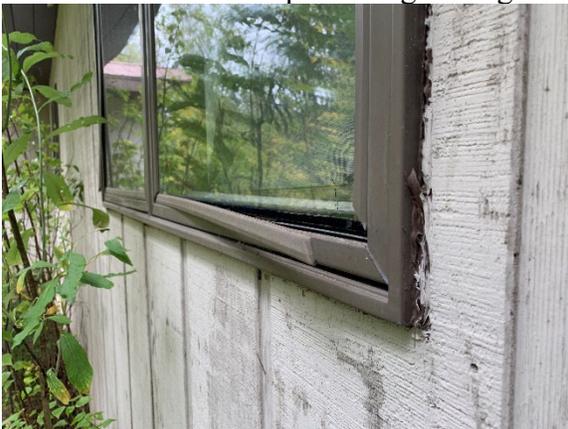
16. Repair all of the windows where the trim and glazing is coming apart. Several windows have the seals that hold the panes of glass together that are starting to fail and will need new glass.

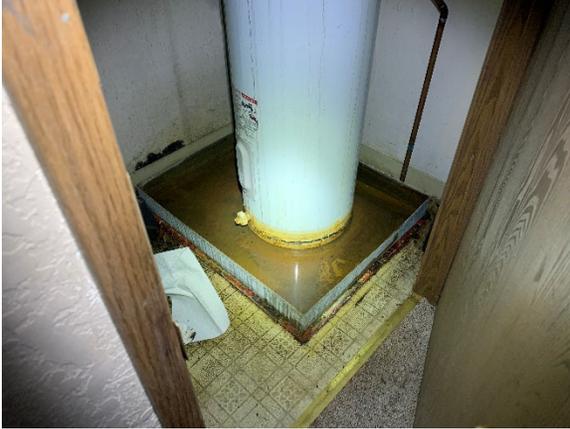
17. Replace the failed hot water tank with new.

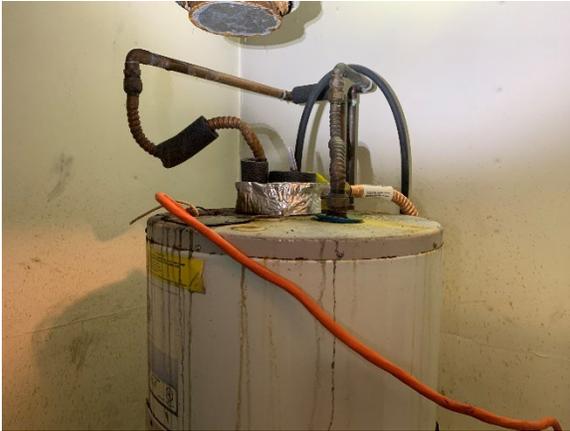
18. Install the Romex at the hot water tank into metal flex or conduit.

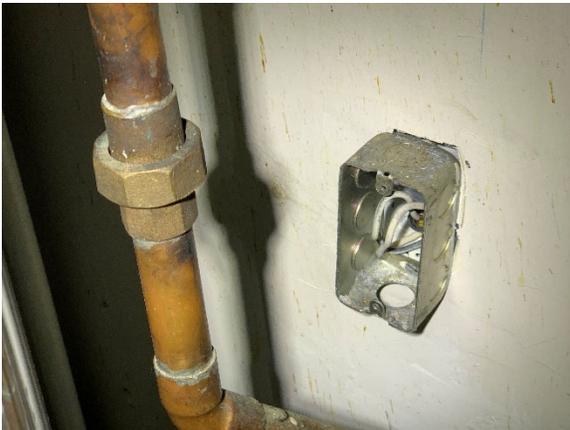
19. Install a cover plate where missing on the open junction box located adjacent to the hot water heater.

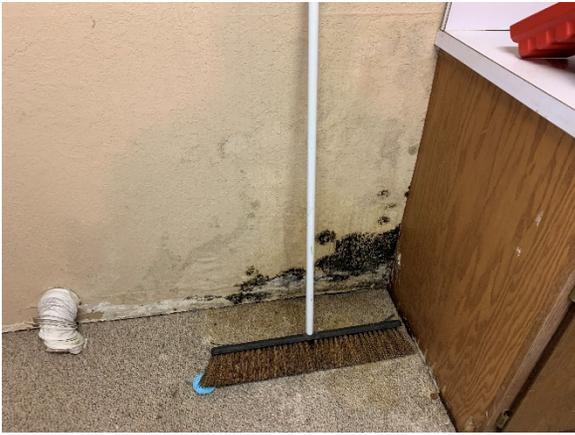
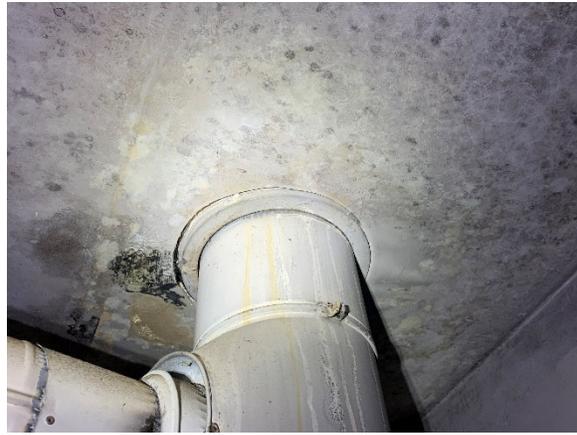
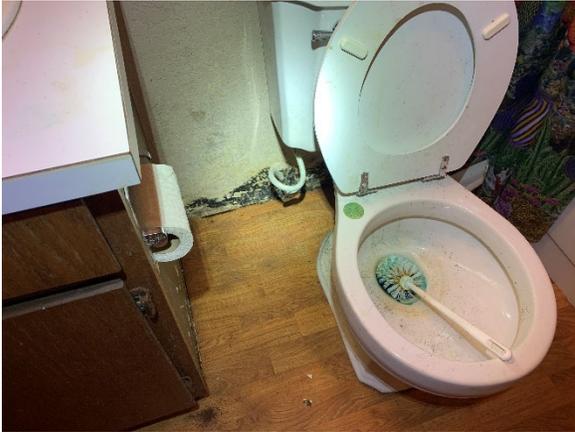
20. There was a substantial amount of significant mold throughout the house. All areas of drywall with mold embedded in the drywall needs to be cut out and the drywall replaced. All other areas can be thoroughly cleaned and scrubbed and disinfected using a broad spectrum germicide disinfectant such as Concrobium.

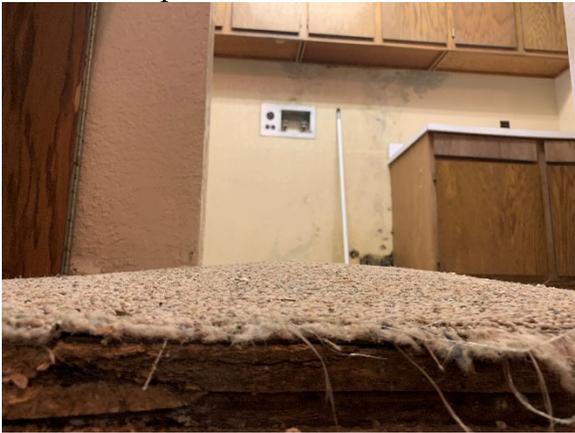
21. Cut out and replace the moisture damaged and swelled subfloor in front of the furnace room. The CDX plywood below seems to be fine but the fiberboard is severely moisture damaged and needs replaced.

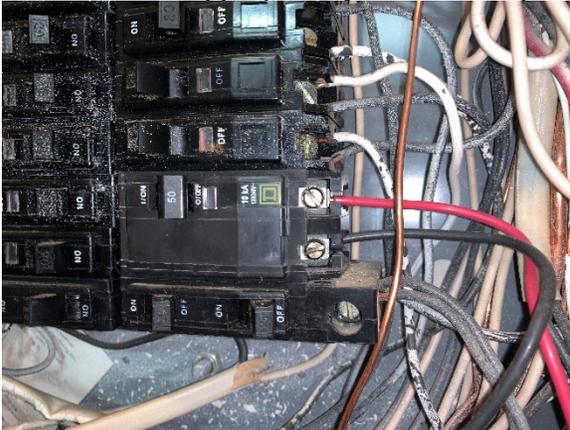
- 
- 
23. At the electric breaker panel, replace the 50 amp circuit breaker for the electric hot water heater with an appropriately sized 30 amp breaker.

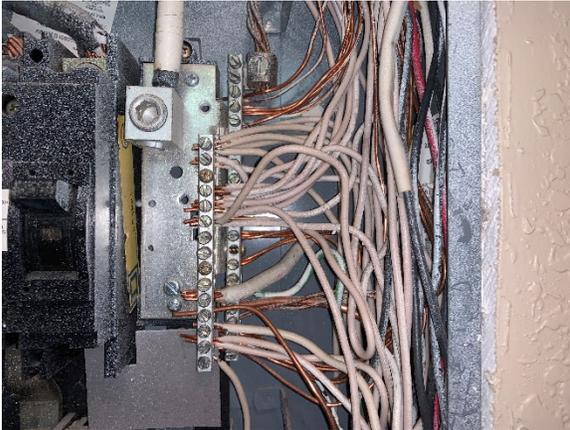
24. At the electric breaker panel, separate all of the equipment grounding conductors off of the isolated neutral bus and bond them to the metal panel using a grounding bus.

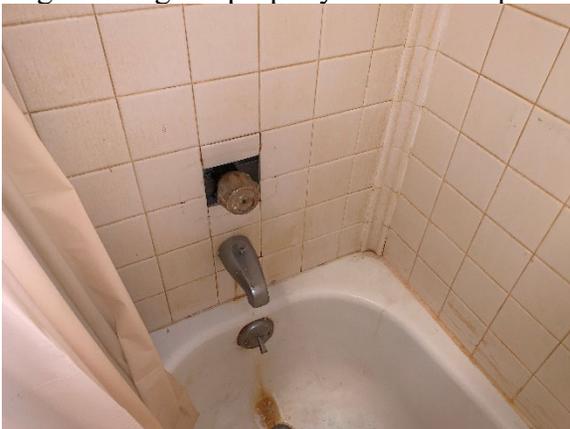
26. Replace the damaged and missing tiles at the shower surround or install sealed metal trim ring ensuring it's properly sealed as to prevent water infiltration.

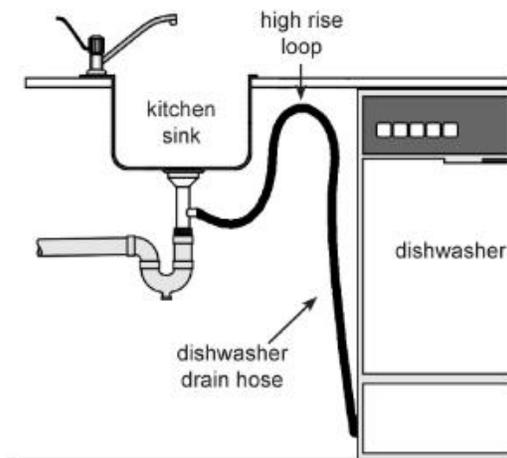
- 
- 
27. Repair the broken window operator mechanism at the southeast bedroom egress window.
  28. Replace the dishwasher with new.
  29. Install Ground Fault Circuit Interrupter (GFCI) protection for all kitchen receptacles that are installed to serve countertop surfaces as required per code. *Reference: NEC 210.8(A)*
  30. Run the drain line from the dishwasher through an air gap device located above the sink or secure the line as high as possible (preferably the bottom of the counter top) before connecting it to the garbage disposal or sink drain so the opportunity for cross contamination is minimized.

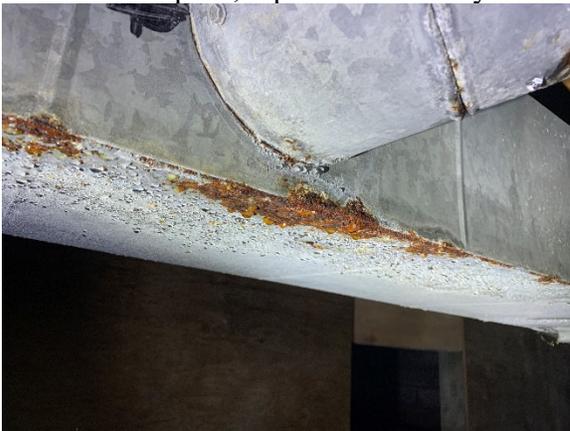
31. In the crawl space, install a 50 CFM bath exhaust fan that vents to the exterior on one side of the crawlspace and install a 4" passive air duct on the other far end of the crawlspace as to allow for ventilation to thoroughly dry out and reduce condensation. Have the fan configured on a humidistat switch so that it will automatically activate when the relative humidity increases above approximately 30%.
32. In the crawl space, replace the heavily corroded sections of heat ducting.

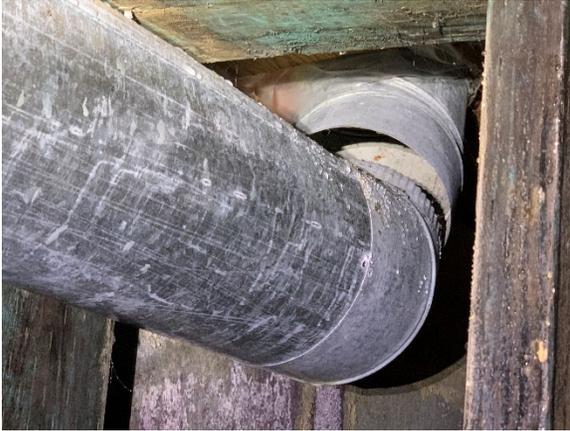
33. In the crawl space, re-seal the loose joints of the heat ducting.

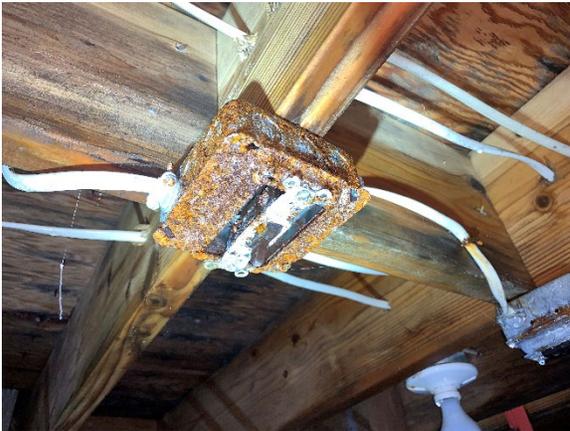
35. In the crawl space, replace all heavily corroded electric receptacles, switches and junction boxes with new.

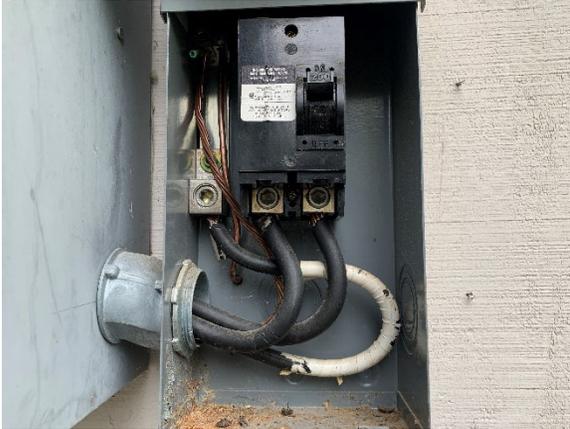
- a. It should be noted that this home according to the borough is not located within a fire service area. This can have an effect on obtaining fire insurance.
- b. The electric service panel was evaluated and found to be NEC compliant with appropriately sized copper conductors for the 100 amp service. The electric feed contains a dedicated equipment grounding conductor and the panel appears to be properly grounded to a grounding electrode.

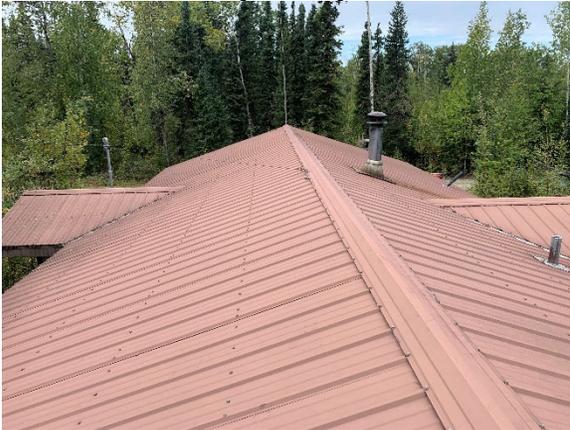
- c. All of the metal roofing screws were found to be tight and overall, the metal roof was found to be in acceptable condition. After repairs are complete it is my opinion that this roof will serve well for many more years.

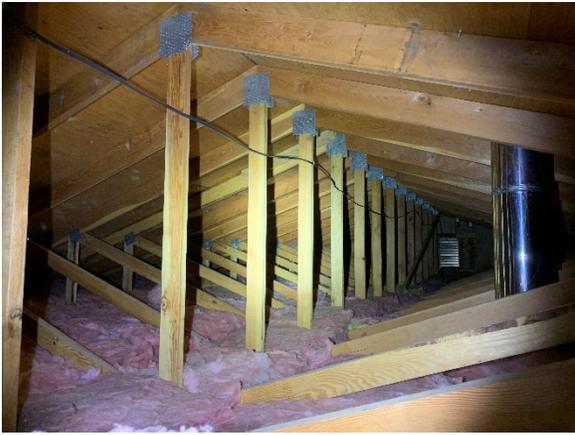
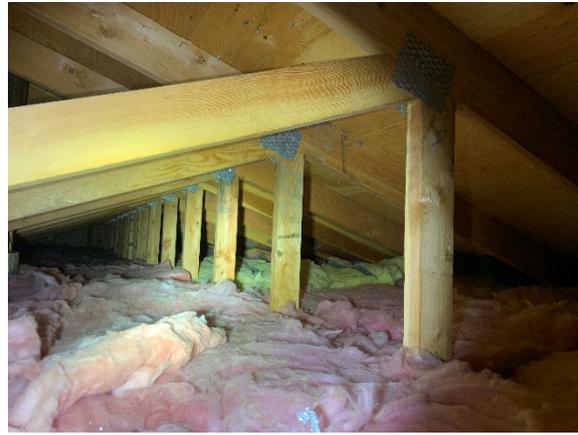
- d. The roof framing consists of Engineered trusses and are considered sufficient for the Fairbanks snow load. Under normal conditions shoveling the roof will not be necessary. Attic insulation was measured around 8 inches thick and consists of fiberglass bats. For increased energy efficiency, consider adding an additional 6 inches or more of blown fiberglass or cellulose taking care not to block the eave vents.

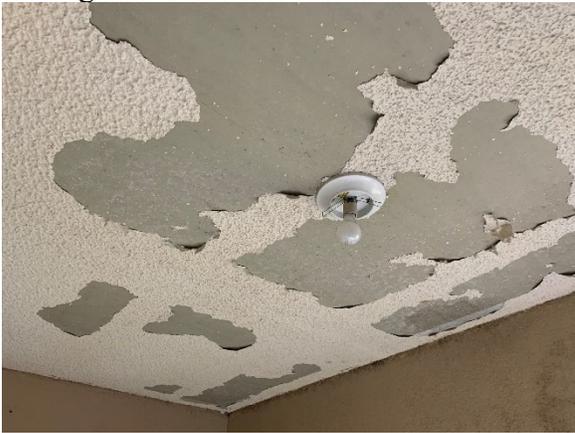
- e. Because the home has been vacant for so long it may be necessary to have the fuel in the fuel tank cleaned and separated for water. There was likely a lot of moisture condensation that develops in this tank over the many years that it has gone unused.
- f. The cosmetic damages throughout the house are significant due to this home being vacant for so long and the condensation and excess moisture that resulted. Buyers should be aware.

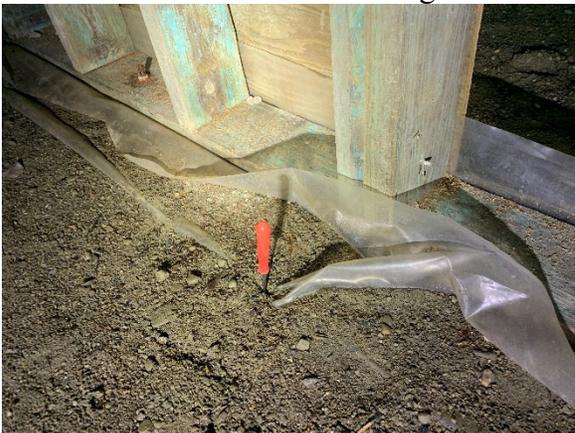
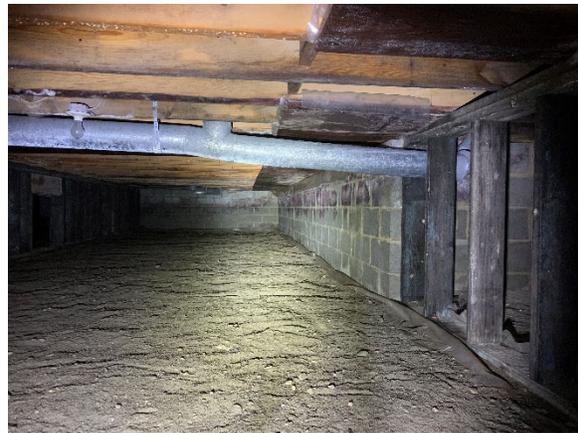
- g. There appears to be a layer of fine crushed rock over top of the plastic vapor barrier in the crawlspace. The vapor barrier does seem to be continuous but moisture was extremely high down there due to the home being vacant and no ventilation.

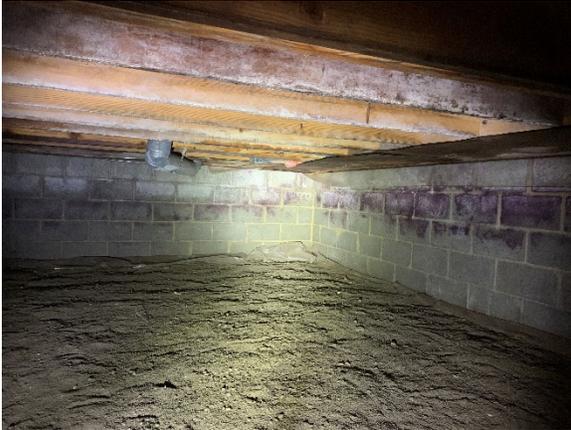
- 
- 
- h. The foundation consists of concrete strip footings with concrete block stem wall that appear to be continuously grout filled. No signs of cracks or movement was observed on the foundation.
