APMA F20229339- Anarraaq & Aktigirug Exploration Program FIELD SUMMARY REPORT

Inspection Date: August 20, 2022
Time: 7:30AM to 10:00AM
Weather: Partly cloudy skies mid-morning clearing later in the afternoon.
Variable light winds with an average air Temperature of 49°F.
Agency Personnel: DNR: Aaron Kruse, Stephen Buckley, William Groom, Carolyn Curley, Ben Wagner
Operator Contact: Rebecca Hager, Emily Hart, Robert Napier
Inspection Objectives: Annual Inspection

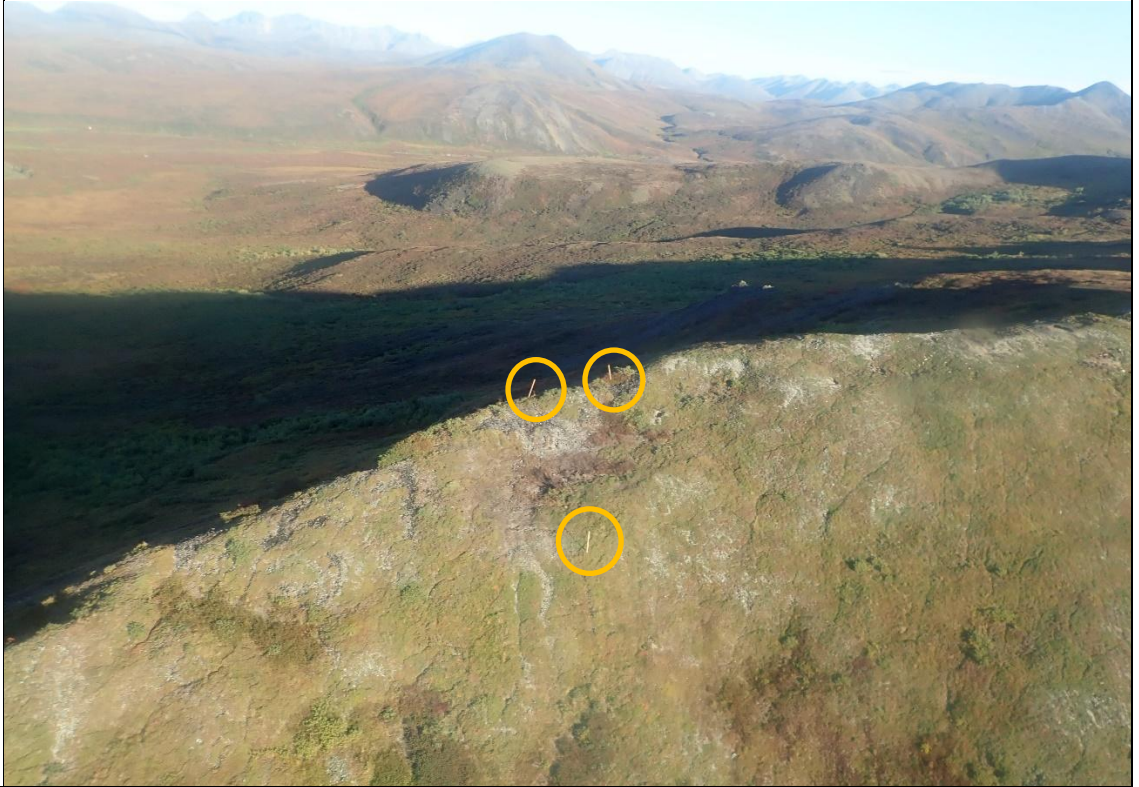
Figure 2

Drill hole ID:
22AAMS01-01
22AAMS01-02
22AAMS01-03

These marked geotechnical drillholes are located at the proposed AA-MS-1 material site.

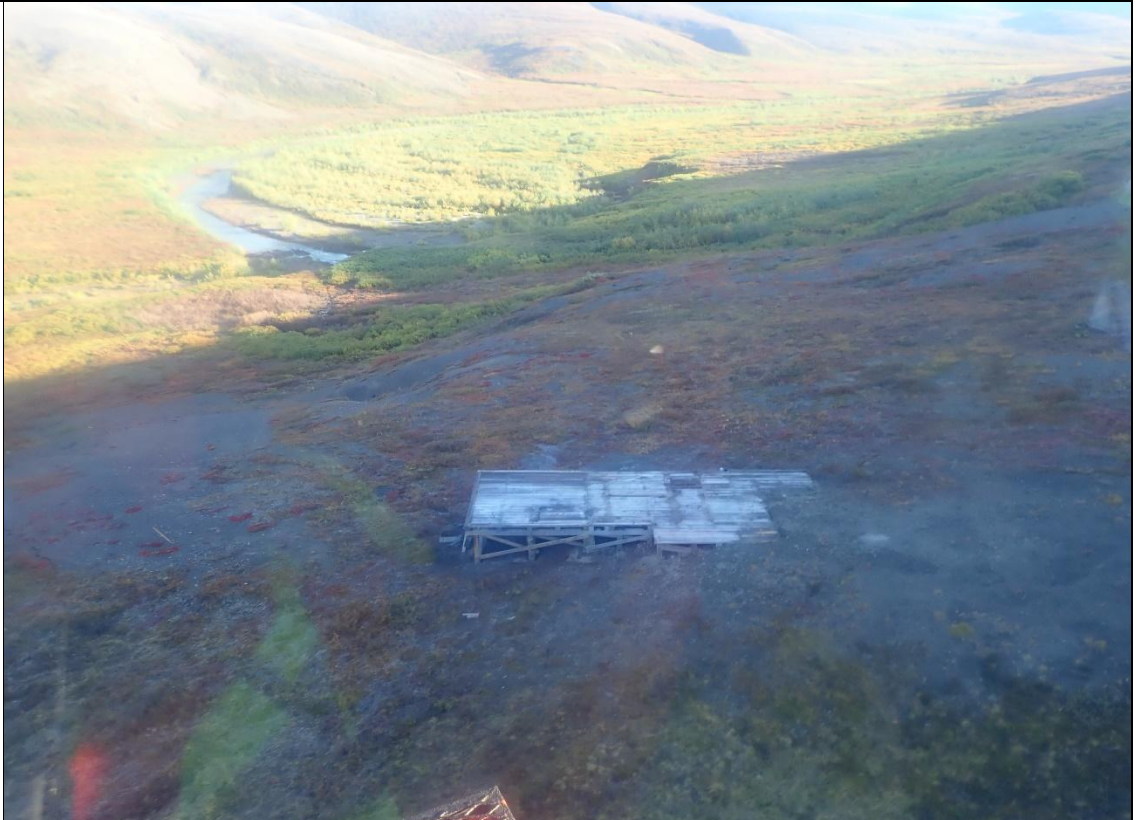
Figure 3

Drill hole ID:
DDH1798G

Geotechnical drill site platform.

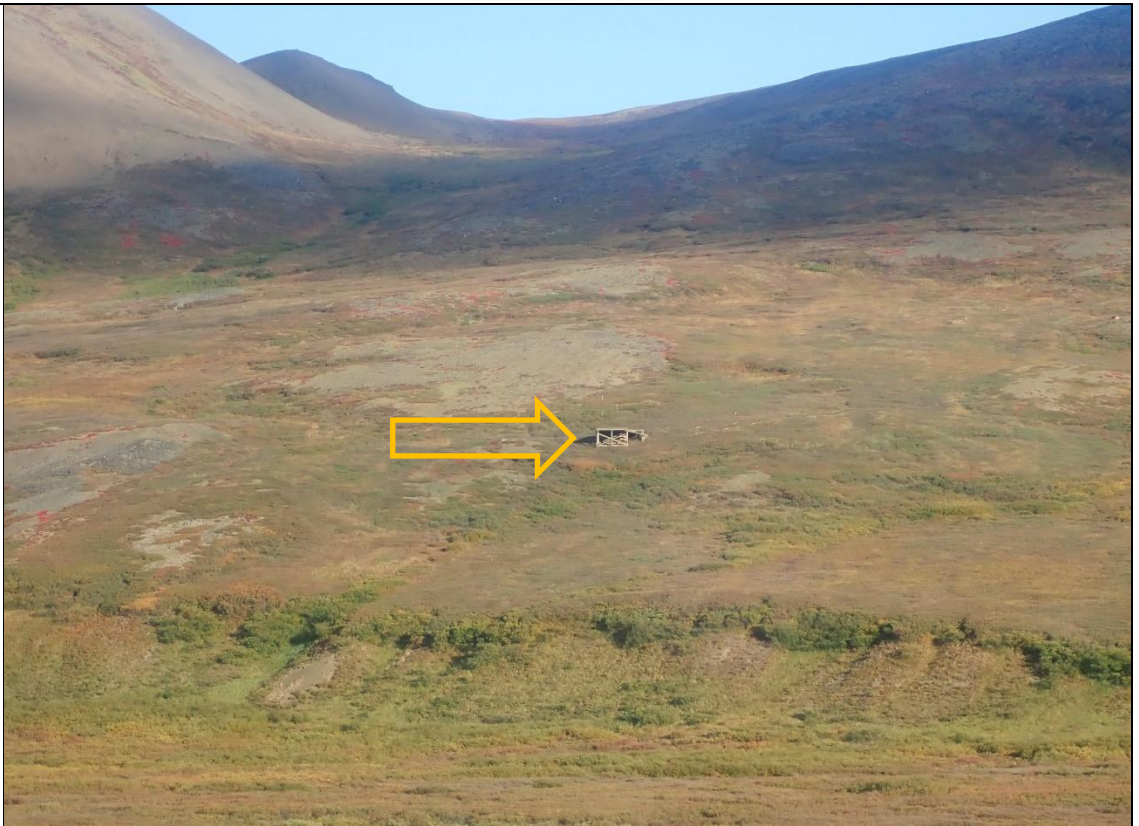
Figure 4

Drill hole ID:
DDH2201G
DDH2200G

Geotechnical drill site
platform.

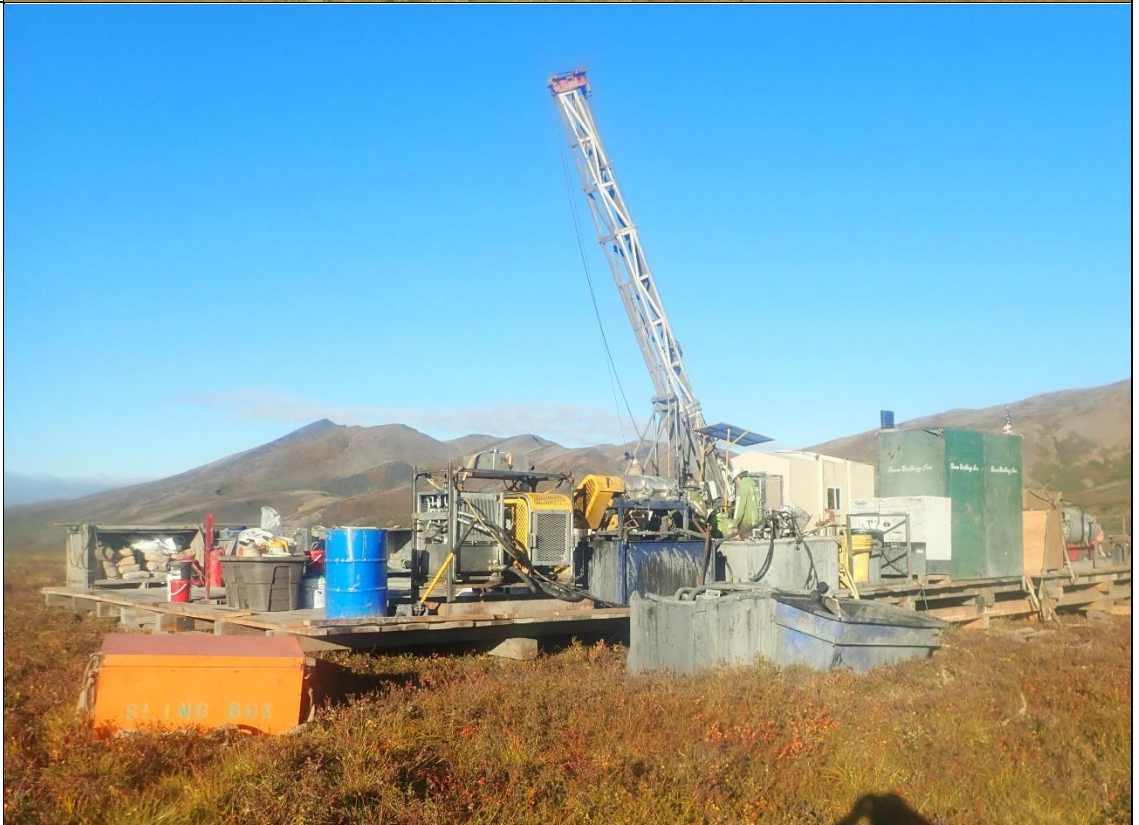
Figure 5

One active geotechnical drill site was observed during this inspection along with several drilling platforms (Figures 3 & 4) and flagged stakes (Figure 2) from previous geotechnical drillhole locations. TAI proposed to use several types of drilling methods to test surficial geology (track mounted auger or sonic rig) along with core drilling to provide the necessary rock characterization. All geotechnical drilling observed in the field resides on private property and has meet the requirements under AS 27.19, Reclamation Act, mining, exploration, and reclamation projects involving less than five acres of disturbance on private land.

Drill hole ID:
DDH1799G

Active geotechnical drilling.

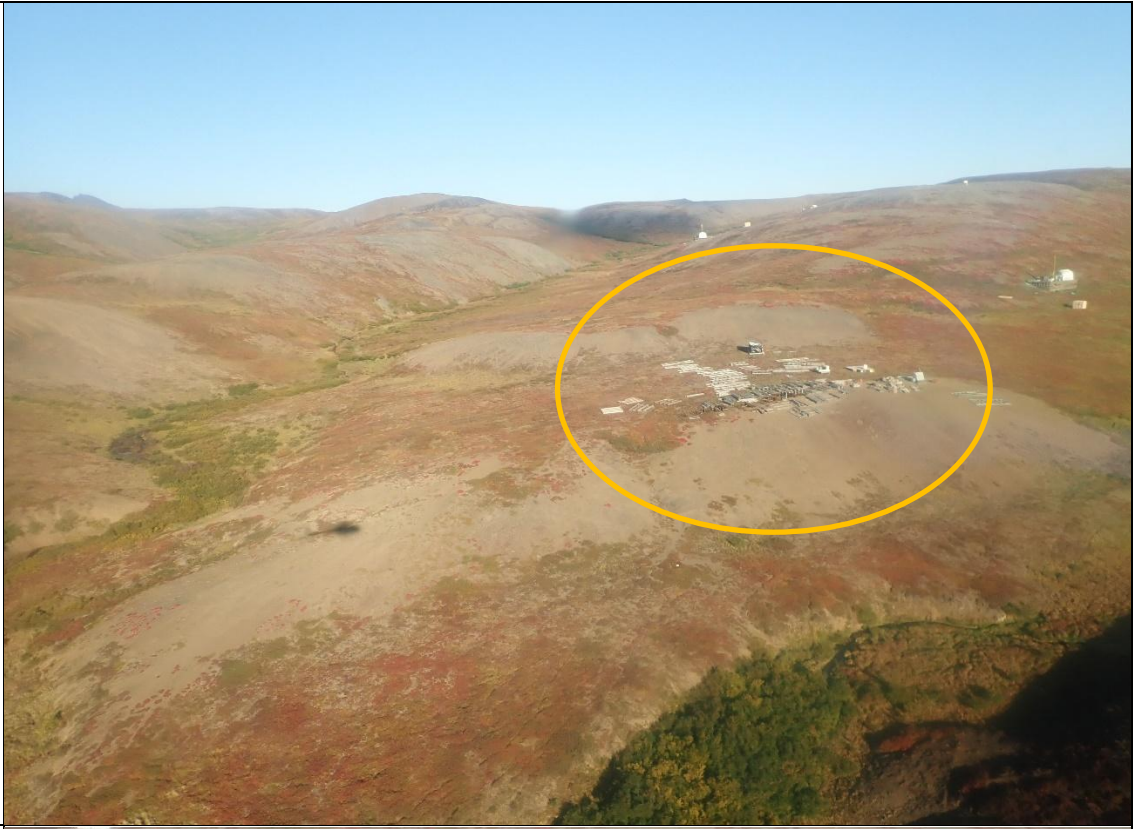
Figure 6

Laydown area to support exploration activities

Several drill rigs are in the background for perspective to show proximity of laydown area for current exploration activities.

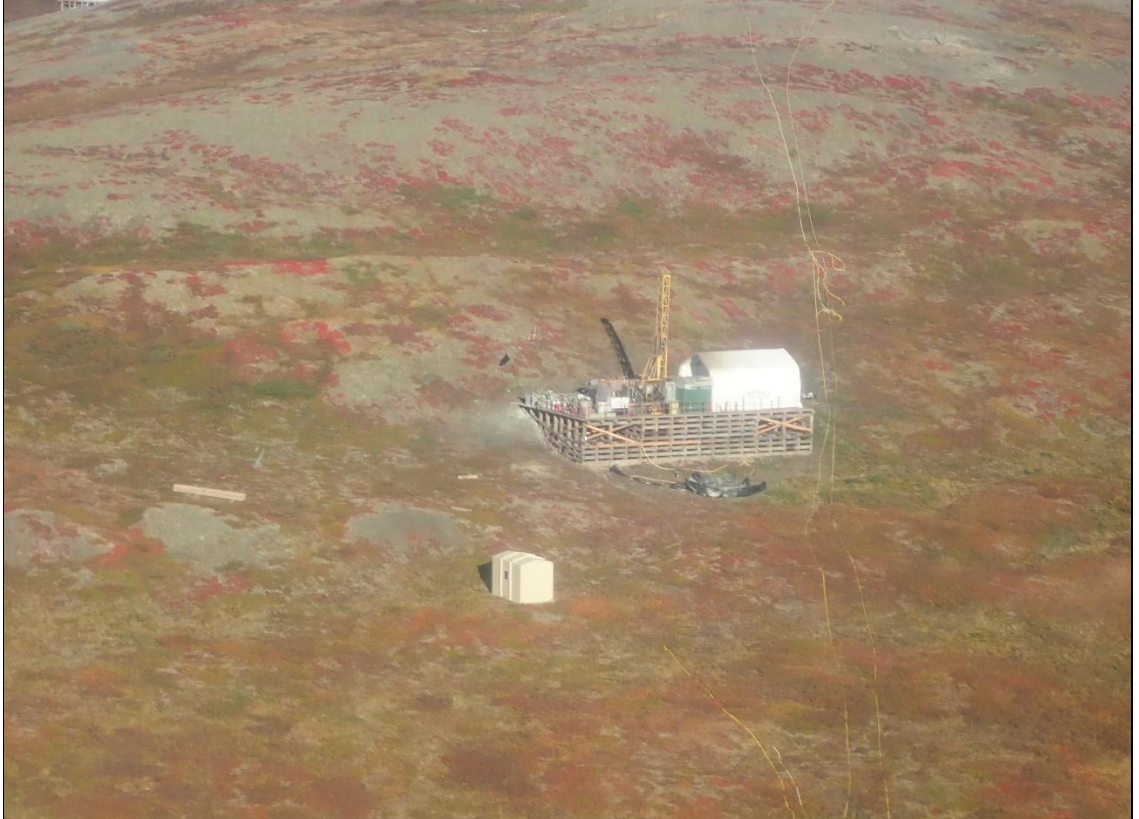
Figure 7

Three active exploration core drilling sites were observed during this inspection on state land. Each location had the drill rig and essential support equipment elevated off the ground on decks to reduce impacts to the surface. Water management used solid recovery units (SRU) to separate out the cuttings and settling tanks in order to re-use drilling fluids. All cuttings are flown back to Red Dog Mine in super sacks for storage. Make up water is stored above each site within one large holding tank (Figure 14) supplied by a pump situated southeast of primary drilling activities from a small tributary of Ikalukrok Creek (Figure 16). Each exploration drill site was observed to be in compliance with the stipulations and regulations outlined in their authorized Miscellaneous Land use Permit (MLUP) for hardrock exploration activities and reclamation.

Active exploration drilling.

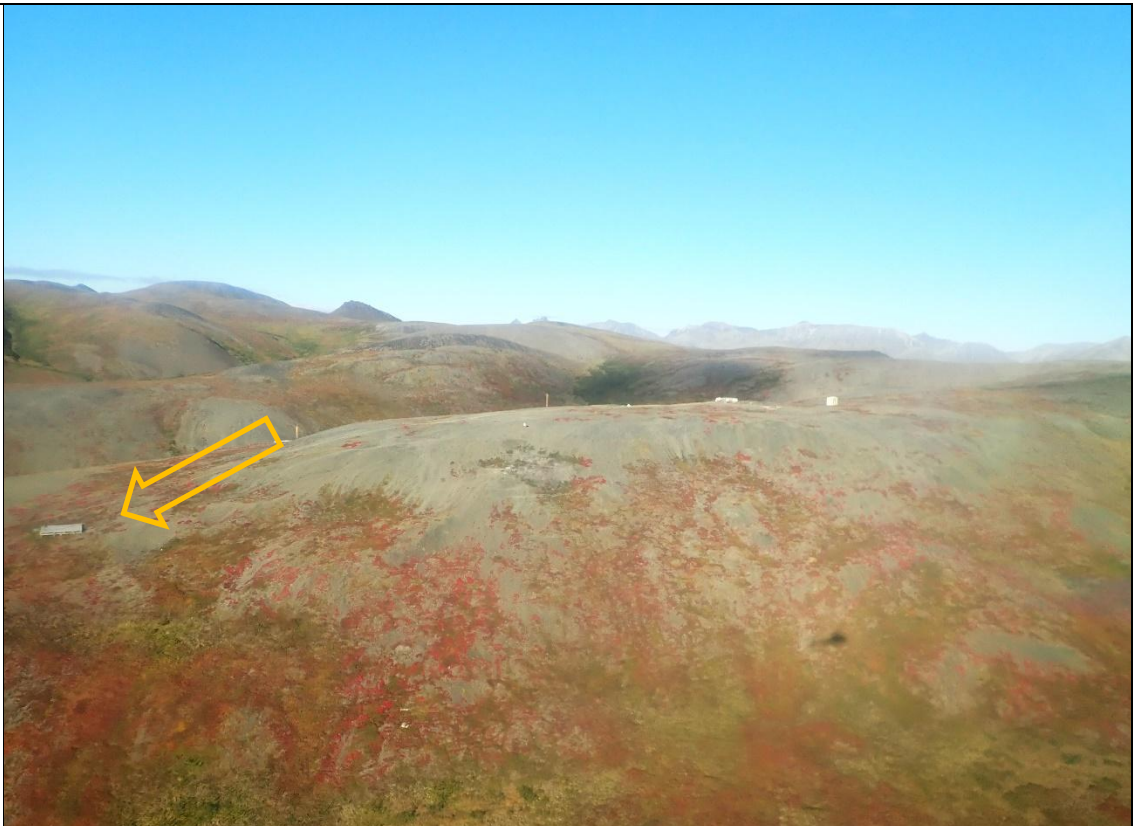
Figure 8

Drill hole ID:
DDH1781
DDH1781_W360

Platform left in place from
previous exploration
activities.

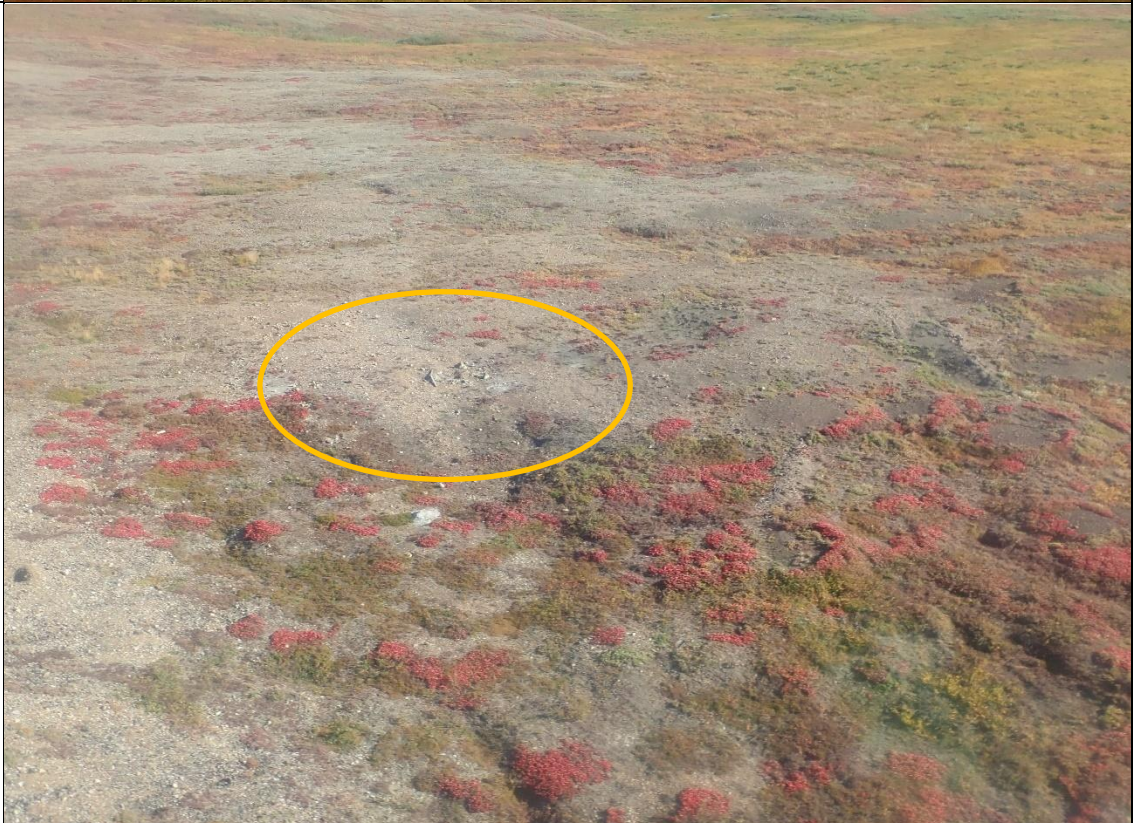
Figure 9

ADNR inspected one exploration drillhole that was recently decommissioned. All casings have been removed above the surface and topsoil contoured and respread in a manner that promotes local vegetation, no erosion concerns noted. All sites were found in acceptable condition according to AS 27.19, 11 AAC 97, and the terms of MLUP F20229339.

Drill hole ID:
DDH1790

Reclaimed drill hole. Casing
has been removed and area
has been restored to pre-
exploration activities.

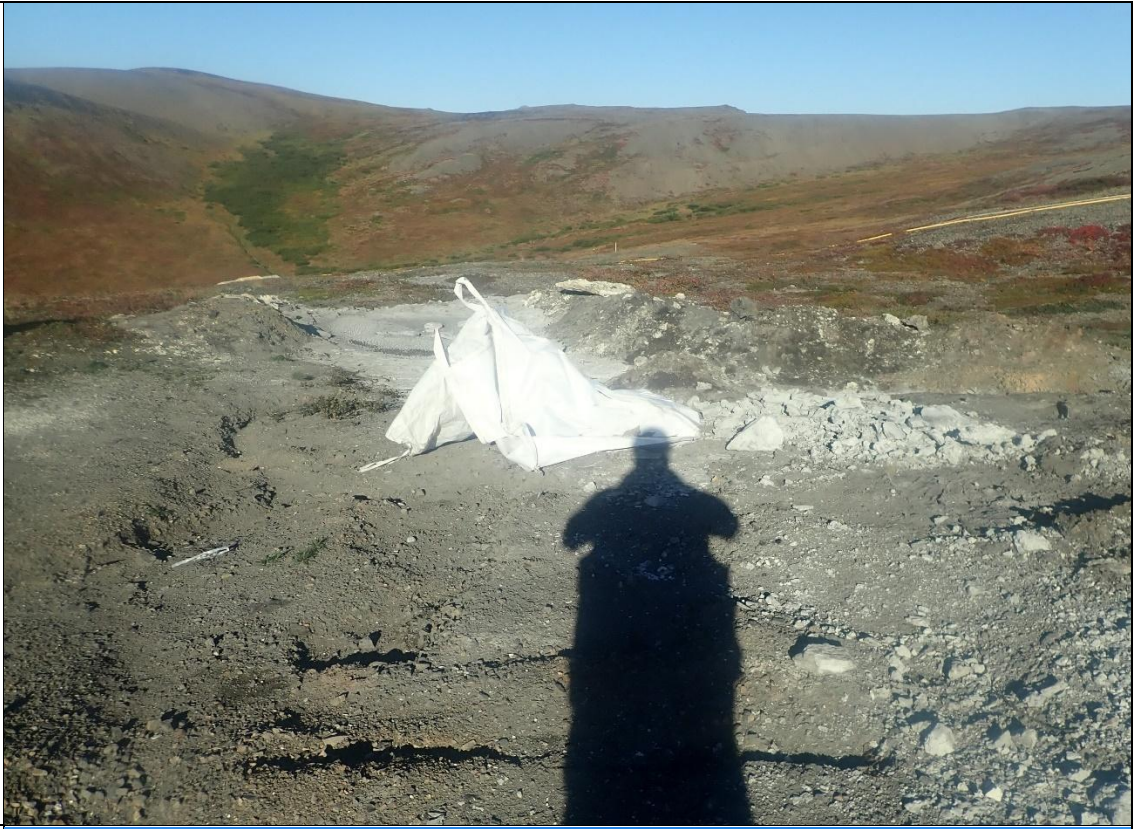
Figure 10

Drill hole ID:
DDH1780
DDH1780_W360
DDH1791
DDH1791_W090

At time of inspection, drill site was not reclaimed. No casings were observed; however, minimal contouring and preparations for revegetation are needed before the state considers reclamation is complete. It is recommended that this location be revisited during the next field inspection.

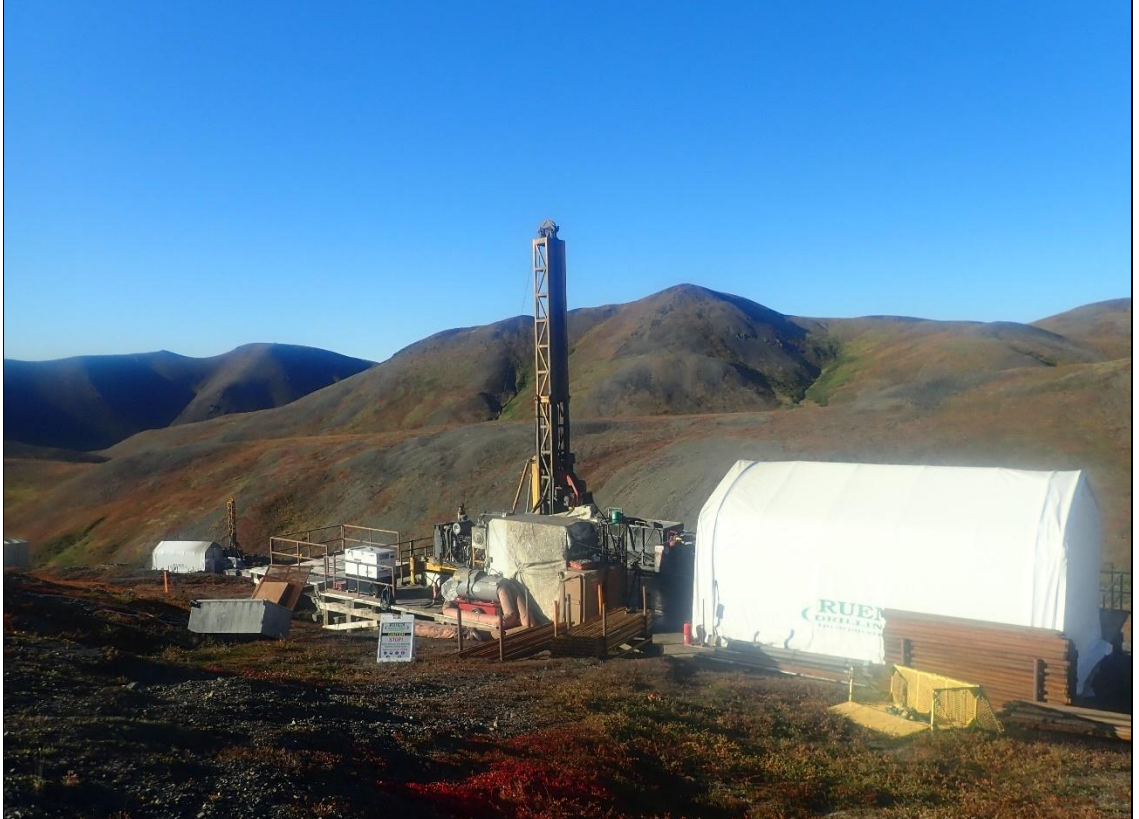
Figure 11

Drill hole ID:
DDH1794
DDH1794_W010
DDH1794_W065
DDH1794_W310

Active exploration drilling.

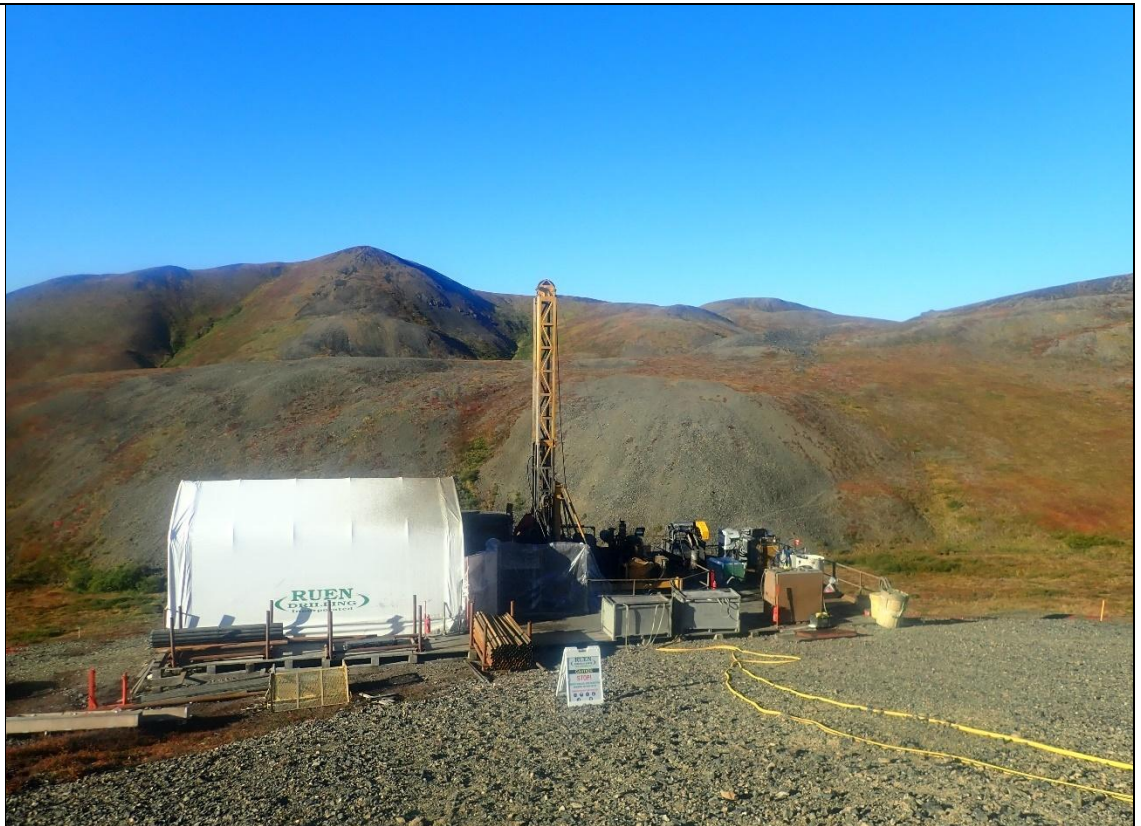
Figure 12

Drill hole ID:
DDH1793
DDH1793_W220
DDH1793_W260
DDH1793_W325

Active exploration drilling.

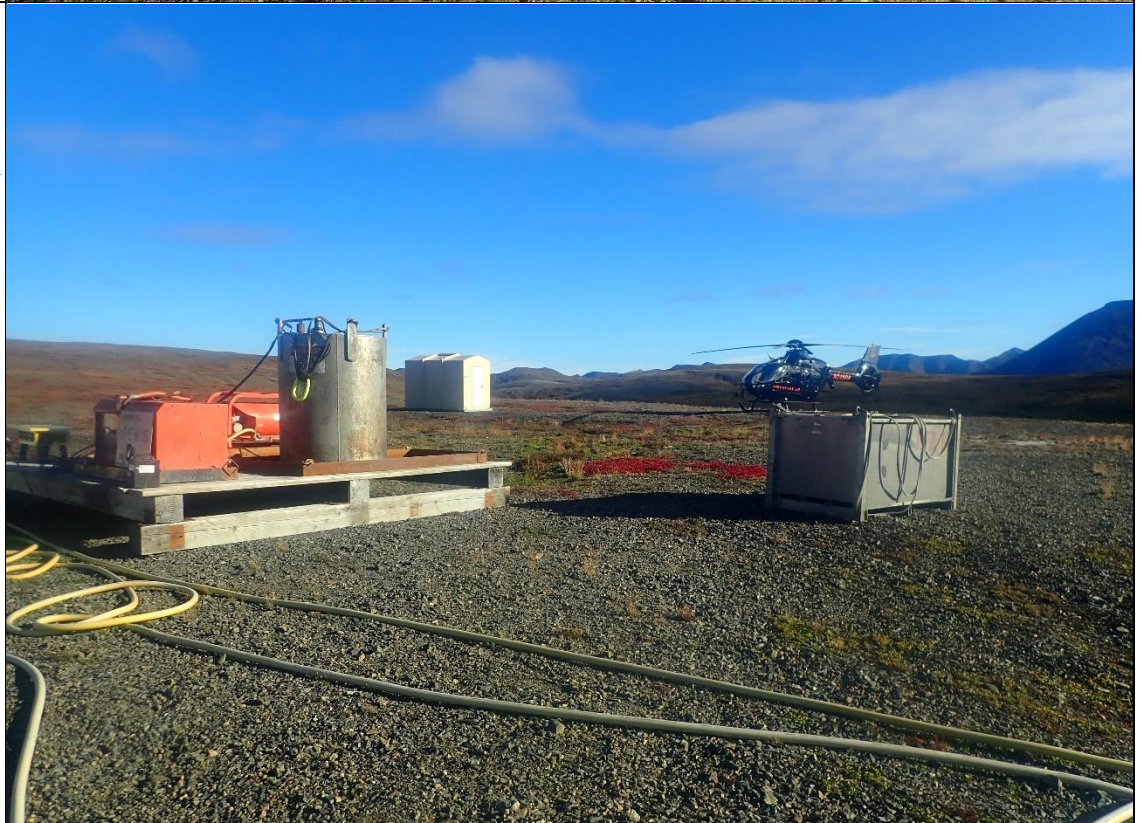
Figure 13

Fly in fuel tank and
equipment stored within spill
containment pans.

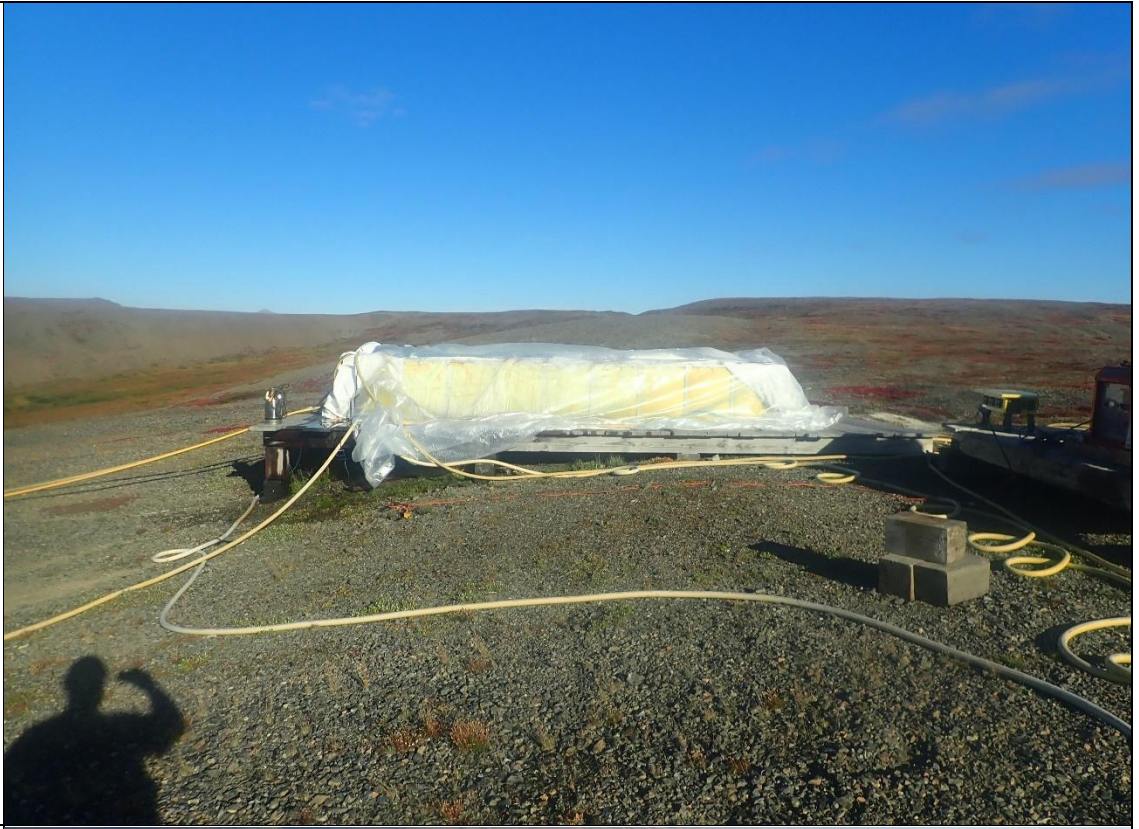
Figure 14

Water storage tank for support of exploration core drilling.

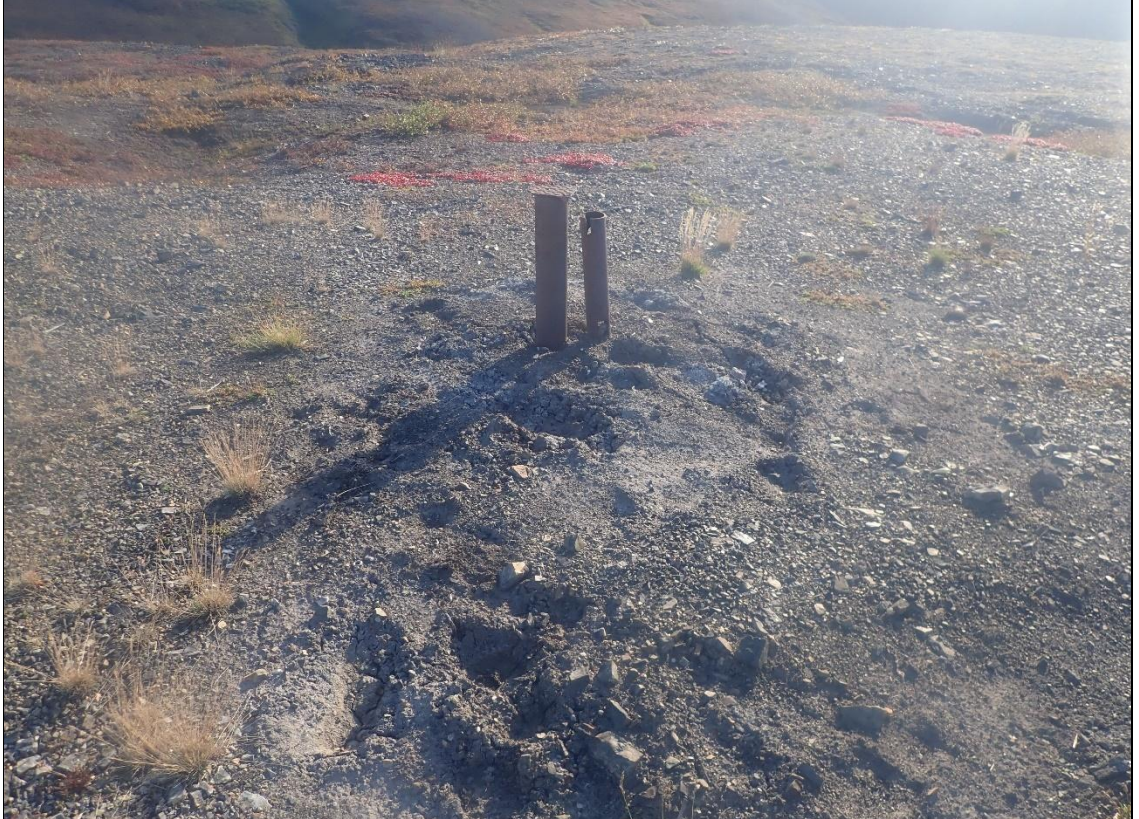
Figure 15

Drill hole ID:
DDH1779

At time of inspection, drill collars are still in place. Status of drill hole is currently unknown. Recommended to revisit site during next inspection.

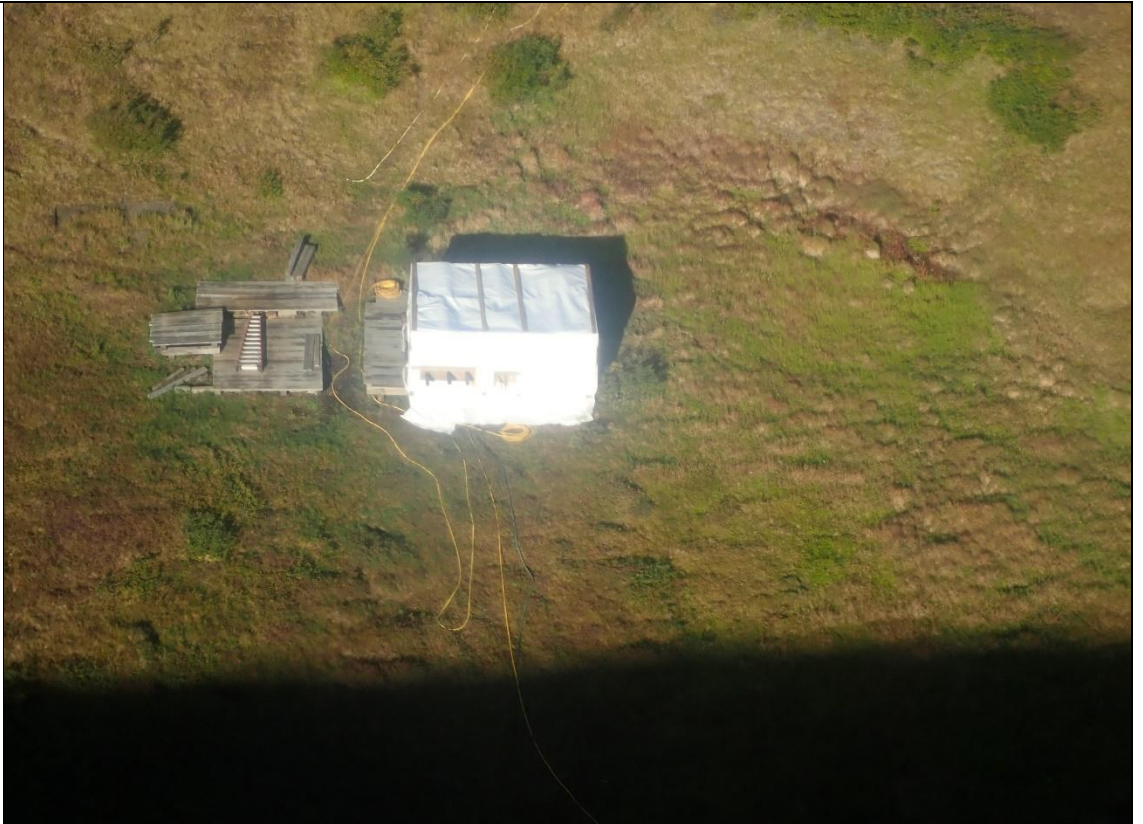
Figure 16

Main water supply pump with lines running up to holding tank.

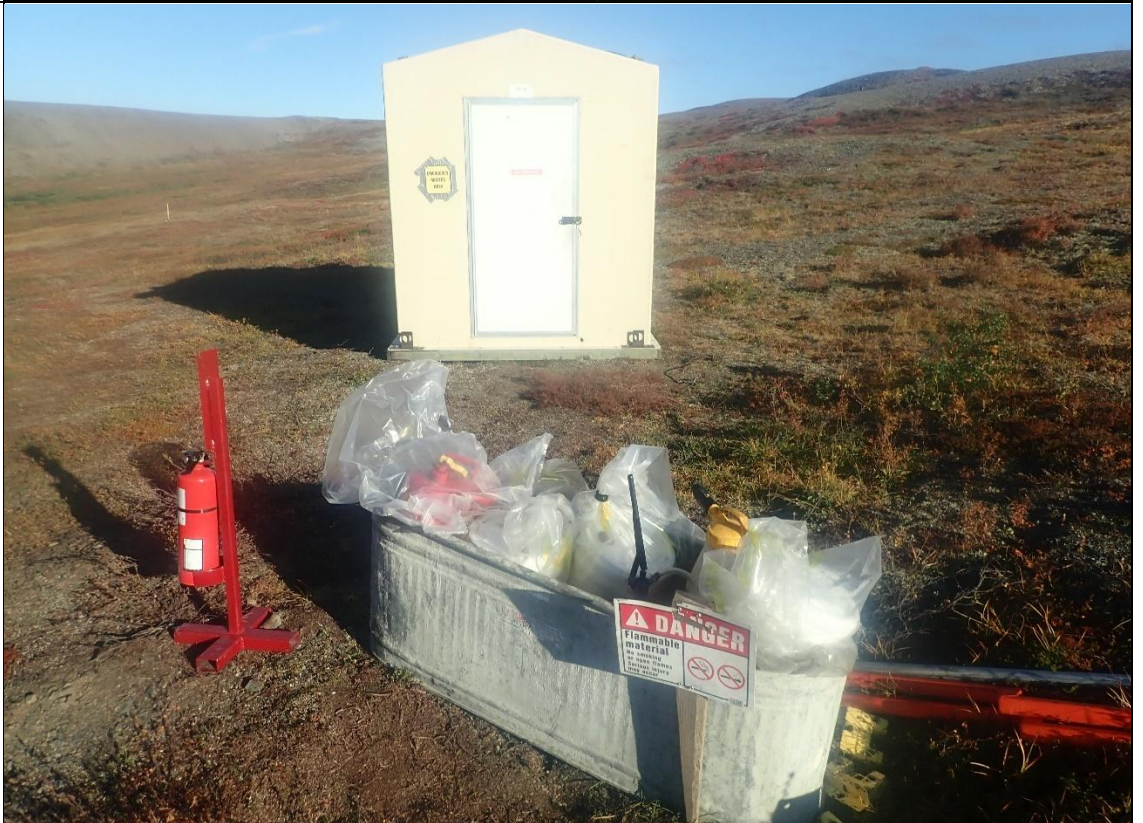
Figure 17

All active drilling locations had emergency muster areas and galvanized stock tanks to hold flammable substances located away from main drilling activities for safety, Figure 17. Fly in fuel tanks were observed to be stored on wooden decks adjacent to the primary water storage, Figures 13 and 14. A lay down yard was situated south of the area of primary exploration drilling activities, Figure 6. All pipe, timber, and support equipment reside directly on the ground to reduce the impact to *in situ* conditions.

Typical muster point and flammable material storage located near areas of active drilling.
