Fort Knox and Gil Satellite Mine Inspection Report

Inspection Date: September 18, 2024
Time: 9:00AM to 4:30PM
Weather: Overcast, light wind with occasional gusts, light rain
Agency Personnel: DNR: Jesse Garnett White and Eli Angel
Operator Contact: Kinross – Fort Knox: Brent Culleton and Jesse Dunshie
Inspection Objectives: Site Inspection

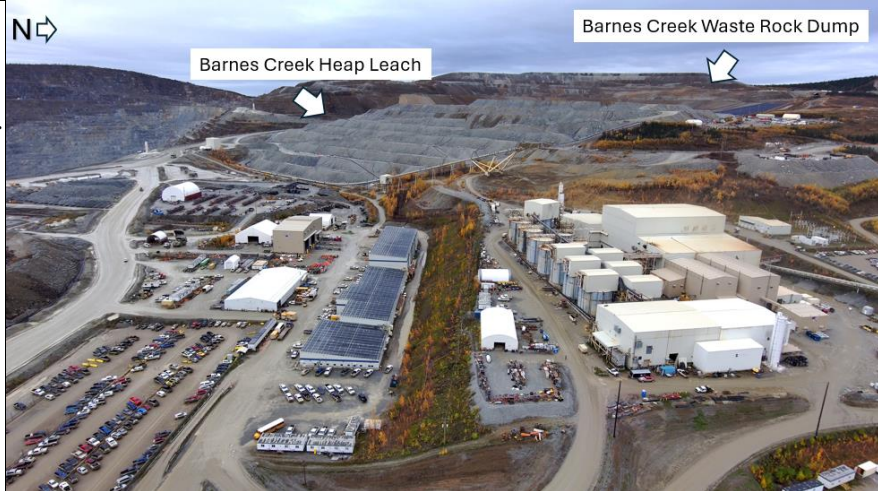
- 1.1. Barnes Creek Heap Leach (BCHL) was active at the time of inspection. The BCHL extends up valley from the existing Barnes Creek conveyor causeway to the base of the BCWRD (Photos 1-3).

Photo 1: Barnes Creek Heap Leach (BCHL). Mill, shops, offices, and parking in the foreground. BCWRD in background. Fort Knox Pit upper right.

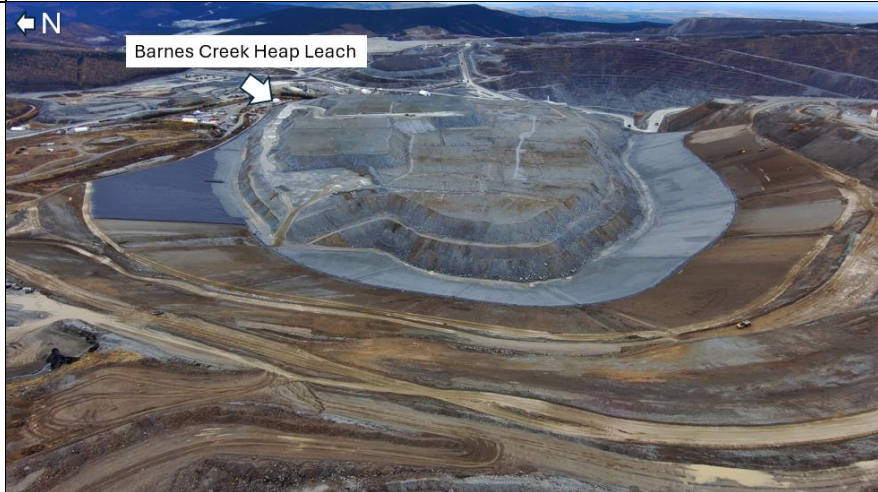
Photo 2: East view of the BCHL. Fort Knox Pit upper right. At the time of inspection BCHL was on target to free additional air space with all the rain.

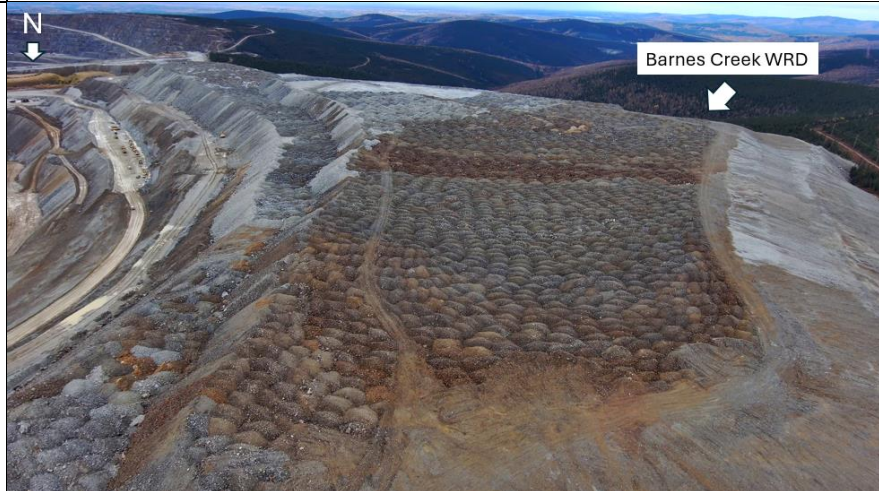
- 1.2. Barnes Creek Waste Rock Dump (BCWRD) is no longer used for tailing emplacement and is in the process of being recontoured (Photos 4-7). No work on this facility was observed during this visit.

Photo 4: Barnes Creek Waste Rock Dump (BCWRD). Southerly view of the top, final deposition of tailings and initial reclamation phase (contouring) of the west and northwest sides.

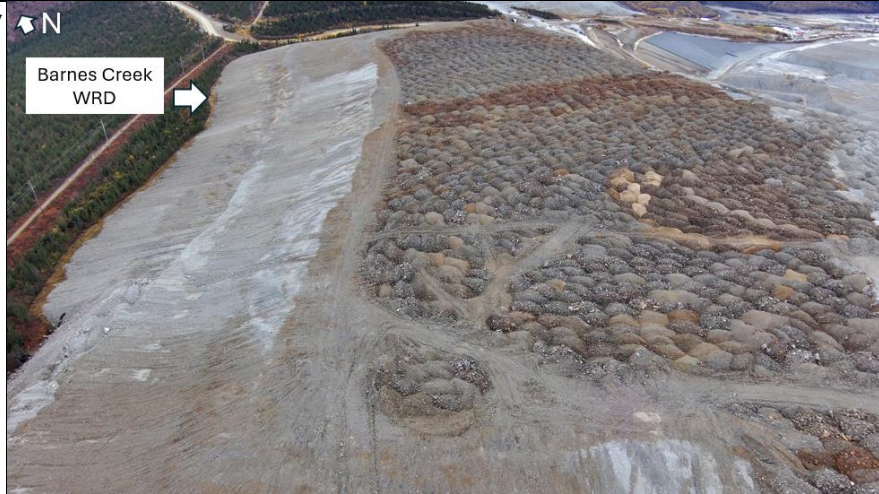
Photo 5: A northeast view of the northwest side of the BCWRD exhibiting final upper layer of deposition and initial phases of reclamation (contouring).

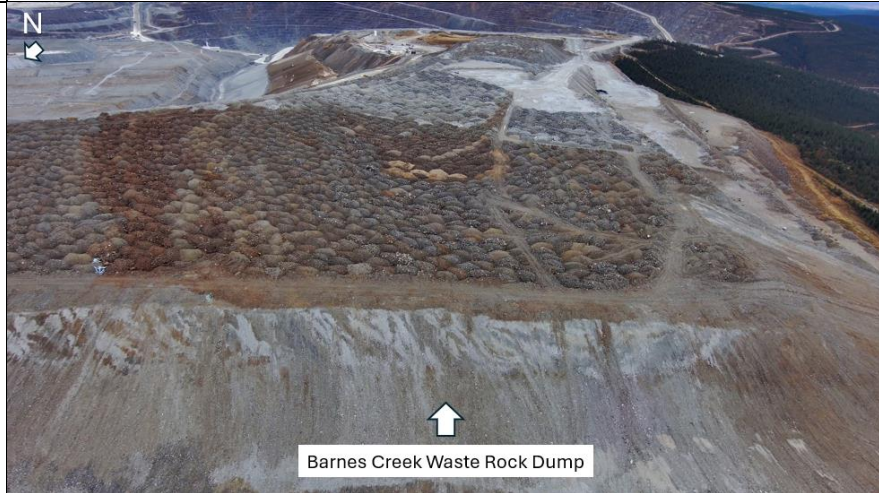
Photo 6: Another view of the north west side of the BCWRD showing final deposition and initial phases of reclamation (contouring).

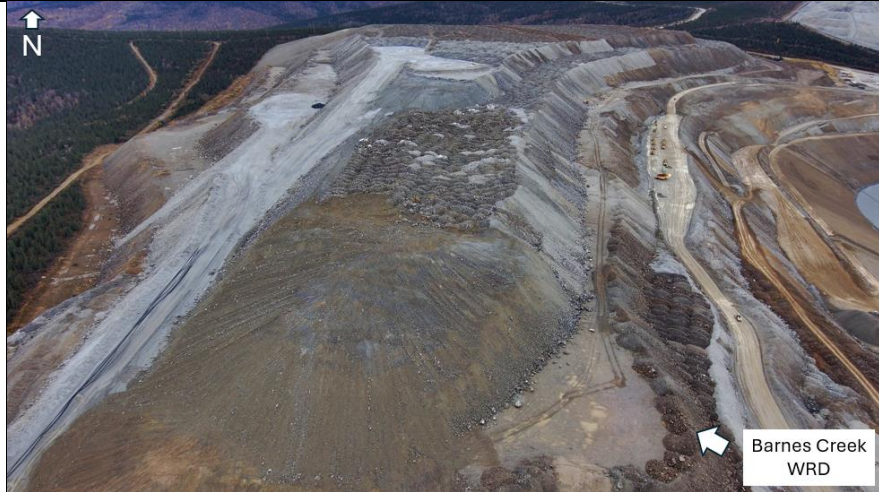
Photo 7: Initial phases of reclamation at the southern end of the BCWRD.

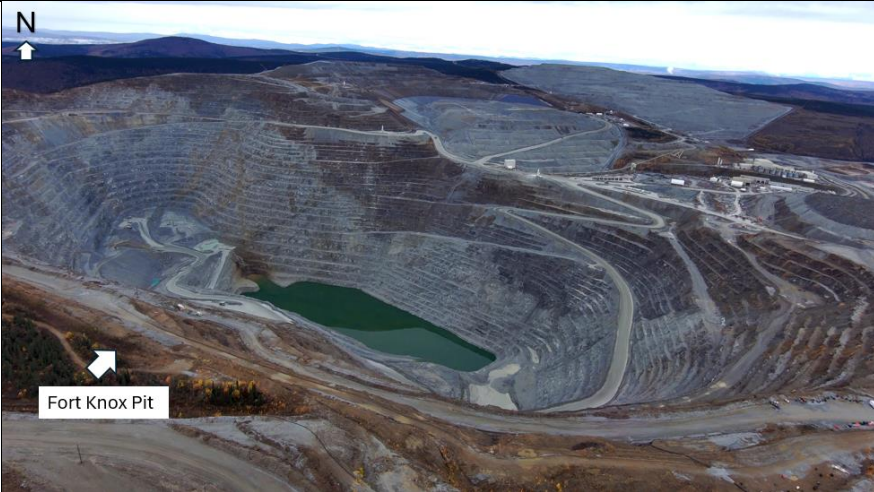
- 1.3. Fort Knox Pit and In-Pit Tailings Disposal. Fort Knox in-pit tailings disposal began in spring 2024. The in-pit pipeline corridor originates at the tails thickener and ends in the bottom of the pit at ~750ft amsl (Photos 8-9).

Photo 9: View of the Fort Knox Pit from the top of YPWRD. The outfall and tailings infill of the pit is increasing in depth. BCHL, BCWRD, and WCHL in background.

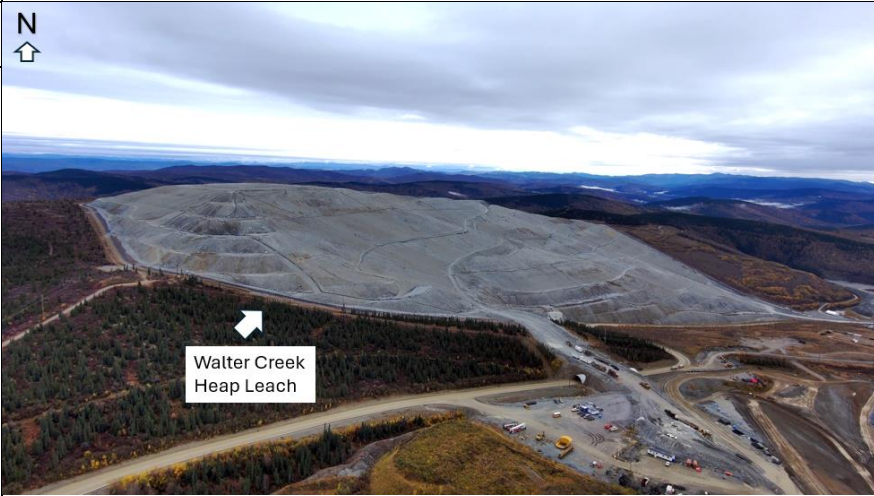
- 1.4. Walter Creek Heap Leach (WCHL) No work on this facility was observed during this visit. (Photos 10-11).
- 1.5. Manh Choh Ore Storage Pad (MCOSP) was active at the time of inspection. Ore from Manh Choh mine is deposited into stockpiles consisting of high-grade oxide, low-grade oxide, high-grade sulfide, and low-grade sulfide just southwest of the WCHL (Photos 12-13).

Photo 10: Walter Creek Heap Leach (WCHL). As of 9/3/24 WCHL levels were down to 1522 and continuing downward.

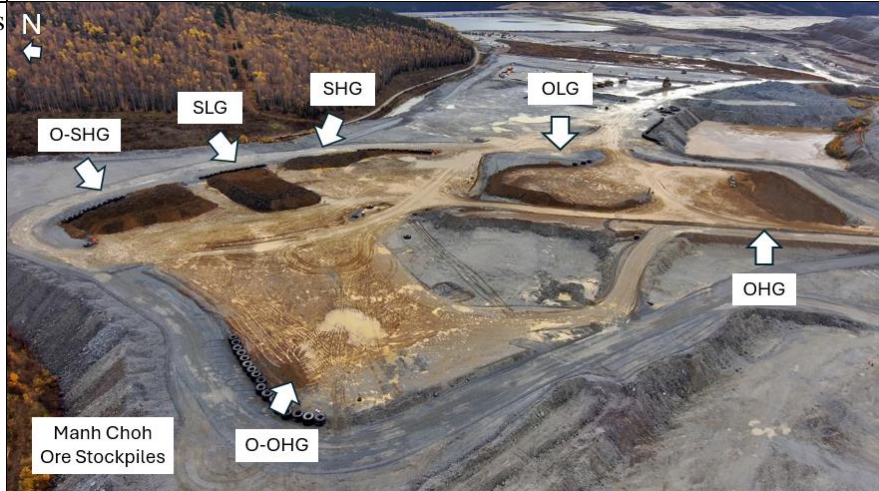
Photo 12: MCOS includes the following: Stockpile 6 Overflow OHG-Oxide High Grade, Stockpile 5 Overflow SHG-Sulfide High Grade, Stockpile 4 SLG Sulfide Low Grade, Stockpile 3 SHG-Sulfide High Grade, Stockpile 2 OLG-Oxide Low Grade, and Stockpile 1 OHG-Oxide High Grade.

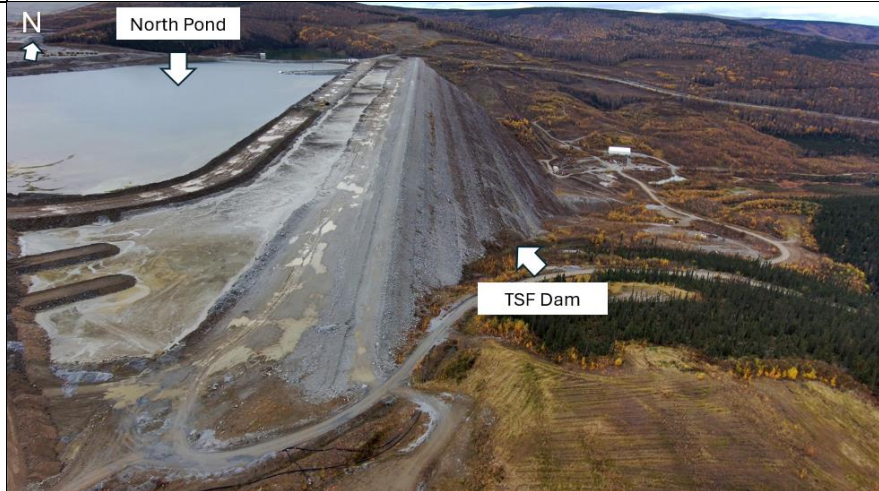
Photo 16: Northern view of the TSF Dam and North Pond. RO2 at the base of the dam. Note the new construction on the Pearl Creek Causeway (PCC).

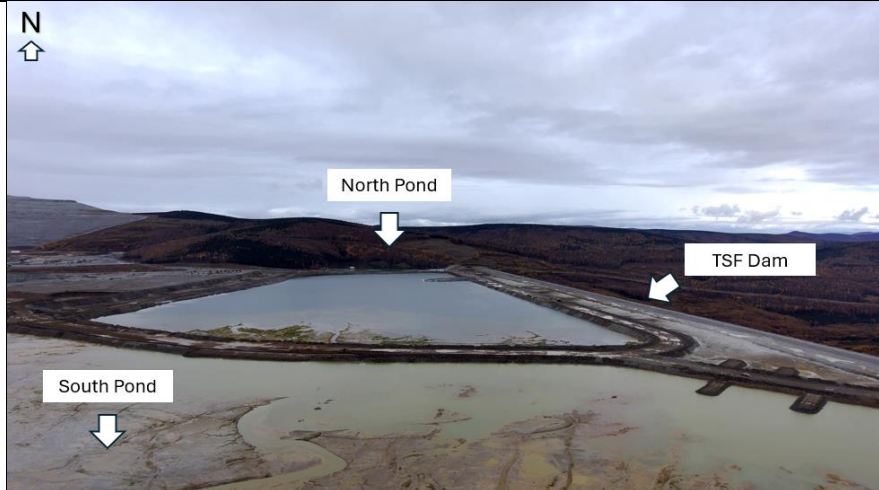
Photo 17: TSF Dam, PCC, and North and South ponds. Note the new construction on the PCC.

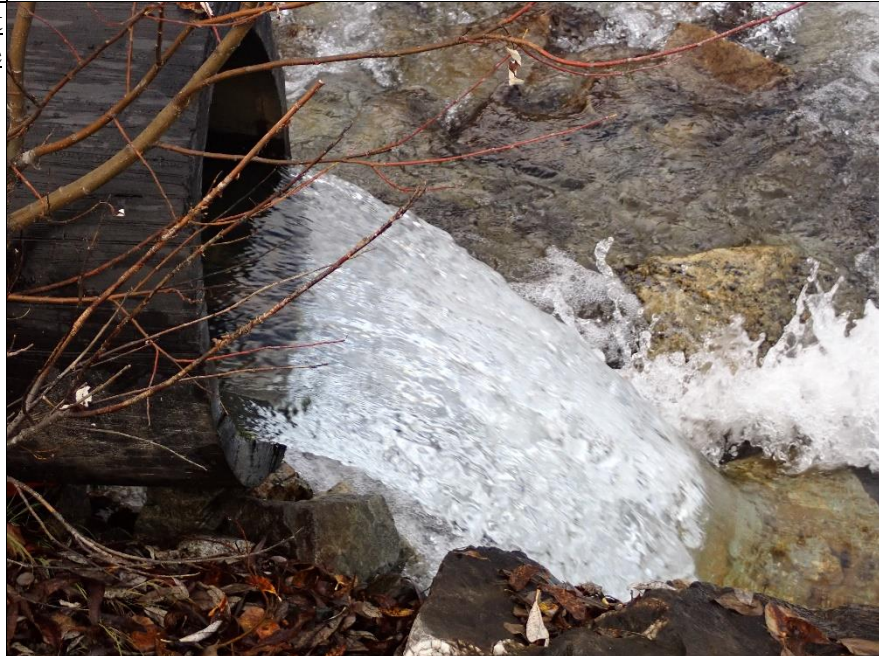
2.1. DNR staff observed the Tailings Storage Facility (TSF), Ponds, Impoundment Dam, RO2, and Outfall 002. (Photo 20).

Photo 20: Outfall 002. At the time of inspection, the Outfall was in good condition and the water looked clear and clean.

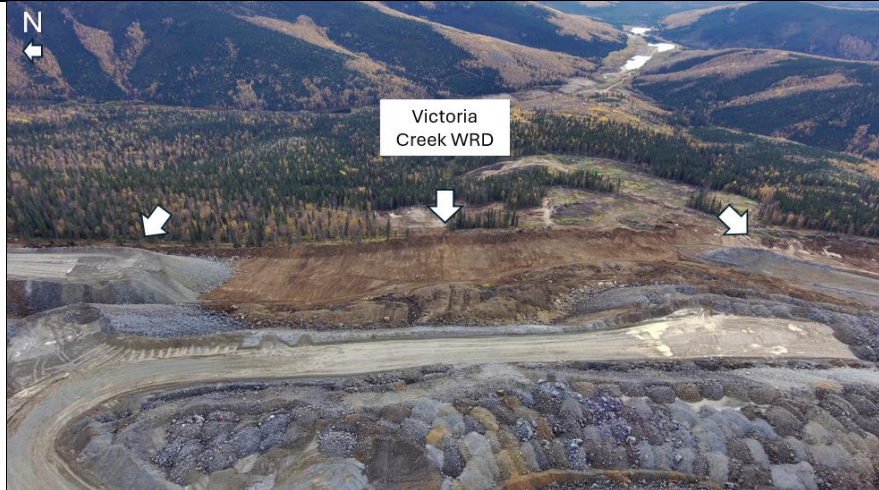
- 1.8. Victoria Creek Waste Rock Dump (VCWRD) (Photos 21-24) and Yellow Pup Waste Rock Dump (YPWRD) (Photos 25-26). The VCWRD is located south of the Fort Knox Pit and YPWRD on leased Mental Health Trust land. VCWRD is being constructed on 500 acres of which 391 acres will be new disturbance. The northern portion of the VCWRD is being developed over a portion of the existing YPWRD footprint and onto adjacent undeveloped land. Part of the VCWRD is being developed south of the YPWRD on a south facing slope of the upper reaches of the Victoria Creek watershed.

Photo 21: East view of Victoria Creek Waste Rock Dump (VCWRD) including cleared ground and areas of deposition. Confluence of Victoria and Johnson creeks and placer operation in the background.

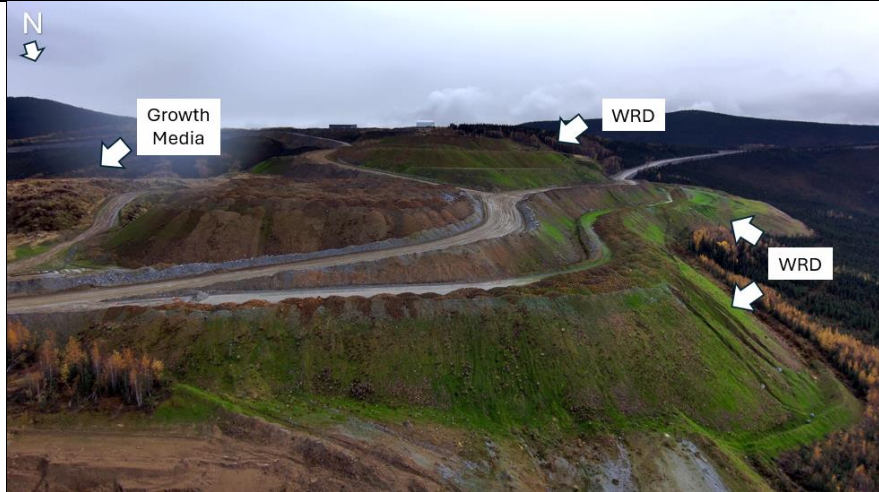
Photo 33: Main Gil GM 4 and GWRD. Note the hydroseeding taking hold on the GWRD.

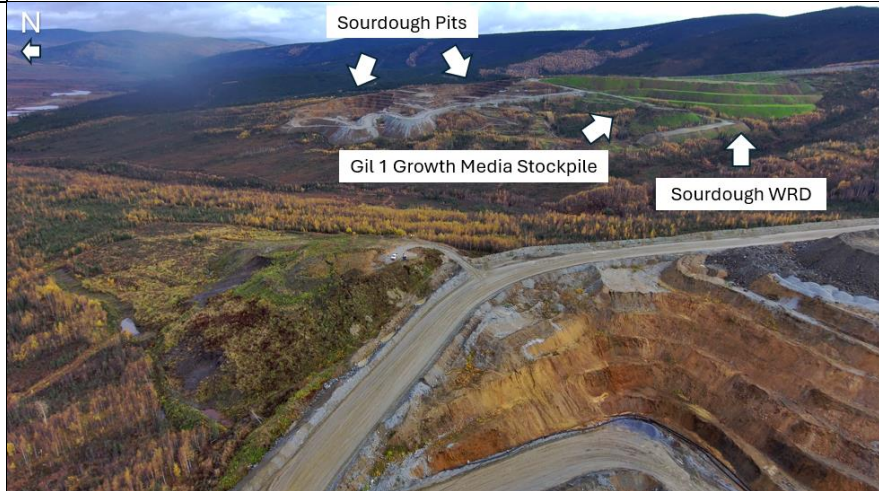
Photo 34: View of Sourdough Ridge from drone above Main Gil Pit. Note hydroseeding taking hold on the SWRD.

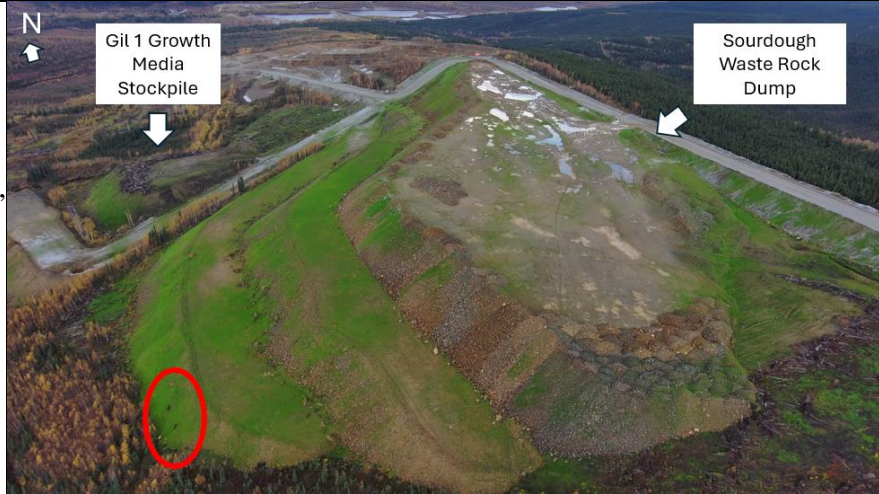
Photo 35: Sourdough Waste Rock Dump (SWRD) and Gil Growth Media Stockpile #1. Hydroseeding is well established on the SWRD, and GM #1, There are two moose grazing on the new growth (bottom left of the SWRD within red circle).

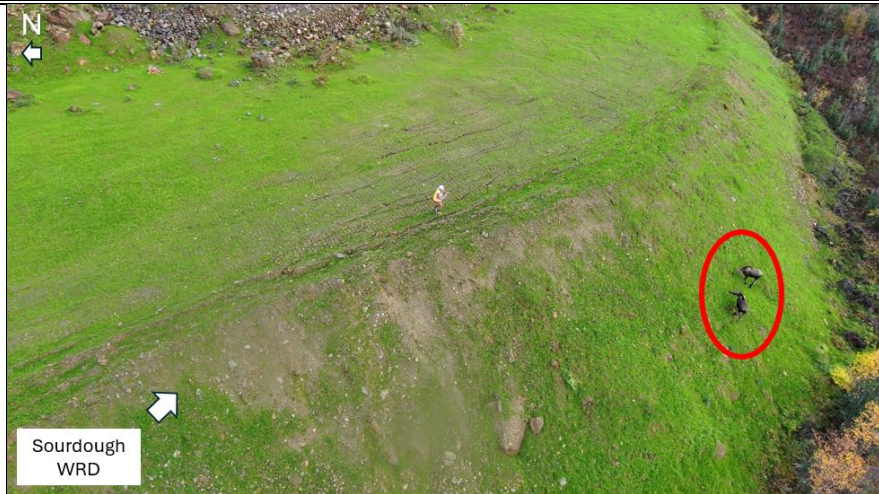
Photo 36: Bottom left of the SWRD exhibiting hydroseeding, Brent Culleton, and two moose.
