## Fort Knox Mine and Gil Project Field Inspection Report

| <b>Inspection Date:</b> | May 20-21, 2025 |
| <b>Inspection Objectives:</b> | Site Inspection |

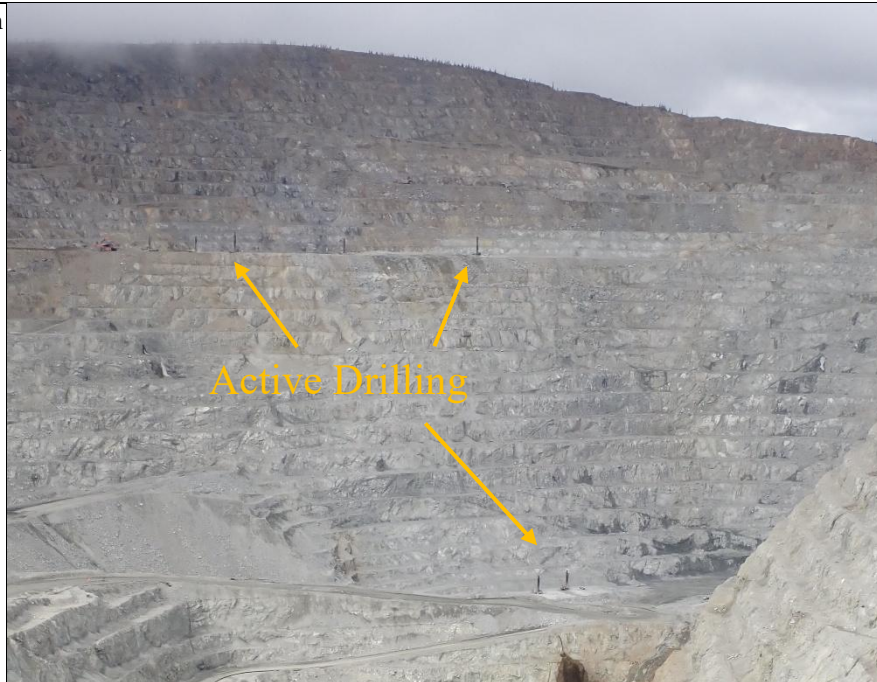
- 1.1. At the Fort Knox Main Pit overlook, DNR observed active drilling on the upper bench (southwest of overlook) and at the base of the pit for the Phase 10 expansion (Photo1). Along the upper reaches of the southwestern extent of the pit was an active RC drill conducting exploration for the Phase 11 pit expansion. Ore stockpiling was observed along the southern base of the pit (Photo 2). At the time of inspection, Manh Choh tailings were being deposited into the in-pit tailings disposal pond (Photo 3). The dewatering barge within the in-pit disposal pond was not operating (Photo 4).

Photo 1: Phase 10 expansion drilling along upper bench.

RC drilling along southern extent of the pit for Phase 11 expansion.

Photo taken from overlook facing southwest.

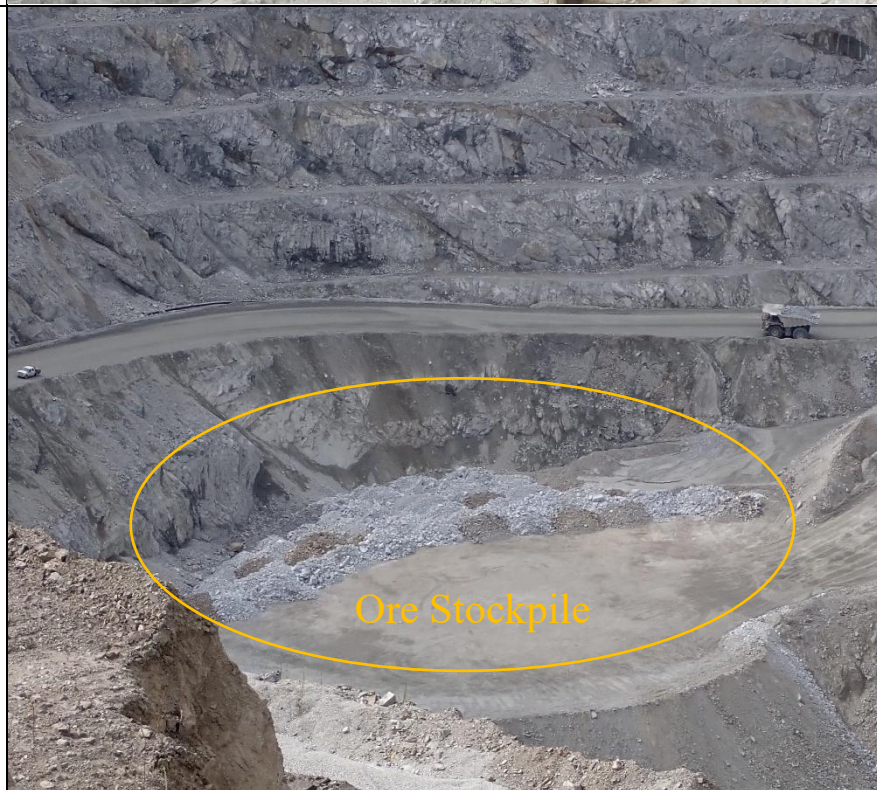
Photo 2: Staged ore stockpiles to be hauled to the mill.

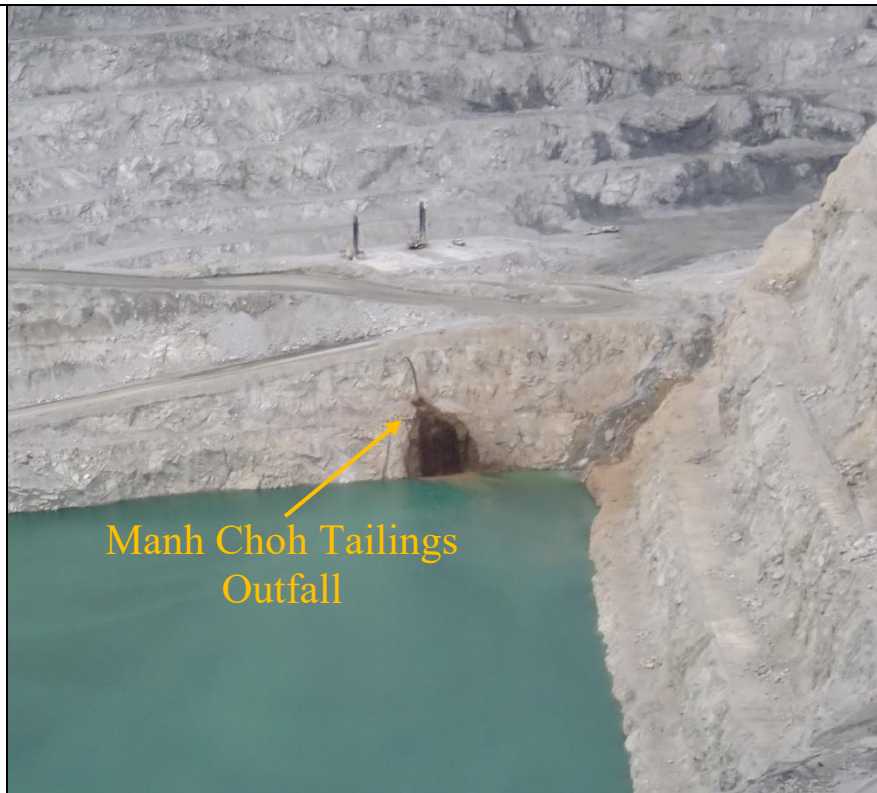
Photo 3: In-pit tailings disposal pond. Active piped tailings discharge into Fort Knox Pit from processing Manh Choh ore.

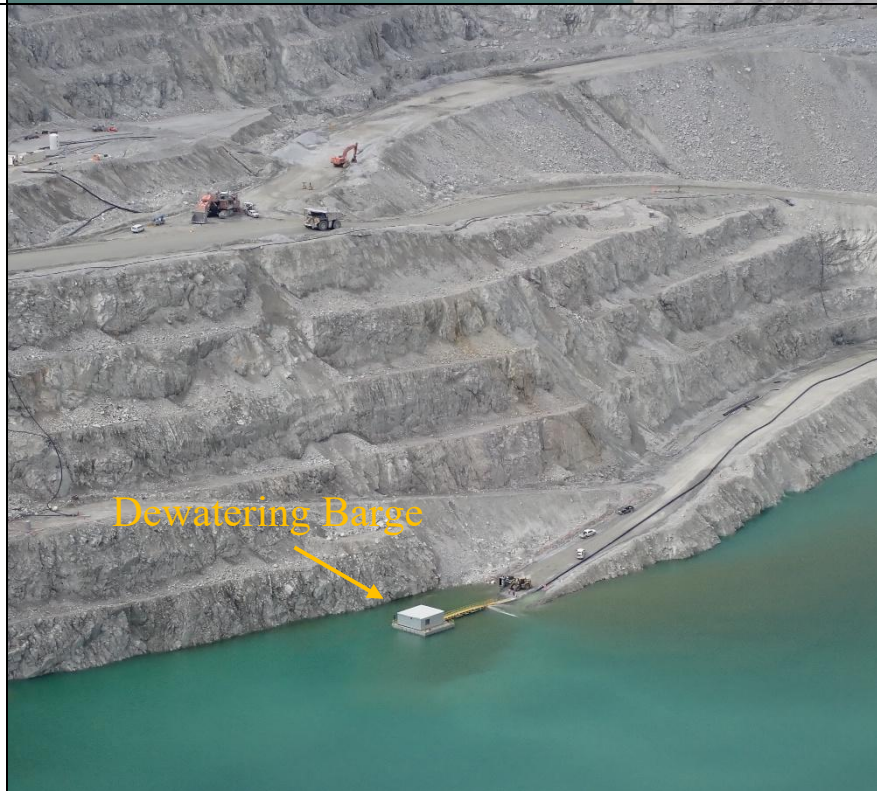
Photo 4: In pit dewatering barge was inactive while tailings were being deposited.

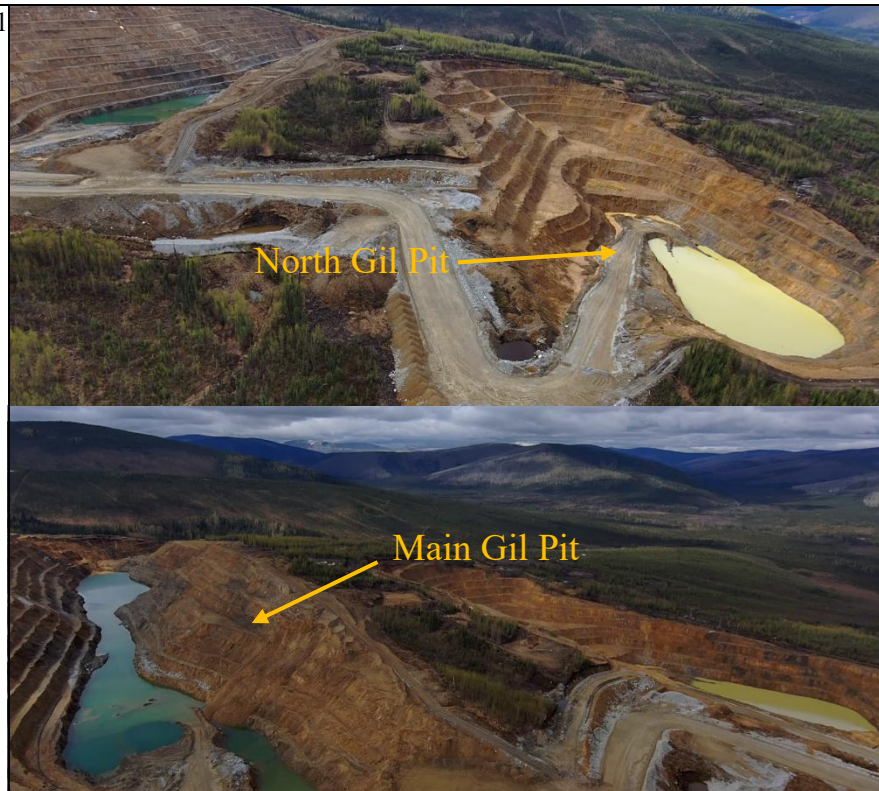
- 1.2. The Gil inspection of both WRD's and all pits was completed using a drone to capture images of surface disturbance and facilities. The first drone launch point was atop a growth media stockpile that is situated between the Main and North Gil pits, just below the Gil WRD. From this vantage point, DNR observed water ponding in each pit (Photo 5) with active instabilities along the Main

Photo 5: Main and North Gil pits with ponded water. Mining is suspended while the project is in a care and maintenance status.

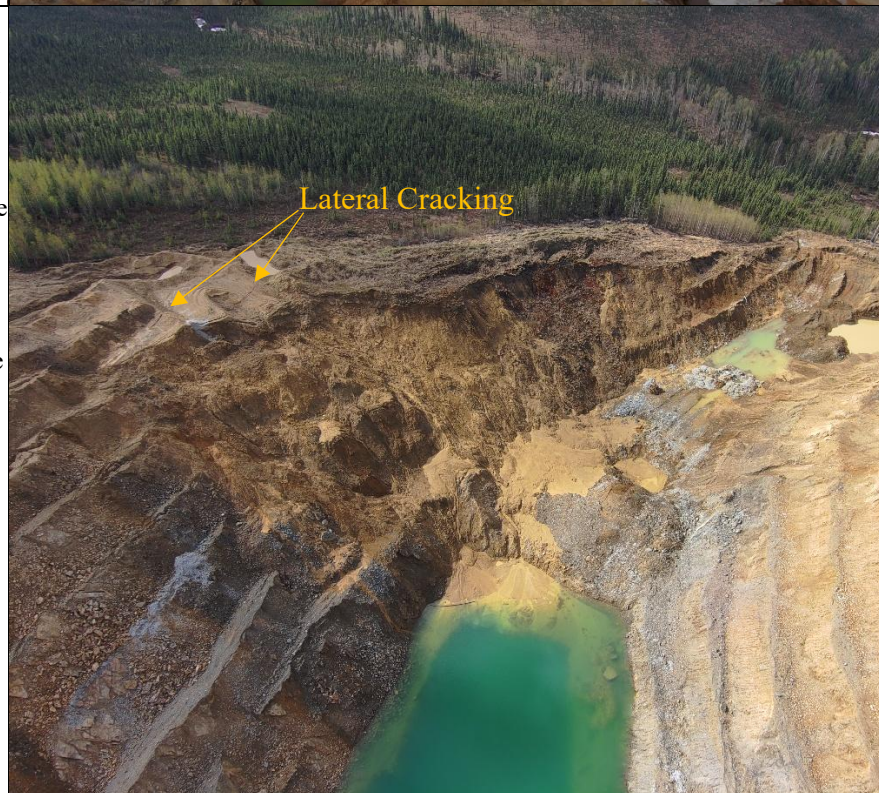
Gil Pit's southern high wall on its west end (Photo 6), and on its northern high wall east end (Photo 7). Both areas of pit wall instabilities extended throughout all benches with the western side having the largest area and volume of material sloughing into the pit. Just south of the Main Gil Pit is the Main Gil WRD and growth media stockpile, both appeared stable without apparent degradation of slopes (Photo 8).

Photo 6: Main Gil pit wall instability west end on southern high wall. Material movement crosses all bench cuts.

Lateral tension cracks can be seen in the crown above the scarp.

DNR will continue to document the stability of the affected area in future inspections.

It is recommended that FGMI evaluates the slope conditions within the Gil Main Pit and Sourdough pits to determine if BMP's may be used to provide stability during a temporary closure.

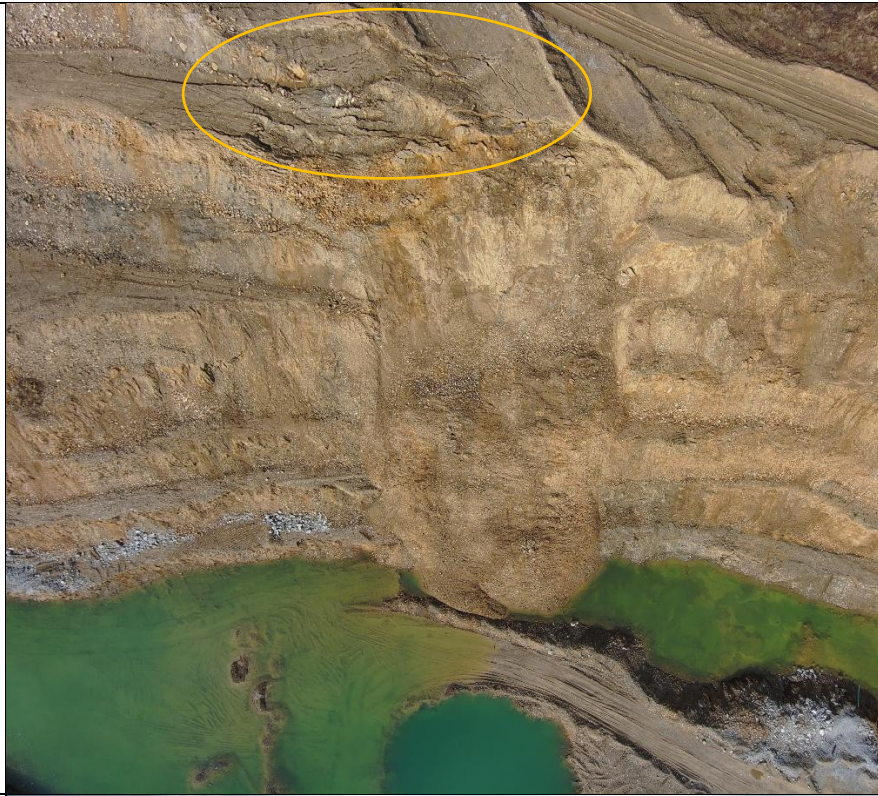
Photo 7: Material instability on the east end of the Main Gil pit northern high wall extending through all benches.

Note the lateral tension cracks perpendicular to the slide within its crown.

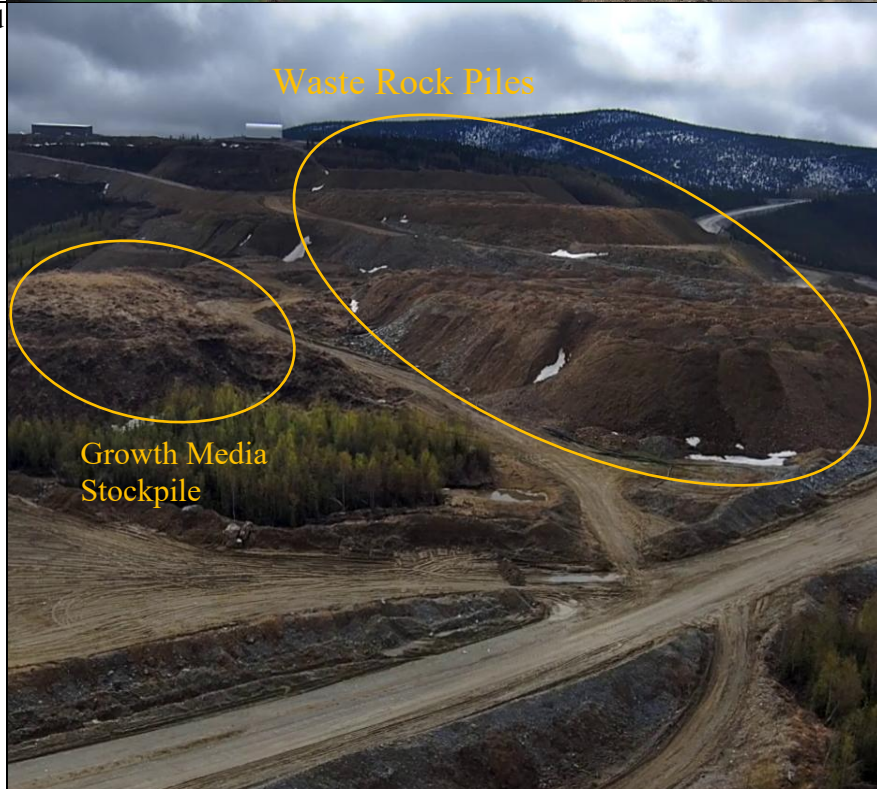
Photo 8: Main Gil WRD and growth media stockpile.

View facing south.

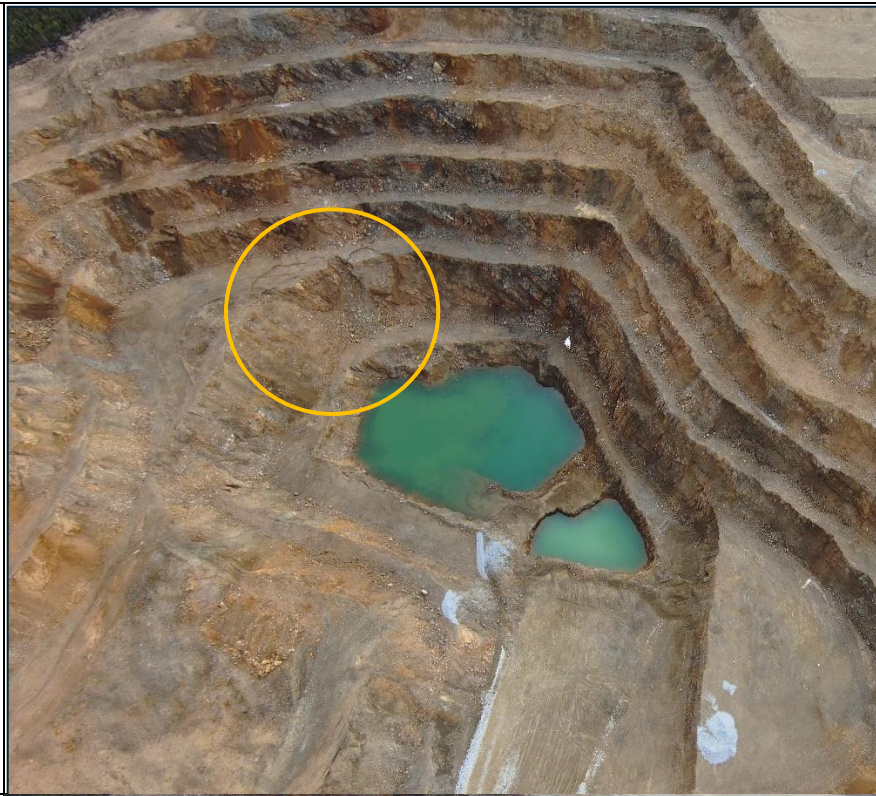
The second drone flight was over NE and SE Sourdough Pits and Sourdough WRD. Ponding water was observed in NE Sourdough Pit with minor in-pit instability along the southern high wall along a lower bench (Photo 9). The SE Sourdough Pit was dry; however, material instability movement of the southern pit wall was observed which extended through several benches (Photo 10). It appears that in the Sourdough pits, only the benches collapsed onto themselves, whereas the Gil Pit lateral tension cracks can be seen forming within the crown above each wall instability suggesting ongoing movement.

Photo 9: Ponding water observed in NE Sourdough Pit with minor in-pit instability.

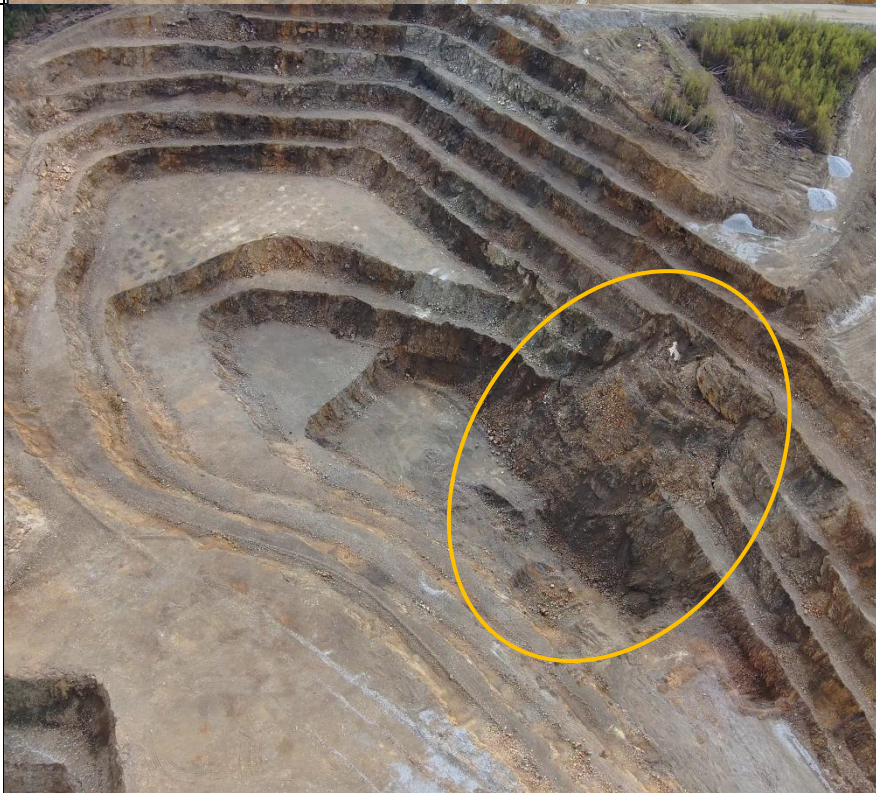
Photo 10: SE Sourdough Pit instability across several benches along the southwestern wall.

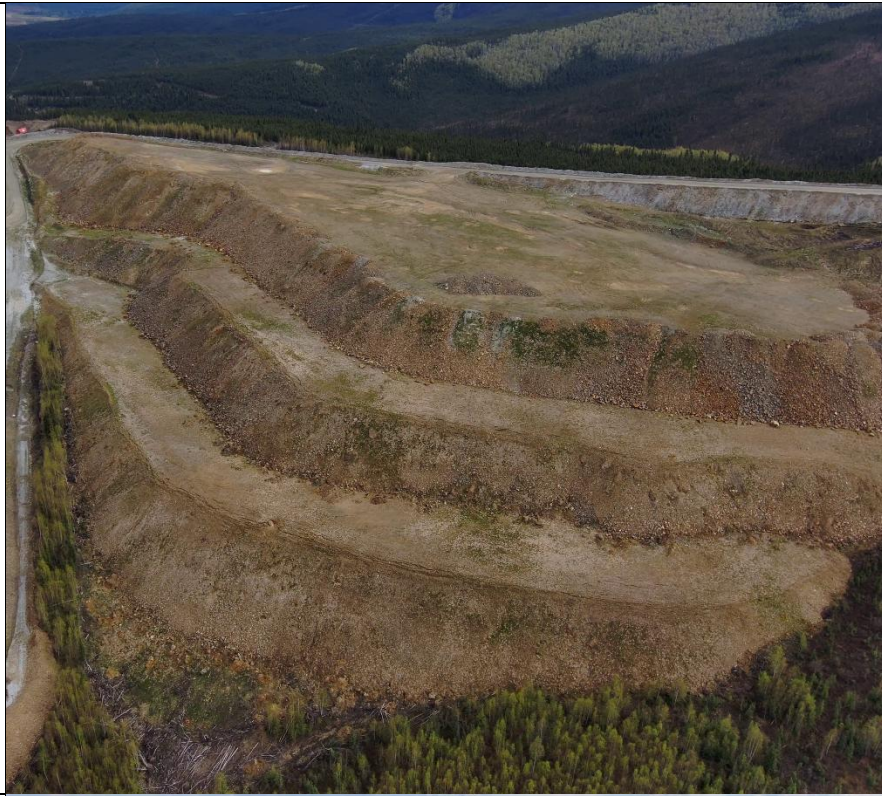
- 1.3. In the fall of 2024, grass seeds were sown atop both the Gil and Sourdough WRDs using aerial seeding methods. DNR observed minimal growth coverage along slopes and surfaces for each WRD (Photo 11). Surrounding native foliage was just beginning to grow leaves with snow still visible at higher elevations. Seed germination progress will be documented with subsequent inspections to monitor best management practices (BMP) for maintaining slope stability. It should be noted that reclamation of the WRDs requires the benches to be graded, contoured, and revegetated as indicated in the Fort Knox Mine Reclamation and Closure Plan.<sup>2</sup>

Photo 11: Pre Green-Up, early spring growth on the Sourdough WRD. Aerial seeding occurred in the fall of 2024. View of WRD looking east.

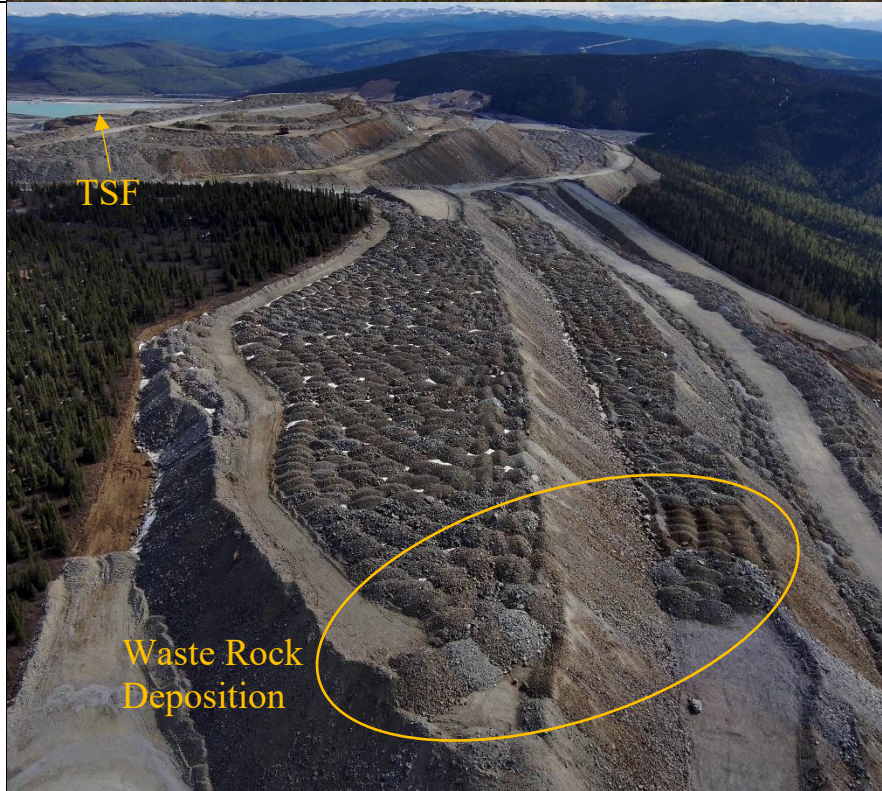
Photo 12: Active deposition of waste rock on the Victoria WRD, foreground.

View looking east, TSF visible.

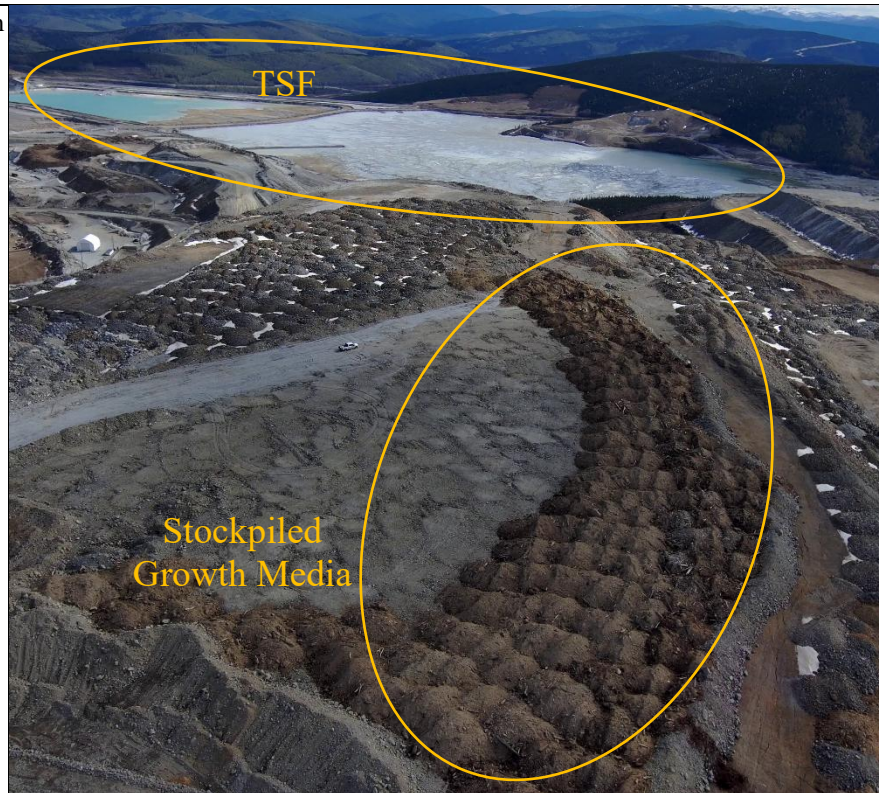
Photo 13: Stockpiled growth media on top of the eastern extent of Victoria Creek WRD.

Note the location of TSF north and south ponds.

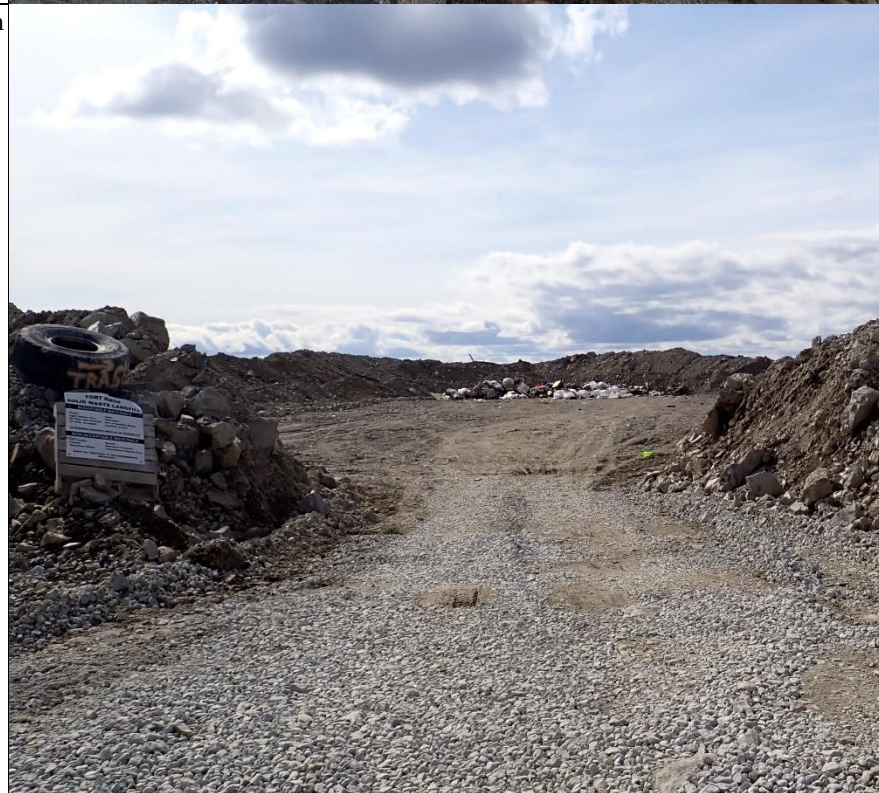
Photo 14: Inert burial site on top of the eastern extent of Victoria Creek WRD.

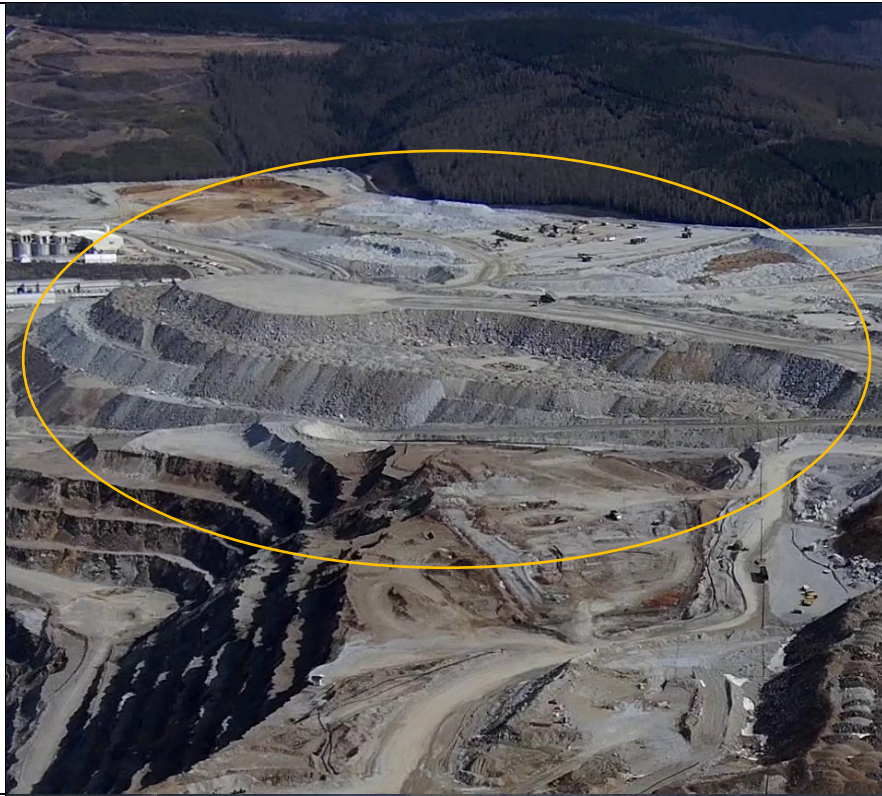
- 1.5. Fish Creek WRD, viewed from several vantage points, had active deposition of waste rock (Photo 15). DNR staff did not visit this site due to active operations of haul trucks.

Photo 15: Active deposition on the Fish Creek WRD.

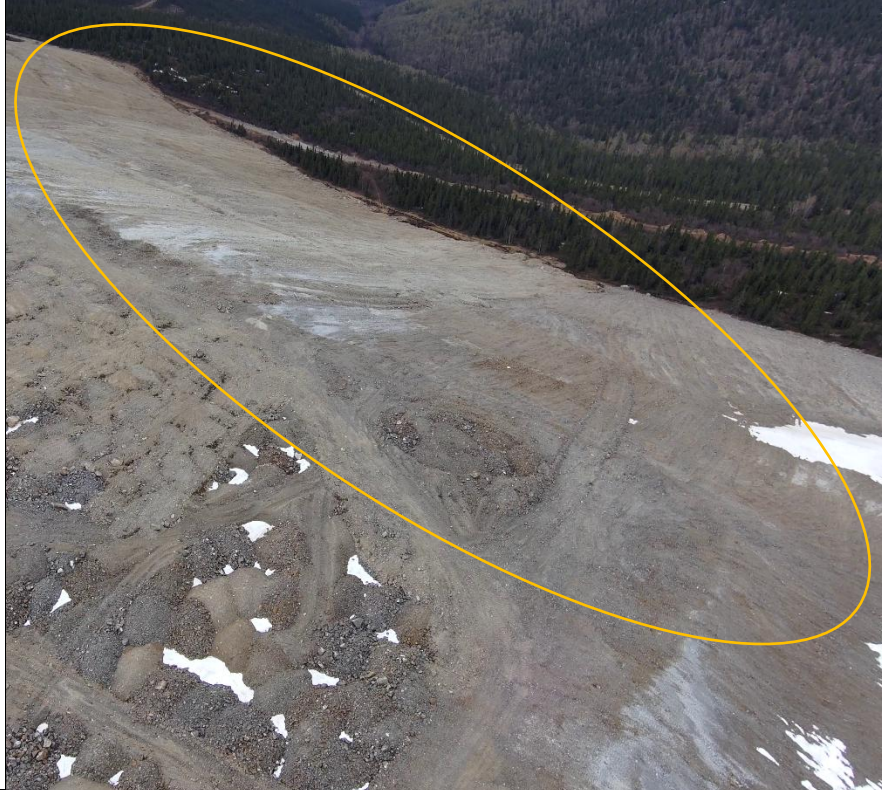
Photo 16: Final grading of benches along the western extent of Barnes Creek WRD.

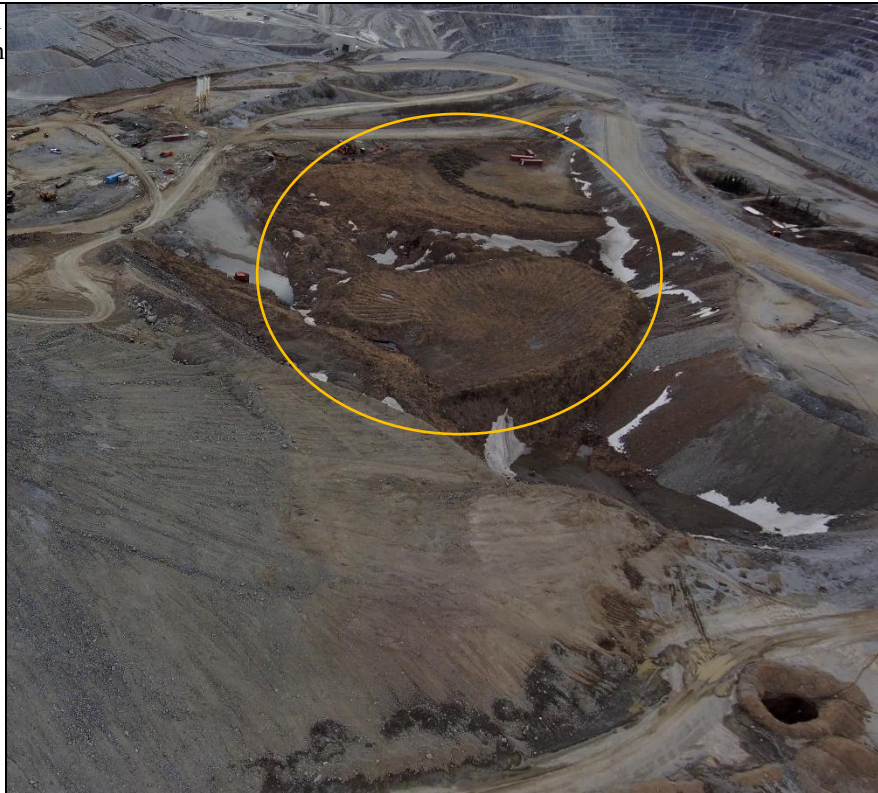
Photo 17: Stockpiled growth media (GM2) at the southern toe of Barnes Creek WRD staged for reclamation.

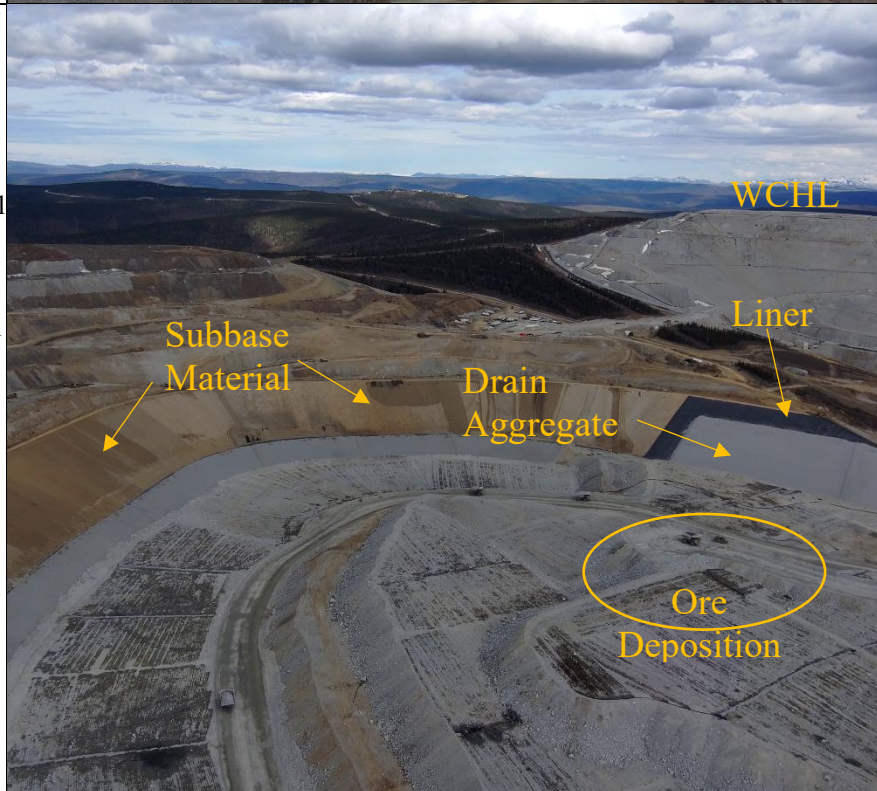
- 1.7. Active haul truck operations at Barnes Creek Heap Leach were observed with continued deposition of ore in tiered sections. The outlying regions of the heap leach facility were undergoing expansion with placement of a liner on a prepared subbase overlain with drain aggregate (Photo 18).

Photo 18: Northeast view of Barnes Creek Heap Leach.

Active deposition of ore on tiered sections. Sectional liner expansion observed placed over subbase material and covered with drain aggregate.

Walter Creek Heap Leach in the background at its final buildout elevation.

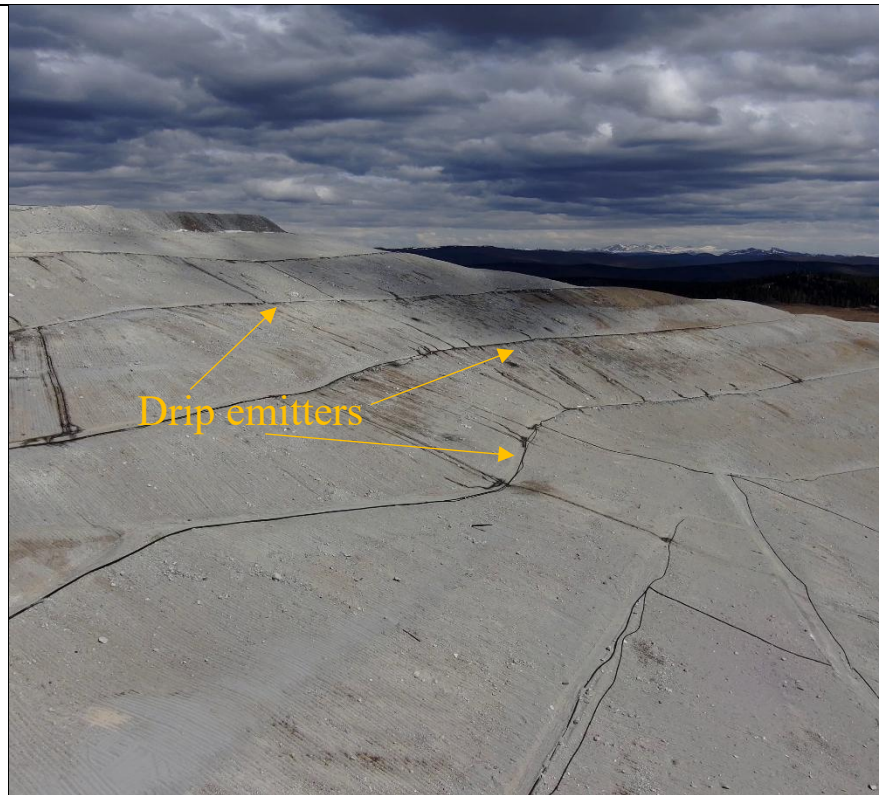
Photo 19: Walter Creek Heap Leach facility with graded slopes. Drip emitter piping runs normal to slope.

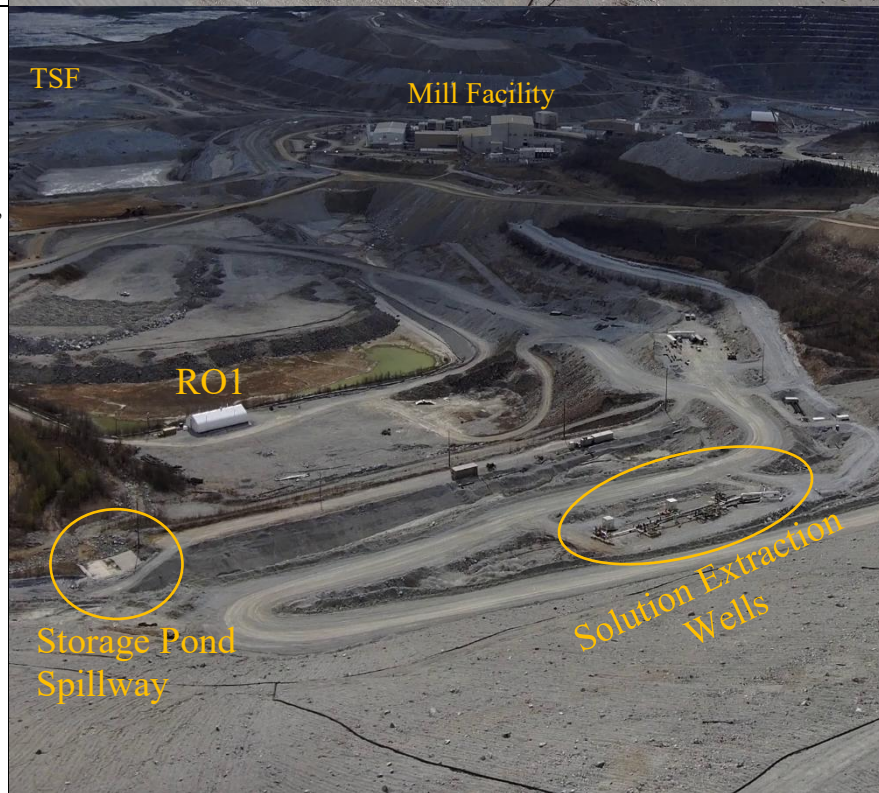
Photo 20: View south from base of Walter Creek Heap Leach Facility.

Note the location of the Leachate Collection and Recovery System structures, RO1 water treatment facility, and storage pond spillway.

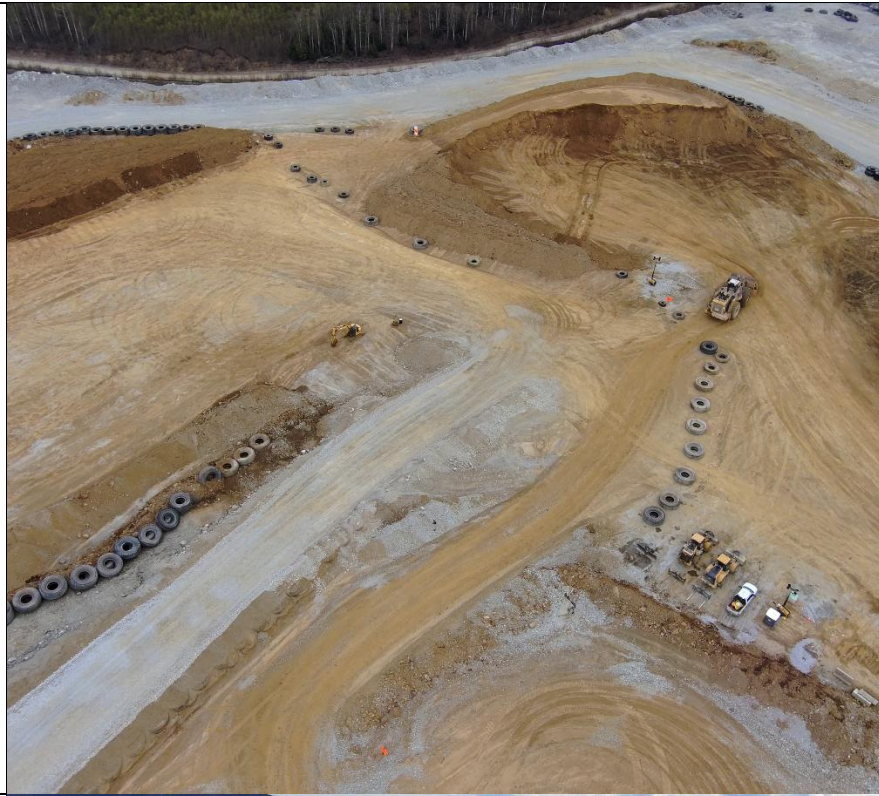
Photo 21: Manh Choh ore stockpile.

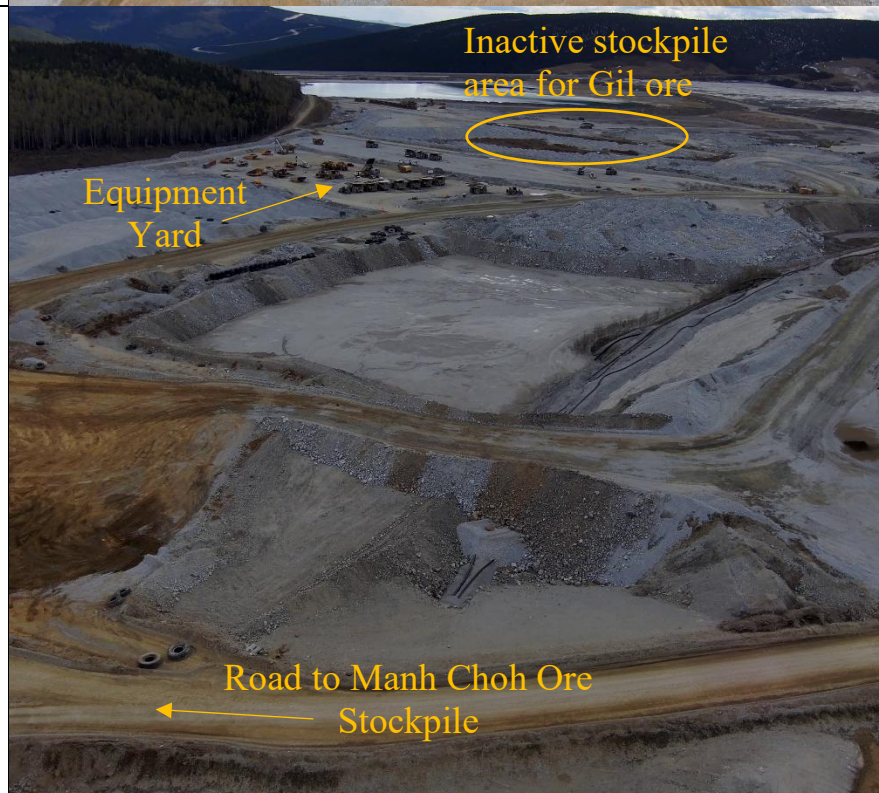
- 1.9. Within the northern end of Central TSF, DNR observed active mobilization of Manh Choh ore using a front-end loader. The stockpile was diminished in volume from previous inspections and the footprint for the area has remained consistent since it first opened in 2024 (Photo 21). The Central TSF is comprised of varying areas of tailings deposition from Fort Knox Main Pit, material stockpiles, an inactive area for the Gil ore stockpile, and an equipment yard. All areas are well managed and organized (Photo 22).

Photo 22: Overview of Central TSF comprised of areas of coarse tailings deposition, equipment yard, and ore stockpiles.

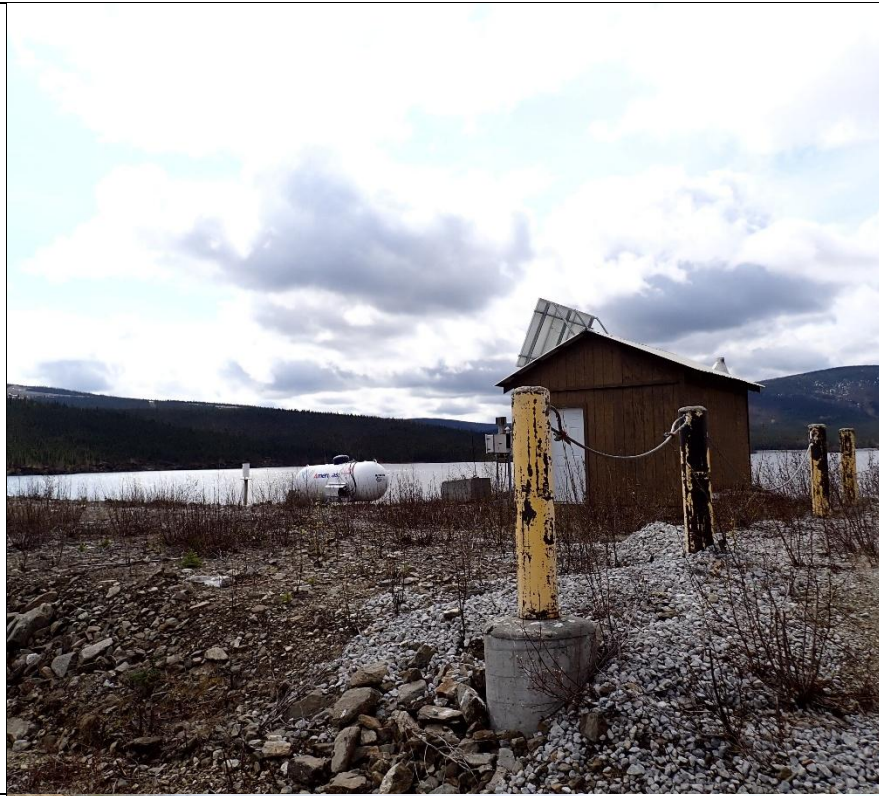
Photo 23: Fresh Water Reservoir valve house located on the northern end of the dam.

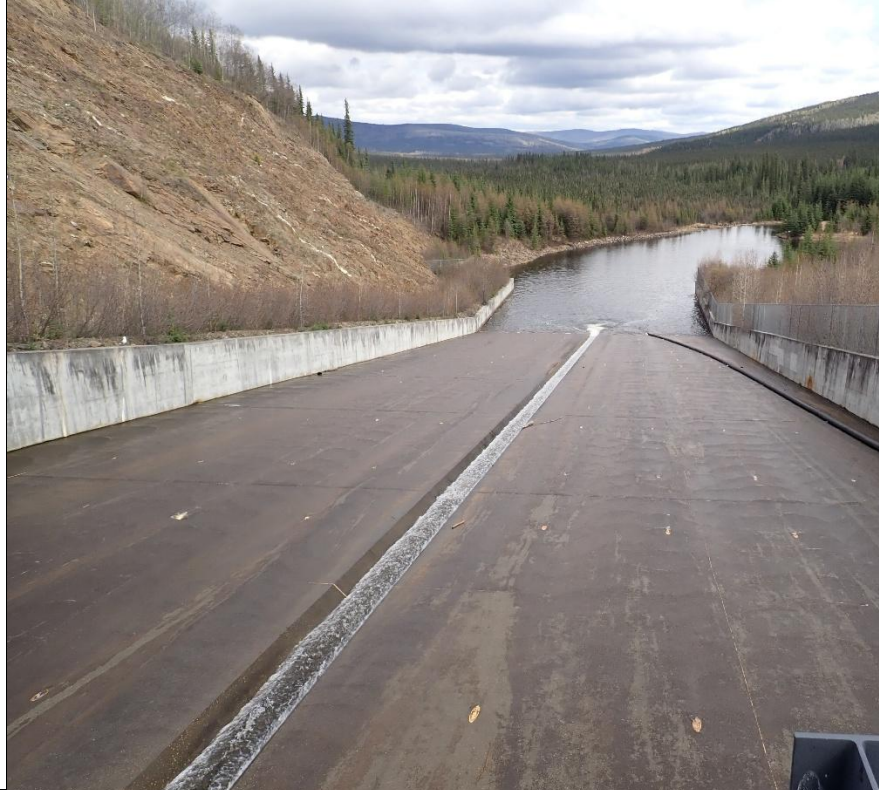
- 2.1. The Fresh Water Reservoir, reported by FGMI staff, was at normal levels for spring melt and precipitation. The average flow rate of the spillway for this time of year had water across its width draining back into Fish Creek (Photo 23 and 24). The Fresh Water Dam and valve house appeared to be in good condition.

Photo 24: Water flowing across the length of the Fresh Water Reservoir Spillway.

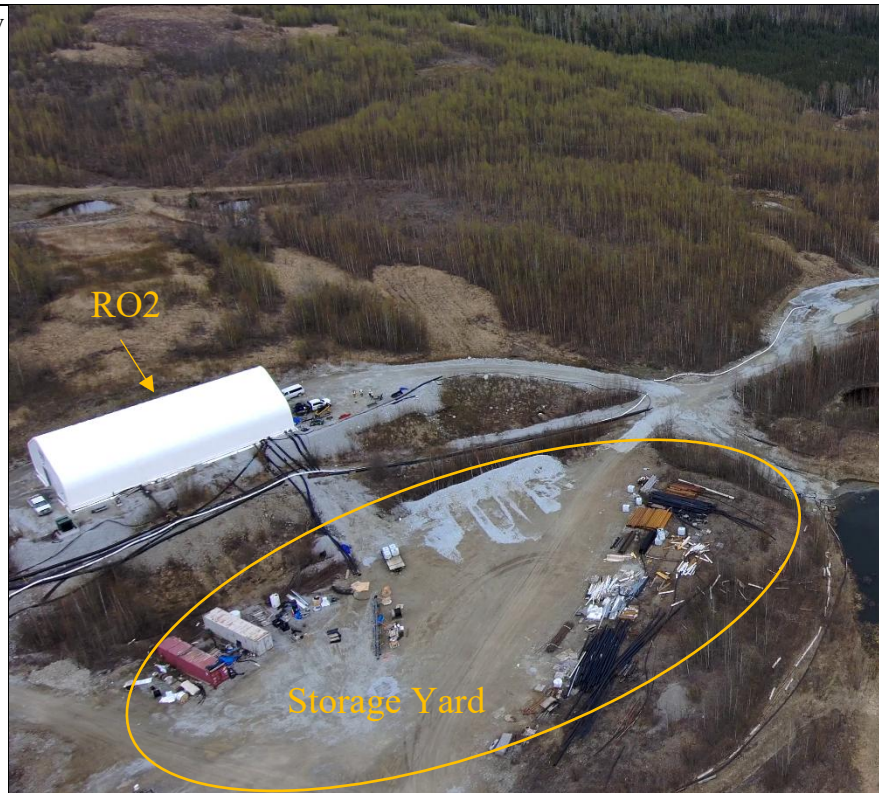
- 2.2. DNR arrived at the RO2 water treatment facility located below the main TSF Dam. The facility and surrounding structures appeared in good shape including a well-organized storage yard consisting of Conex containers, pipe, and construction material (Photo 25). At the time of inspection, discharge from RO2 was reported to be 2000 gallons per minute into the wetlands complex (Photos 26 and 27).

Photo 25: Northeastern view of the RO2 water treatment facility for the TSF.

The TSF Dam is immediately behind water treatment facility and storage yard.

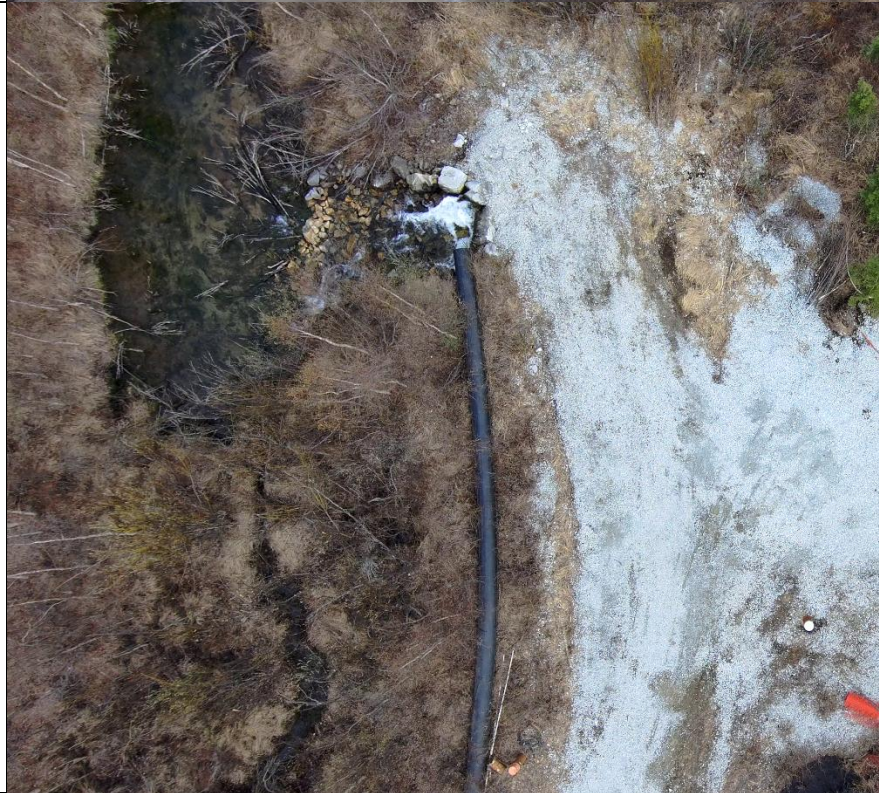
Photo 26: Treated water discharging from RO2 into the wetlands complex and Fish Creek.

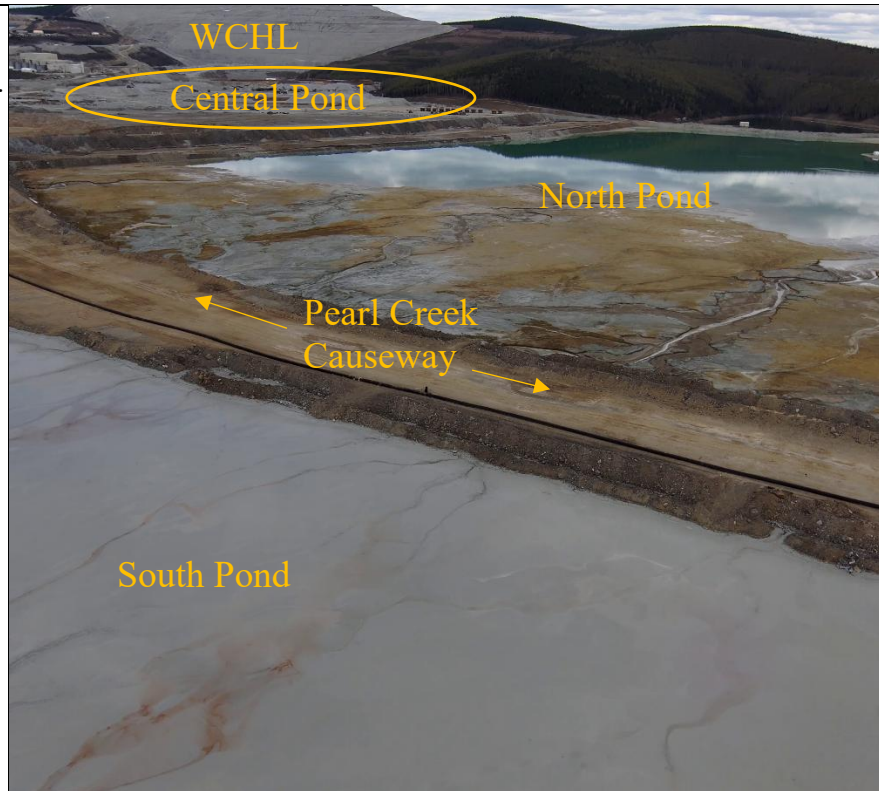
Photo 27: Pearl Creek Causeway separating the North and South TSF ponds.

Northwestern view towards Walter Creek Heap Leach facility.

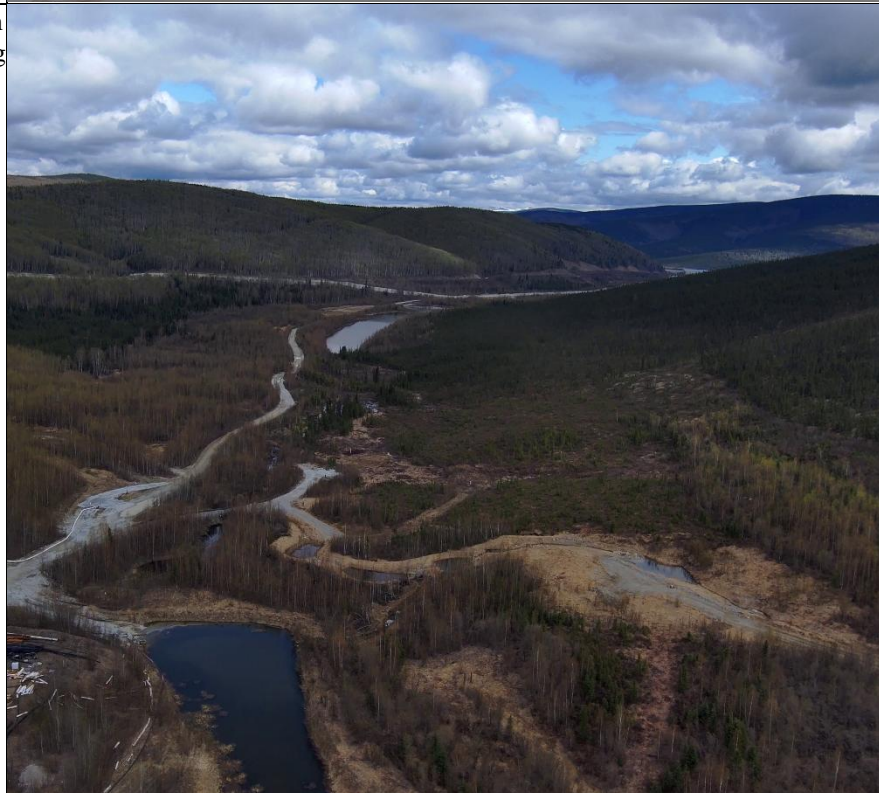
Photo 28: Eastern view from top of TSF Dam overlooking the wetlands complex.

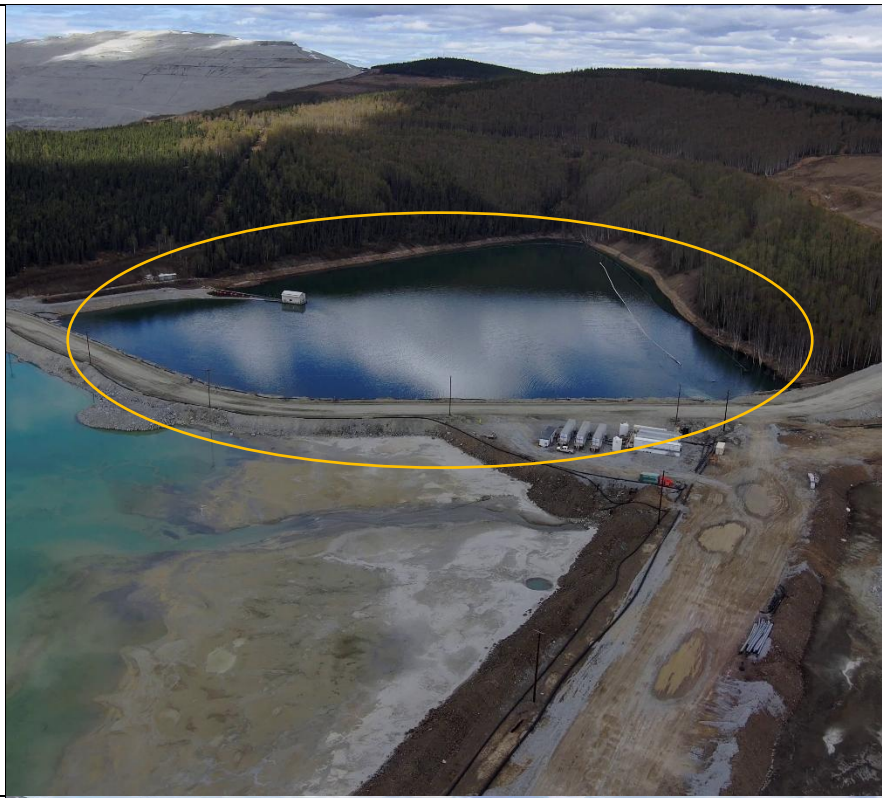
Photo 29: Mill water intake from barge pond.
