## Fort Knox Mine and Gil Project Field Inspection Report

| <b>Inspection Date:</b> | May 20-21, 2025 |
| <b>Inspection Objectives:</b> | Site Inspection |

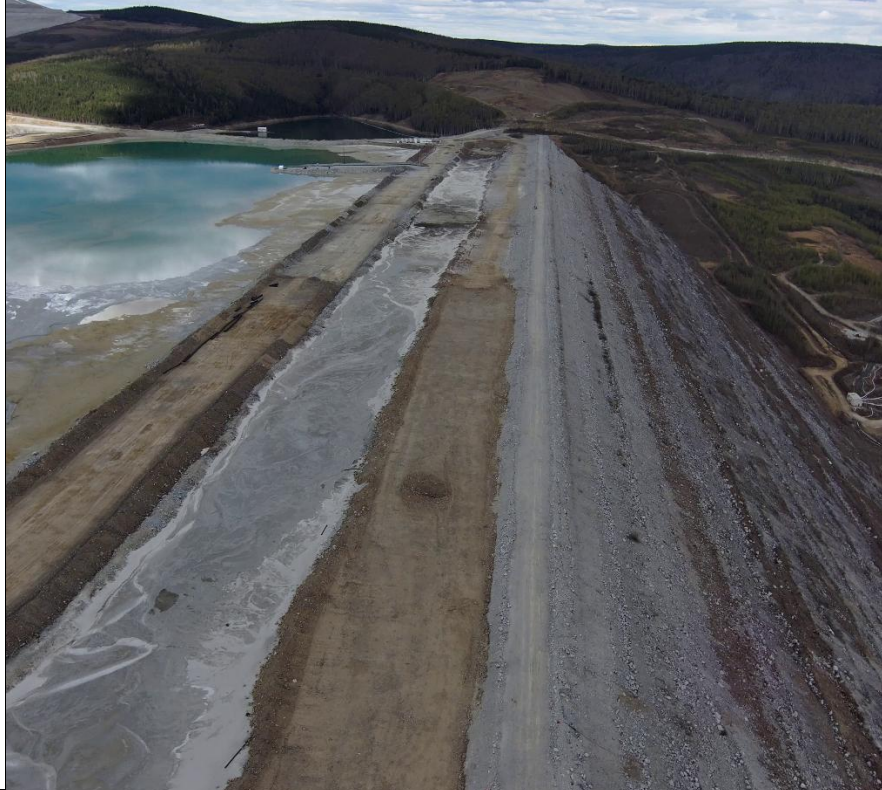
- 2.3. DNR staff deployed a drone from the Pearl Creek Causeway at a central point between the TSF South and North Ponds, TSF Dam, and Barge Pond. Aerial imagery shows a good segregation between waters within the South Pond, laden with tails, compared with the North Pond and Barge Pond (Photos 28 and 29). The TSF Dam appeared well maintained with some surface activity, possibly in preparation for the proposed dam raise that is planned to begin later this season (Photo 30).

Photo 30: Northern view of the TSF Dam crest and face, north pond, and barge pond.
