GLOBAL
a moran company

Hawk Inlet Diffuser and Pipeline Inspection

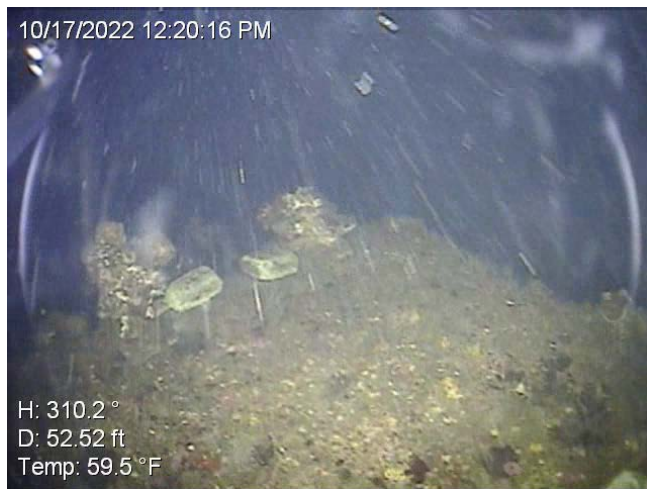
Type-4 Anchor Block Anodes

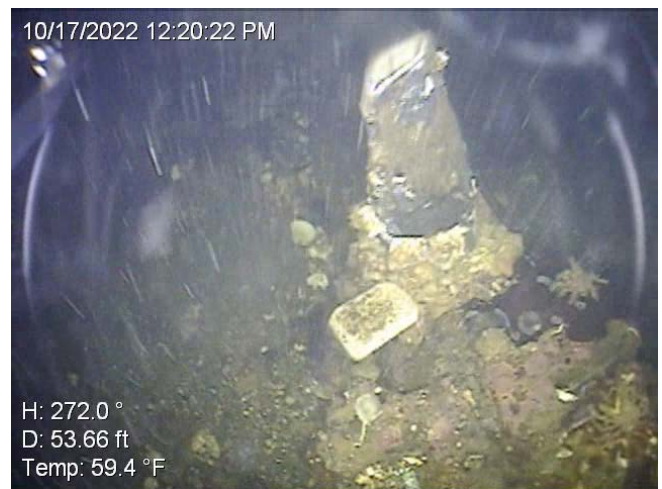
Typical Diffuser Condition

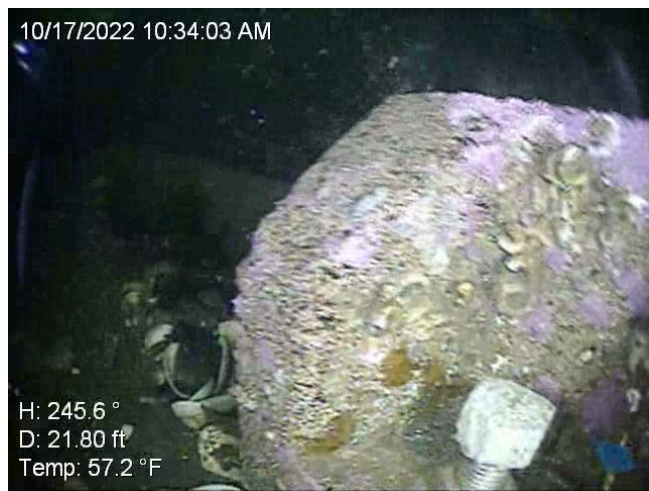
Good Zinc Nut on Anchor Block
