Hecla Greens Creek 2012 Site 23/D Annual Report

July 9, 2013

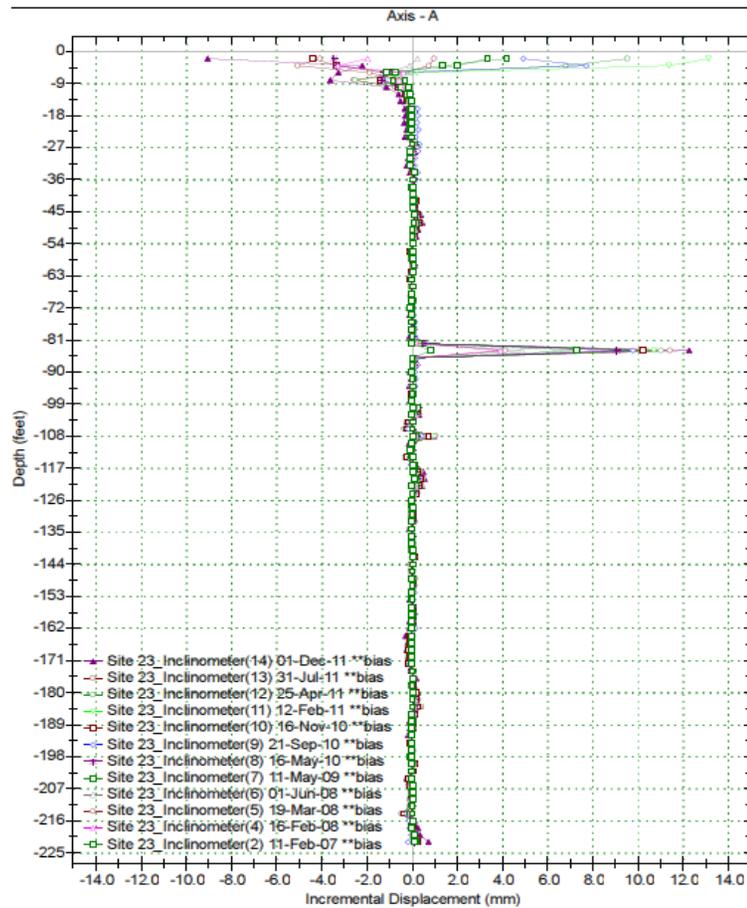
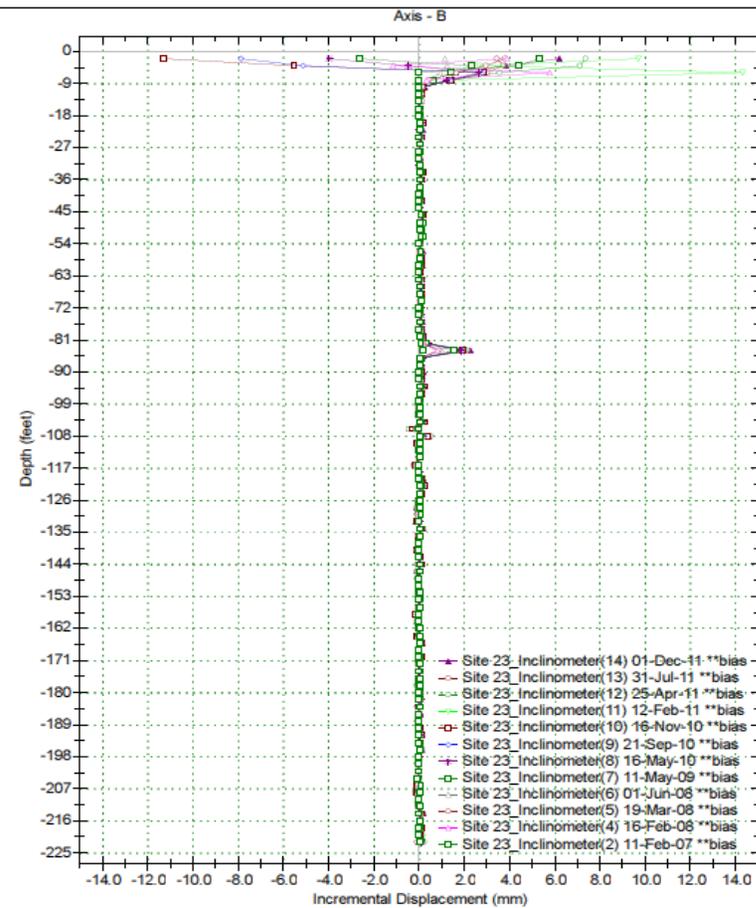
Figure 3.30 IN-23-05-01 Incremental Displacement

- Slope monitoring
 - 13 survey hubs monitored with GPS during 2012
 - No large movements were identified
 - Inclinometer readings
 - IN-23-05-01 shows a minor creep at 79.3' (~1.7mm/yr)
 - IN-23-10-01 shows no movement since installation in 2010
 - IN-23-10-02 shows a minor creep at 114.4' (~1.1 mm/yr)
 - IN-23-10-08 shows a movement zone from 125.8' to 135.8' with the maximum movement at 131.8' (1.5 mm/yr)
 - IN-T-10-21 shows slight movement of less than 0.5 mm at 47.7', 67.7', and 1 mm at 79.7'
 - IN-920-10-05 shows slight movement of less than 0.75 mm at 12.7'
 - IN-1350-10-01 shows a minor creep at 83.5' (~3.2 mm)

Notes:
Zero reference is top of casing, at ~4.7 ft above ground surface.
Top section of casing/damage joint replaced in July 2011.
Bias-shift correction by pinning data sets at 150-ft depth (A_B axis).

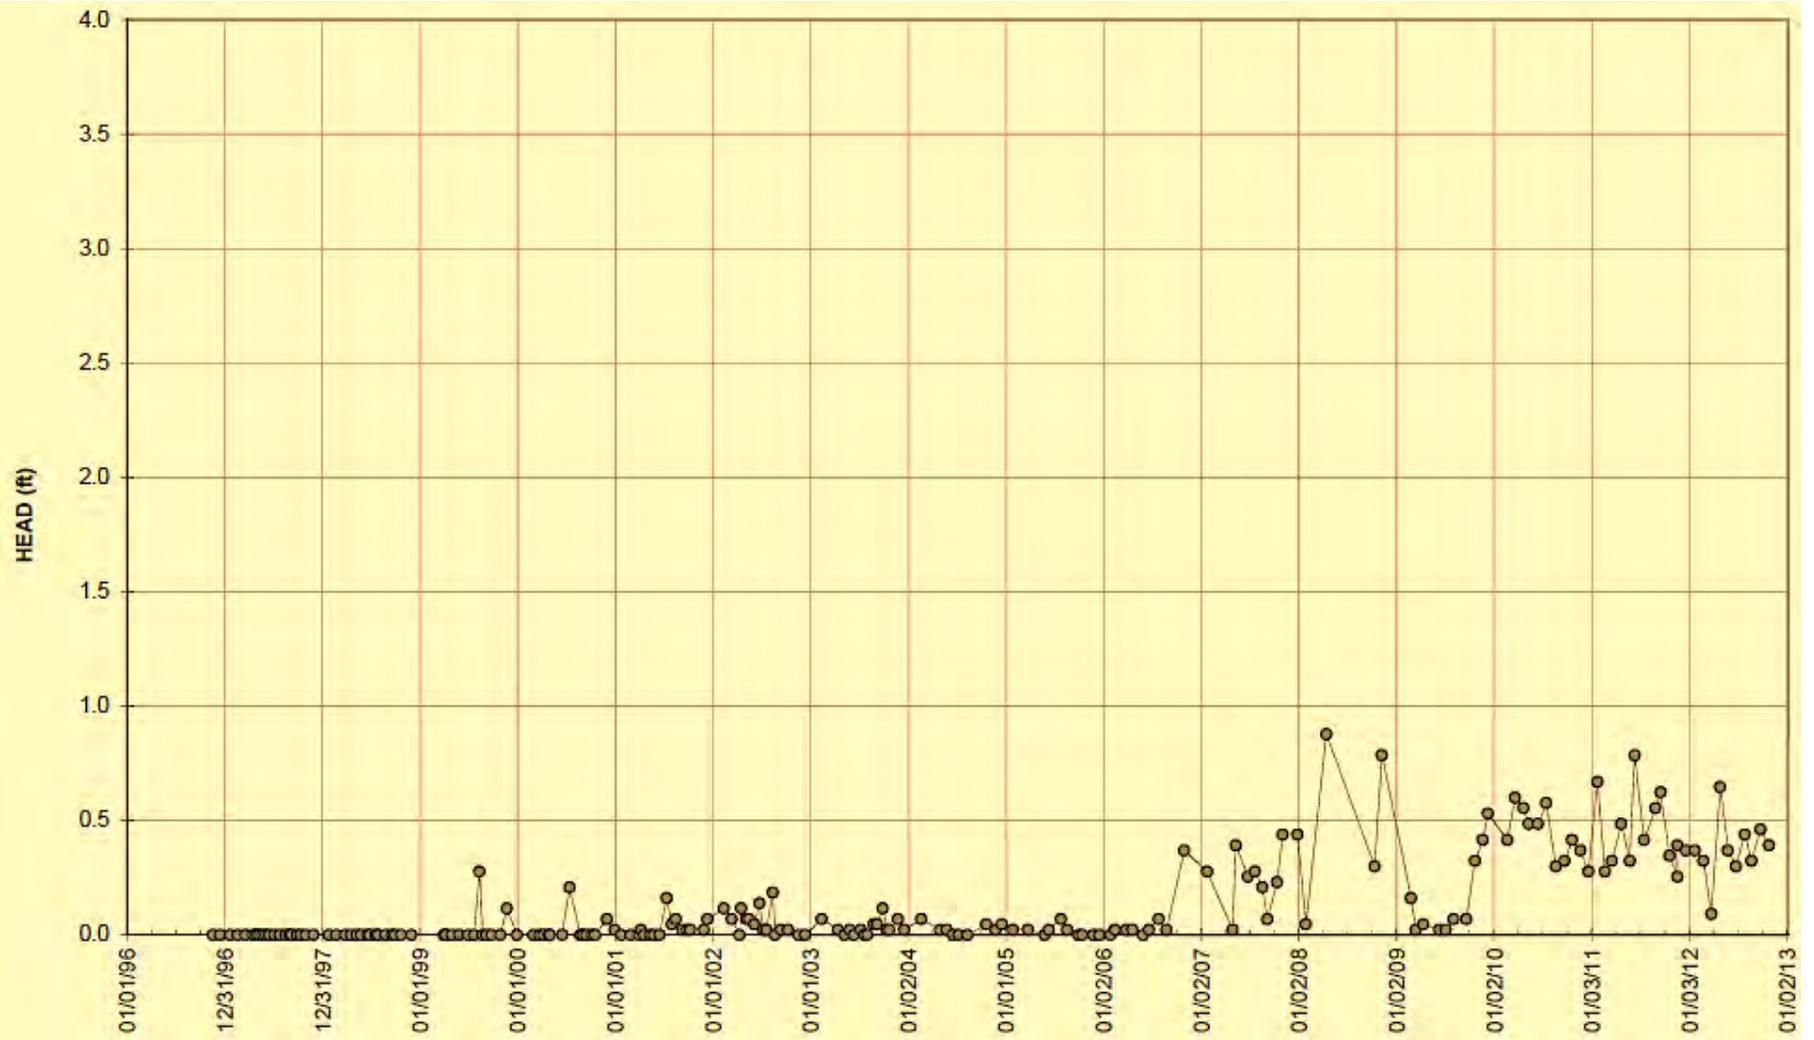
Figure 3.1 Pressure Data for Piezometer 52

- Water table is below base of pile
- Well-drained pile and foundation indicate pile stability is maximized
- Perched water tables in colluvial wedge and alluvial sands
- Braided flow paths
- Distinct seasonal pattern, especially in alluvial sands
- Silt/clay till below colluvial wedge inhibits downward water movement

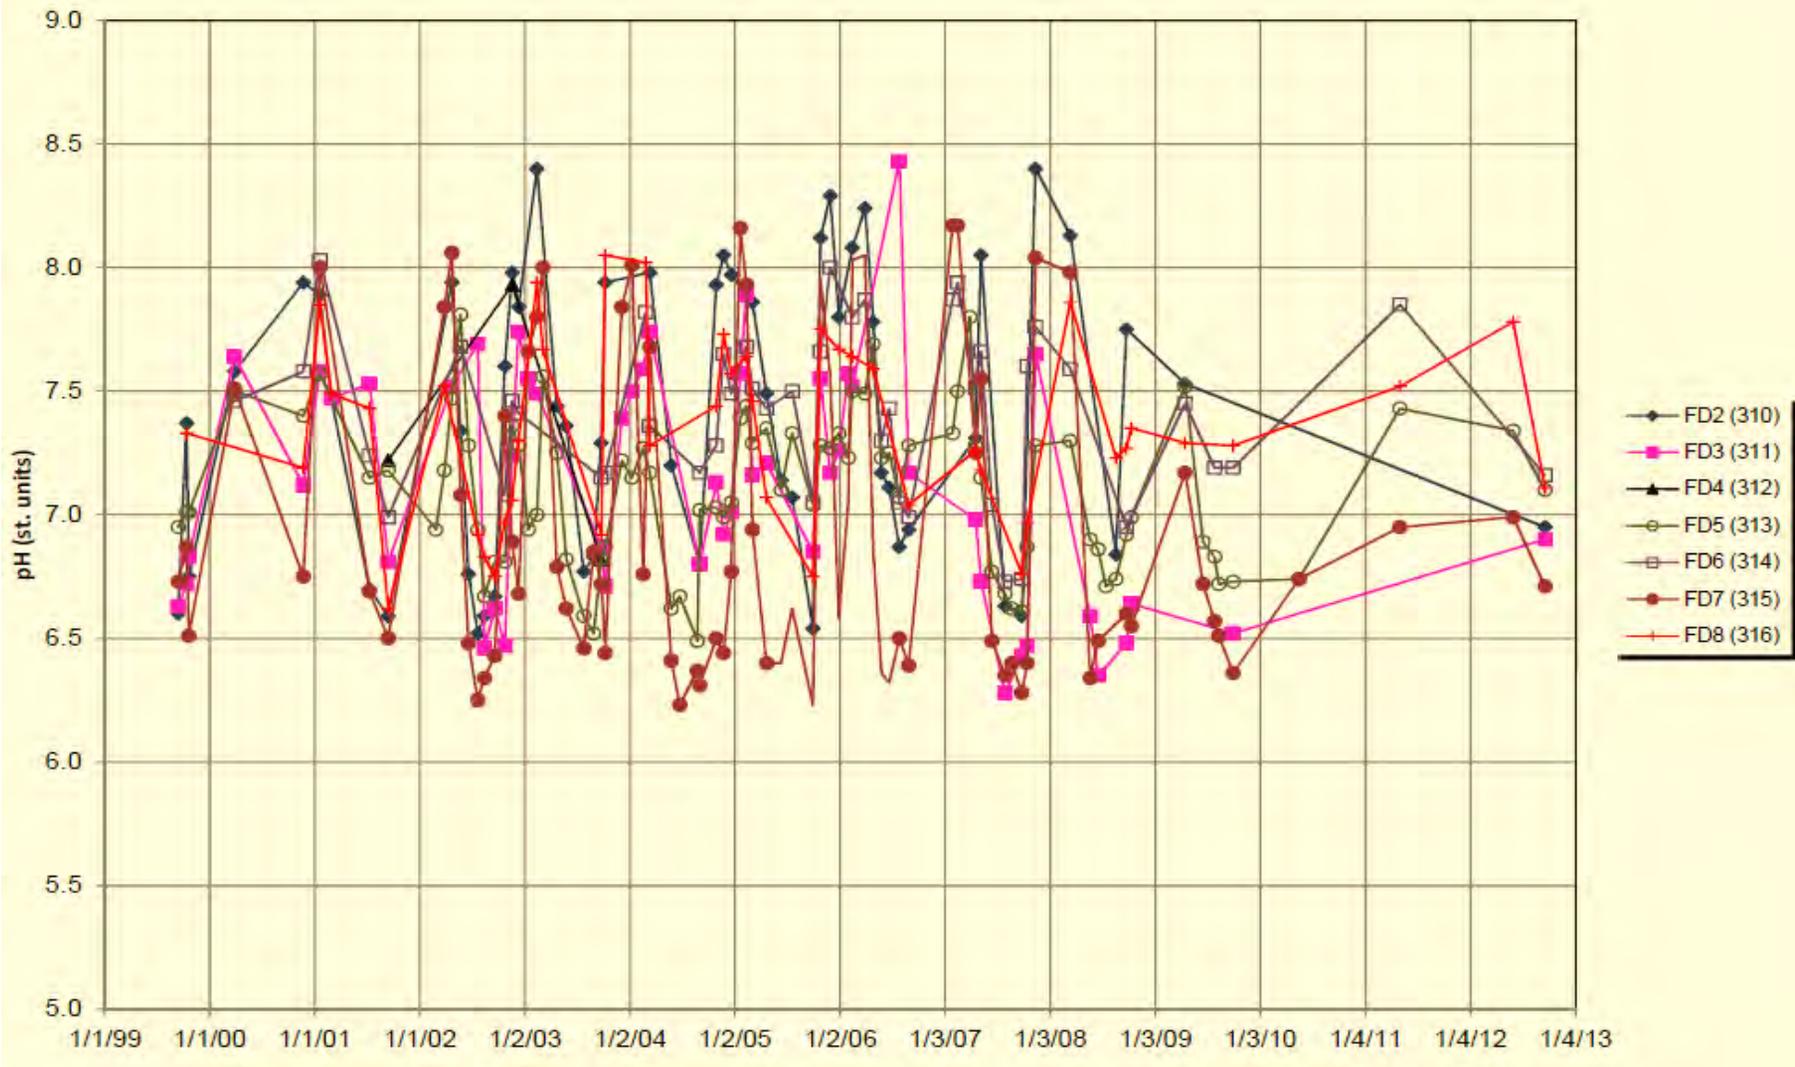
Site 23/D Finger Drains Figure 3.14a – pH

- Internal site waters are captured, treated, and discharged per HGCMC's NPDES/APDES permit
- pH values are between 6.3 and 8.0 (high buffering capacity)
- Conductivities are between 200 and 5000 umho/cm
- Variations in conductivity reflect differences in contributions of groundwater and infiltration, seasonal fluctuations
- Zinc concentrations are variable (typically less than 5 mg/l)
- Precipitation, mixing, and sorption mechanisms determine metals concentrations
