BEST MANAGEMENT PRACTICES PLAN  
2022 ANNUAL REPORT

Hecla Greens Creek Mining Company

1 March 2023

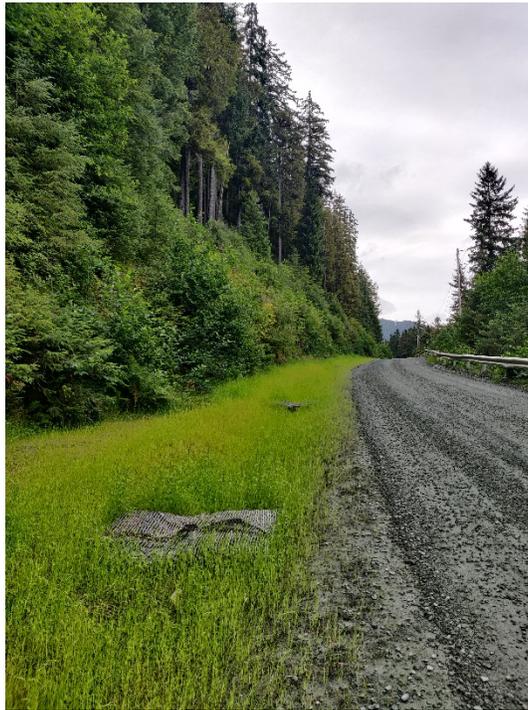
Ditch repair, maintenance and stabilization activities began in April as soon as snowmelt and ground thaw allowed and continued throughout the summer and fall. After sections of the ditch were maintained, they were hydroseeded to establish vegetation for stabilization. Rock check dams were installed in steeper sections of the ditch below 3.4-mile to slow runoff velocity and reduce scouring of the ditch. Photo 1 shows a vegetated section of ditch with rock check dams below the 3.4.

PHOTO 1. Ditch maintenance below 3.4-mile bridge.

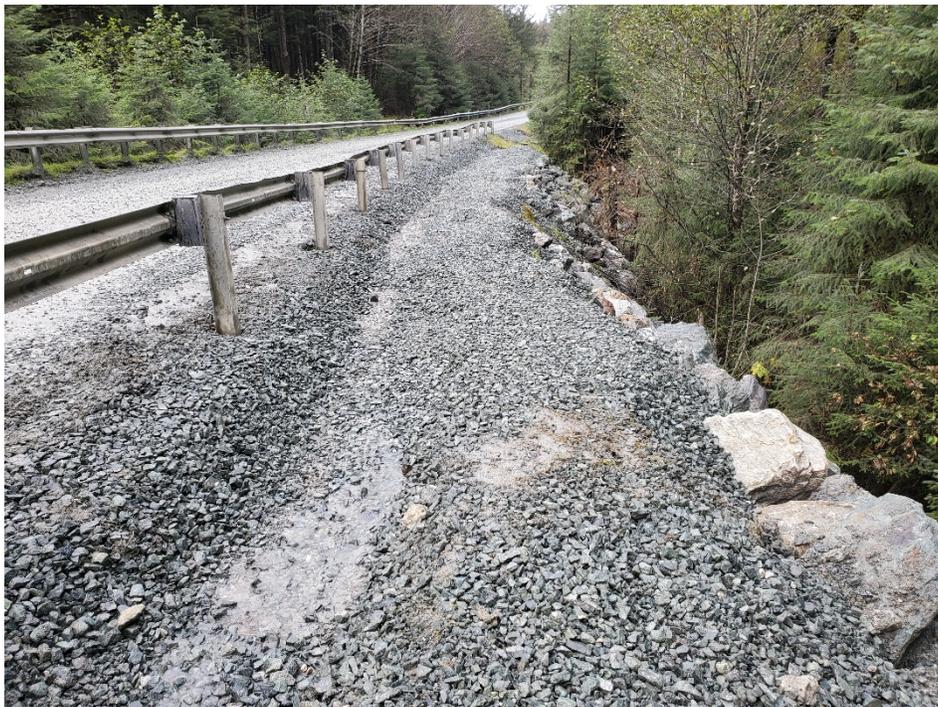
During the December 2020 storm event, extreme runoff caused a failure of the roadside ditch and erosion of the slope at approximately 3.2-Mile on the B-Road. A temporary repair of the ditch was performed in 2021. In September 2022 a project was completed to armor the eroded slope with large rock and reconstruct a stabilized ditch. Photo 2 shows the ditch at project completion.

PHOTO 2. Stabilized slope and reconstructed ditch at 3.2-Mile.

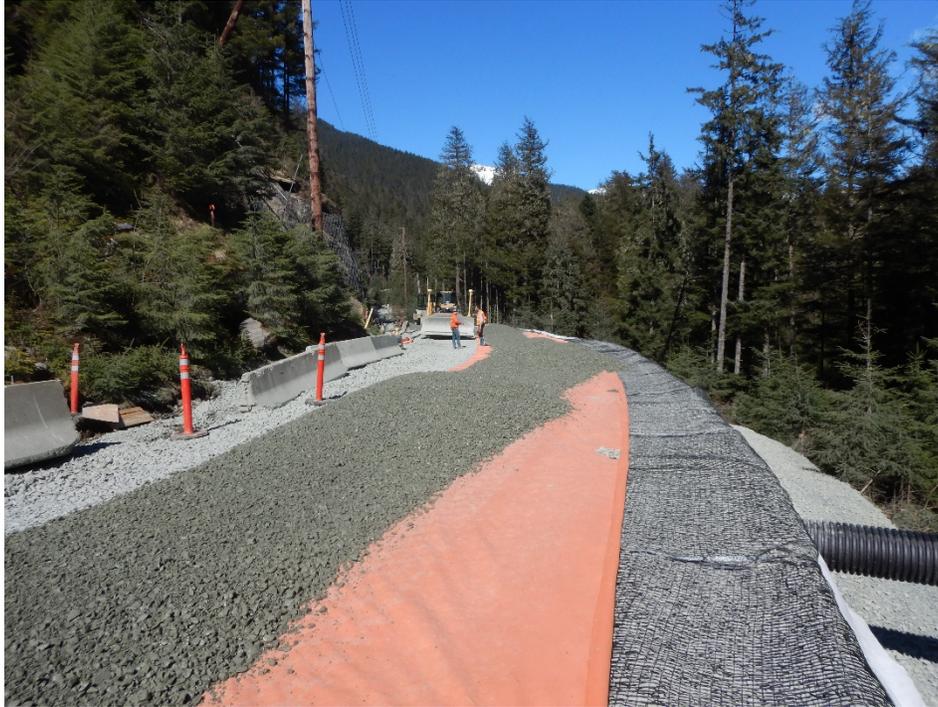
In May, a section of the road by 5.6-Mile was reconstructed to install a Mechanically Stabilized Earth (MSE) wall to mitigate slope stability concerns in this area. This included raising the road surface, importing new road base material, installing multiple new culverts, and reestablishing the roadside ditch. Photo 3 shows new road rock being placed near completion of the project.

PHOTO 3. 5.6-Mile MSE wall construction project.

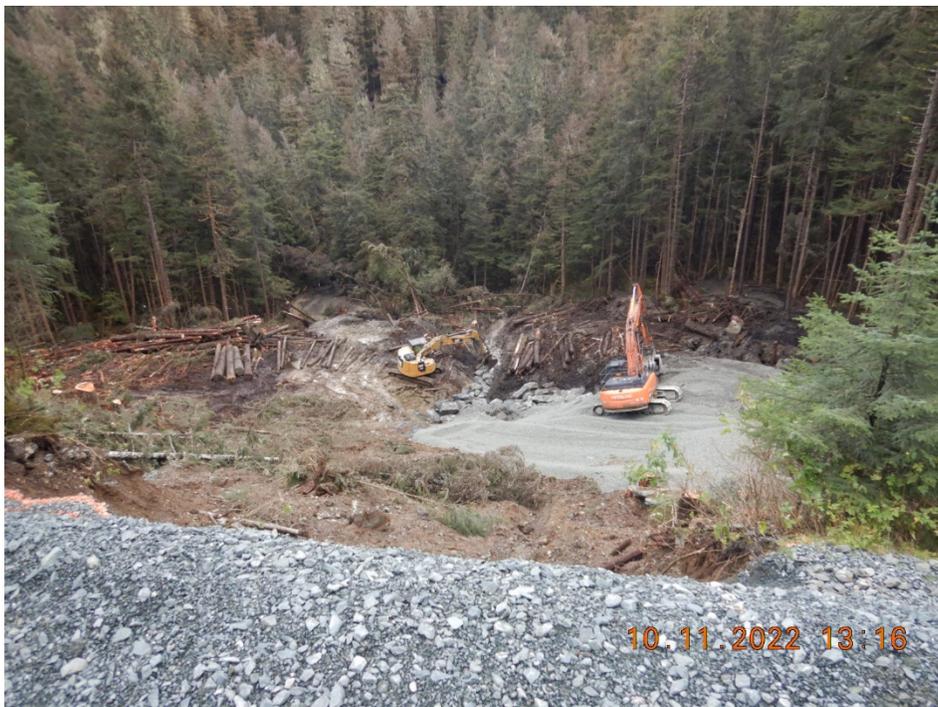
In September, a landslide occurred below the road in this area during a major storm event. In order to prevent failure of the road, a large buttress was constructed to stabilize the slide area. HGCMC utilized fallen trees from the slide, silt fence and straw wattles as construction BMPs to minimize erosion and contain sediment during the project. Photo 4 shows excavators preparing the foundation for the buttress and photo 5 shows the completed buttress.

PHOTO 4. Preparing foundation for buttress below 5.6-Mile after landslide.

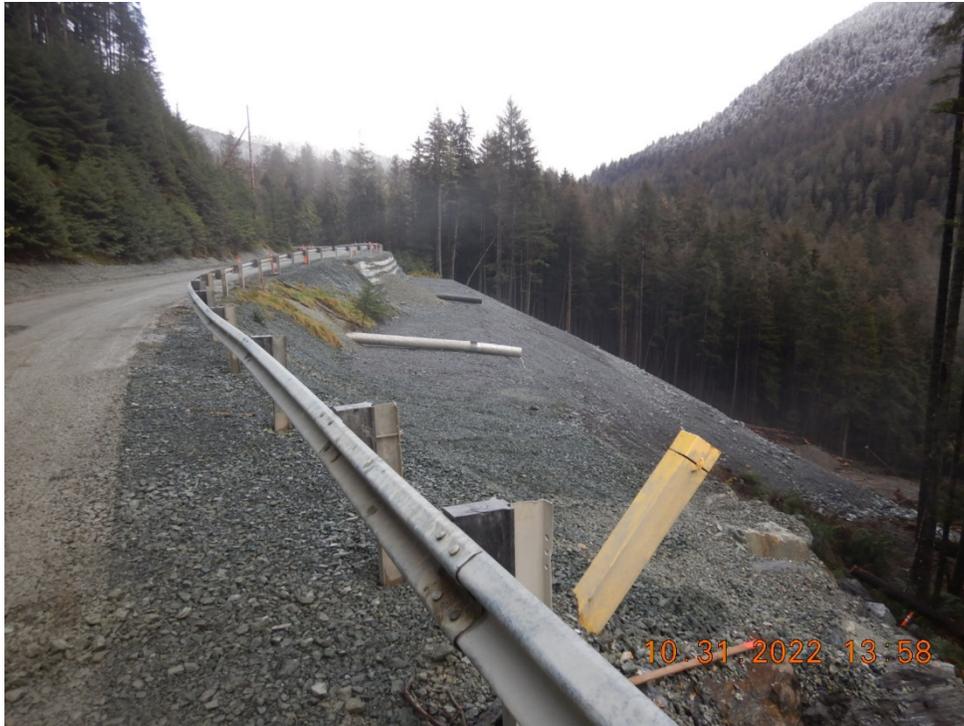
PHOTO 5. Stabilized slope at 5.6-Mile.

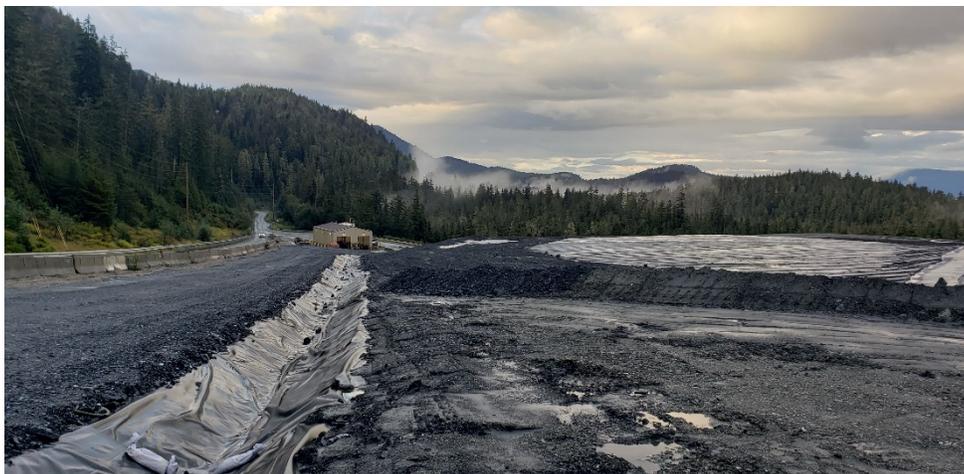
HGCMC continued implementing measures throughout 2022 to reduce fugitive dust from the TDF. Excavated sediments from the B-Road ditch maintenance and materials removed from the inactive waste rock area Site E were hauled to the TDF and used to cap areas that were not going to be used for active tailings placement for an extended period. Logs from trees that were cut during the previous TDF expansion were placed around the facility to provide wind breaks. Wind screen continues to be maintained along the south embankment road. A water truck was also used as needed on accessible areas to control dust. Photo 6 shows an area of the TDF being capped with waste rock and a recently installed lined ditch for managing runoff.

PHOTO 6. Capping tailings with waste rock to control erosion and fugitive dust.
