GLOBAL
a moran company

2025 - HAWK INLET DIFFUSER AND PIPELINE INSPECTION

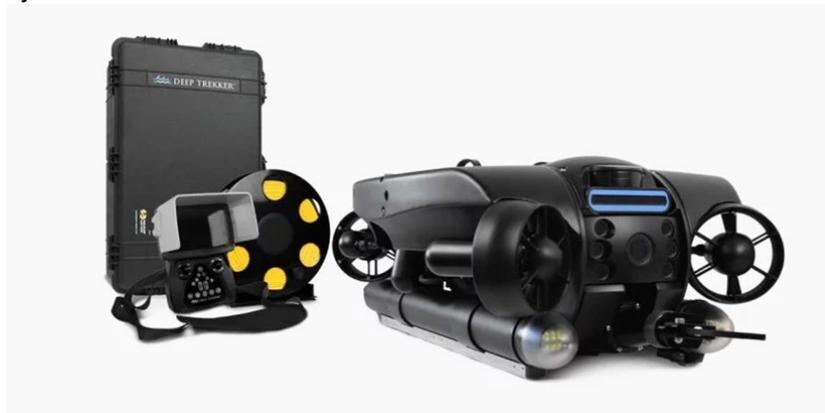
Figure 1 - DEEP TREKKER Revolution Remote Operated Vehicle

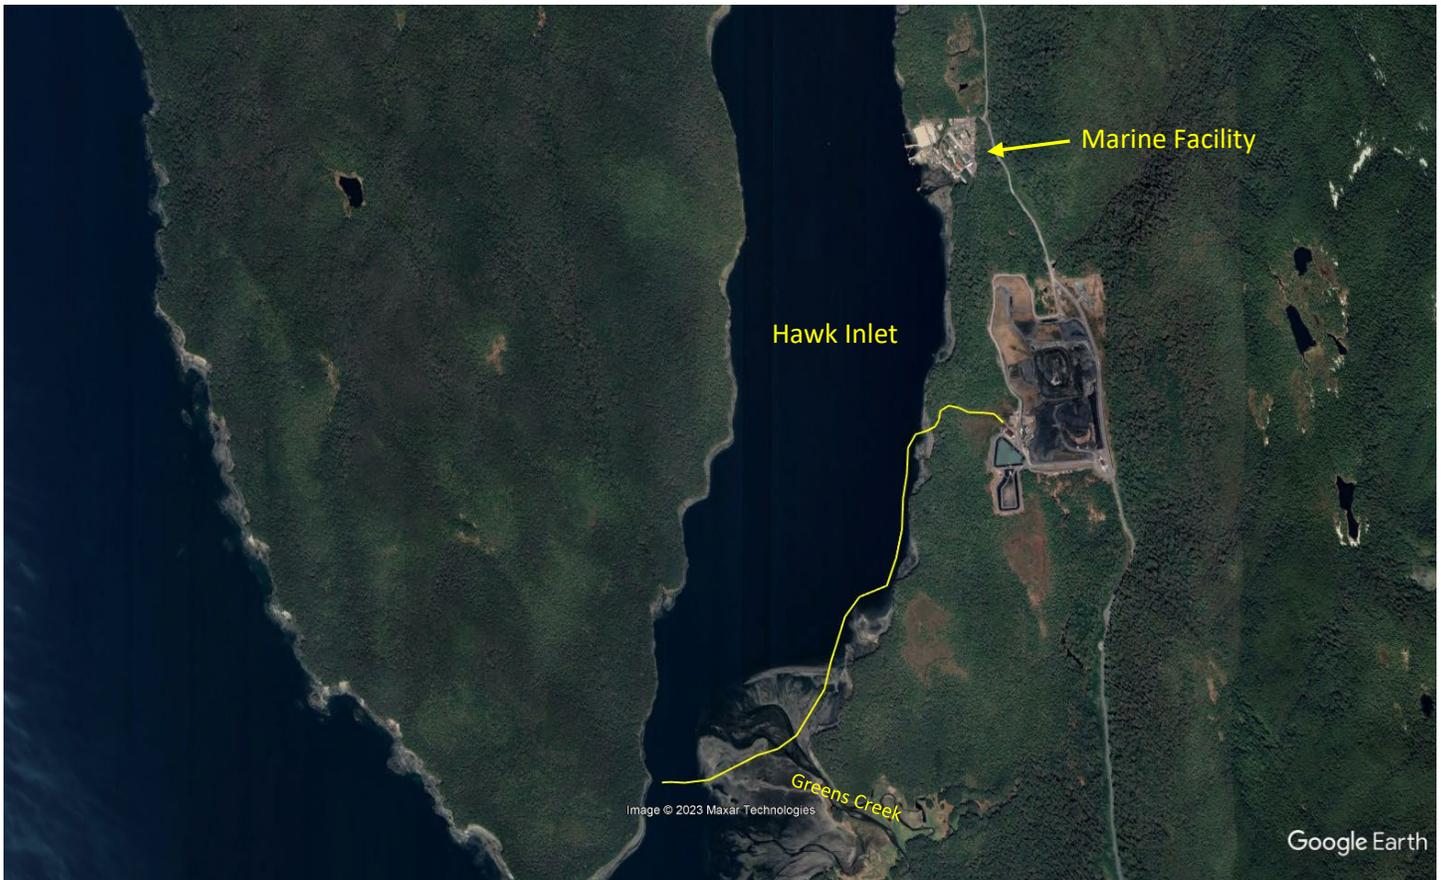
Figure 2 - General location of Outfall

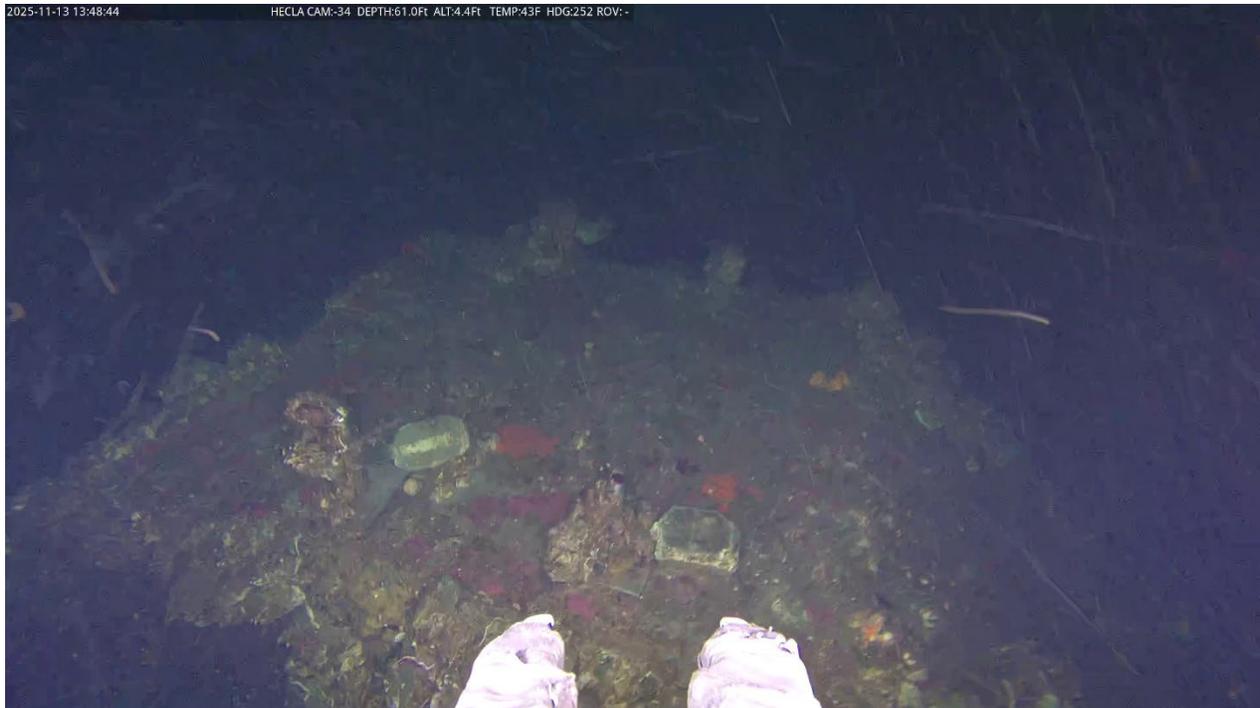
Figure 3 - Typical Type 4 Anchor Block with Anodes, typical

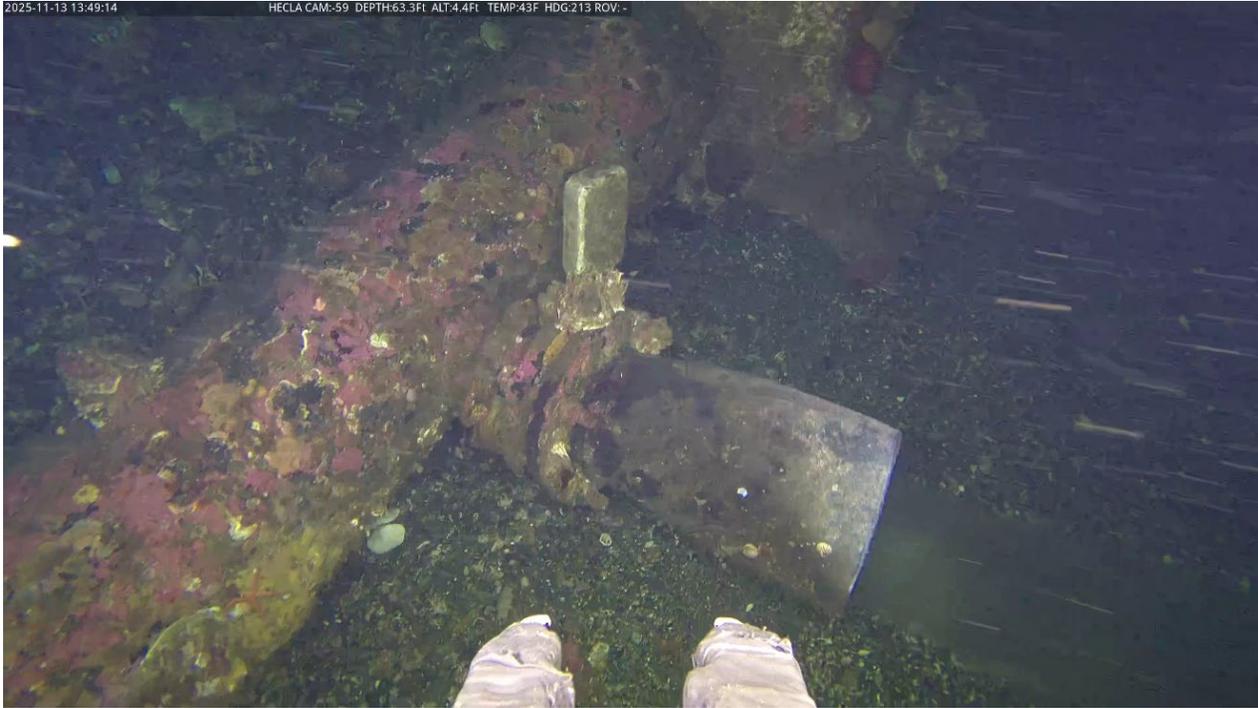
Figure 4 - Typical Duckbill Valve Condition

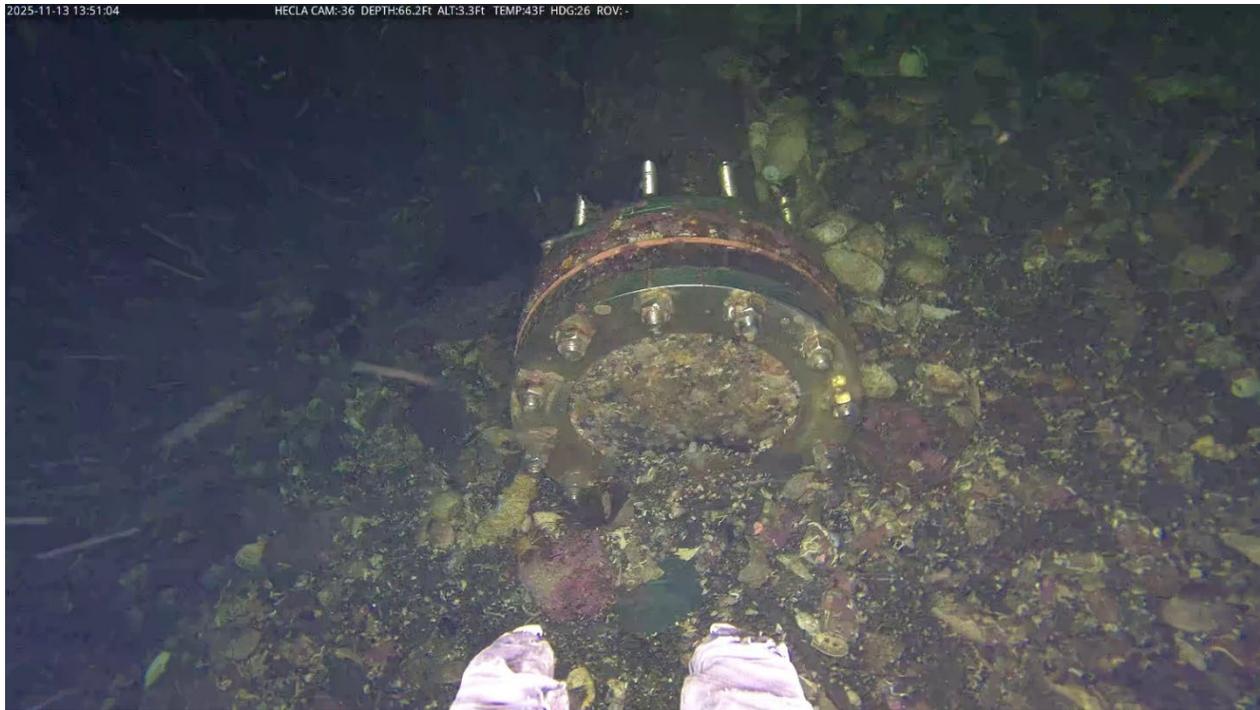
Figure 5 - Diffuser end flange, as designed

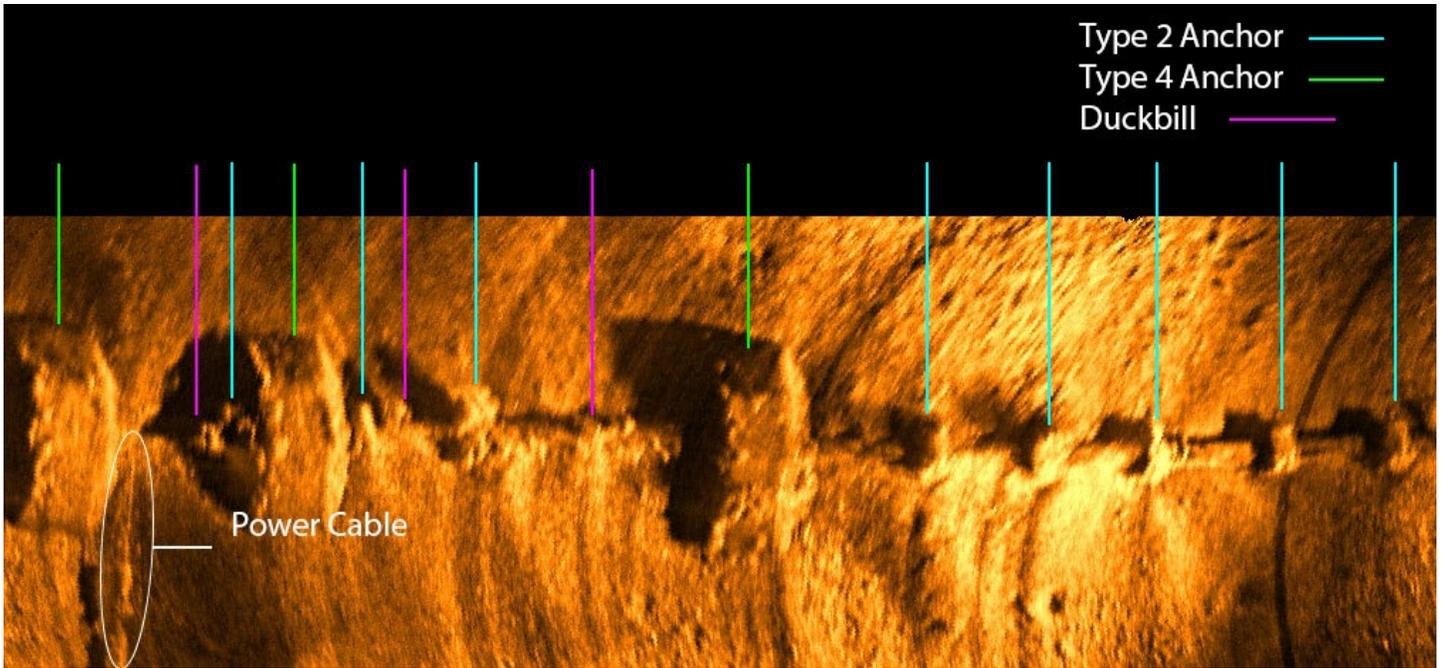
Figure 9 – Continuation of mosaic with power cable noted, moving east

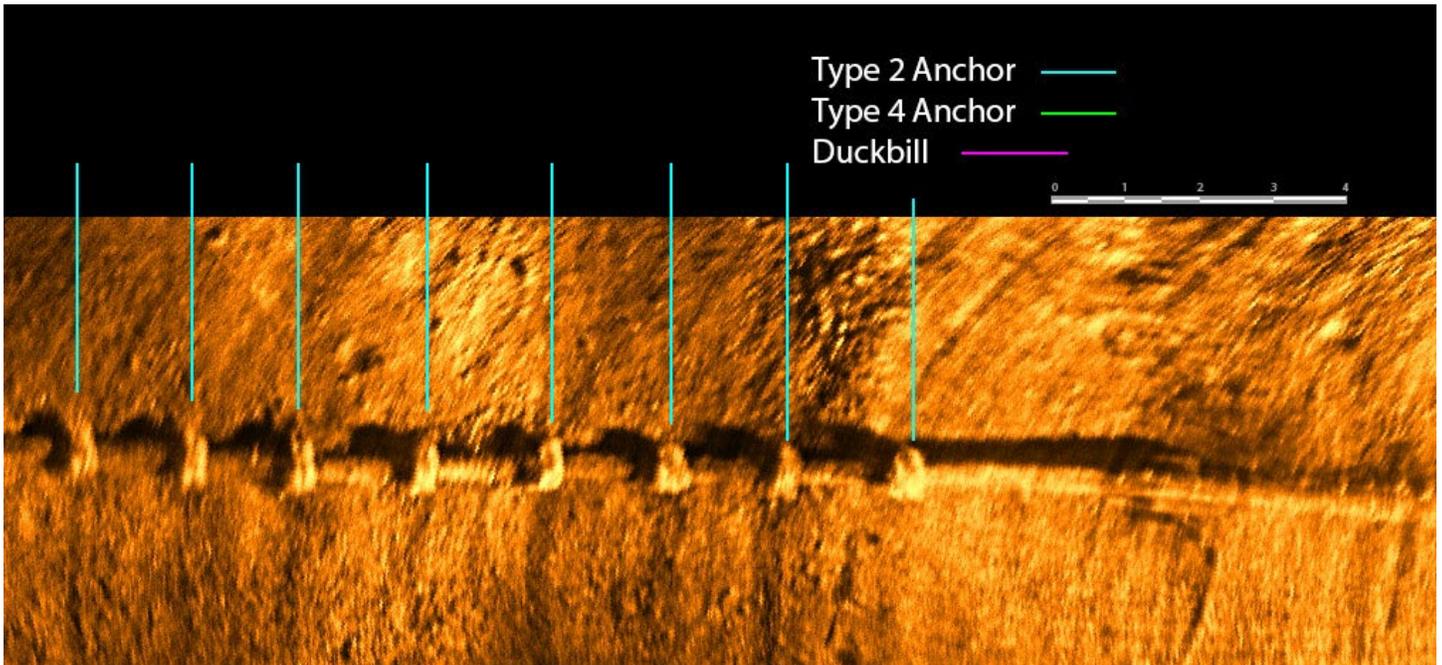
Figure 10 – End of mosaic where punch-out in the East begins

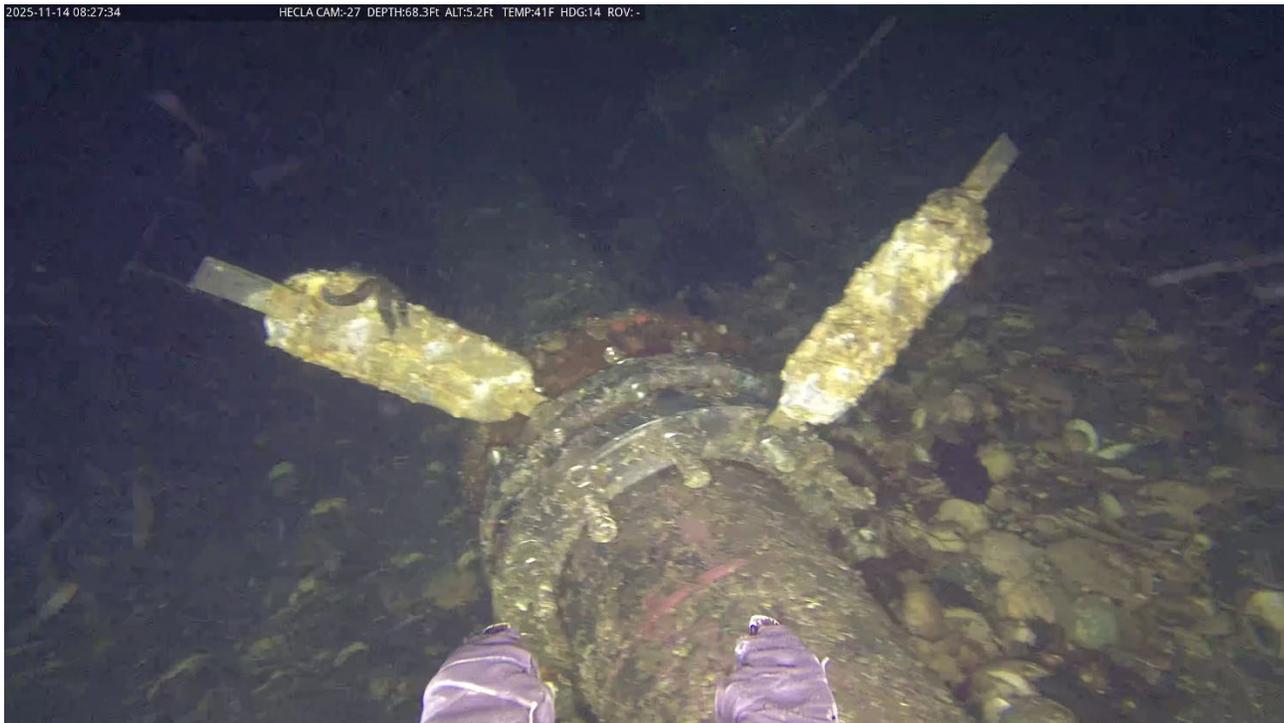
Figure 11 – Flange 1 @ 67 ft, Good Condition, as designed

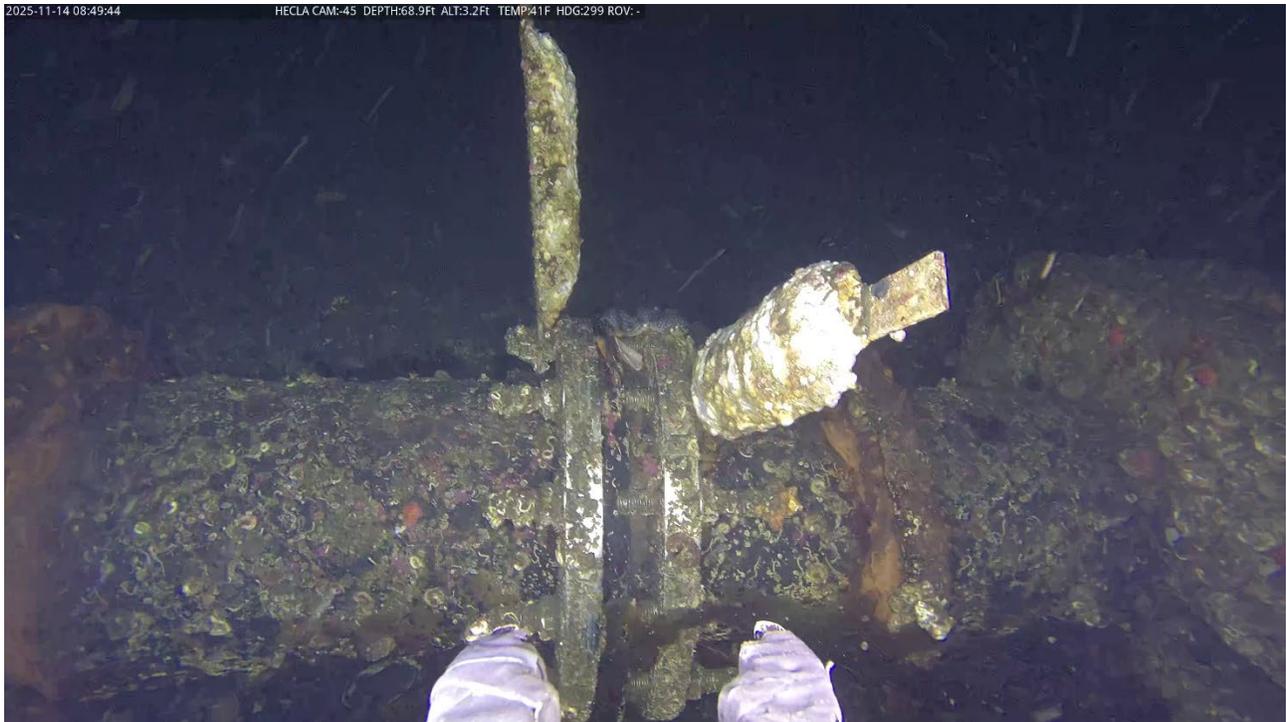
Figure 12 – Flange 2 @ 69 ft, good condition, as designed

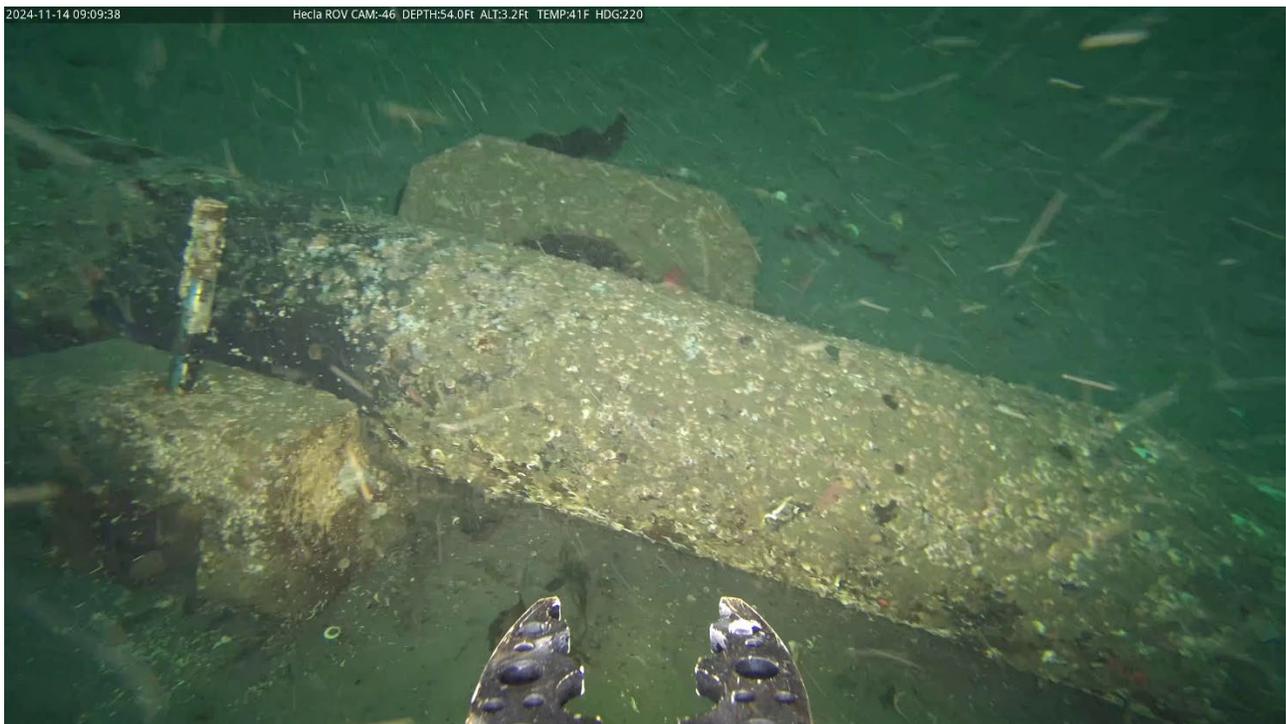
Figure 13 – Weight #18 South of flange 2, fallen apart 2024

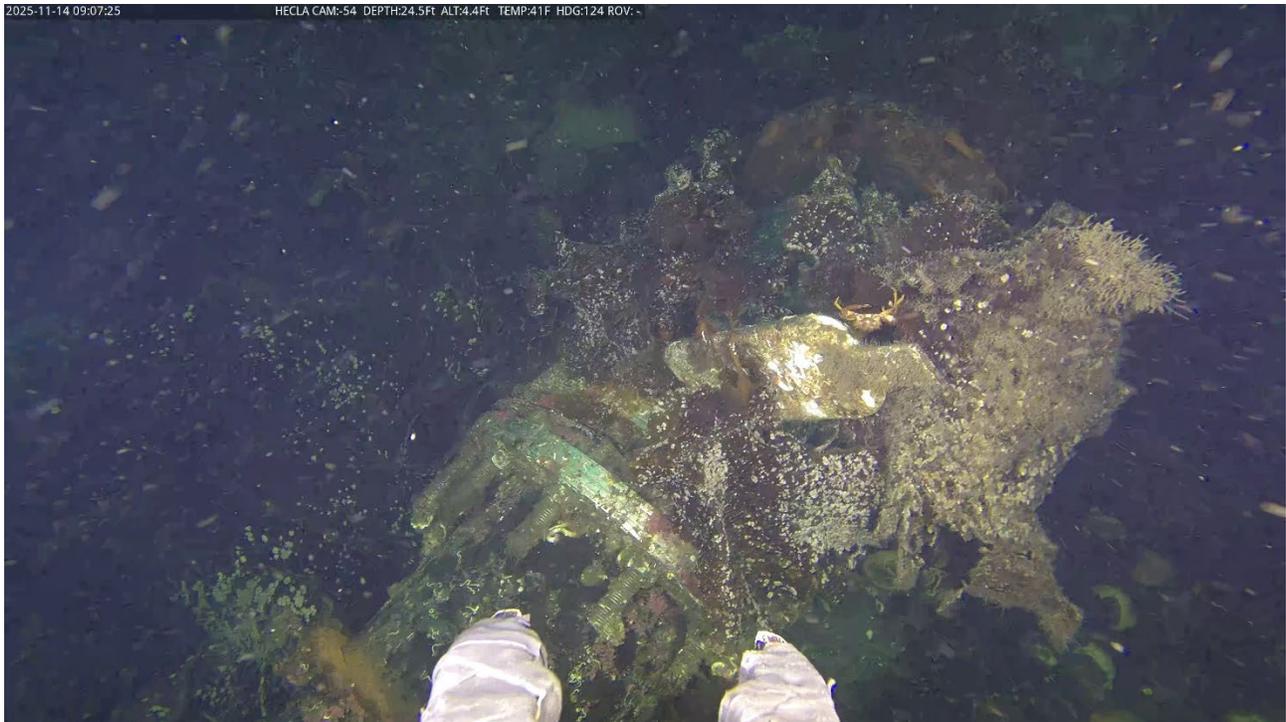
Figure 16 – Flange 3 @ 28 ft, appears good condition heavy marine growth noted, as designed

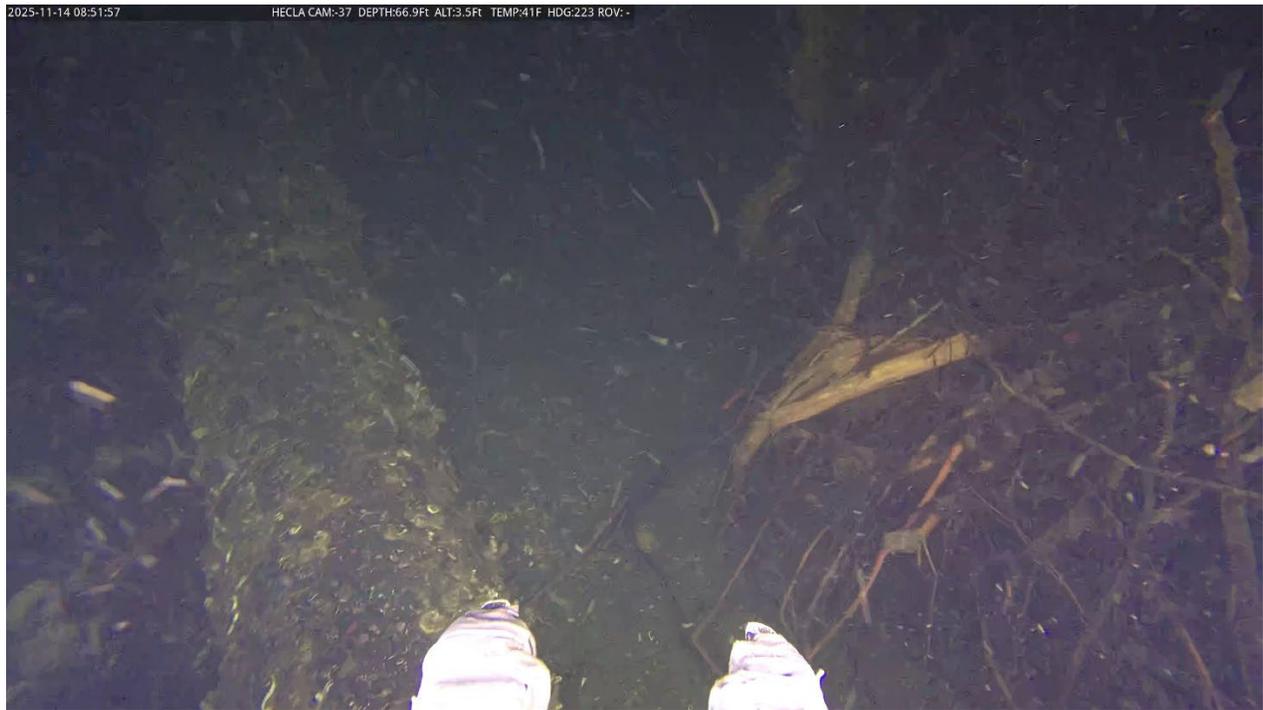
Figure 17 – Root ball of tree noted 5' west pipeline at 70' depth and 20' South of second flange

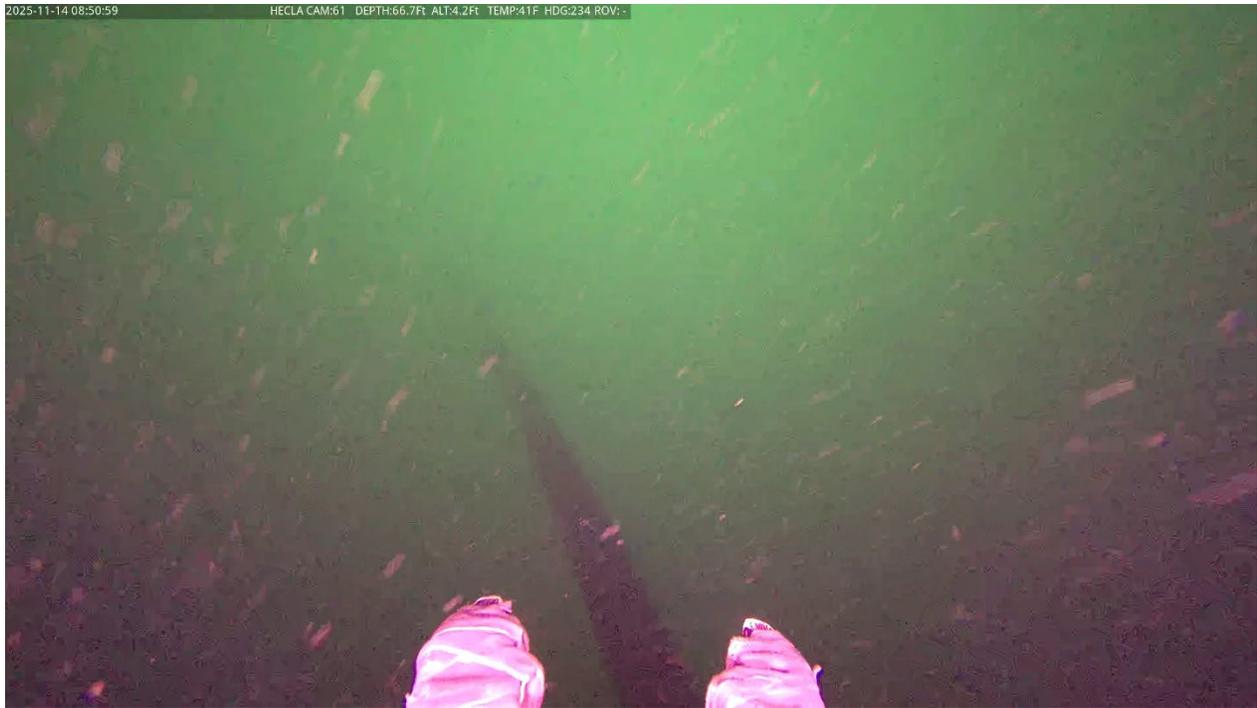
Figure 18 – Upwards view of tree reaching towards surface, construction light and work vest already in place on surface
