BEST MANAGEMENT PRACTICES PLAN 2019 ANNUAL REPORT

Hecla Greens Creek Mining Company

March 1, 2020

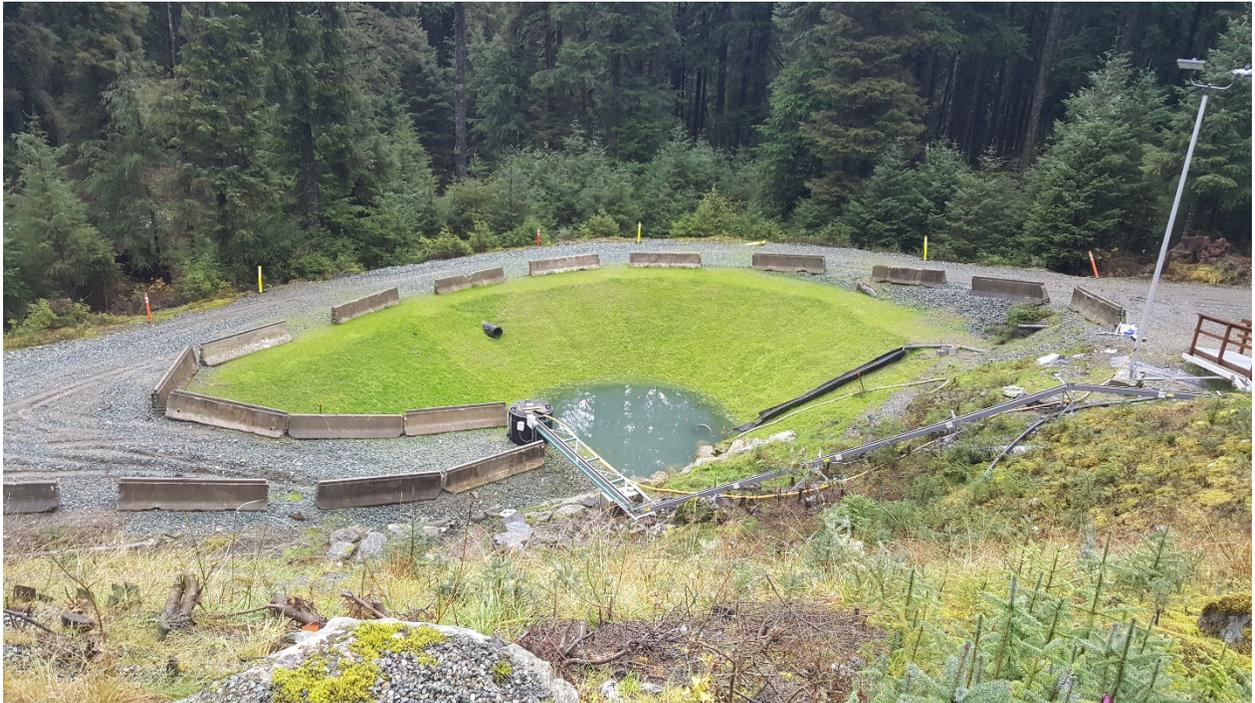
In 2019 the outer berm of Lower Pond C was modified to eliminate a zone of high permeability that was identified in 2018. Following excavation, a layer of HDPE liner was placed along the inside edge of the outer berm and then backfilled with clay and appropriate bedding material. The modifications to Lower Pond C improved the storm water management capabilities for the 860 area. Photo 6 shows the pond following completion of earthwork activities. The cover photo for this report shows the pond with vegetation established.

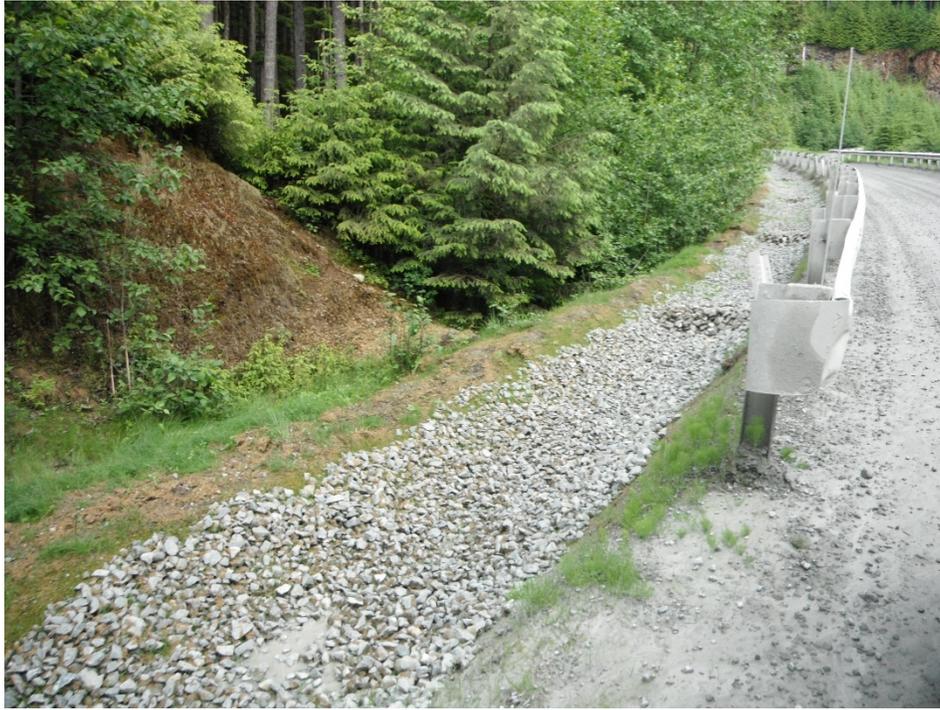
PHOTO 1. Ditch stabilization measures above 3.0-mile bridge.

Ditch maintenance and stabilization activities began in mid-March as soon as snow melt and ground thaw allowed. Between March and June approximately 4,800 cubic yards of ditch sediments were excavated to re-establish the proper ditch geometry. Rock lining and/or rock check dams were added to the steeper gradient sections to reduce flow velocity and erosion. The entire ditch was hydroseeded in May, and redone in June as needed, to establish vegetation for stabilization. Photos 1-3 illustrate the ditch maintenance activities performed in 2019.

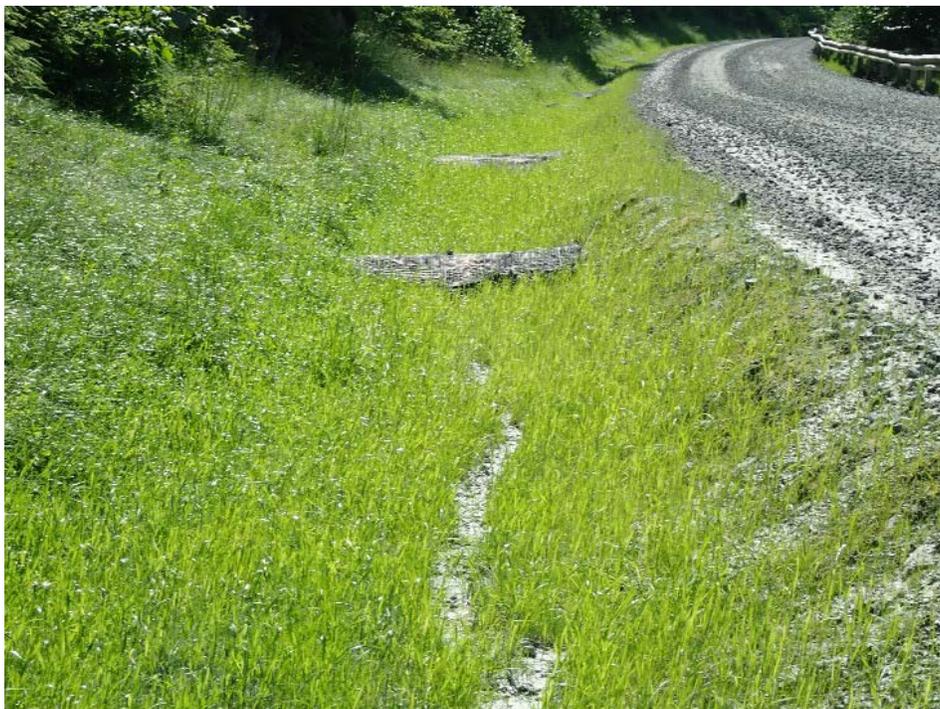
PHOTO 2. Rock check dams and vegetation for ditch stabilization.

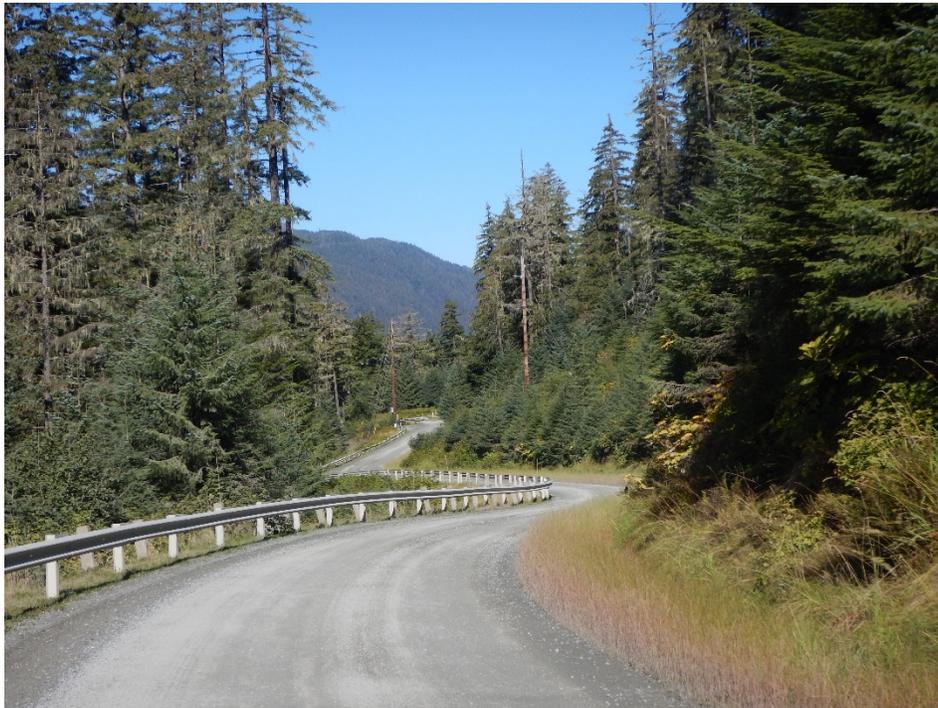
PHOTO 3. Vegetation in roadside ditch for erosion control.

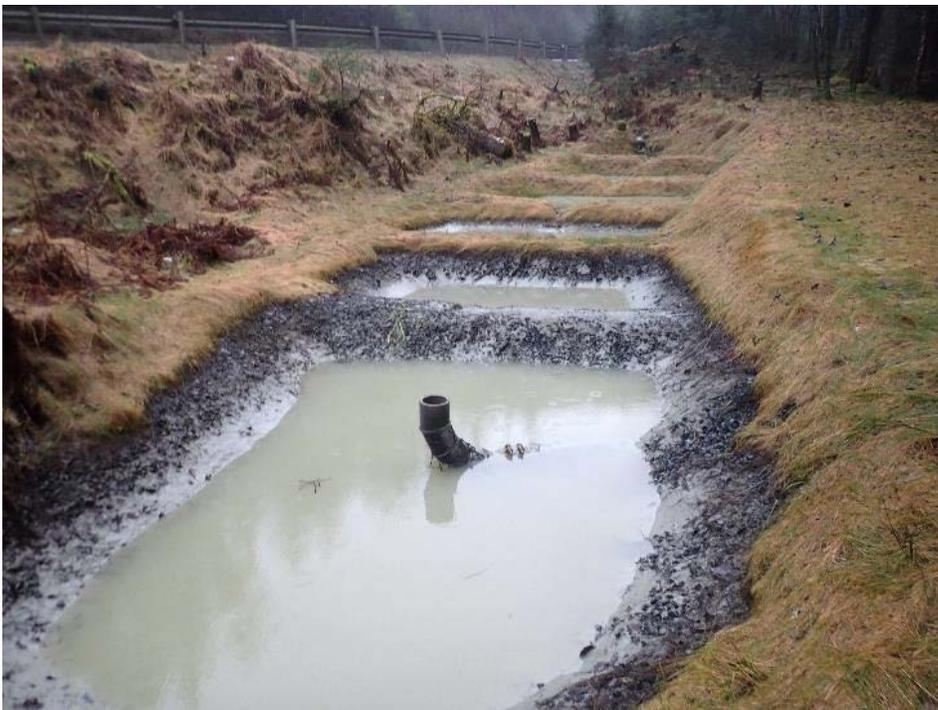
PHOTO 4. Improved settling ponds above 3.0-mile bridge.

The sediment ponds near 3.1-mile B-Road were cleaned and hydroseed was applied to the berms and adjacent areas. The surge capacity of the ponds was increased by drilling small holes in the vertical riser discharge pipe to allow the pond to slowly drain following precipitation events (Photo 4).

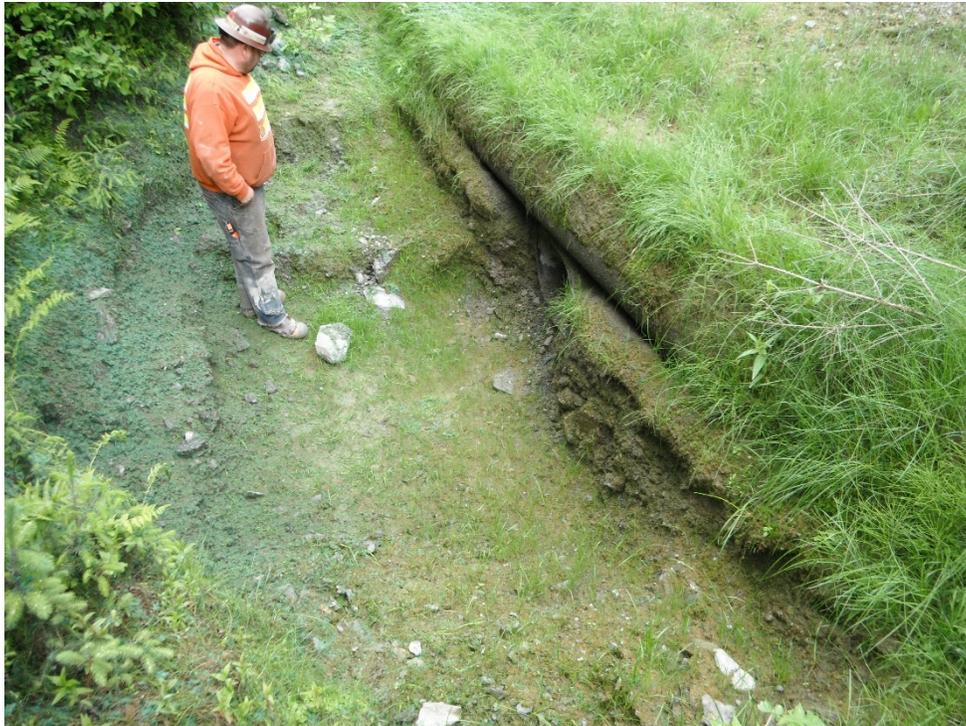
PHOTO 5. Inlet sump at 7.8-mile B Road culvert after cleaning and seeding.

Accumulated sediment was removed from the inlet sump at the 7.8-Mile culvert on May 10. The sump and roadside ditch were hydroseeded to establish vegetation. Enlargement of the sump and removal of fine-grained sediment restored the infiltrative capacity of the sump such that there was no observed discharge through the stormwater outfall in 2019. The culvert was observed during multiple large rain events from August through October. Photo 5 shows the condition of the sump on June 12.

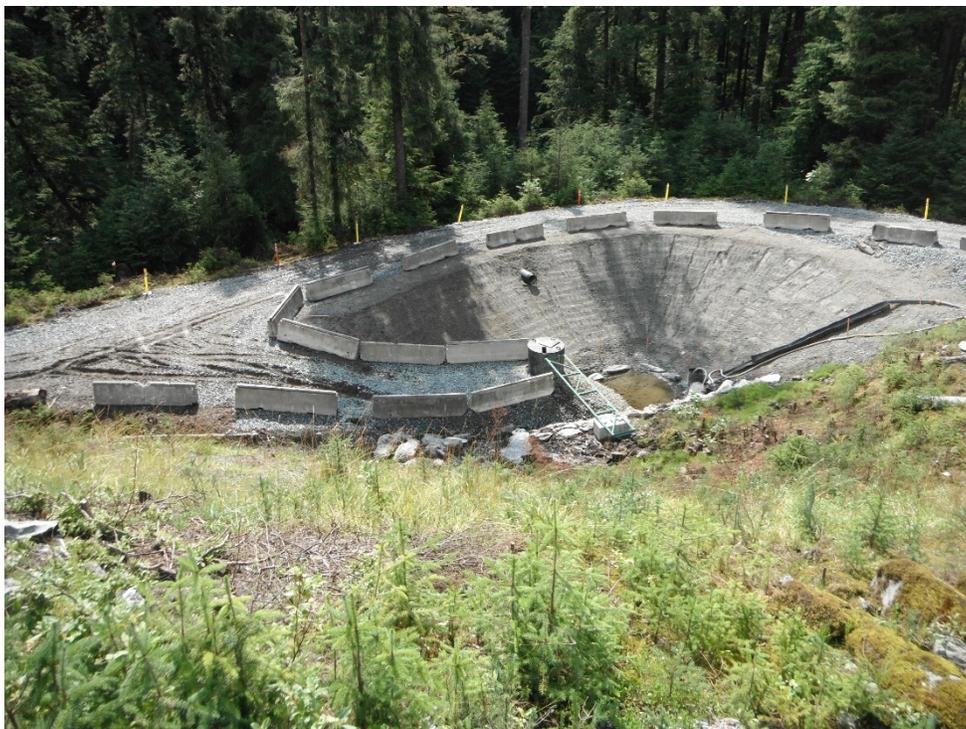
PHOTO 6. Modified Lower Pond C near project completion.

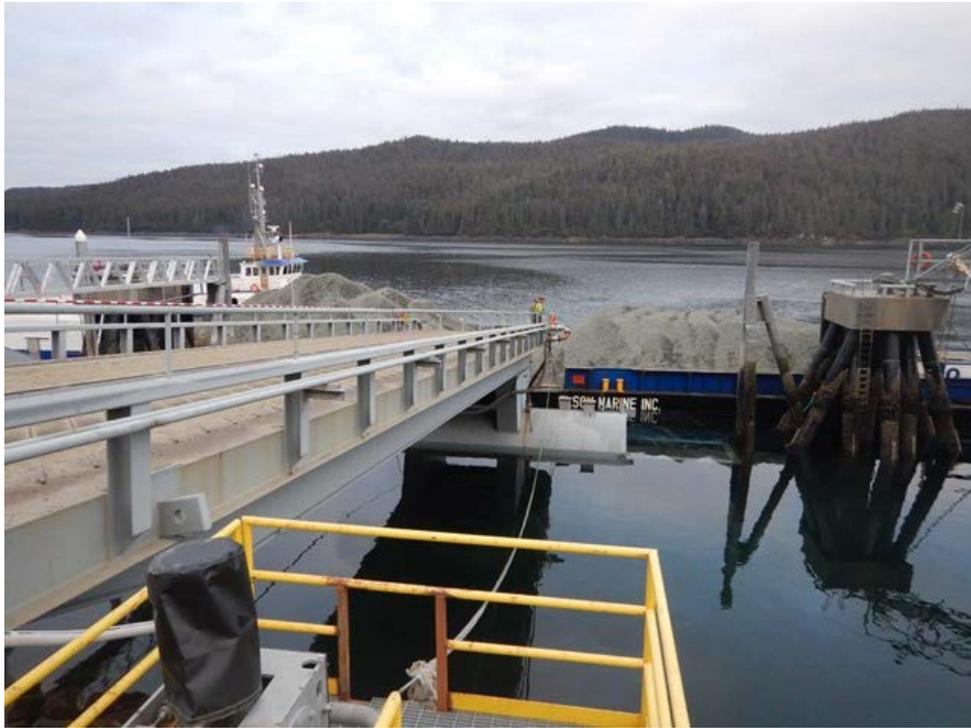
PHOTO 7. Barge load of rock for road re-surfacing.

In 2019, HGCMC imported ten barge loads gravel, consisting of three different material specifications, for use in road maintenance. Imported materials first pass a geochemical and geotechnical screening process to demonstrate suitability for use on the road system. Photo 7 shows one of the gravel barges arriving at the HGCMC dock.

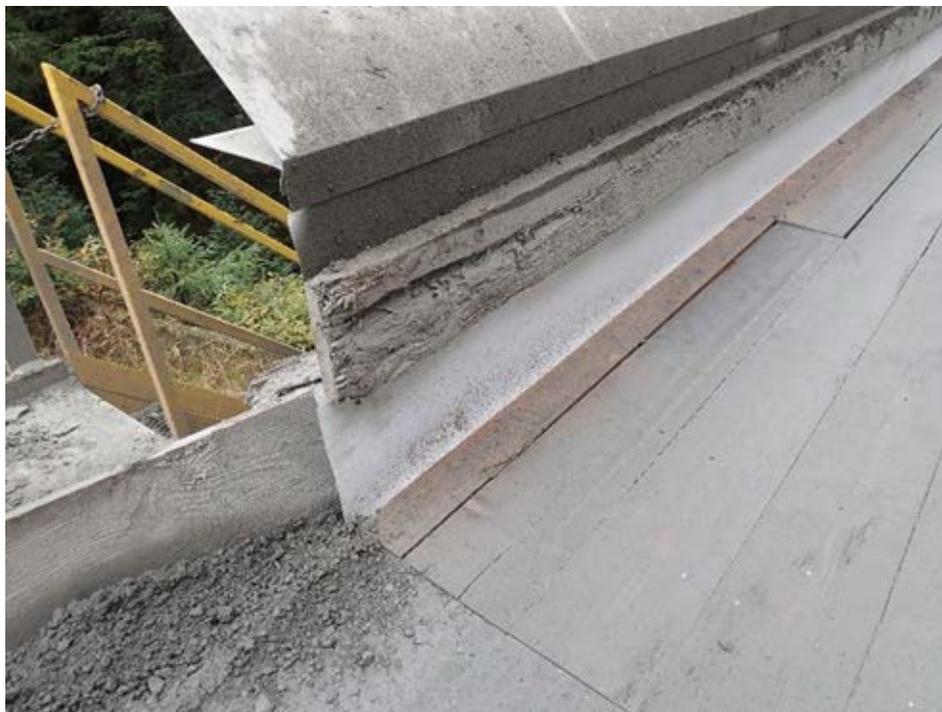
PHOTO 8. HDPE liner installed beneath new wood decking on 7.4-mile bridge.

- 80-mil HDPE liner and both layers of wood decking were replaced on the 7.4-mile and 3.4-mile bridges (Photo 8).
- Partial replacement of wood decking on the 3.0-mile bridge.
- Installed steel retaining wall for slope stabilization at 7.4-mile bridge (Photo 9).
- Hydroseed abutments beneath 3.0-mile and 7.4-mile bridges.

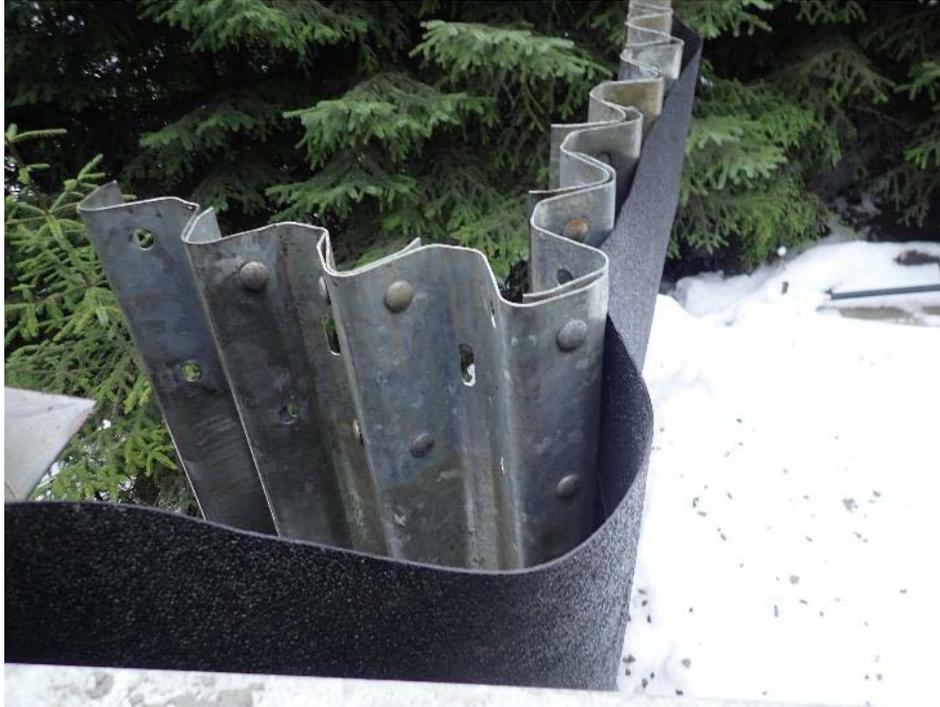
PHOTO 9. Bank stabilization at 7.4-mile bridge abutment.

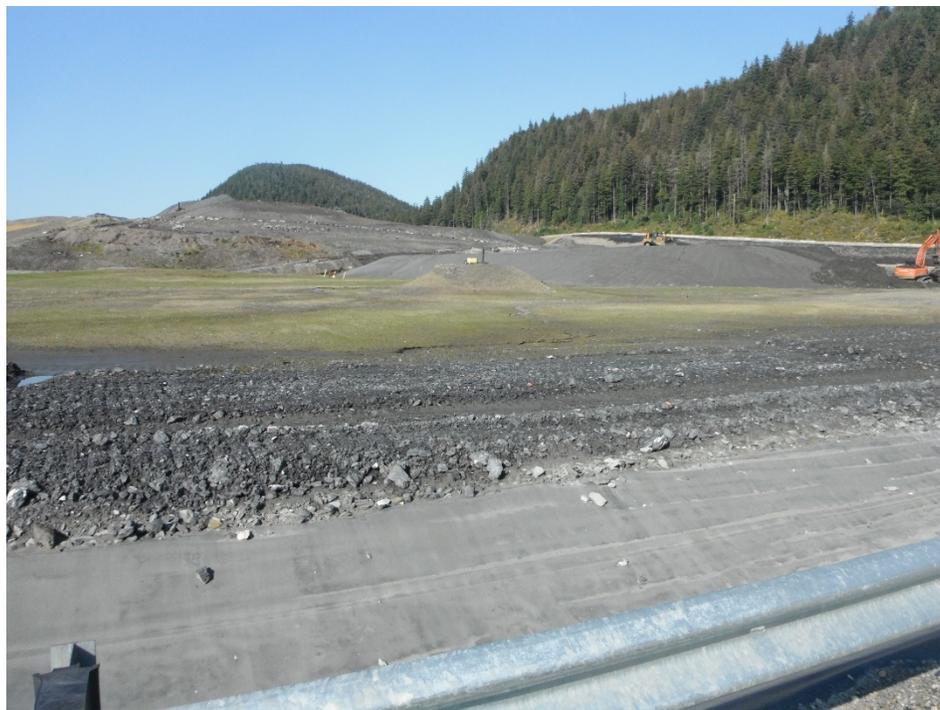
PHOTO 10. Capping and vegetation to control fugitive dust from tailings facility.

- On June 11, the speed limit on the B-Road was reduced from 30 mph to 25 mph for all vehicles. The lower speed reduces the amount of airborne dust created from traffic and is also expected to reduce the rate of degradation of road surface material and generation of fine sediment.
- Excavated sediments from the B-Road ditch maintenance were hauled to the TDF and used to cap areas that were not going to be used for active tailings placement in 2019. These areas were then hydroseeded to establish vegetation and stabilize the surficial materials. Photo 10 shows a portion of the TDF with newly established vegetation.
