This 2013 Best Management Practices (BMP) and Storm Water Report is submitted by Hecla Greens Creek Mining Company (HGCMC) pursuant to Sections II.F.1 and II.F.2 of NPDES Permit AK-004320-6, effective 1 July 2005. Authority over the federal permitting, compliance and enforcement NPDES program transferred to the State (ADEC) in November of 2010 for the mining industry. The Report summarizes the scope and dates of the comprehensive site compliance inspections/evaluations, major observations related to implementation of the BMP Plan, corrective actions taken as a result of the inspections/evaluations, identification of potential incidents of noncompliance as they pertain to the BMP Plan, description of the quantity and quality of the storm water discharged, and BMP Plan modifications made during the year. The final section of this report contains the required annual certification under Section II.F.2.

IV. HGCMC 2013 Annual Storm Water Monitoring Report

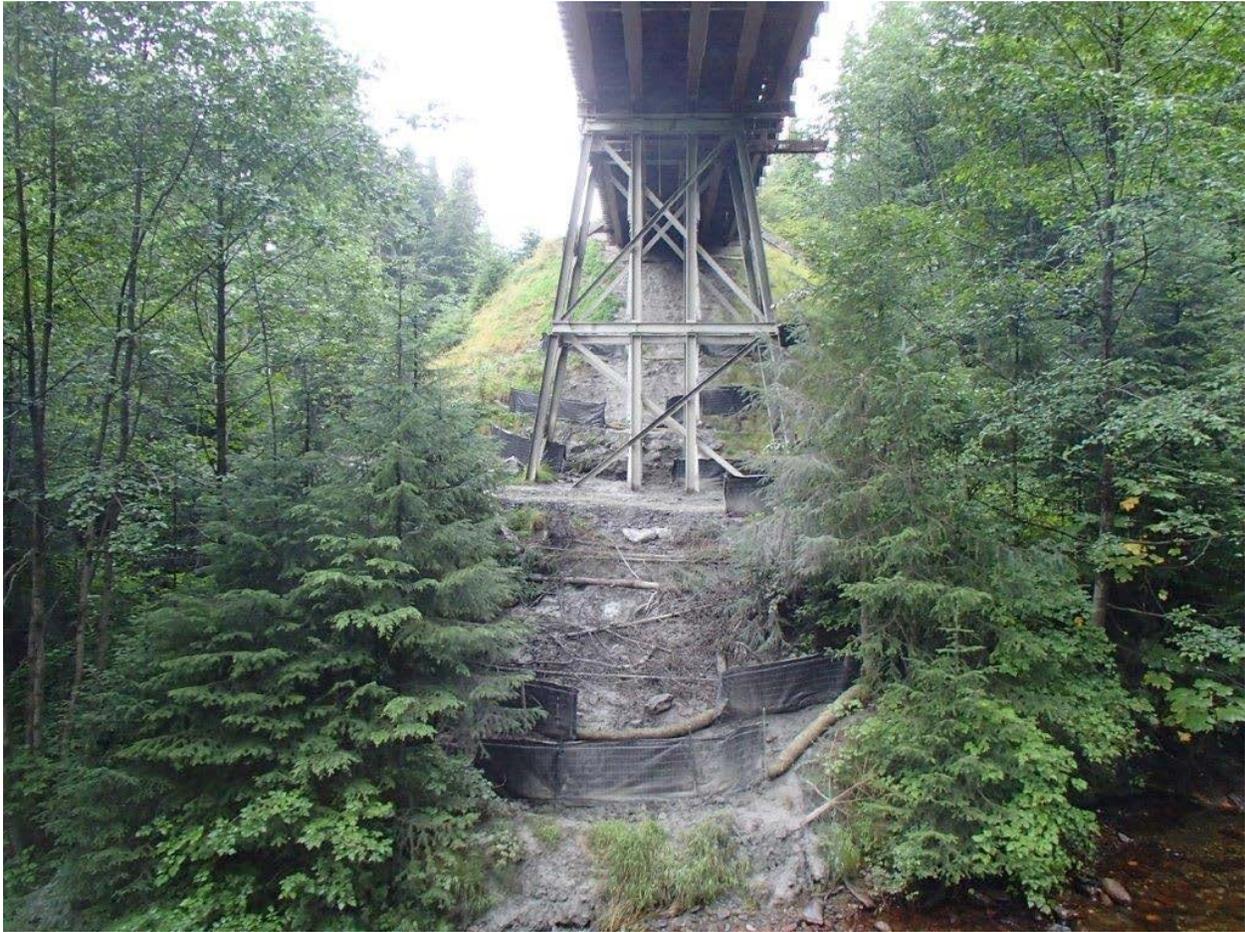
PHOTO 1. Reestablishment of silt fencing underneath the 3 mile bridge, designed to allow for the passage of bears.

- After the winter, spring clean-out of most of the settling ponds along the road should occur. This was accomplished in May and June.
- Sediment under the Zinc Creek Bridge was removed in July and the silt fencing was reestablished (damaged by bears). The reestablished silt fencing was installed to allow for bear crossing, while still preventing sediment runoff.
- In October, the caisson at Outfall 003 was over flowing, because of limited discharge capacity with the pump. This was rectified by increasing the size of the discharge line tripling the pumping capacity of the system.

Routine maintenance of existing BMPs was performed in 2013. This included the reestablishment of the small spur road adjacent to the abutment for gaining equipment access for under the bridge. Sediment accumulation was cleared from underneath the bridge and the silt fencing was reinstalled in a way to allow for bear crossing (Photo 1). It is a yearly occurrence to have the sediment fencing damaged by the bears while they travel over it.

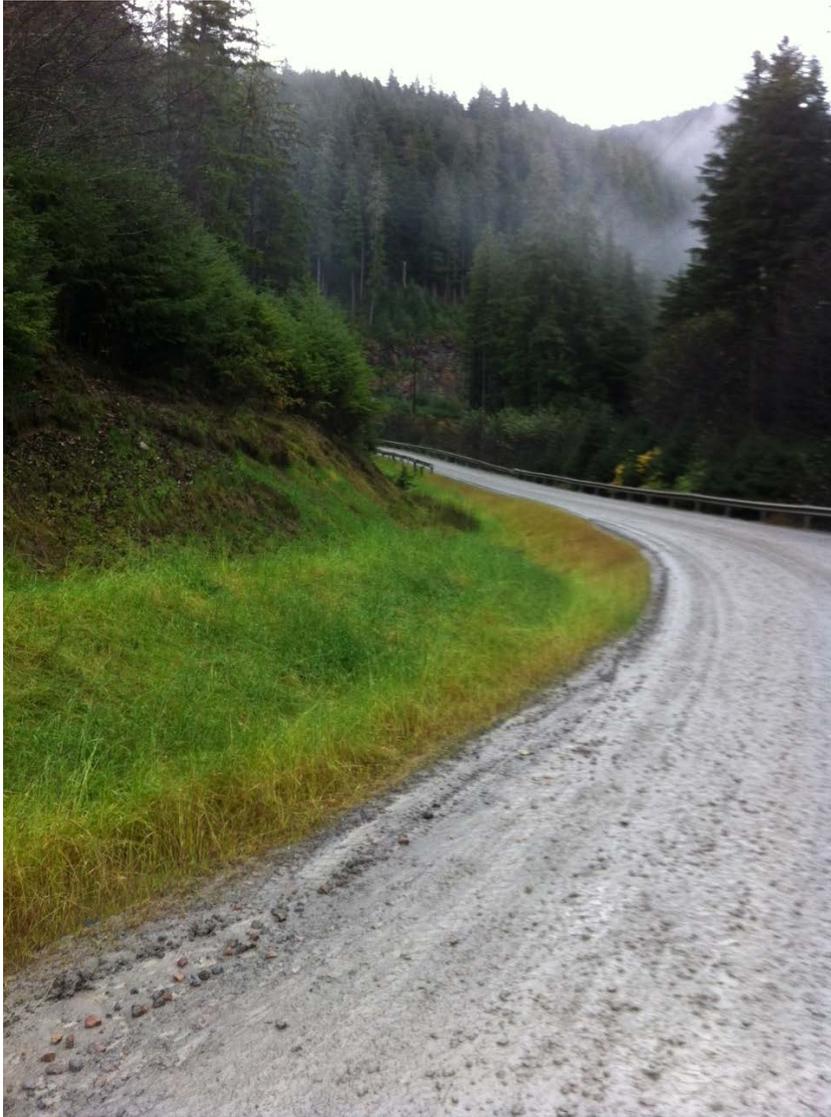
PHOTO 2. Ditch work and hydro seeding along the B Road, uphill from the 3 mile bridge.
