GREENS CREEK MINE 2024 Reclamation Plan Approval Audit

FINAL

December 2024

Hecla Greens Creek Mining Company

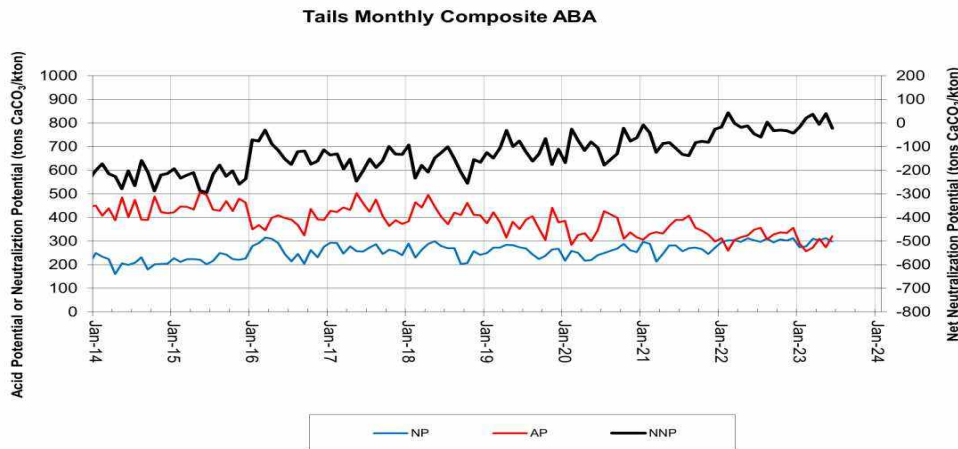
Figure 1. Tails Monthly Composite ABA

2023	Acid Potential	Neutralization Potential	Net Neutralization Potential
July	359.47	302.85	-56.62
August	361.26	289.16	-72.10
September	259.02	303.24	44.22
October	256.15	298.75	42.60
November	292.74	283.47	-9.27
December	370.95	229.59	-141.36
Average	316.60	284.51	-32.09

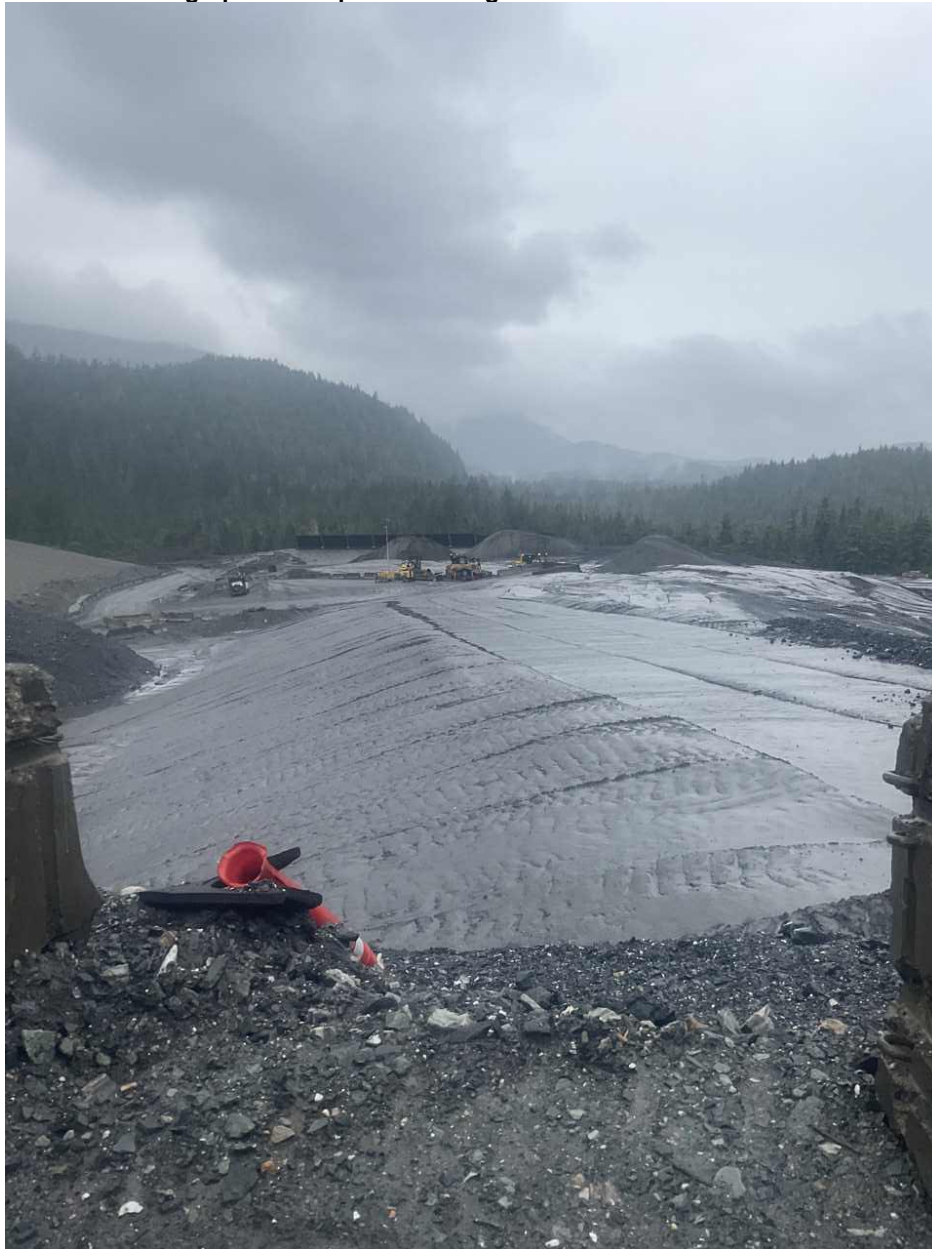
The audit team observed tailings being delivered to the TDF by lidded trailer trucks from the mill. Tailings were being end-dumped on site, actively spread with a dozer, and then vibratory roller compacted in small discreet areas (see Appendix A, **Photograph 1**). The Audit Team did not observe tailings disposal occurring outside of the TDF boundary, and tailings were being graded smooth to promote surface water runoff and prevent ponding.

Photograph 1. Compacted Tailings and Waste Rock at the TDF

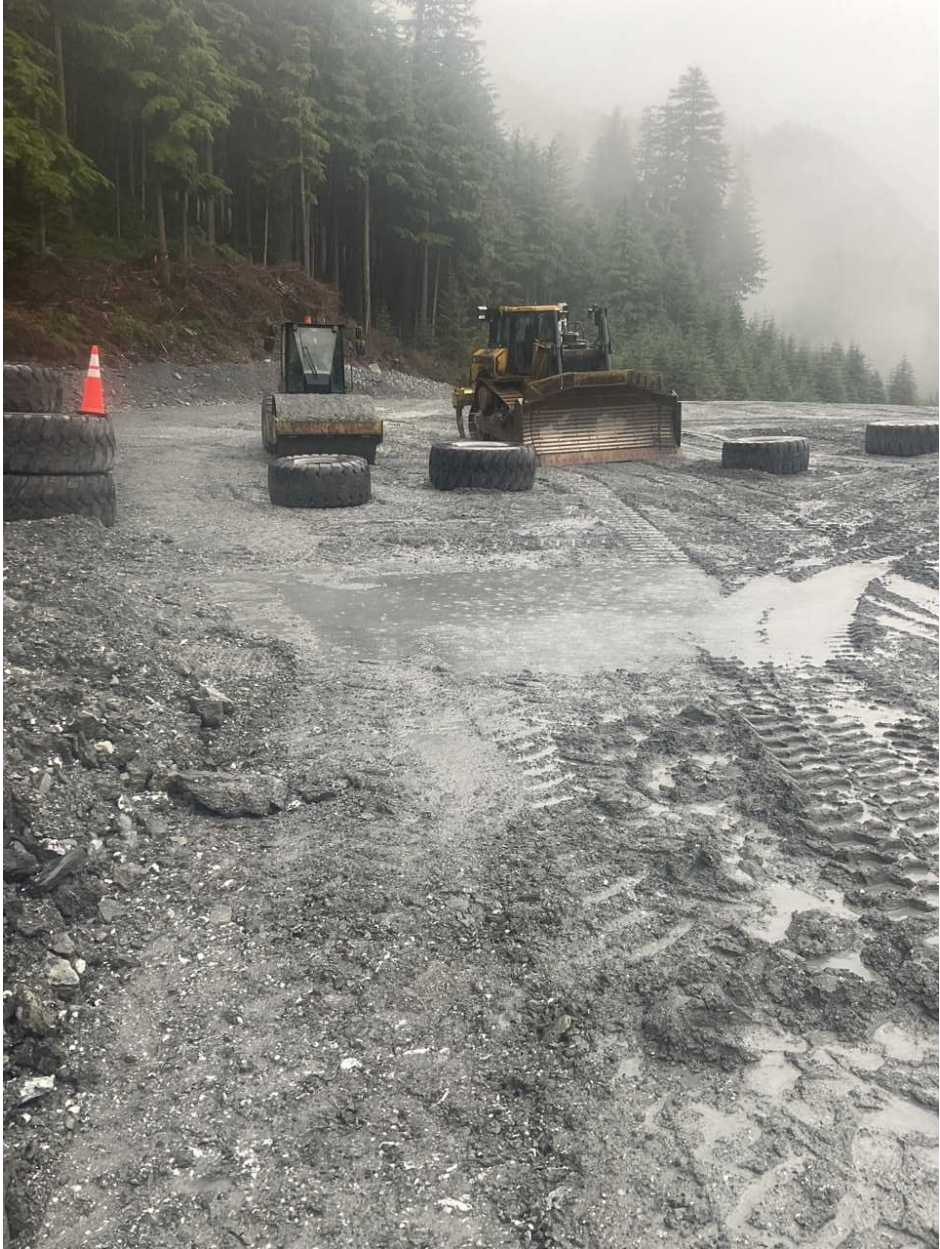
HGCMC constructed an upstream diversion ditch to reduce run-on to Site 23 where the majority of the mine’s waste rock is stored. In addition, waste rock is compacted to reduce infiltration and erosion and improve surface water quality, see Appendix A, **Photograph 2**. A geomembrane lined diversion ditch captures surface runoff at the toe of Site 23 where it is pumped and piped to the water treatment plant.

Photograph 2. Compacted Waste Rock at Site 23

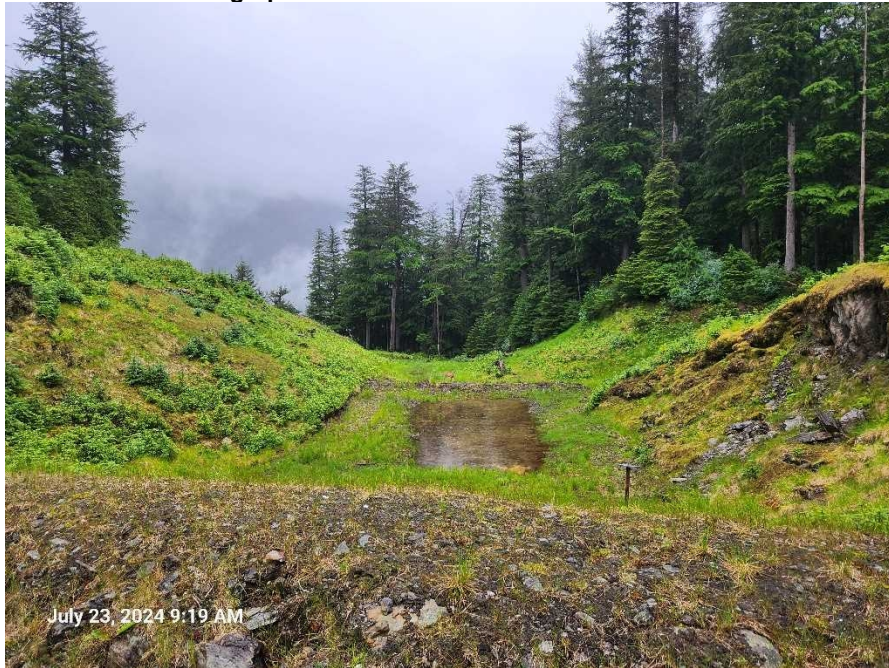
Photograph 3. Reclamation Area at the 1350 Portal

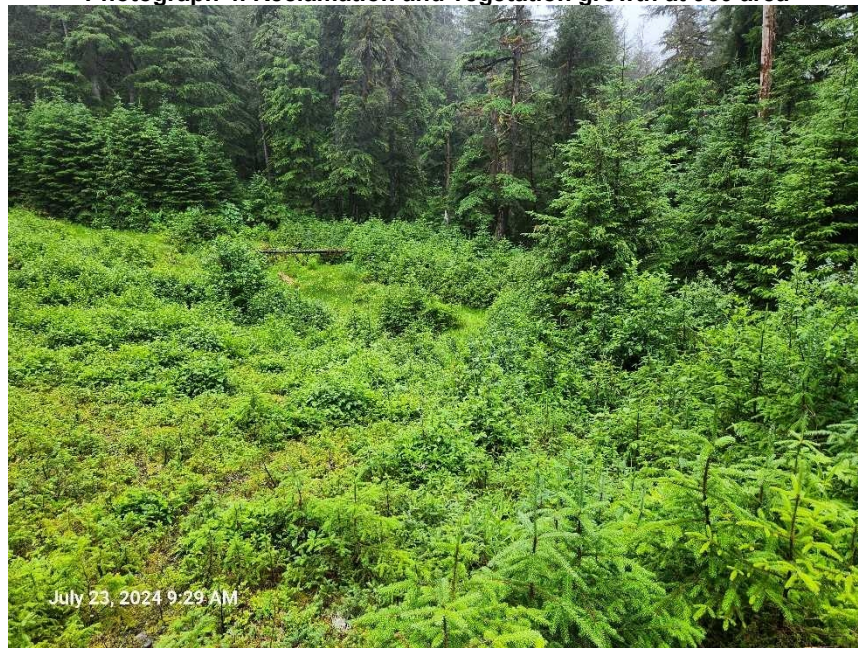
Photograph 4. Reclamation and vegetation growth at 960 area

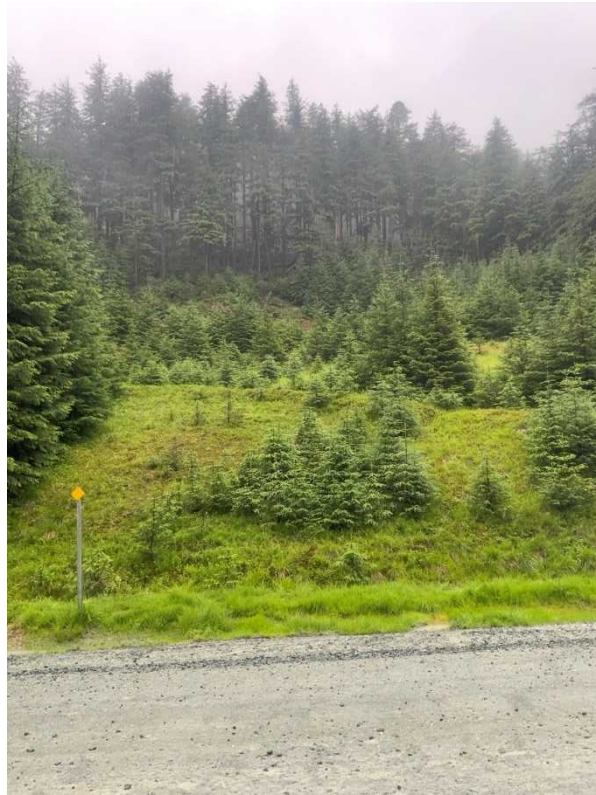
Photograph 5. Vegetation growth at Pit 405

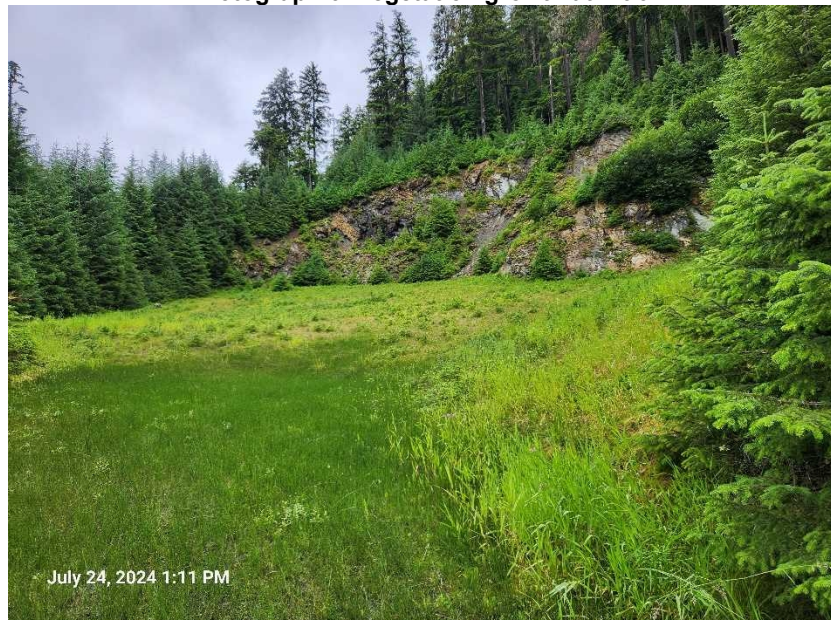
Photograph 6. Vegetation growth at Pit 6.

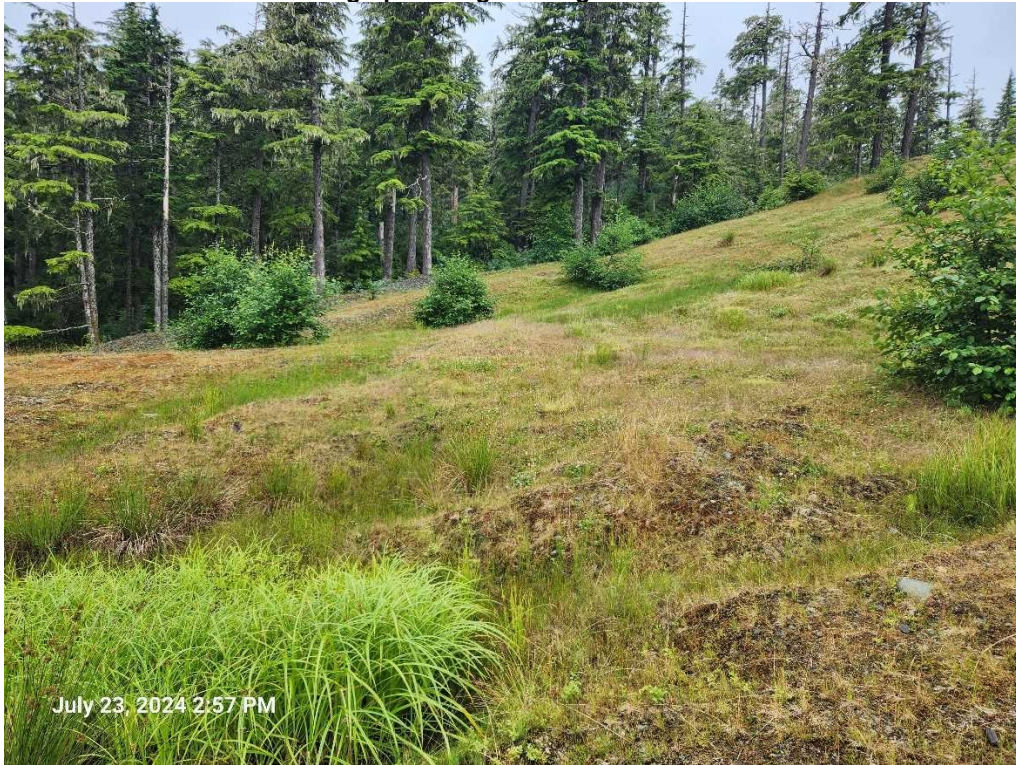
Photograph 7. Vegetation growth at Pit 7.

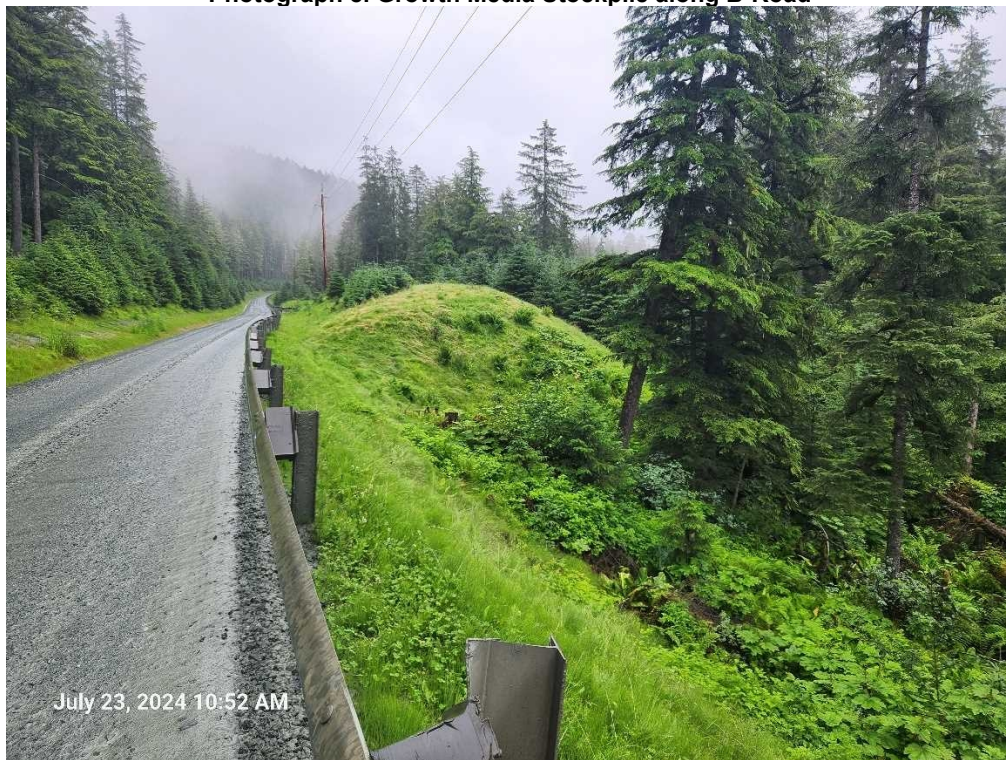
Photograph 8. Growth Media Stockpile along B-Road

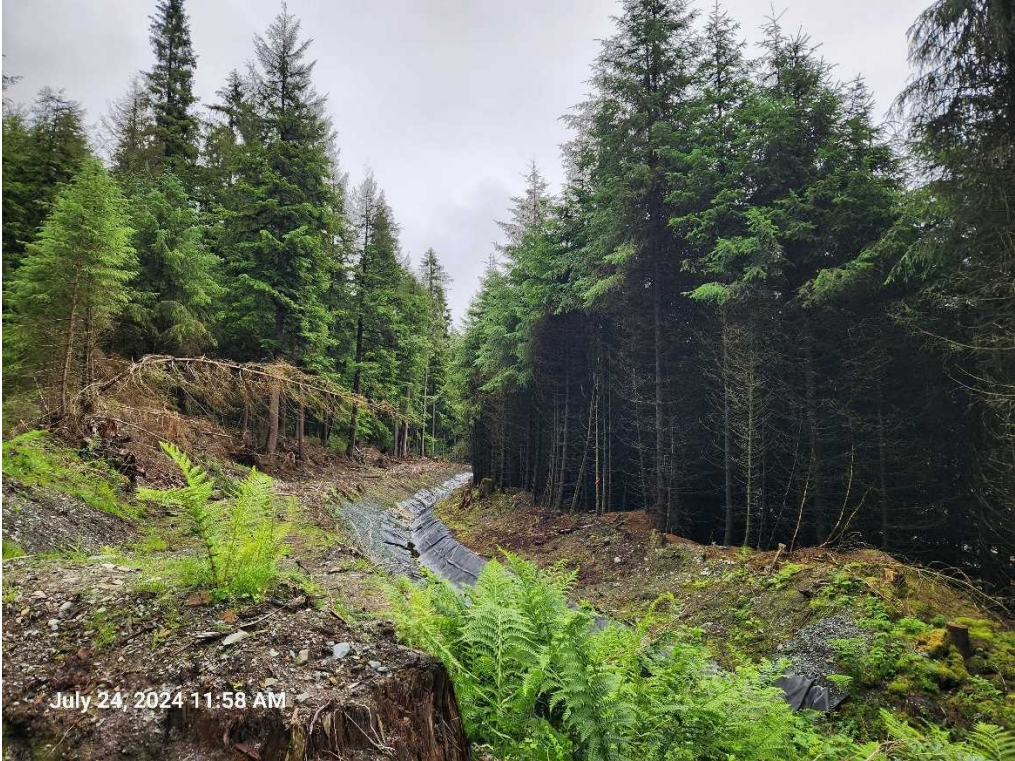
Photograph 9. New Drainage on Mill Backslope

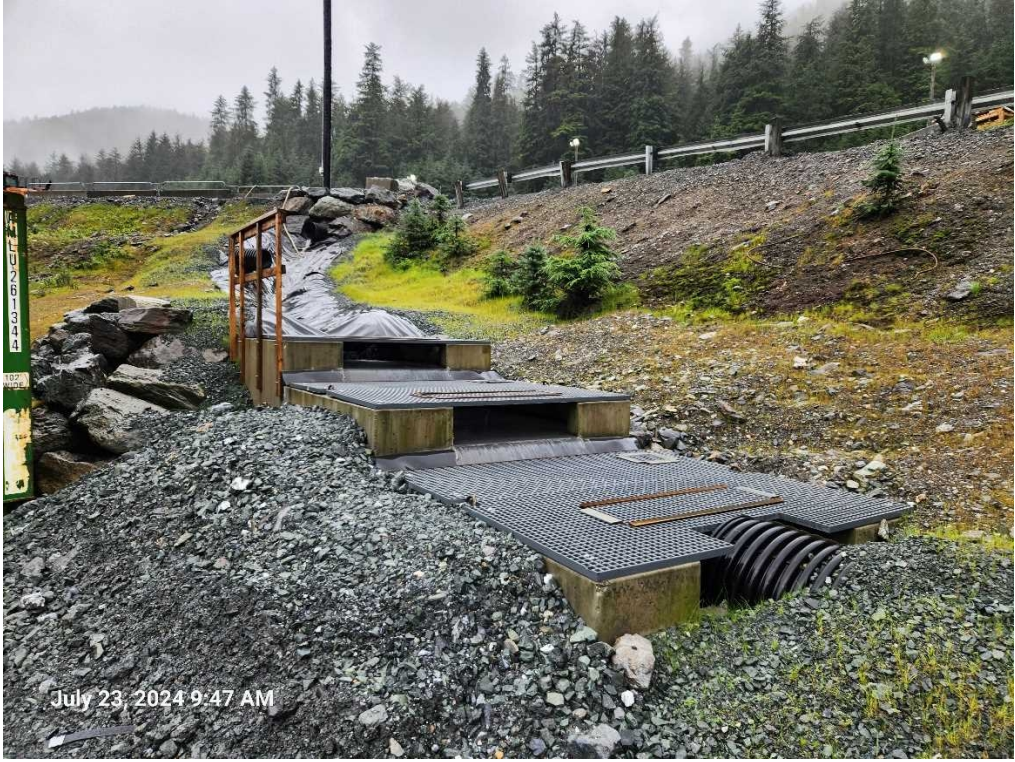
Photograph 10. New Sediment Capture Structure Near Ore Pad
