# **Environmental Audit Of the Greens Creek Mine**

## **FINAL REPORT**

**SRK Project 1UK005.001**

**March 2009**

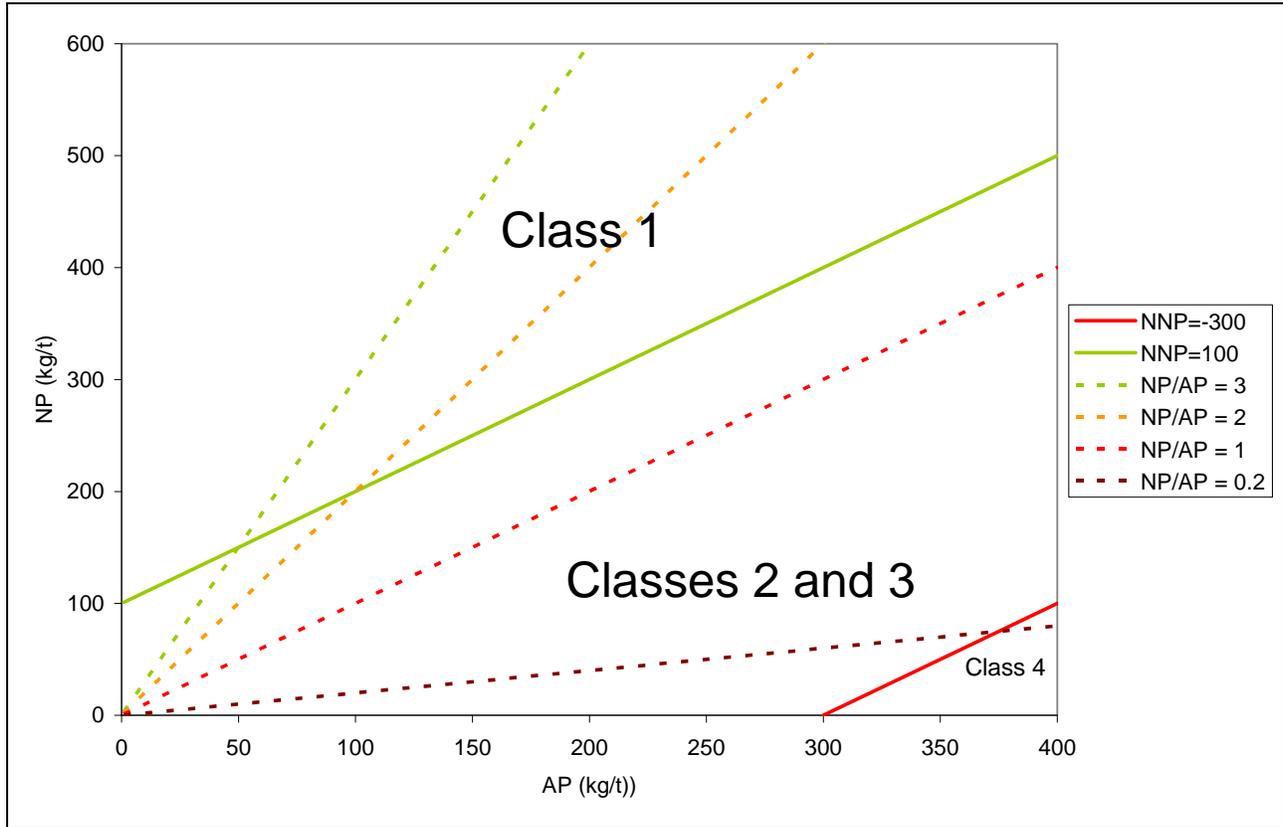
**Figure 3: Production Rock Classification System – Comparison of NNP and NP/AP Criteria**

- Dispatch system – the possibility for classification errors exist. This is mitigated by the visual association of Class 1 with the argillites which are darker than the phyllites. During the audit, the piles were visibly distinctive.

In summary, the classification system has limitations; however these do not fundamentally affect the assessment of the geochemical stability of the production rock dump.

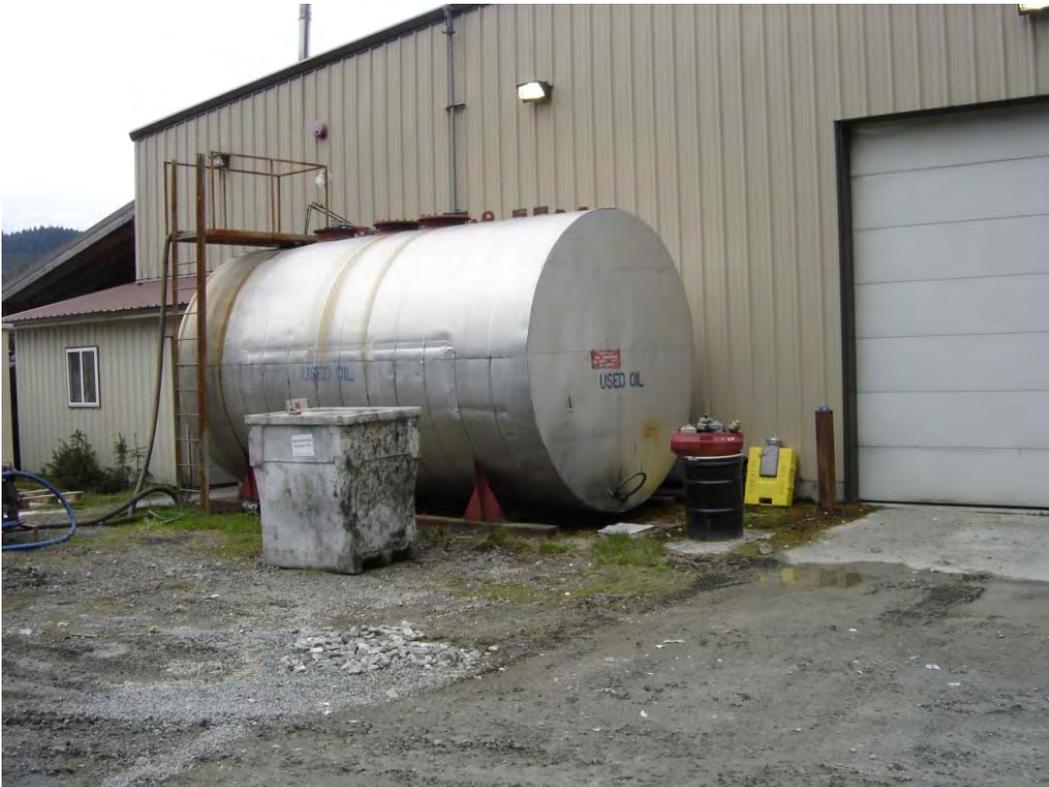
There is a 10,000-gallon tank containing used oil located at the Hawk Inlet Warehouse for which no secondary containment is provided (Photo 2). SRK recommends that HGCMC consider providing secondary containment for this tank.

**Photo 2: Used Oil Tank at Hawk Inlet Warehouse**

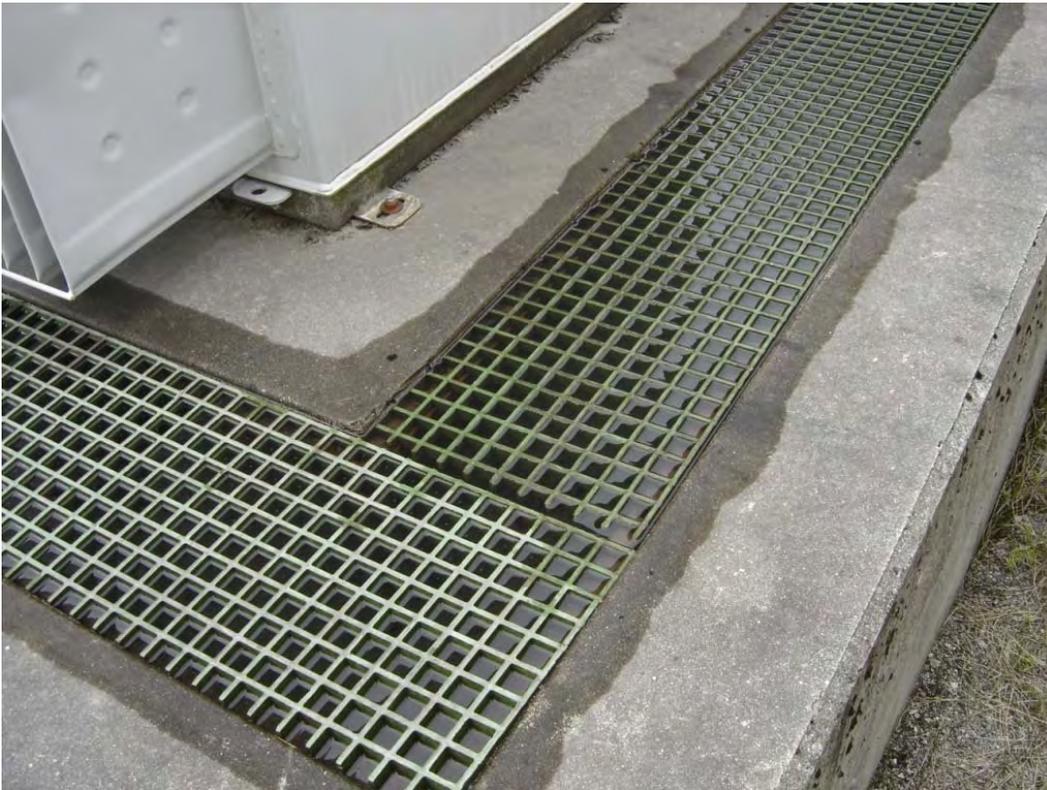
| Level | Finding | Report Section |
|---|--|---|
| 2 | The secondary containment on the transformer located behind the old water treatment plant at the Tailings Disposal Facility was found to be full of water, eliminating the containment capacity. Inspections of secondary containment of transformer areas could not be verified during the audit (Photo 3). | 4.2.10.5 |

**Photo 3: Transformer Secondary Containment**

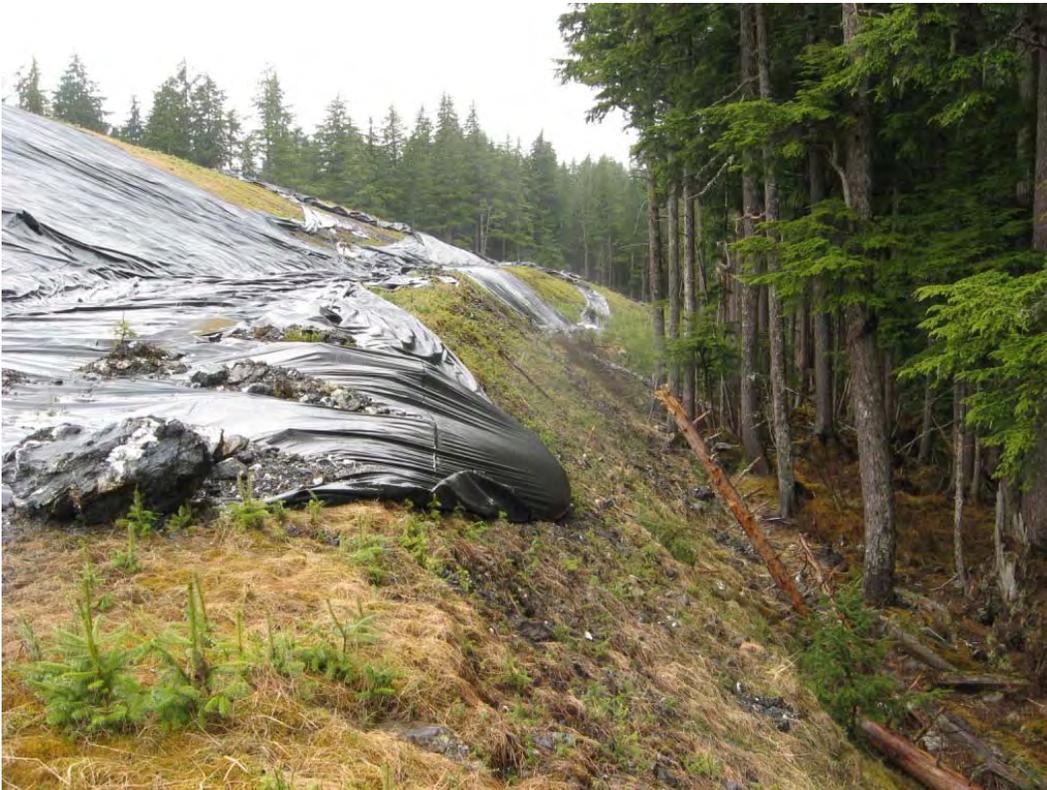
**Photo 14: Part of Site E has been covered by a geomembrane to reduce infiltration in the short term**

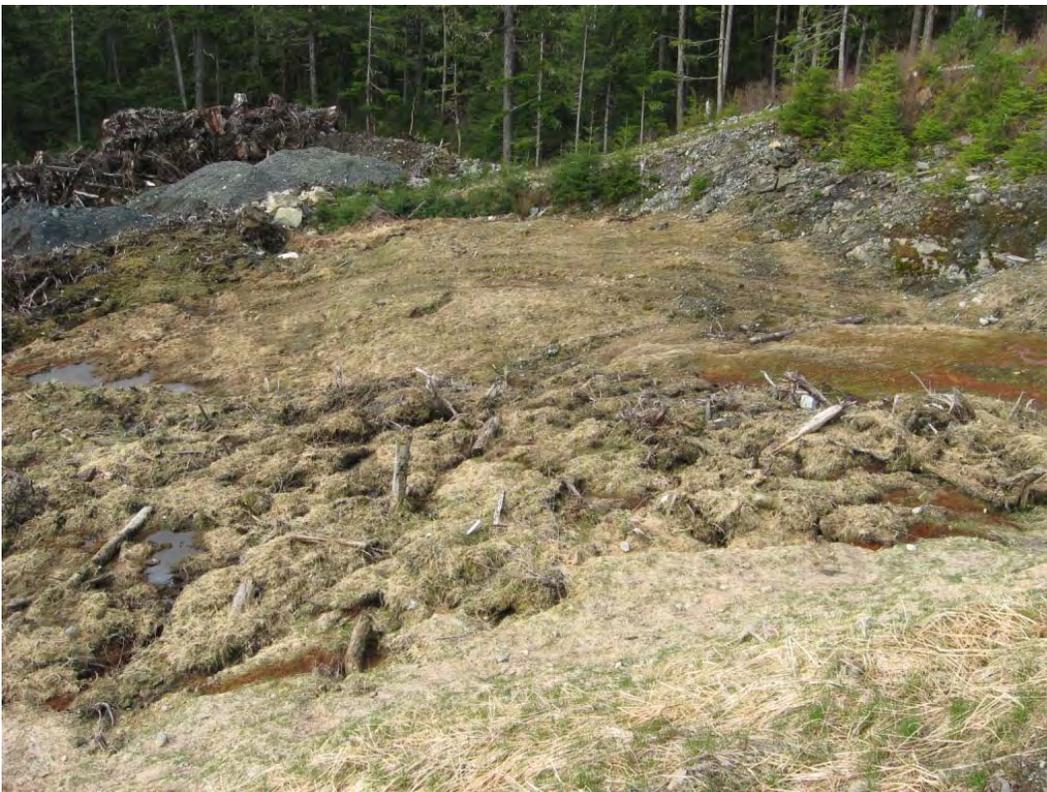
**Photo 22: At Pit 7 looking downslope over the saturated toe of what is primarily overburden hauled from the quarry at 1.5 km on the A road**

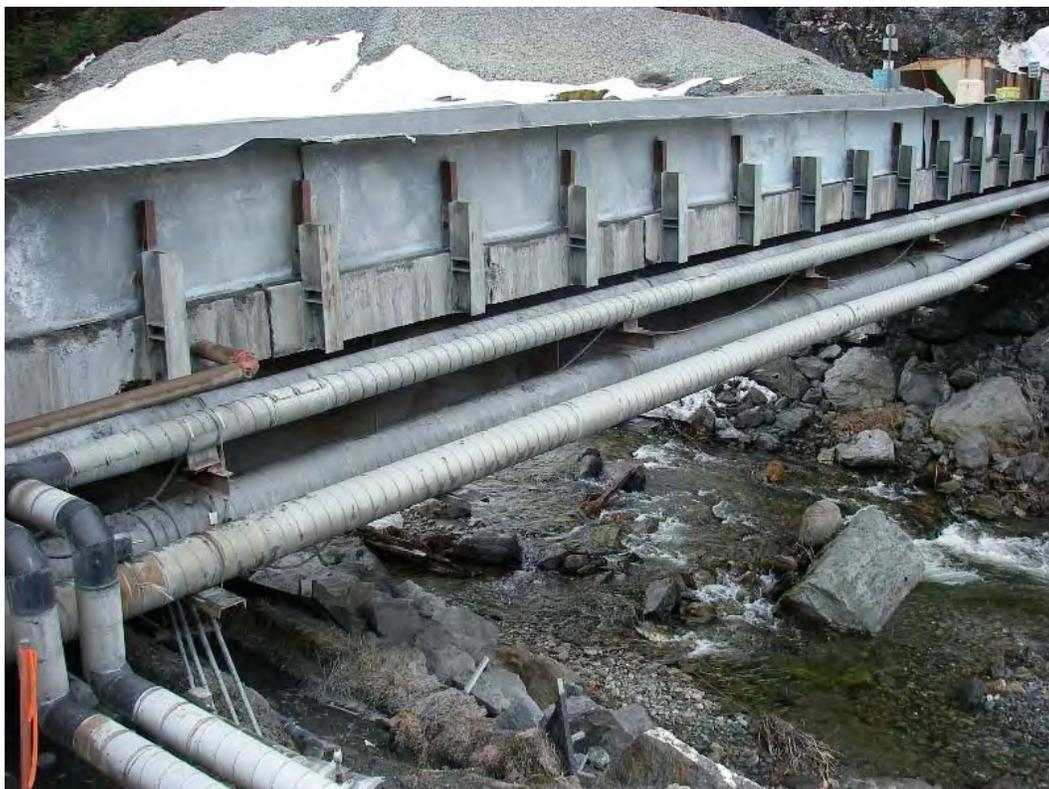
| Level | Finding | Report Section |
|---|--|---|
| 2 | The various pipelines crossing Greens Creek between the underground mine and the mill area do not have appropriate secondary containment to contain material and prevent it from entering the creek in the event of a rupture or other type of failure (Photo 28). | 4.2.10.5 |

**Photo 28: Pipelines attached to the bridge that crosses Greens Creek at the 920 Area**
