FIELD INSPECTION REPORT HECLA GREENS CREEK MINING COMPANY

Inspection Date: October 9, 2012, 5:00 AM – 2:00 PM

Report Date: October 17, 2012

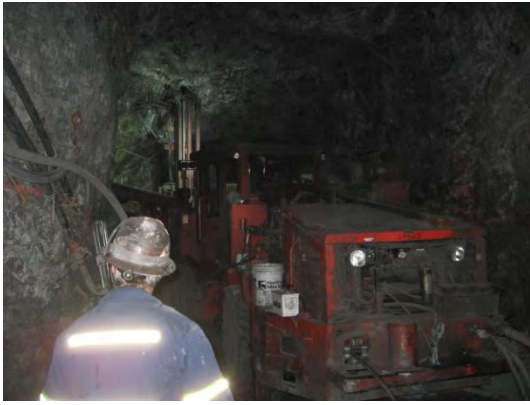
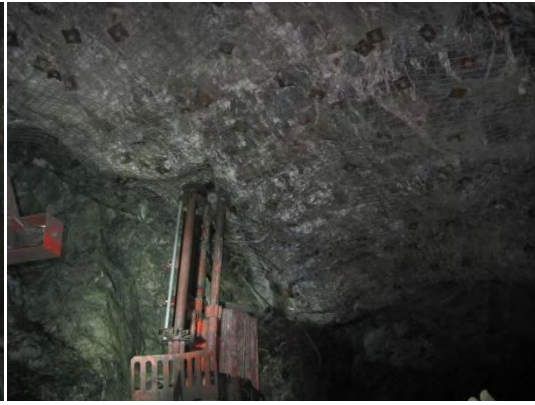
Rock bolting safety mesh.

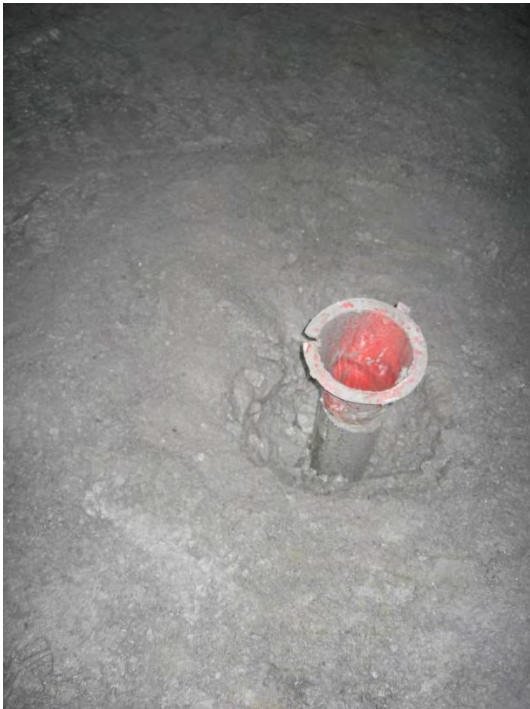
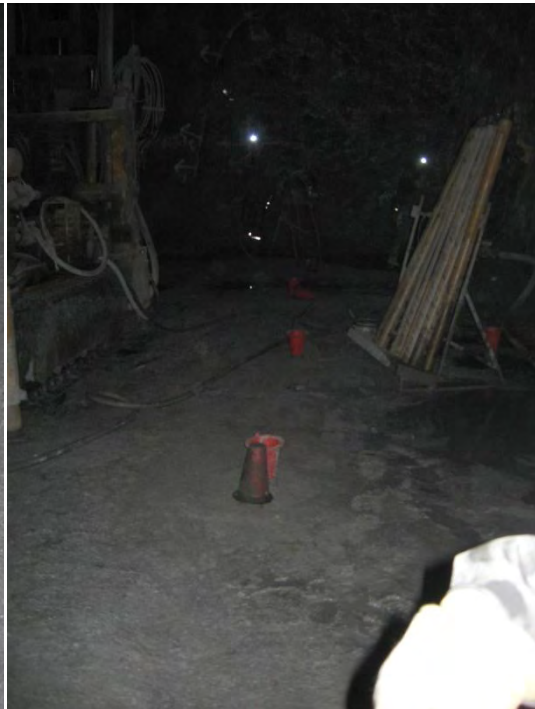
4" diameter holes in the ore body/stope filled with explosive.

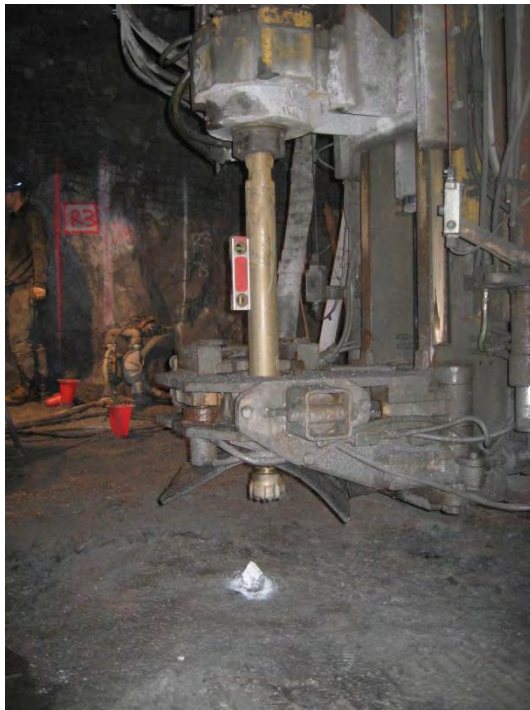
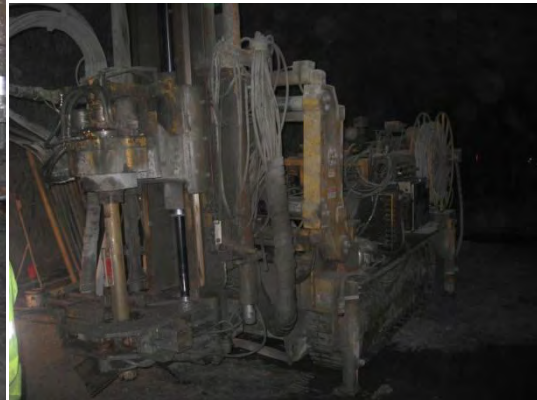
Drill and drill rig for 4" diameter downholes in the stope.

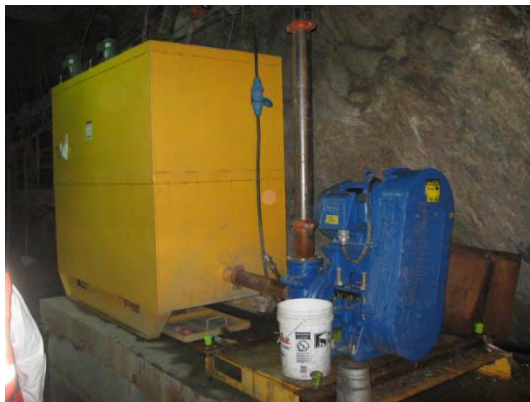
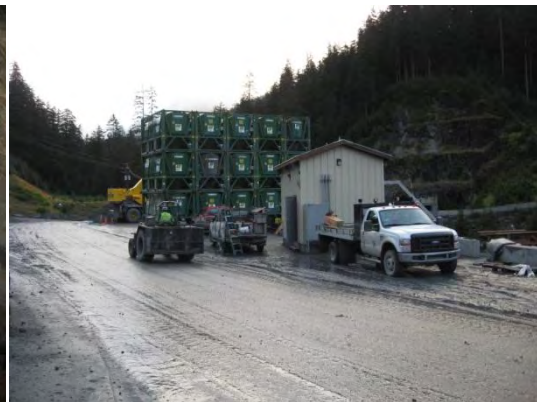
The tour comprised visits to active drilling and open stopes to show the drill patterns and rock bolting, and how stopes are backfilled with paste, comprised of tailings and cement, in order to mine out the ore next to the filled stope. Two sumps were also inspected, the 45 sump, which is comprised of four large compartments, and the sump near the portal. A change is being made such that drain water will be pumped, with sediment, up to a sediment separation unit at the surface near the mill. The excess water is directed to A pond the solids to the tailings thickener, after which they are pressed and sent to tailings. This change in operation will result in less frequent cleaning of the underground sumps. The mine workings presently go down to elevation -450ft and up to elevation 1350ft.

Mine drainage tank and drainage/sediment pump; surface degritting chamber.

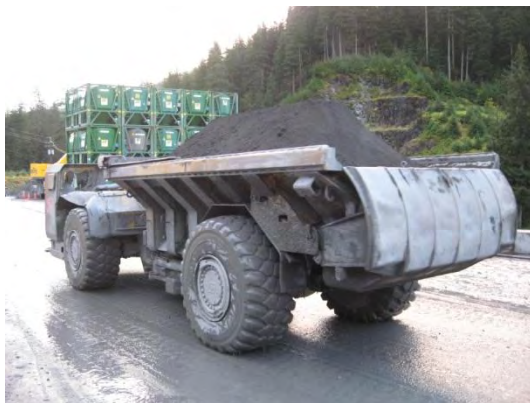
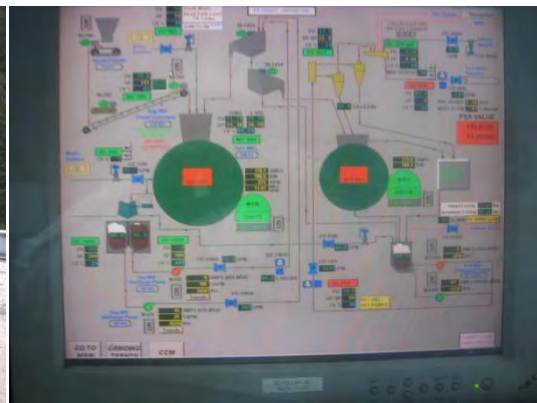
Tailings being transported underground for incorporation into paste tails backfill.

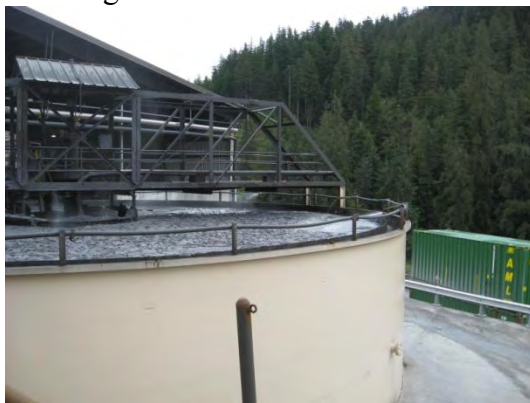
Thickener tank

After going through the mill, the tour was to Site 1350, Site 23, Site D, Site E and tailings. At the mill retention of the contents of the largest thickener tank outside the mill was discussed. The road outside the mill has been concreted and a short wall constructed on the Greens Creek side of the road. It is possible that the wall will be extended a little further towards Site 23. It is thought that the contents of the tank would then be captured in this area; flow from the road is to pond A via a storm drain, so there would be no discharge to Greens Creek.

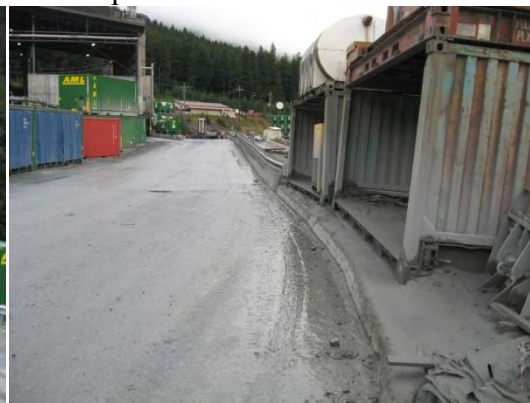
Road / containment for thickener tank spill

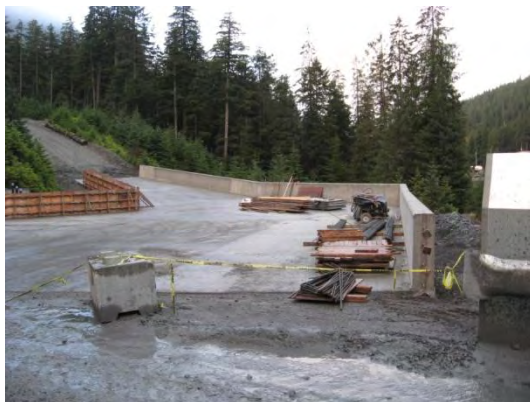
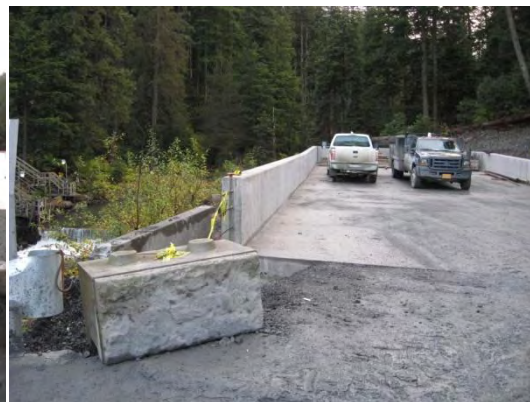
New concrete pads and retaining walls were nearing completion outside the 920 mine entrance. This will allow the storage of materials without the risk of the materials entering Greens Creek. New high wall panels had been installed on the bridge over Greens Creek. These high wall panels prevent material that has been picked up by the large wheels of the haul trucks from going into Greens Creek.

Concrete pads and walls to each side of the 920 mine entrance.

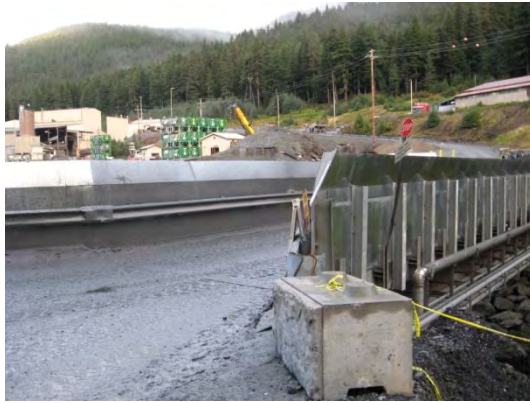
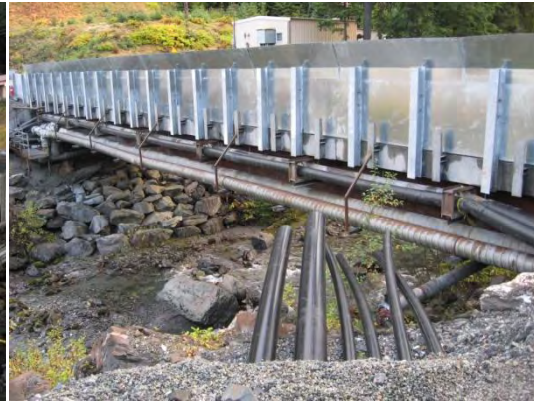
High splash walls on the bridge over Greens Creek outside the 920 portal.

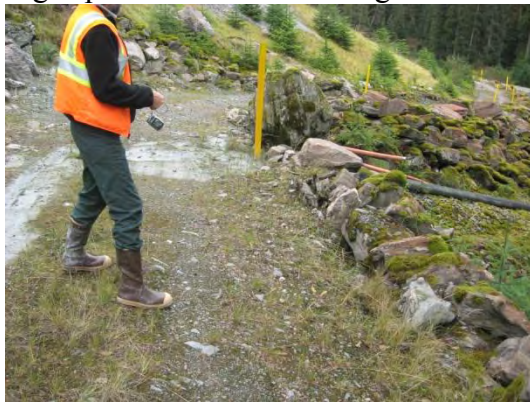
At the downhill end of Site D road drainage was seen to run from the B road and down an embankment to Greens Creek. Since there could be pollutants associated with this drainage, and since there is a new sampling point to be established in or near the area where this drainage enters Greens Creek, it was thought best to redirect this road drainage flow to Pond D such that it could be sent for treatment at the tailings treatment plant. At site E the generator for the pump at the storm water sump at the entrance to the site had been shut down. Operation of the generator at site E is dependent upon the precipitation and is only started as needed. Usually by October 1st the pump at site E is shut down for the season, because of soon to be freezing conditions at the site and they do not use the pump in the winter during freezing conditions. A water sample from the sump (site number 1055) had been taken on 19 September 2012.

Road drainage adjacent to Site D

1. Re-direct the road runoff water and sediments from the downhill end of Site D to Pond D. [Note – task completed: The auxiliary entrance road to D-pile was reshaped to redirect the water to Pond D on 15 October 2012.]

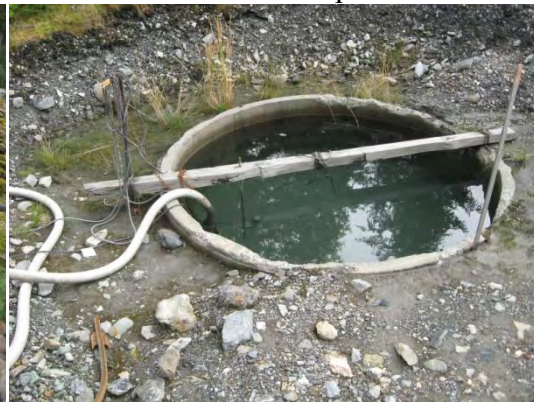
Sump at Site E

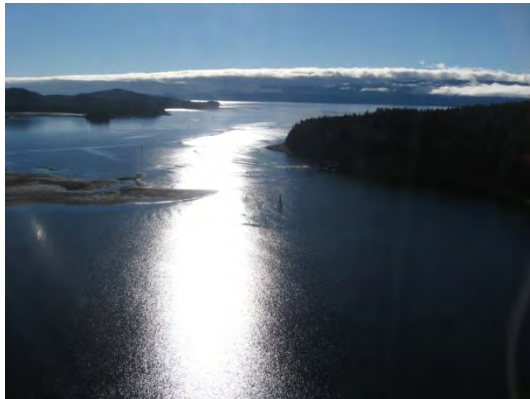
Location of outfall diffuser (in narrow channel).
