**INACTIVE PRODUCTION ROCK SITES AND QUARRIES  
2010 ANNUAL REPORT**

**Hecla Greens Creek Mining Company**

**April 15, 2011**

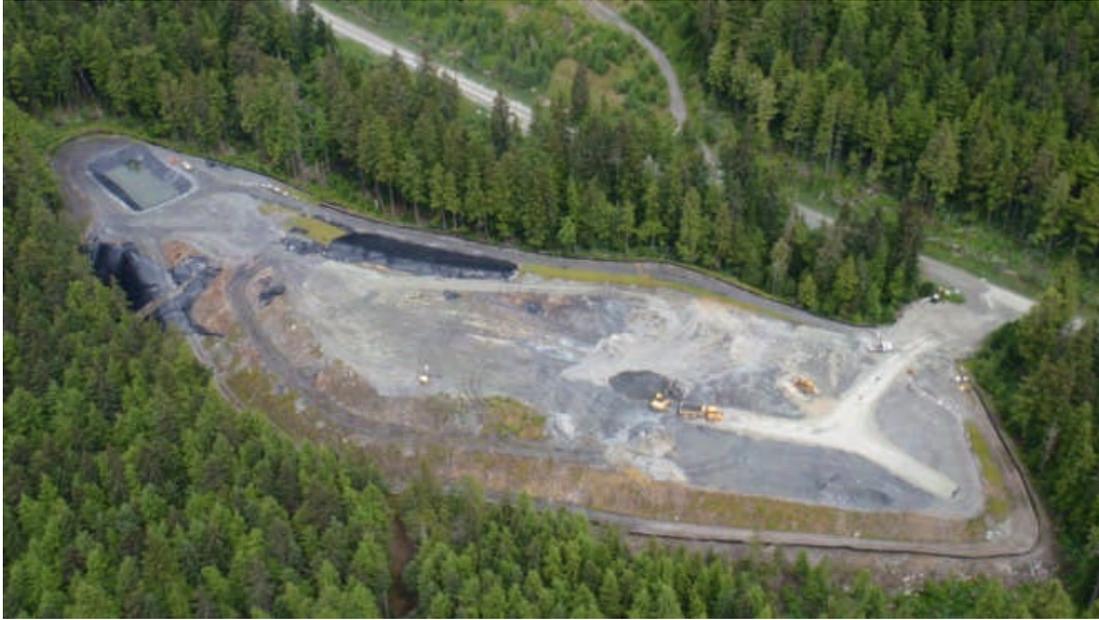
Figure 2.4 Site E Removal July 2010

A total of 7,100 cubic yards of waste rock from Site E was hauled to the Tailings Facility to create a stabilizing berm in the Southeast II area in 2006. No material was removed from the site in 2008. A portion (1 acre) of the Site E pile was covered in the fall of 2006, and this cover was extended in October 2007. Even though the waste rock storage site had an existing layer of vegetation covering most of its surface, there appeared to be additional benefits to placing a synthetic cover on it, including reduction of the moisture content of the waste rock (to improve handling and codisposal properties for the pending removal activities in 2009) and reduction of the amount of seepage from the pile. However, the liner proved extremely difficult to maintain: the presence of small spruce trees, uneven ground, and high winds compromised the effectiveness of the cover, and led to its poor condition noted during an EPA inspection in June 2009. An additional issue with a liner is oxidation processes: while covers can limit the flushing of oxidation products, they do not stop oxidation from occurring. Oxidation processes result in evaporative salts that can build up underneath a liner. When a liner is removed and the material is exposed to runoff, these salts can increase the dissolved load of runoff waters, at least initially. Due to these two difficulties and concerns with the liner, its use as a BMP at Site E was discontinued at the end of 2009.

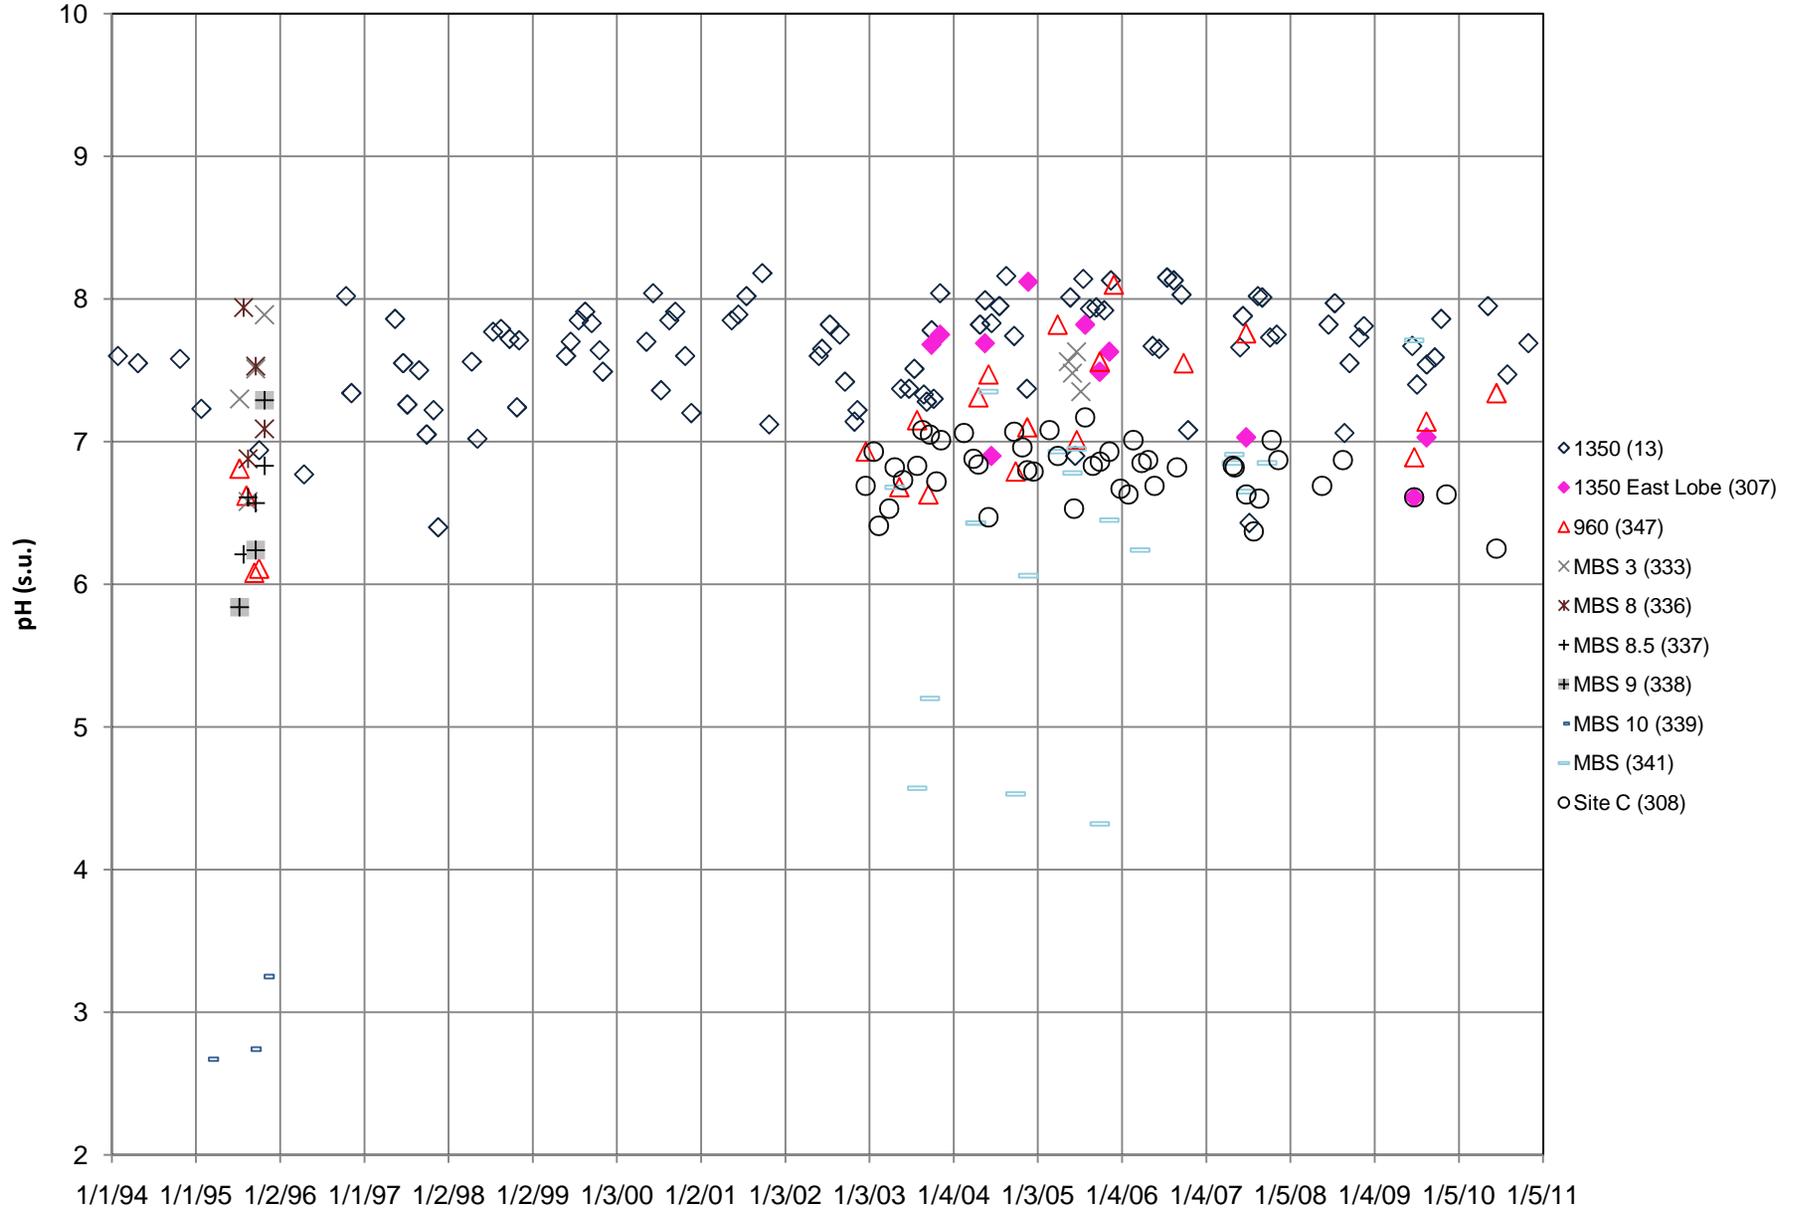
Figure 2.6 Inactive Production Rock Site pH Data

Figures 2.6 and 2.21 show pH data from inactive site sampling locations. Lower pH values can represent influences from pyrite oxidation and/or organic acids from muskeg and forest soils. The data show that the vast majority of the site drainage remains above pH 6.0. The sample from the Mill Backslope in 1995 was runoff collected from a bench containing zones of heavily pyritized rock. For a brief period in 1998 and 1999, acidic conditions began developing at the 960 (site 347). HGCMC applied lime and removed 1000 cubic yards of oxidized pyritic rock from the site in 2000. The pH of the drainage quickly rebounded and has remained near-neutral since 2000. Removal of additional Site 960 material in 2003, 2004 and 2005 is discussed below in Section 2.3. The material removal activities may also be responsible for the pH of 8.0 measured at the 960 site in 2005. This is the highest recorded for this site. The reason for the elevated pH is likely due to the removal of pyritic rock that had consumed much of its readily available buffering capacity. Fresh carbonate mineral surfaces exposed during the excavation and the placement of the toe buttress may have contributed to the higher pH values observed. Alkalinity data presented in Figures 2.7 and 2.22 are consistent with the pH results in Figures 2.6 and 2.21. Sample locations continued to maintain measurable alkalinity provided by dissolution of carbonate minerals.

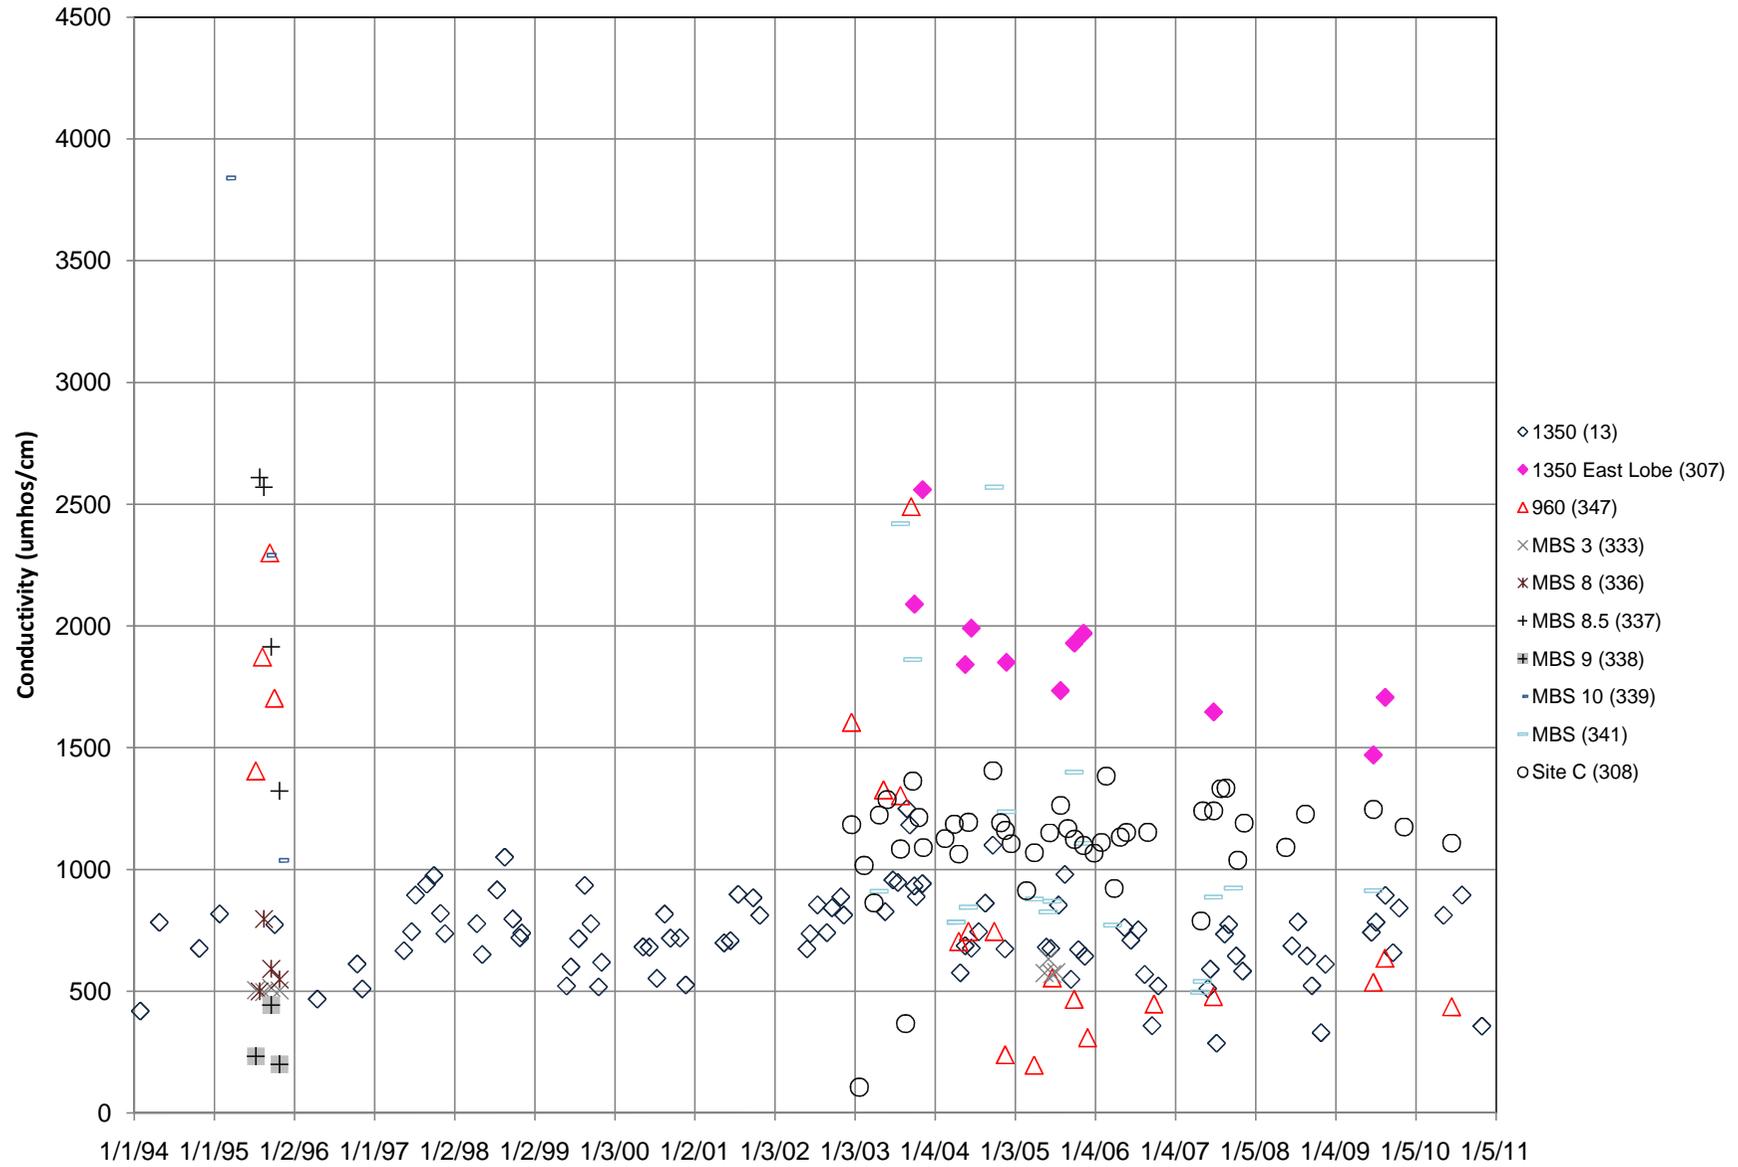
Figure 2.8 Inactive Production Rock Site Conductivity Data

Conductivity data are shown in Figures 2.8 and 2.23. Conductivity indicates the amount of dissolved constituents in the water. HGCMC samples having higher conductivity values usually have higher sulfate, calcium and magnesium (hardness) concentrations, reflecting influences from sulfide oxidation and carbonate mineral dissolution. Water that has contacted production rock is expected to have higher conductivity values than background waters. The 960 (Site 347) shows an overall decreasing trend in conductivity, while the Site 1350 data remains unchanged. The combined drainage from the Mill Backslope area (Site 341) continued to have a lower dissolved load relative to 2003 and 2004 values. The decreasing trends apparent in Figures 2.8 and 2.23 are

the result of decreasing reactive surface area available for oxidation and dissolution. The reactive surface area decreases as reactants are consumed and mineral surfaces become coated with oxidation products. The results for sulfate, magnesium and hardness, shown in Figures 2.9 and 2.24, 2.10 and 2.25, and 2.11 and 2.26, respectively, correlate with conductivity results and are consistent with the concept of generally decreasing or static reactive surface area.

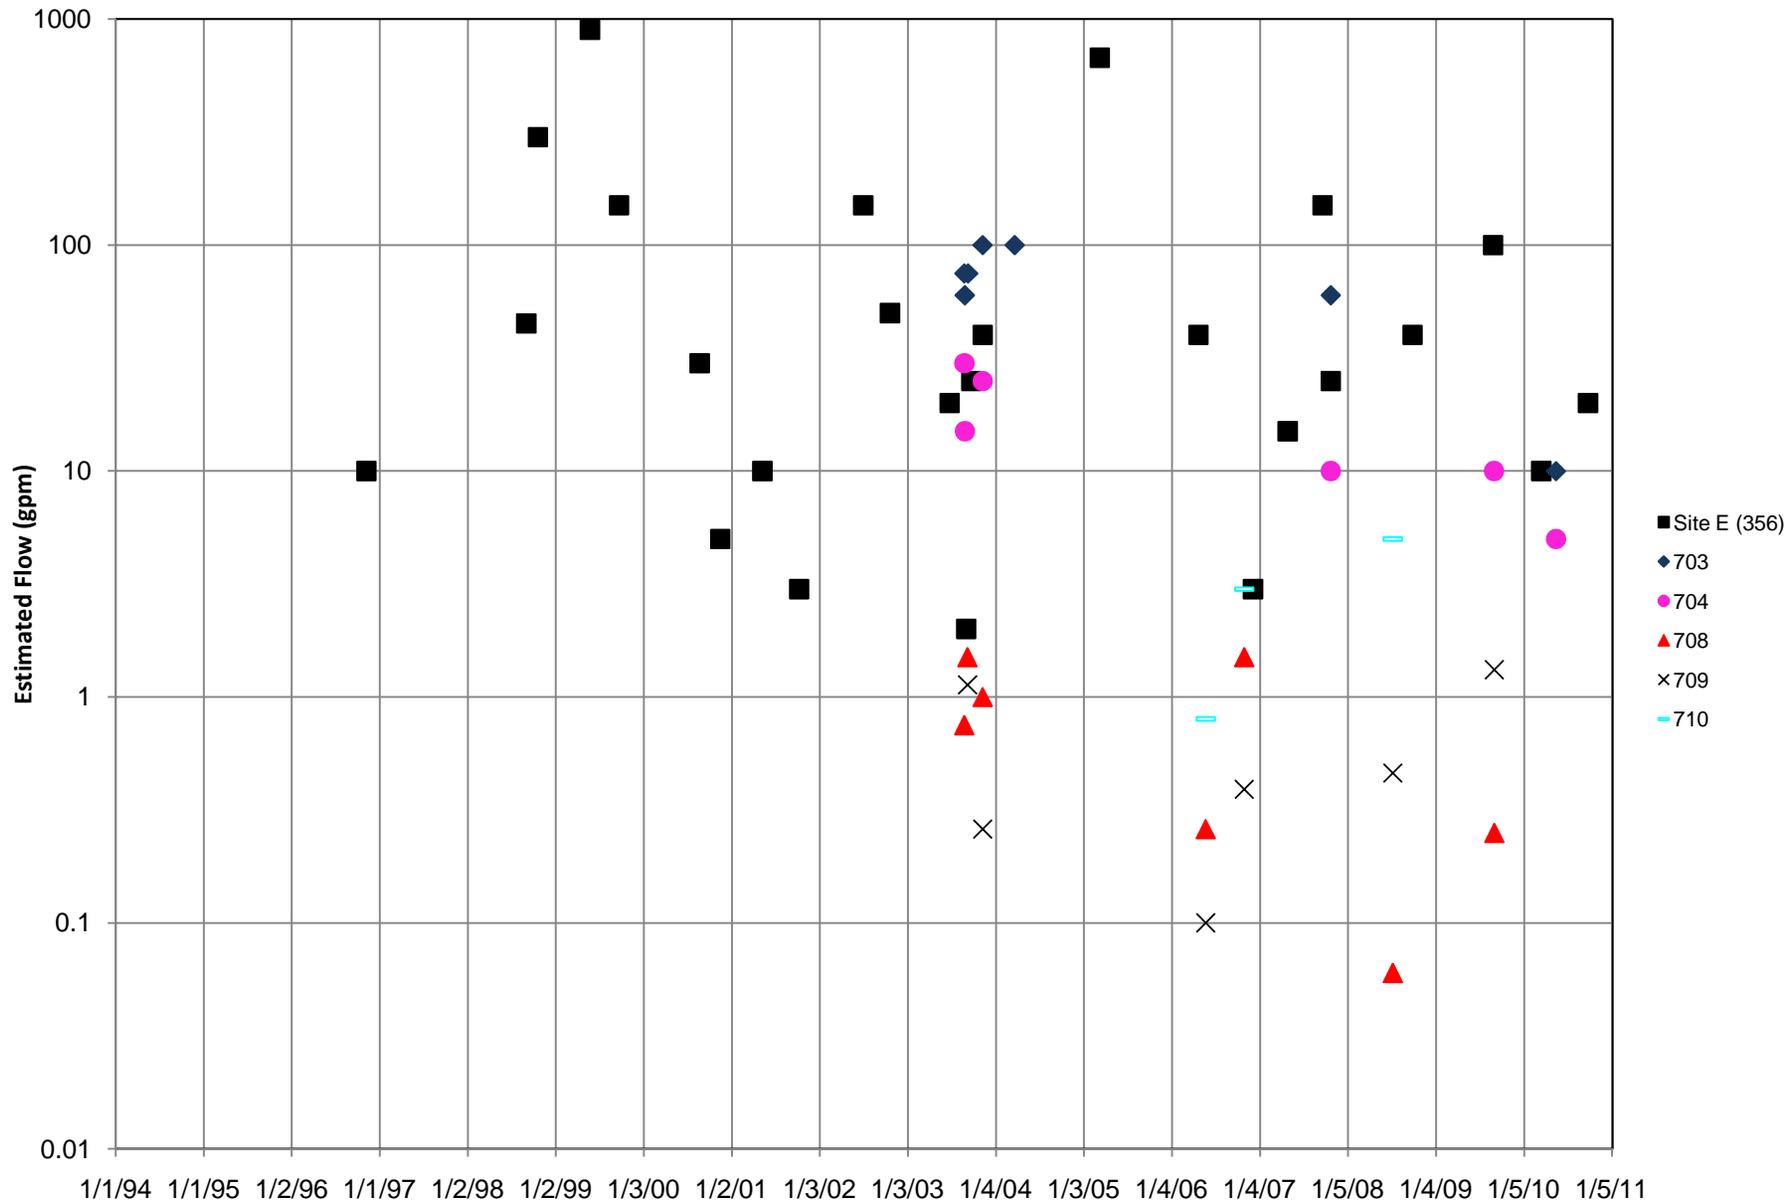
Figure 2.20 Inactive Production Rock Site E Flow Data

Flow data presented in Figures 2.5 and 2.20 demonstrate that flows at most of the sample locations are generally low (less than 10 gpm) with the exception of Site E. Some of the flow data were collected as part of the NPDES stormwater monitoring program. Collected during or following storm events, flow data from these locations (e.g. Site E 356, 960 347) represent short-term maximum flow values in response to relatively large precipitation events. Lack of significant flow from inactive sites is a positive characteristic because it reflects minimization of potential off-site impacts.

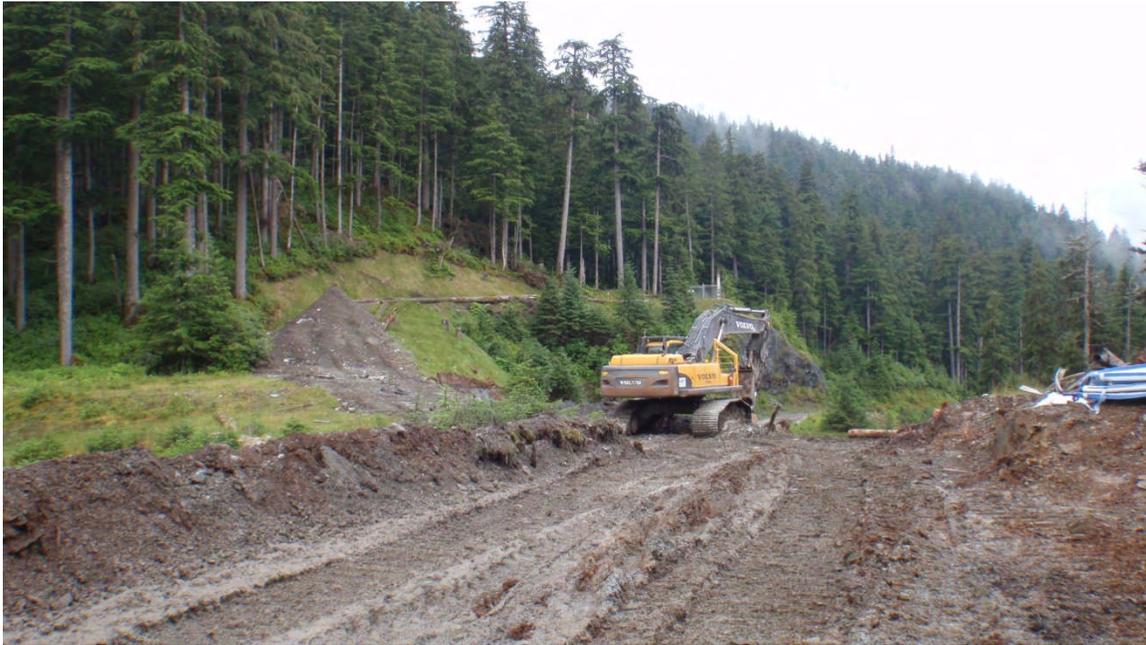
Figure 2.35 1350 Removal August 2010

Steep slopes precluded constructing an oxygen-limiting soil cover on the site in its current configuration. Consequently, removing the rock is the planned reclamation strategy for this site. To date approximately 19,957 cubic yards (cy) have been removed from the 1350. In 2005, 4,120 cy of material was removed, and a portion of that material was returned to the underground as backfill while the remainder was placed into Site 23. The material placed in Site 23 was weakly oxidized and contained low pyrite and abundant carbonate. Inclement weather and lack of backfill capacity underground prevented haulage of additional waste rock from the 1350 in 2006. In September 2007, 2,560 cy of material was removed from the 1350 and hauled underground. In 2008 approximately 4,220 cy were removed and placed in the new Site 23 interim storage facility. In 2010 approximately 9,057 cy were removed and placed in the Site 23 interim storage facility (Figure 2.35).

An area of hydrocarbon contaminated soil was encountered during 2010 removal activities. This contamination was believed to be associated with the 1978 camp fuel tank spill. An estimated 20 to 30 cy of soil was excavated (to bedrock) and disposed of offsite.

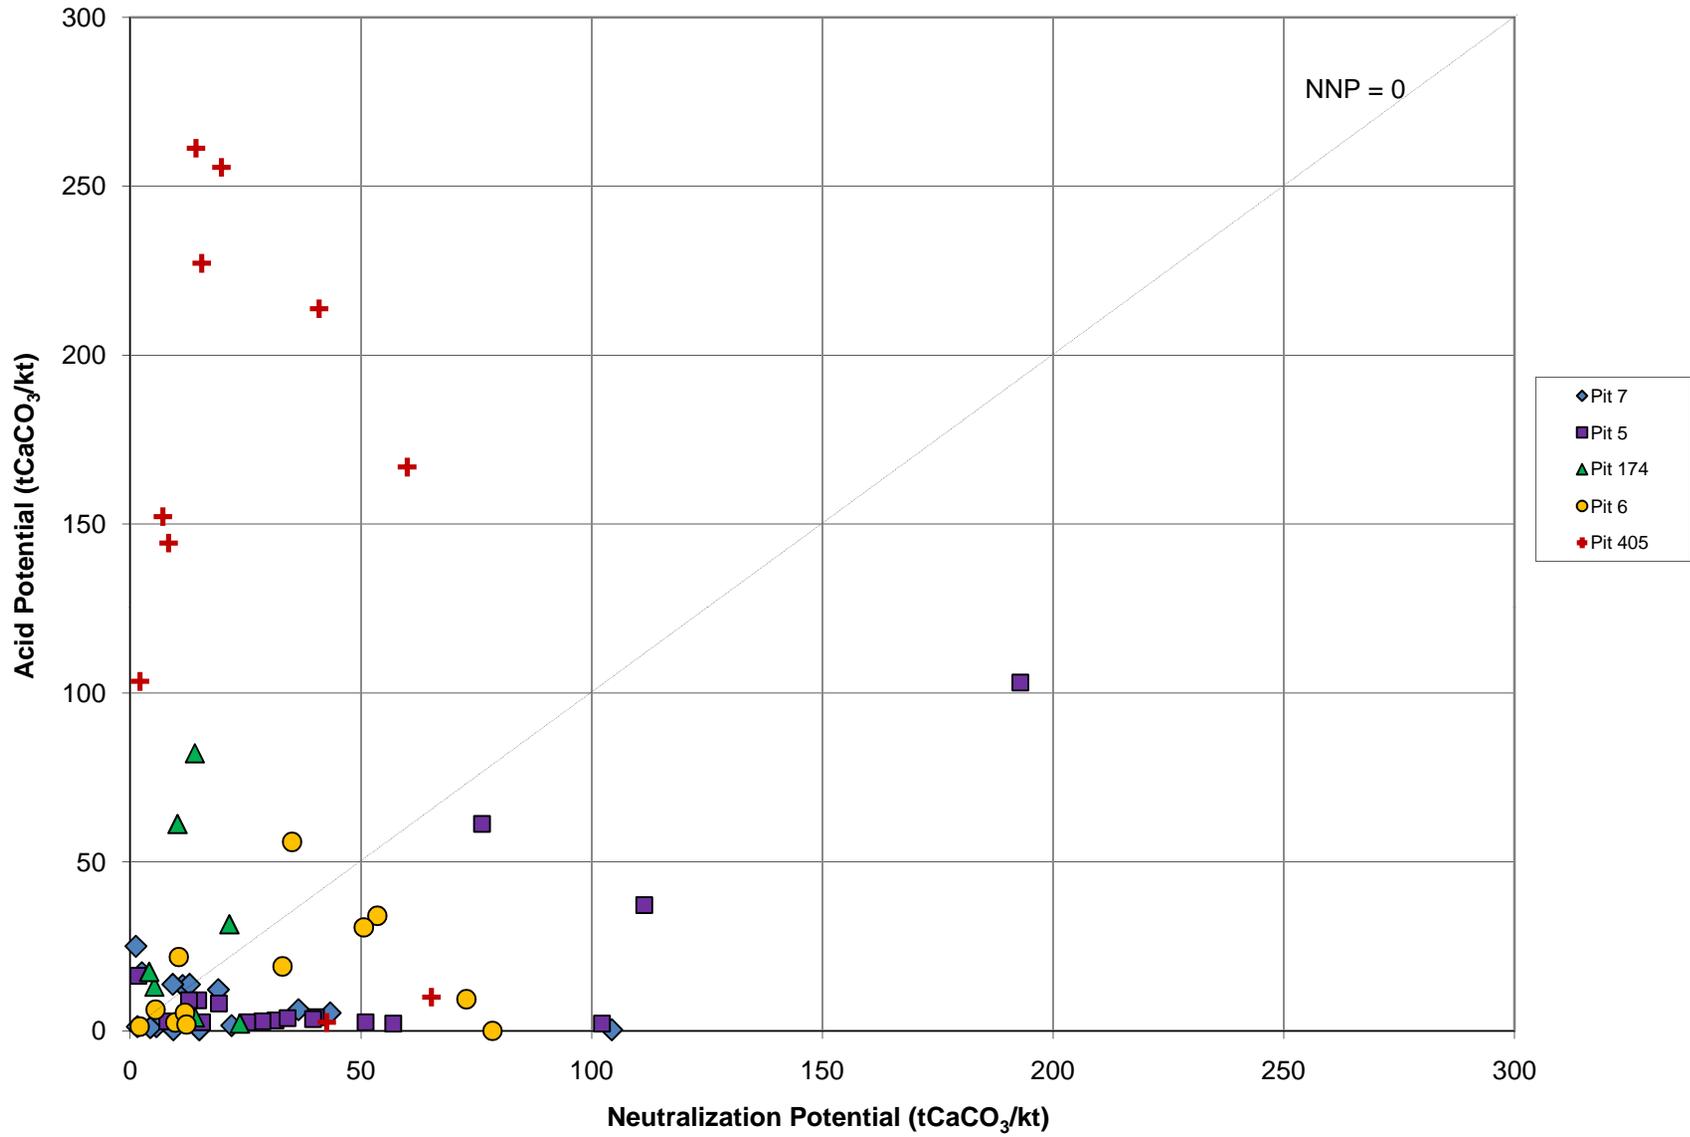
FIGURE 3.16a 2002-2008 QUARRY SITE ABA DATA

Acid Base Accounting data collected from 2002 to 2008 are summarized in Figures 3.16a and 3.16b. Pit 405 and Pit 174 have significant exposures of potentially acid generating rock and produced several samples with acidic rinse pH. Pit 6 and Pit 7 produced samples showing a broad distribution of NNP and rinse pH, and Pit 5 generally produced acid neutralizing samples with alkaline rinse pH. Buildup of oxidation products (salts) on overhanging quarry walls was noted at each of the five quarry sites and may have contributed to the lower rinse pH readings for several samples.
