MEMORANDUM

State of Alaska

SUBJECT: Kennecott Greens Creek Site
Visit
April 14, 2005

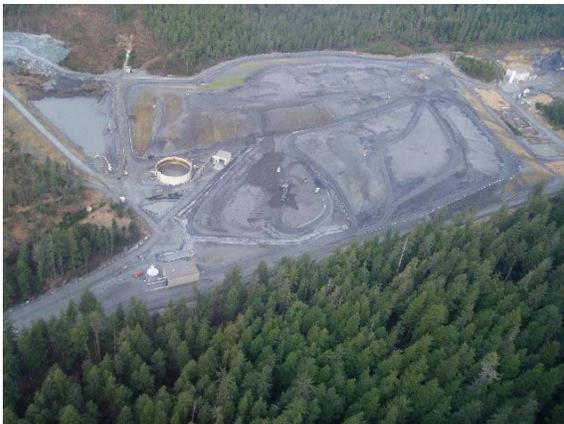
Tailings Disposal Site (looking west)

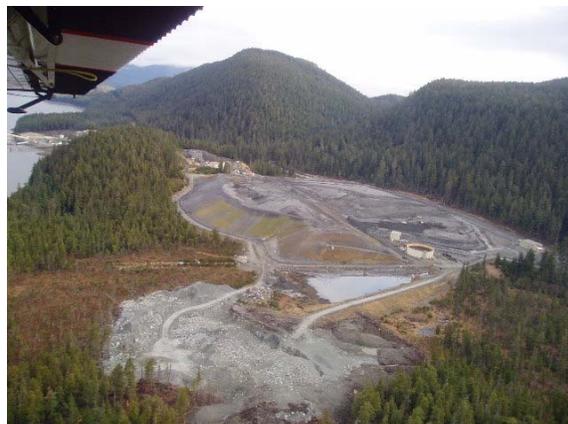
Tailings Disposal Site (looking northeast)

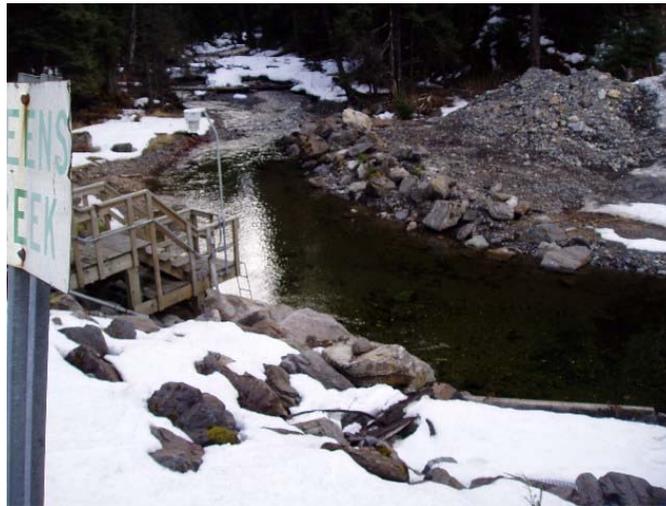
At 10:21am we stopped at the upper Greens Creek water intake located just above the bridge to the mine portal (approximately 920 feet above sea level). Approximately 700 gallons of water per minute is taken from this intake. Most of this water is used at the mill.

Upper Greens Creek Water Intake

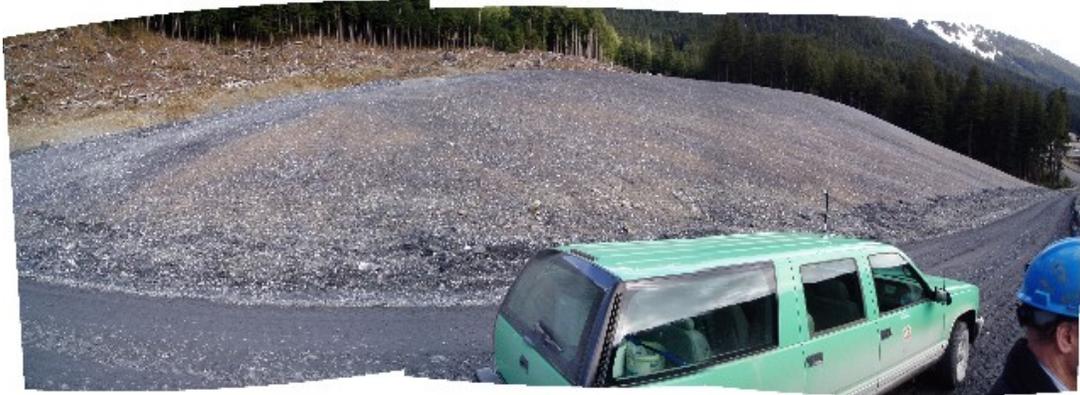
Site 23

At 11:10 we arrived at Waste Rock Site 23. We observed that both Class II and Class III waste rock was mixed at the site and placed against the colluvium at the back surfaces of the landfill. Class I material was placed at the outward/exposed slopes in order to provide both armoring and neutralizing capacity. Patty McGrath was shown the 2-acre test section of the Engineered cover system.

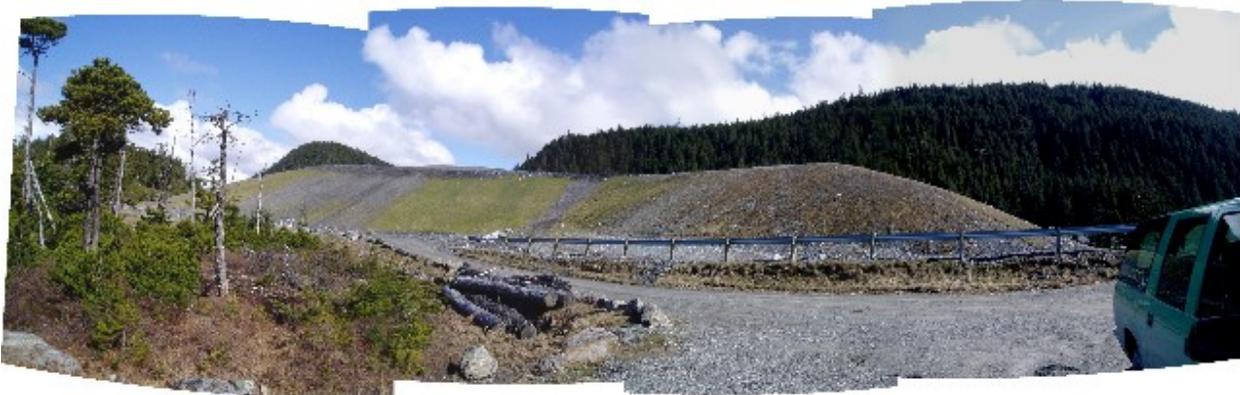
At 11:50am we arrived at the tailings facility where the NPDES outfall and monitoring station and sulfate reduction monitoring program was observed. The B-road had been relocated and a new truck wash building was completed according to the 2005 tailings expansion work plan. Tank 6 has been taken out of commission and all water diverted to Pond 6 prior to being treated and discharged via the NPDES outfall. Pond 7 was being excavated and there had been no work accomplished on the Southeast expansion. Both Pond 7 and Southeast expansion are scheduled for completion later this summer.

Tailings Disposal Site from Southwest at NPDES Monitoring Station

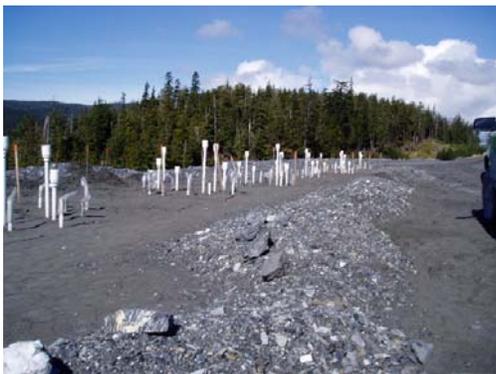
Sulfate Reduction Monitoring Study

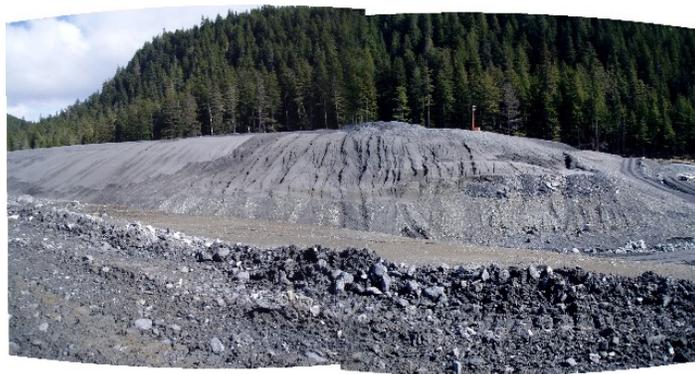
Internal Tailings
