FIELD INSPECTION REPORT GREENS CREEK MINE

Inspection Date: November 30, 2005
Report Date: January 3, 2006
Weather: Clear. Temp 21°F., Wind 8mph with gusts to 18mph
Inspection Objectives: Observe the effects of a large storm event on the various Greens Creek disposal and containment facilities
Operator Contact: Bill Oelklaus, Kennecott Greens Creek Mining Co. (KGCMC)
State Personnel: Ed Emswiler, ADEC; Charlie Cobb, ADNR,
Other Personnel: Tom Zimmer, KGCMC; Eric Sundberg, KGCMC;
Steve Hohensee, USDA Forest Service
Documentation: Photos were taken and are available for inspection at ADEC in Juneau and ADNR in Anchorage

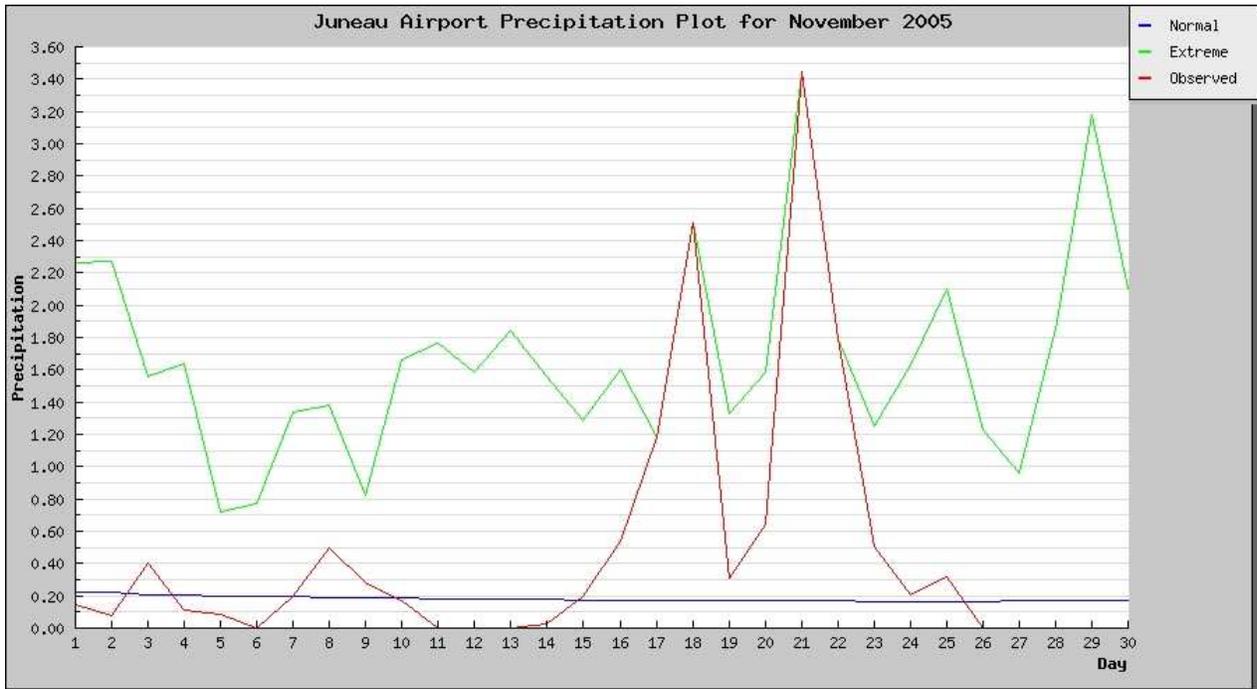
According to the National Weather Service, approximately 10.7 inches of precipitation was measured at the Juneau airport over a seven day period between November 16-23, 2005 (see graph below). KGCMC reported 13.5 inches of precipitation during this period. The mill was

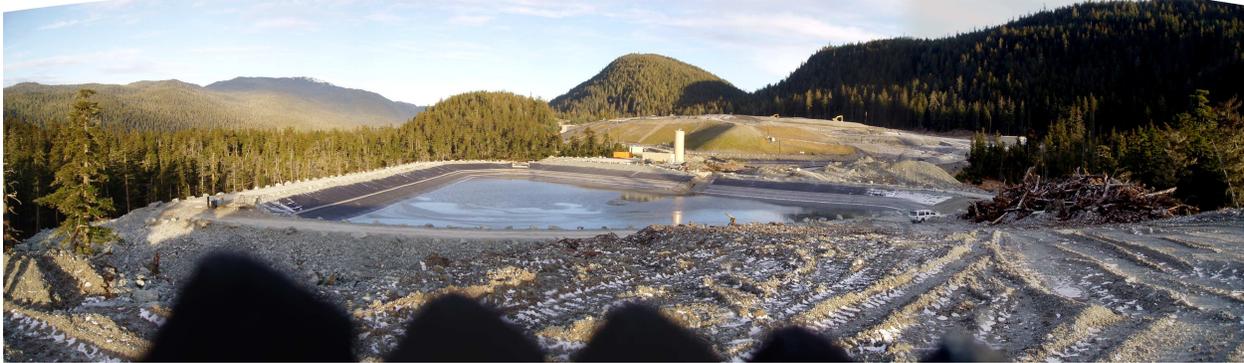
At approximately 09:15 we visited Pond 7. Since the June 27, 2005 site visit conducted by Charles Cobb and myself, Pond 7 construction was substantially completed, including the HDPE geomembrane liner. Pond 7 functioned effectively to contain excess flows from the November 16-23 storm event.

*Panorama: Pond 7 Retention Basin
Panorama Photo taken from the adjacent southwest Soils Pile looking northeast
Note: spillway, tailings facility, Tank 7, and inlet from Pond 6*

Final construction work needed for Pond 7 included:

- completion of the pumping system pumps from the wet well at the southwest aspect of the impoundment to pump water directly to the Pit 5 water treatment plant
- connection of the suction lysimeters that act as leak detection below the pond
- a discharge chute and stilling basin at the end of spillway from Pond 7

- minor earth fill at crest of dam at spillway
- final improvements to the inlet from Pond 6
- sediment traps at Pond 6 and Pond 7

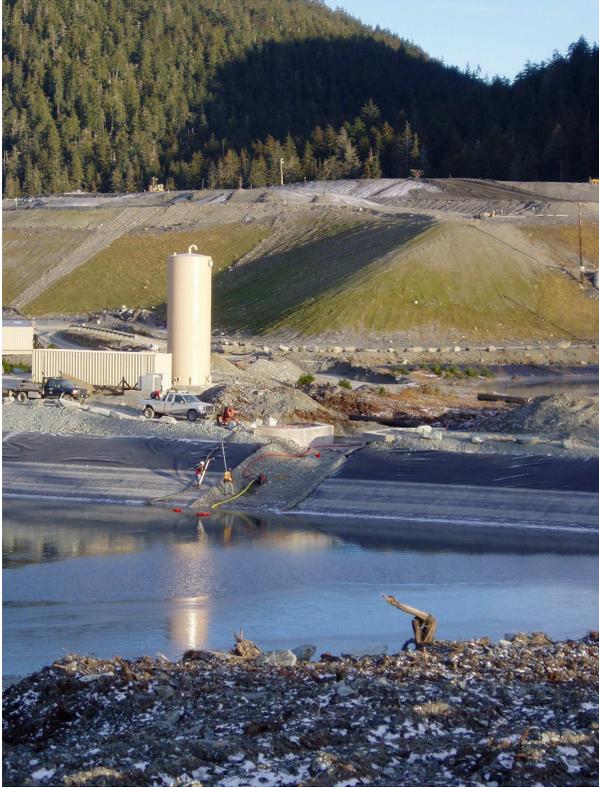
*Tank 7 and Inlet from Pond 6
Into Pond 7 (picture center)*

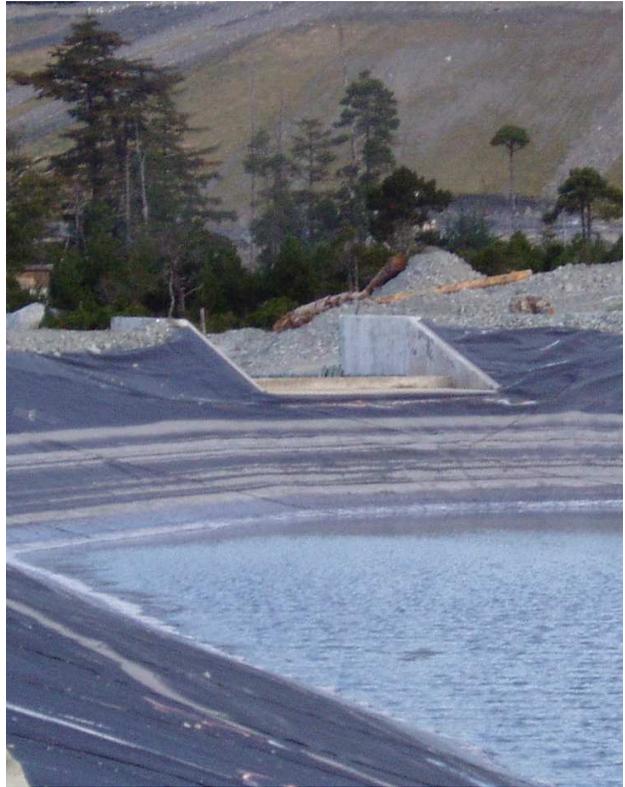
The pond sill elevation is 140-feet above MSL. The elevation of water in Pond 7 reached its highest level of 137.3-feet on November 23rd when inflow to Pond 7 stopped (see photo below). Pumping to Pond 6 started on November 25th at the rate of approximately 700 gallons per minute (gpm) while water delivery was continued from Pond 6 to the Pit 5 plant for treatment and ultimate disposition through the NPDES permitted outfall (Outfall 002) into Hawk Inlet.

*Pond 7 Spillway – Note: Highest Water Level
Reached During the Storm Event*

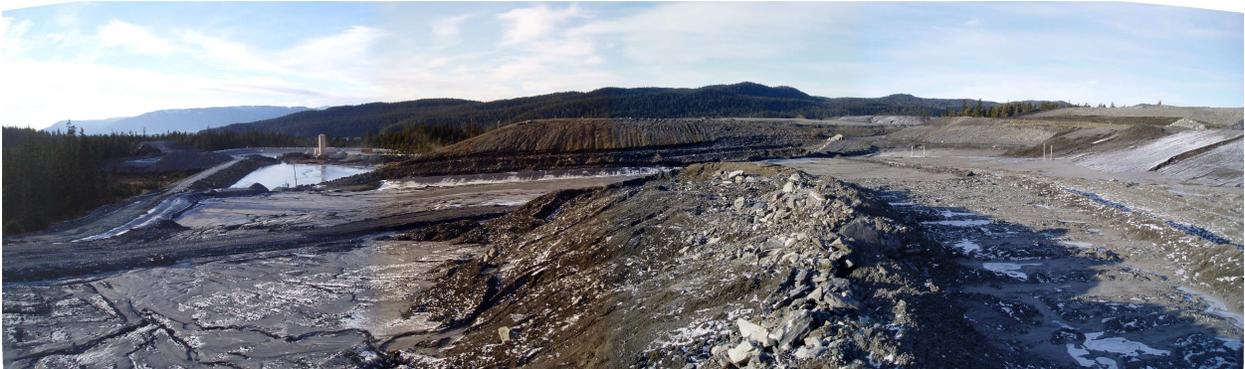
Panorama: Southeast aspect of Tailings Disposal Site Looking West

At approximately 10:00am we visited the tailings disposal facility. Since the June 27, 2005 site visit conducted by Charles Cobb and myself, the Southeast Expansion Area 2 liner, buttress and drainage system to Pond 6 had been completed. Tailings had been placed into this area to an approximate thickness of 1-2 feet although it was not actively used for disposal at the time of this site visit.

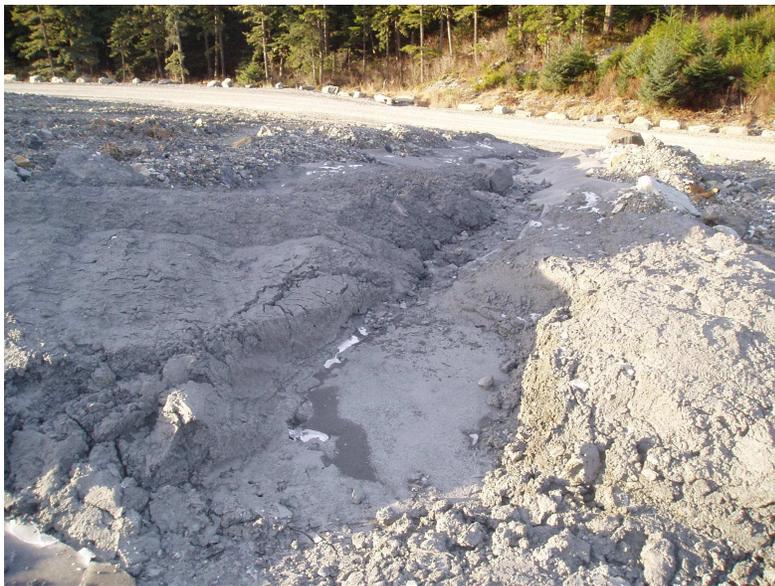
Tailings Disposal Site – West Buttress Area

External (outside) areas of the facility experienced no significant erosion. Some minor rill erosion was observed on internal slopes at the Southeast Expansion Area 1. It was reported this was not the result of the storm event. It was also reported that sheet flow of precipitation at the tailings facility was managed effectively by dozers to minimize rill erosion on external slopes. A lined channel was installed in the area of the west buttress to allow egress of water from the upper surface (see photo below). A diversion ditch fitted with a geosynthetic liner was installed to prevent water from entering the Southeast Expansion Area 2 where tailings were placed (see photo below). There were observed gaps in the lined ditch where the liner overlapped. The lined ditch was likely reasonably effective. However, this ditch is all internal to the system which merely redirects surface waters within the Tailings containment facility, and did not allow the escape of waste or water from the facility.

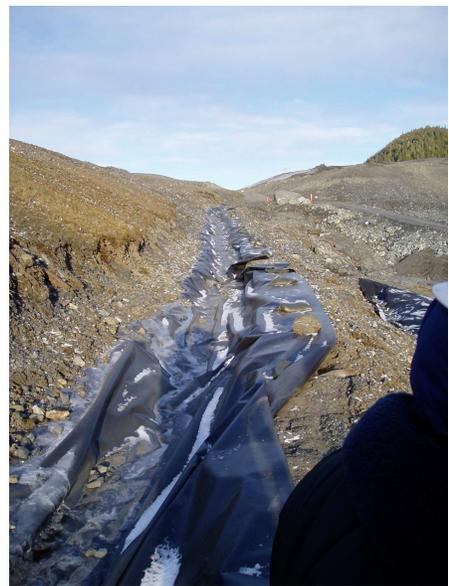
East Area of Tailings Site

Lined Stormwater Ditch Channels Made During Storm Event

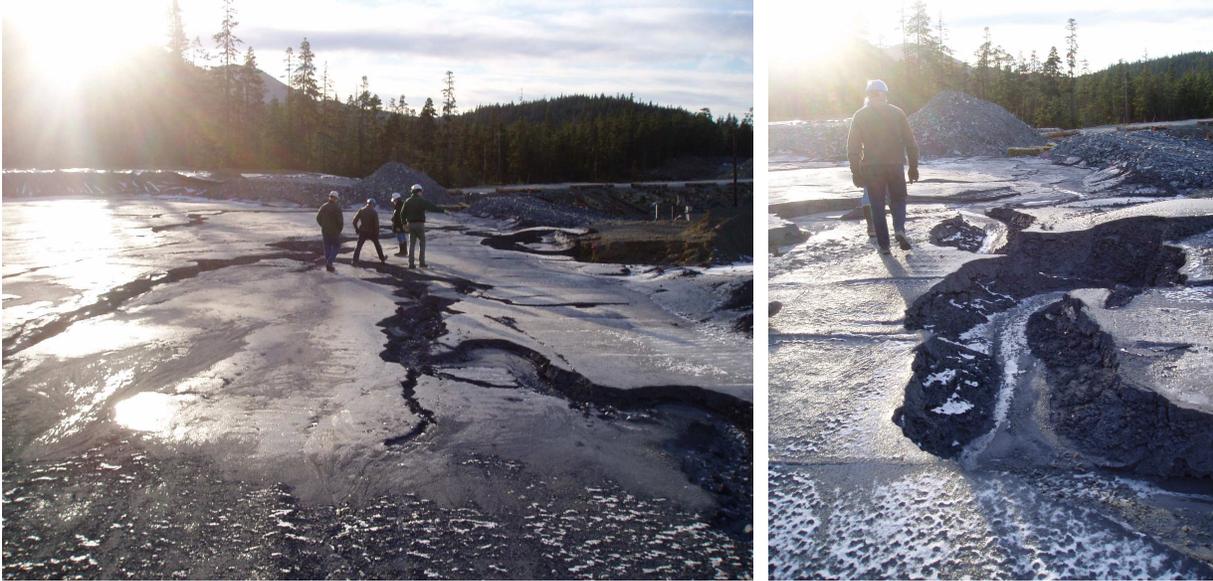
The Southeast Expansion Area 2 where tailings had been placed experienced moderate to severe rill erosion (see photo below) during previous rain events. The active water management conducted by KGCMC on the pile during the November storm prevented further erosion in this area.. The erosion has exposed the sand protective layer and the liner system in some areas, but no damage to the liner system was observed. However, all sediment that resulted from erosion throughout the facility was captured in Pond 6 and Pond 7 and did not leave the facility. Sediment traps are projected to be constructed at both Pond 6 and Pond 7. This should be incorporated into the “Stage 2 Tailings Facility Expansion 2006 Work Summary”.

*Tailings Disposal Site – Southeast Expansion Area 2
Note: Rill Erosion from previous precipitation events*

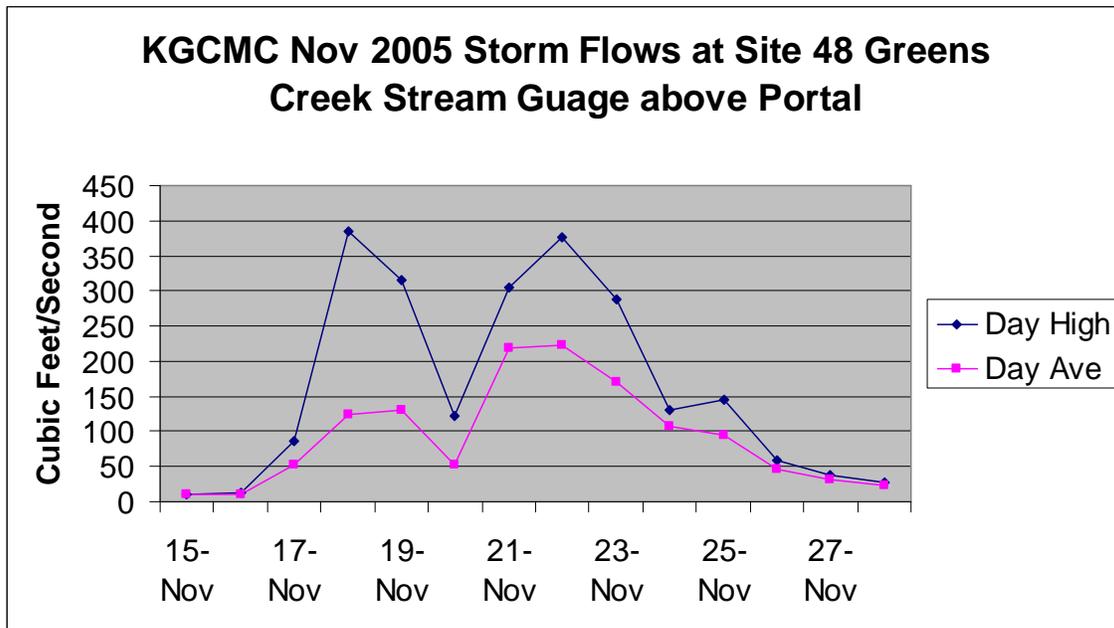
Creek experienced maximum flow rate over 375cfs on two occasions during the November storm event (see graph below).

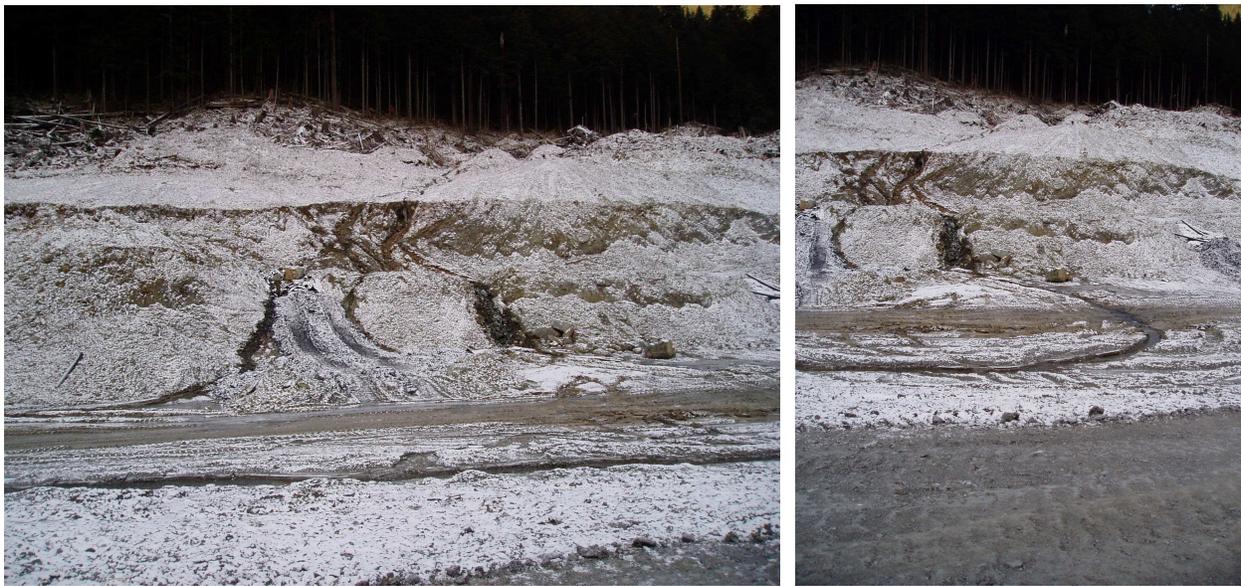
At approximately 11:30am we visited the Site 23 production rock facility. The only significant change with respect to this facility over previous visits was related to the development of a spring located above the back wall to the disposal site (see photo below) that flowed onto the site between two finger drains. The spring developed before the storm event and is reported to react to precipitation events. The spring flowed onto the production rock site at an approximate rate of 20gpm during this site visit. It is reported this flow could be as much as 200gpm during high precipitation events. After flowing onto the site the water channeled its way along the pile access road ditch into the lined ditch at the pile toe that terminates in Pond 23 where it is collected and transmitted ultimately to treatment. The plan is to connect this spring's drainage to one of the finger drains as the pile development progresses further up the hill. The finger drain should be able to handle the flow from the spring as the finger drains are made from a 6-inch HDPE pipe that is capable of handling a flow of approximately 2,000gpm.

*Production Rock Site 23 (foreground), and Backwall (background)
Note: Spring Running Onto Site*
