# MEMORANDUM

State of Alaska

SUBJECT: Kennecott Greens Creek Site Visit February 13, 2008

FROM: Kenwyn George, ADEC, Water Quality Section

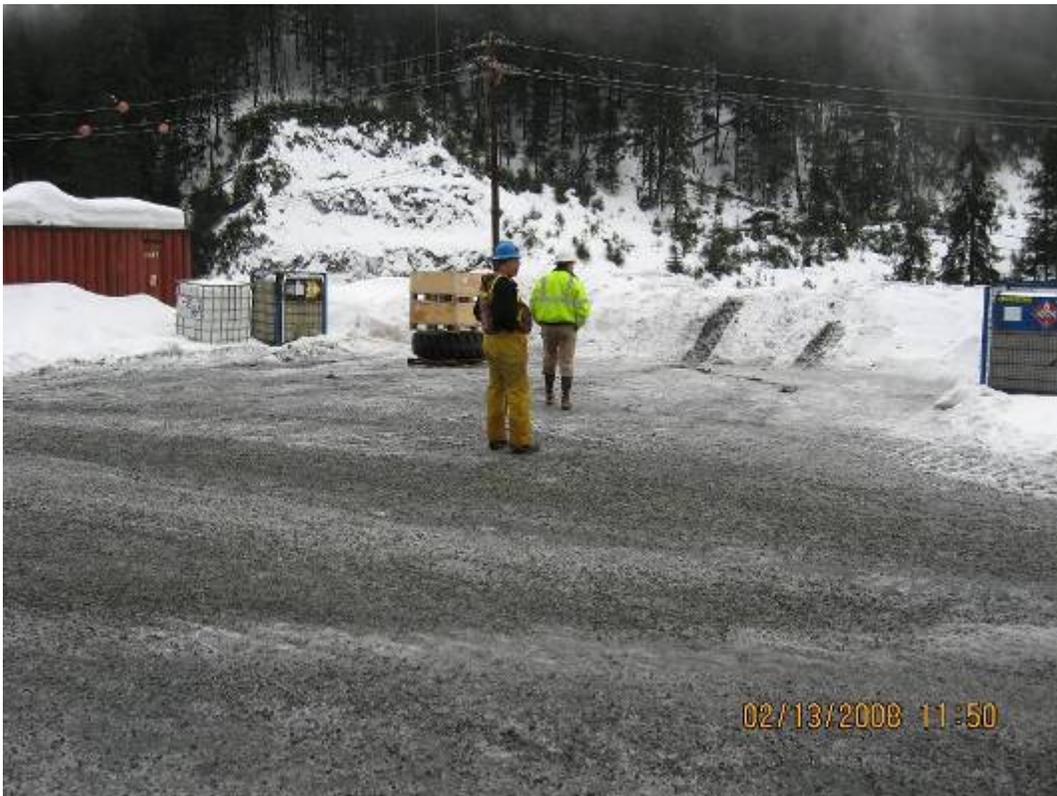
During the tour the area of the hydrogen peroxide spill was inspected. The tote with the break was at the site. There were no signs of the spill. Any drainage from this area reports to Pond A; from there it goes to the treatment plant. Other totes containing Methyl Isobutyl Carbinol were at the site in similar containers to the Hydrogen Peroxide. All these totes will be stored within a contained area that is to be constructed in 2008. At the far side of the warehouse were several 350 gallon totes containing various hydrocarbon products (motor, gear, and lube oils and hydraulic fluid). There is no secondary containment for these should there be a leak. This was pointed out to Kerry Lear who said they had been discussing containment for these totes. The USFS will note this for attention in their site report.

Hydrogen peroxide spill area, damaged container to the left.

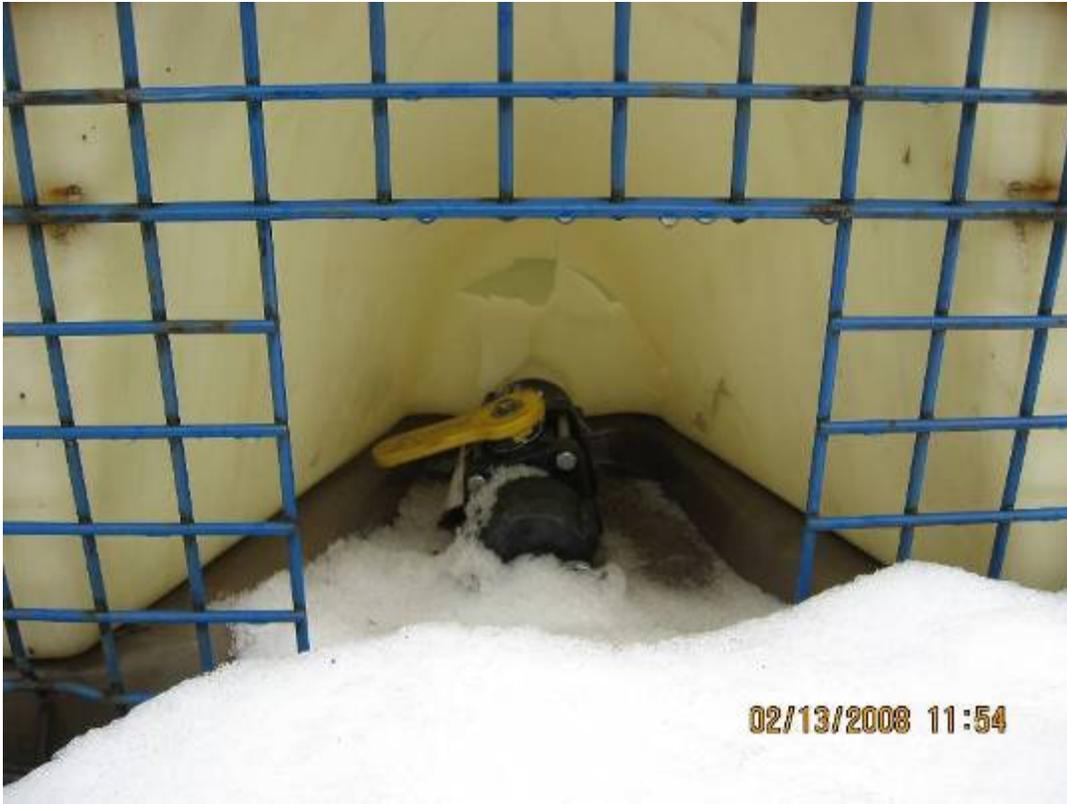
Break in container

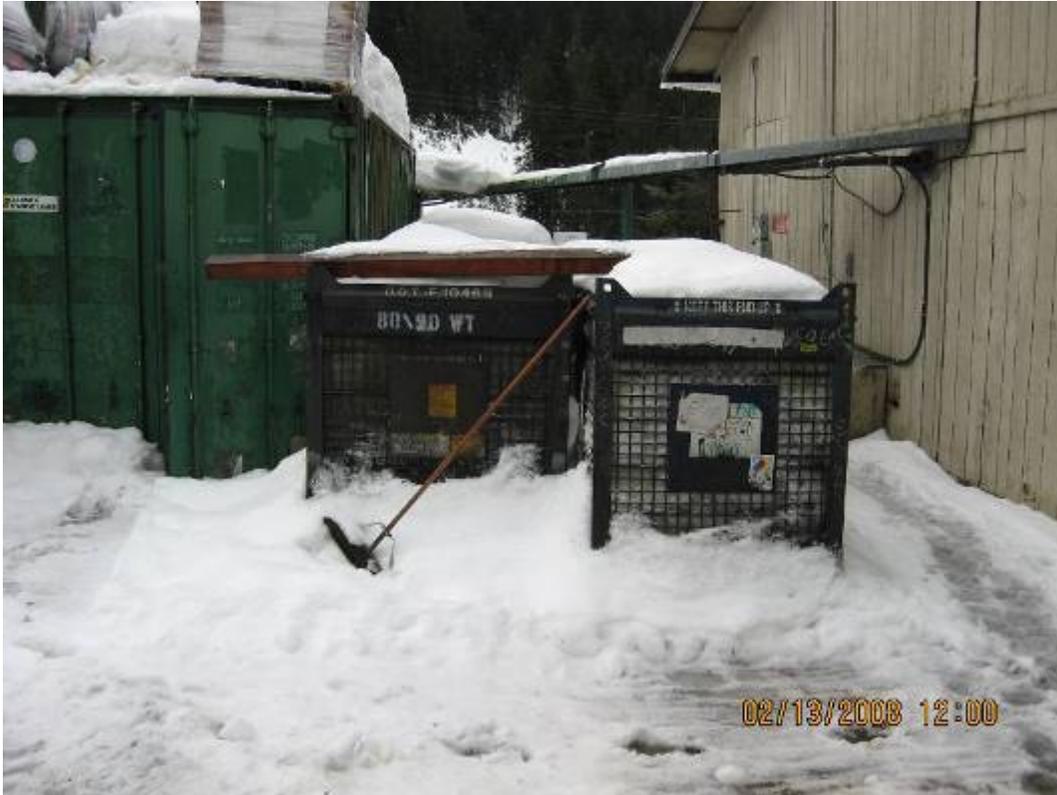
Hydrocarbon totes located behind the 920 warehouse.

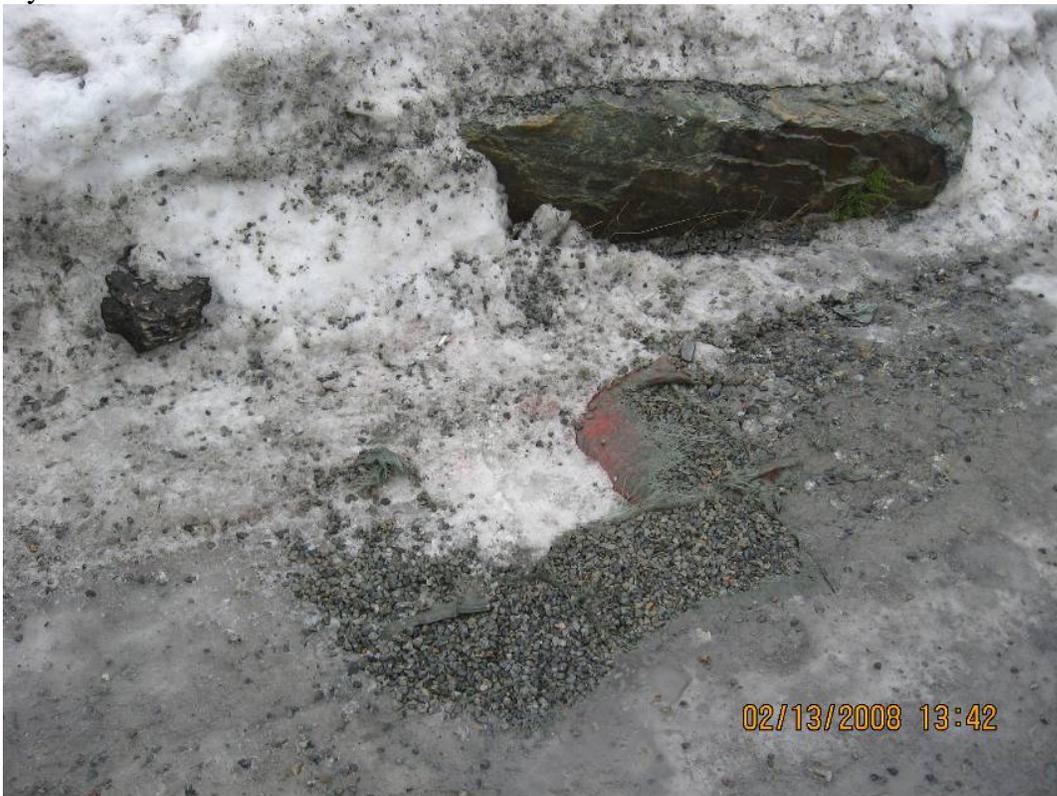
Storm water drain located on the lower Hawk Inlet truck pad.

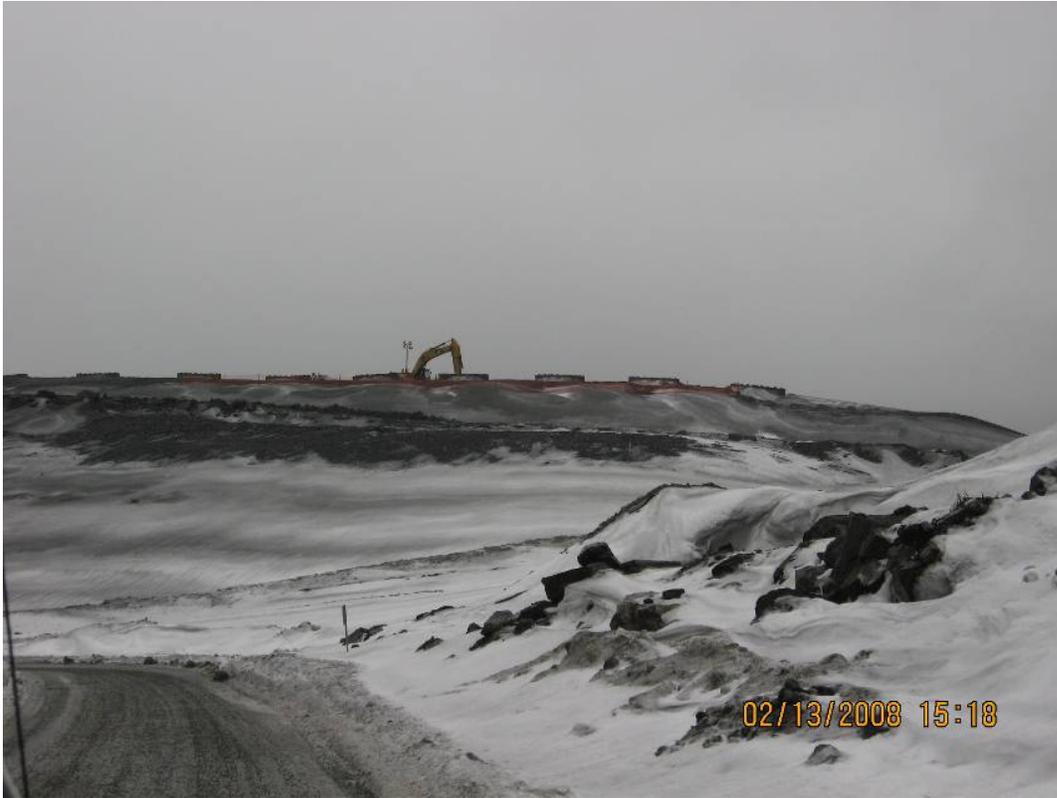
The new water treatment plant at the tailings facility is totally enclosed and work continues within it. KGCMC has employed windbreaks at the top of the tailing pile to reduce dust transport, which can occur during periods of cold, dry winter weather. Tailings dust may account for elevated metals concentrations in some shallow wells surrounding the facility.

Windbreaks on top of the tailings
