FIELD INSPECTION REPORT HECLA GREENS CREEK MINING COMPANY

Inspection Date: July 31, 2008, Thursday
Report Date: August 7, 2008
Report Written By: Ed Emswiler, ADEC Solid Waste Program
Weather: 53 degrees F., 0.17 inches precip., wind 8.2 mph NE, light rain, fog and cloudy (reported at Juneau Weather Forecast Office NWS)

Purpose of visit: To observe progress on the installation of a liner in the Northwest Pit 5 portion of the tailings disposal site

Pit 5 Area of the Northwest Expansion – Tailings Disposal Facility

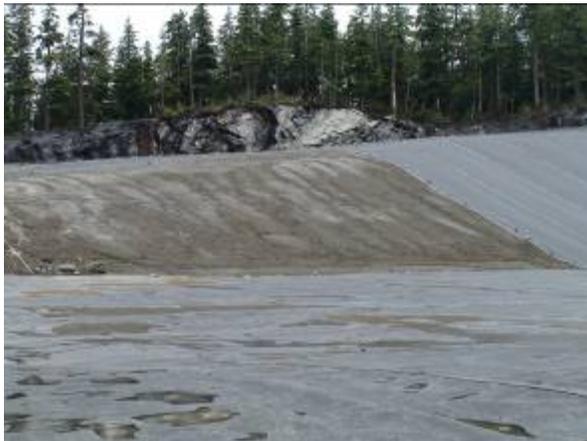
At the Pit 5 area of the tailings disposal facility installation of the liner system was put on hold due to weather (light rain). HGCMC was waiting on acceptable weather conditions as the fusion process requires there be no precipitation. Approximately 85% of the liner in the Pit 5 area of

Exposed Sand Bedding Layer

1. Liner placement was halted because of the weather causing the bedding sand layer below the liner to be vulnerable to erosion. The liner should be placed as soon as conditions improve. Underdrain piping and other inputs to both surface water and ground water collection throughout the tailings facility was observed.

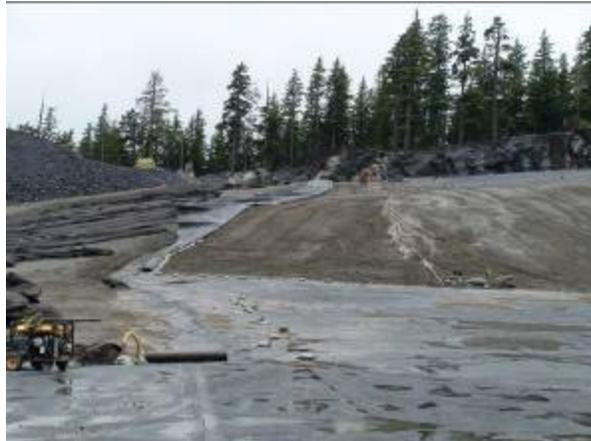
Note: Pumping of Water Below Liner (lower left) to Northwest Corridor

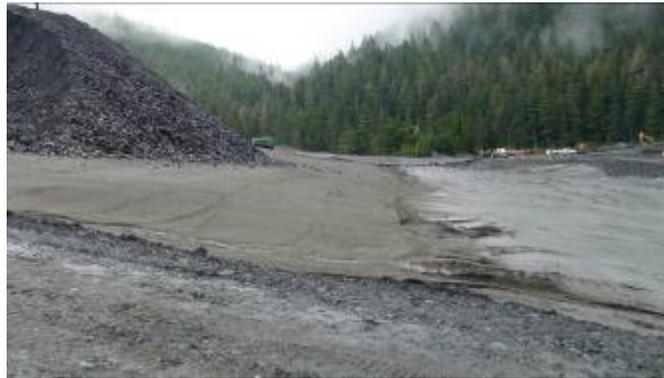
Once the geotextile is placed a 6-inch compacted service layer of sand (hydraulic conductivity of 1×10^{-2} cm/sec) is installed in areas with a slope less than 15% prior to the placement of tailings. In areas where the slope is greater than 15%, this service layer of sand is 24-inches. This sand will be provided as the tailings development progresses vertically.

Sand Service Layer above Geotextile

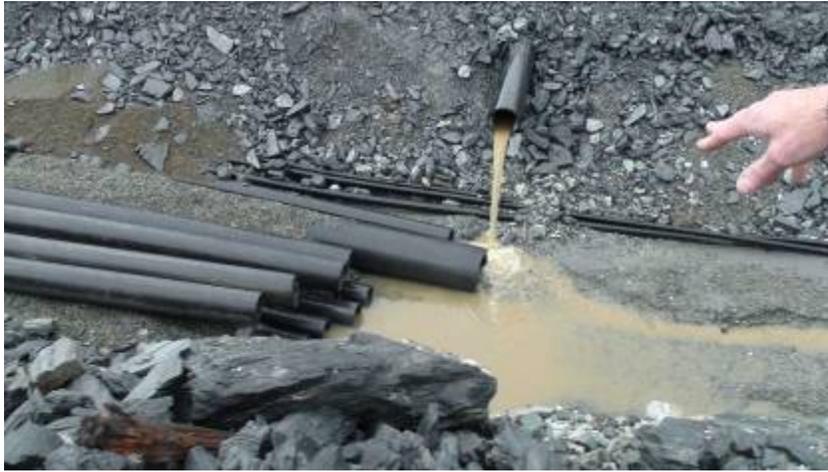
Hardpipes exiting North to West Corridor to Surface Water Ditch within Containment

- **8-inch pipe above carrying water from below liner in Northwest Pit 5 area**
- **Large 18-inch pipe from Northeast Retention Pond**
- **Medium sized 8-inch pipes carry water from finger drains above and below liner in Northwest Expansion and DB04 from truck wash at Cannery**
- **Smaller pipes carry conduit for piezometers and lysimeters**

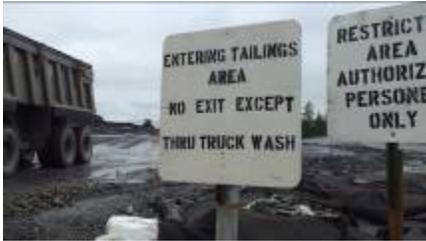
The placement of tailings was observed at the Northwest portion. There was proper signage instructing drivers about the use of clean and dirty roads. Haulers were instructed to use the truck wash. Barriers were placed between the clean road and the road in which waste (tailings) was hauled and delivered to the site. No vehicles were observed driving from “dirty” roads to “clean” roads at this inspection. HGCMC should continue to be vigilant in maintaining separation between dirty and clean roads and the use of the truck wash for vehicles that come into contact with the tailings disposal site.

Signage Instructing Users

1. HGCMC should continue to be vigilant in maintaining separation between dirty and clean roads and the use of the truck wash for vehicles that come into contact with the tailings disposal facility.
2. ADEC supports and encourages HGCMC's plan to construct the tailings storage building to facilitate more effective tailings disposal.
3. The 1.4-mile sandpit is the source of all of the sand for placing the liner system and for performing other functions requiring this material at the mine. The 1.4-mile sandpit sand source is nearly exhausted within the confines of the existing permitted lease boundary.

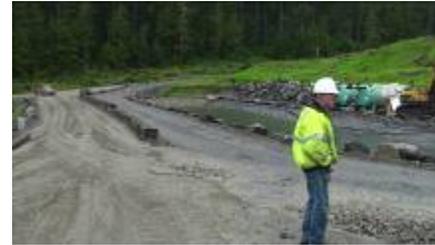
Barrier Between Clean/Dirty Roads

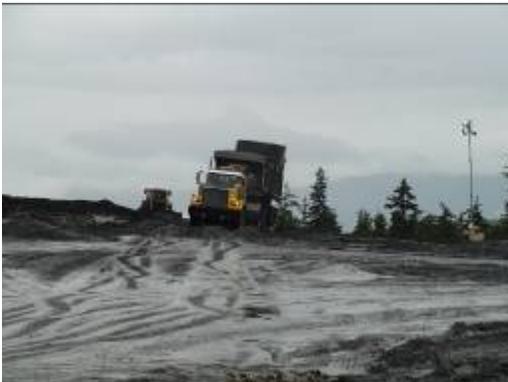
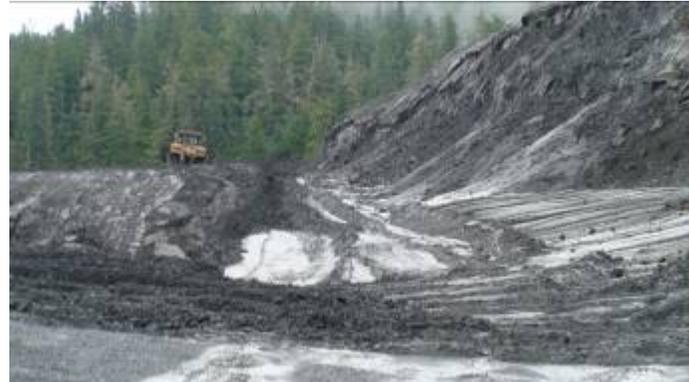
Because of weather conditions, the tailings disposal area was rather sloppy. Argillite production rock was hauled and laid down in areas that were too sloppy to manage tailings. Sundberg mentioned that these conditions would be alleviated if the planned tailings storage building was constructed and tailings could be delivered to it instead. ADEC supports and encourages HGCMC's plan to construct this tailings storage building to facilitate more effective tailings disposal.

Tailings Disposal, Grading and Management (wet/sloppy)

2. Disposal was accomplished at the tailings disposal facility. However, tailings were being disposed in a wet/sloppy condition which could be greatly improved by developing the tailings storage building.

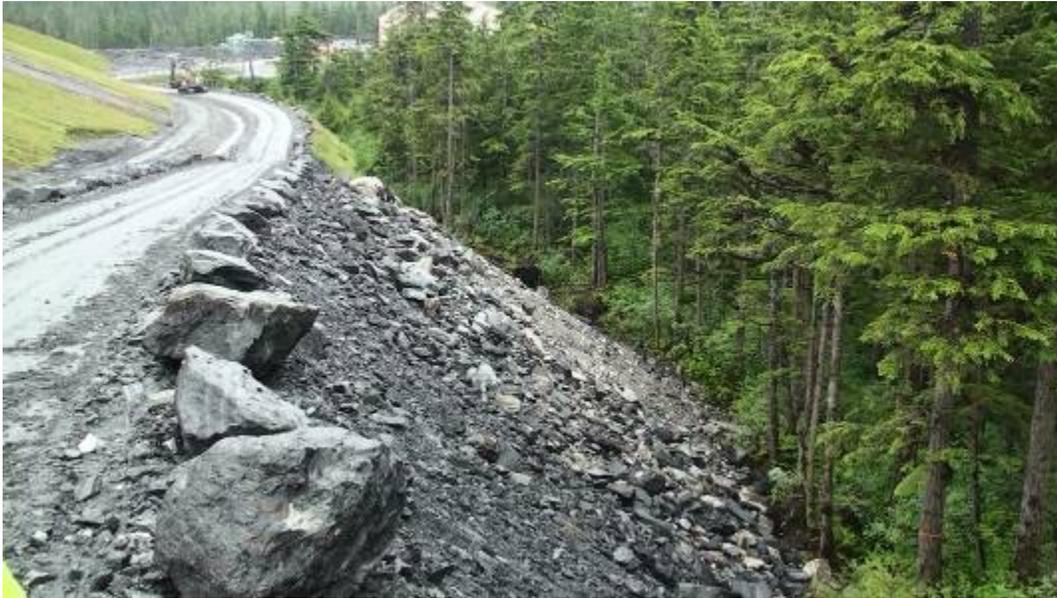
Sundberg reported an area of road at the western portion of the landfill between the West Buttress and the Northwest Expansion that was developed with quarry rock from the 2007 Northwest Expansion area. According to HGCMC, some of the rock contains pyrite (up to 2% by volume) which likely has contributed to the increase in dissolved load (notably sulfate and zinc) observed in drainage outside containment (HGCMC 2008 Annual Report). HGCMC reported the sulfate and zinc concentrations have decreased in the monitoring conducted since the pyritic material was placed.

Clean Road (right of drainage ditch), Dirty Road (left of drainage ditch) at toe of West Buttress
Note: material at right is outside of containment and is a source of potential contaminants

An action plan should be provided that deals with the sulfidic rock that was placed outside of containment. This plan should be written for ADEC approval and should comply with all relevant requirements in Sections 2 and 7 of the Waste Management Permit. A sampling plan should also be provided that shows sampling locations, parameters to be analyzed, frequency of sample collection, how data will be analyzed, triggers for notification and triggers for additional action and QA/QC. There should be a projection of future water quality in this area. It should provide a contingency plan in the case that water quality standards are not met in the foreseeable future. All data pertaining to this issue should be provided along with an interpretation of the data in comparison with water quality standards.

1. Continue monitoring the drainage of the area downgradient of the road that has pyrite from the NW expansion area.
2. Submit an action plan that deals with the sulfidic rock placed outside of containment. This plan should be written for ADEC approval and should comply with all relevant requirements in Sections 2 and 7 of the Waste Management Permit. Submit a sampling plan that shows the location of samples, parameters, frequency, data analysis, triggers for notification and triggers for additional action and QA/QC. There should be a projection of future water quality in this area. It should provide a contingency plan in the case that water quality standards are not met in the foreseeable future. All data pertaining to this issue should be provided along with an interpretation of the data in comparison with water quality standards.

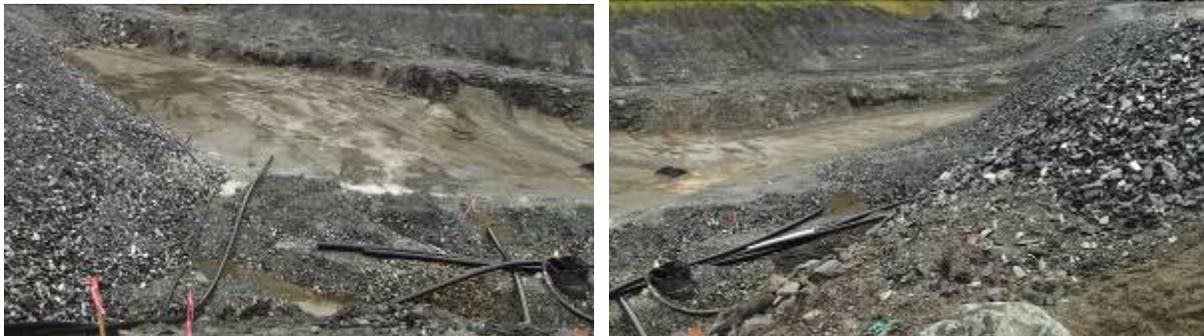
We briefly stopped at the Pond 6 area. The pond had been excavated to the hard till layer and a layer of bedding sand was placed above that to protect the till from damage. Approximately 10 finger drains (HDPE pipes) from the southern portion of the landfill inclusive of wet wells were positioned into the pond area where they would eventually be connected to a temporary sump that was in place at the time of this inspection. Their discharge is by gravity into Pond 6. A 30-foot tall caisson (Wet Well “A”) would initially be developed in the area of the sump and would be extended as the landfill increased in height. During operation, water would be pumped from the sump (caisson) to the water treatment plant for treatment and ultimate disposition through the permitted NPDES outfall. At closure, a 14-inch hardpipe would be connected to the sump and be directed by gravity (free draining) through the downgradient slurry wall into the NPDES marine outfall line.

Pond 6: Note Underdrain Pipes and Sump where Caisson (Wet Well) Will Be Installed. Also Note Sand Layer Over Hard Till Layer

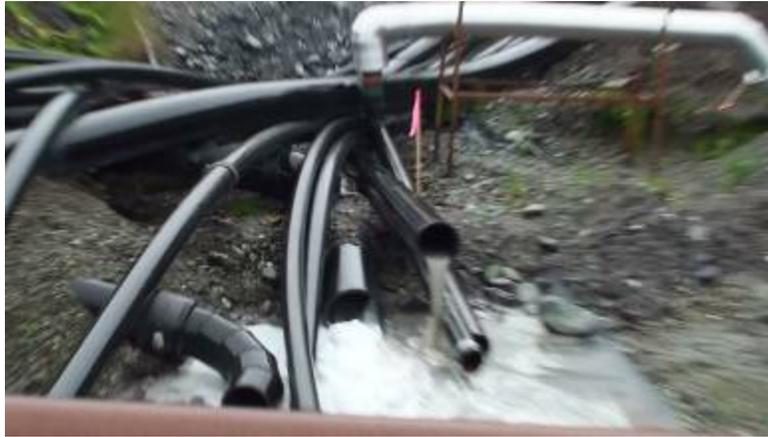
Several pipes were observed in the area of the proposed de-grit pad near the bridge between Pond 6 and Pond 7 many of which were discharging water to Pond 7. Although not specifically identified, Sundberg reported each pipe could be identified via plan (each one is surveyed) as to the source of water for each pipe.

Several pipes in the area of the proposed de-grit pad at the bridge between Pond 6 and Pond 7 discharging water to Pond 7
