FIELD INSPECTION REPORT HECLA GREENS CREEK MINING COMPANY

Inspection Date: August 21, 2008, 7:30 AM to 11:30 AM.
Report Date: August 25, 2008

To observe the installation of the new 18" polyethylene storm water pipe.

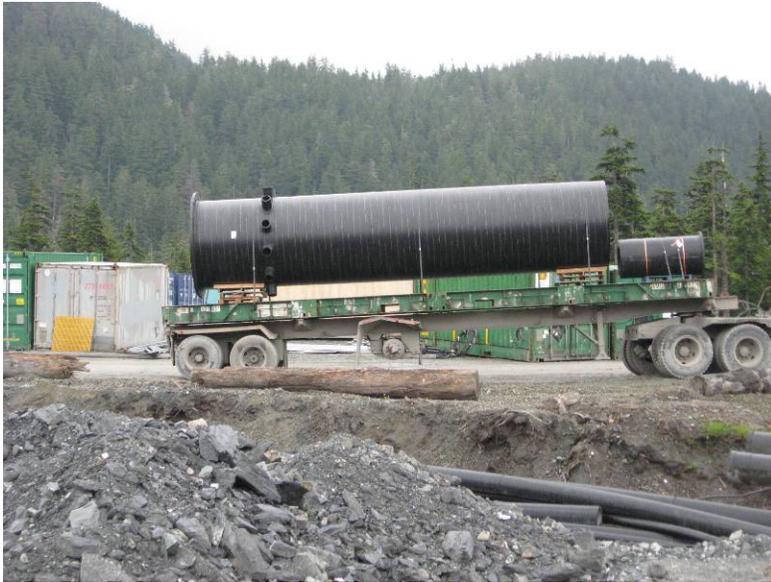
The pond was not inspected. However, the wet well being installed to the south side had arrived and was on a flatbed, ready to be installed the next day. It is approximately 20 feet deep/tall. Sampler pipes are to be installed at some of the incoming pipes from the tailings site drainage area. Once installed HGCMC will not be entering the wet well should there ever be problems with the sampling pipes, however it will be possible to backflush them to clean them out.

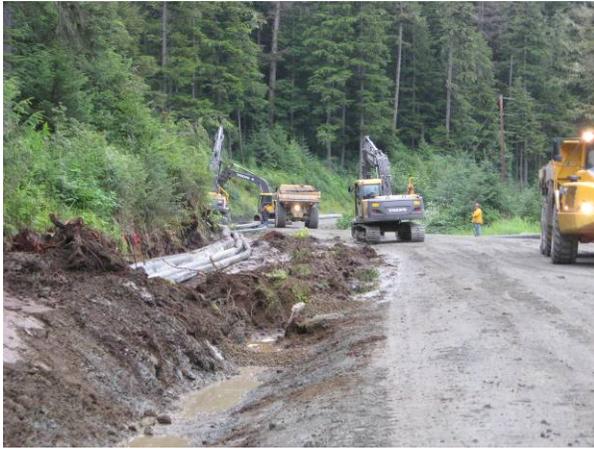
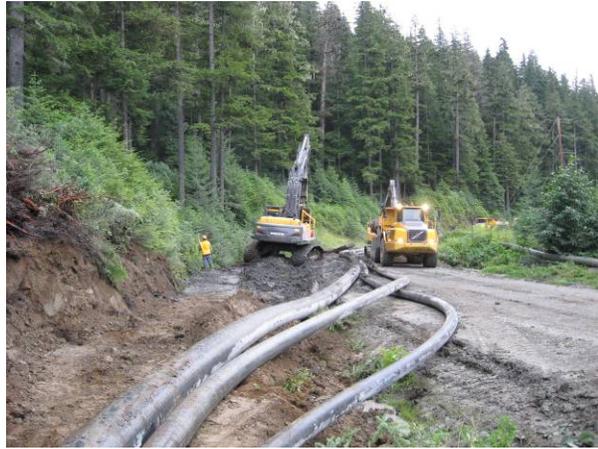
Mile 1.5 to 1.6

Installation of this pipeline was in progress at Mile 1.5-1.6 of the “B” road. This pipe is carrying all flows from Pond 23 and Pond D. The existing 8” and 10” pipes enter a manifold on the 18” pipe just down from Pond 23. This water management practice was considered more convenient during construction since the existing pipes and the 18” pipe have to be moved around beside the road while the bedding preparation is done. At the time of the visit work was being done on a clean water culvert. There will be dirty water culverts to each side of the clean water culvert. The pipes are being bedded on sand from the pit alongside the “A” road. This material will also be an indicator of the presence of the pipes during future maintenance work. The pipe is being laid such that there are no low spots, all the way from the treatment plant/Pond 7 to Pond 23. Where there is suitable land adjacent to the road the pipes are being laid side-by-side. Where there is rock there will be no blasting or moving the road, so the pipes will be stacked and held in place by cover material. Air valves will be installed on tees (the riser will have a large opening to allow easy capture of air and act as an air “reservoir”) after the completion of installation. Installation of the pipe is expected to take 1 ½ months (with completion around mid-October). 8” pipe between mile 1.8 and Pond 6 that presently resides to the west of the road will be removed for re-use elsewhere.

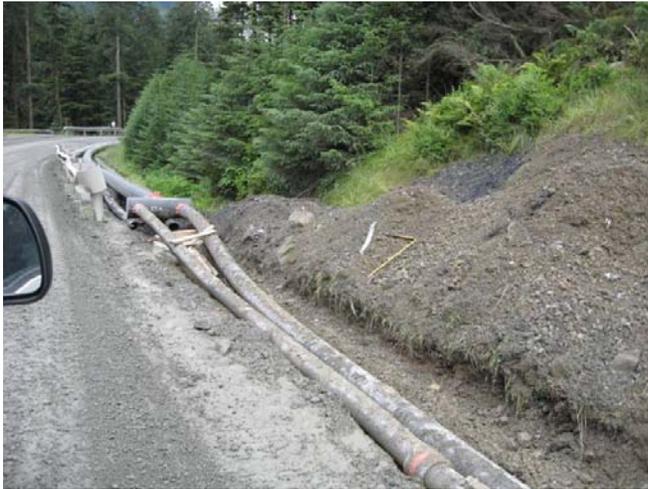
Manifold just downstream from Pond 23

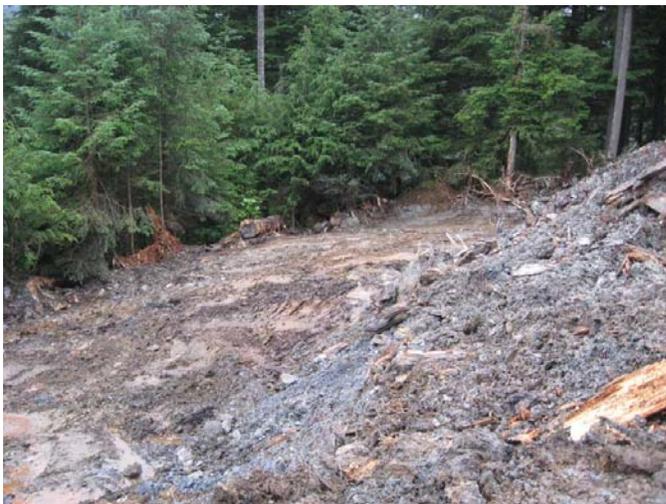
Site 1350

Approximately 40-60,000 cy of waste material was deposited at this site around 1987. Approximately 15%-25% of the material has been excavated and taken to the pad on Site 23 where it is being treated with lime and temporarily stored.

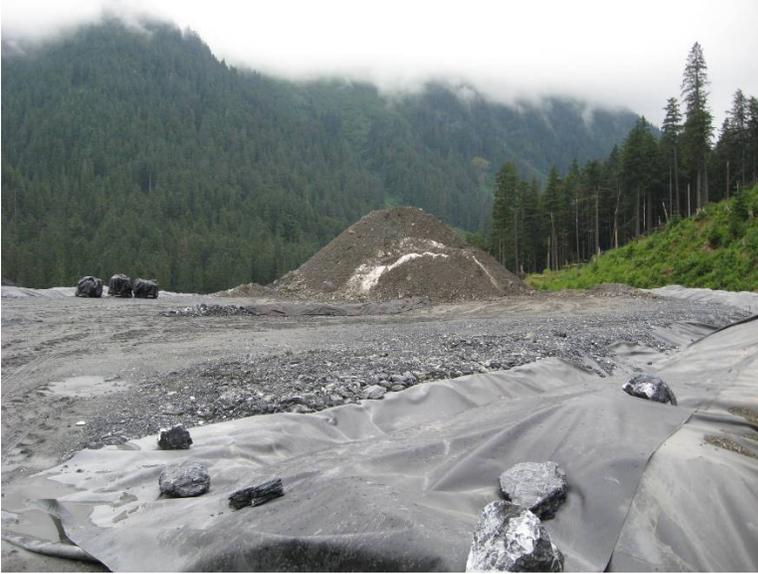
Site 23 pad

The pad is now receiving waste rock from Site 1350. It has a “belly” drain to collect seepage rain and seepage waters for later treatment at the treatment plant.

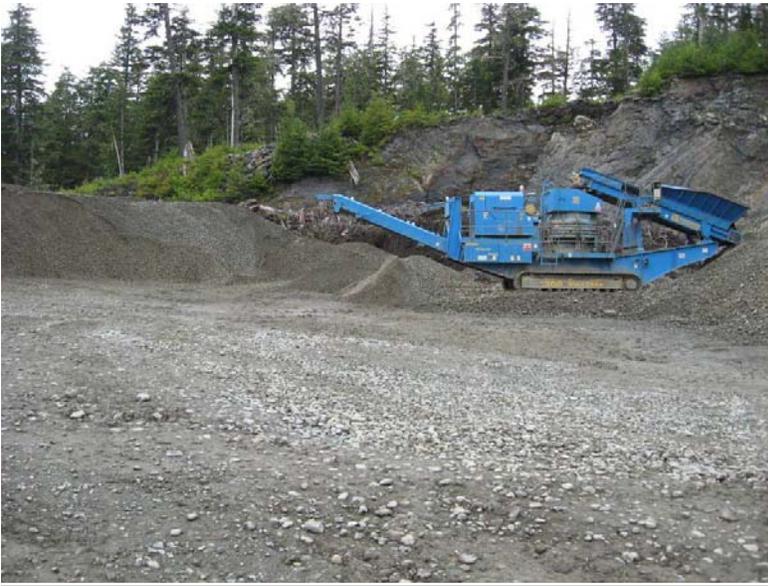
Pit 7

Rock segregated from the sand at the pit on the “A” road is stored at this site. Some of the rock is being crushed. This rock is used for storm water rock “burritos” and for roads in the tailings site.
