# STATE OF ALASKA

## DEPARTMENT OF ENVIRONMENTAL CONSERVATION

### FIELD INSPECTION REPORT HECLA GREENS CREEK MINING COMPANY

**Inspection Date:** November 10, 10:30 AM – 2 PM.

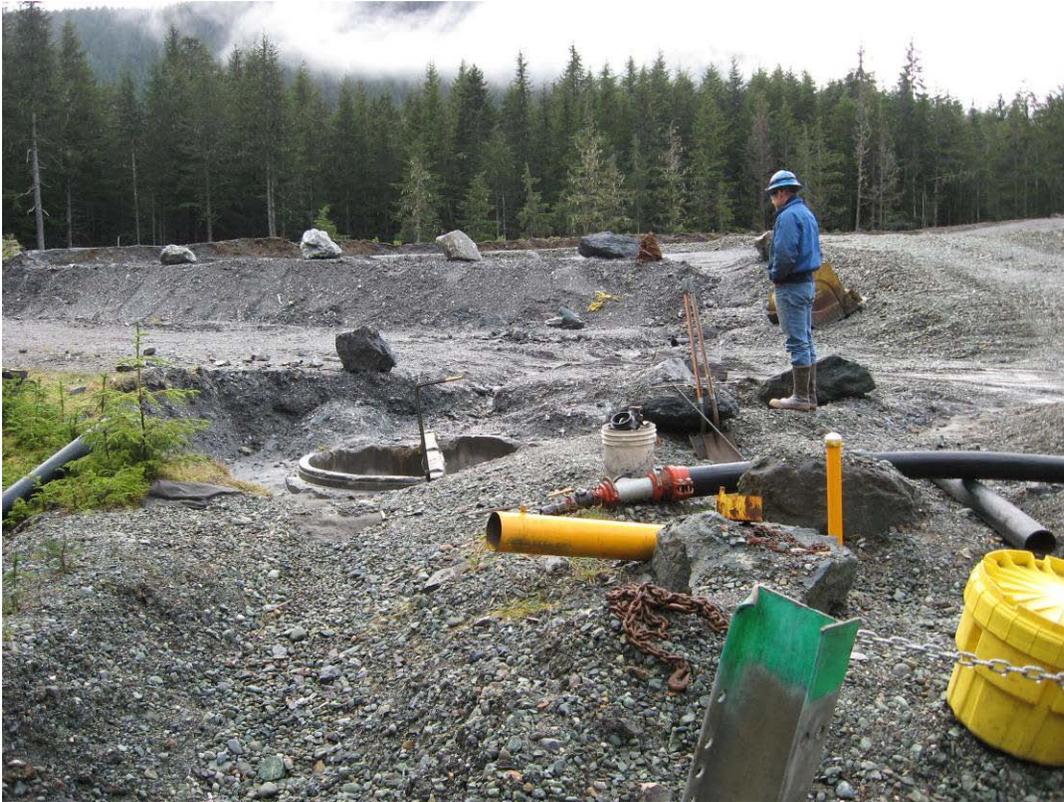
Photo 1. Pump sump at Site E and drainage ditch

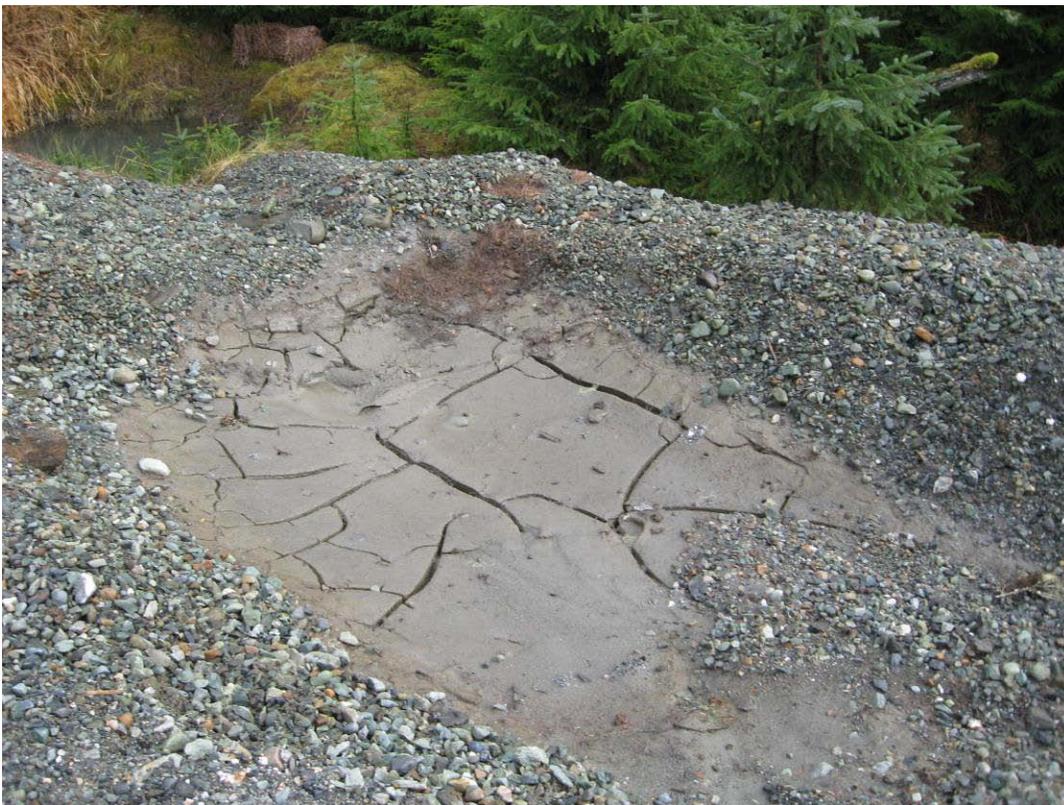
Photo 2. Drainage ditch leads to a settling basin.

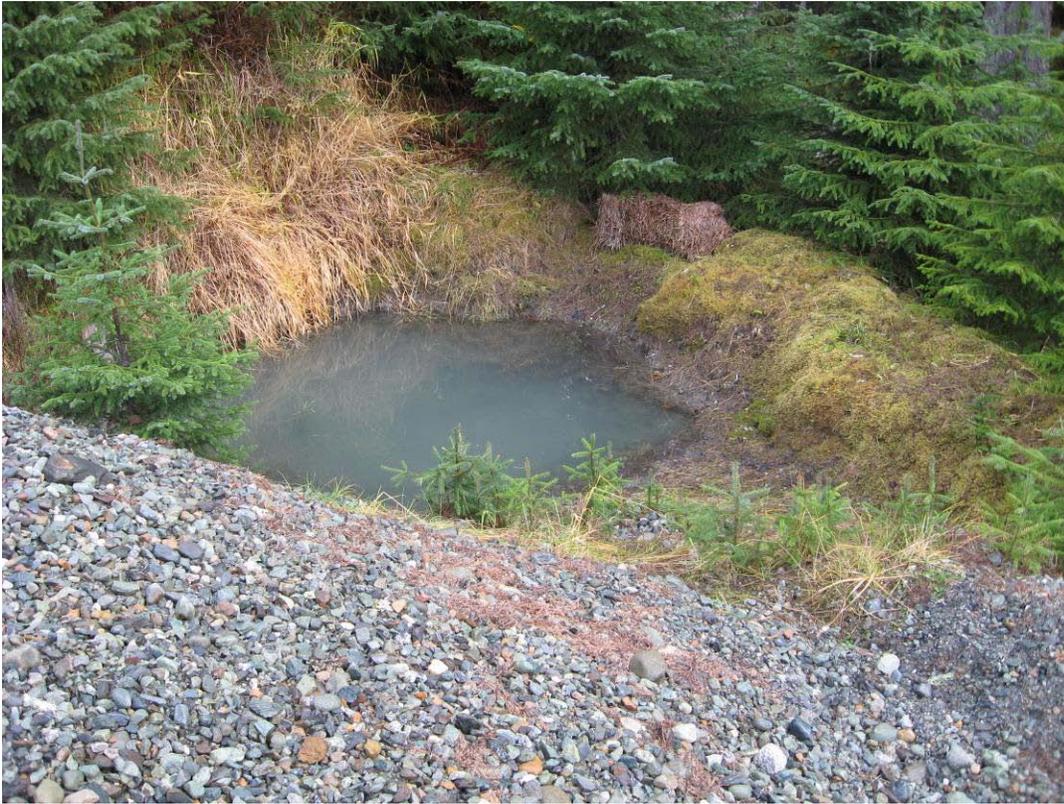
Photo 3. The settling basin leads to a second sediment catchment with a bale at the outlet.

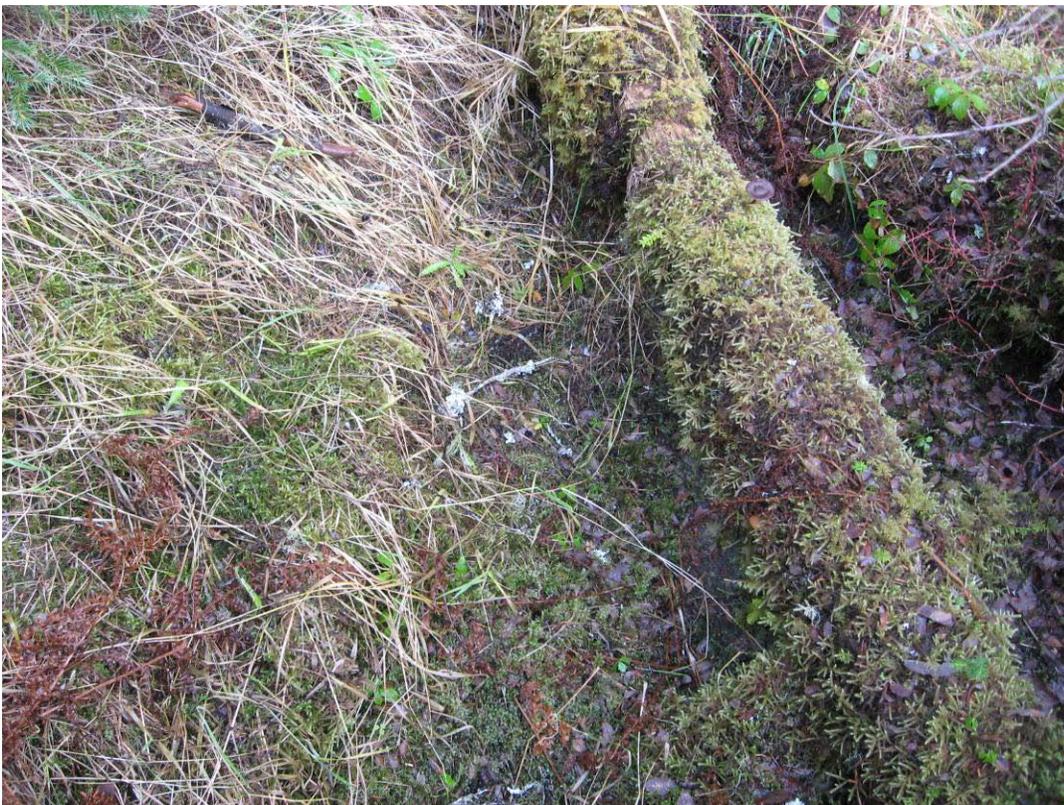
Photo 4. The settling basin discharges to a wooded area and undergrowth – no sediments were visible in this vegetated area.

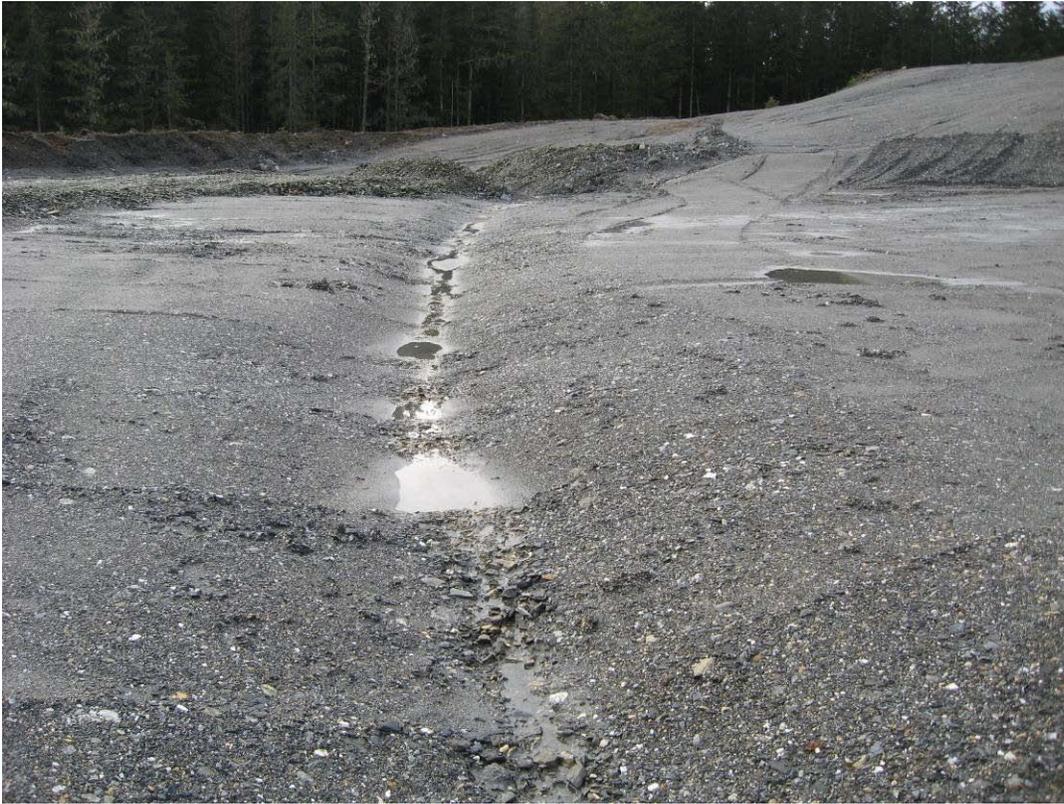
Photo 5. Bales will be placed in this drainage ditch to catch sediments.

suggested as a further BMP to capture any fine sediments from surface runoff that straw bales be installed in the storm water conveyance ditch on disturbed area that directed water to the caisson. Kerry Lear said he would install bales in this area. Pete Condon was encountered in the Hawk Inlet canteen. We discussed the water quality in the sump water, which had experienced WQ exceedences. Pete said the quality was the same as the other flows from the site pre-disturbance. He will send me copies of the test results that show this. Considering all the above I could see no reason not to approve allowing the rolled, compacted surface in lieu of a polyethylene cover.

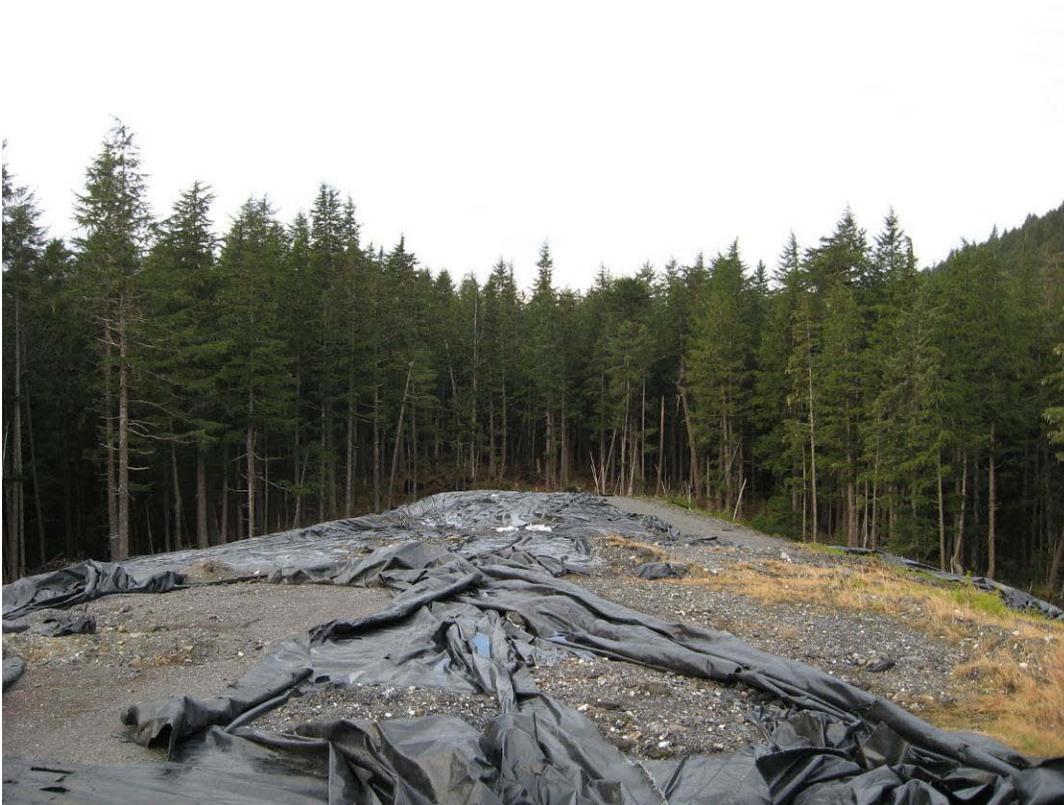
The pile was walked to observe the far side over the peak. Here there was a partial polyethylene cover where it had not blown off. The site for the proposed sediment basin could also be seen. Hecla intends to construct this basin in the spring of 2010 and direct all surface flows to it. I

Photo 6. Far (NW) side of Site E, proposed sedimentation basin location at the far end.

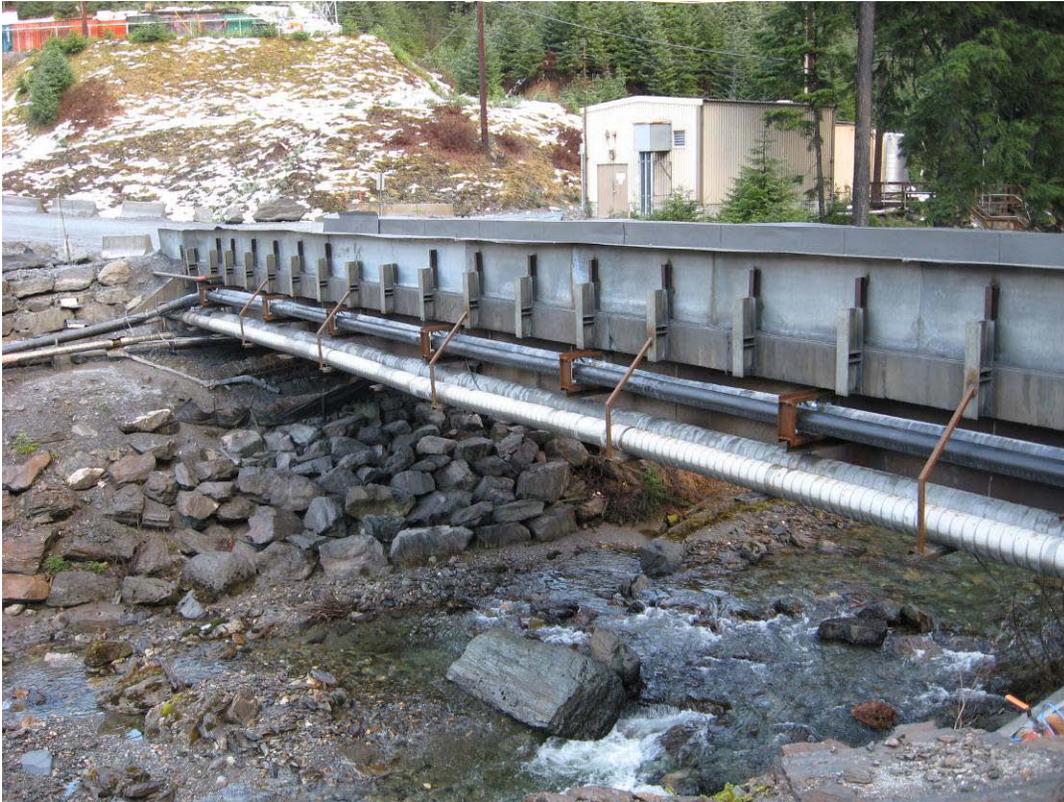
A tour was conducted which included Site 1350, Site D pond, Site 23 and the tailings facility. At the bridge at the 920 portal, two double-walled pipes had been installed; one for fresh water going underground and the other for mine drainage water coming out of the mine. Both pipes had heat trace. (Photo 7)

Photo 7. New double-walled pipes at the 920 bridge.

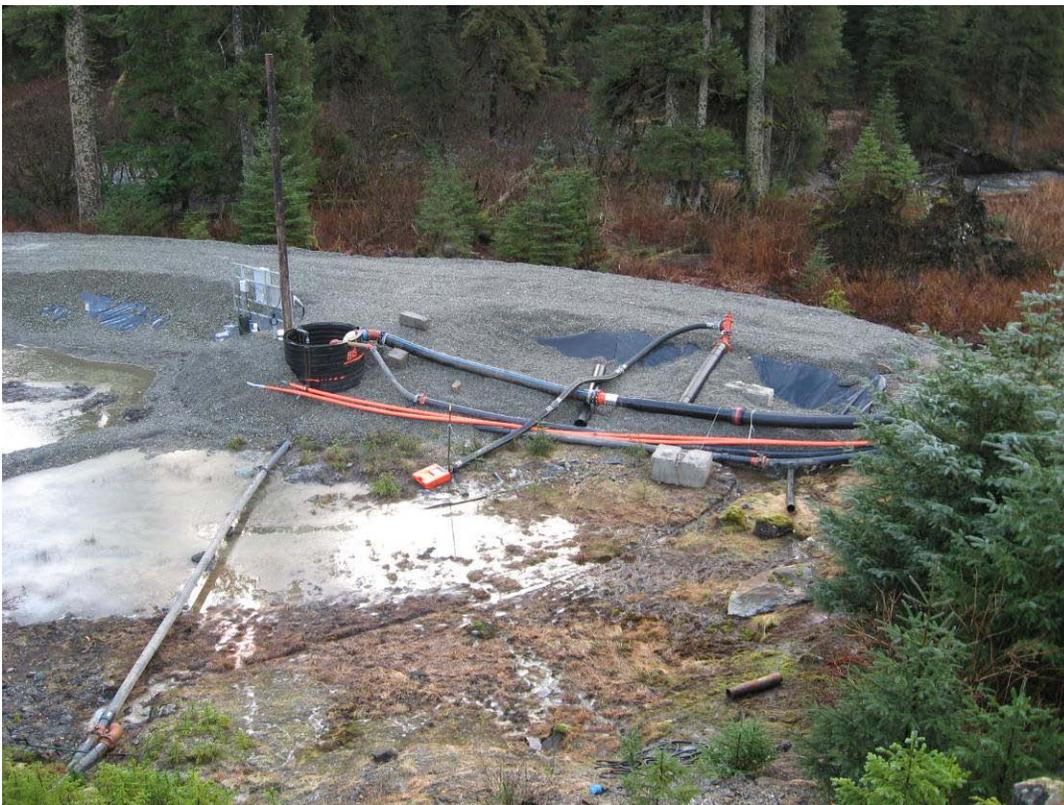
Pond D. (Photo 8) Re-construction of the outer berm, all pump and pipework were complete. A polyethylene liner was installed within the berm, bedded into native material with bentonite, to prevent leakage from the pond to Greens Creek. This liner is for the main pond; it terminates in the mid-part of the turn-around road.

Photo 8. Pond D, pump sump and reconstructed berm.

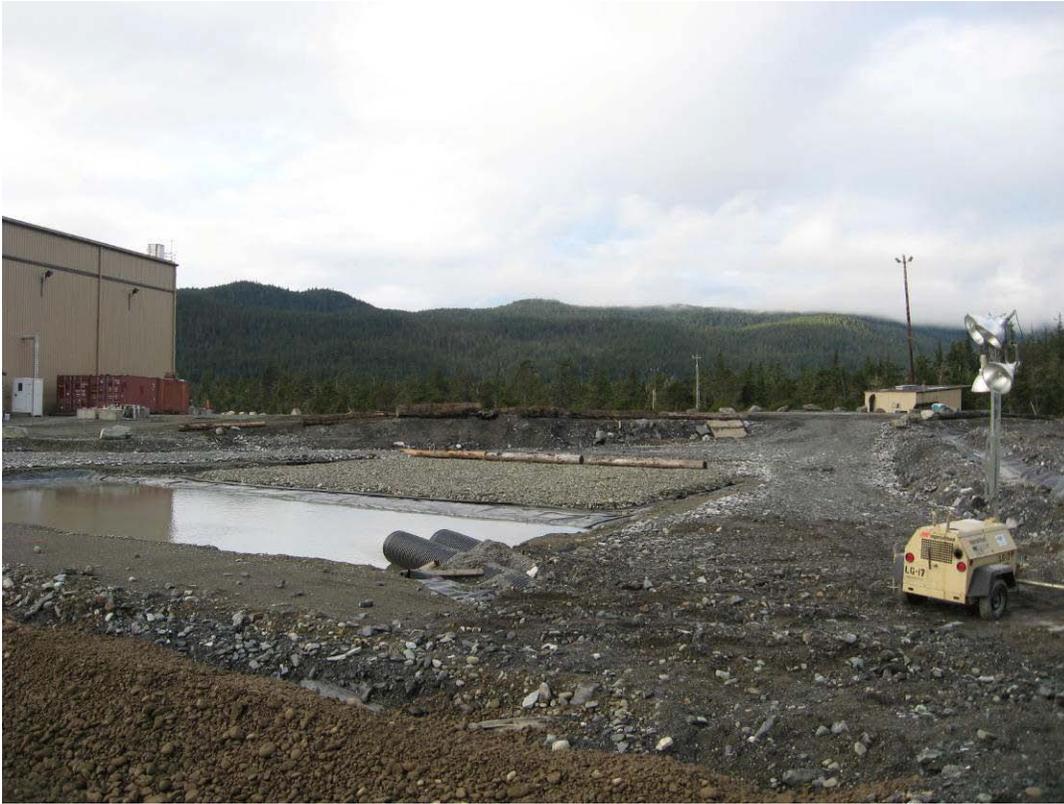
The filter bags had been removed. Larger bags (60' long x 22' circumference) are to be placed adjacent to a pre-sedimentation pond to Pond 7. Tails are being placed in the NW expansion area.

Photo 9. Pond 7 pre-sedimentation basin and pad for filter bags.

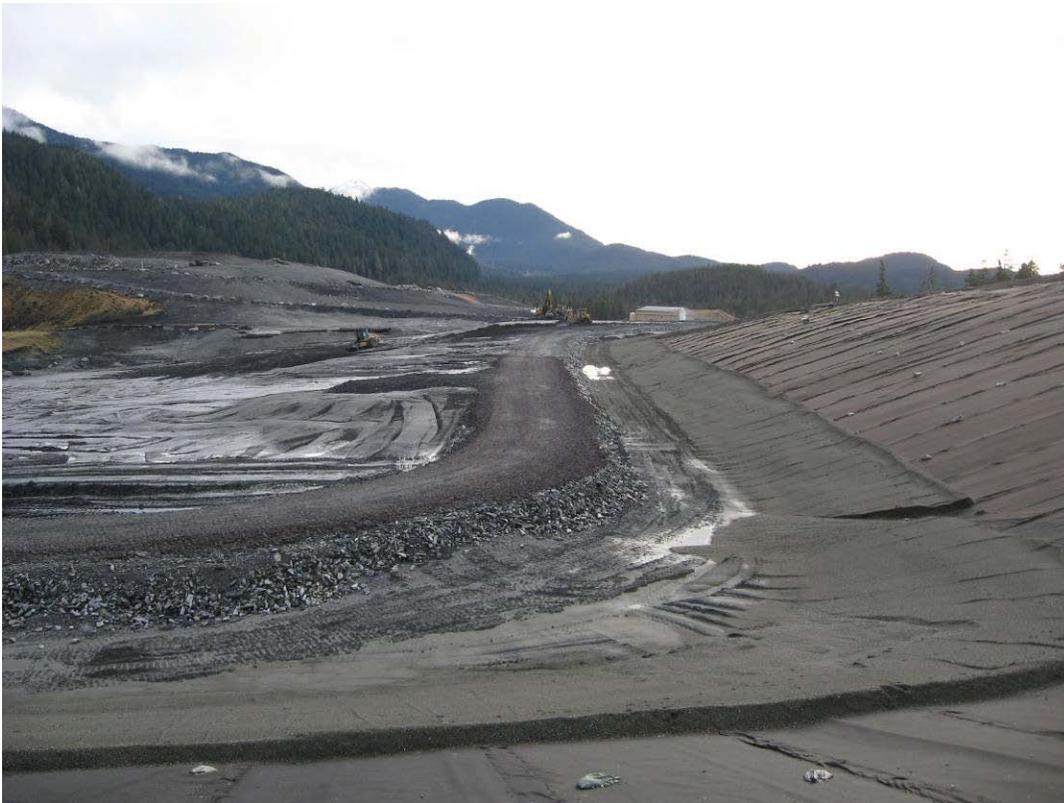
Photo 10. Tailings placement in NW corner
