## **Greens Creek Mine Inspection Report**

**Inspection Date:** April 29 2025  
**Time:** 7:00AM to 4:00PM  
**Weather:** Light rain, scattered low thick broken clouds and high overcast  
**Agency Personnel:** Jesse Garnett White, Carolyn Curley, Jenny March, Jonathan Kummer, and Steve Buckley  
**Operator Contacts:** Paula Lillesve, Jennifer Stoutamore, and Todd Atwood  
**Inspection Objectives:** Site Inspection

The DNR inspection is based on the Hecla Greens Creek Mine Reclamation Plan Approval (No. J20202682RPA Extension) and focused on documentation of and compliance with State of Alaska reclamation requirements. Inspection routes were tracked with GPS. A drone was deployed to capture aerial imagery of the tailings disposal facility (TDF), and photos were taken at other inspection sites. Primary objectives for the field inspection were to review sites of active disturbance, water management, and reclaimed areas. Major facilities at the mine include the 920 Area, 1350 Area, 860 Area, Site 23 waste rock storage facility (WRS), tailings disposal facility (TDF), water treatment plant (WTP), water diversion system and ponds, material and growth media sites, roads and bridges, You

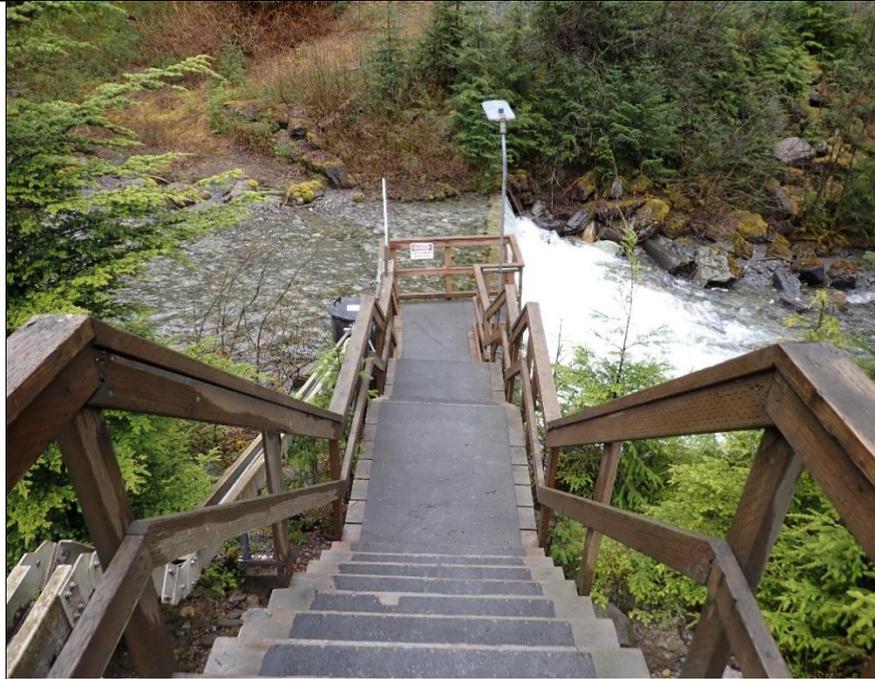
B-Road was in adequate condition from Hawk Inlet to the 920 Area. The 920 Area was also in good condition at the time of inspection (Map 2, Photos 1-6). We viewed the weir in Greens Creek above the 920 Portal bridge and below the pumphouse followed by a brief tour of both the pumphouse and filtration system building. Everything was in good working order. Mine traffic to and from the 920 Portal was regular and steady. The entire 920 Area including the bridge was very muddy due to recent precipitation and snowmelt. The splash guards on the bridge were working, looked well maintained, and didn't exhibit any damage. There was minor damage to the guardrail. The Degrit Basin 001, Pond-A access road, and Pond-A were also in good working condition. Pond-A was receiving mine site contact water and the liner above the water line did not exhibit any damage.

Photo 1: Stairway to Greens  
Creek Weir upstream from  
920 Portal Bridge.

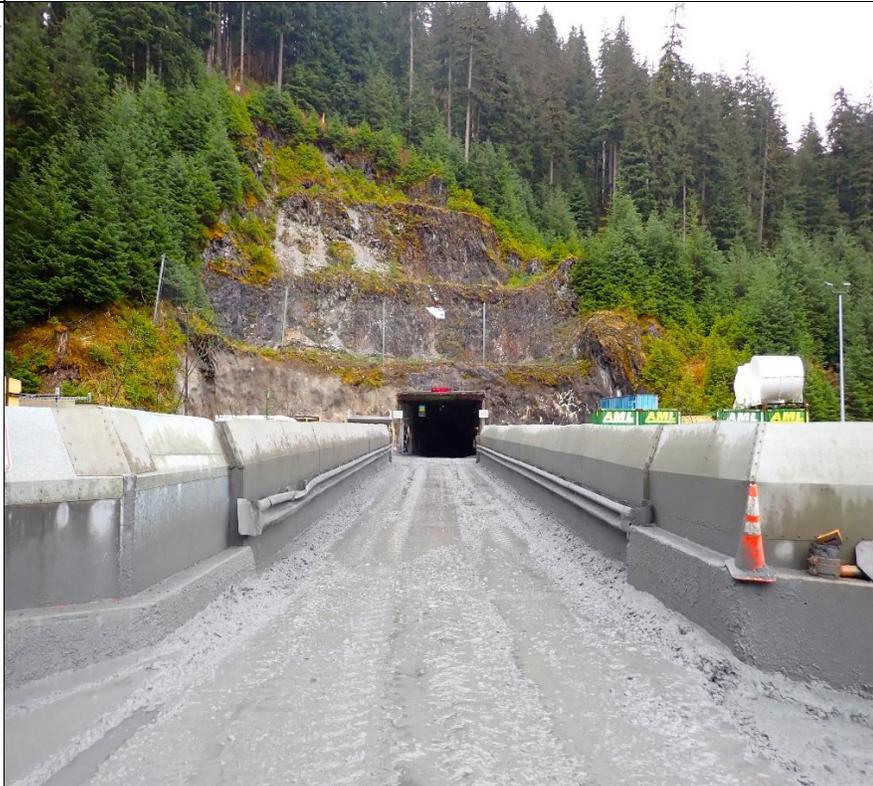
Photo 4: 920 Area Portal and Bridge over Greens Creek. Note the splash guards on the bridge to help prevent mud and sediments from entering Greens Creek.

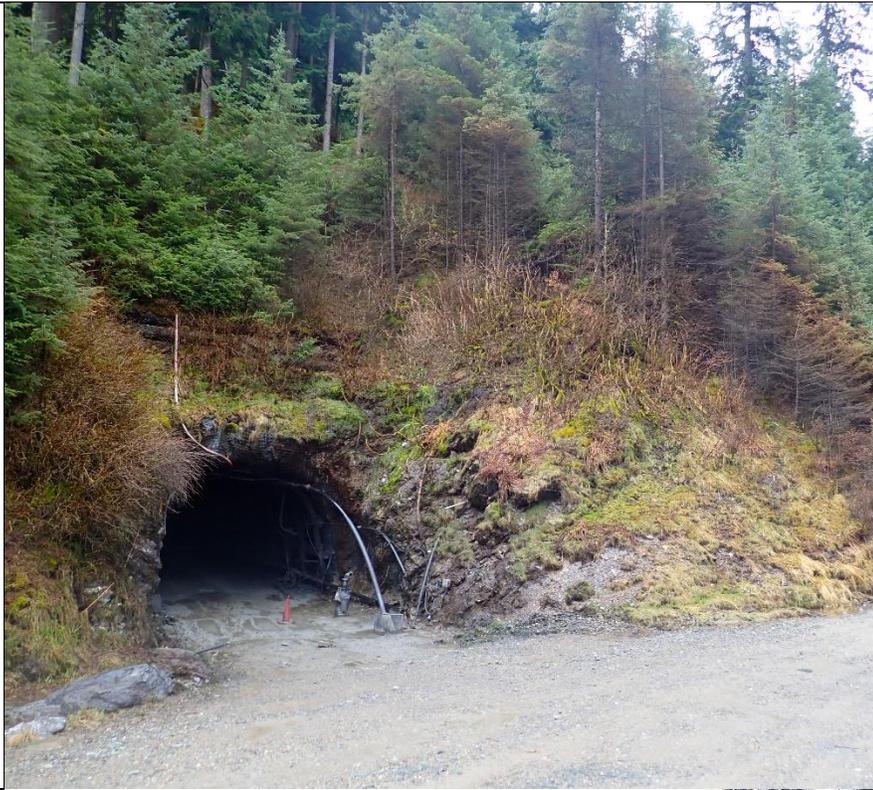
At the 1350 Portal (Map 2, Photos 7-8) we observed the water collection pond, slopes around the pond, and the portal. The collection pond had a small amount of water present, and the slopes are well vegetated with grass and small trees. The portal is currently being used as an escapeway and mine exhaust. The area immediately above and on either side of the portal is heavily vegetated with grass and trees.

Photo 7: 1350 Area Portal exhaust and escapeway.

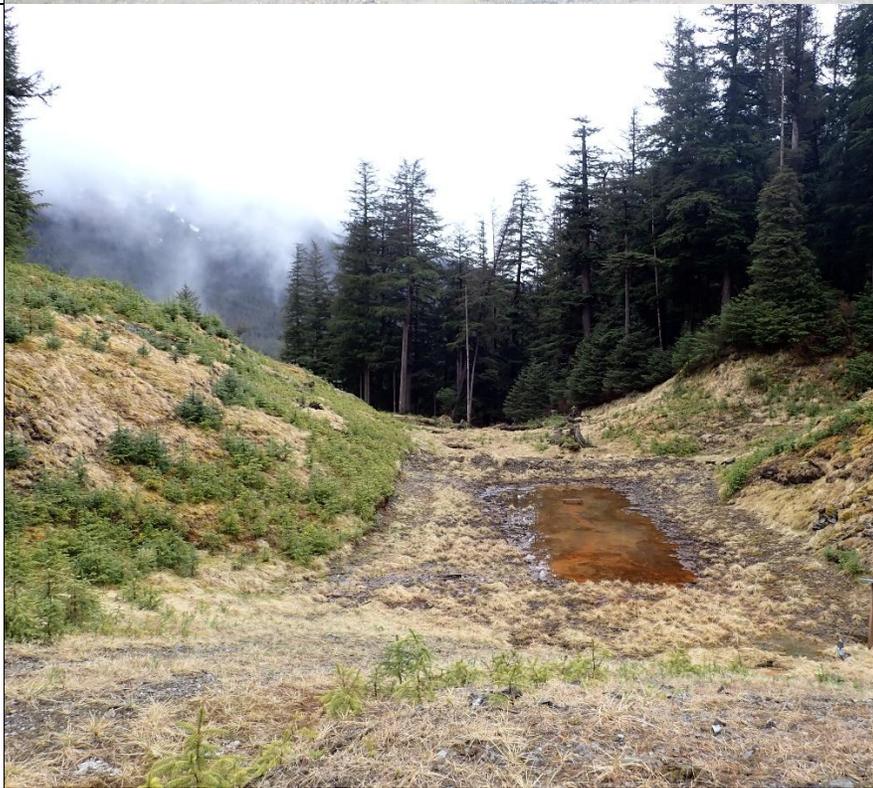
Photo 8: 1350 Area seep collection structure.

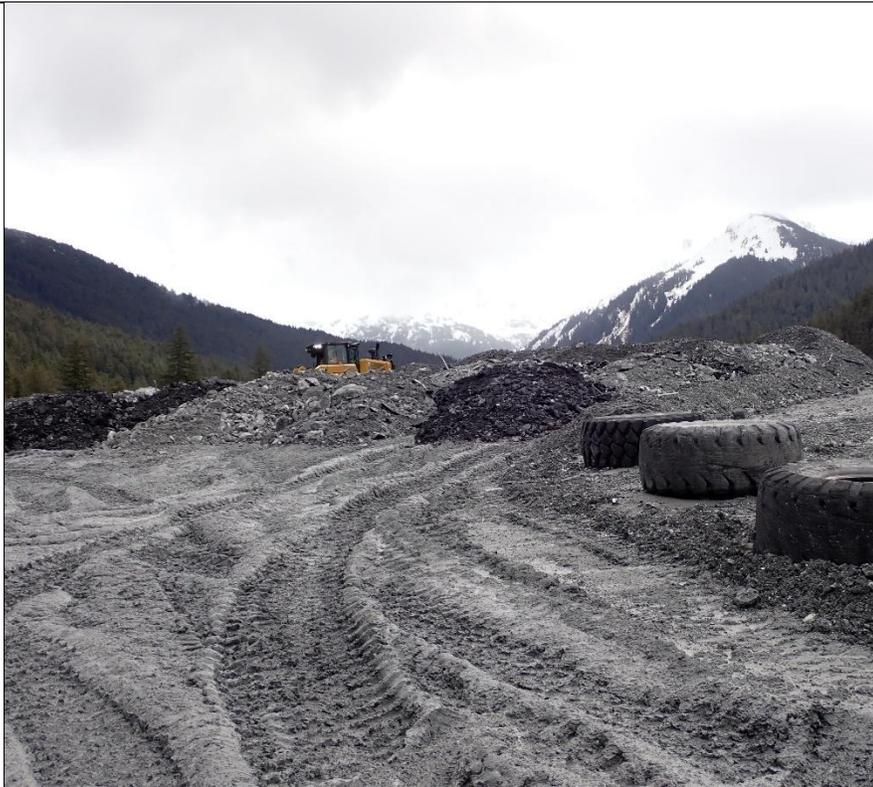
At the time of inspection, Site 23 WRS Placement Areas (Map 2, Photo 19) were active with an operating bulldozer and single drum roller. Class 1, 2, and 3 waste rock are deposited at this location. We did not leave the vehicle due to conditions on the ground and activity. Reclaimed and stabilized areas on the flanks and lower slopes of the WRS are well established. Material that is not currently stabilized with vegetation is graded and maintained.

Photo 19: Top of Site 23  
WRS.

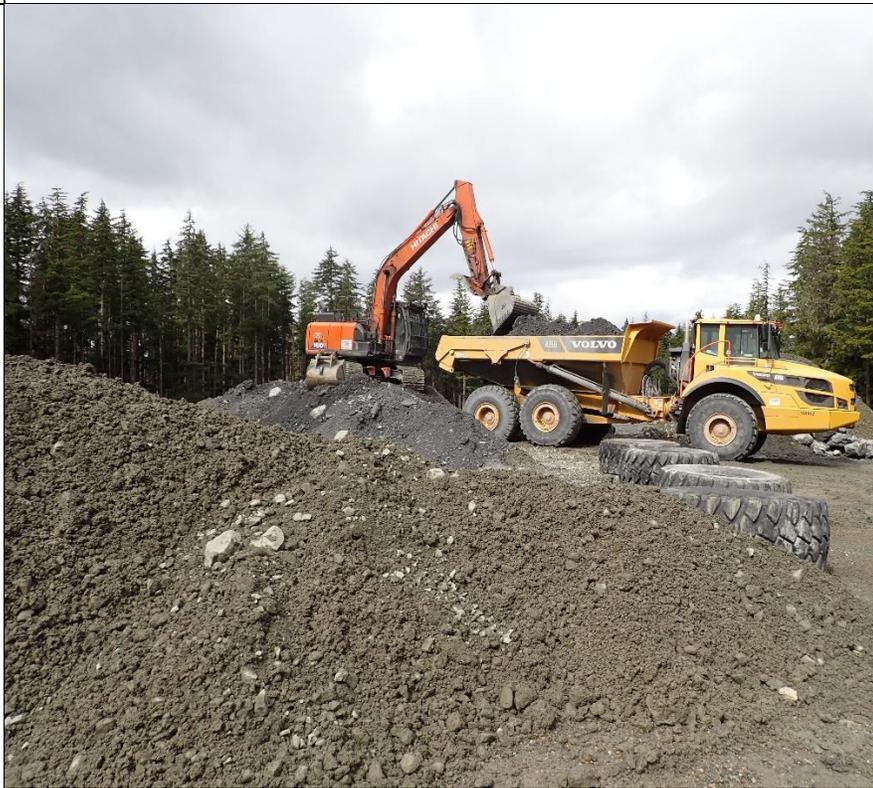
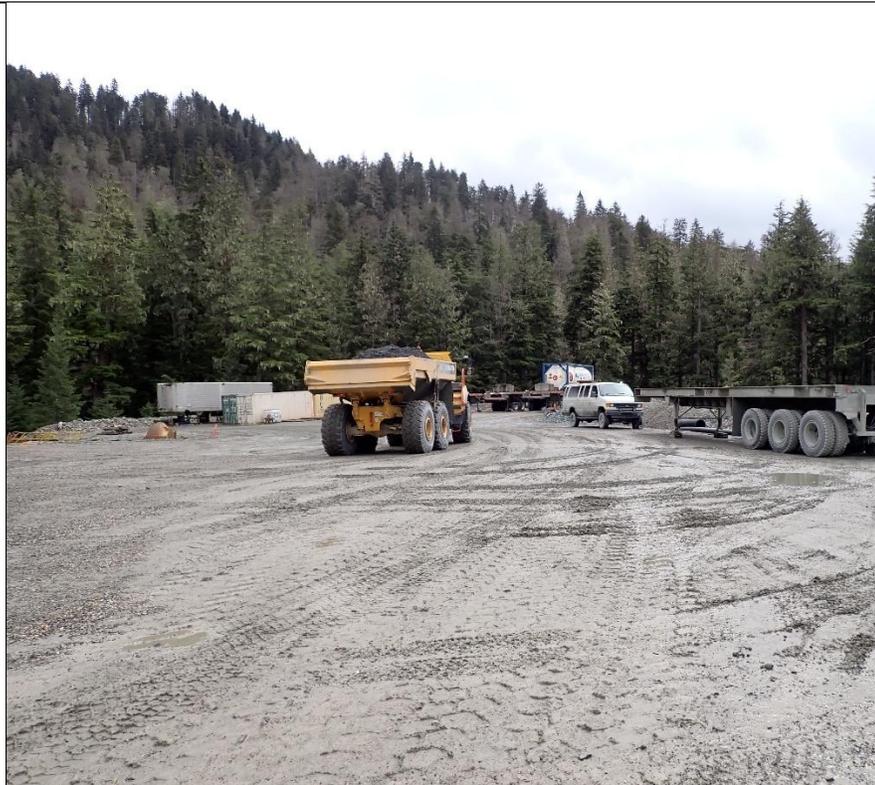
At the time of inspection, the area was active with an operating excavator and articulated dump truck. We were able to leave the vehicle briefly during work stoppage. The area was graded with berms with parts of the site being used as a laydown yard, storage area, and material site (gravel pile). (Map 3, Photos 22-23).

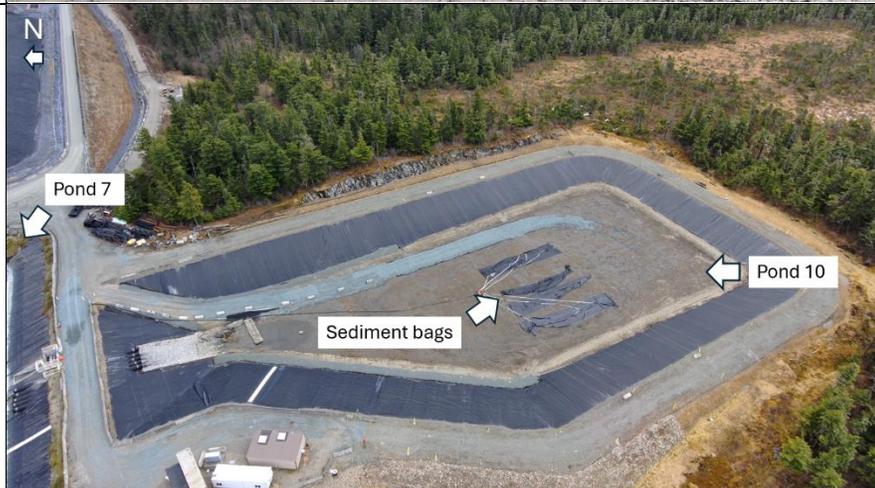
Ponds 7 and 10 are located at the southwestern end of the TDF near the WTF. Pond 10 was nearly devoid of water except for accumulated rainwater. Mine site water was actively discharging into Pond 7 (Photo 25) creating a sediment delta. There was an active dredge operating in the pond.

Photo 24: TDF – Pond 10 including staged sediment (dewatering) bags.

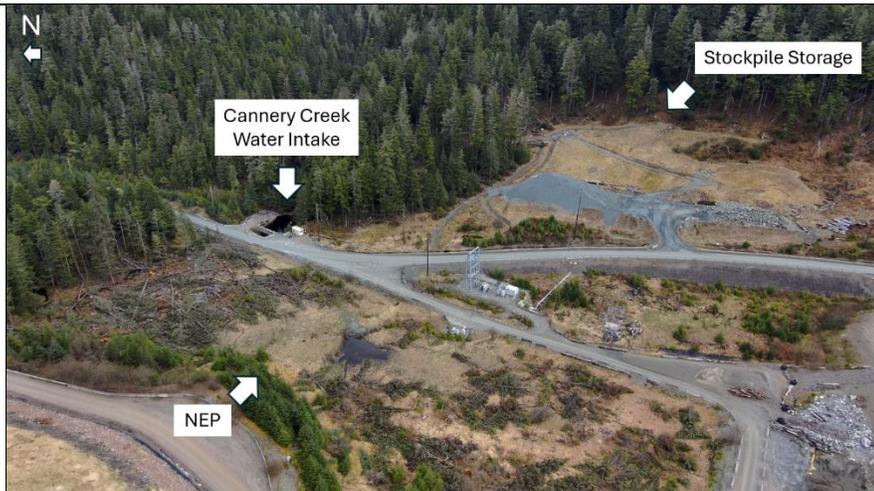
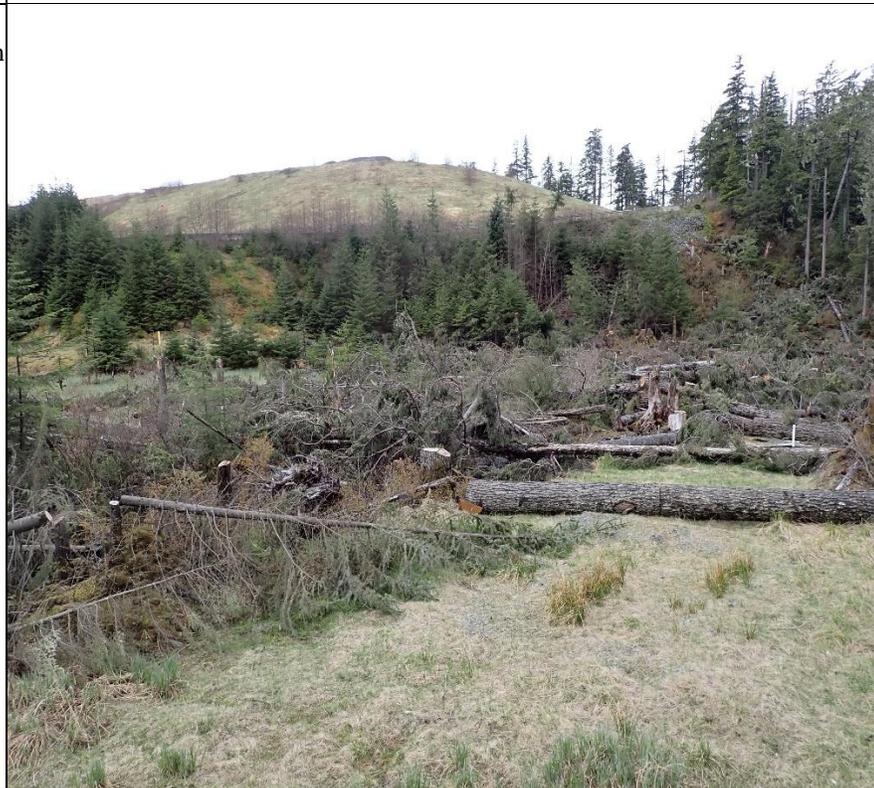
The Wetlands Area north of Pond 9, North Expansion Project (NEP) was in the beginning phases of Stage 1. Trees had been felled in the Wetlands Area but not removed at the time of inspection (Photo 29-30).

Photo 29: TDF – Stockpile Storage Area, Cannery Creek Intake, and Northern Expansion Project (NEP).

Photo 30: Northern Expansion Project Area from B-Road.

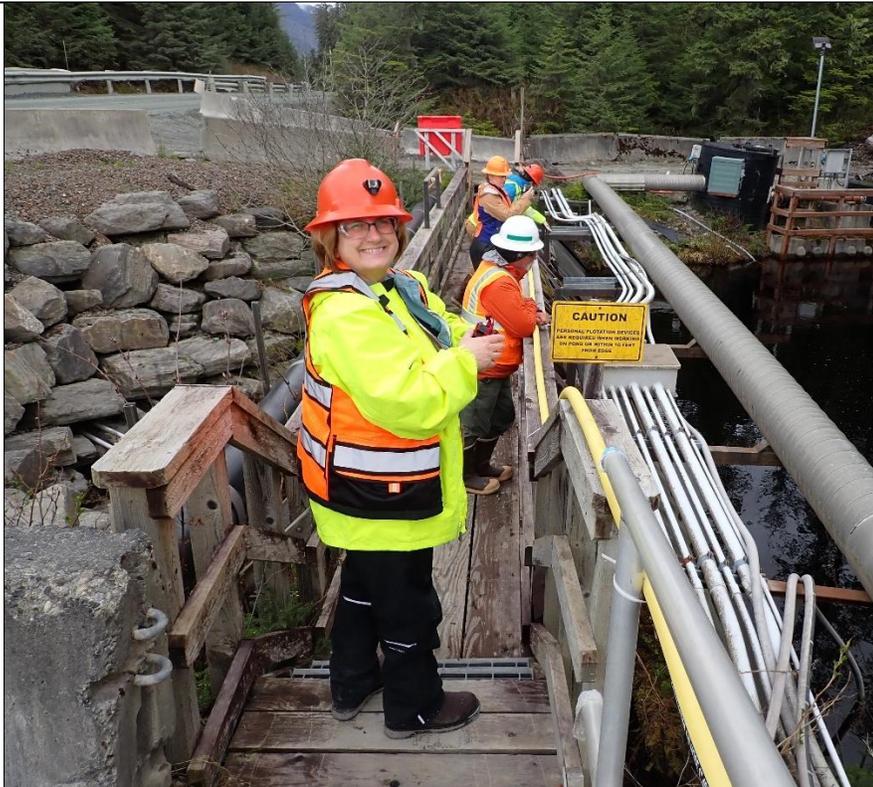
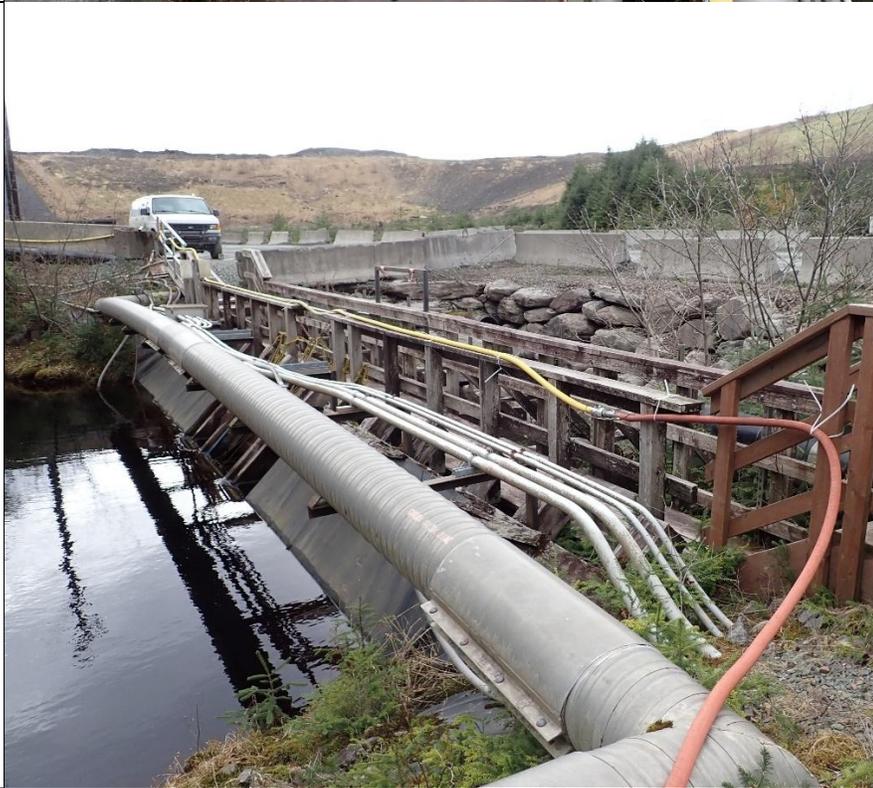
We also visited Cannery Creek Water Intake where everything was in good working order (Photos 31-32).

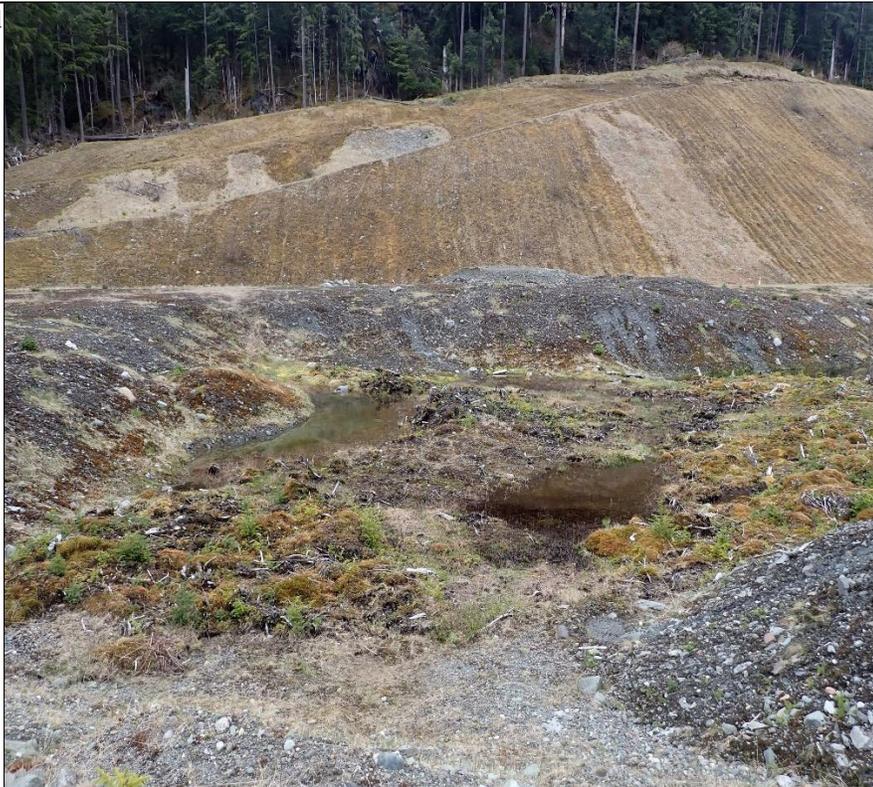
A-Road was in adequate condition during the inspection. Reclamation surrounding Sand Pit was stable with various grasses, ferns, and small tree growth. This area was reclaimed about 5 years ago, which gives an indicator at the rate re-vegetation is occurring. The graded eastern slopes were also stable and in good condition. The pit contained water and growth media including peat, various grasses, and woody debris. The spillway was well above the current pit water level and in good condition. Some flat areas along the access road surrounding the pit are now temporary laydown and storage sites (Map 5, Photos 33-35).

Photo 33: Sand Pit reclaimed slopes. Peat and organics in water collection pond.

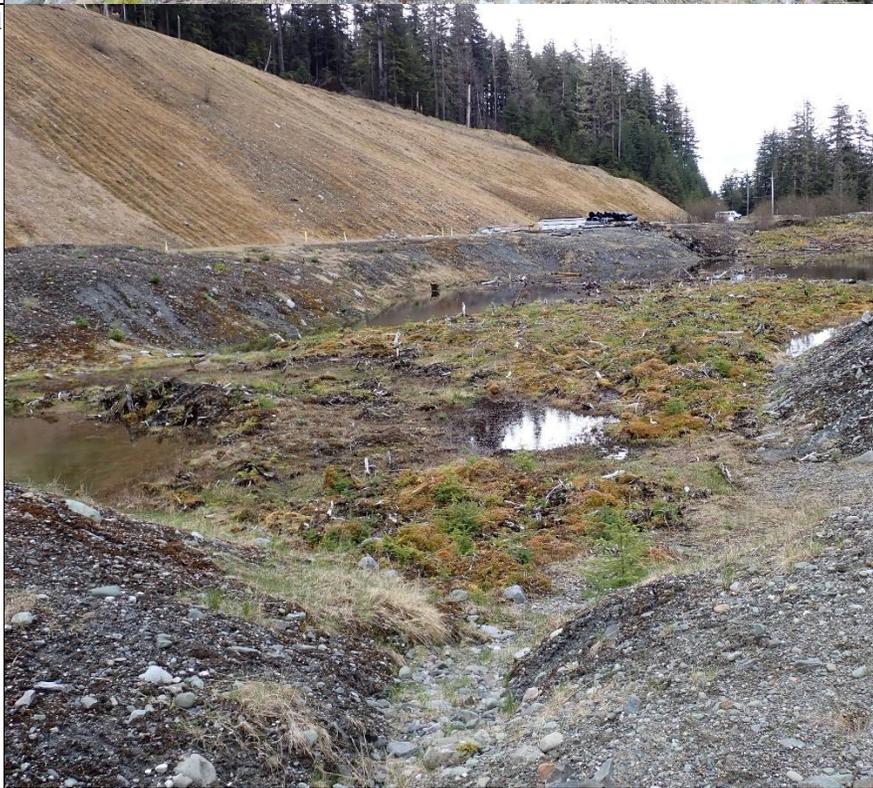
Photo 34: Sand Pit reclaimed slopes. Peat and organics in water collection pond.

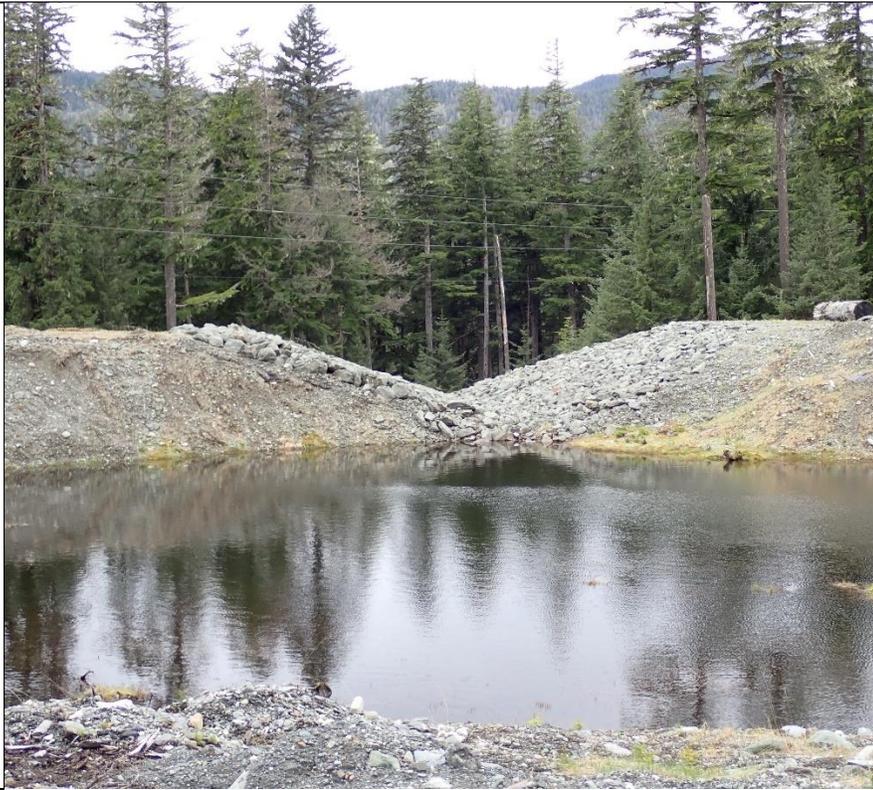
Photo 35: Sand Pit Dam and spillway.

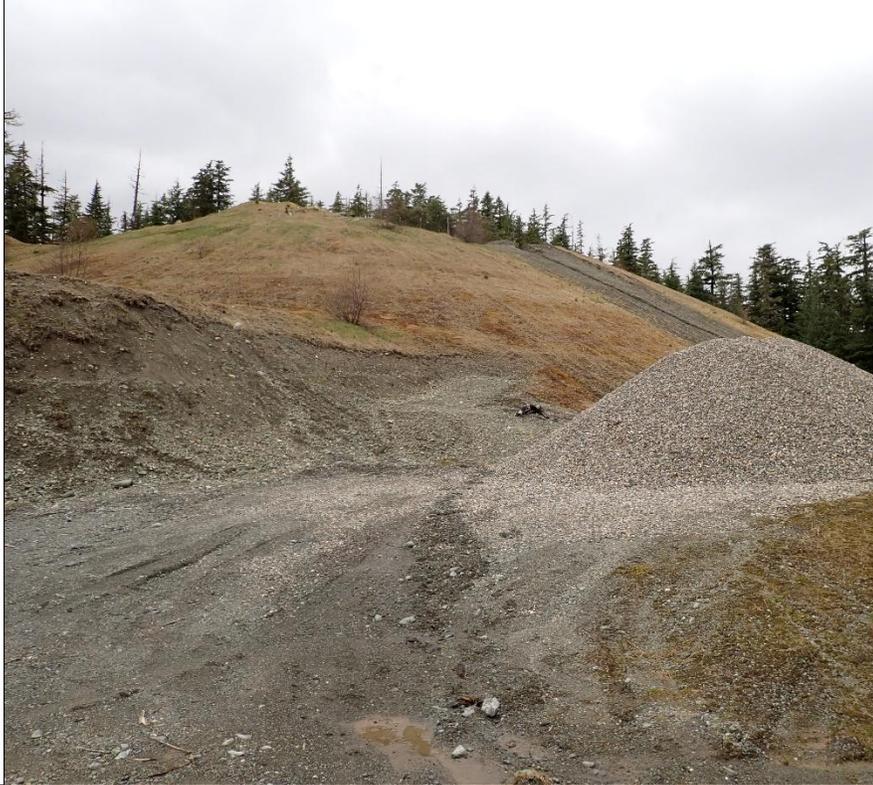
Photo 36: Pit 7

Pit 7 was previously a rock quarry but is now a stockpile for material brought in for the road. The slopes of the older portion of the material site have been graded, stabilized, and re-seeded, except for a minor slump exposing gravels. There is some erosion that has occurred in the reclaimed area. It has not changed significantly since our previous visit. At the time of inspection there were some rusting pipes, piles of gravel, and boulders (Map 5, Photos 36-37). Supersacks on site contain clean material for the paste plant.

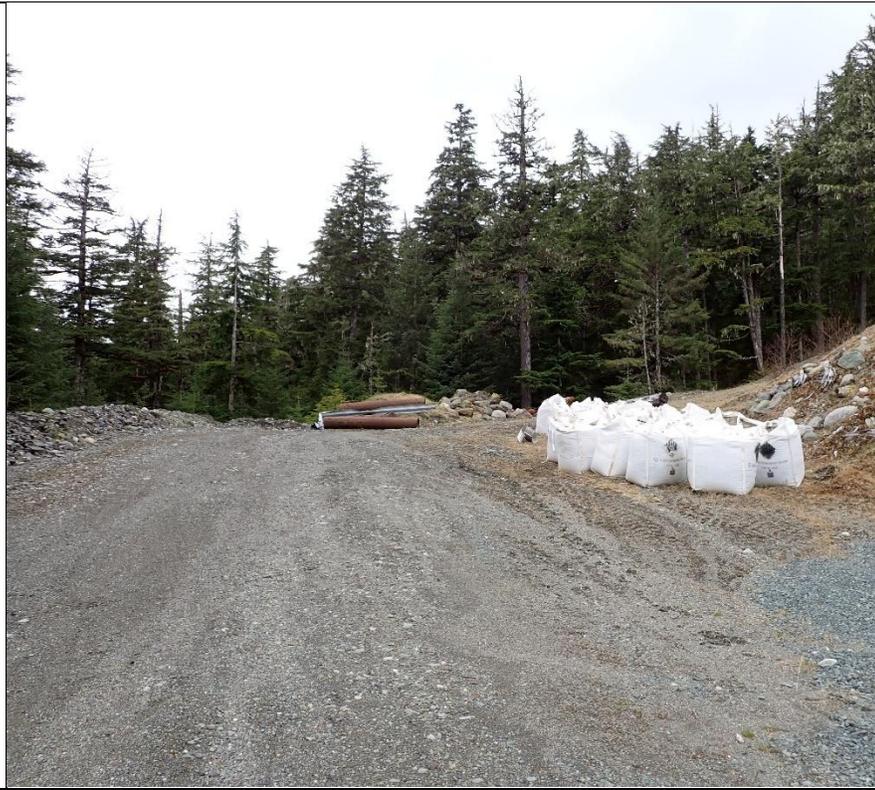
Photo 37: Pit 7 laydown including supersacks filled with clean material for the paste plant.
