## INSPECTION REPORT: GREENS CREEK MINE

Date of Inspection: Thursday, June 8, 2017  
Date of Report: Friday, July 7, 2017  
USDA Forest Service Inspector: Richard Dudek

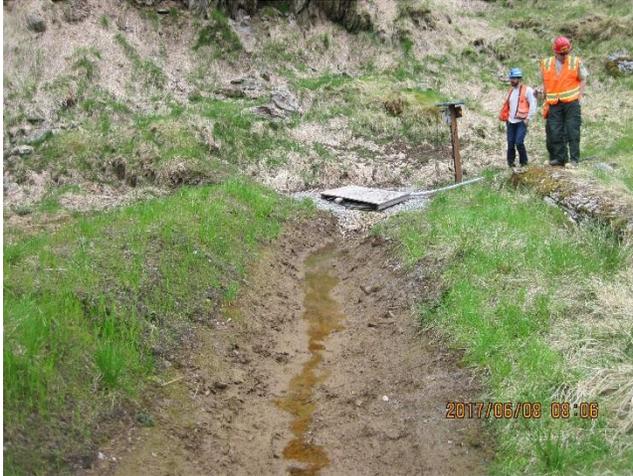
The pump for the 1350 area was in place for the summer months (Photo 1). Since the installation of the trench and pump, water quality testing results from FWMP site 13 show that zinc levels have decreased. The water collected in the 1350 trench/sump is pumped into the 1350 adit and then piped to Pond A. The water will be treated and discharge under the current APDES permit.

**Photo 1. Pump and trench located in the 1350 area.**

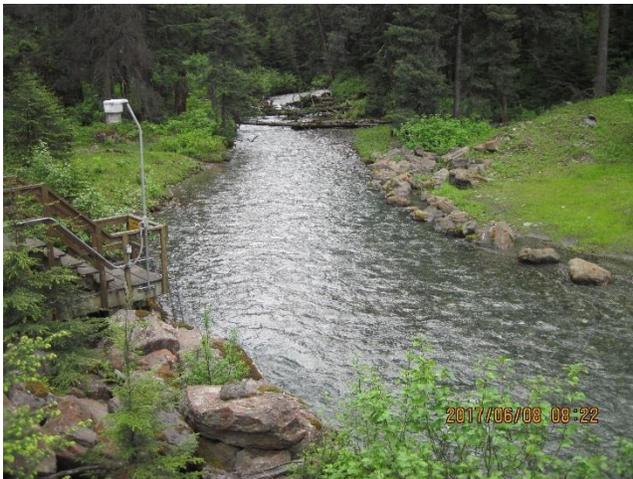
The flow for Greens Creek (Photo 2) was 88 cubic feet per second (cfs), and HGCMC Surface Operations are properly maintaining the 920 portal bridge (Photo 3).

**Photo 2. Greens Creek (920 area).**

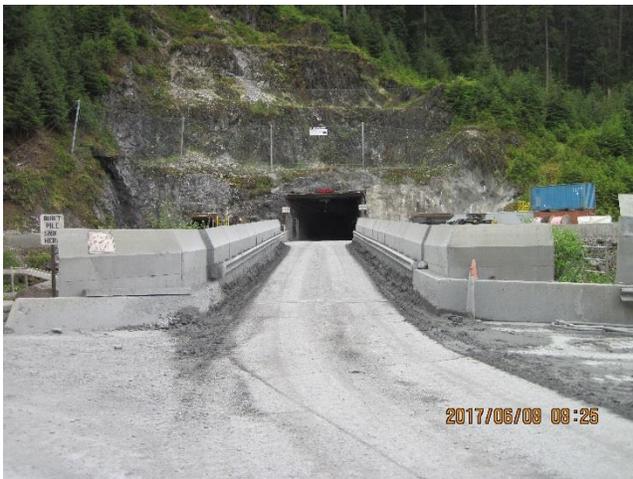
**Photo 3. 920 bridge.**

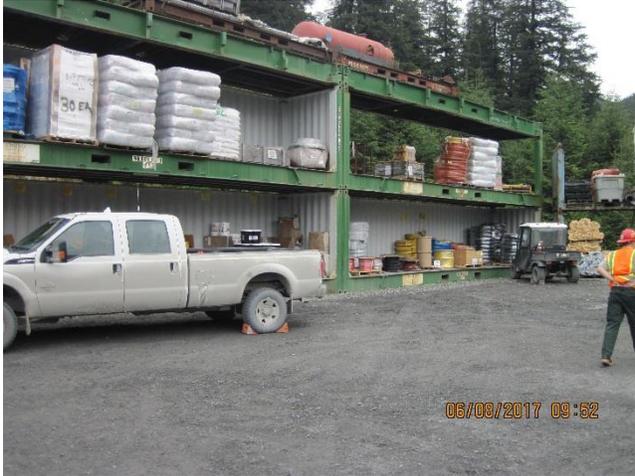
The 920 warehouse area was tidy and in order (Photo 4).

**Photo 4. 920 warehouse area.**

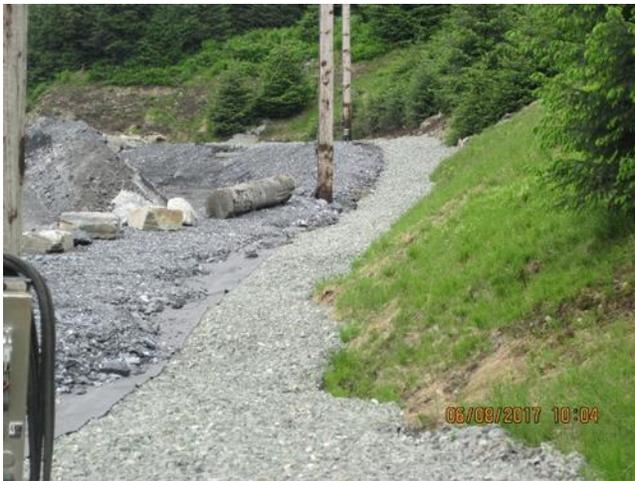
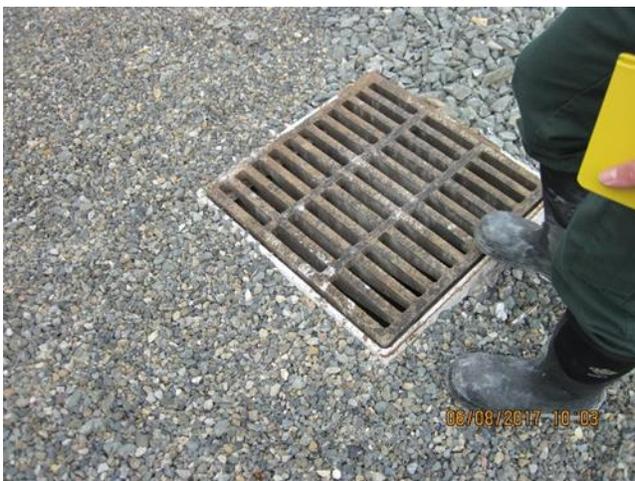
The construction for the 920 area contact water drainage is completed (Photos 5-6). The improvements made will help minimize maintenance of the area. The contact water will be routed to Pond A, and then piped to Pond 7 for treatment and discharged under the current APDES permits.

**Photo 5. 920 ore pad/warehouse improved contact water drainage (Image 1 of 2).**

**Photo 6. 920 area improved culvert for routing contact water to Pond A (Image 2 of 2).**

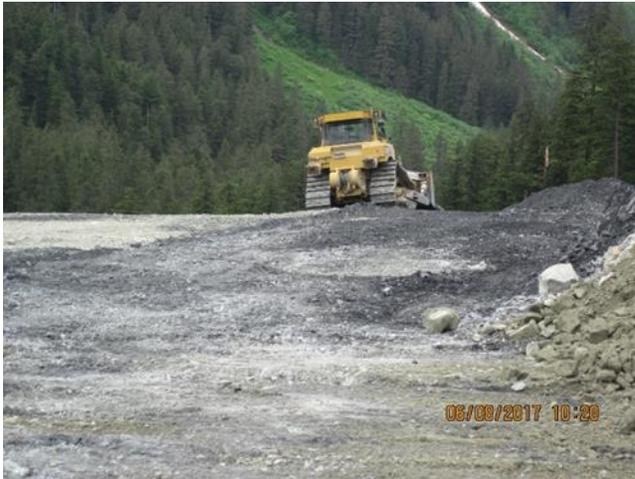
HGCMC continues to place class 2/3 waste rock (Photo 7) at this site (Appendix 1; Section 3.1).

**Photo 7. Site 23 class 2/3 waste rock.**

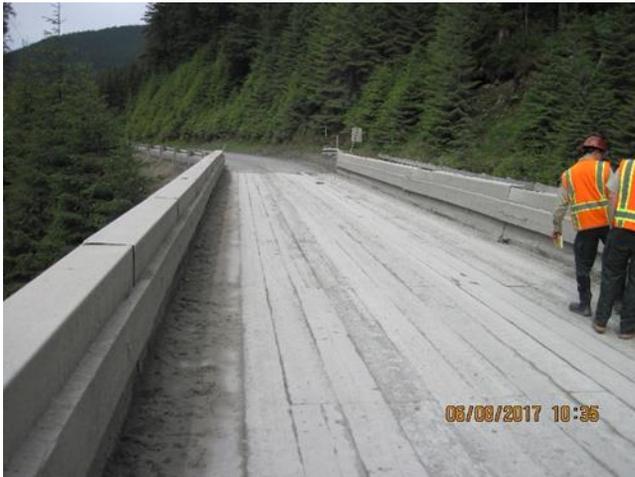
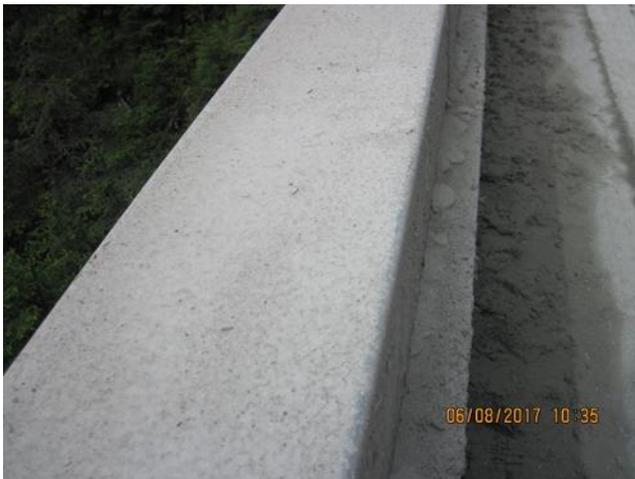
**Photo 8. 7.4-mile B-road Bridge (Killer Creek Bridge).**

**Photo 9. Sediment build up on the rails for 7.4 mile B-road Bridge.**

Surface Operations will be installing splashguards along the bridge (Photos 8-9) once the other B-road bridges are completed. The splashguards will help prevent sediments from accumulating on the rails and splash over from vehicle traffic on the bridges.

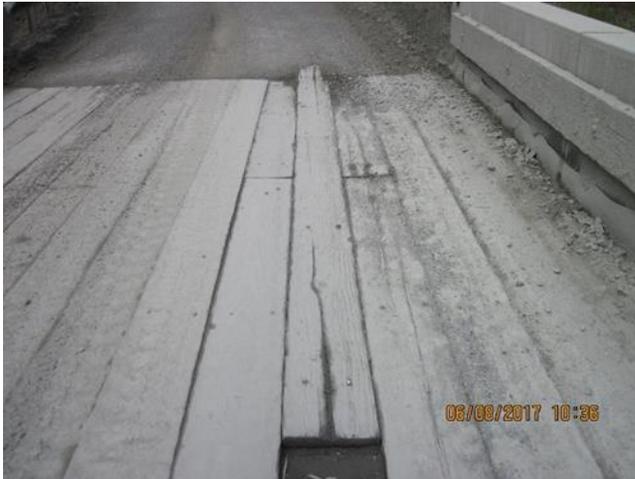
Some of the wear layer boards for the bridge need to be replaced (Photo 10), and the downhill side abutment of the bridge requires a more effective liner to prevent sediments from entering into the creek (Photo 11).

**Photo 10. Boards for the wear layer need to be replaced (7.4-mile B-road Bridge).**

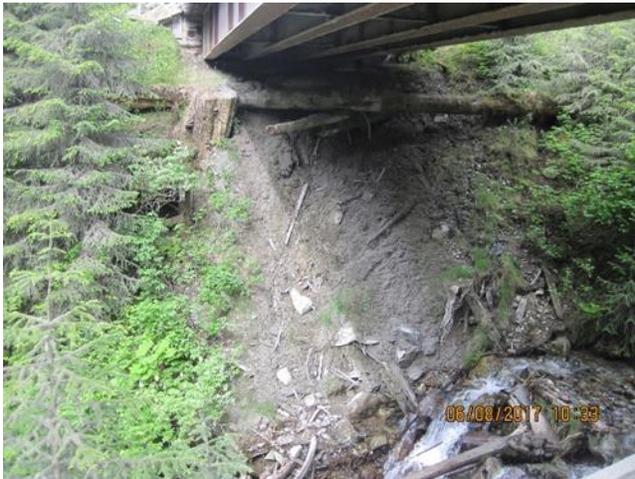
**Photo 11. The downhill side abutment (7.4-mile B-road Bridge).**

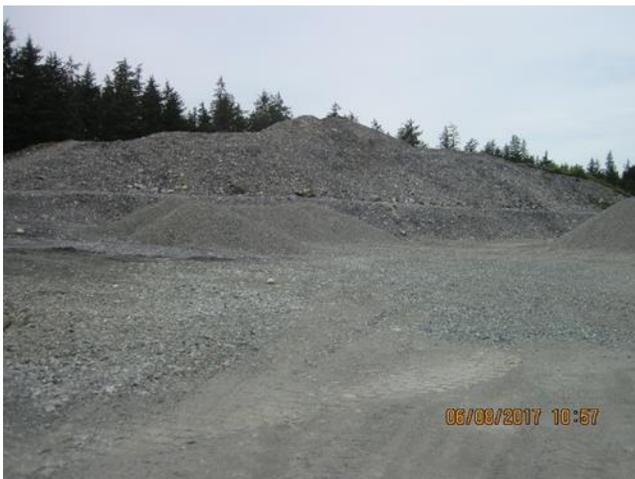
The material stockpiled (Photo 12) at Waste site E is from the construction of the 920 area. The lined retention pond has an electric fence (Photo 13) around the perimeter to prevent wildlife from entering the pond. During the site visit, reddish color seepage was observed on the western side of the stockpile (Photo 14). HGCMC annually monitors Site E's downgradient water quality and reports in the Annual Inactive Reports and quarterly reports as part of the Integrated Waste Management Permit. Since the monitoring began in 2003, the pH remains neutral at Site E.

**Photo 12. Site E (B-road).**

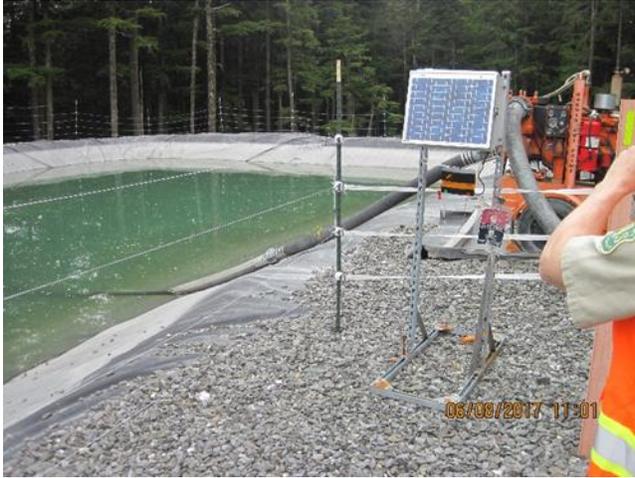
**Photo 13. Site E's retention pond with an electric fence around the perimeter.**

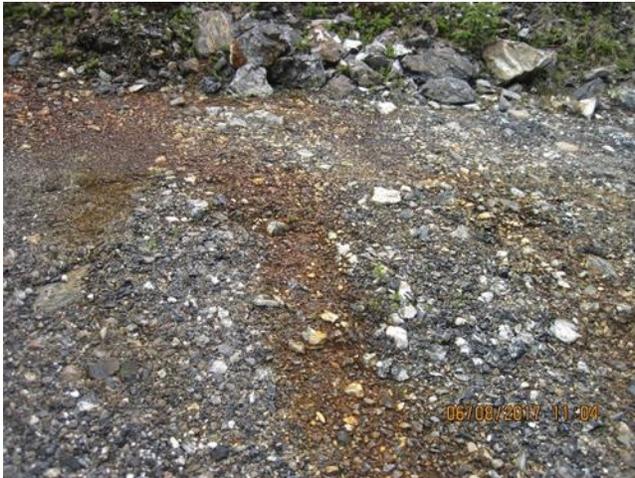
**Photo 14. Reddish color seepage was observed on the west side of Site E's waste rock pile.**

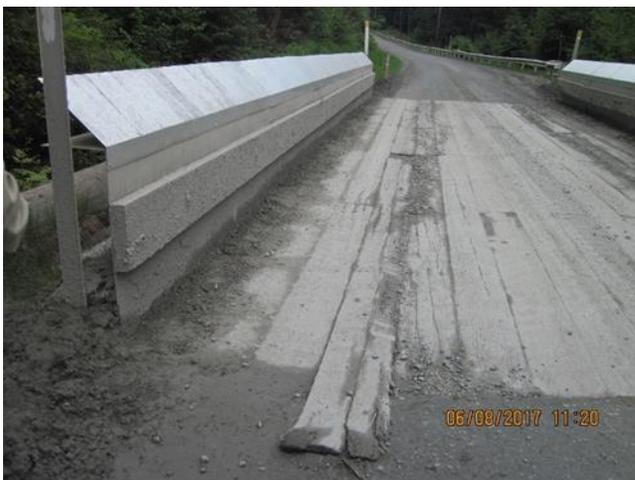
Surface Operations have installed splashguard along the rails of the bridge (Photo 15). Some of the bridge wear layer boards need to be replaced (Photo 15), and sedimentation is still occurring below the bridge (Photos 16).

**Photo 15. 3.4-mile B-road bridge (Falls Creek Bridge).**

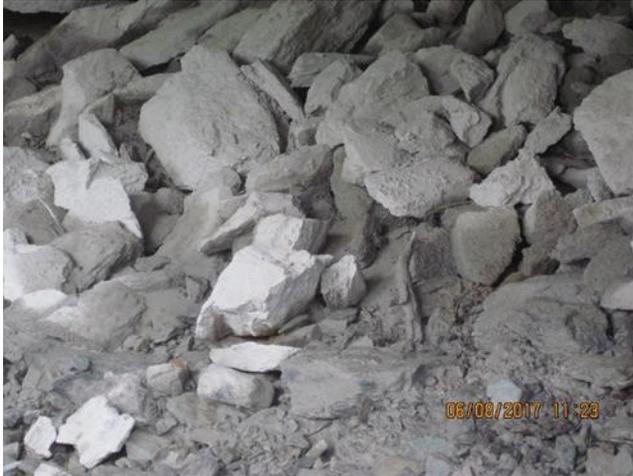
**Photo 16. Sediment accumulation underneath the 3.4-mile B-road Bridge (Falls Creek Bridge).**

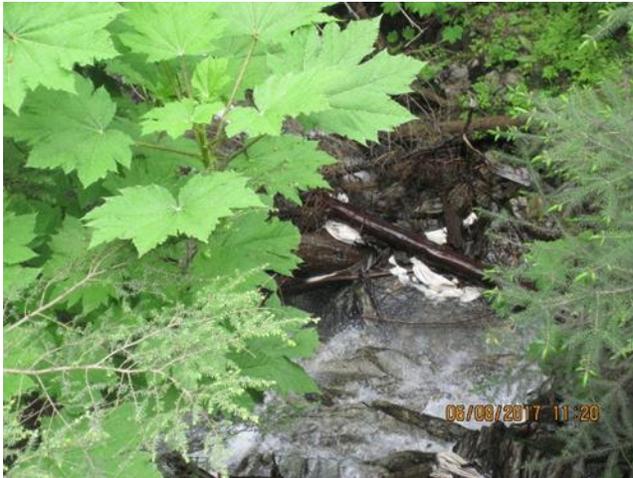
In 2016, high flows washed out the sandbags below the bridge. The sandbags are still in the creek and need to be removed (Photo 17). HGCMC is working on a safety plan for personnel during removal of the sandbags.

**Photo 17. Sandbags are still in Falls Creek.**

- 3.2-mile B-road culvert: Sediment filters need to be installed.
- 3.4-mile B-road Bridge: Sand bags are still in the creek and need to be removed.

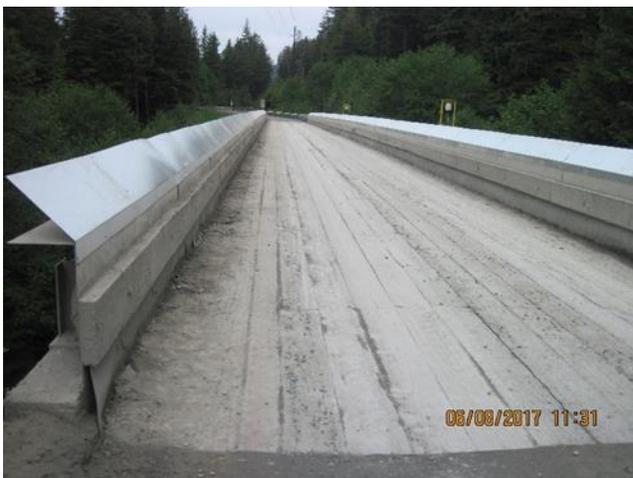
The new splashguards (Photo 18) attached to the rails for Zinc Creek Bridge.

**Photo 18. 3.0-mile B-road Bridge (Zinc Creek Bridge).**

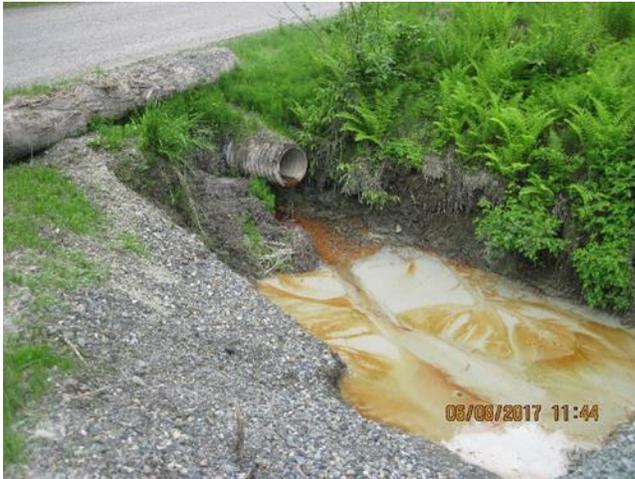
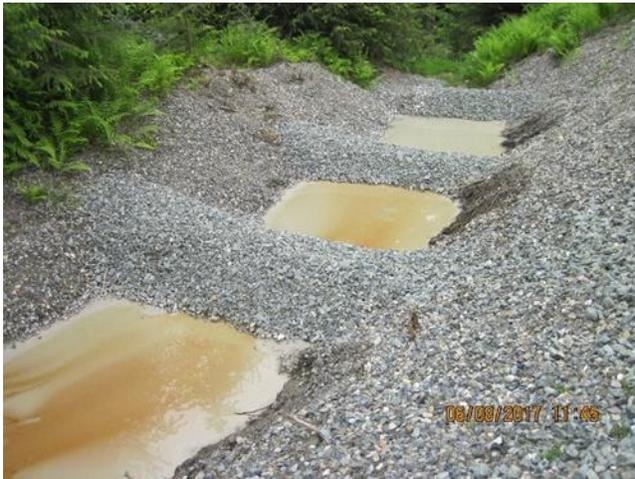
The settling ponds and rock check dams for a culvert at 3.2-mile B-road require improvements (Photos 19-20). Turbid water was observed after the BMP structures and possibly entering into the forest

**Photo 19. 3.2-mile B-road culvert.**

**Photo 20. Sediment filters need to be installed.**

(Photos 21-22). Sediment filters should be installed to capture sediments that pass through the rock check dams.

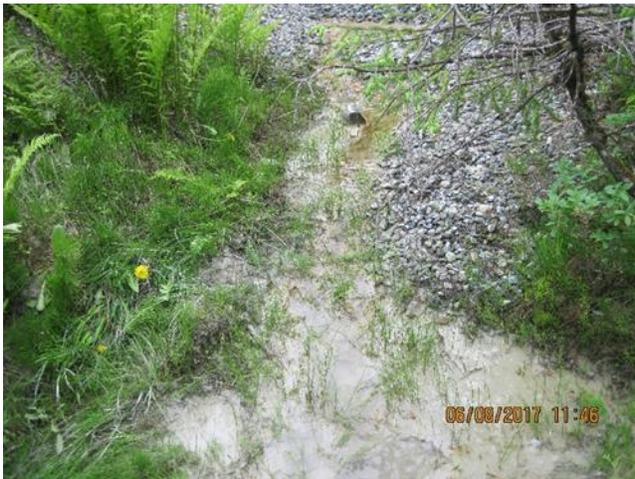
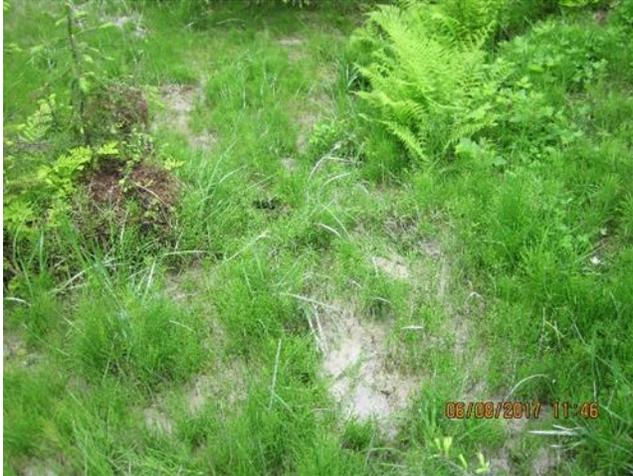
**Photo 5. Turbid water was observed beyond the rock check dams (Image 1 of 2).**

**Photo 6. Turbid water in the vegetation (image 2 of 2) (3.2-mile B-road culvert).**

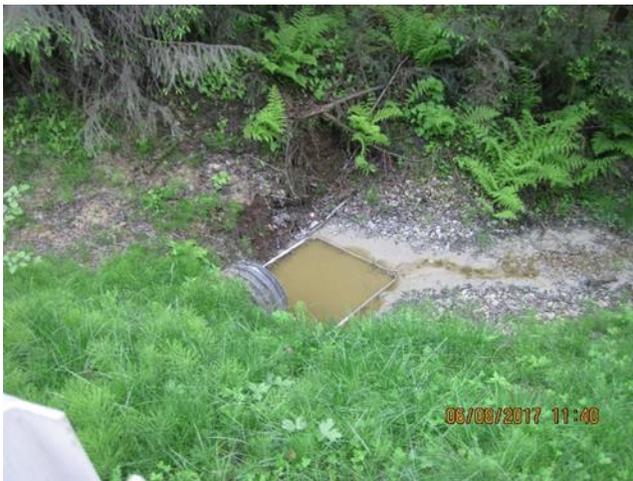
The 3.1-mile B-road removable sediment screen needs to be cleaned out (Photo 23). Sediment accumulation has exceeded the maximum capacity for the screen (75%), and is no longer effectively containing sediments.

**Photo 7. 3.1-mile B-road removable sediment screen.**

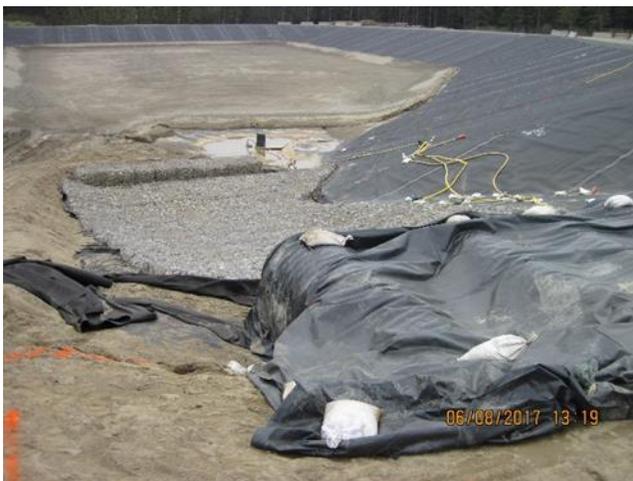
The construction for Pond 10 is near completion (Photo 24).

**Photo 8. TDF area Pond 10.**

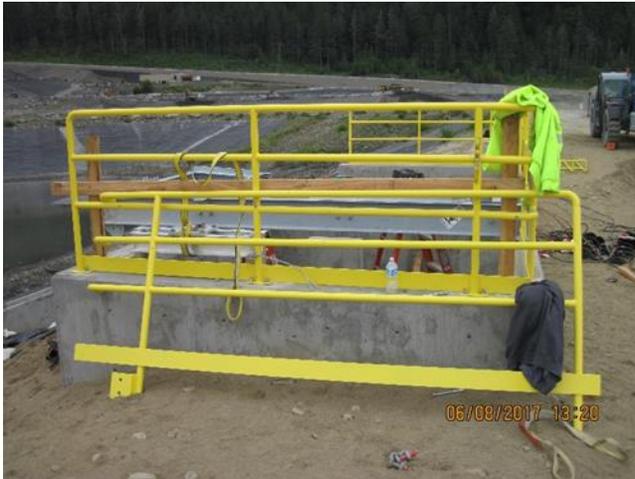
A concrete surge flow (Photo 25) was constructed between Pond 7 and Pond 10 to allow water to flow from one to another in the event of a major storm occurs.

**Photo 9. The concrete flow control structure was constructed between Ponds 7 and 10 (TDF area).**

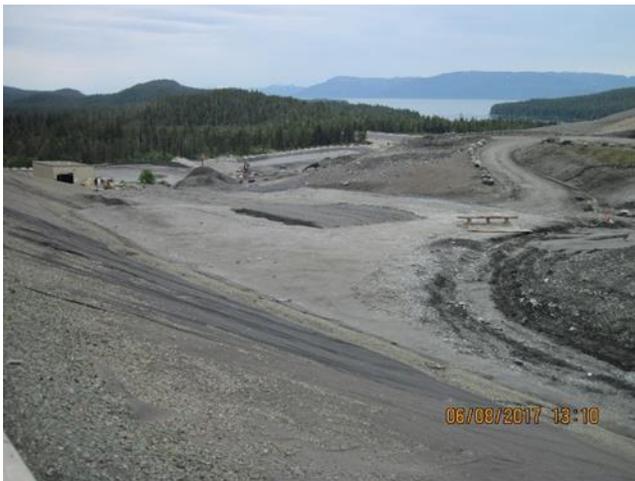
HGCMC continues to place tailings in the S3P1 southern end of the TDF area (Photo 26). Approximately 145.592 yd<sup>3</sup> of material has been placed in the S3P1 area (including 1175 yd<sup>3</sup> of process sand).

**Photo 10. HGCMC continues to actively place tailings at the East Ridge and S3P1 area of the TDF.**

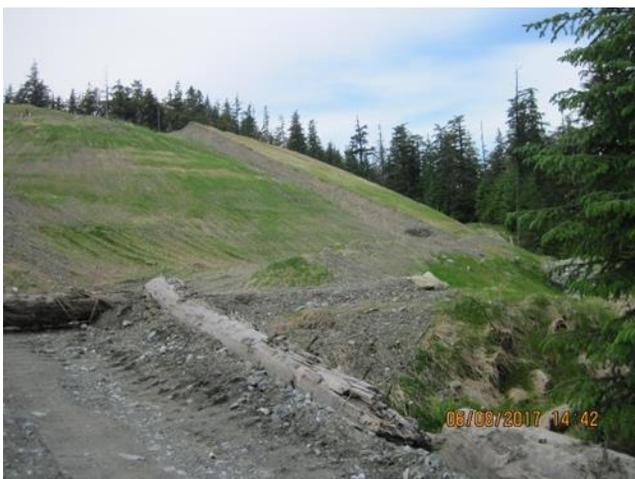
There has been no recent activity at this location (Photo 27).

**Photo 11. Pit 7.**

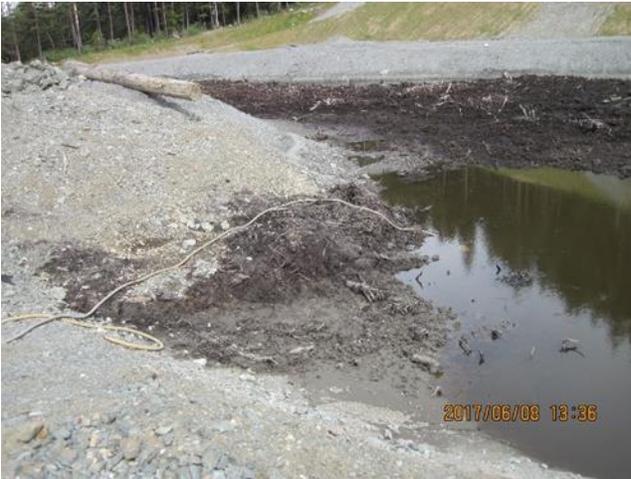
HGCMC Surface Operations installed a pump to remove water inside the sand pit (28). The accumulation of water is from surface runoff and wet soils in the pit. The water is being pumped into the riprap channel, then into a culvert, and finally into the forest duff.

**Photo 12. Sand Pit.**
