## INSPECTION REPORT: GREENS CREEK MINE

Date of Inspection: Friday October 6, 2017  
Date of Report: Wednesday, October 25, 2017  
USDA Forest Service Inspector: Richard Dudek

Ranger District: Admiralty National Monument, Juneau Ranger District  
Weather Conditions: Cloudy with some rain Temperature: mid 40's (°F).

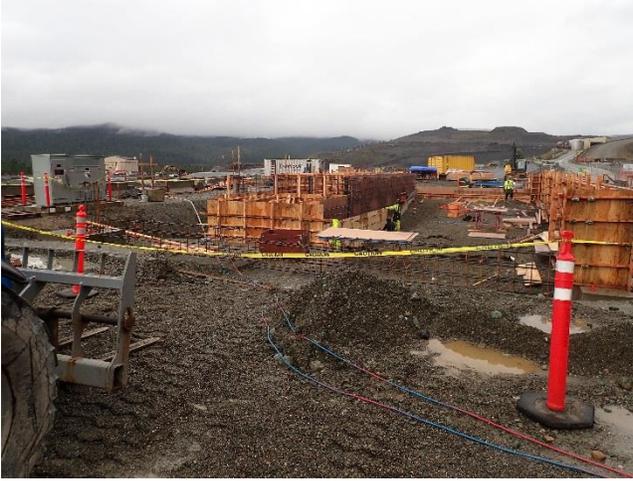
Contractors continue with the construction of the new wheel wash station for the TDF area (Photo 1). A temporary cement batch plant is staged at the Hawk Inlet facilities (Photo 2) and is currently being utilized to generate the concrete for the wheel wash station.

**Photo 1. The new wheel wash facility is currently under construction at the TDF area.**

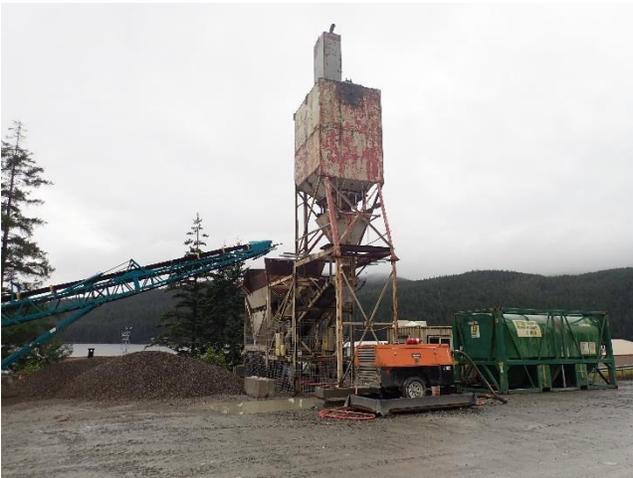
**Photo 2. The temporary cement batch plant located at the Hawk Inlet facilities.**

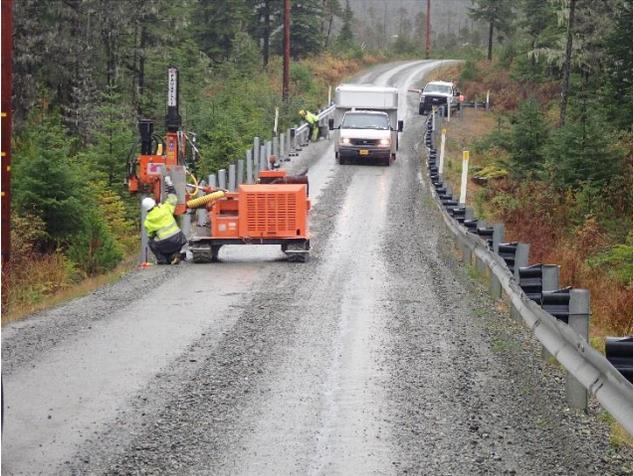
At the time of the inspection, sections along the B-road have developed erosional features (potholes and wash boarding), which will require maintenance. However, Surface operations are scheduled to conduct routine maintenance on the access roads later on in the day (Appendix 8 Road Operations and Maintenance; Table 8.1). During the inspection for the sites located along the A-road, contractors were installing guardrails (Photo 3) in the vicinity of the 2-mile marker (Photo 3). Therefore, the entire A-road system could not be driven during the inspection.

**Photo 3. Contractors installing guardrails along the A-road.**

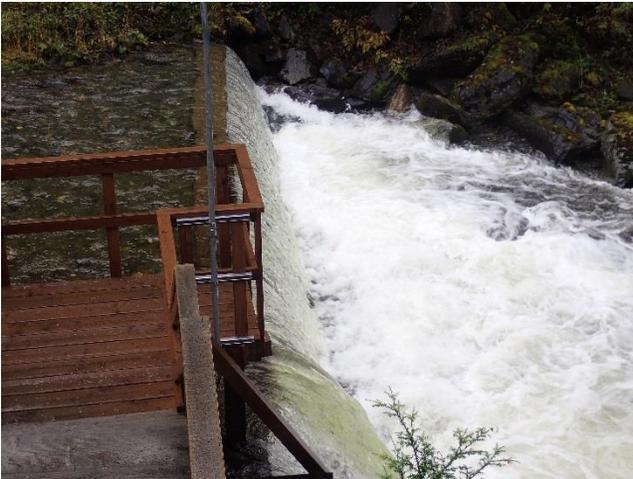
The recorded flow rate for Greens Creek (Photo 4) on 10/06/2017 was 66.6 cubic feet per second (cfs), and the water withdrawal for the 920 water system remains at 1.5 cfs.

**Photo 4. Greens Creek weir.**

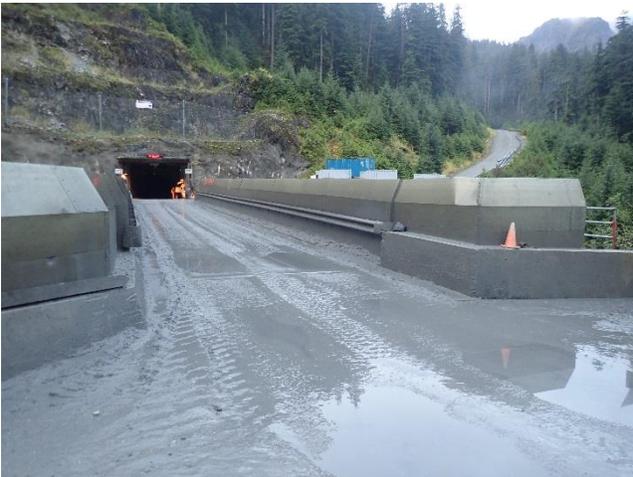
**Photo 5. 920 Bridge**

HGCMC Surface operations are properly maintaining the 920 Bridge, and sedimentation at the bridge ends was minimal (Photo 5).

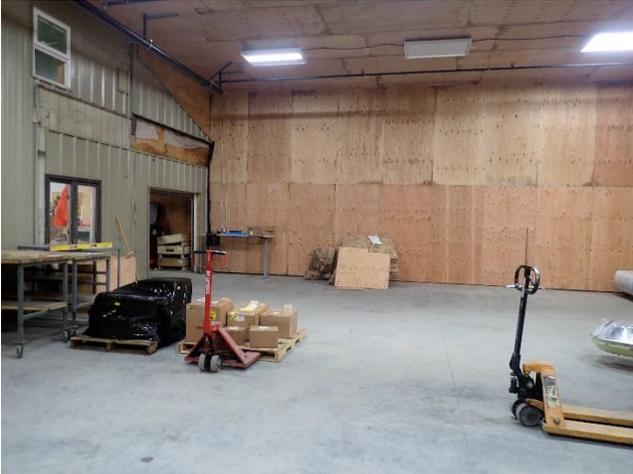
The warehouse expansion is complete (Photo 6) and HGCMC has begun utilizing the additional 2,080 square feet for staging supplies. The parking area was enhanced for vehicle traffic, and new guardrails were installed (Photo 7).

**Photo 6. 920 warehouse expansion.**

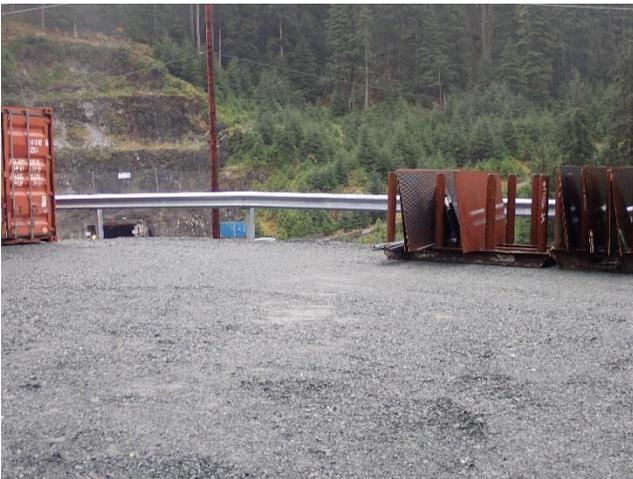
**Photo 7. New guardrails were installed at the 920 warehouse.**

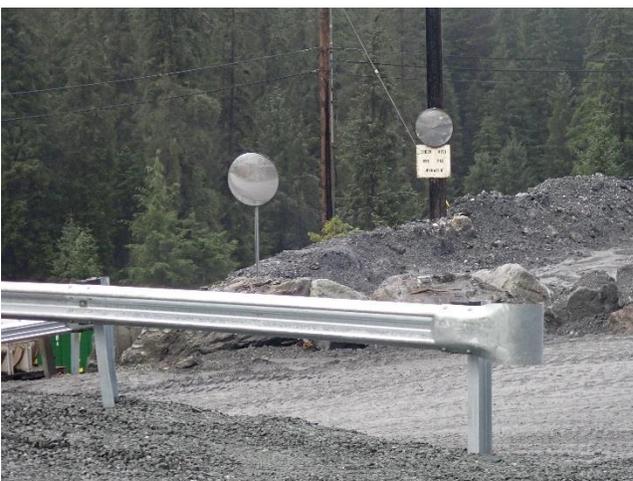
An additional traffic mirror (Photo 8) was installed for inbound/outbound traffic along the access road for the ore pad/warehouse.

**Photo 8. A new traffic mirror was installed near the 920 warehouse.**

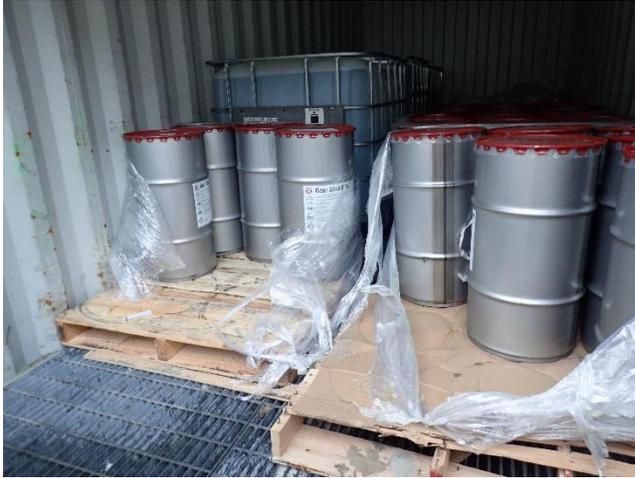
Good housekeeping practices were observed at the 920 warehouse storage area (Photo 9) (Appendix 5 BMP Plan; pages 39-40).

**Photo 9. Petroleum products stored within secondary containment.**

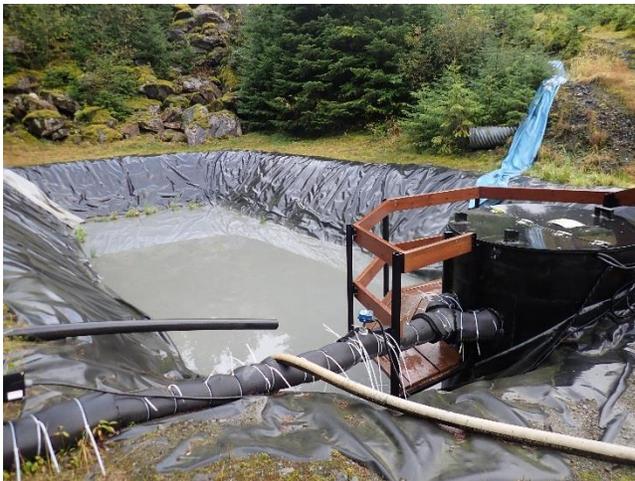
**Photo 10. Upper Pond C.**

Both upper and lower ponds are functioning as intended (Photos 10-11). Both ponds receive surface water runoff from the 860 area, and APDES Outfall 007 is located at this site.

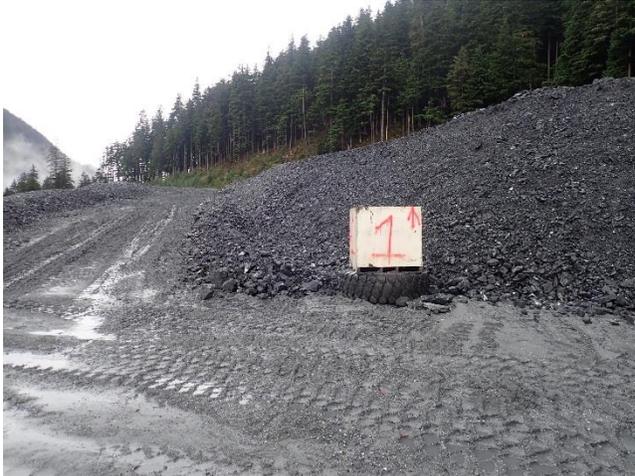
This is the active site for waste rock storage (Appendix 1; Section 3.1), and the area was tidy and in order (Photos 12-13).

Photo 12. Site 23 Class 1 waste rock stockpile.

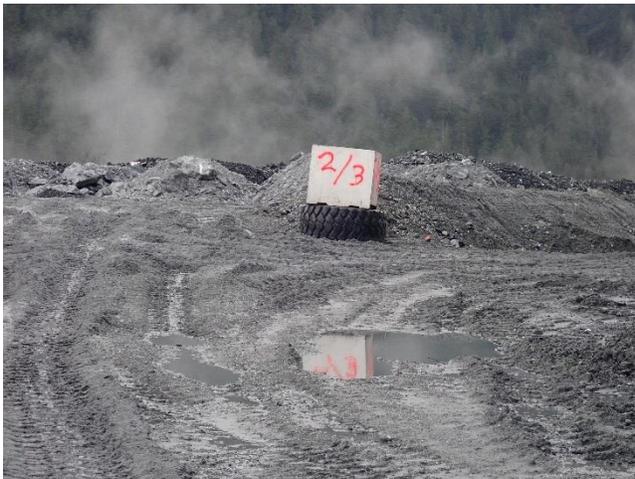
Photo 13. Site 23 Class 2/3 waste rock stockpile.

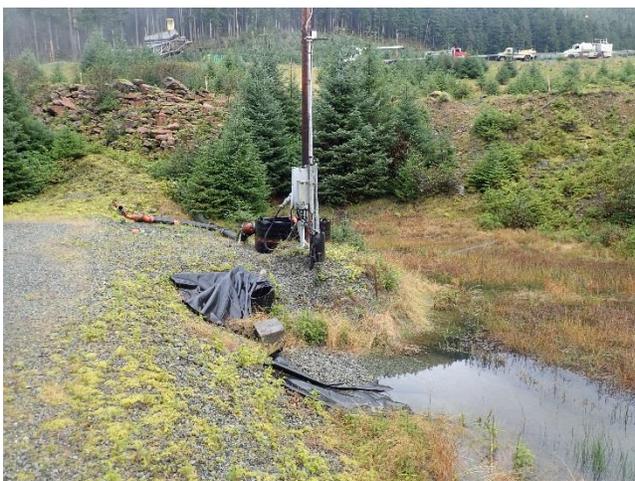
This site is properly working as intended (Photos 14-15). Surface water runoff from Site D reports to this location and APDES Outfall 006 is located at this site.

Photo 14. Pond D with Site D in the background.

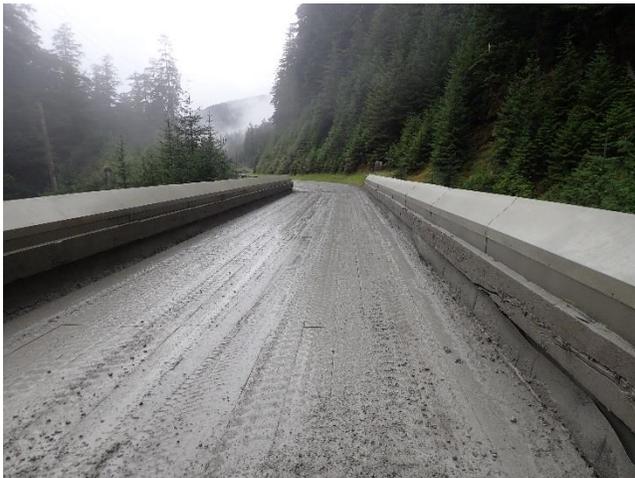
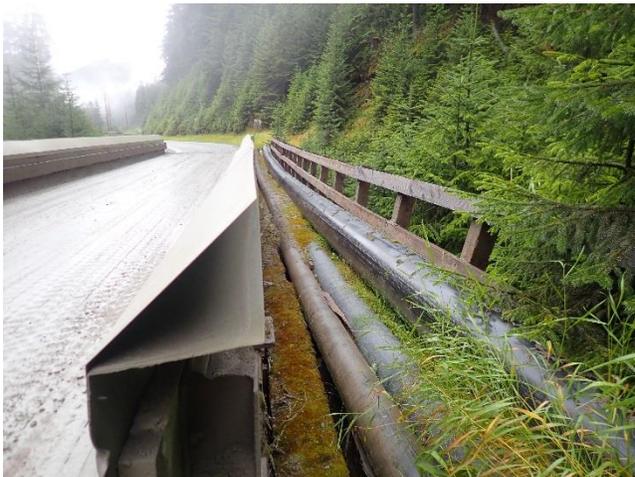
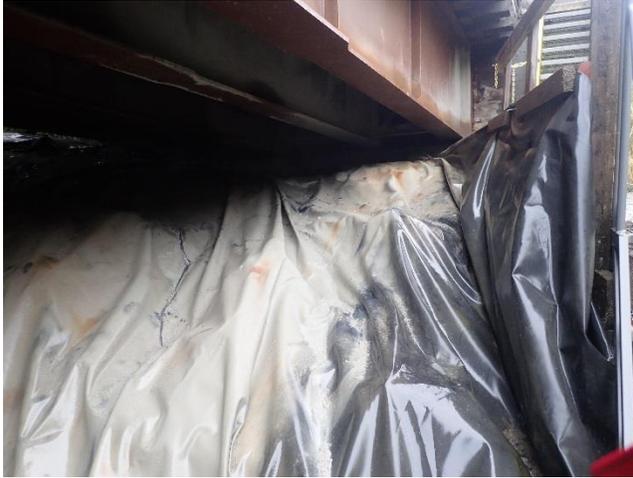
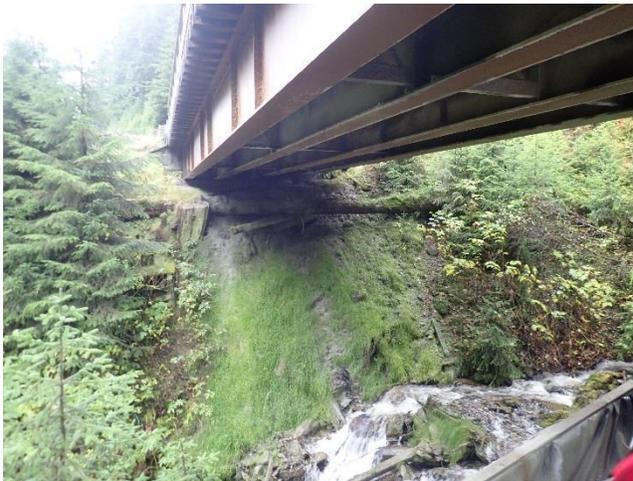
The bridge (Photos 16-19) and the abutments are being maintained by Surface operations, which comply with Appendix 5 BMP Plan; page 13.

**Photo 16. 7.4 mile B-road Bridge (Killer Creek Bridge).**

**Photo 17. 7.4 mile B-road Bridge guardrail.**

**Photo 18. 7.4 mile B-road bridge uphill side abutment.**

**Photo 19. 7.4 mile B-road bridge downhill side abutment.**

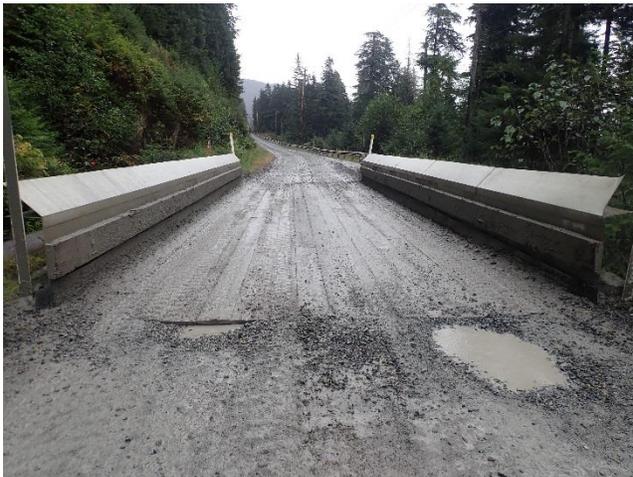
**Photo 20. 3.4 mile B-road Bridge (Falls Creek Bridge).**

The bridge is being properly maintained by Surface operations (Photo 20), and the splashguards are preventing sediment splash over from vehicle traffic.

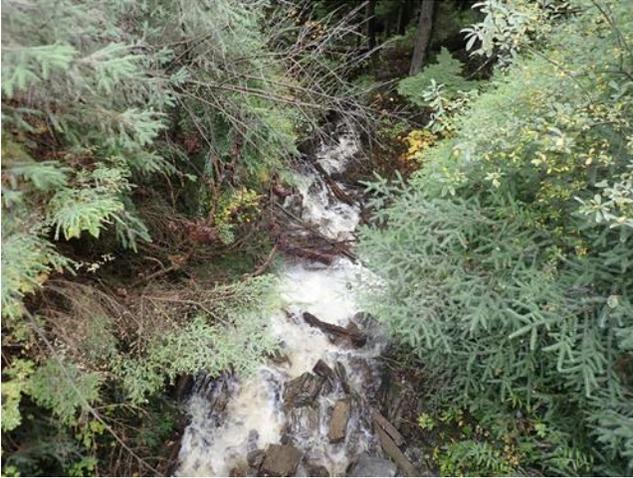
Reported in previous inspection reports from 2016 through 2017, sand bags below the bridge were washed out, and remained downstream of the bridge. In late September 2017, HGCMC personnel were able to go downstream and remove the sand bags (Photos 21).

**Photo 21. Sand bags have been removed from Falls Creek.**

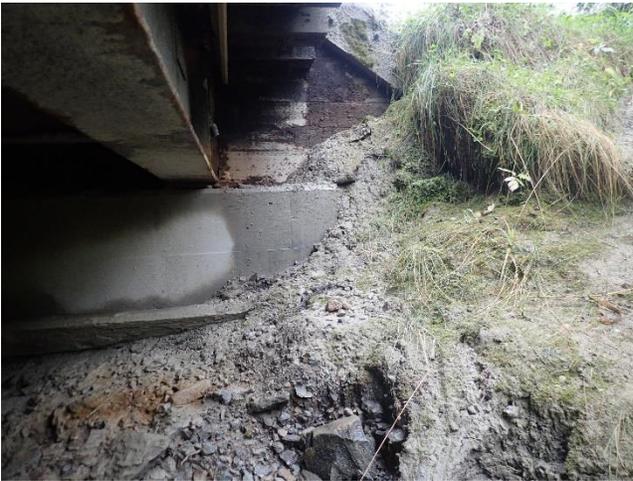
Sedimentation was observed underneath the bridge (Photo 22). The current criteria for sediment removal where no BMP structures are located, is to conduct a visual inspection and remove the sediments when deemed necessary. A practical alternative would be to install a BMP structure that will help mitigate sediment runoff near the bridge ends.

**Photo 22. Sediment accumulation continues below Falls Creek Bridge.**

Conduct a site inspection of the standpipe's outlet at the Zinc Creek Bridge abutment's.  
Inspect the BMP's around the B-road bridges for sediment accumulation.

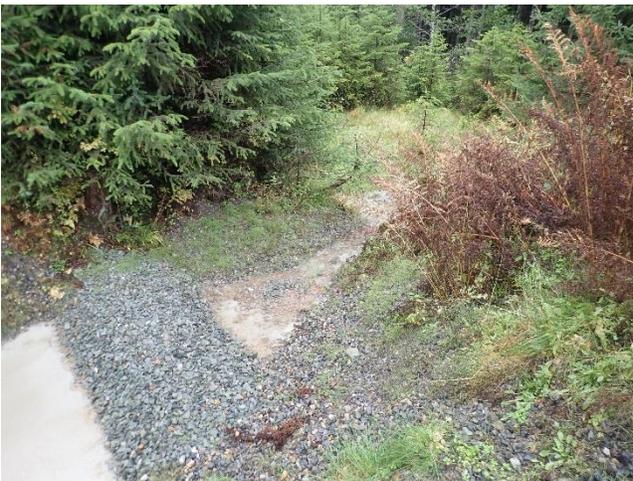
The sumps/rock check dams are properly working by allowing sediments to settle in the ponds, and check dams are slowing down the waters velocity, with clear water flowing into the vegetation (Photo 23).

**Photo 23. The final settling pond/rock check damn for the 3.2 mile B-road culvert.**

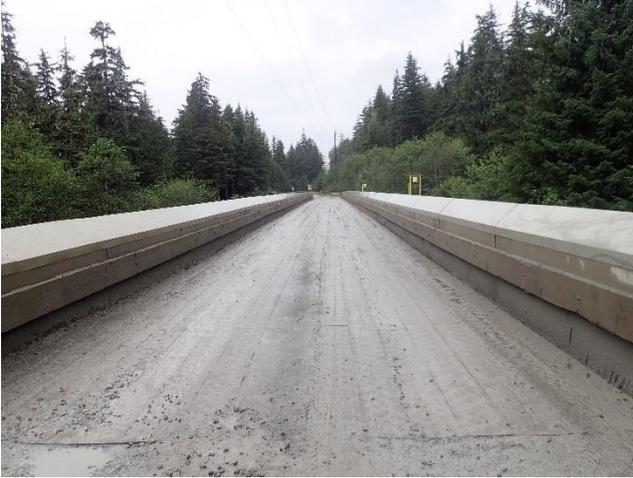
**Photo 24. 3.0-mile B-road Bridge (Zinc Creek Bridge).**

The bridge is being properly maintained by Surface operations, and the splashguards are effectively working by preventing sediment splash over (Photo 24).

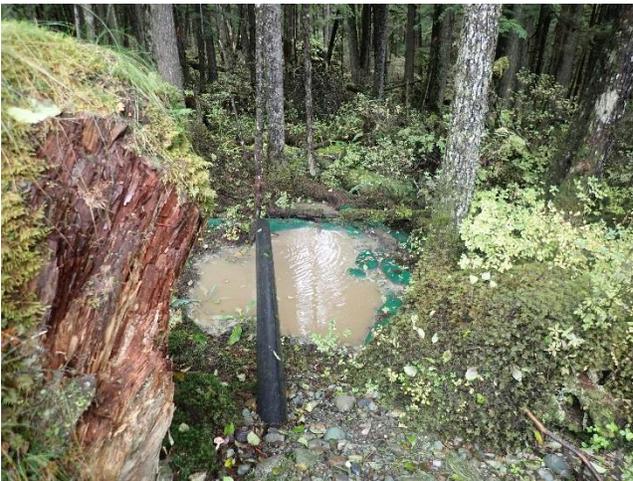
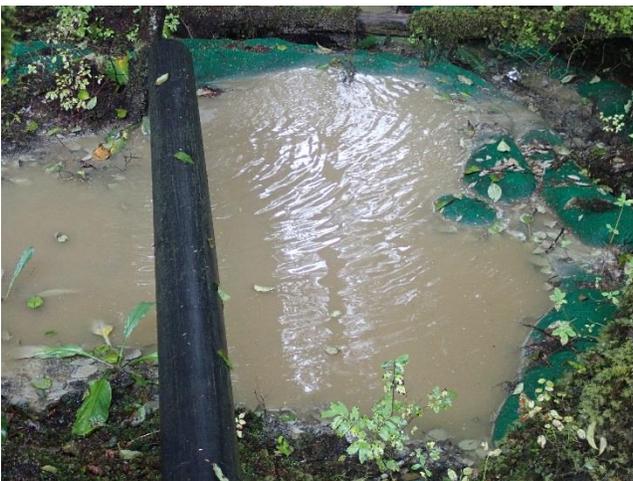
Turbid water was observed exiting the standpipe's outlet that is located at the uphill/downstream side abutment. After further observations, it was noted, that some turbid water was flowing beyond the discharge point (Photos 25-26) and into the forest. This area should be frequently monitored to ensure sediments are not impacting Zinc Creek.

**Photo 25. The standpipe's outlet drain.**

**Photo 26. Turbid water observed flowing beyond the discharge point and into the forest.**

- The 3.0 mile B-road standpipe's outlet discharge point will need to be inspected for sediment accumulation. Sediments are to be removed if the accumulation exceeds one-half of the above ground capacity for fiber rolls (Appendix 5 BMP Plan; page BMP-17).

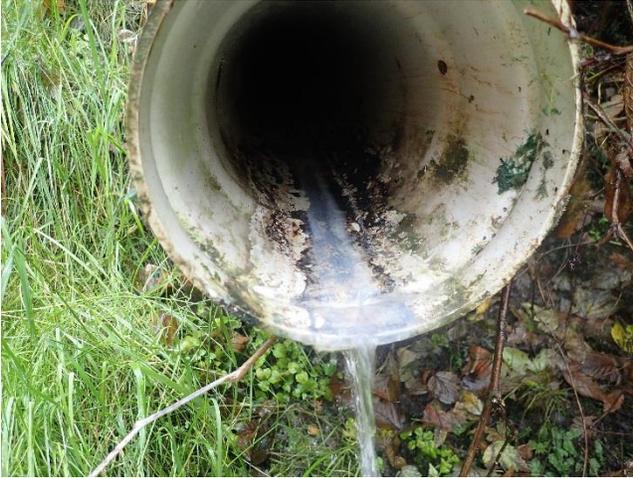
HGCMC personnel cleaned out the abutment drain (Photo 27), and will continue to monitor for the white precipitate.

**Photo 27. The cleaned abutment drain.**

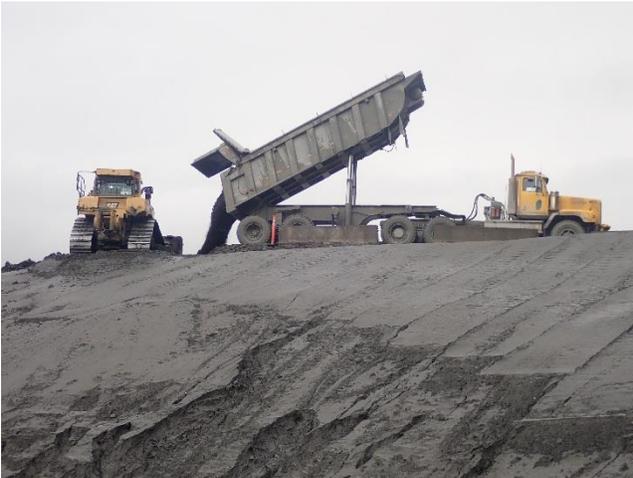
HGCMC continues to deposit tailings in the S3P1 area (Photo 28).

**Photo 28. The S3P1 TDF expansion area.**

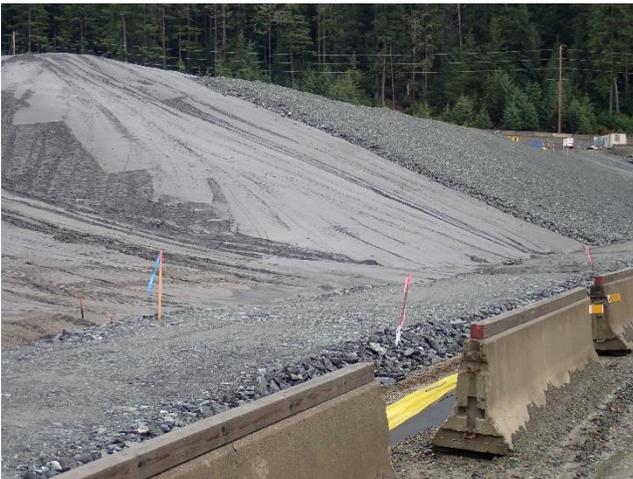
HGCMC personnel began depositing Class 1 waste rock along the southern outer slopes of the S3P1 area (Photo 29) as an armor to help prevent erosion.

**Photo 29. Class 1 waste rock was placed along sections of the outer slope.**

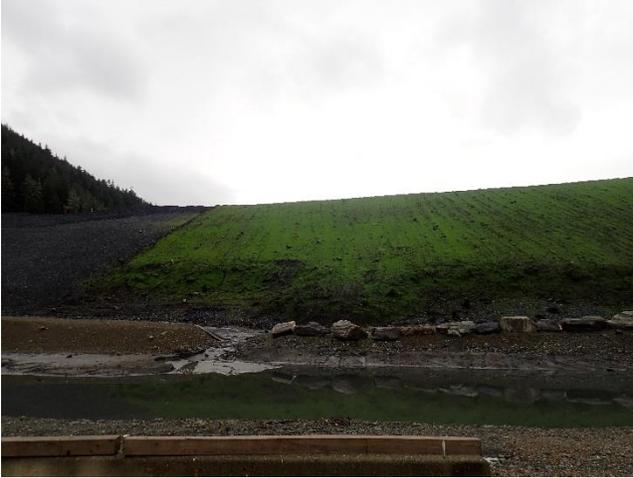
HGCMC personnel continue to hydroseed the northwest slopes (Photo 30) of the TDF. The vegetation will help soil stability, and minimize erosion to the slopes (Appendix 5 BMP Plan; page 13).

Photo 30. Hydroseeded northwest slopes in the TDF area.

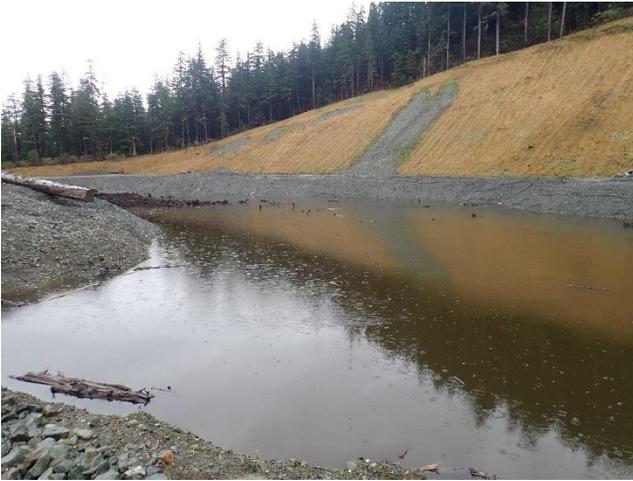
Photo 31. The Sand Pit.

This site is currently inactive (Photo 31).
