INSPECTION REPORT: GREENS CREEK MINE

Date of Inspection: Monday October 30, 2017
Date of Report: Thursday November 16, 2017
USDA Forest Service Inspector: Richard Dudek

Ranger District: Admiralty National Monument, Juneau Ranger District
Weather Conditions: Cloudy with rain Temperature: low 40's (°F).

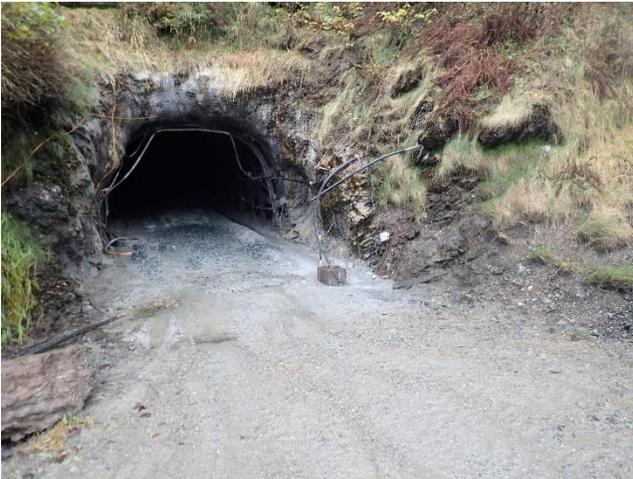
The 1350 adit and trench/pump (Photo 1) is being maintained by Environmental operations. The trench and pump (Photo 2) are working as intended to convey runoff in the reclaimed area. As the winter season approaches, HGCMC will remove the pump to prevent ice damage.

Photo 1. The 1350 adit.

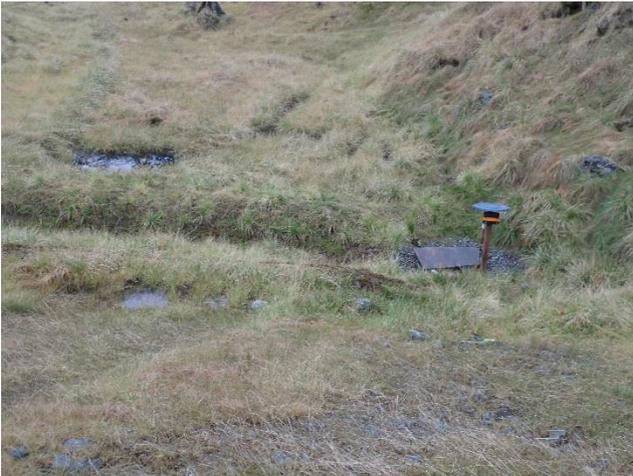
Photo 2. The 1350 trench and pump.

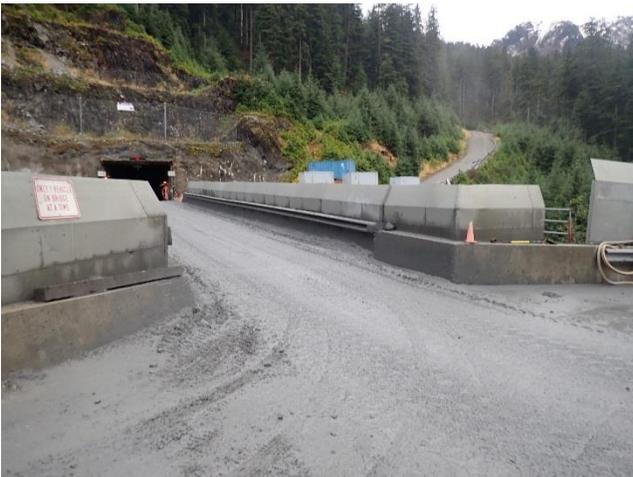
The recorded flow rate for Greens Creek (Photo 3) on 10/30/2017 was 61.5 cfs and the water withdrawal for the 920 system remains at 1.5 cfs.

Photo 3. The 920 Bridge.

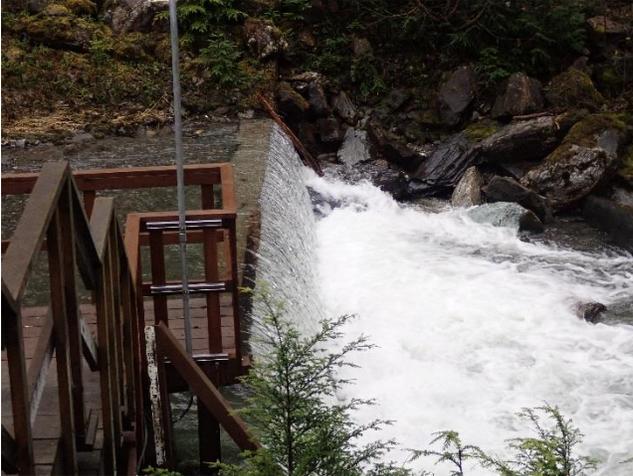
The 920 bridge maintenance complies with the Plan of Operations and the sediment accumulation at the bridge ends was minimal (Photo 4).

Photo 4. The 920 Greens Creek weir.

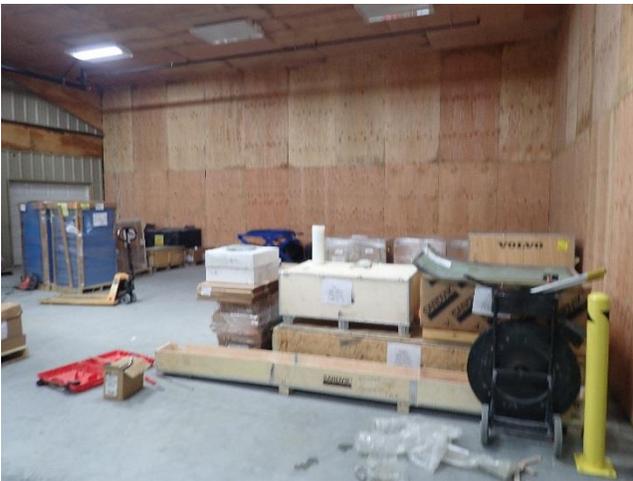
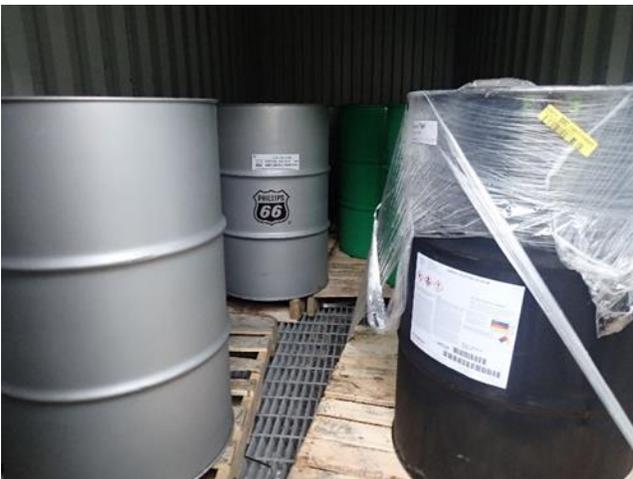
Good housekeeping practices (Appendix 5 BMP plan; page 39) were observed inside the warehouse and the storage vans (Photos 5-6).

Photo 5. The 920 warehouse expansion.

Photo 6. Petroleum products stored within secondary containment.

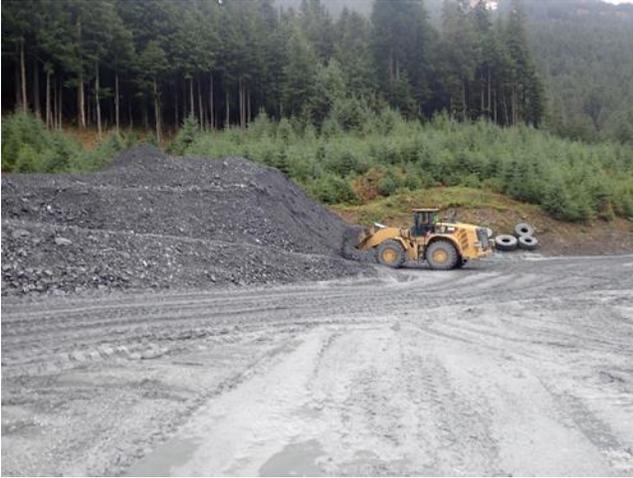
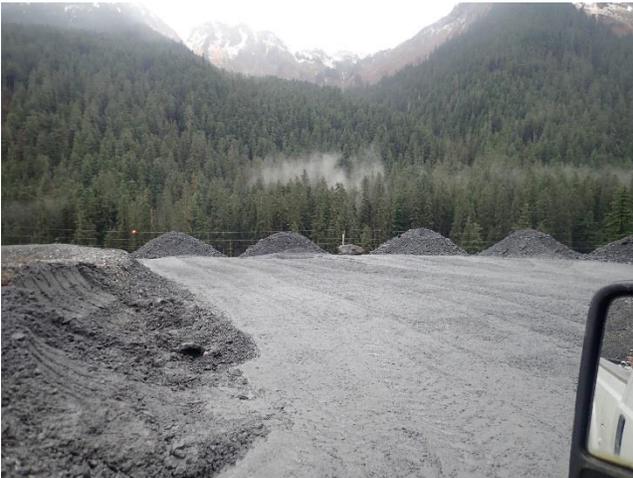
To maximize storage capacity, HGCMC is staging Class 1 waste rock along the site's perimeter (Photos 7-8).

Photo 7. HGCMC personnel recently began stockpiling Class 1 waste rock along the edge of the site.

Photo 8. Additional Class 1 waste rock has been stockpiled near the burn pile at Site 23.

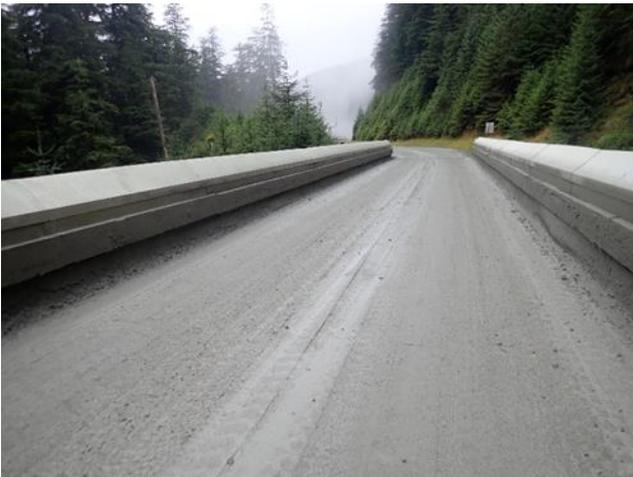
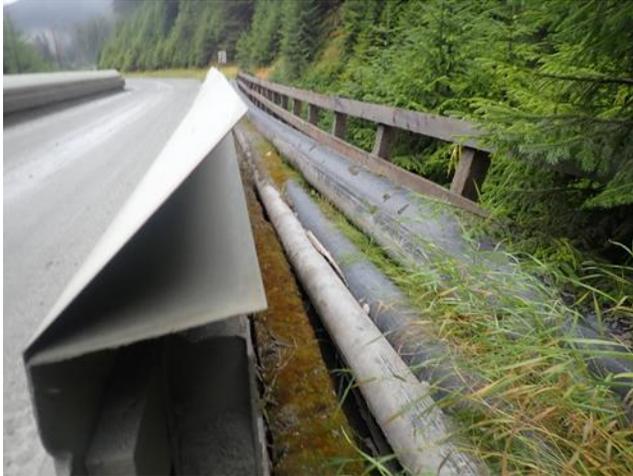
The bridge decking is being maintained and the splashguards are effectively preventing vehicular sediment splash over (Photos 9-10). Below the bridge, sediment accumulation was minimal at both bridge abutments (Photos 11-12).

Photo 9. 7.4 mile B-road Bridge (Killer Creek Bridge).

Photo 10. 7.4 mile B-road Bridge splashguard.

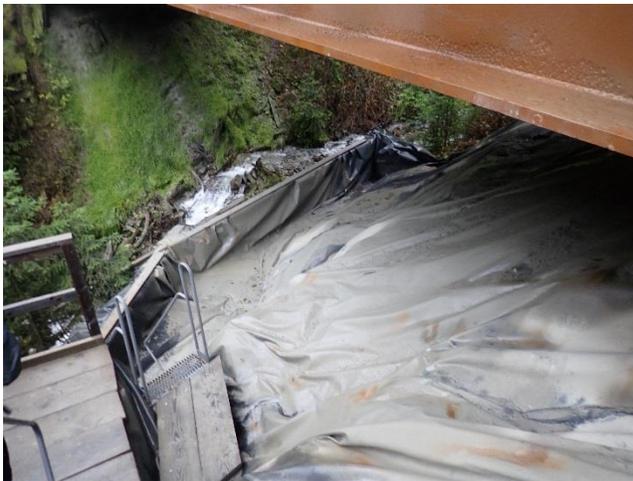
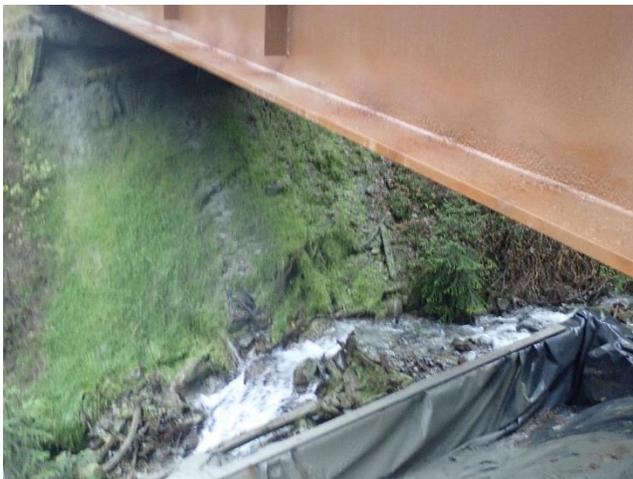
Photo 11. The uphill side bridge abutment (Killer Creek Bridge).

Photo 12. The downhill side bridge abutment (Killer Creek Bridge).

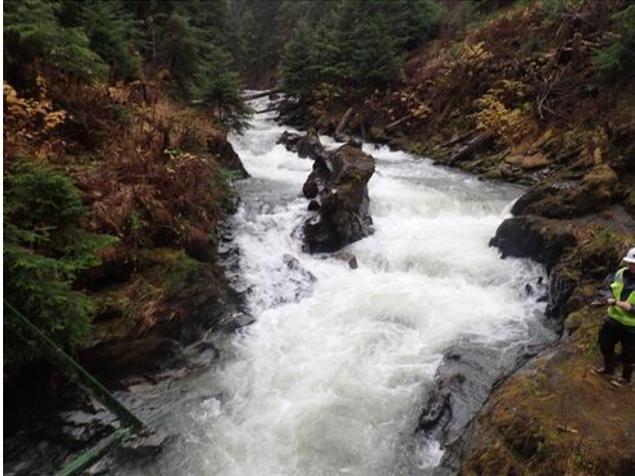
Reconstructing the Greens Creek fish pass (Photo 13) was a mitigation requirement in the 2013 TDF Expansion Final Environmental Impact Statement and Record of Decision. The reconstruction included installation of three concrete steel-capped weirs and plunge pools. Additionally, HGCMC was issued a fish habitat permit (FH11-I-0123) from ADF&G. This permit requires HGCMC to monitor and maintain the Greens Creek fish pass in perpetuity. Under the State of Alaska Waste Management Permit 2014DB0003, HGCMC is required to measure the abundance and condition of juvenile fish upstream of the fish pass. HGCMC plans to continue contracting this work with the ADF&G Habitat division.

Photo 13. The Greens Creek fish pass.

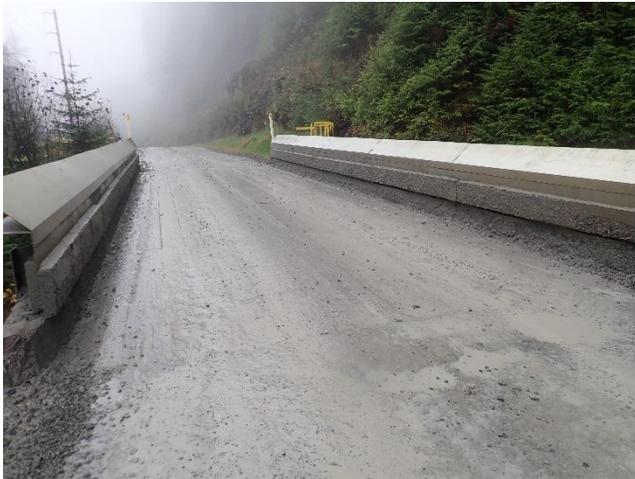
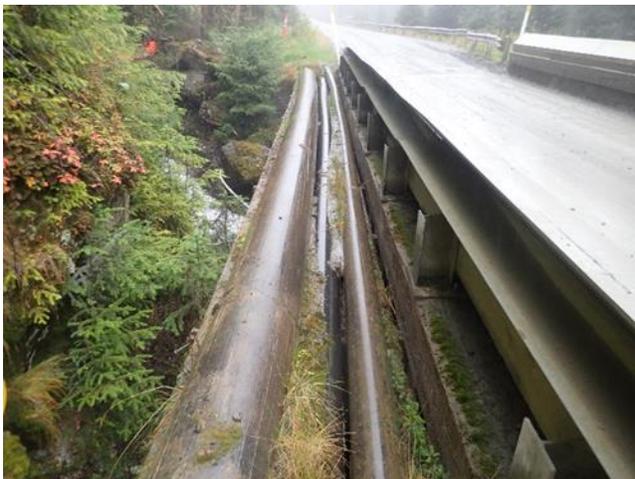
The bridge decking is being maintained and the splashguards are preventing vehicular sediment splash over (Photos 14-15). However, sediment buildup was observed at the bridge ends (Photos 16-18) and will require removal. To minimize the sediment loading below the bridge, a BMP structure should be installed at or near the uphill/downstream side of the bridge. Below the bridge, HGCMC personnel did remove some sediments prior to this inspection. The amount sediment accumulation just below the

Photo 14. 3.4 mile B-road Bridge (Falls Creek Bridge).

Photo 15. No sediments were observed on the pipes.

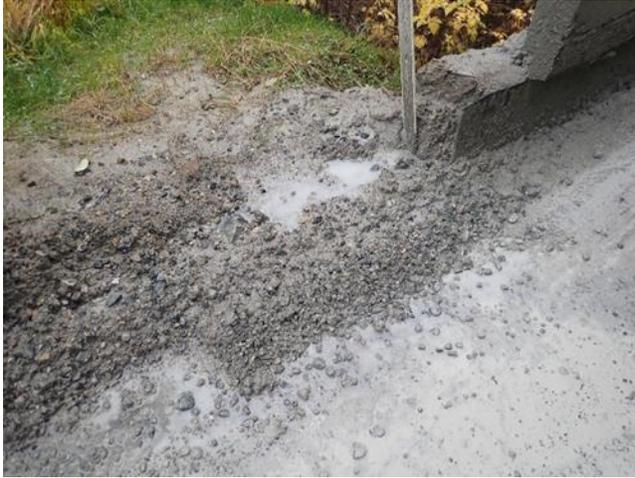
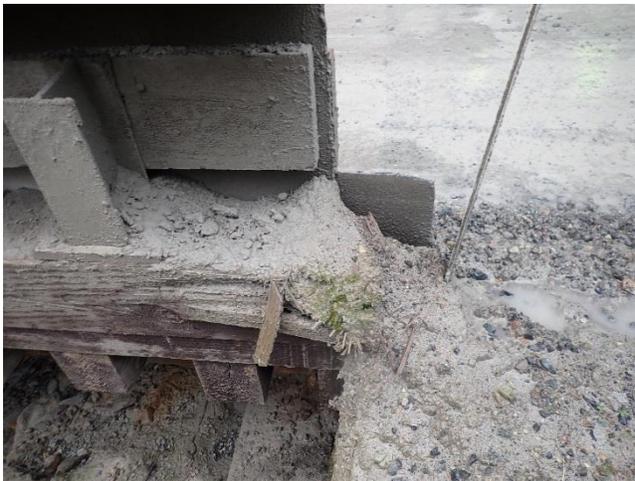
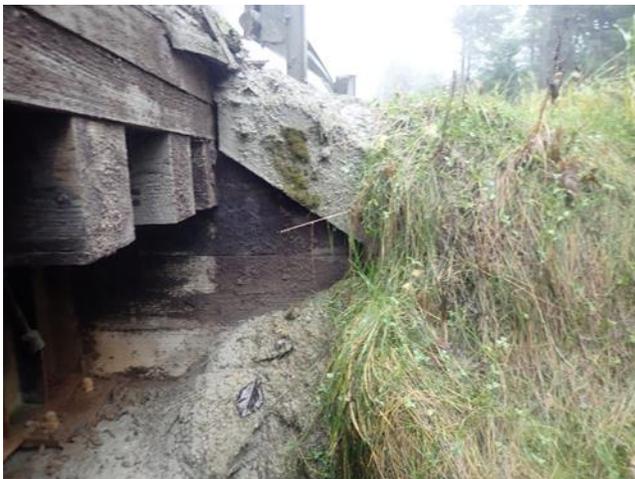
Photo 16. Sediment accumulation at the bridge ends for 3.4 mile B-road Bridge (Falls Creek Bridge).

Photo 17. Sediment accumulation at the bridge end.

Photo 18. Some of the sediments have been removed. However, residual sediments still remain underneath the bridge.

- Turbid water was observed flowing beyond the 3.2 mile B-road culvert's rock check dams and into the forest duff and vegetation. Additional mitigations and/or modifications to the existing BMP's need to be implemented at this site.
- Sedimentation removal is required at the 3.4 mile B-road bridge ends.
- The 3.4 mile B-road culvert requires cleaning. Sediment accumulation has exceeded the allowable limits.

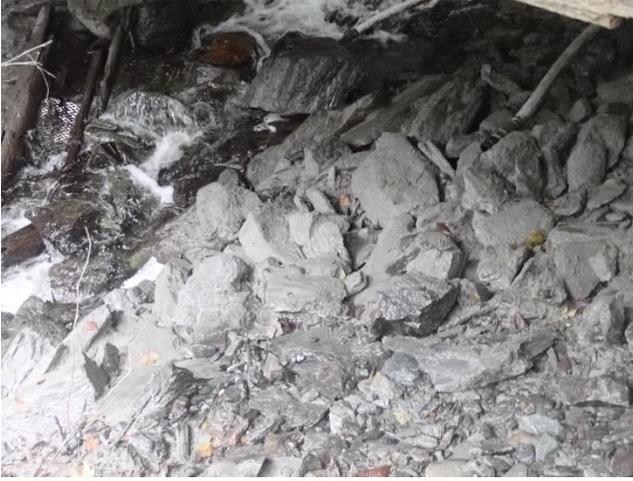
bridge (Photo 19) was less than compared to what was observed and documented in the previous inspection report (HGCMC 388).

Photo 19. Sediments covering rocks below the bridge.

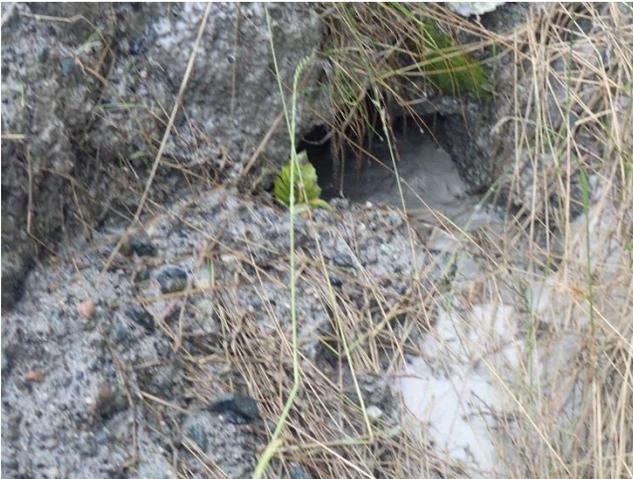
The culvert (Photo 20) will require cleaning due to sediment buildup. HGCMC's Appendix 8 Road Operations and Maintenance plan page 8-6 states that culverts with more than four inches of accumulation will be scheduled for prompt cleaning.

Photo 20. Sediment accumulation has exceeded the allowable amount at the 3.4 mile B-road culverts intake.

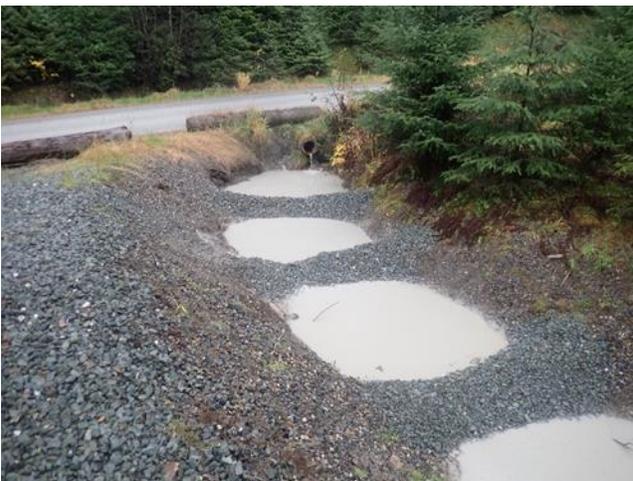
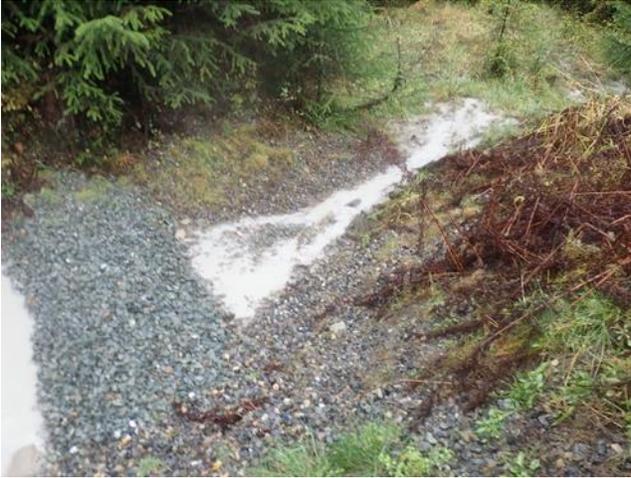
Turbid water was observed flowing beyond the final settling pond/rock check dam (Photos 21-22) and into the vegetation. Although the forest duff is an acceptable place to allow finer sediments to settle out. Additional mitigations or improvements to the BMP's in place should be implemented to help minimize fine materials in the surface water flowing beyond the BMP's.

Photo 21. 3.2 mile B-road culvert with structural BMP's

Photo 22. Turbid water observed exiting and into vegetation.

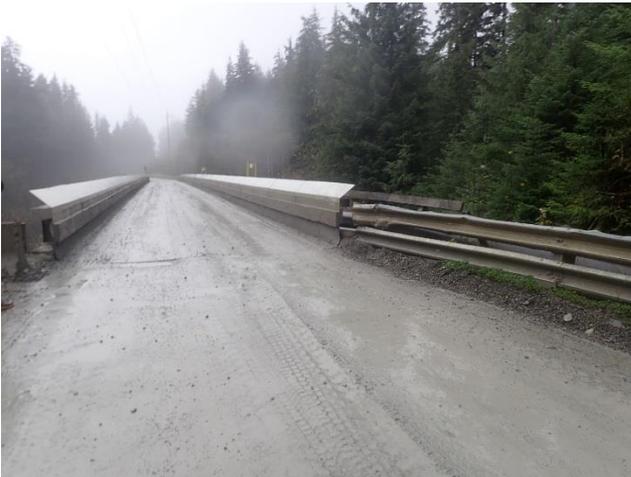
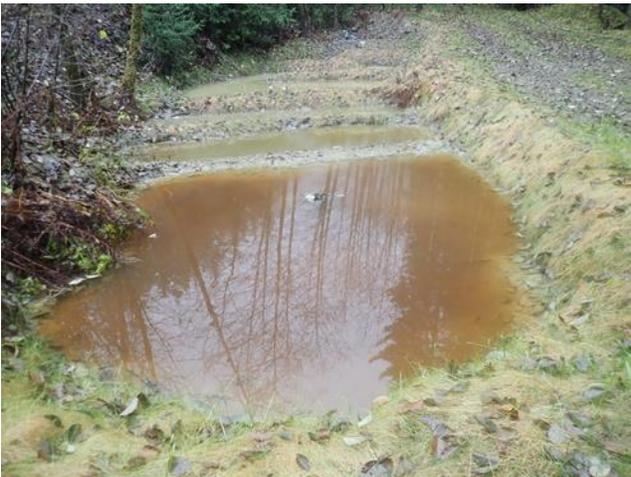
The bridge is being maintained and the structural BMP's are working as intended (Photos 23-24). Turbid water was exiting the standpipes outlet. Mostly clear water was observed flowing beyond the discharge point (Photo 25-26). This area should be frequently inspected by HGCMC personnel and perform the necessary maintenance when sedimentation levels exceed the allowable limits. The uphill side abutment drain was cleaned as stated in Inspection Report 388, and mostly clear water was exiting the drain (Photos 27-28).

Photo 23. 3.0 mile B-road Bridge (Zinc Creek Bridge).

Photo 24. Structural BMP's near Zinc Creek Bridge.

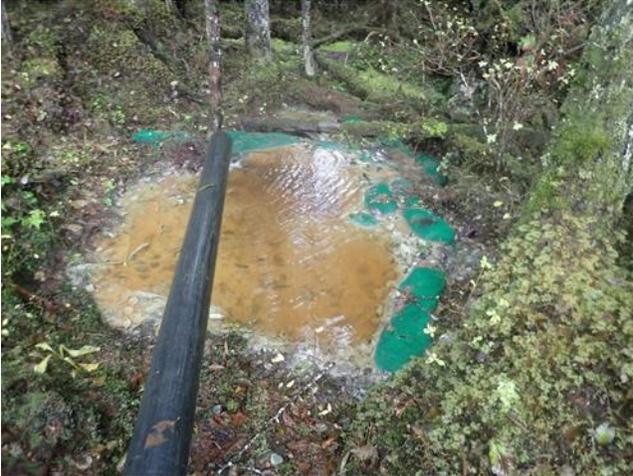
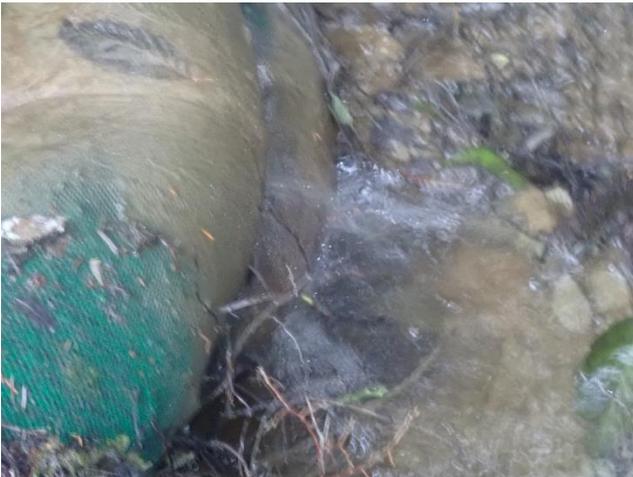
Photo 25. The standpipe outlet drain.

Photo 26. Mostly clear water was exiting beyond the standpipes discharge point and onto the forest duff.

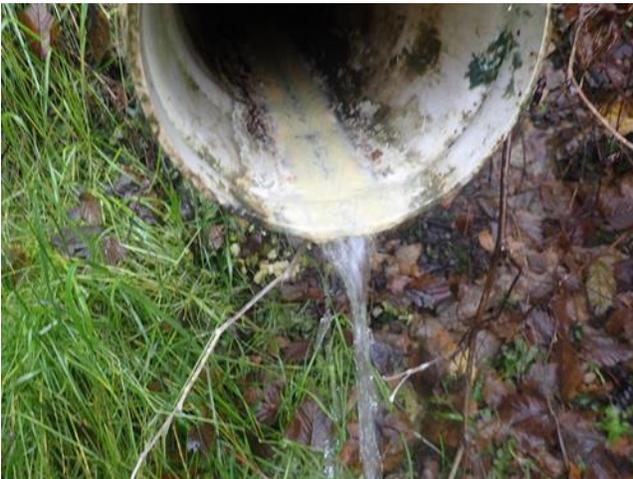
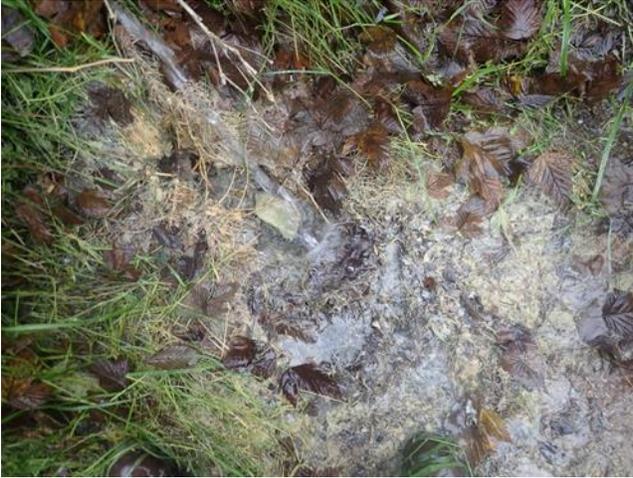
Photo 27. Zinc Creek abutment drain had mostly clear water flowing out.

Photo 28. Mostly clear water from the Zinc Creek abutment drain.

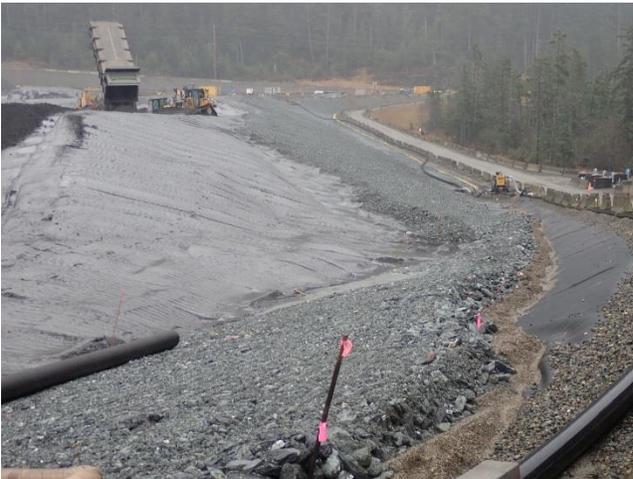
Clarification to Inspection Report (IR) HGCMC 388 – stated in IR HGCMC 388, the rock that was being placed on the southern abutments was Class 1 waste rock. The rock that is being utilized along the abutments is from the 0.9 mile B-road stockpile (Photo 29).

Photo 29. The rock placed at the toe of the tailings pile is from the 0.9 mile B-road rock stockpile.

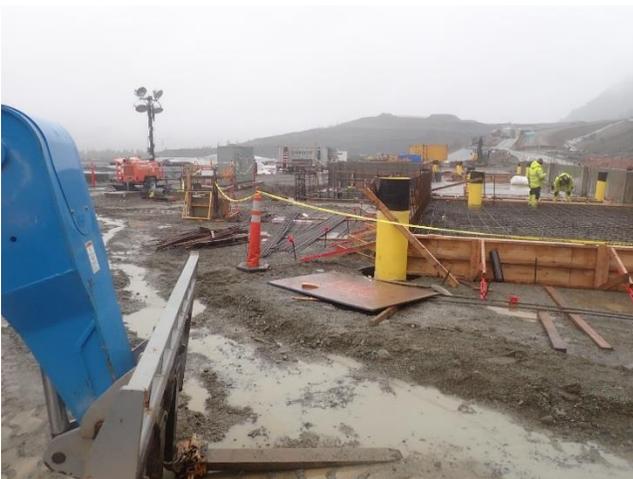
Contractors continue with the construction of the new TDF wheel wash station (Photo 30).

Photo 30. Contractors continue with the construction of the TDF wheel wash station.

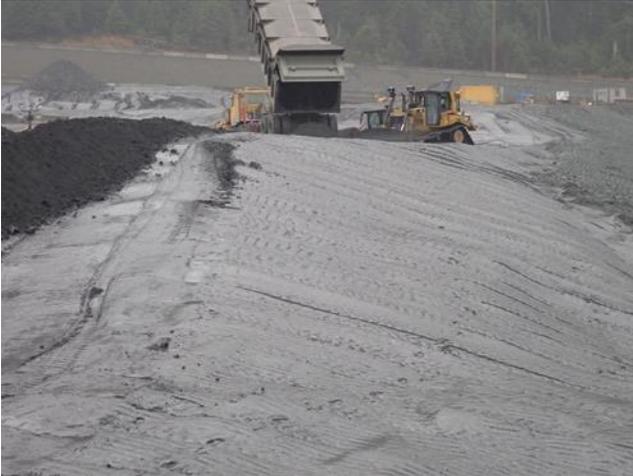
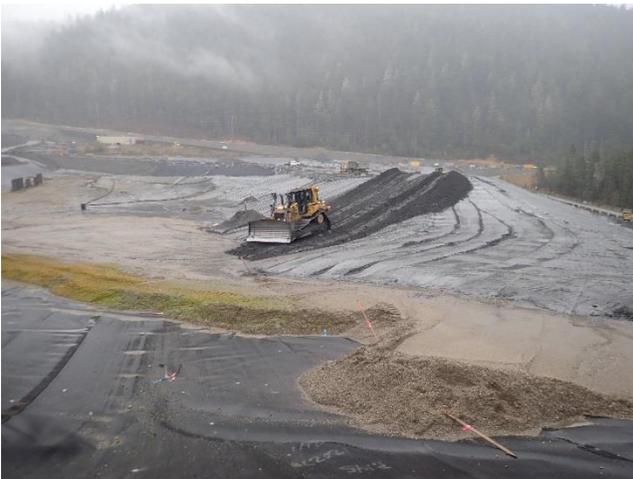
HGCMC TDF personnel continue to deposit tailings in the S3P1 area (Photos 31-32).

Photo 31. HGCMC continues placing tailings in the S3P1 area.

Photo 32. A bulldozer was in the process of compacting and contouring a tailings pile in the S3P1 area.
