## INSPECTION REPORT: GREENS CREEK MINE

Date of Inspection: Thursday November 30, 2017  
Date of Report: December 29, 2017  
USDA Forest Service Inspector: Richard Dudek

Ranger District: Admiralty National Monument, Juneau Ranger District  
Weather Conditions: Cloudy with rain Temperature: low 30's (°F).

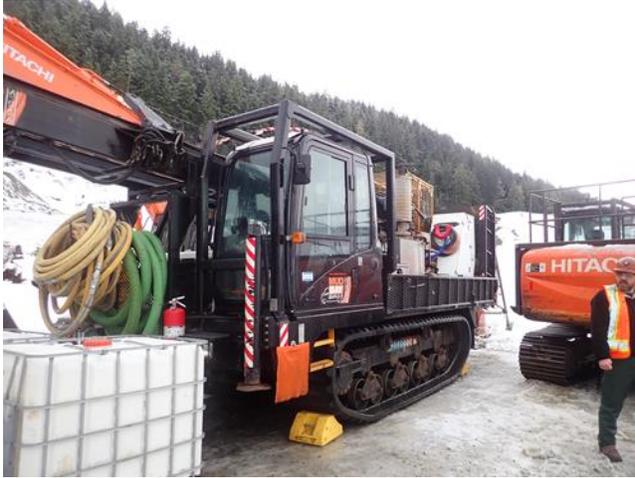
HGCMC has hired contractors to conduct geotechnical drilling for a feasibility study in the northern TDF area (Photos 1-2).

**Photo 1. A drill rig that will be used for conducting a feasibility study in the northern TDF area.**

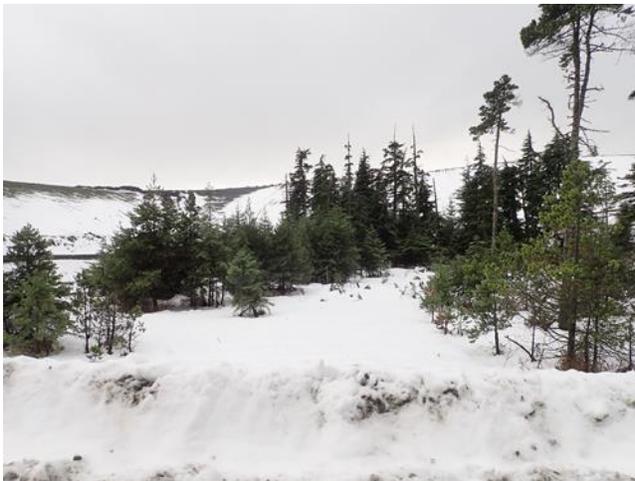
**Photo 2. One of two locations for geotechnical drilling in the northern TDF area will take place.**

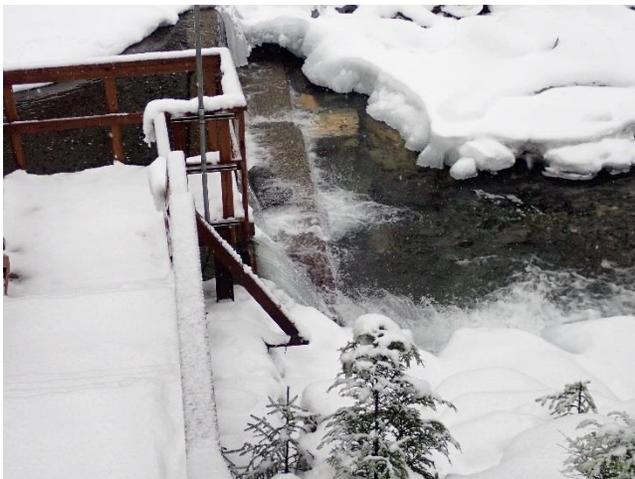
The recorded volumetric flow rate for Greens Creek (Photo 3) on 11/30/2017 was 13.2 cubic feet per second (cfs) and the water withdrawal for the 920 system remains at 1.5 cfs.

**Photo 3. The Greens Creek weir is located in the 920 area.**

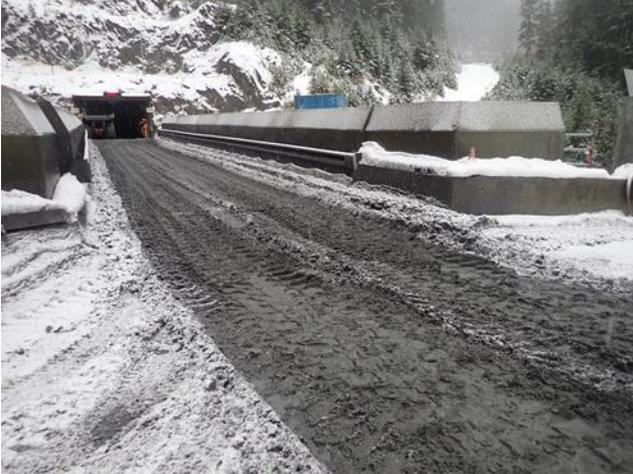
Due to rugged driving conditions, which may lead to haul trucks accidently spilling ore, snow removal is required at the 920 Bridge ends and road leading to the ore pad (Photo 4-5).

**Photo 4. The 920 Bridge.**

- **Snow removal is required at the 920 Bridge and the ore pad access road.**

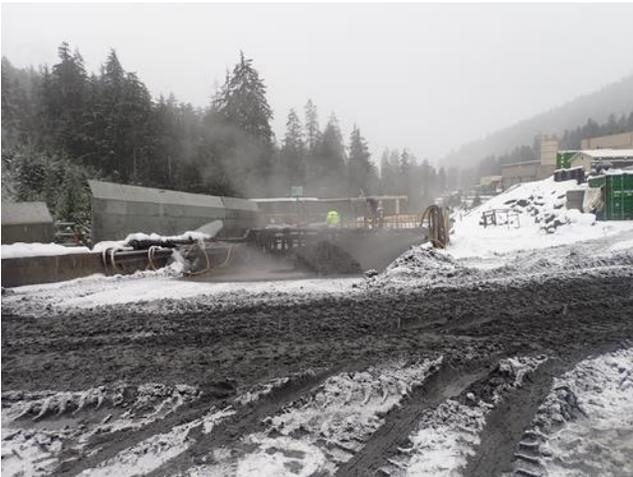
**Photo 5. Snow mixed with sediments has created rugged driving conditions near the 920 Bridge.**

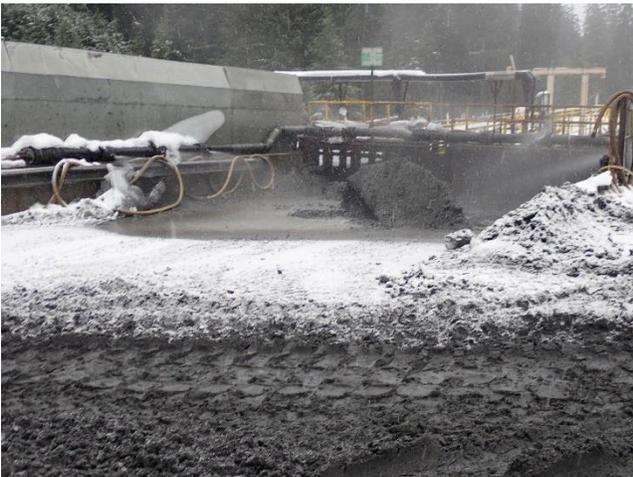
De-grit Basin 01 (DB-01) was in use during the site inspection (Photo 6). All melt water in DB-01 is routed to Pond-A and sediments will be disposed of in the TDF.

**Photo 6. De-grit basin 01 (DB-01).**

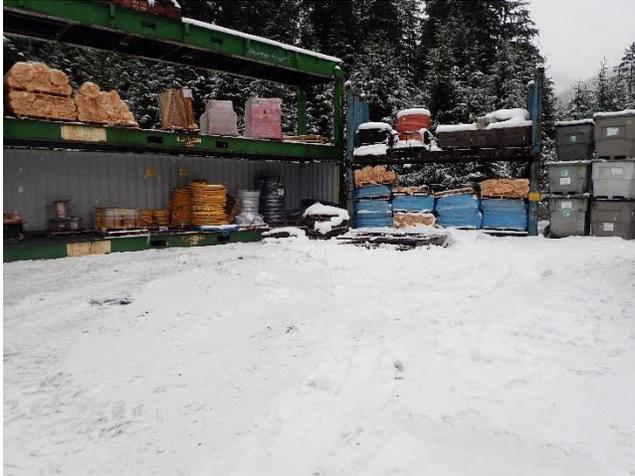
Good housekeeping practices were observed inside the warehouse (Photos 7-8) and in the conexas (Appendix 5 BMP plan; page 39).

Photo 7. The 920-warehouse storage area.

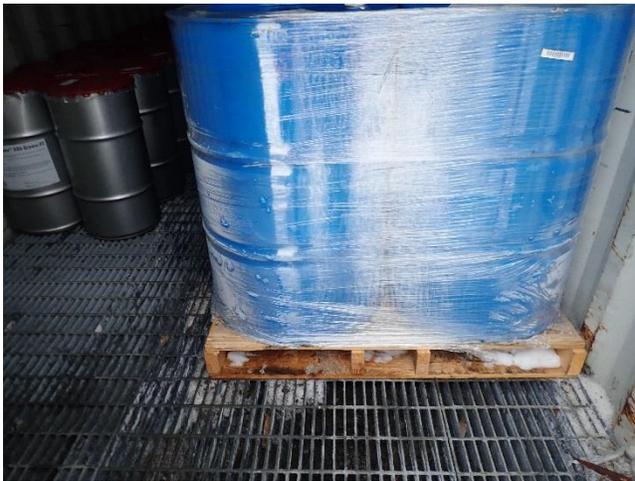
Photo 8. Petroleum products stored within secondary containment.

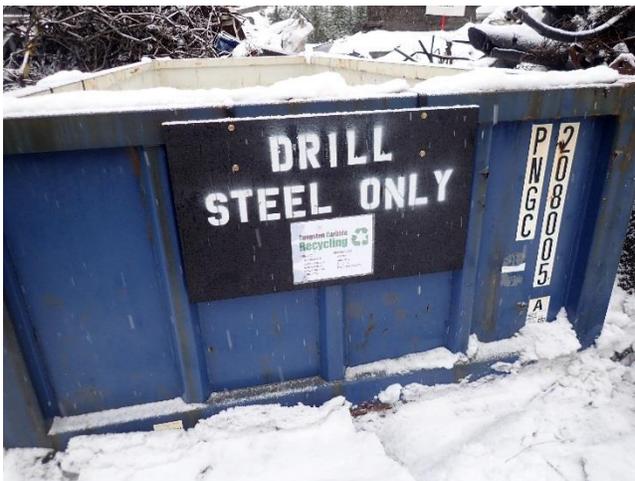
HGCMC recently incorporated drilling steel into the recycling program (Photo 9).

Photo 9. New storage container for used drilling steel is located in the 920 recycling staging area.

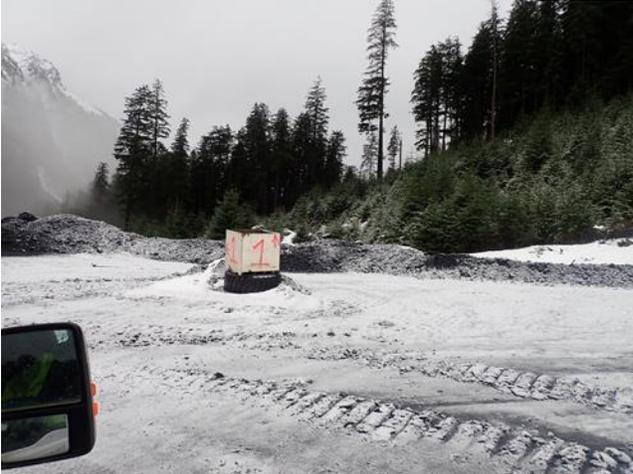
HGCMC continues staging Class 1 waste rock along the site's perimeter (Photos 10-11), and additional Class 2/3 waste rock has been recently deposited at this location. De-grit basin 03 (DB-03) is working as intended (Photo 12), and melt water from the basin is reporting to Pond 23 which is routed to the TDF water treatment plant before discharge.

**Photo 10. Class 1 waste rock stockpiled at Site 23.**

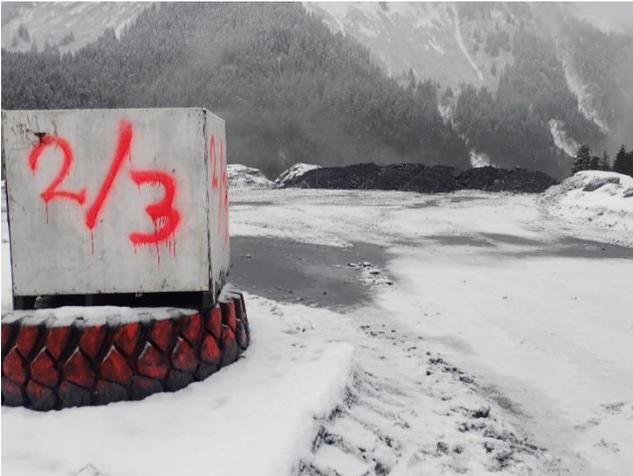
**Photo 11. Class 2/3 waste rock at Site 23.**

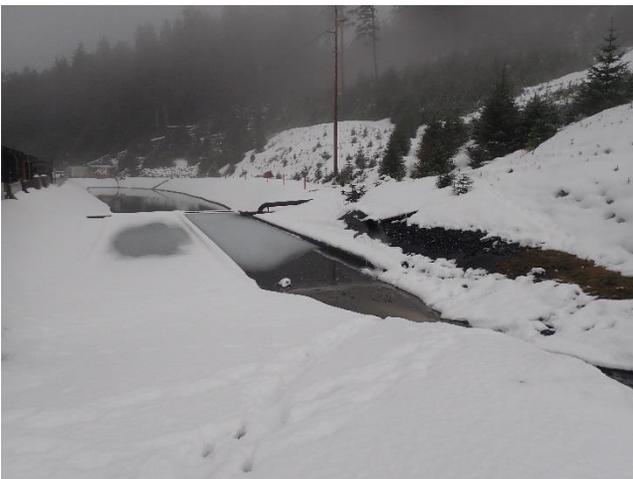
**Photo 12. DB-03 and Pond 23 located down gradient of Site 23.**

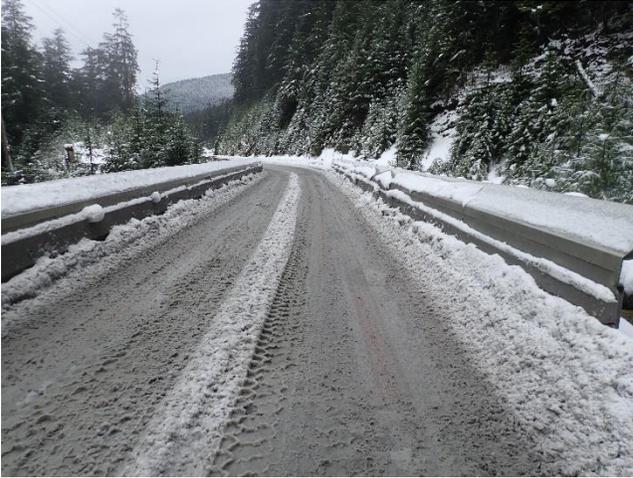
Surface operations are removing snow from the bridge's surface, and the splashguards are effectively preventing sediment splash over from vehicular traffic (Photos 13-14).

**Photo 13. 7.4 mile B-road Bridge (Killer Creek Bridge).**

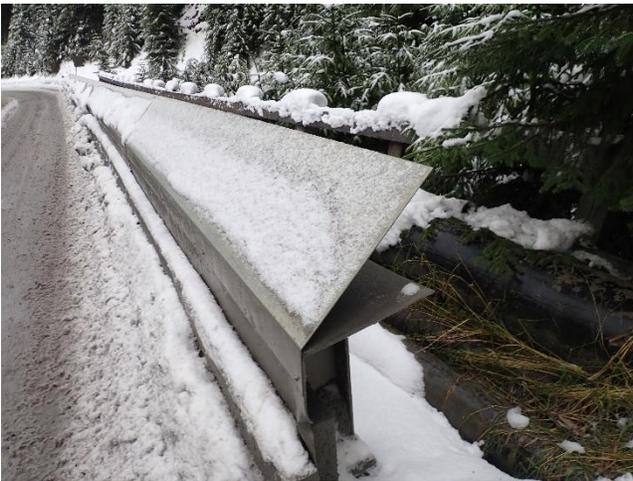
**Photo 14. Splashguards for the 7.4-mile B-road Bridge.**

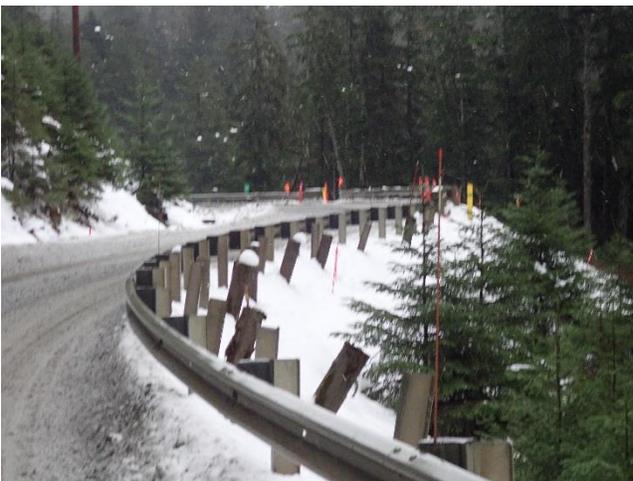
Geotechnical drilling has concluded in the vicinity of the 5.6 mile B-road. The drilling activities that took place in this area included installing four inclinometers for monitoring slope stability and four piezometers for monitoring head pressure in groundwater (Photos 15-17). The areas where drilling activities took place have been partially reclaimed as per the requirements stated in the approved 2017 Drill Program for B-Road Stability Monitoring. When the winter season ends, HGCMC will apply hydro-seed to the disturbed areas to establish vegetation to complete the reclamation.

**Photo 15. The location for where geotechnical drilling took place along the 5.6 mile B-road.**

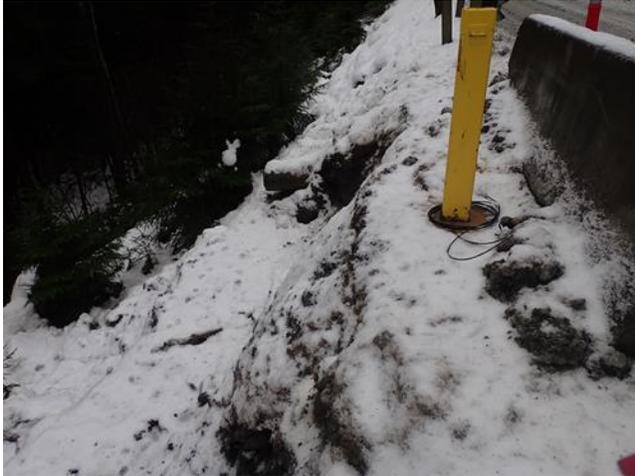
**Photo 16. installed inclinometer.**

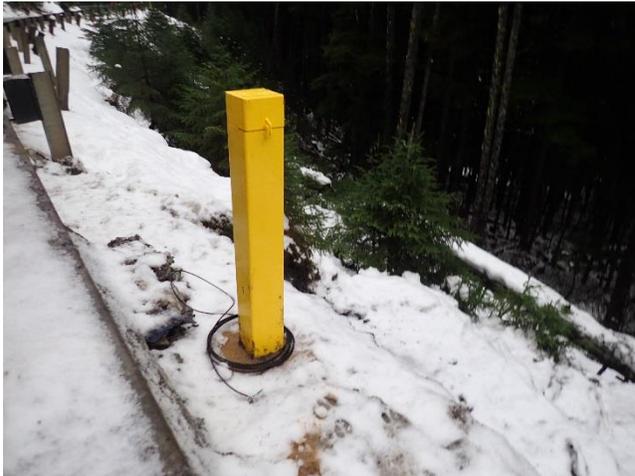
**Photo 17. The inclinometers installed will be used for monitoring slope stability.**

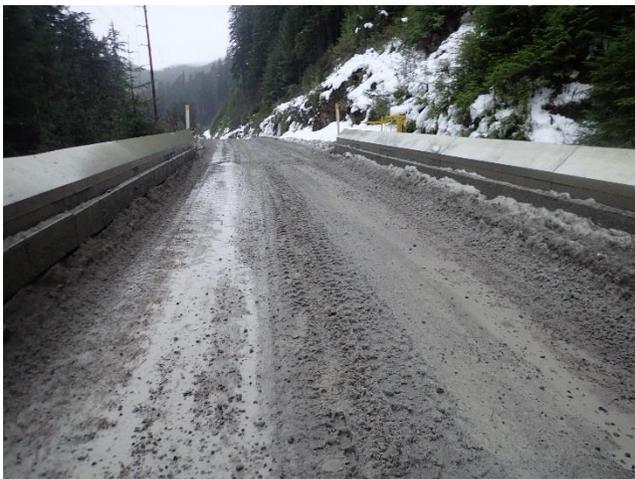
Surface operations are plowing snow from the bridge's surface, and the splashguards are effectively working by preventing vehicular traffic splash over of sediments into the creek (Photos 18-19).

**Photo 18. The 3.4 mile B-road Bridge (Falls Creek Bridge).**

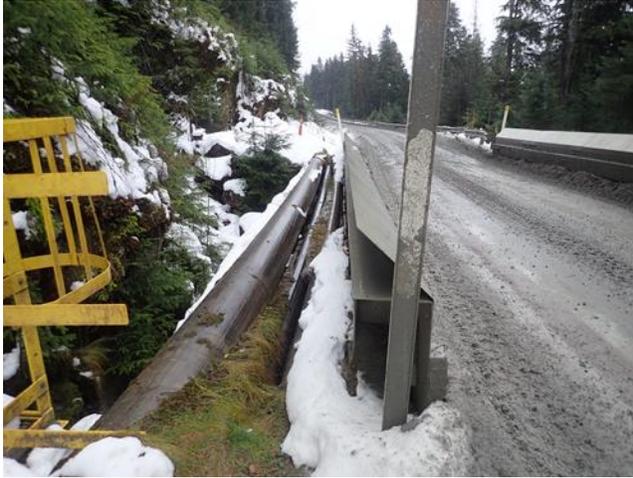
**Photo 19. The splashguards are effectively working by preventing sediment splash over.**

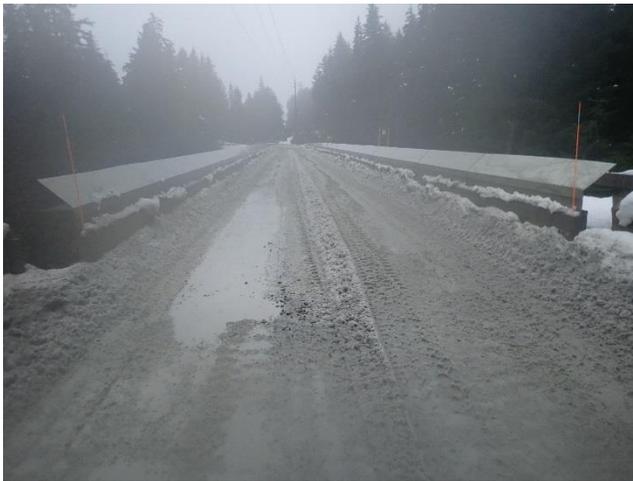
HGCMC personnel are removing snow from the bridge's surface (Photo 20) and the structural BMP's located on the downstream/uphill side abutment are covered in snow.

**Photo 20. The 3.0-mile B-road Bridge (Zinc Creek Bridge).**

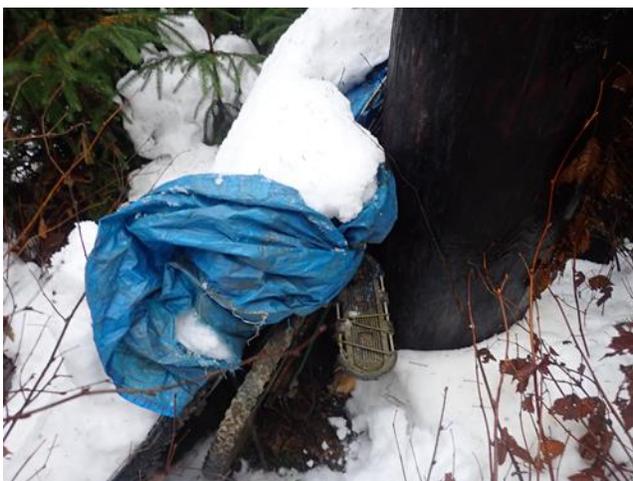
Two privately owned bicycles were found chained to an electrical post in the vicinity of the 2.5 mile B-road (Photo 21). It is believed that hunters own the bicycles, and use them as transportation while hunting along the B-road. These bicycles when used are a safety concern due to the high volume of traffic along the B-road, which may result in personal injury or damage to HGCMC's equipment.

**Photo 21. Two privately owned bikes were found chained to an electrical post in the vicinity of the 2.0 mile B-road,.**

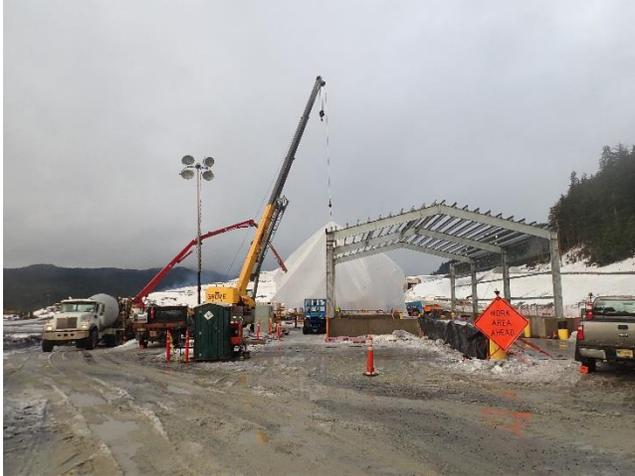
Contractors continue with the construction of the new TDF wheel wash station (Photo 22).

**Photo 22. Contractors continue with construction of the TDF's new wheel station.**

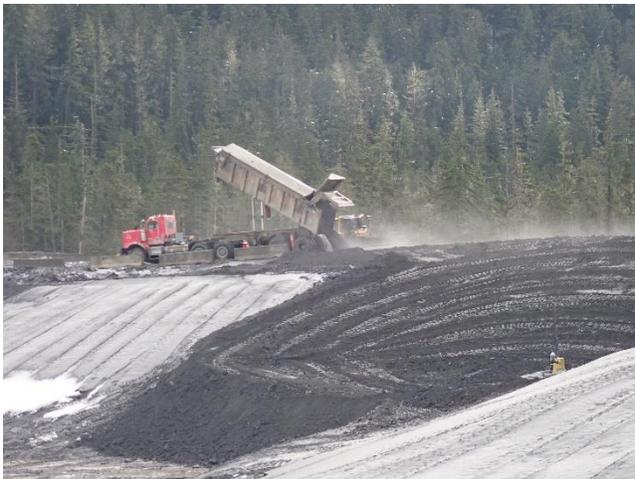
HGCMC TDF personnel continue to deposit tailings in the S3P1 area (Photo 23). The 2017 year to date total of tailing deposited in the expansion area is approximately 301,000 tons.

**Photo 23. HGCMC TDF personnel continue to place tailings in the S3P1 area.**

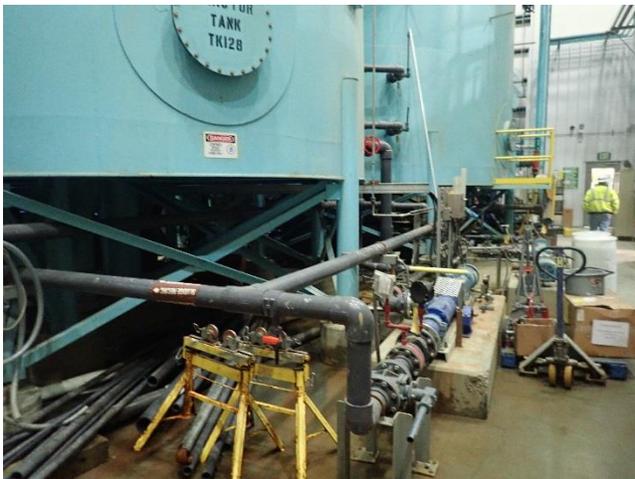
The recorded flow rate on 11/28/2017 for the water treatment plant was 1,200 gallons per minute (gpm). The monthly average discharge rate for November through Outfall 002 was 903.2 gpm. All water discharged through Outfall 002 is limited and monitored per APDES permit requirements. The water treatment plant was tidy and in order (Photo 24).

**Photo 24. HGCMC's water treatment plant.**

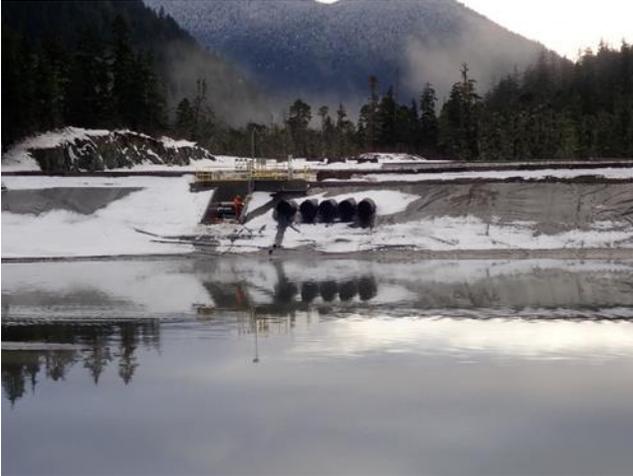
During the site visit, contractors continue to work on the concrete flow control structure for ponds 7 and 10 (Photo 25).

**Photo 25. The concrete flow control structure for Pond's 7 and 10.**

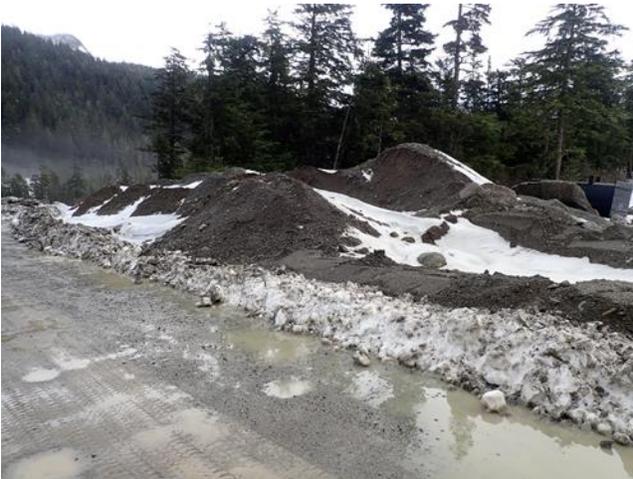
The gravel (Photo 26) staged at this location will be used as ballast material to counter upwelling for the above liner at Pond-10.

**Photo 26. The material staged near Pond-10 will be used as ballast material.**

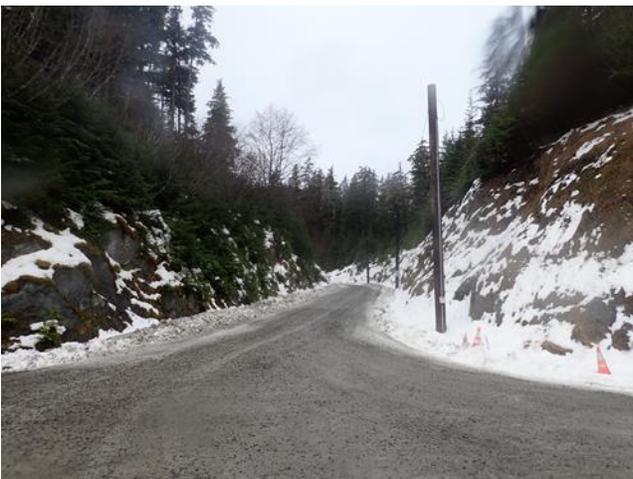
The A-road was in adequate condition, from the junction to Young's Bay (Photo 27), with snow removed/plowed from the road, and pea gravel was placed for traction (Appendix 8 Road Operations and Maintenance; page 8-5).

**Photo 27. The end of the A-road is Young's Bay parking area for the crew bus.**

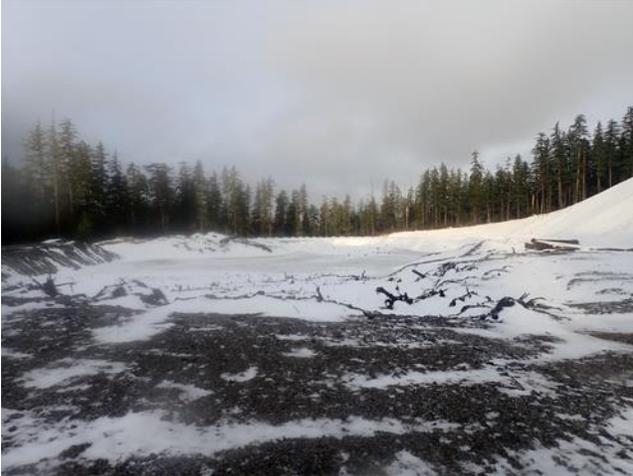
This area is currently inactive (Photo 28).

**Photo 28. The Sand pit.**
