INSPECTION REPORT: GREENS CREEK MINE

Date of Inspection: Wednesday January 10, 2018
Date of Report: Tuesday January 30, 2018
USDA Forest Service Inspector: Richard Dudek

The site inspection included the B road system, 920 area, Site 23, 7.4 mile B-road Bridge (Killer Creek Bridge), 3.4 mile B-road Bridge (Falls Creek Bridge), 3.0 mile B-road Bridge (Zinc Creek Bridge), and the Tailings Disposal Facility (TDF).

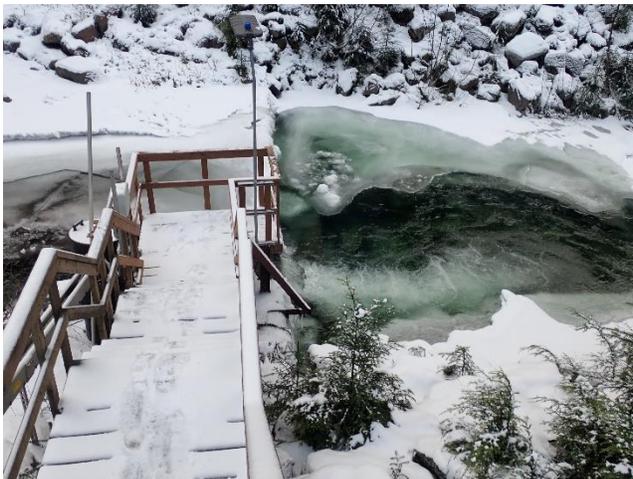
Photo 1. The 920 Greens Creek weir.

The recorded discharge rate for Greens Creek weir (Photo 1) on 01/10/2018 was 29.65 cubic feet per second (cfs). Due to the mill being temporarily offline for scheduled maintenance, HGCMC was not withdrawing 1.5 cfs for the 920 water system from Greens Creek.

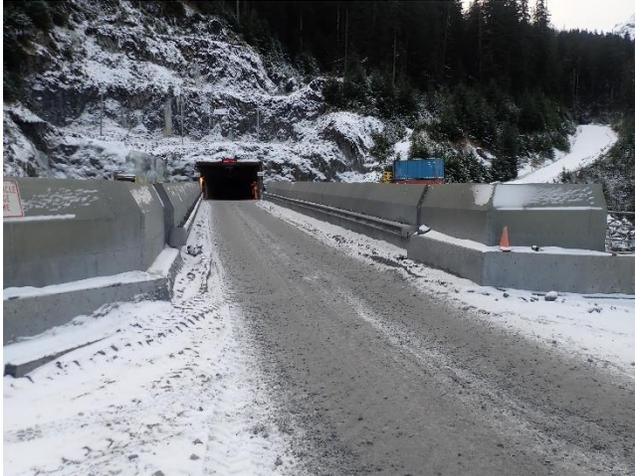
Photo 2. The 920 Bridge.

The 920 bridge (Photo 2) is being properly maintained by Surface operations. Snow is being plowed away from the bridge, and gravel is placed on the bridge decking for traction.

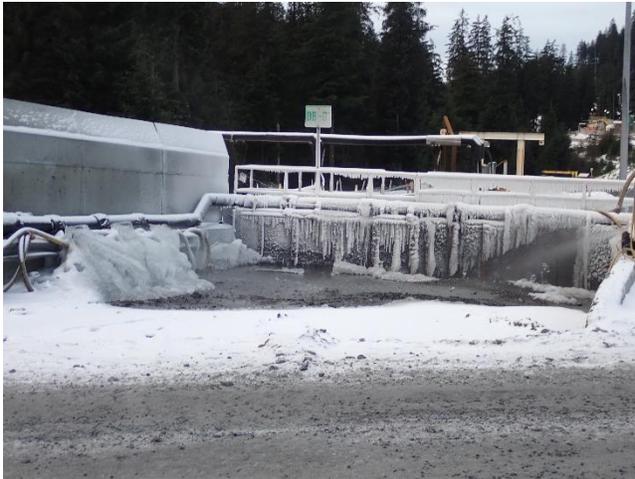
Photo 3. The 920 area de-grit basin 01 (DB-01).

De-grit Basin 01 (DB-01) was in use during the site inspection (Photo 3). All melt water in DB-01 is routed to Pond-A, and the sediments collected in the basin are disposed of in the TDF.

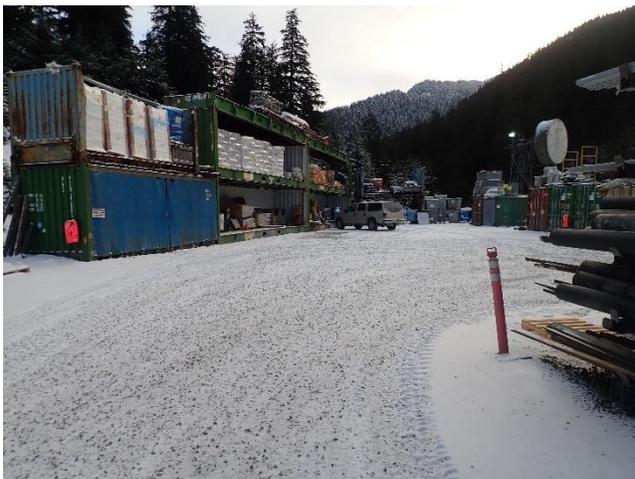
Photo 4. The 920 warehouse storage area.

Good housekeeping practices were observed at the warehouse (Photos 4-5) and in the storage containers. All chemicals and petroleum products were properly stored with secondary containment (Appendix 5 BMP plan; page 39).

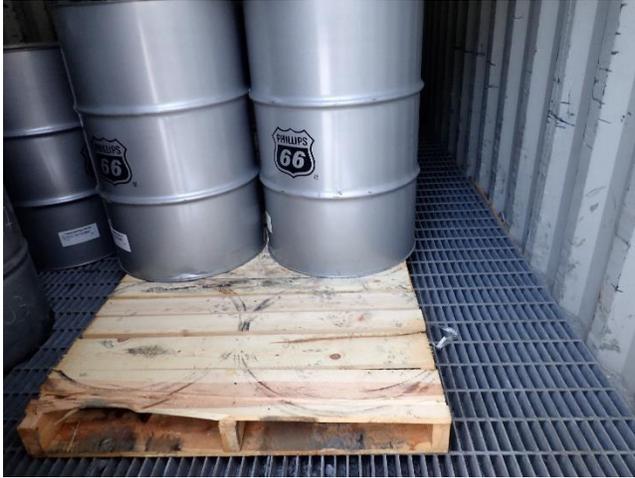
Photo 5. A storage container at the 920 warehouse with secondary containment.

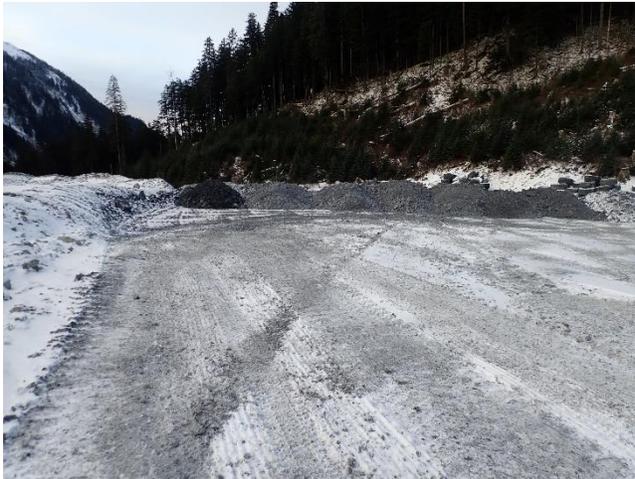
Photo 6. Site 23

Additional Class 2/3 waste rock has been recently stockpiled at this location (Photo 6).

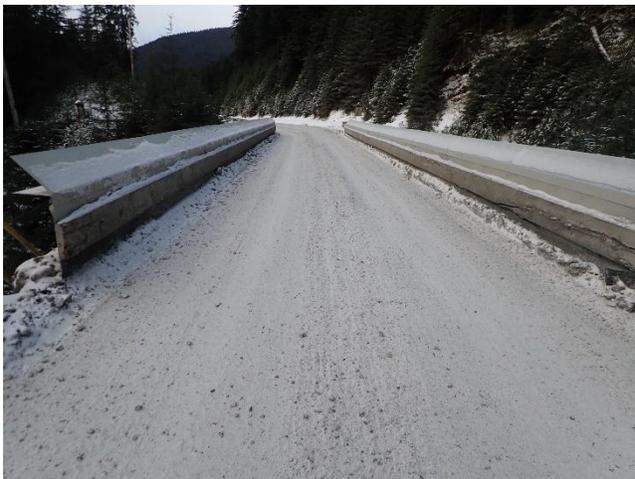
Photo 7. The 7.4-mile B-road Bridge (Killer Creek Bridge).

Snow is being plowed from the decking, and gravel is placed for traction. The splashguards are effectively preventing sediment splash over from vehicular traffic (Photos 7-8).

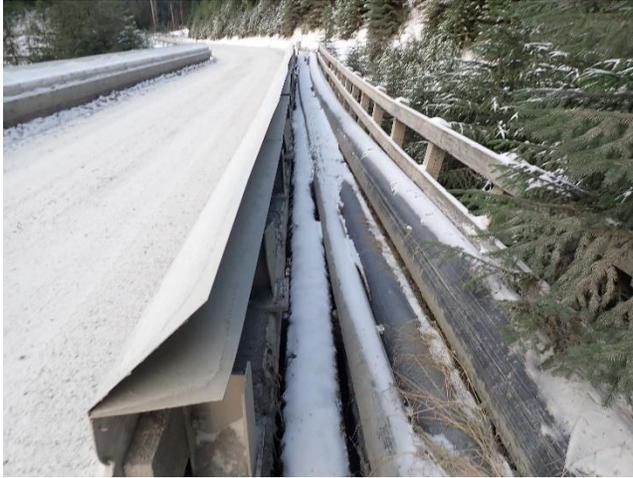
Photo 8. No sediments were observed on the pipeline.

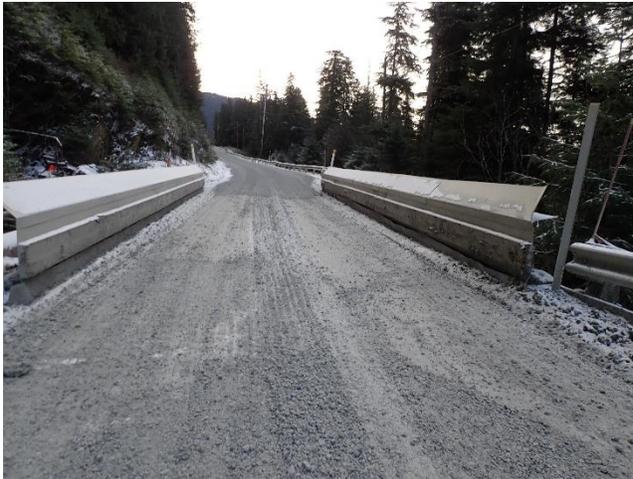
Photo 9. 3.4 mile B-road Bridge (Falls Creek Bridge).

Snow is being removed and gravel is being placed on the bridge's decking for traction (Photo 9). The splashguards are effectively preventing sediment splash over from vehicular traffic.

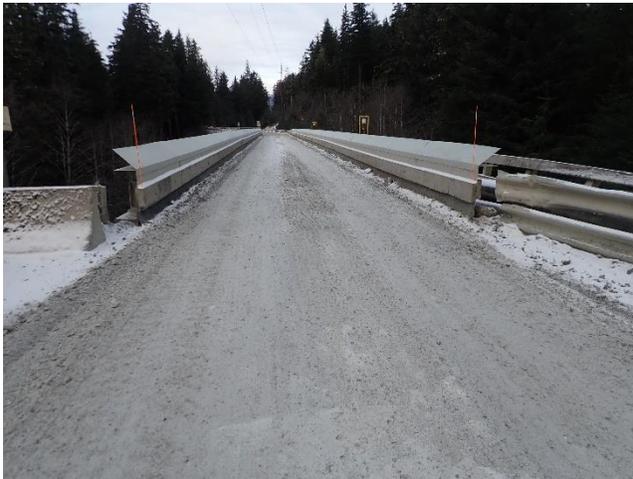
Photo 10. 3.0 Mile B-road Bridge (Zinc Creek Bridge).

HGCMC personnel are removing snow and placing gravel for traction on the decking (Photo 10).

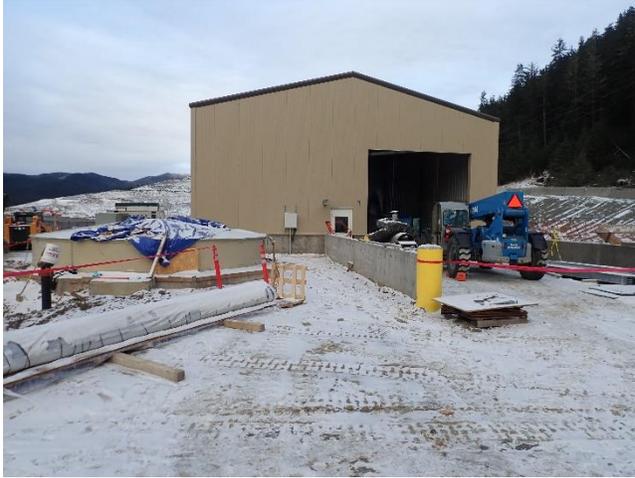
Contractors continue with the construction of the new TDF wheel wash station (Photo 11).

Photo 11. Contractors continue with the construction of the new wheel wash station.

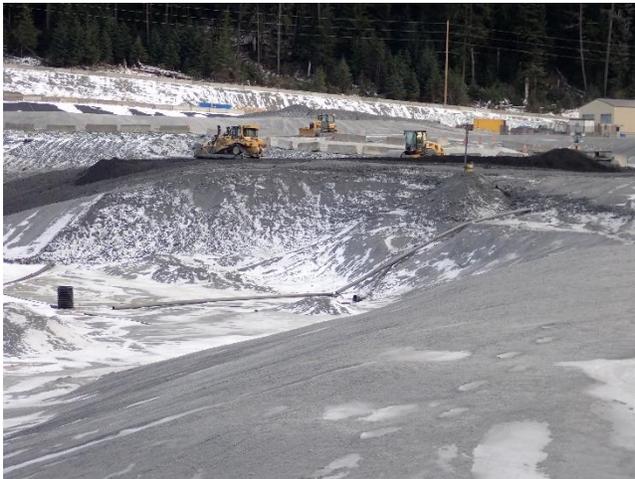
HGCMC TDF personnel continue to deposit tailings in the S3P1 expansion area (Photo 12). Due to recent high winds, some fugitive dust was observed outside of the S3P1 containment area near the TDF's southern access road. During the winter months, HGCMC will use a number of dust mitigation controls such as minimizing tailings placement areas, portable and/or fixed windscreens, and water. Additional portable and/or fixed windscreens should be staged in the S3P1 expansion area for fugitive dust control. HGCMC is currently waiting for parts for the TDF water misting system, which should help minimize fugitive dust.

Photo 12. HGCMC continues placing tailings in the S3P1 expansion area.

- **Install additional fugitive dust controls in the S3P1 containment area near the southern access road.**

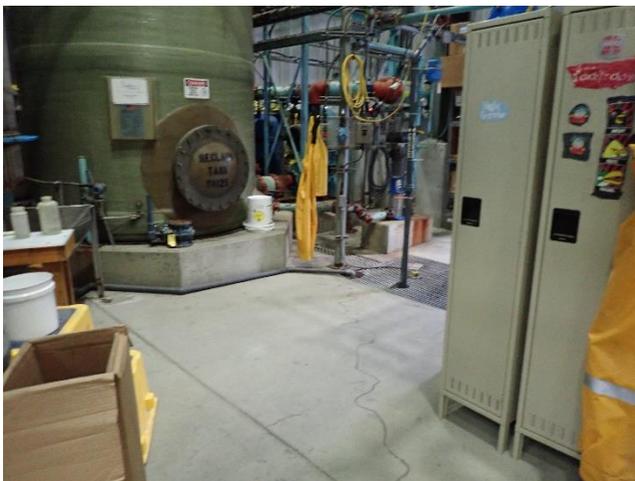
Photo 13. HGCMC's water treatment plant.

limited and monitored per APDES permit requirements. Good housekeeping practices were observed inside the water treatment plant (Photo 13).

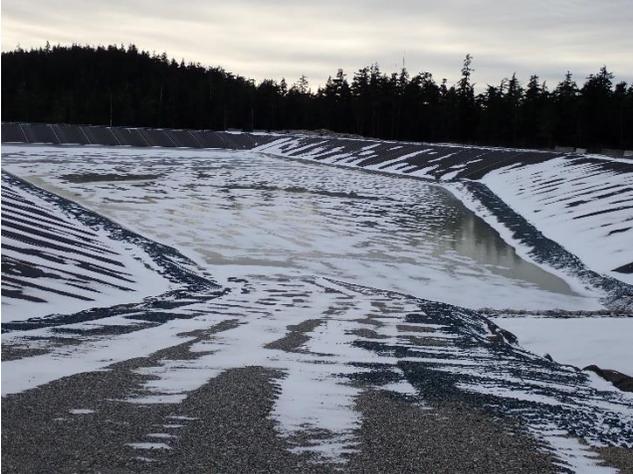
Photo 14. Pond 10.

Due to rain events in December 2017, water from Pond 7 overflowed and entered Pond 10 (Photo 14). HGCMC did report this to the Alaska Department of Natural Resources, Dam Safety division (ADNR). During the site inspection on 1/10/2018, the water was frozen in Pond 10.

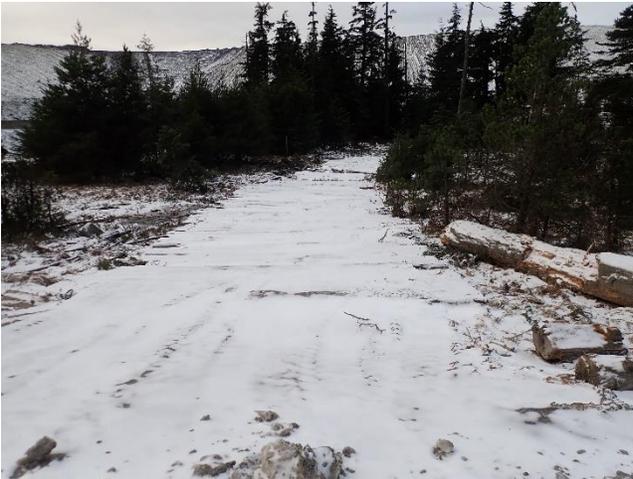
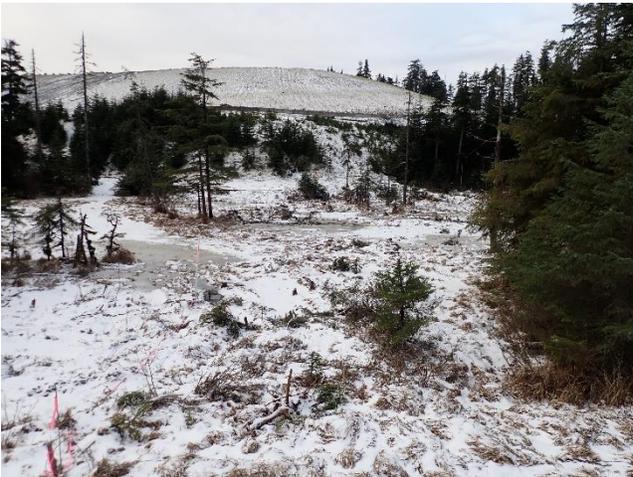
In mid-January, contractors will continue with geotechnical drilling in the wetlands near the northern TDF area. HGCMC has constructed temporary access roads out of log-cord and rig mats to access drill sites. Some trees will be cut, which the Forest Service approved tree removal for this project (Photos 15-16).

Photo 15. The vicinity in the TDF area where geotechnical drilling will take place.

Photo 16. An additional location where geotechnical drilling will be conducted.

Ensure drill sites are reclaimed after geotechnical drilling has concluded.

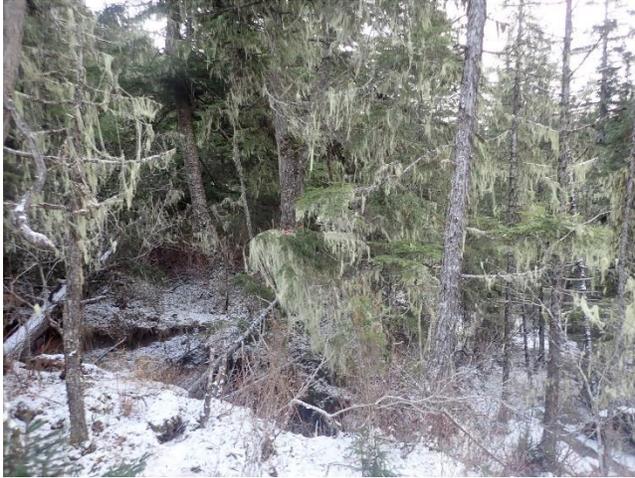
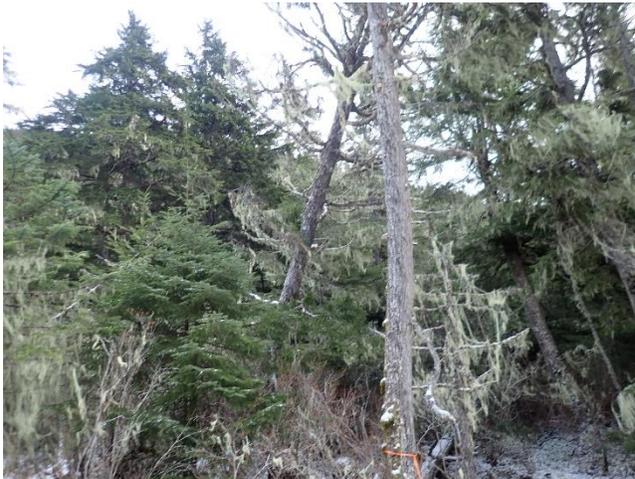
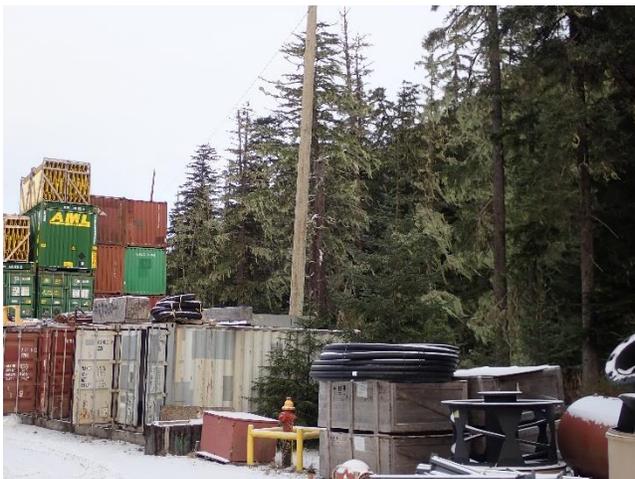
HGCMC will be contacting the Forest Service to request the removal of several hazard trees (Photos 17-19) behind the housing facilities. These hazard trees could potentially cause damage to powerlines, equipment and/or injury to personnel.

Photo 17. Hazard trees near the housing facility.

Photo 18. An additional image of hazard trees located behind the housing facility.

Photo 19. Additional hazard trees were observed along the perimeter of a storage area behind the housing facilities.
