INSPECTION REPORT: GREENS CREEK MINE

Date of Inspection: Tuesday February 13, 2018
Date of Report: Tuesday February 27, 2018
USDA Forest Service Inspector: Richard Dudek

The site inspection included the Access Road B, 920 area, Site 23, 7.4 mile B-road Bridge (Killer Creek Bridge), 3.4 mile B-road Bridge (Falls Creek Bridge), 3.0 mile B-road Bridge (Zinc Creek Bridge), Tailings Disposal Facility (TDF), and the Access Road A.

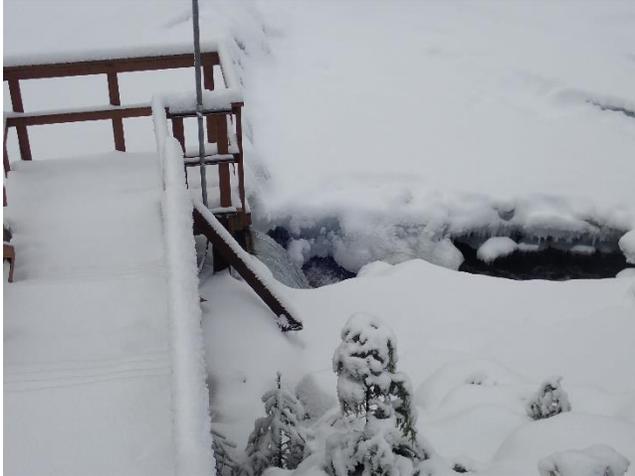
The recorded discharge rate for Greens Creek weir (Photo 1) on 2/13/2018 was 10.30 cubic feet per second (cfs). The 920 area water withdrawal rate from Green Creeks was 1.5 cfs.

Photo 1. The 920 Greens Creek Weir.

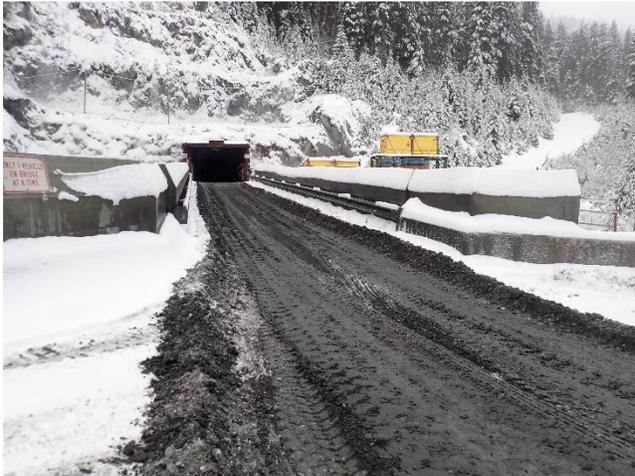
At the 920 bridge (Photo 2), snow is being plowed away from the bridge, and gravel is placed on the bridge decking for traction.

Photo 2. The 920 Bridge.

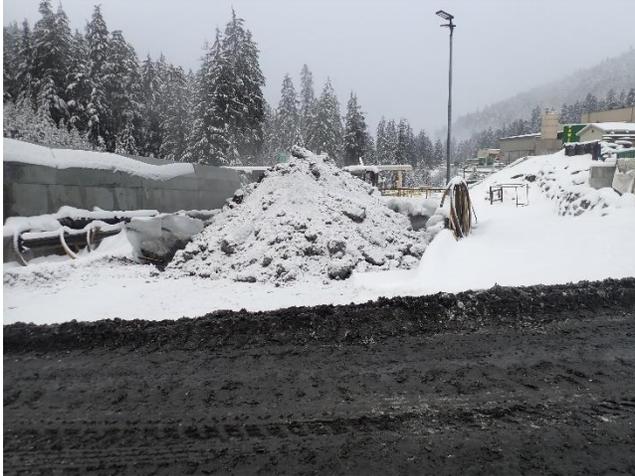
De-grit Basin 01 (DB-01) was in use during the site inspection (Photo 4). All melt water in DB-01 is routed to Pond-A. Sediments collected in DB-01 are disposed of in the TDF.

Photo 4. DB-01.

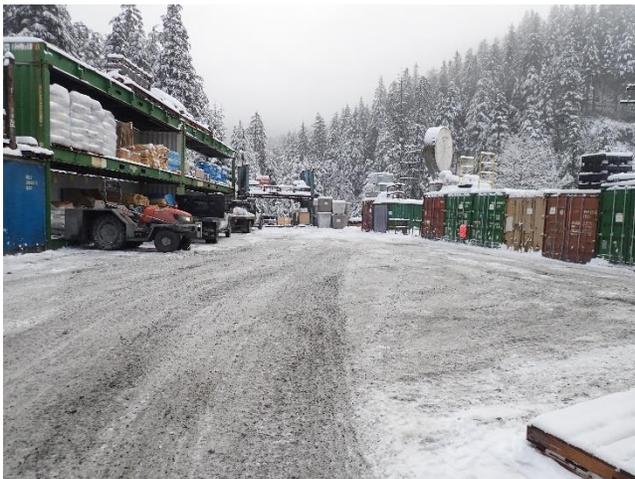
Good housekeeping practices were observed at the warehouse (Photos 5-6) and in the storage containers. All chemical and petroleum products were properly stored within secondary containment (Appendix 5 BMP plan; page 39).

Photo 5. The 920 warehouse area.

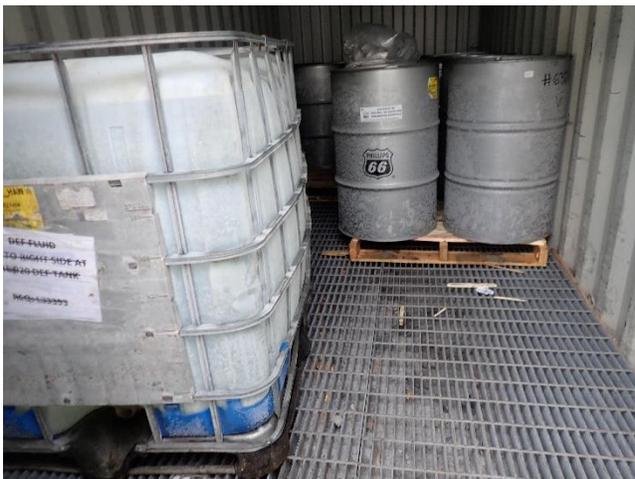
Photo 6. Storage containers in secondary containment.

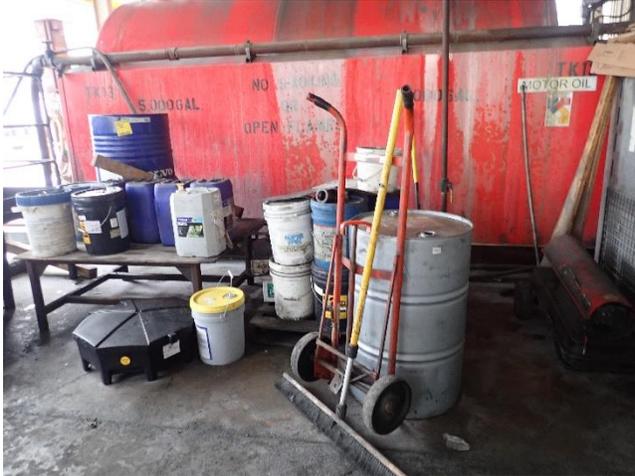
Good housekeeping practices were observed at the maintenance shop's petroleum storage area (Photos 7-8). All petroleum products were properly stored within secondary containment. HGCMC is currently evaluating different options to make improvements to the area. These options may include replacing both 5,000-gallon tanks with isotainers, and enclosing the area to avoid excess precipitation and freezing conditions.

Photo 7. The petroleum storage area.

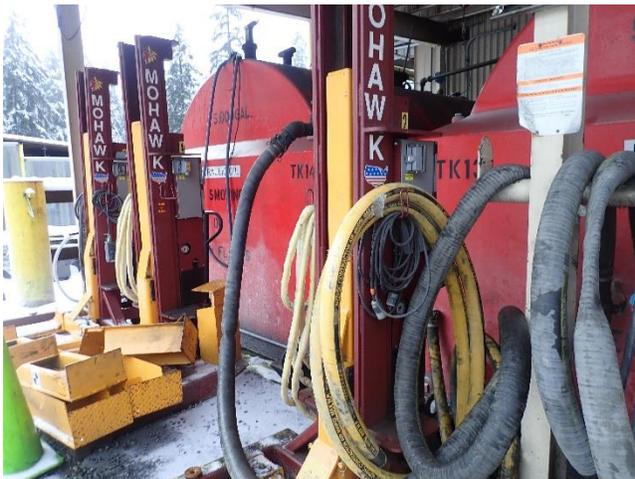
Photo 8. The maintenance shop's two 5,000-gallon tanks containing motor oil and hydraulic fluid.

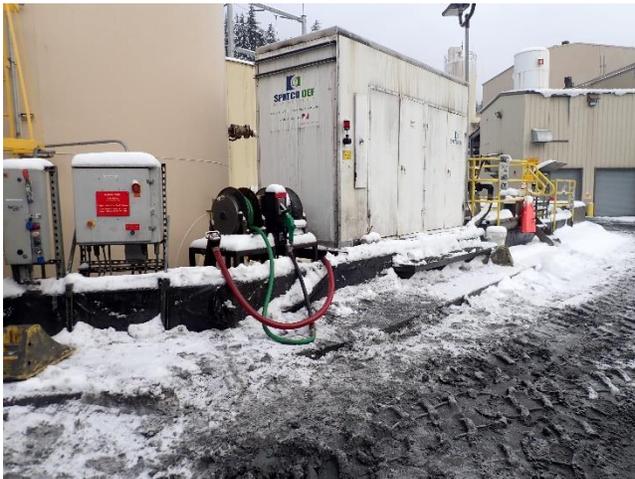
Good housekeeping practices were observed at the diesel refueling station (Photo 9).

Photo 9. The Diesel refueling station.

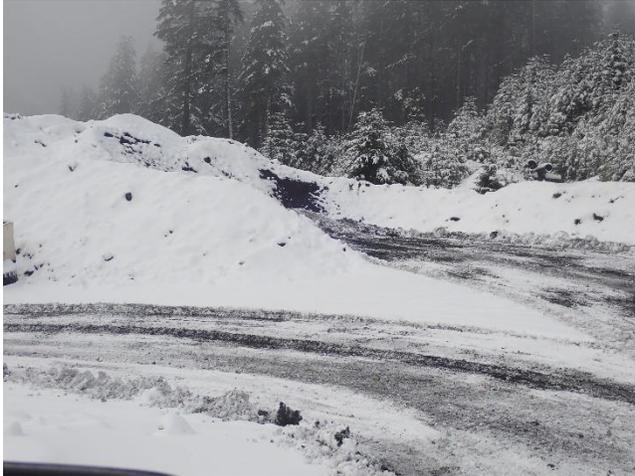
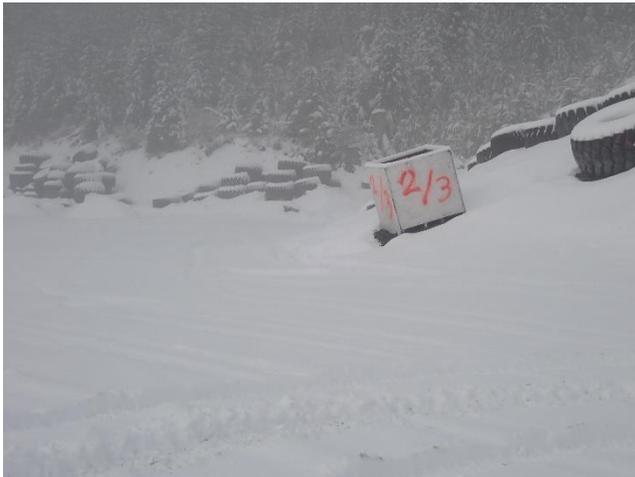
At the time of the inspection, no new waste rock has been deposited at this location (Photo 10-11). Waste rock remains underground and utilized as backfill when it is not deposited at this site.

Photo 10. Site 23 Class 1 waste rock stockpiles.

Photo 11. Site 23 Class 2/3 waste rock stockpiles.

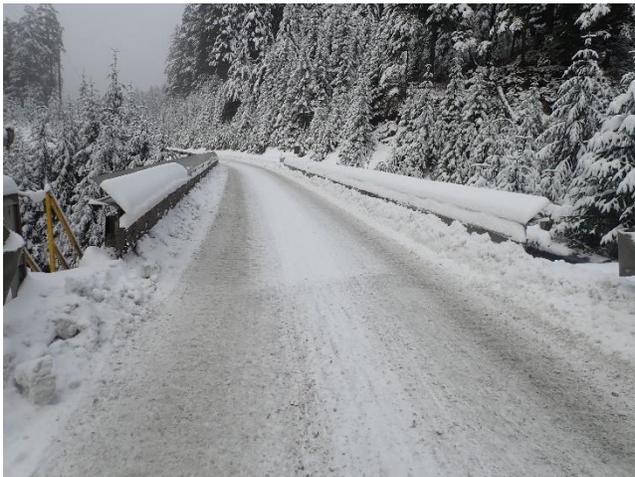
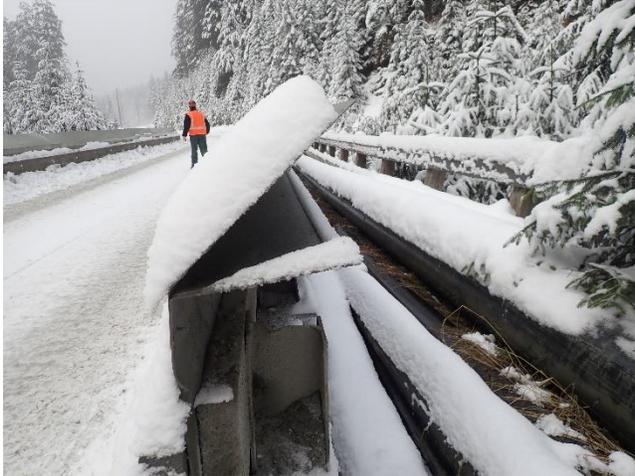
Snow is being plowed from the decking and gravel is placed for traction. The splashguards are effectively preventing sediment splash-over from vehicular traffic (Photos 12-13).

Photo 12. 7.4 Mile B-road Bridge (Killer Creek Bridge).

Photo 13. Killer Creek Bridge splashguards.

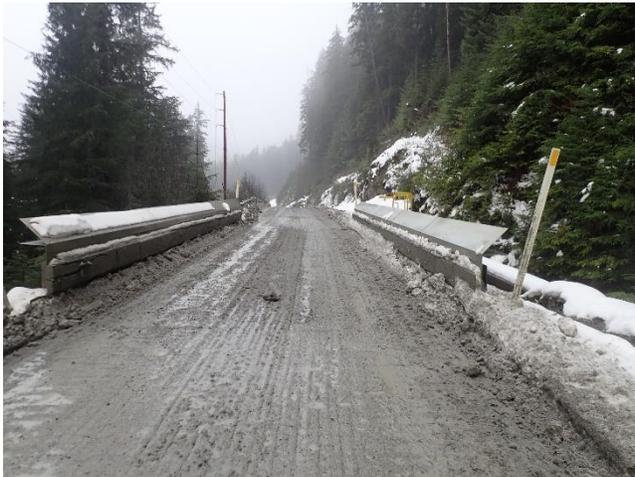
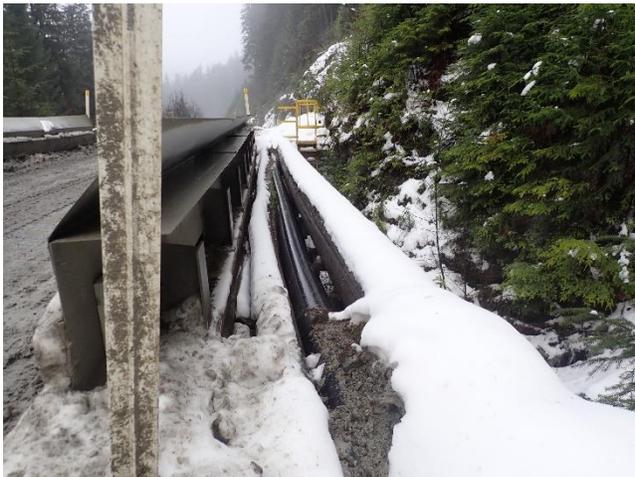
Snow is being removed and gravel is being placed on the bridge's decking for traction (Photo 14-15). The splashguards are effectively preventing sediment splash-over from vehicular traffic.

Photo 14. 3.4 Mile B-road Bridge (Falls Creek Bridge).

Photo 15. Falls Creek Bridge splashguards.

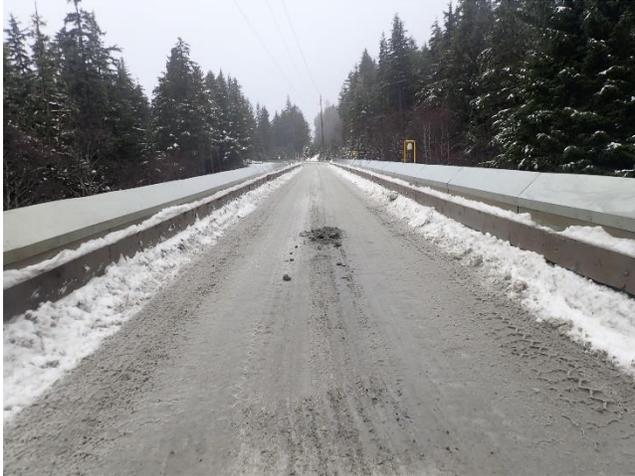
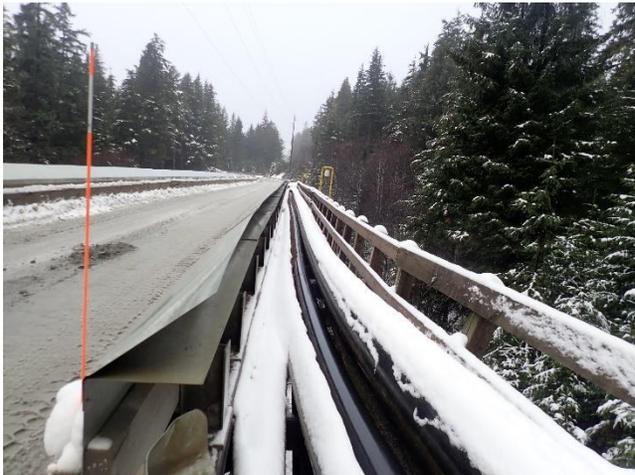
HGCMC personnel are removing snow and placing gravel for traction on the decking (Photo 16-17).

Photo 16. 3.0 Mile B-road Bridge (Zinc Creek Bridge).

Photo 17. Zinc Creek Bridge splashguards.

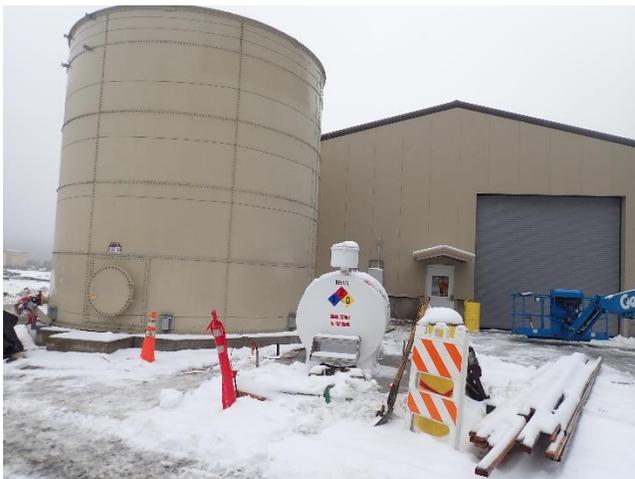
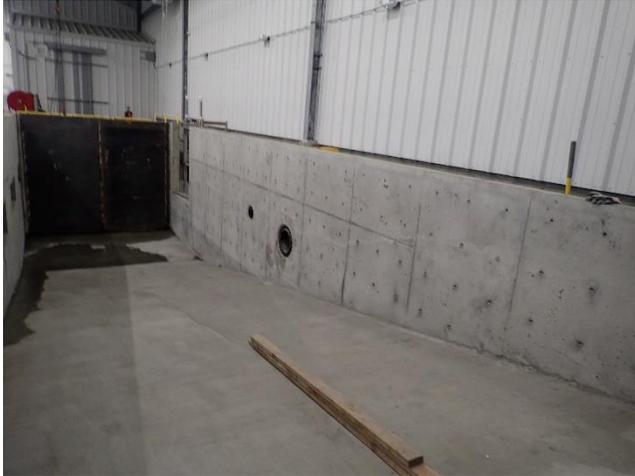
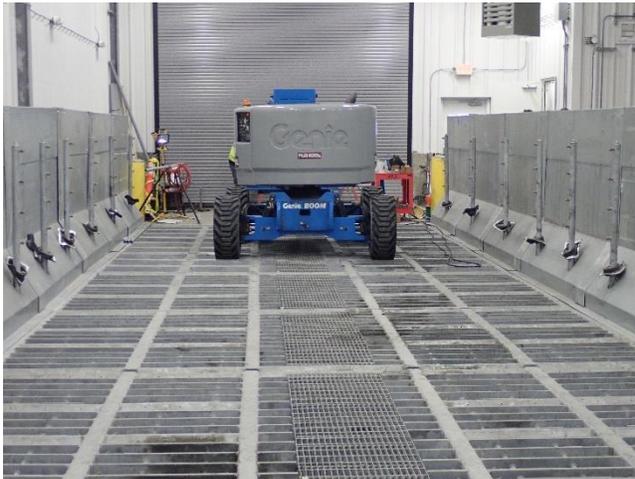
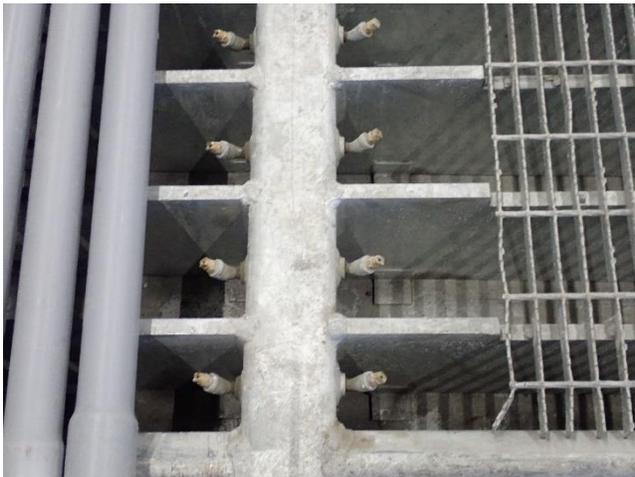
Construction of the new wheel wash station is almost complete (Photos 18-21). HGCMC anticipates the wheel wash station will be commissioned in the next couple of months. Once the new wheel wash station is in operations, the old truck wash station will be decommissioned.

Photo 18. The TDF area's new wheel wash facility.

Photo 19. A de-grit basin inside the wheel wash station.

Photo 20. The wheel wash station.

Photo 21. The water jets for the wheel washing station.

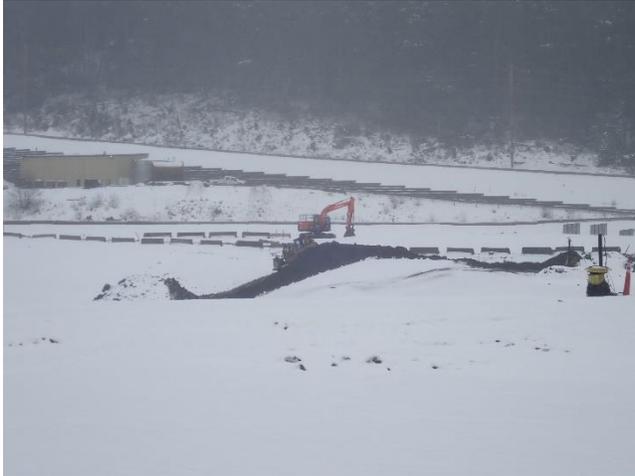
HGCMC TDF personnel continue to deposit tailings in the S3P1 expansion area (Photo 22). During the winter months, HGCMC uses a number of dust mitigation controls such as minimizing tailings placement areas, portable and/or fixed windscreens, and water.

Photo 22. The TDF' S3P1 tailings disposal area.

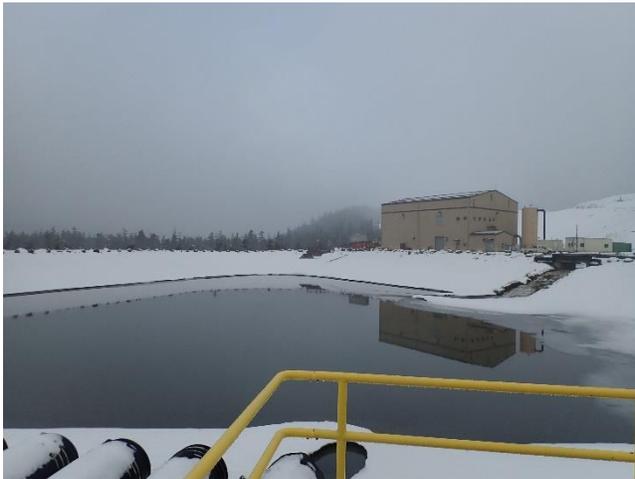
Pond 7 was receiving mine site water and Pond 10 was frozen over and covered in snow (Photos 24-25).

Photo 23. The TDF area's Pond 7

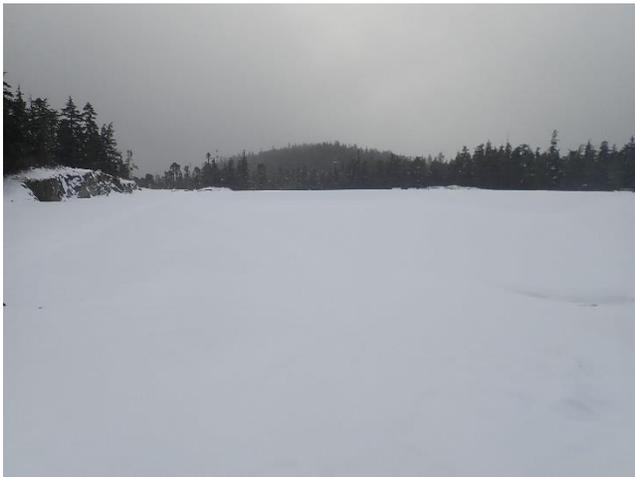
Photo 24 The TDF's Pond 10 was covered in snow.

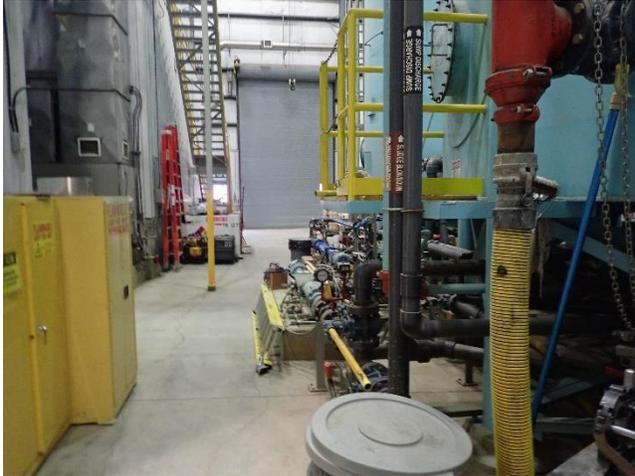
The recorded discharge rate on 2/13/2018 for the water treatment plant was 1,297 gallons per minute (gpm), with 584 gpm being discharged through Outfall 002. The treated water that is not discharged through Outfall 002 is returned back to Pond 7. All water discharged through Outfall 002 is limited and monitored per APDES permit requirements. Good housekeeping practices were observed inside the water treatment plant (Photo 23).

Photo 25. The TDF water treatment plant.

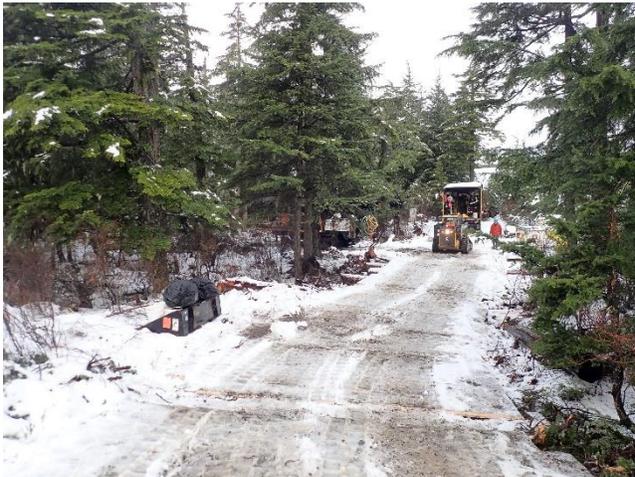
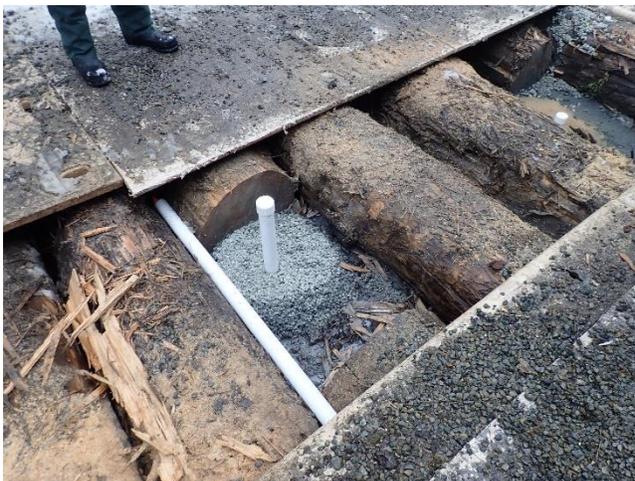
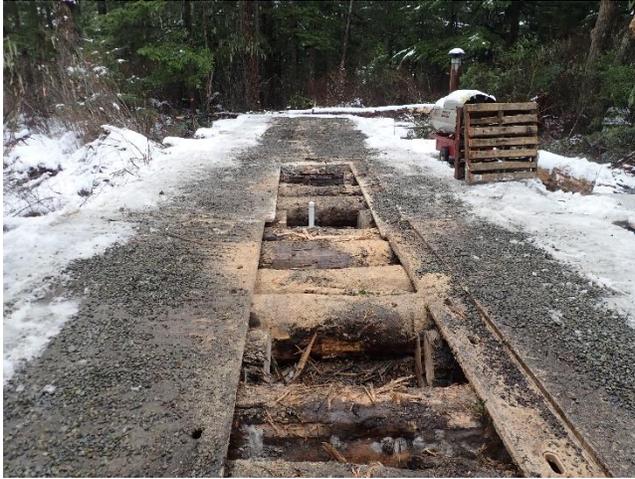
Geotechnical drilling at one location in the southwest area has concluded (Photos 26-28). The two monitoring wells installed MW-T-18-05A (bedrock) and MW-T-18-05B (glacial-marine sediments) are part of a feasibility study for bedrock competency. During the site inspection, the area was tidy and in order.

Photo 26. Geotechnical drilling in the northwest TDF area.

Photo 27. Two inclinometers installed at this location.

Photo 28. The site location for geotechnical drilling.
