INSPECTION REPORT: GREENS CREEK MINE

Date of Inspection: Thursday March 15, 2018
Date of Report: Tuesday March 27, 2018
USDA Forest Service Inspector: Richard Dudek

Ranger District: Admiralty National Monument, Juneau Ranger District
Weather Conditions: Cloudy with sun Temperature: low 40's (°F).

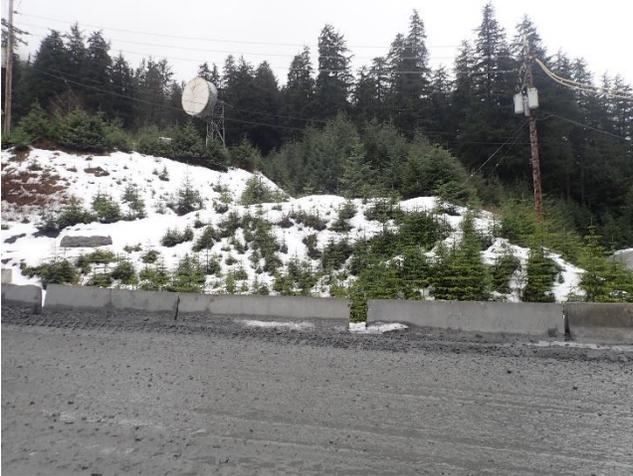
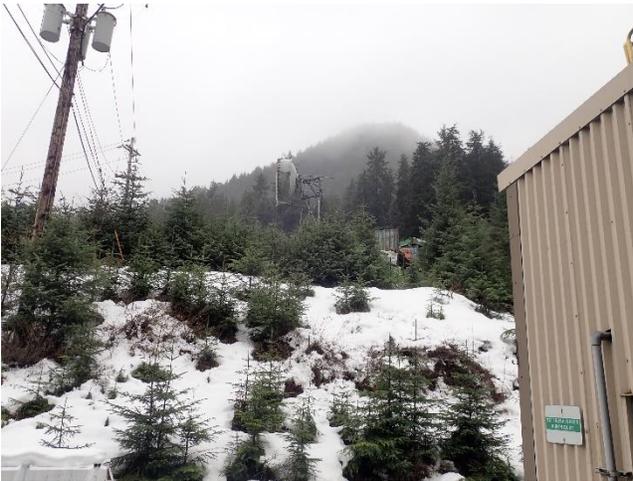
HGCMC will be submitting a proposal to the Forest Service to remove 900 cubic yards of waste rock located near the 920-pump house, and construct an electrical switchgear pad to supply additional power to the underground mine (Photos 1-2).

Photo 1. The proposed location for the removal of waste rock and new electrical switchgear pad.

Photo 2. A side view of the proposed location for the electrical switchgear pad.

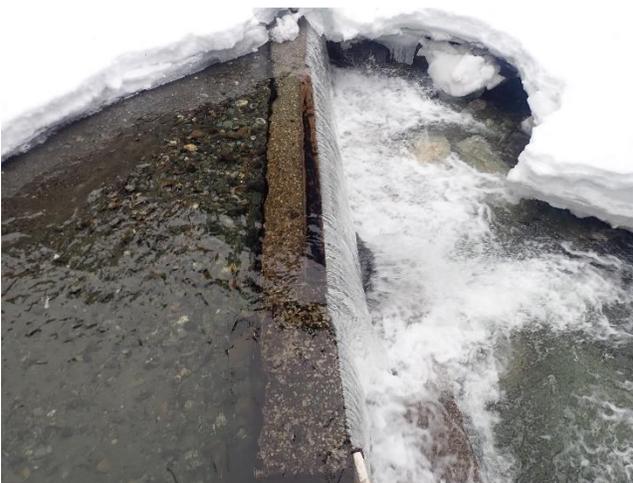
The recorded discharge rate for the Greens Creek weir (Photo 3) on 3/15/2018 was 19.84 cubic feet per second (cfs). The 920-area water withdrawal rate from Green Creeks was 1.5 cfs.

Photo 3. Green Creek Weir.

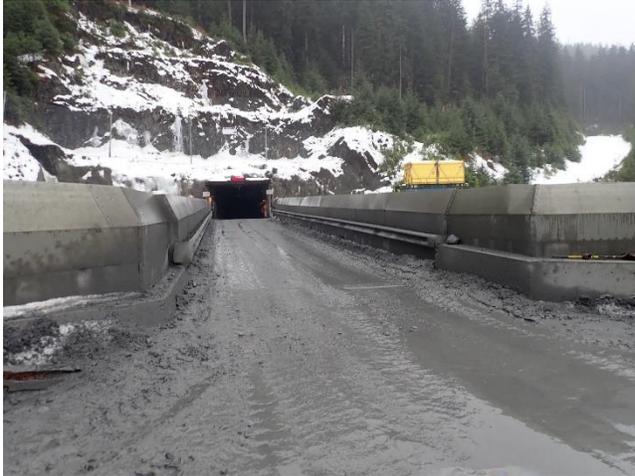
The 920 bridge (Photo 4) splashguards are effectively working to prevent sediment splash over from vehicular traffic. HGCMC Surface operations are aware of the sediment accumulation along the bridge, and will be conducting routine maintenance to remove the sediments.

Photo 4. The 920 Bridge.

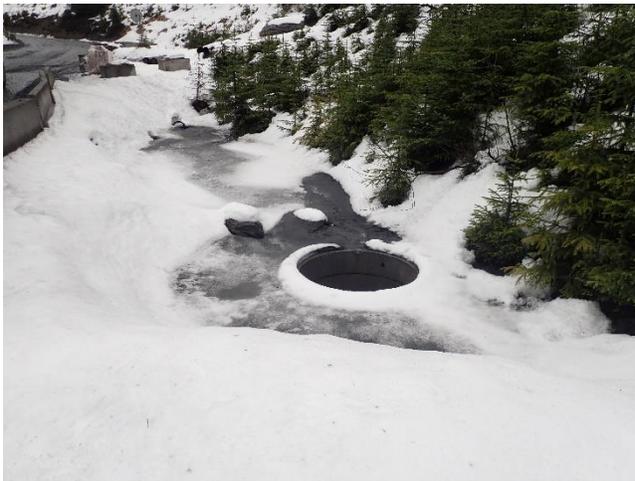
The sediment collection sump (Photo 5) near the 920-pump house will need to be mucked once warmer conditions persist (Appendix 8 Road Operations and Maintenance; page 8-6).

Photo 5. Sediment collection sump.

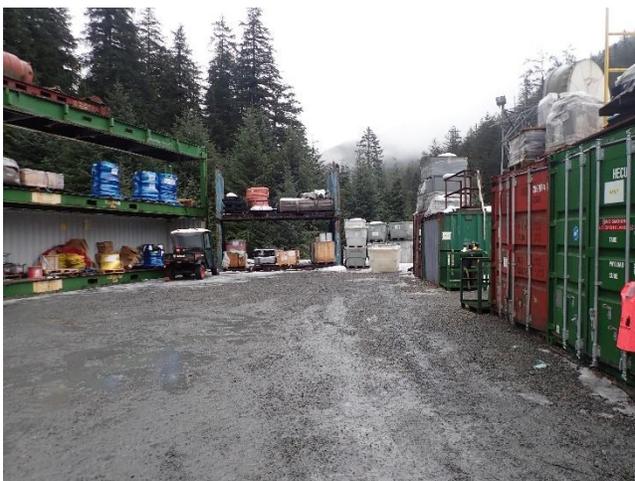
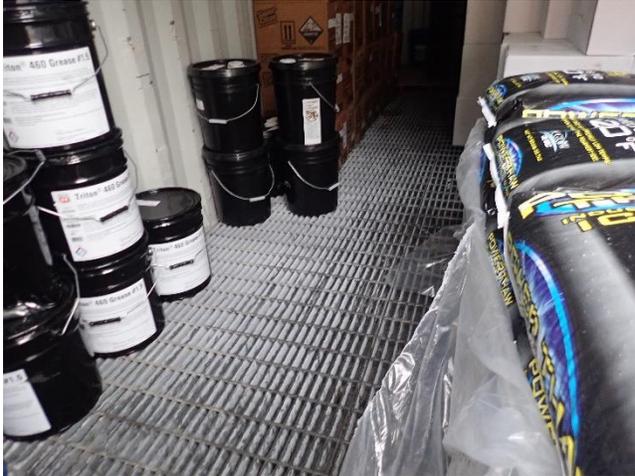
Good housekeeping practices were observed at the warehouse (Photos 6-7) and in the storage containers. All chemical and petroleum products were properly stored within secondary containment (Appendix 5 BMP plan; page 39).

Photo 6. The 920 warehouse storage area.

Photo 7. Grease and rock salt stored inside a container with secondary containment.

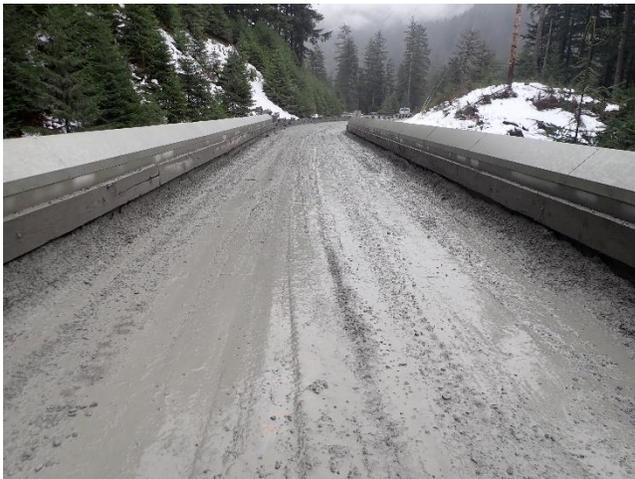
The bridge decking was in good condition (Photo 8), and the splashguards are effectively preventing sediment splash over from vehicular traffic (Photo 9). As warmer temperatures persist, sediment accumulation at the bridge ends will need to be monitored to prevent sediments from entering into the creek.

Photo 8. The 7.4 Mile B-road Bridge (Killer Creek).

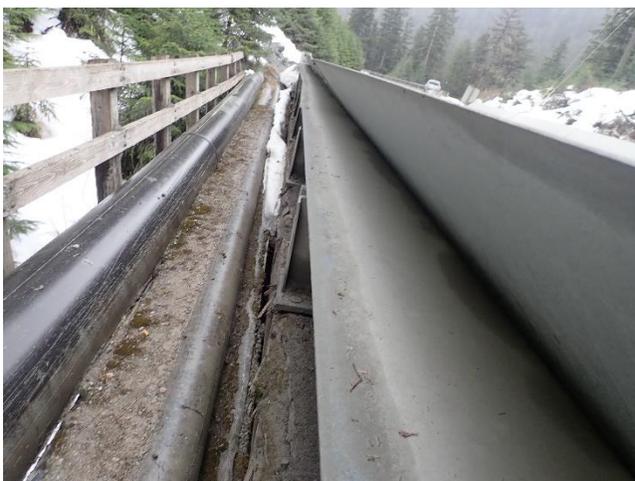
Photo 9. Splashguards are effectively working to prevent sediment splash over.

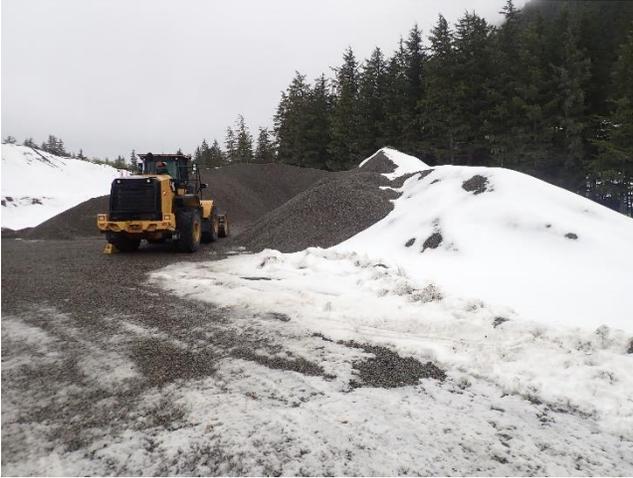
HGCMC is currently staging road base material at this location (Photo 10). To prevent cross contamination with waste rock, a sacrificial base layer was placed on the ground. In the summer of 2018, HGCMC plans to remove all of the old waste rock (Photo 11) from this location and dispose of it in the TDF.

Photo 10. Road base material staged at Site E.

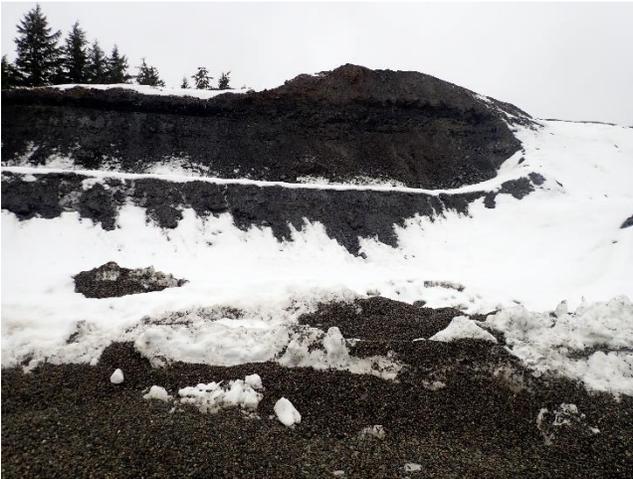
Photo 11. Waste rock staged at Site E.

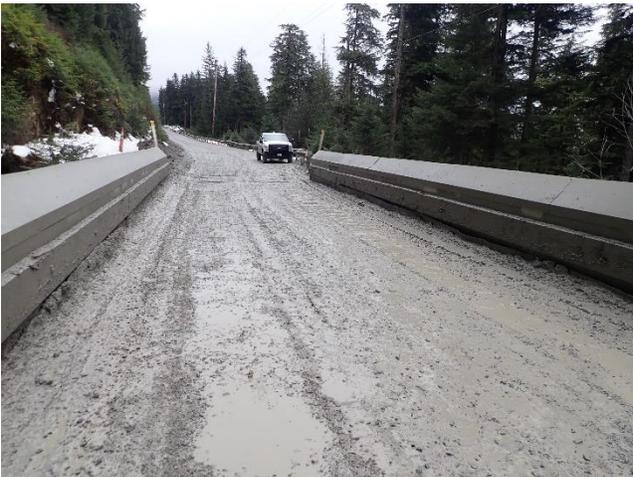
Photo 12. 3.4 Mile B-road Bridge (Falls Creek Bridge).

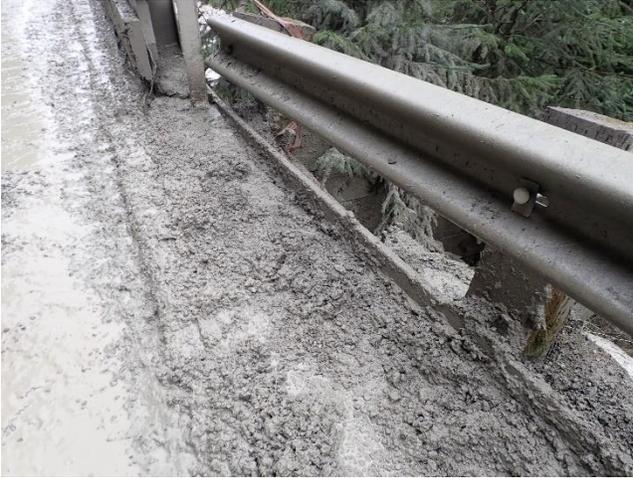
The bridge wear layer was in good condition (Photo 12). As warmer temperatures persist, the bridge ends should be frequently monitored to prevent road sediments from flowing down the abutments and into the creek. Observed at the downhill/stream side, the temporary barrier's (Photo 13) sediment accumulation has exceeded one-third of the height and requires cleaning. The Forest Service considers a temporary barrier's maintenance the same as silt fencing. Sediments are removed when accumulation reaches one-third of the fence height (Appendix 5 BMP Plan; page BMP-12).

Photo 13. Sediment accumulation at the bridge end.

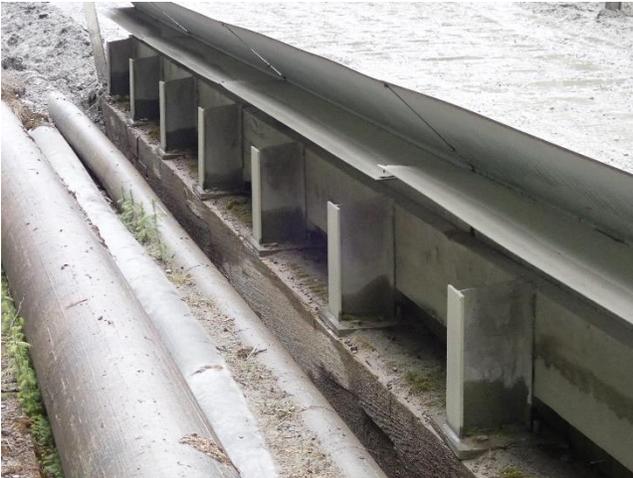
The splashguards are effectively preventing sediment splash over from vehicular traffic (Photo 14).

Photo 14. Splashguard rail at the Falls Creek Bridge.

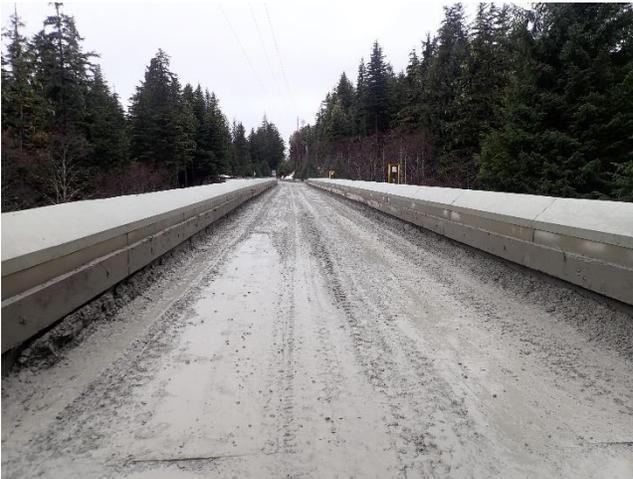
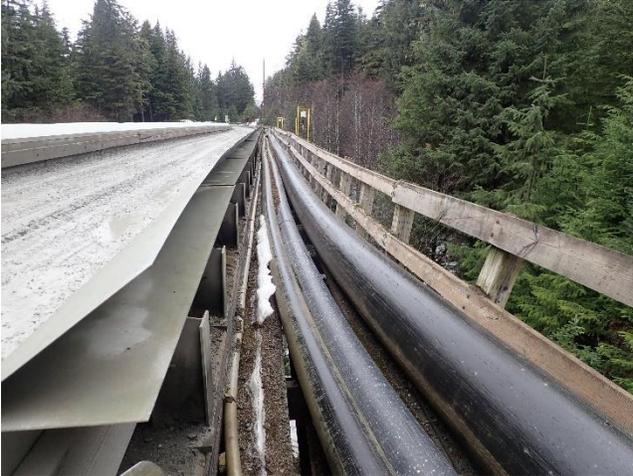
The bridge wear layer was in good condition (Photo 15), and the splashguards are effectively preventing sediment splash over from vehicles (Photo 16).

Photo 15. 3.0 Mile B-road Bridge (Zinc Creek Bridge).

Photo 16. Zinc Creek Bridge splashguard rail.

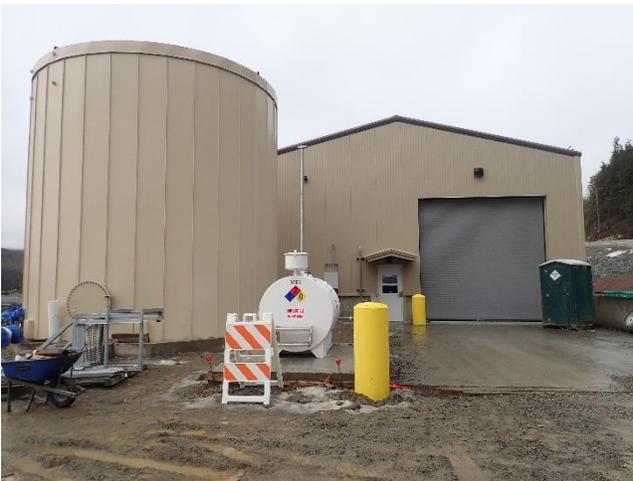
Photo 17. The new wheel wash station.

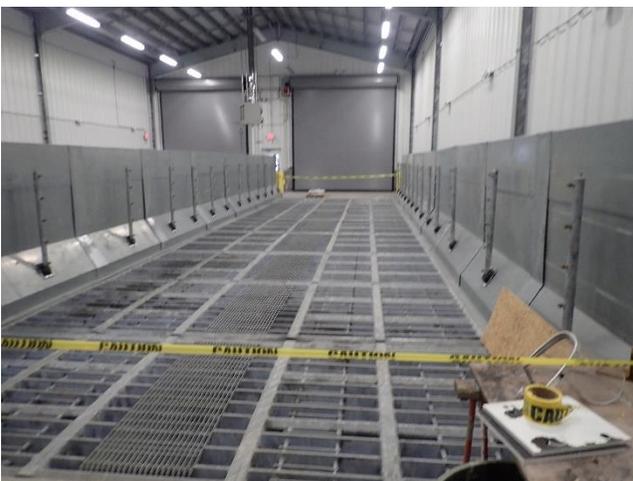
Construction of the new wheel wash station is almost complete (Photos 17). During construction of the wash station, HGCMC recognized the potential for the floor nozzles breaking off when tire chains pass over them (Photo 18). HGCMC addressed this concern with the manufacturer of the wheel wash station. The manufacturer then developed and engineered a solution that still met the design requirements. The change was implemented, and the site installation contractors drilled small holes into the floor of the washing station where water will spray onto the truck wheels. The water source for the wheel wash station will be from Cannery Creek, and groundwater from the S3P1 below liner drains.

Photo 18. Wheel wash station washing area.

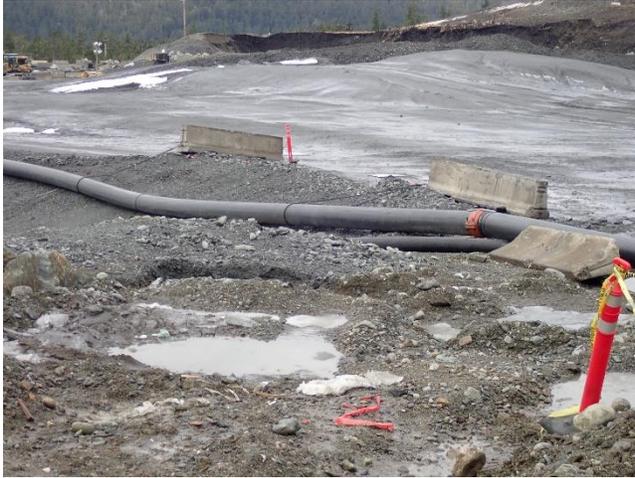
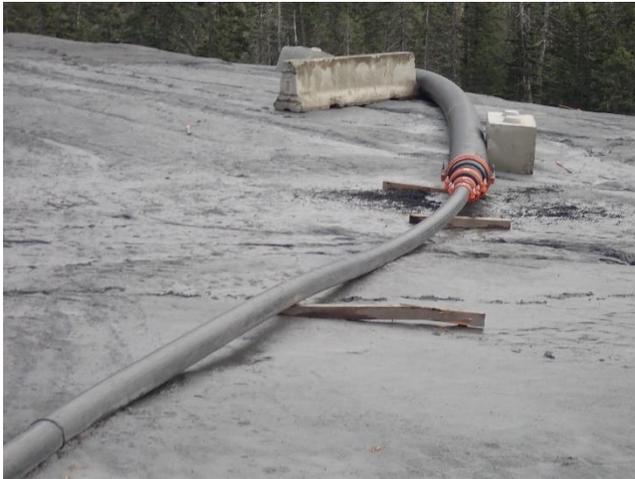
HGCMC Surface Operations has begun routing an effluent drainpipe from the wheel wash station across the S3P1 area and into pond 7 (Photos 19-20). The plan is bury the pipeline under tailings, and install cleanouts for maintenance.

Figure 19. The wheel wash station drainpipe to Pond 7.

Photo 20. The wheel wash station drainage pipe routing water to Pond 7.

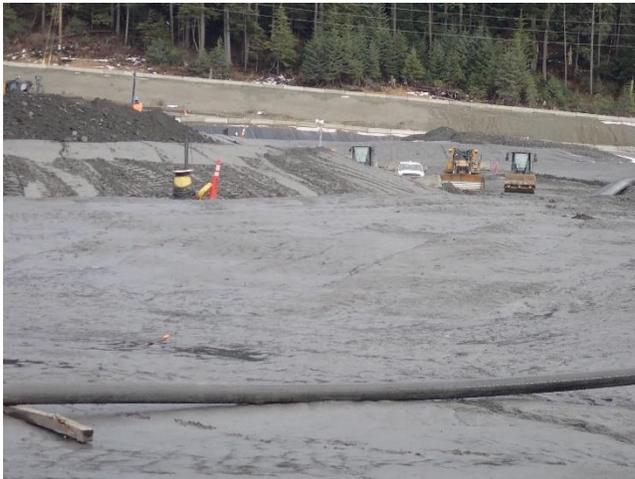
Surface Operations continues to deposit tailings in the S3P1 expansion area (Photos 21). During the winter months, HGCMC uses a number of dust mitigation controls such as minimizing tailings placement areas and windscreens. HGCMC is currently waiting for some components to arrive for the TDF water misting system, another dust mitigation strategy.

Photo 21. TDF personnel compacting tailings in the S3P1 area.

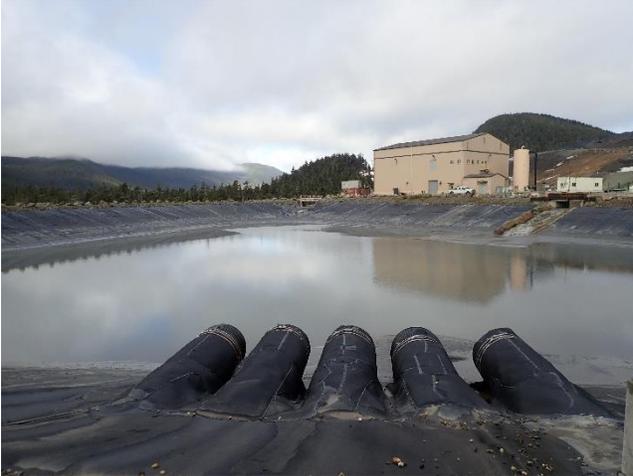
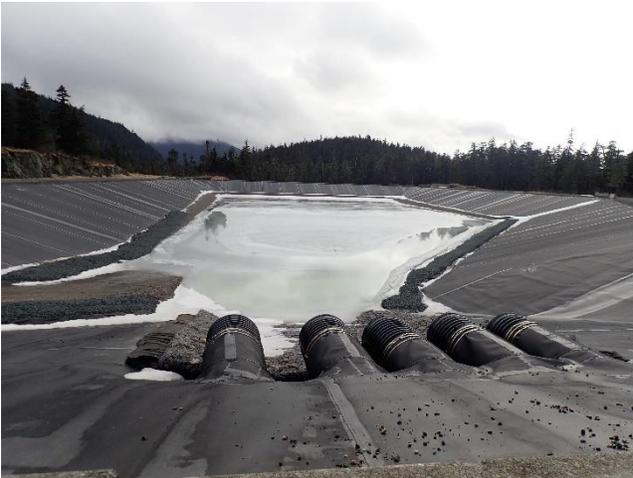
Pond 7 was receiving mine site water. Pond 10 is still inactive and only had snow and ice accumulation (Photos 22-23).

Photo 22. Pond 7.

Photo 23. Pond 10.

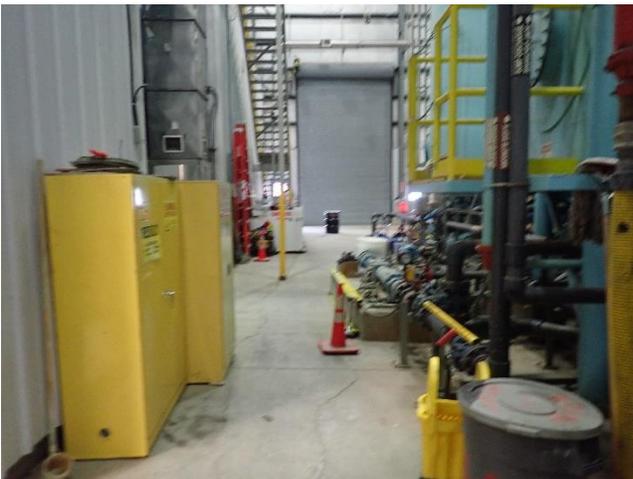
The recorded discharge rate on 3/15/2018 for the water treatment plant was 1,344 gallons per minute (gpm), with 1,300 gpm being discharged through Outfall 002. The treated water that is not discharged through Outfall 002 is recycled back into Pond 7. All water discharged through Outfall 002 is limited and monitored per APDES permit requirements. Good housekeeping practices were observed inside the water treatment plant (Photo 24).

Photo 24. The TDF water treatment plant.

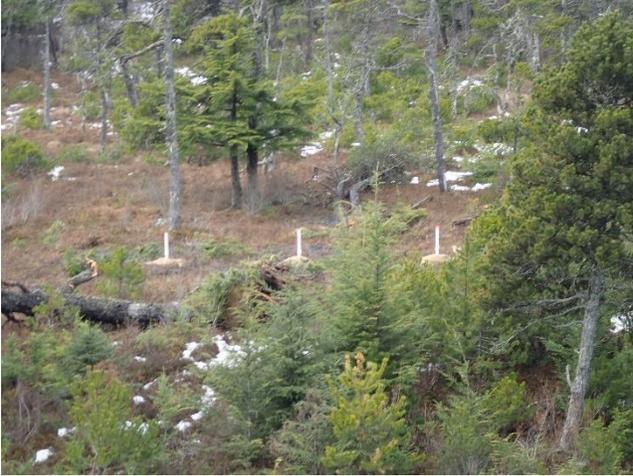
Geotechnical drilling in the wetlands behind Pond 7 has concluded (Photos 25). The three monitoring wells installed (well screen depths: bedrock, glacial till, and peat) as part of a feasibility study.

Photo 25. The three monitoring well installed for HGCMC's feasibility study.
