INSPECTION REPORT: GREENS CREEK MINE

Date of Inspection: Thursday December 6, 2018
Date of Report: Tuesday December 18, 2018
USDA Forest Service Inspector: Richard Dudek

The site inspection included the Access Road B, 920 area, 860 area, 7.4 mile B-road Bridge (Killer Creek Bridge), 3.4 mile B-road Bridge (Falls Creek Bridge), 3.0 mile B-road Bridge (Zinc Creek Bridge), and the Tailings Disposal Facility (TDF).

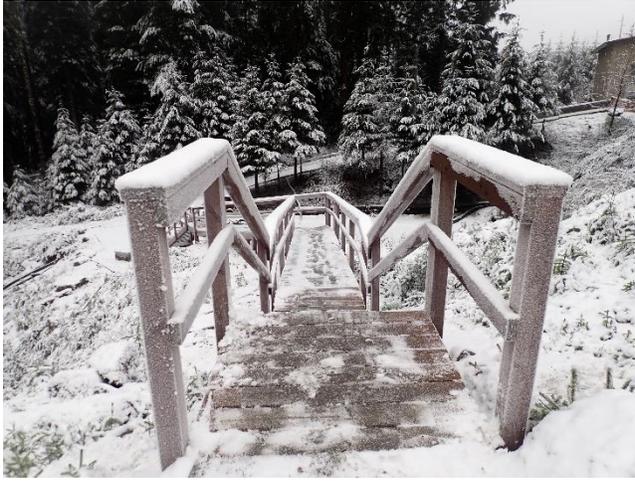
The 860 stairway that leads to upper C-Pond is now completed (Photo 1).

Figure 1. The 860 stairway for safely accessing upper and lower C-pond.

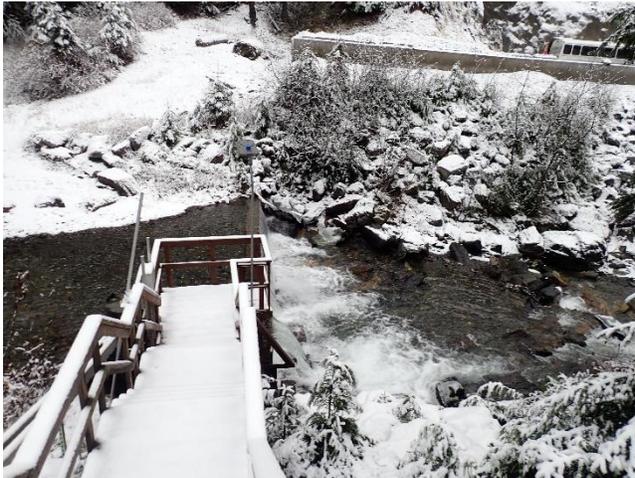
The recorded discharge rate for the Greens Creek weir (Photo 2-3) on 12/6/2018 was 22.04 cubic feet per second (cfs). The 920-area water withdrawal rate from Greens Creek was 1.5 cfs.

Photo 2. Greens Creek weir.

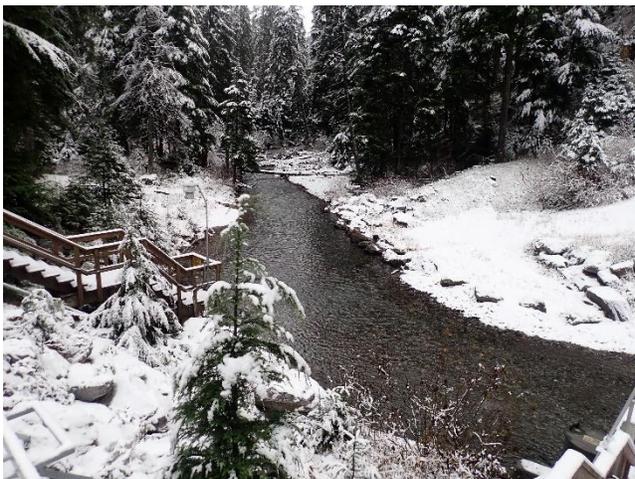
Photo 3. An upstream view of Greens Creek.

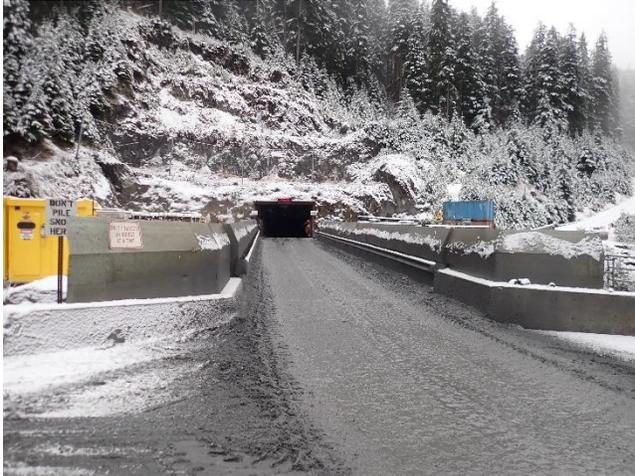
The 920 Bridge is being properly maintained and the splashguards are effective in preventing sediment splash over from vehicular traffic (Photo 4).

Photo 4. The 920 Bridge with the 920 adit in the background.

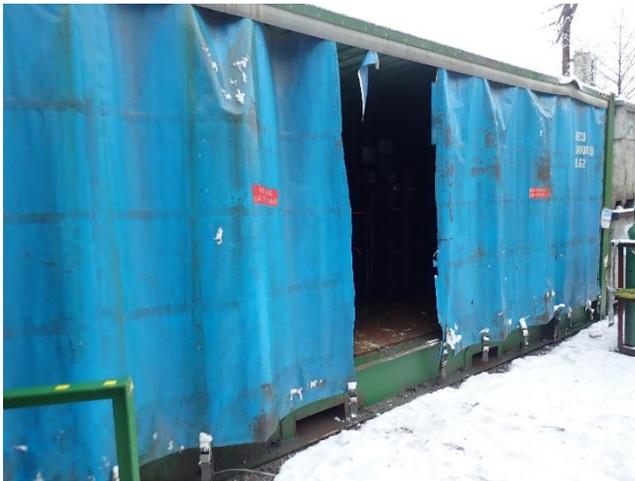
HGCMC personnel recently staged a storage container that will store gas cylinders for welding at the 920 warehouse (Photo 5-6). Good housekeeping practices were observed at the warehouse (Photo 7). All chemical and petroleum products were stored within secondary containment (Appendix 5 BMP plan; page 39).

Photo 5. A new storage container for welding gas cylinders.

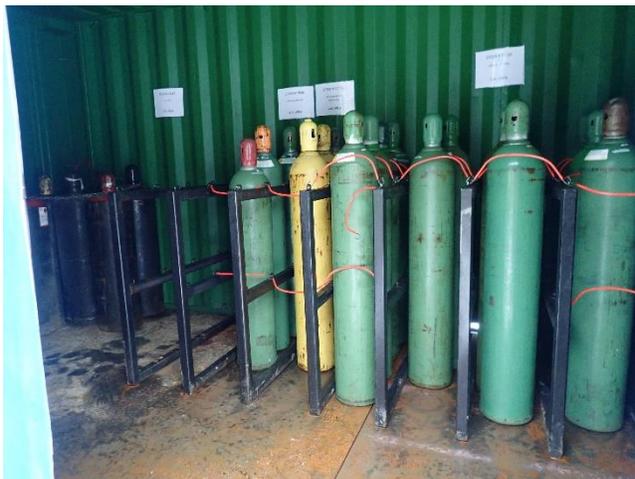
Photo 6. Inside the container are gas cylinder brackets for securing the cylinders.

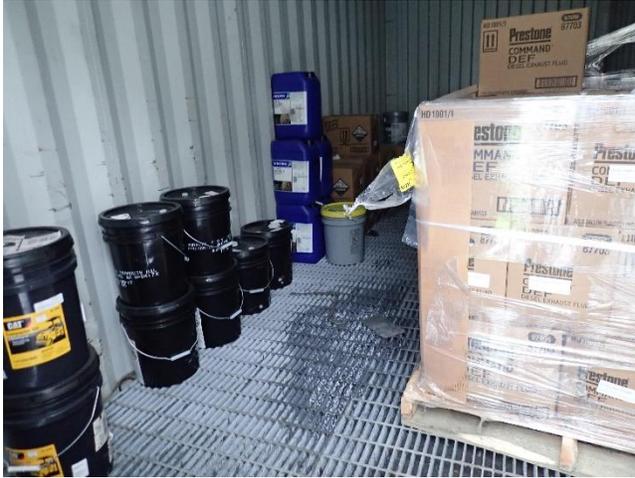
Photo 7. Petrochemicals were properly stored within secondary containment.

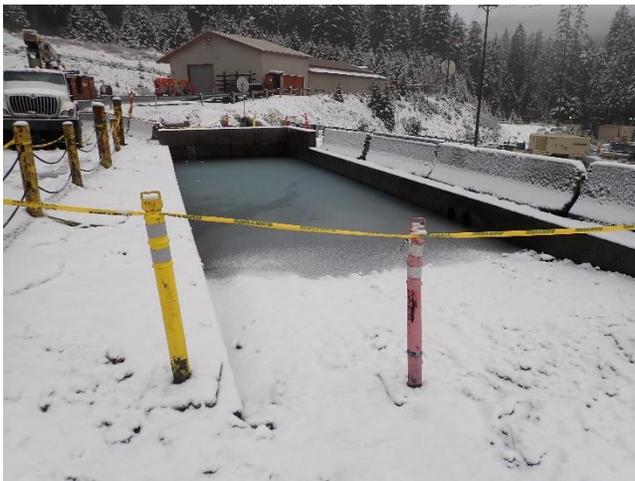
The new 920 ore pad de-grit basin (Photo 8) is functioning as intended.

Photo 8. The 920 de-grit basin.

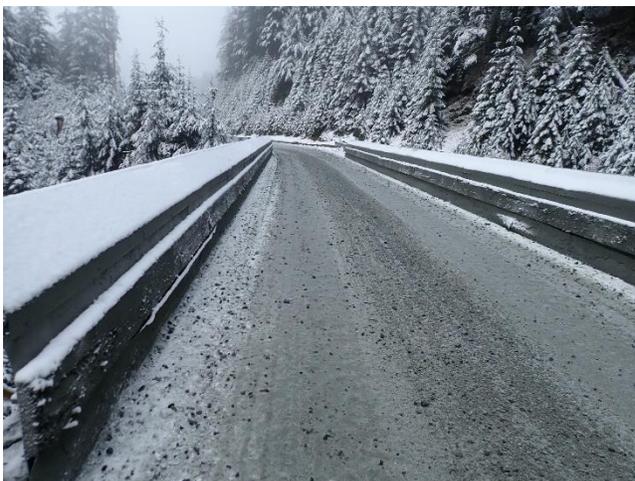
The bridge's decking is being adequately maintained by HGCMC Surface Operations (Photos 9). The bridges splashguards are effective in preventing sediment splash over from vehicular traffic.

Photo 9. The 7.4 mile B-road Bridge (Killer Creek Bridge).

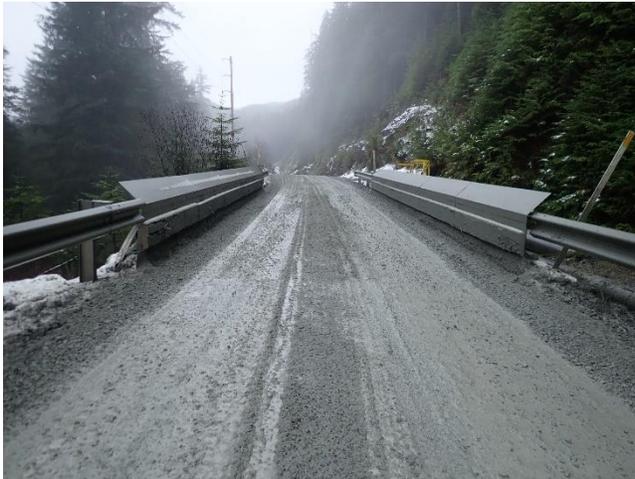
The bridge's decking is being properly maintained by HGCMC Surface Operations (Photo 10).

Photo 10. The 3.4 mile B-road Bridge (Falls Creek Bridge).

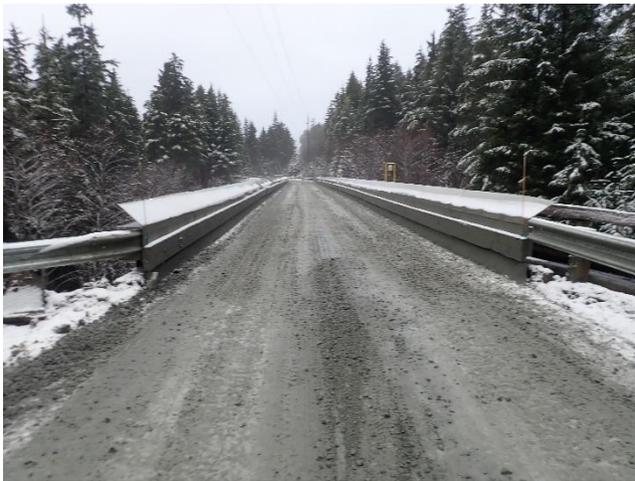
HGCMC Surface Operations are maintaining the bridge, and the BMPs at the abutment. (Photos 11-12).

Photo 11. The 3.0 mile B-road Bridge (Zinc Creek Bridge).

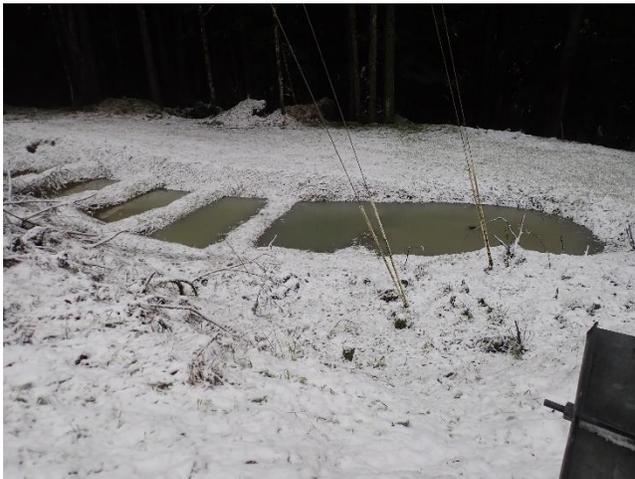
Photo 12. Zinc Creek bridge abutment BMPs.

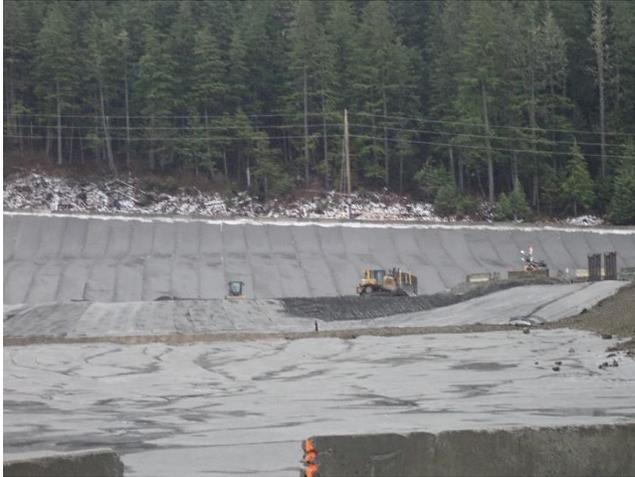
Surface Operations continue to deposit tailings in the S3P1 expansion area (Photo 13). HGCMC personnel have staged portable wind screens (Photo 14) in active tailings placement areas for fugitive dust mitigation.

Photo 13. The S3P1 tailings expansion area.

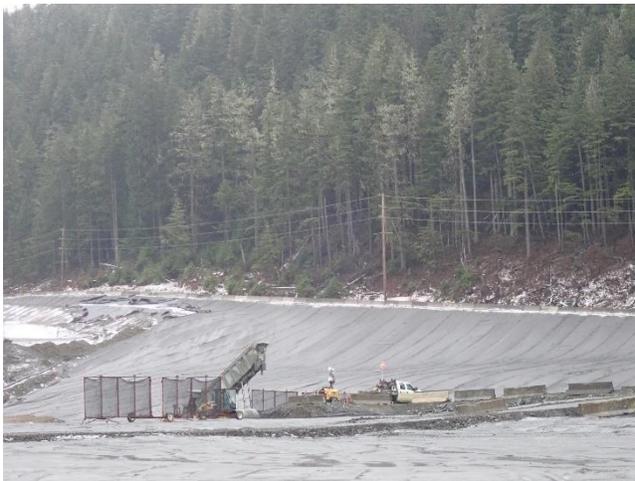
Photo 14. Portable wind screens staged in active tailings placement areas.

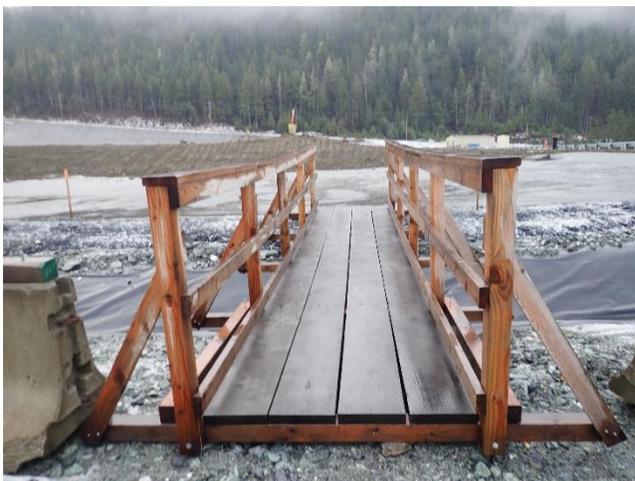
Surface Operations recently constructed a walkway (Photo 15-16) over the ditch to give personnel safer access when entering the S3P1 area.

Photo 15. The S3P1 walkway.

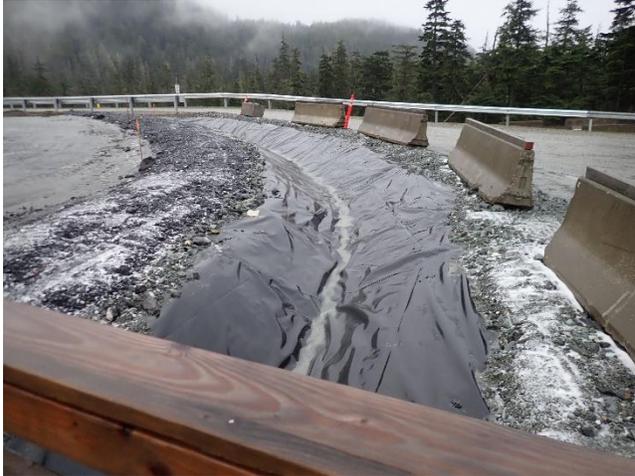
Photo 16. The S3P1 contact water perimeter ditch.

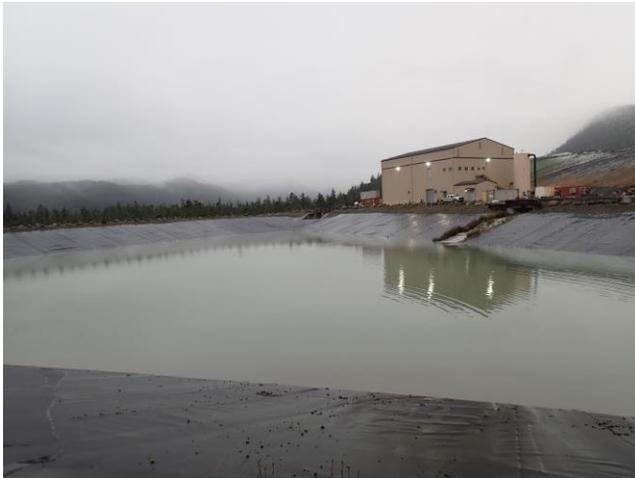
Photo 17. Pond 7.

Pond 7 (Photo 17) was receiving influent water, and Pond 10 (Photo 18) is collecting direct precipitation.

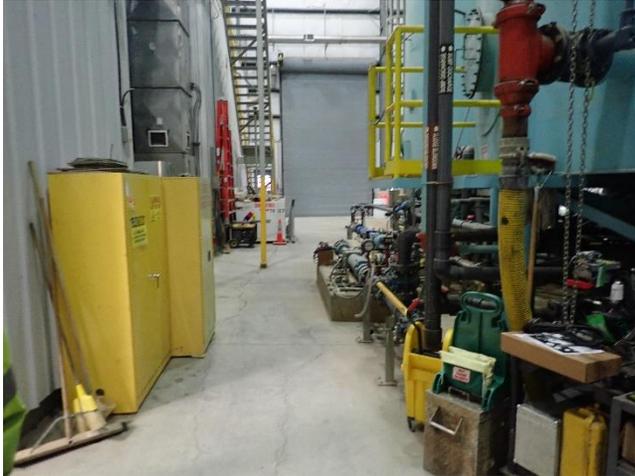
On 12/6/2018 the water treatment plant was treating 1,086 gallons per minute (gpm). Good housekeeping practices were observed inside the water treatment plant (Photo 19).

Photo 19. The water treatment plant.
