INSPECTION REPORT: GREENS CREEK MINE

Date of Inspection: Tuesday, February 26, 2019
Date of Report: Tuesday, March 5, 2019
USDA Forest Service Inspector: Matthew Reece

The site inspection included the Access Road B, 920 area, 860 area, Site 23, Site E, 7.4 mile B-road Bridge (Killer Creek Bridge), 3.4 mile B-road Bridge (Falls Creek Bridge), 3.0 mile B-road Bridge (Zinc Creek Bridge), and the Tailings Disposal Facility (TDF).

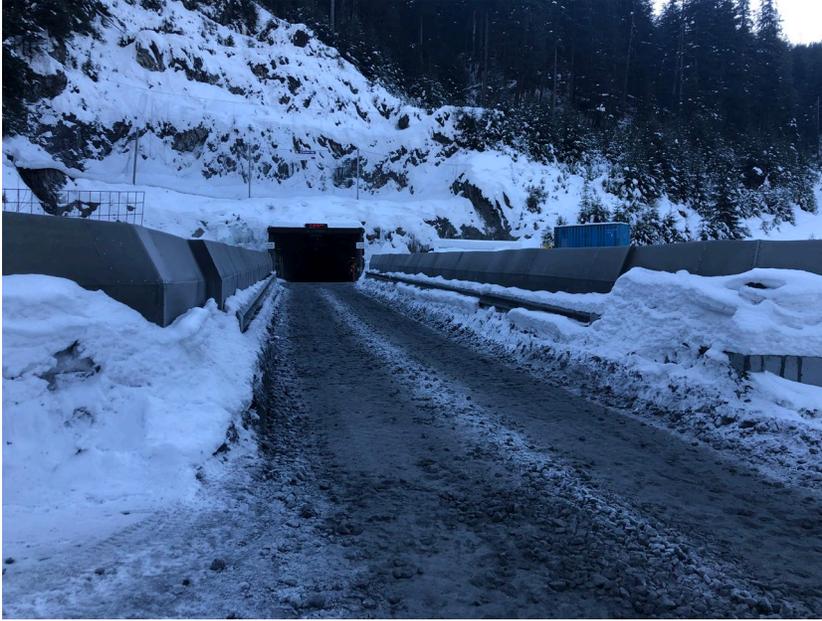
Photo 1. Greens Creek Bridge.

The 920 Bridge is being properly maintained and the splashguards are effective in preventing sediment splash over from vehicular traffic (Photo 1).

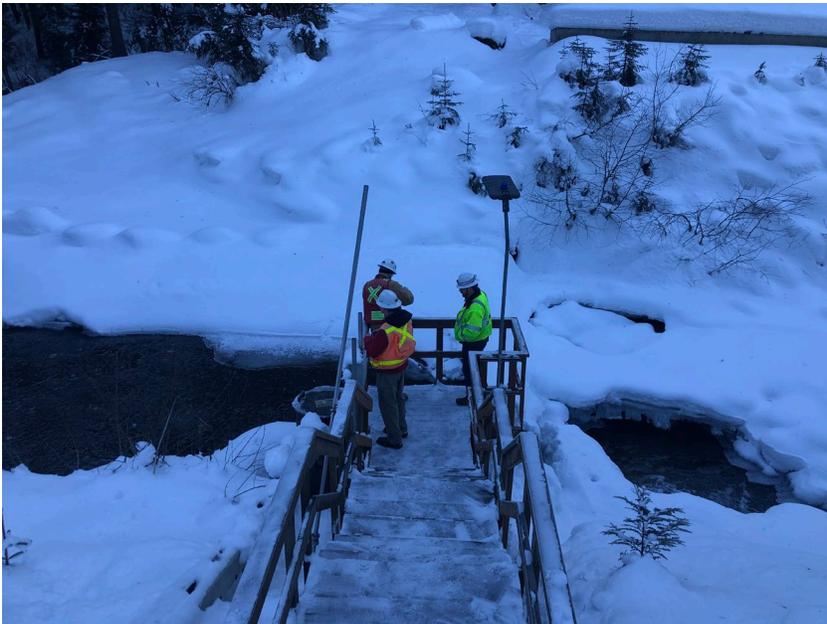
Photo 2. BLM and HGCMC staff at the Greens Creek weir.

Due to low temperatures and freezing conditions, flows in Greens Creek have occasionally dropped low enough to prohibit freshwater withdrawals. HGCMC is maintaining compliance with their minimum discharge rates through the Greens Creek weir. (Photo 2)

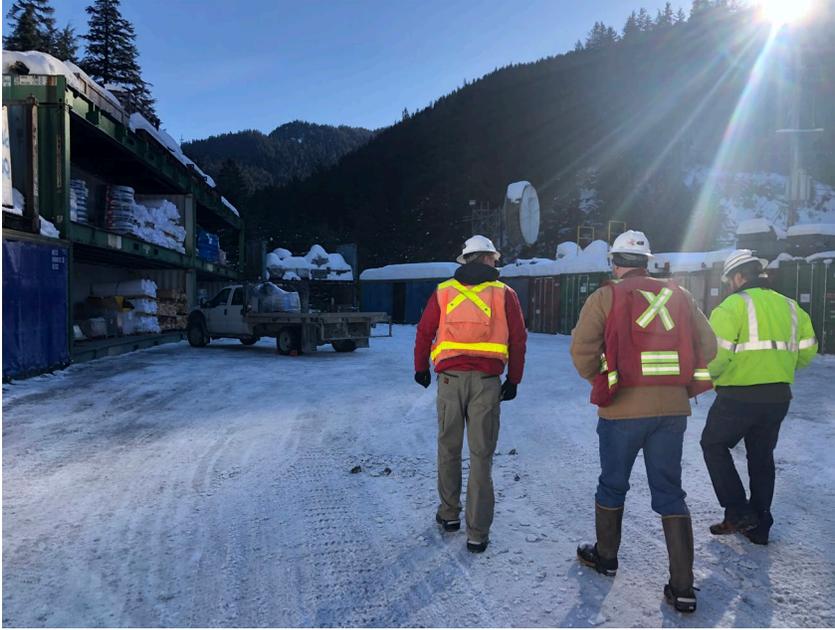
Photo 3. External storage at the 920 Warehouse.

The 920 warehouse was tidy and in order. All petroleum and chemical products were properly stored within secondary containment (Photo 3).

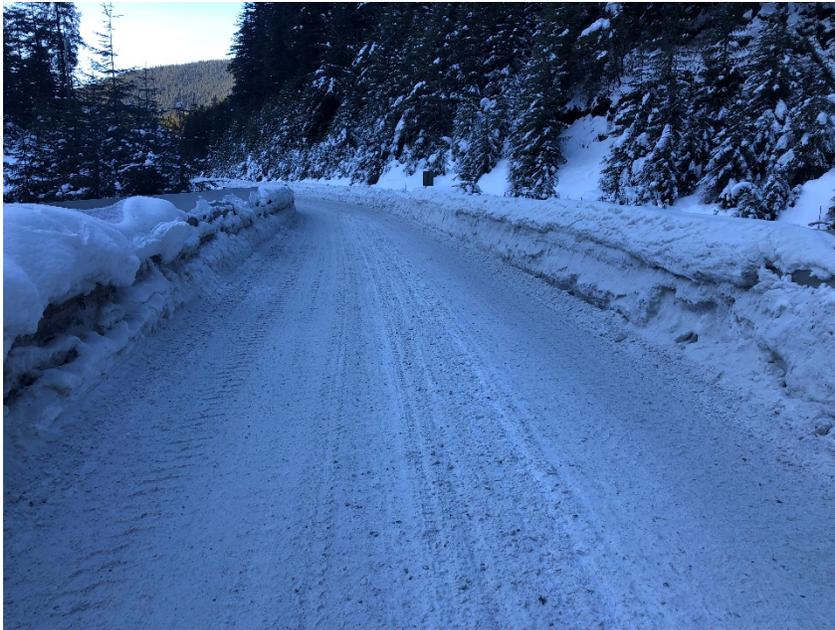
Photo 4. 7.4 Mile Bridge.

The bridge's decking is being adequately maintained by HGCMC Surface Operations. The bridges splashguards are effective in preventing sediment splash over from vehicular traffic (Photo 4).

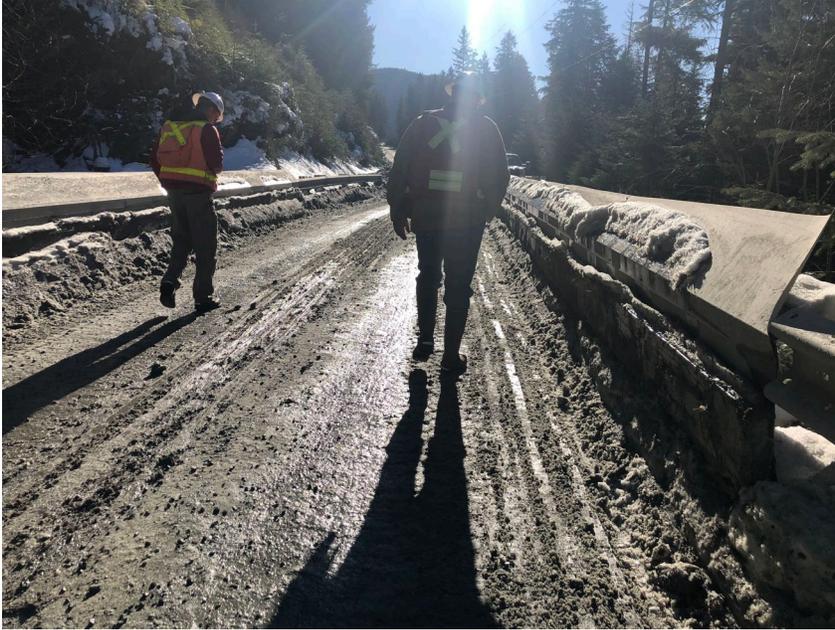
Photo 5. 3.4 Mile Bridge.

The bridge's decking is being properly maintained by HGCMC Surface Operations. The bridges splashguards are effectively working to prevent sediment splash over from vehicular traffic (Photo 5).

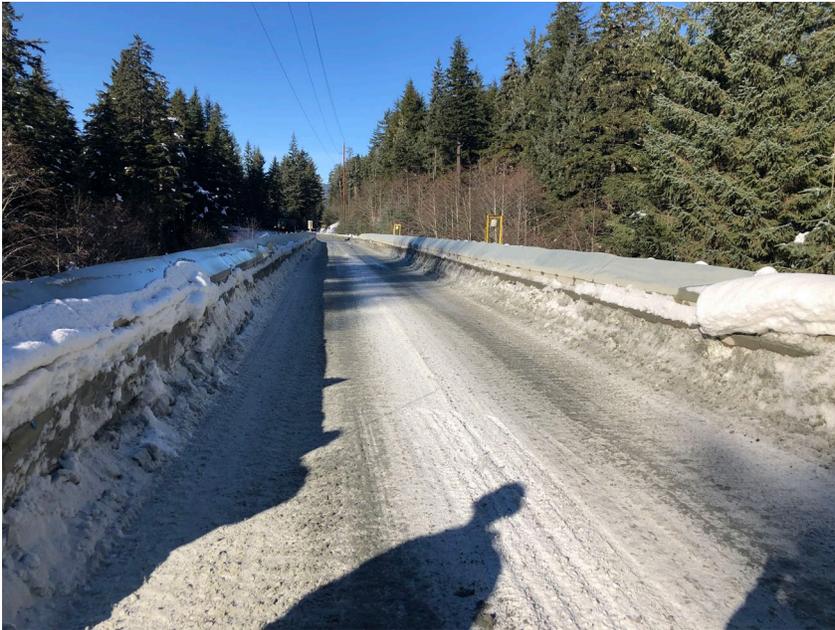
Photo 6. 3 Mile Bridge.

HGCMC Surface Operations are maintaining the bridge, and the BMPs at the abutment are covered in snow and ice (Photo 6).

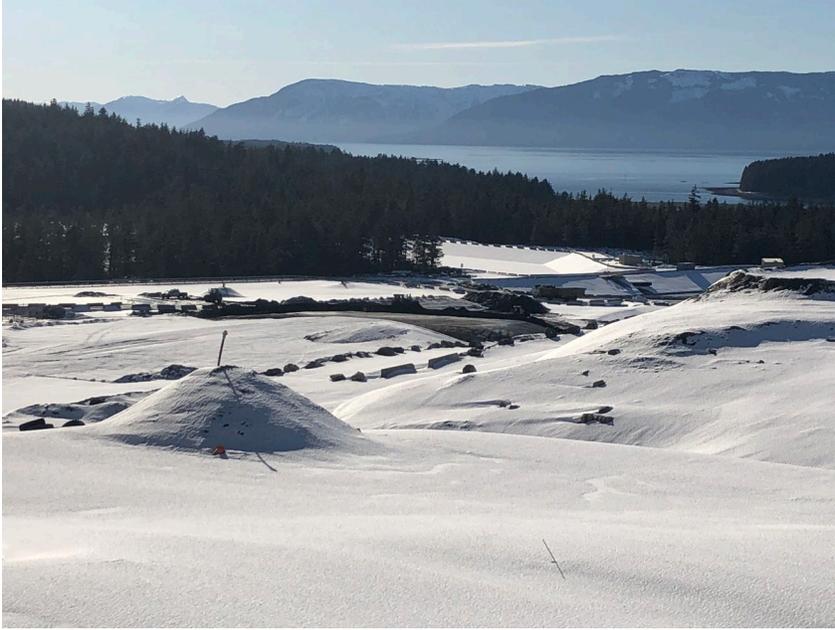
Surface Operations continue to deposit tailings in the S3P1 expansion area (Photo 7).

Photo 7. Active placement of tailings in the S3P1 Expansion area (center of frame)
