INSPECTION REPORT: GREENS CREEK MINE

Date of Inspection: Thursday, March 28, 2019
Date of Report: Thursday, April 18, 2019
USDA Forest Service Inspector: Richard Dudek

Ranger District: Admiralty National Monument, Juneau Ranger District
Weather Conditions: Cloudy with low fog Temperature: High 30's (°F).

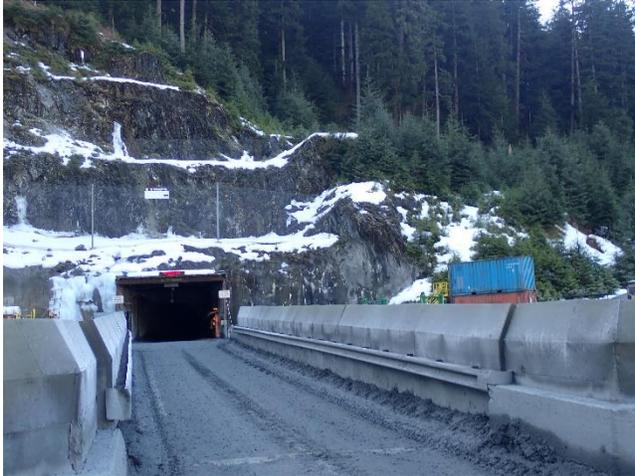
Photo 1. 920 Bridge

The bridge is being maintained and the splashguards are effective in preventing sediment splash over from vehicular traffic (Photo 1).

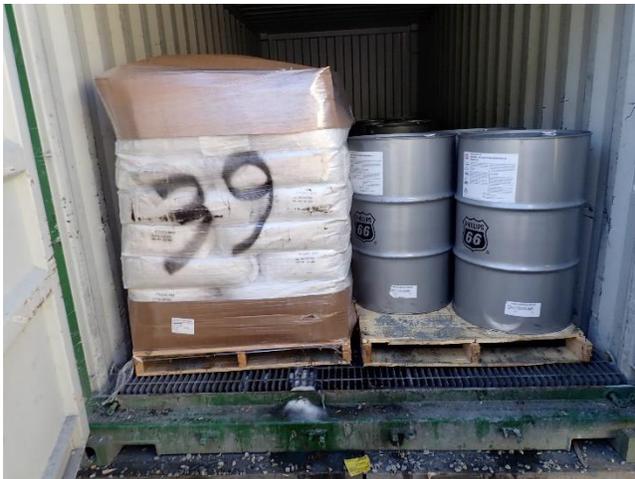
The 920 warehouse was tidy and in order. All chemical/petroleum products were stored inside appropriate containers (Photo 2).

Photo 2. A 920 warehouse container with petrochemicals properly stored.

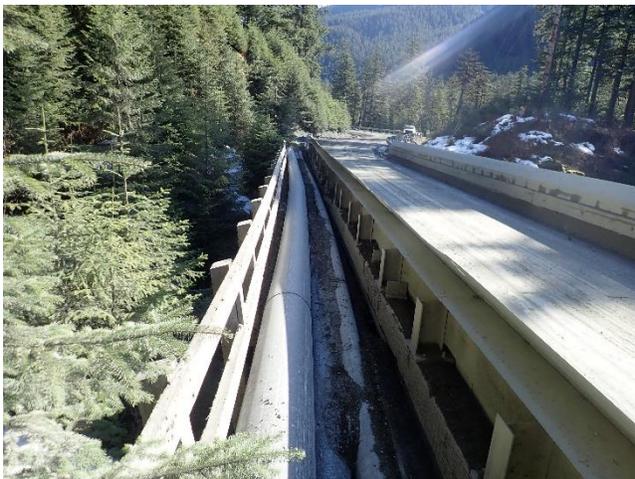
Photo 3. 7.4 mile B-Road Bridge (Killer Creek Bridge).

The bridge's decking is being adequately maintained by HGCMC Surface Operations (Photo 3). The bridges splashguards are preventing sediment splash over from vehicular traffic.

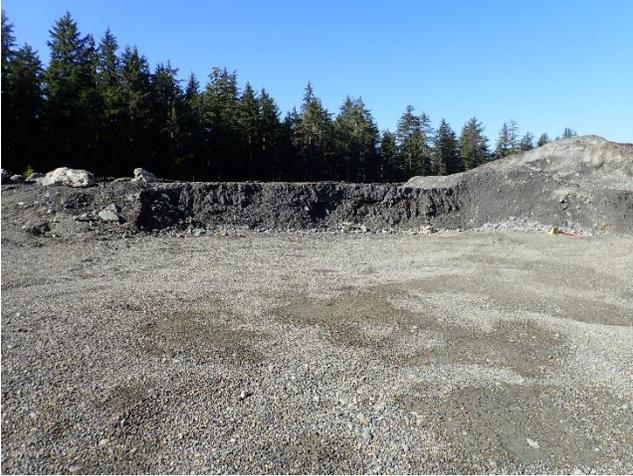
Photo 4. Waste Site (4.7 Mile B-Road).

Since February, HGCMC personnel have removed approximately 8,600 cubic yards of waste rock from this site and disposed of it in the TDF (Photo 4).

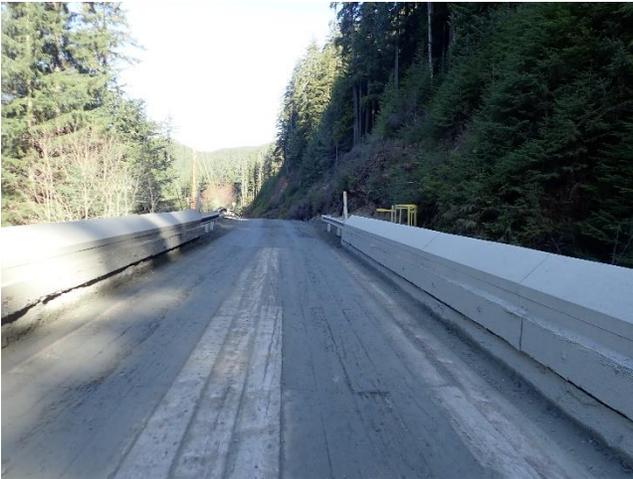
Photo 5. 3.4 Mile B-Road Bridge (Falls Creek Bridge).

The bridge's decking is being properly maintained by HGCMC Surface Operations (Photo 5).

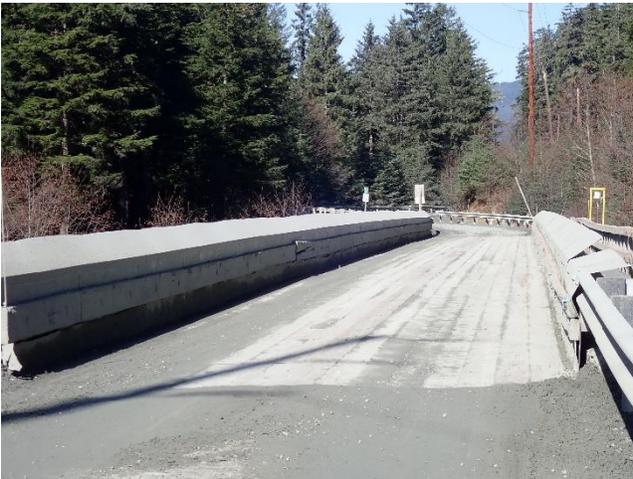
Photo 6. 3.0 Mile B-road Bridge (Zinc Creek Bridge).

HGCMC Surface Operations are maintaining the bridge, and the BMPs at the bridge abutment are mostly covered in snow and ice (Photos 6).

3.0 mile B-road Bridge damaged splashguard is fixed.

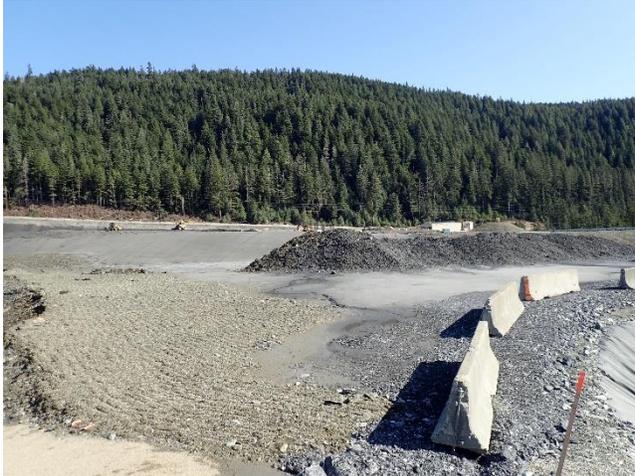
Surface Operations continue to deposit tailings in the S3P1 expansion area (Photo 7).

Photo 7. The TDF's S3P1 expansion area.

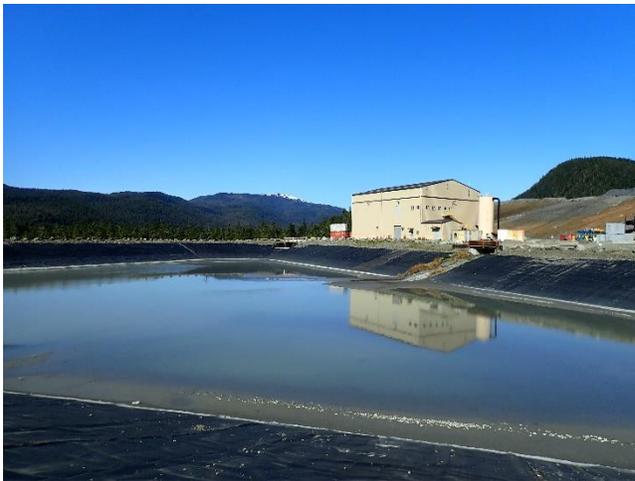
Photo 8. Pond 7.

Pond 7 (Photo 8) was receiving influent water, and Pond 10 (Photo 9) is collecting direct precipitation.

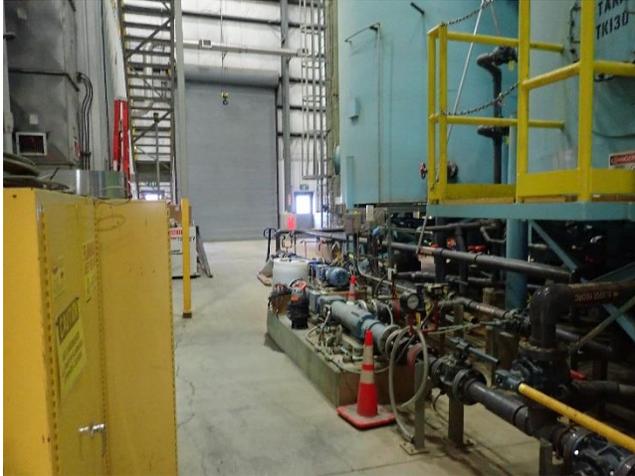
On 3/28/2019 the water treatment plant was treating 1,400 gallons per minute (gpm). Good housekeeping practices were observed inside the water treatment plant (Photo 10).

Photo 10. The water treatment plant.
