INSPECTION REPORT: GREENS CREEK MINE

Date of Inspection: Wednesday May 1, 2019
Date of Report: Thursday May 16, 2019
USDA Forest Service Inspector: Richard Dudek

The site inspection included: B-road, 920 area, 860 area, Site 23, 7.4 mile B-road Bridge (Killer Creek Bridge), Site E (4.7 B-road), 3.4 mile B-road Bridge (Falls Creek Bridge), 3.0 mile B-road Bridge (Zinc Creek Bridge), the Tailings Disposal Facility (TDF), and the sand pit (1.4 mile A-Road).

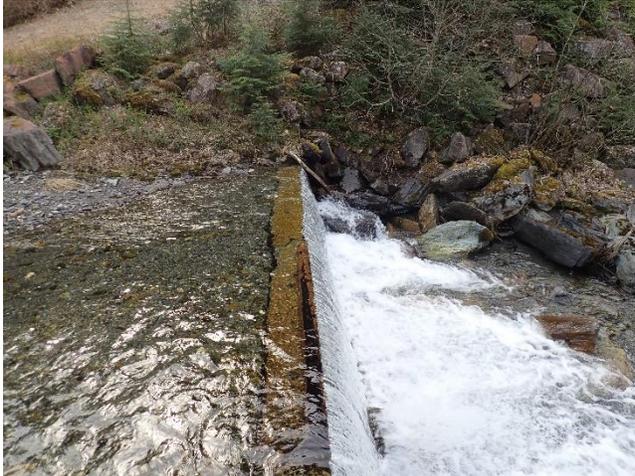
The recorded flow rate for the Greens Creek (Photo 1) on the day of the inspection was 26.5 cubic feet per second (cfs). The 920-area water withdrawal rate from Greens Creek was approximately 0.9 cfs.

Photo 1. Greens Creek Weir.

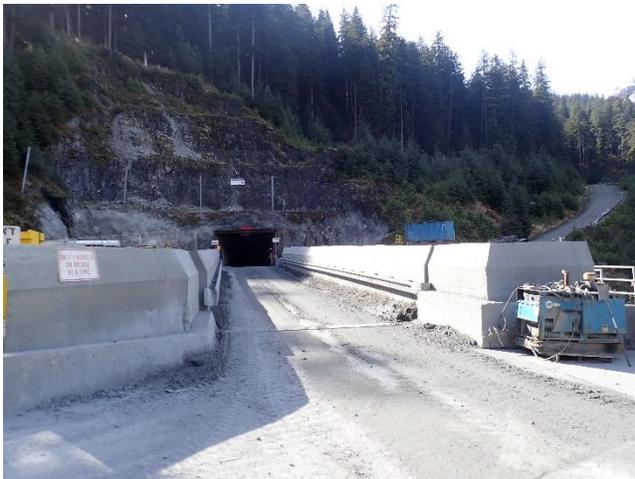
The bridge's splashguards are effectively preventing sediment splash over from vehicular traffic (Photo 2).

Photo 2. The 920 Bridge.

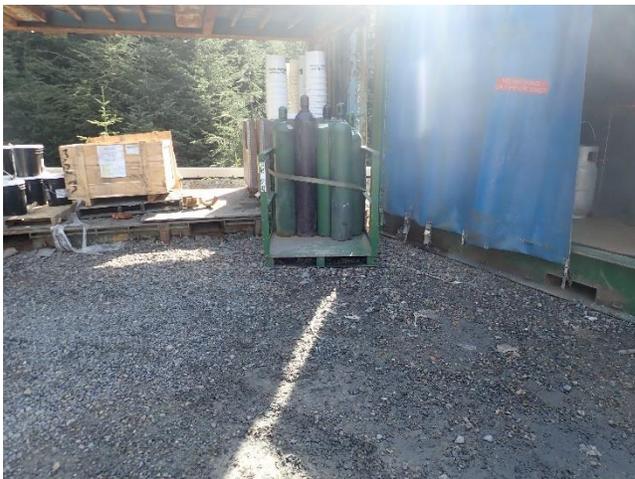
Good housekeeping practices were observed at the 920 warehouse (Appendix 05 BMP Plan 2015, pages 39-40). All chemical/petroleum products and compressed gases for welding were stored inside appropriate containers (Photo 3).

Photo 3. Compressed gas cylinders were properly secured.

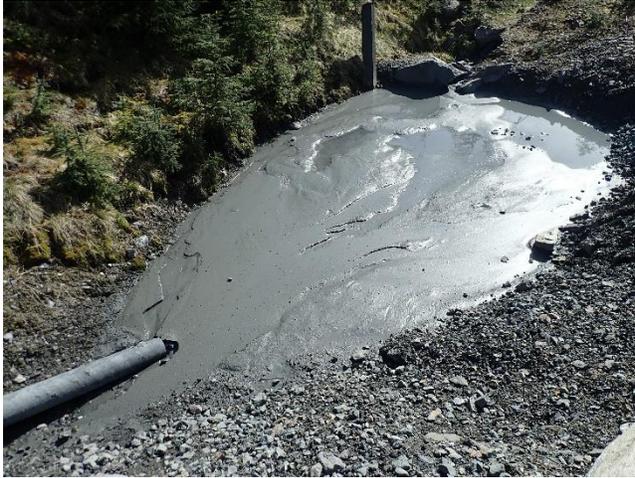
The ore pad hill's sediment sump requires mucking (Photos 4).

Photo 4. Sediment sump at the base of Ore Pad hill requires mucking.

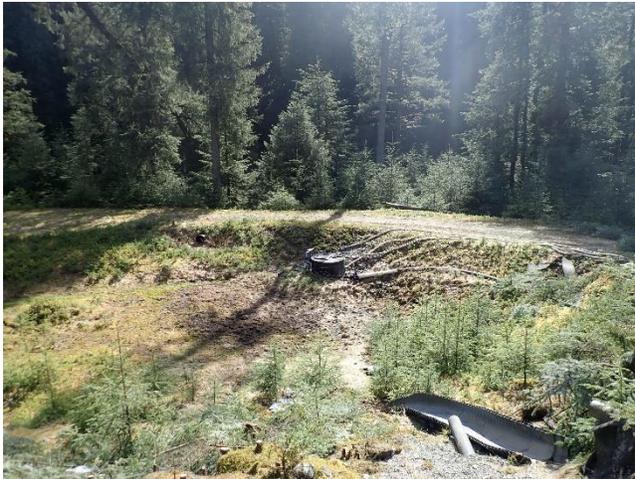
This summer, HGCMC personnel will be making improvements Lower C-Pond (Photo 5). HGCMC Surface Operations will be installing a HDPE liner to prevent water from percolation through the berm. During this project, the caisson will be also moved several feet into the pond.

Photo 5. The 860 area's lower C-pond.

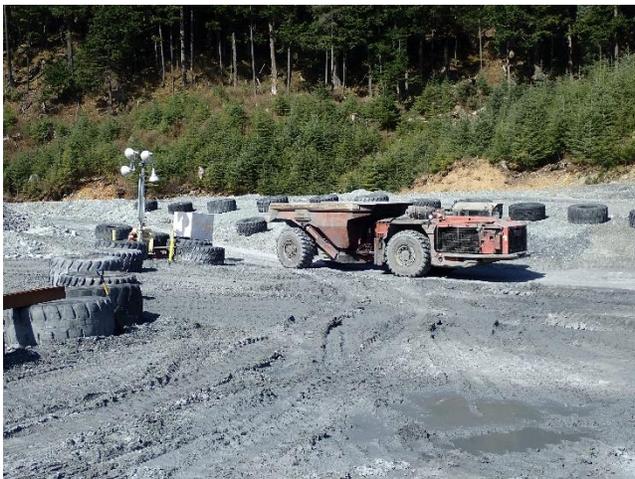
Photo 6. A haul truck depositing class 2 and 3 waste rock at Site 23.

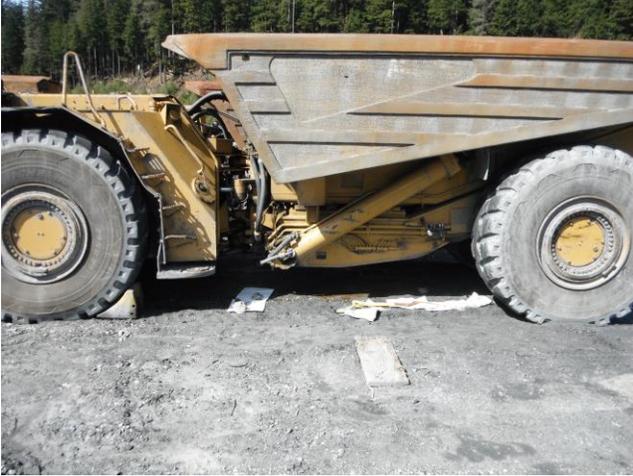
HGCMC continues to deposit class 1, 2, and 3 waste rock at this location (Photo 6). At the time of the inspection, it was observed that a parked haul truck (Photo 7) was leaking hydraulic fluids. The fluids were promptly cleaned up by Dave Landes from HGCMC Environmental Operations.

Photo 7. A haul truck with a couple of fluid leaks.

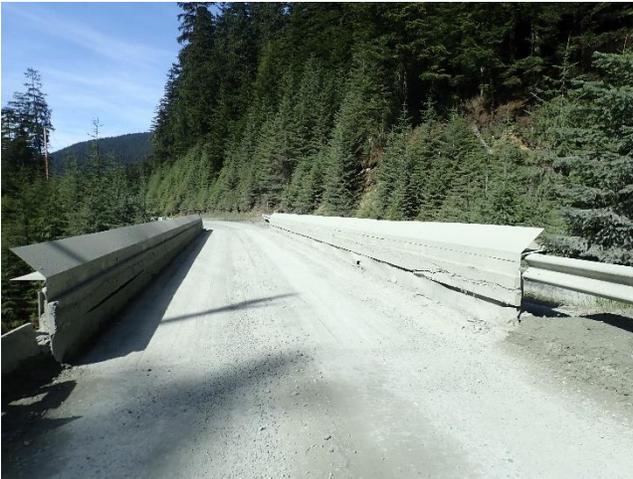
Photo 8. The 7.4 mile B-road Bridge (Killer Creek Bridge).

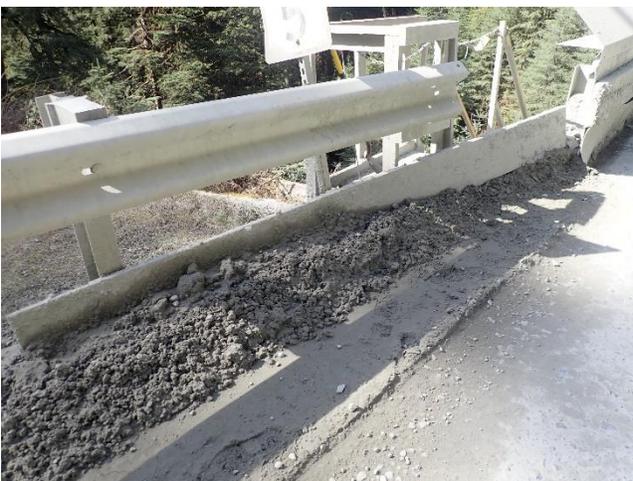
Photo 9. Sediment removal required at Killer Creek Bridge ends.

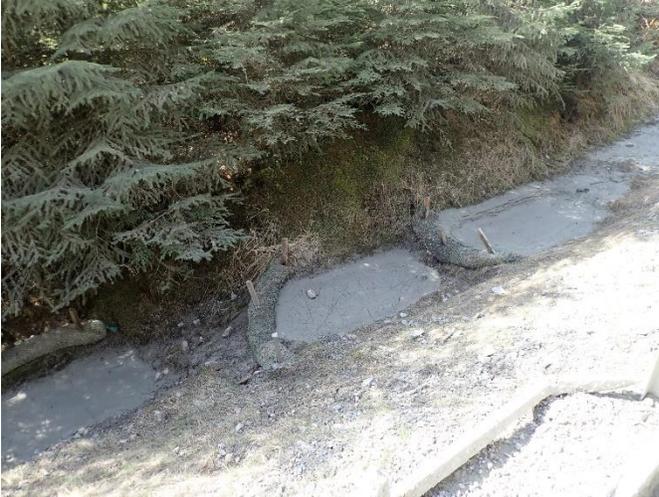
Photo 10. Sediment sump require mucking at the 7.4 mile B-road Bridge.

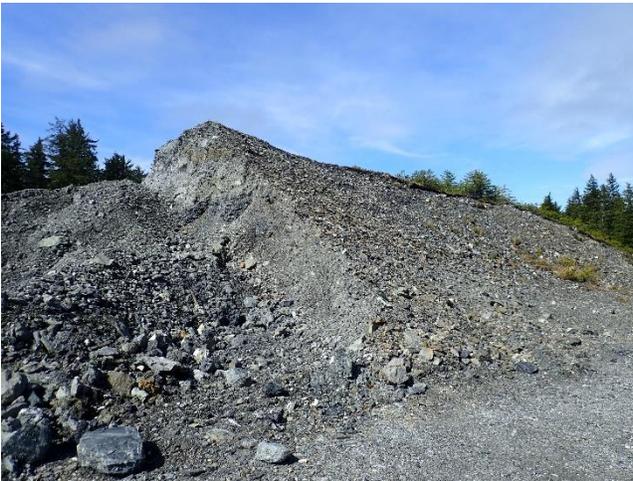
HGCMC personnel continue to remove waste rock from this site for co-disposal in the TDF (Photo 11).

Photo 11. Waste rock at Site E.

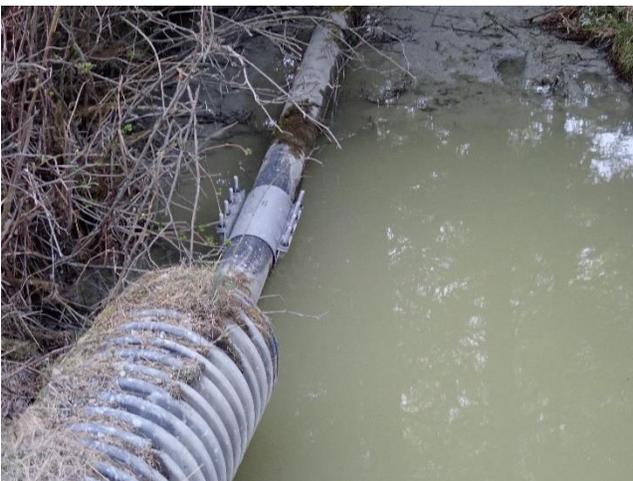
In the fall 2018, the influent waterline for the pond was leaking. Due to the colder temperatures in the fall months, the pond's pump was turned off until warmer temperatures persist and the repairs could be made. To stop the leak, HGCMC personnel placed a pipe clamp over the damaged section (Photo 12).

Photo 12. At Site E, a steel clamp was placed over the leaking section of the pipe.

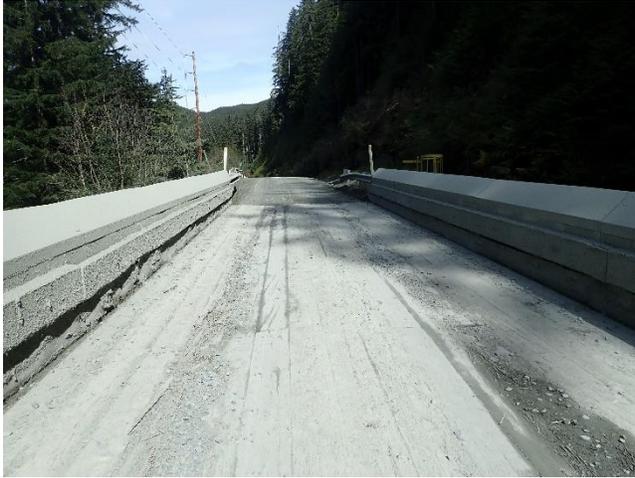
Photo 13. The 3.4 mile B-road Bridge (Falls Creek Bridge).

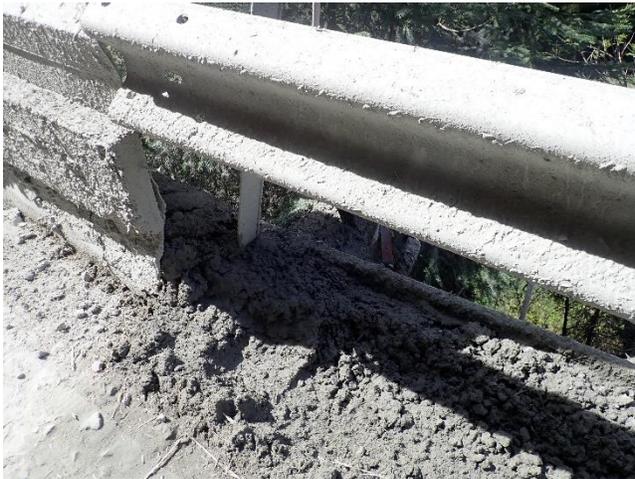
The bridge decking is being properly maintained by HGCMC Surface Operations (Photo 13). Sediment cleanup/removal is needed at the bridge ends (Photo 14).

Photo 14. Sediment removal is required at the 3.4 mile B-road bridge ends.

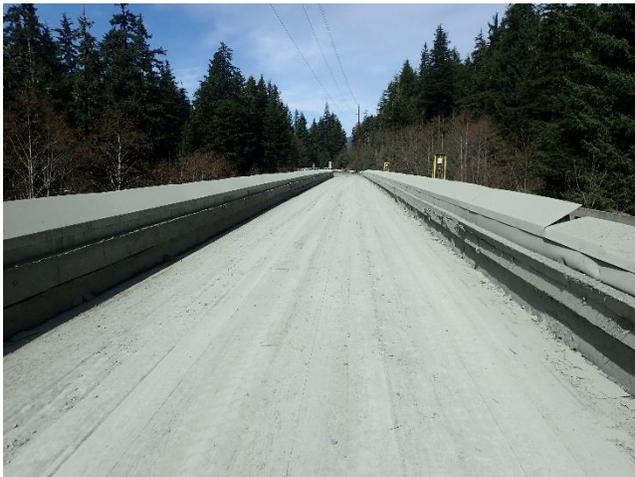
HGCMC Surface Operations are maintaining the bridge (Photo 15).

Photo 15. The 3.0 mile B-road Bridge (Zinc Creek Bridge).

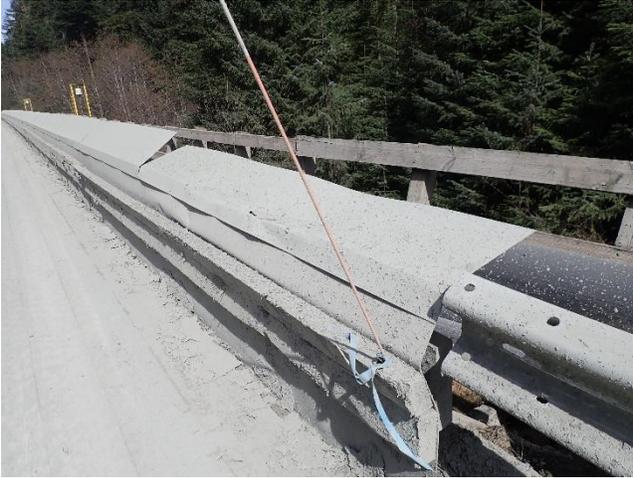
Photo 16. The damaged section splashguard requires repair/replacement.

In the coming weeks, Surface Operations plan on repairing the damaged section of the splashguard (Photo 16).

3.0 mile B-Road Bridge damaged splashguard is fixed.

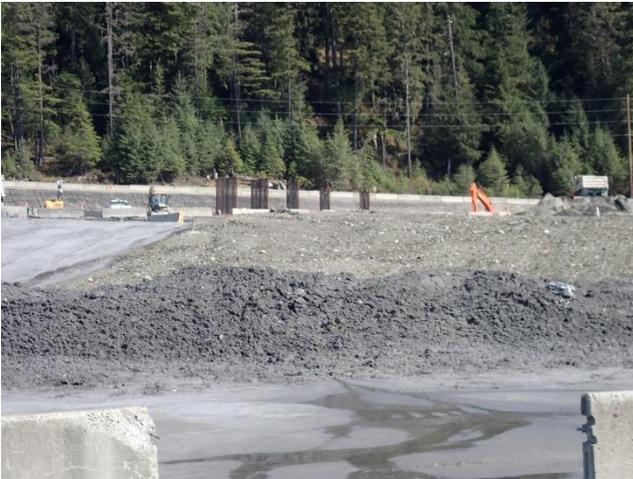
Surface Operations continue to deposit tailings in the S3P1 expansion area (Photo 17).

Photo 17. The S3P1 tailings disposal area.

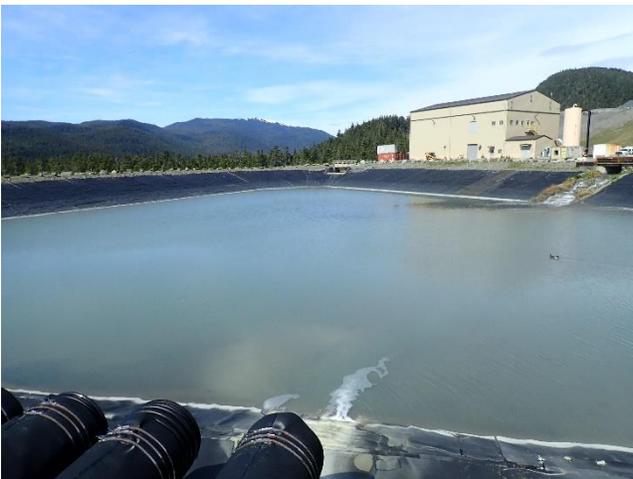
Photo 18. Pond 7.

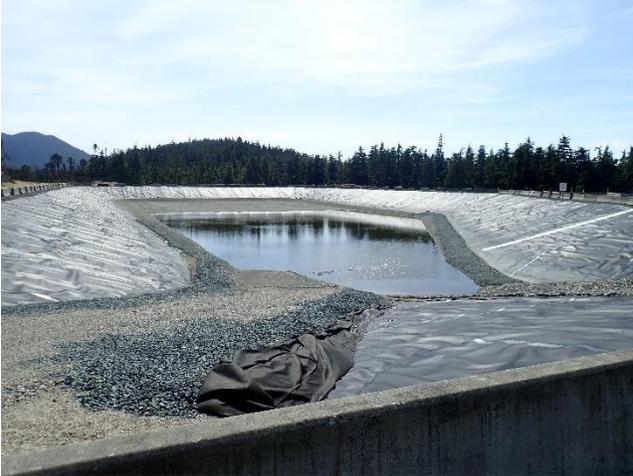
Photo 19. Pond 10.

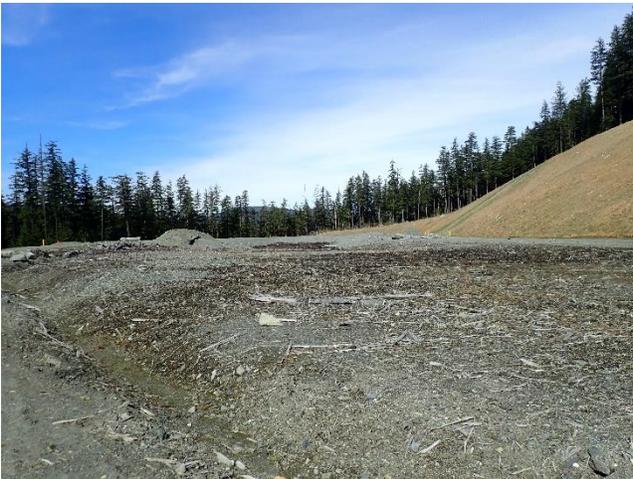
This site is currently inactive (Photo 20).

Photo 20. The sand pit (1.4 mile A-Road).
