INSPECTION REPORT: GREENS CREEK MINE

Date of Inspection: Wednesday June 26, 2019
Date of Report: Friday July 12, 2019
USDA Forest Service Inspector: Richard Dudek

Ranger District: Admiralty National Monument, Juneau Ranger District
Weather Conditions: Sunny. Temperature: Low 80's (°F).

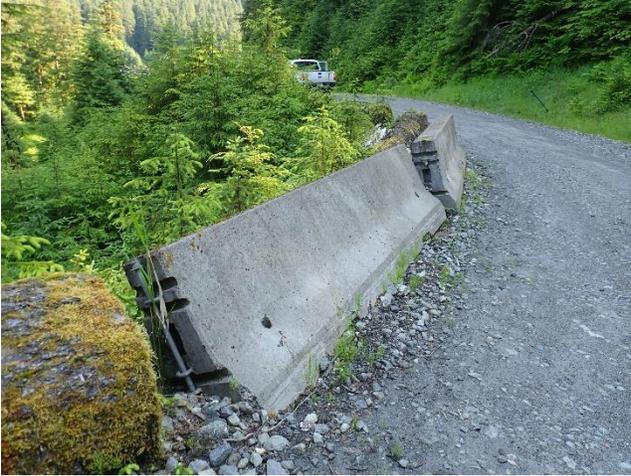
- A leaning jersey barrier needs to be restaged along the 1350 access road. This barrier will eventually fall down a steep slope (Photo 1).

Photo 1. A jersey barrier is starting to lean which will eventually fall down the steep slope.

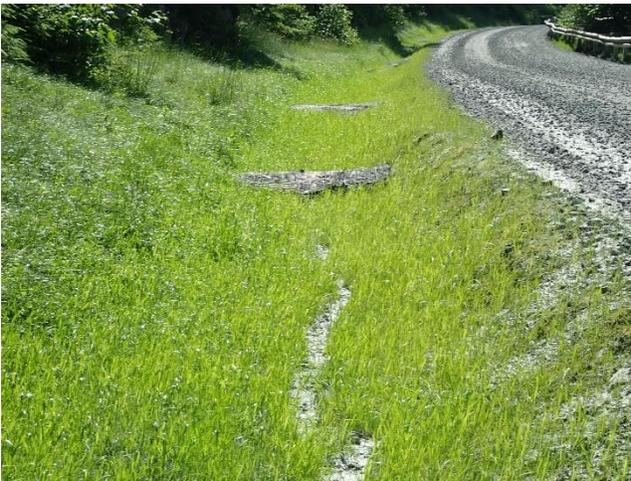
At the time of the inspection, both A and B-roads were in good condition. During spring maintenance for the B-road ditches, improvements were made to rock check dams (Photos 2-3).

Photo 2. The B-road rock check dams.

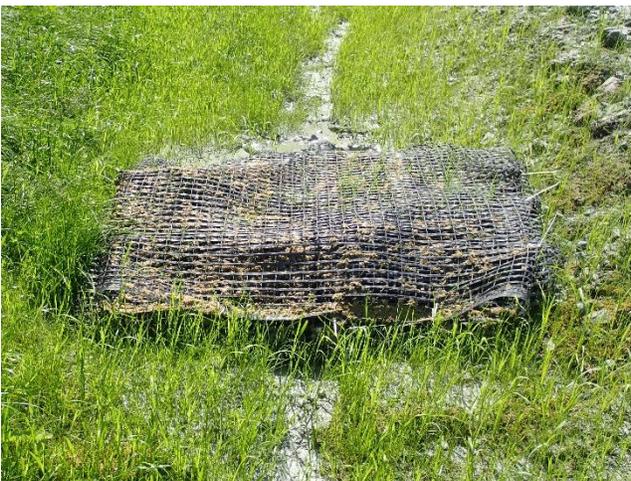
Photo 3. A close up of the rock check dam covered by a mesh screen.

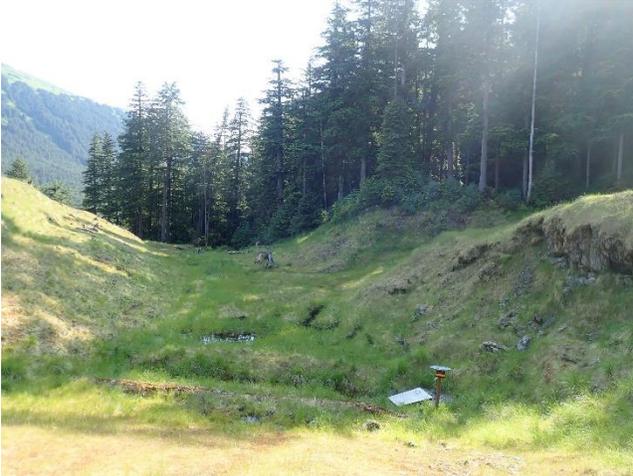
The pump is in place for the 1350 area surface runoff collection trench (Photo 4). HGCMC Environmental Operations is currently monitoring groundwater seeps in the 1350 area (Photo 5).

Photo 4. The 1350 area.

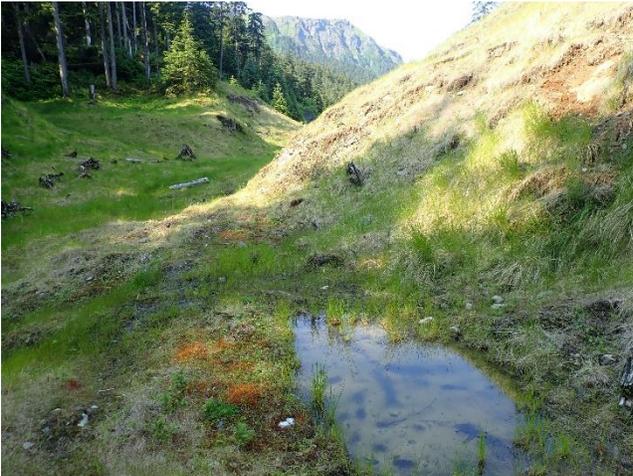
Photo 5. Pooling water down gradient from the 1350 trench.

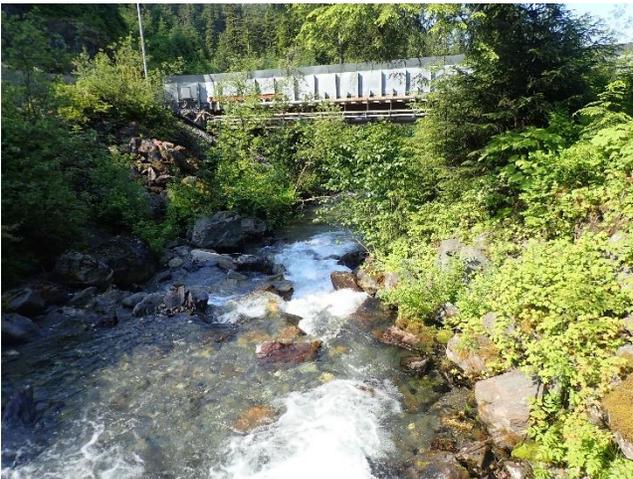
The recorded flow rate for Greens Creek (Photo 6) on the day of the inspection was 30.56 cubic feet per second (cfs). The 920-area water withdrawal rate from Greens Creek was approximately 1.5 cfs.

Photo 6. Greens Creek.

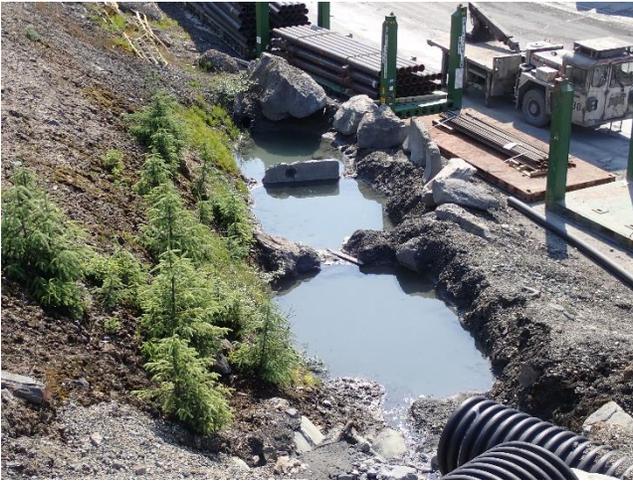
The sediment sumps associated with the 920 area have been mucked and are functioning as intended (Photos 7-8).

Photo 7. The ore pad's sediment sump was cleaned and is working as intended.

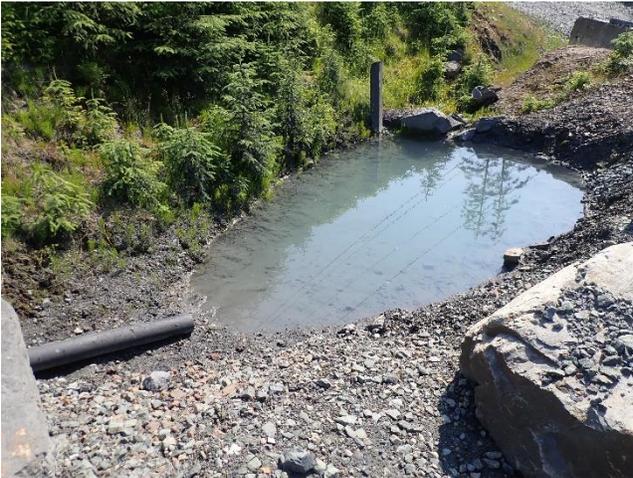
Photo 8. Ore pad hill's sediment sump is working as intended.

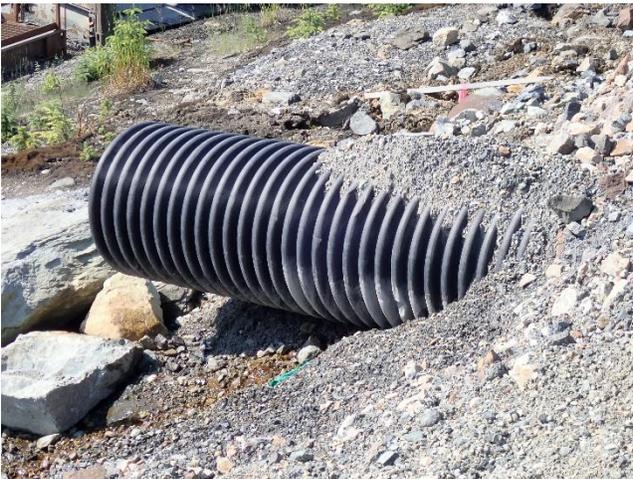
Water appeared to be flowing from underneath the culvert's outlet (Photo 9). Dave Landes from HGCMC Environmental Operations checked with Surface Operations and was told this condition has existed since the improvements were made to the culvert. The pipe bedding material serves as a French drain to help collect seeps and shallow groundwater in that area.

Photo 9. Water was observed flowing underneath the corrugated drain pipe.

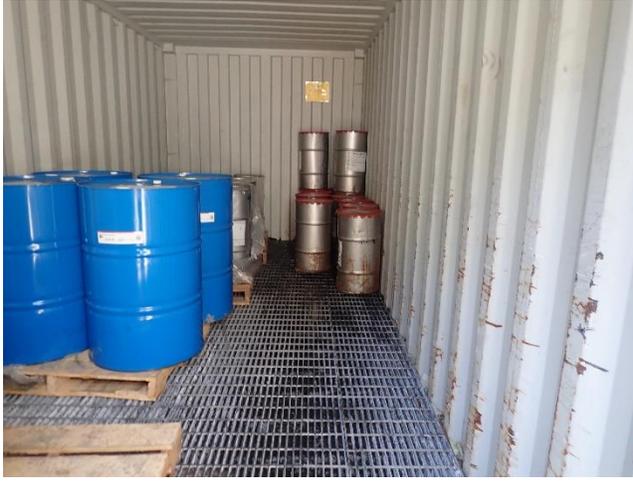
A potential oil leak may have occurred inside storage van #7 (Photo 10). The containers secondary containment is designed to prevent fluids from escaping and entering the environment. Dave Landes documented the potential leak and will contact the 920-Warehouse Manager to confirm if a leak did take place. Dave Landes stated that it was determined that the liquid in the containment is water, and was caused by the slow accumulation of precipitation. The water will be removed to restore the containment volume.

Photo 10. Storage van 7, where liquid was observed in containment.

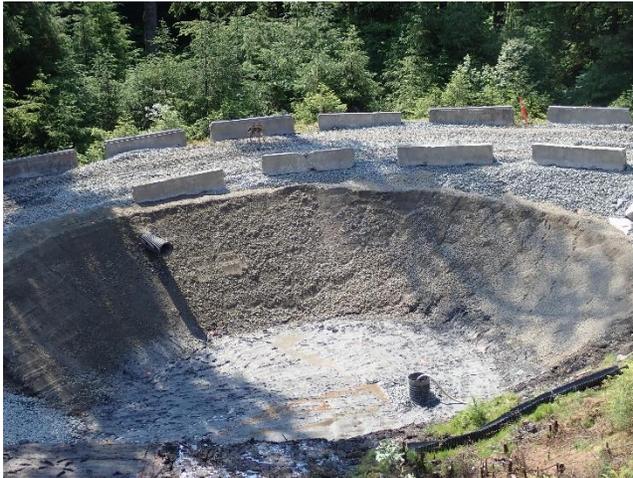
The improvements being made to the lower C pond are nearly completed (Photo 11). On 6/28/2019, contractors will be on site installing the liner for the pond.

Photo 11. Lower C pond (860 area)

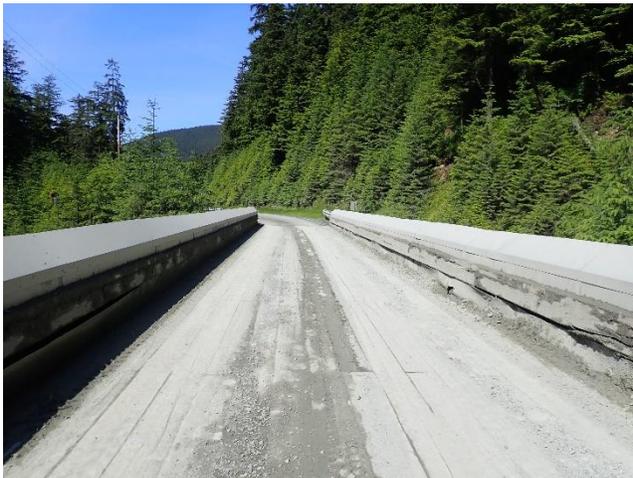
The bridge decking and bridge ends are being maintained by HGCMC Surface Operations (Photo 12). The splashguards are preventing sediment splash over from vehicular traffic.

Photo 12. 7.4 Mile B-Road Bridge (Killer Creek Bridge).

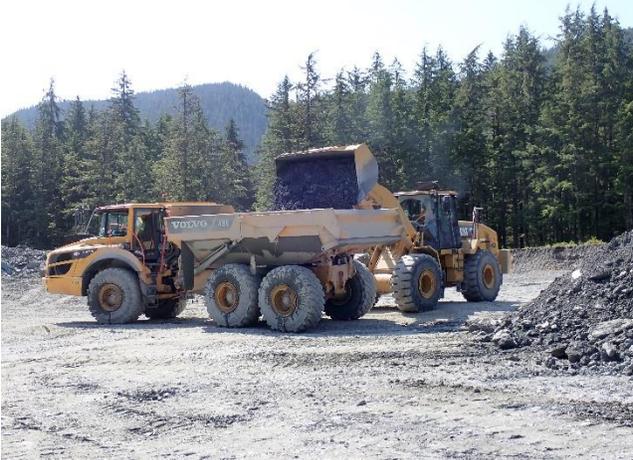
Approximately 15,700 cubic yards of waste rock has been removed from this location and disposed of in the TDF (Photo 13).

Photo 13. Waste rock removal at Site E.

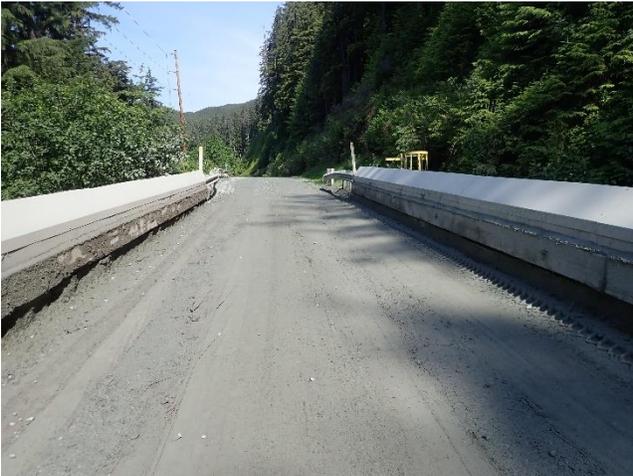
The bridge decking and the bridge ends are being maintained by HGCMC Surface Operations (Photo 14).

Photo 14. 3.4 Mile B-Road Bridge (Falls Creek Bridge).

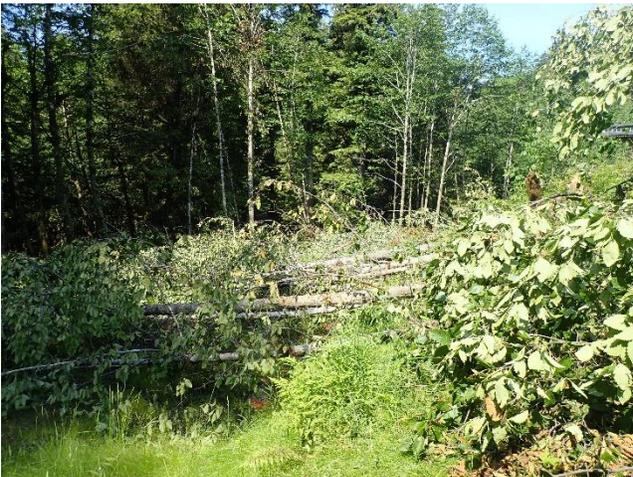
An electrical distribution systems contractor recently removed hazard trees near the bridge (Photo 15). This was done as a mitigation to prevent tree branches from coming in contact with electrical powerlines. Surface Operations will remove the cut trees during routine scheduled maintenance.

Photo 15. Cut hazard trees at the abutment of Zinc Creek Bridge.

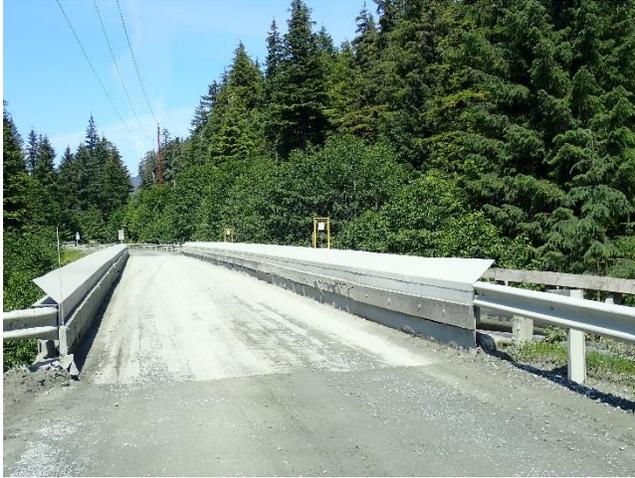
HGCMC Surface Operations are maintaining the bridge (Photo 16) and the damaged splashguard was repaired. The structural BMPs located on the uphill side abutment are working as intended (Photo 17-18). HGCMC Surface Operations is currently examining potential improvements to the settling pond with the standup drainpipe. One design would be to modify the standpipe to allow the pond to slowly drain instead of remaining full to the pipe inlet.

Photo 16. 3.0 Mile B-Road Bridge (Zinc Creek Bridge).

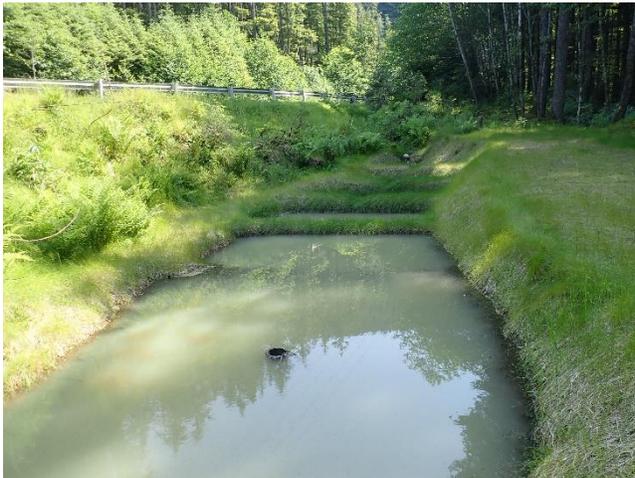
Photo 17. Zinc Creek Bridge BMPs.

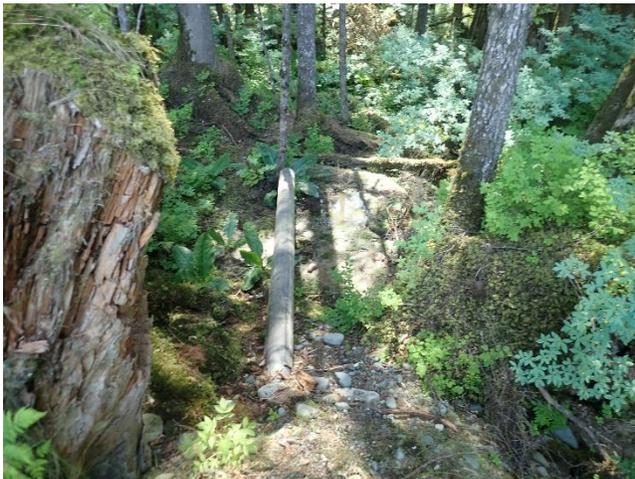
Photo 18. The standpipe's discharge site.

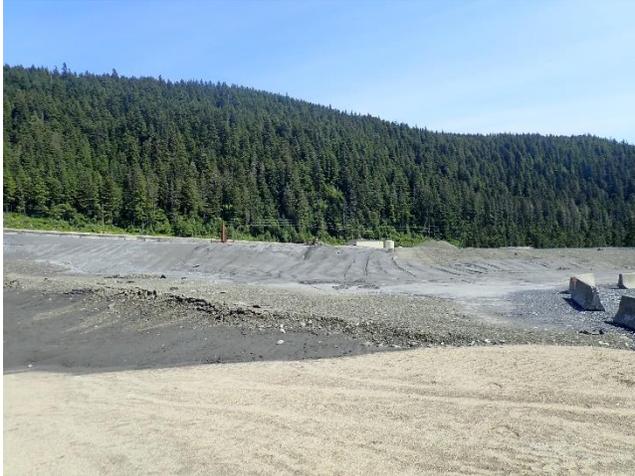
Surface Operations continue to deposit tailings in the S3P1 expansion area (Photo 19).

Photo 19. The S3P1 area.

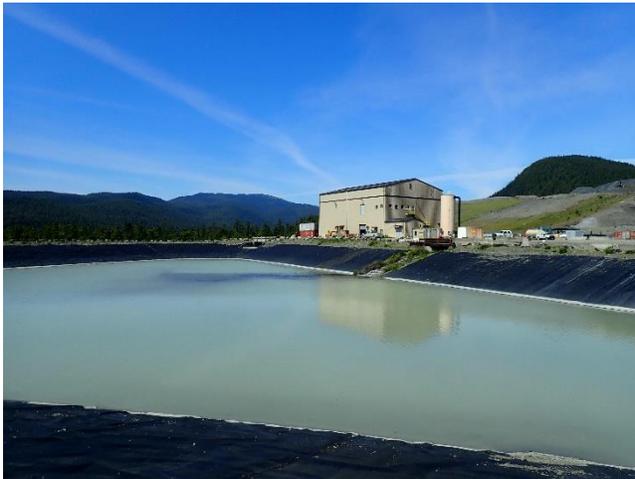
Pond 7 (Photo 20) was collecting site water and recirculated water from the treatment plant, and Pond 10 (Photo 21) is collecting direct precipitation.

Photo 20. Pond 7.

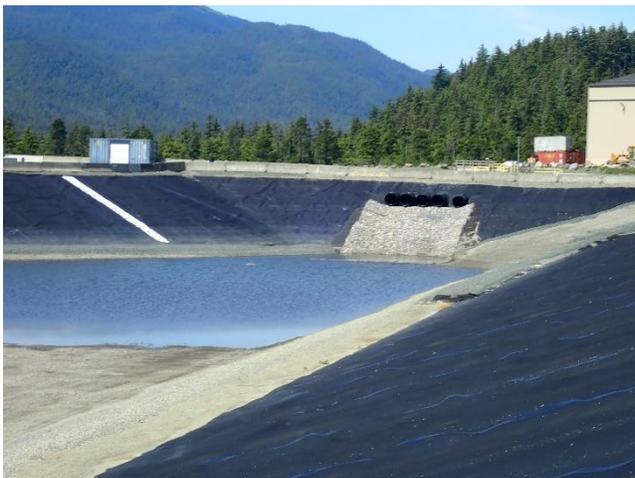
Photo 21. Pond 10.

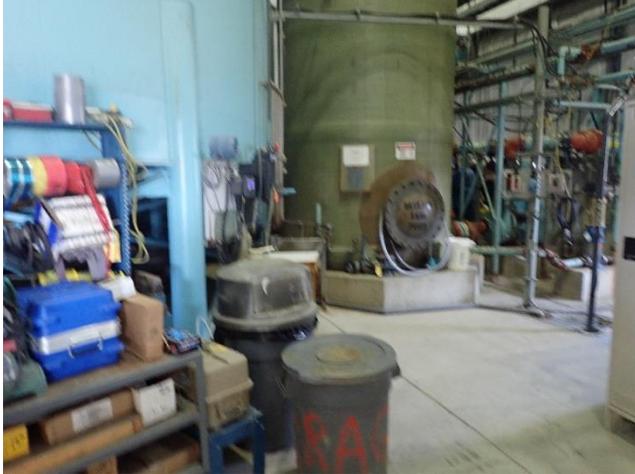
On 6/26/2019 the water treatment plant was treating 1300-gpm and discharging 540-gallons per minute (gpm). Approximately 760-gpm of treated water was being recirculated back into Pond-7. Good housekeeping practices were observed inside the water treatment plant (Photo 22).

Photo 22. The TDF water treatment plant.
