INSPECTION REPORT: GREENS CREEK MINE

Date of Inspection: Tuesday July 30, 2019
Date of Report: Thursday August 8, 2019
USDA Forest Service Inspector: Richard Dudek

Ranger District: Admiralty National Monument, Juneau Ranger District
Weather Conditions: Sunny. Temperature: Mid 60's (°F).

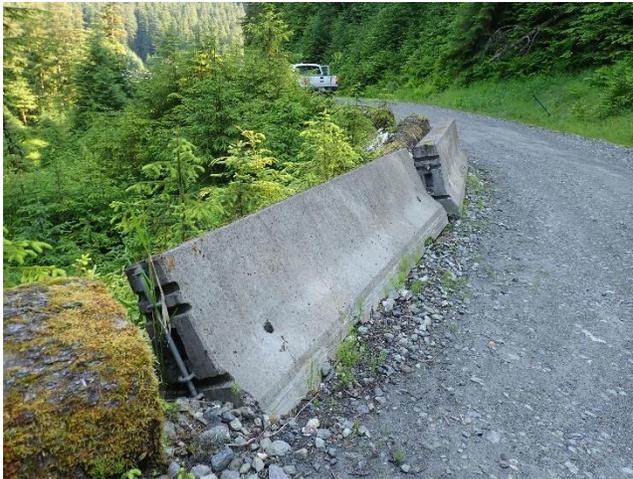
- The leaning jersey barrier (Photo 1) mentioned in a previous inspection report (IR #406) was restaged by Surface Operations on the weekend of August 3rd – 4th.
- On 7/31/2019, Environmental Operations removed the patch of noxious weeds (Canadian thistle) near the 3.4 mile B-road Bridge (Photo 2).

Photo 1. Now restaged, the jersey barrier that was leaning along the edge of the 1350 access road.

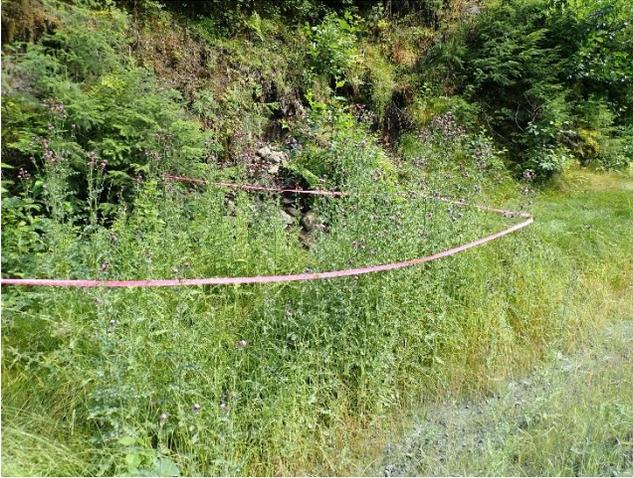
Photo 2. A patch of Canadian thistle identified between 3.3 and 3.4 mile B-road.

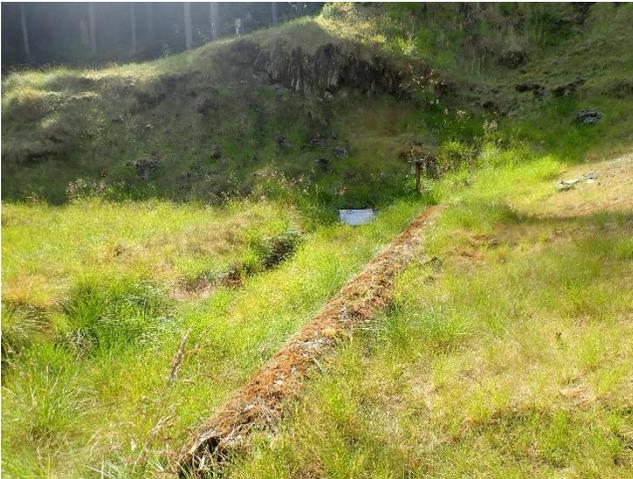
The pump for the trench is operating as intended (Photo 3). The influent water that is collected is routed to Pond-A. From there, the influent will be routed to the TDF water treatment plant for treatment and then discharged.

Photo 3. The 1350 pump and trench for collecting contact water from remnant waste rock piles.

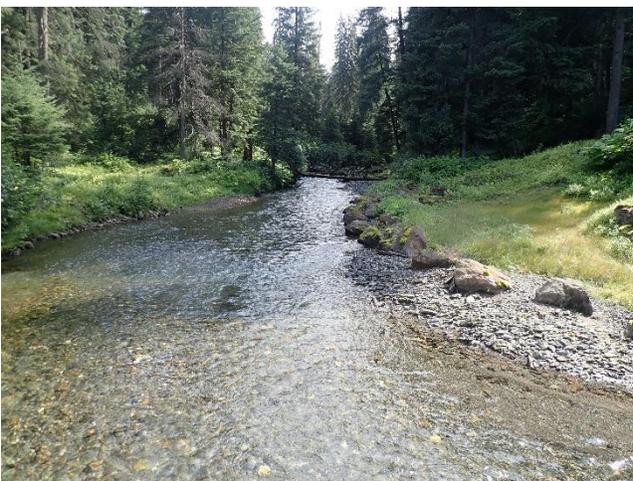
The recorded flow rate for Greens Creek (Photo 4) on 7/30/2019 was 22.4 cubic feet per second (cfs). The 920-area water withdrawal rate from Greens Creek was approximately 1.5-cfs.

Photo 4. A view of Upper Greens Creek from the weir.

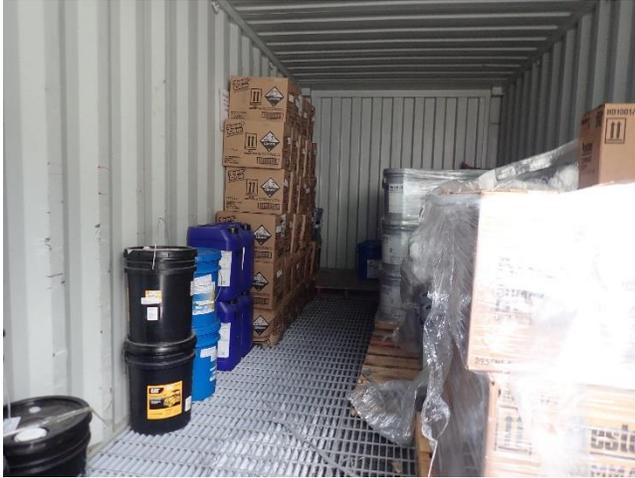
All petroleum and chemicals were properly stored within secondary containment (Photo 5).

Photo 5. The storage containers were tidy and in order.

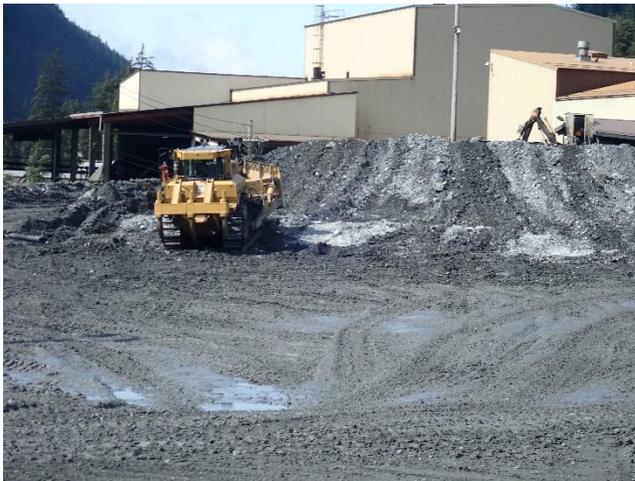
During the mine site visit, the 920 ore pad had multiple haul trucks depositing ore, and the bull dozer was blending the ore (Photo 6) prior to the milling process.

Photo 6. The 920 ore pad.

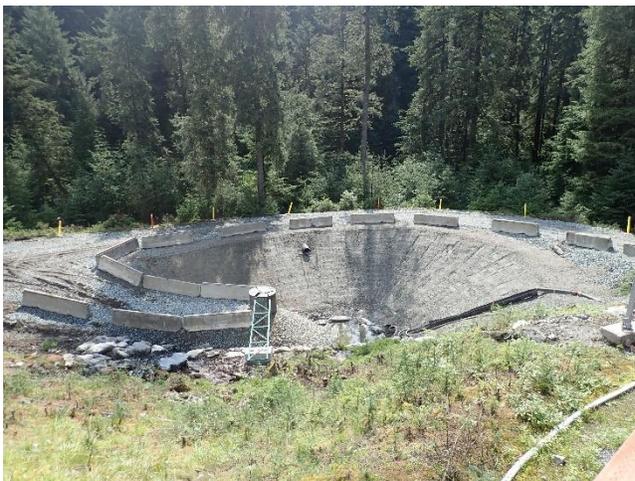
The improvements are still being made to the lower C pond (Photo 7). The liner and caisson for the pond have been installed. The next stage of improvements will be installing the new discharge pipelines for the pond.

Photo 7. Lower C-pond.

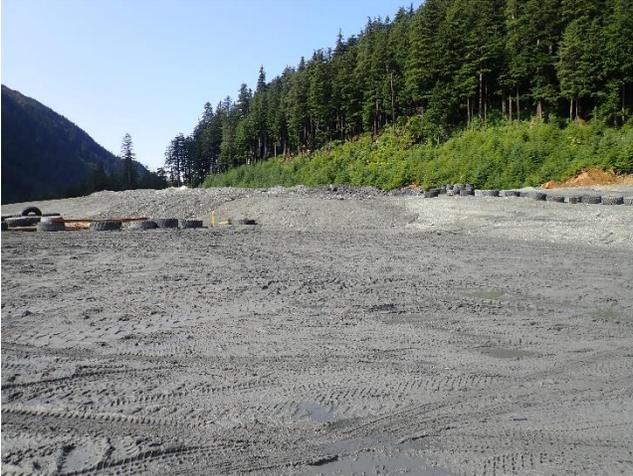
HGCMC continues to separately stockpile class 1 away from class 2/3 waste rock (Photo 8). This is due to the rock type's geochemical classification (Appendix 1 Integrated Monitoring Plan § 3.1).

Photo 8. Class 2/3 waste rock staging area.

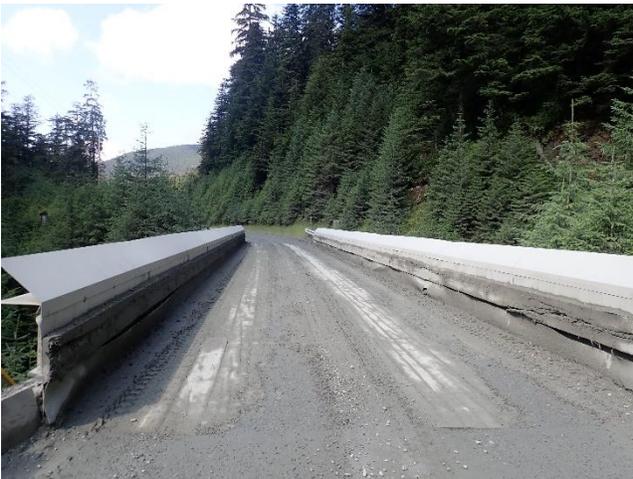
The bridge is being maintained by HGCMC Surface Operations (Photo 9). The splashguards are preventing splash over from vehicular traffic. In September of 2019, Surface Operations will be replacing the liner, and decking for all the B-road Bridges.

Photo 9. 7.4 Mile B-Road Bridge (Killer Creek Bridge).

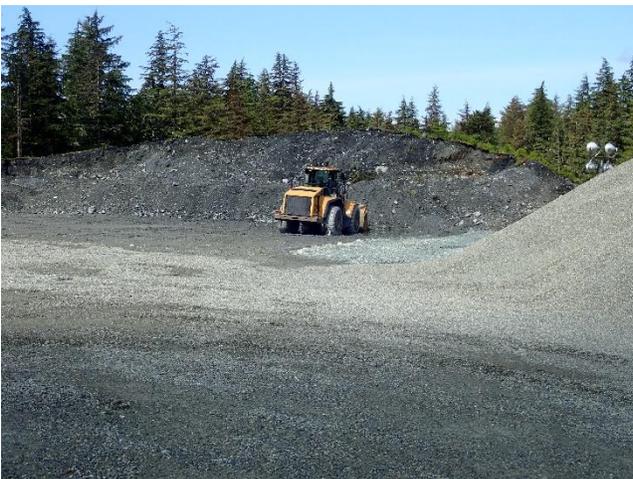
HGCMC personnel continue to remove waste rock from this location for disposal in the TDF. Approximately 23,015 cubic yards of waste rock (Photo 10) has been removed from this site.

Photo 10. Site E (4.7 mile B-road).

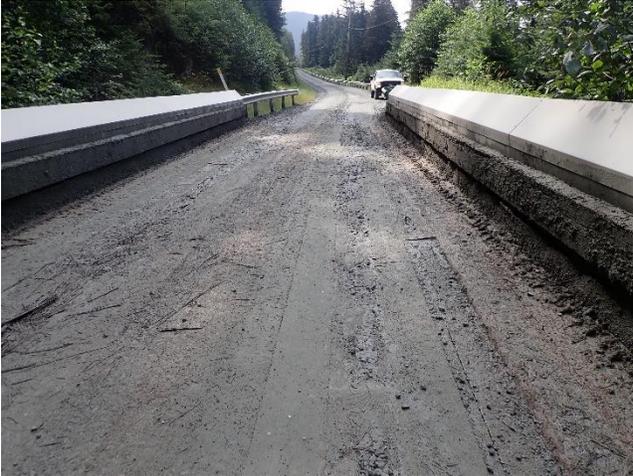
The bridge is being maintained by HGCMC Surface Operations (Photo 11).

Photo 11. 3.4 Mile B-road Bridge (Falls Creek Bridge).

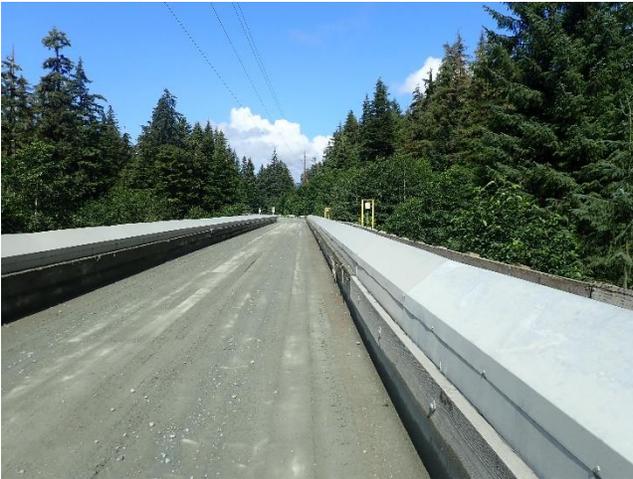
HGCMC Surface Operations are maintaining the bridge (Photo 12), and the structural BMPs located on the uphill side abutment are function as intended (Photo 13).

Photo 12. The 3.0 mile B-road Bridge (Zinc Creek Bridge).

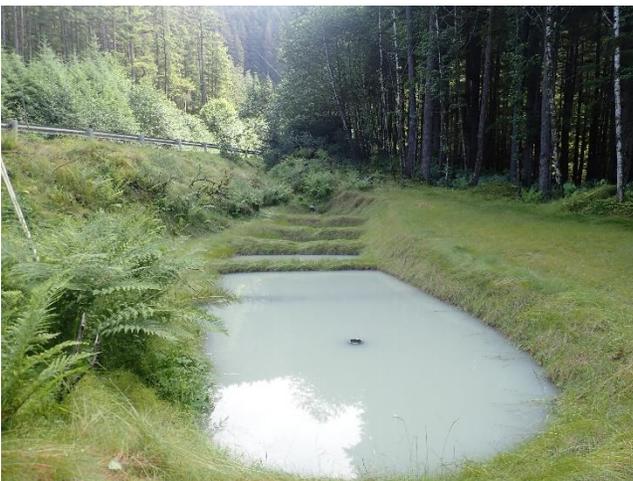
Photo 13. BMPs at Zinc Creek Bridge abutment.

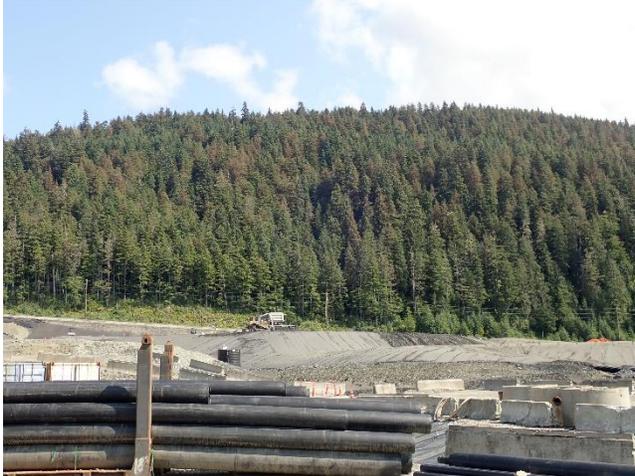
Surface Operations continue to deposit tailings in the S3P1 expansion area (Photo 14).

Photo 14. S3P1 tailings disposal area.

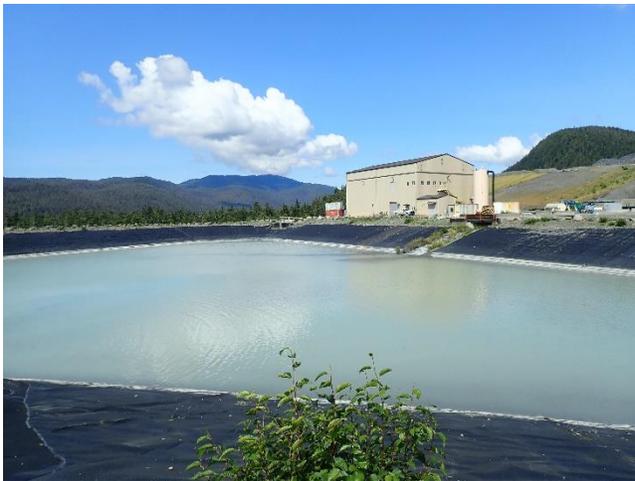
Photo 15. Pond 7.

Pond 7 (Photo 15) was collecting mine site water, and water from the TDF water treatment plant. Pond 10 (Photo 16) is collecting only direct precipitation.

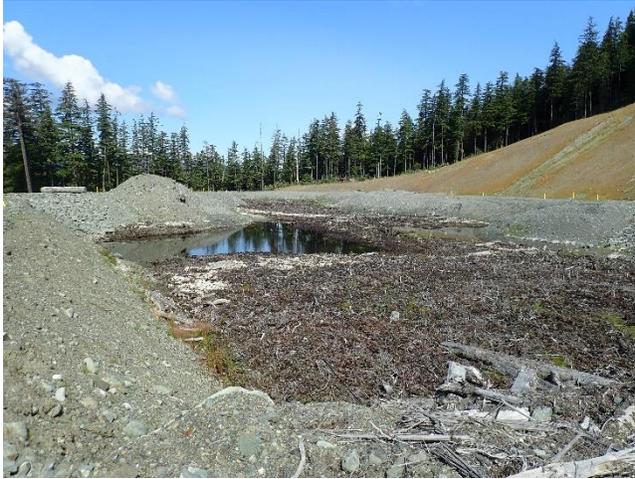
This site is currently inactive (Photo 17).

Photo 17. The sand pit is currently inactive.
