## INSPECTION REPORT: GREENS CREEK MINE

Date of Inspection: Wednesday December 11, 2019  
Date of Report: Friday December 20, 2019  
USDA Forest Service Inspector: Richard Dudek

Ranger District: Admiralty National Monument, Juneau Ranger District  
Weather Conditions: Cloudy with some rain. Temperature: low 40's (°F).

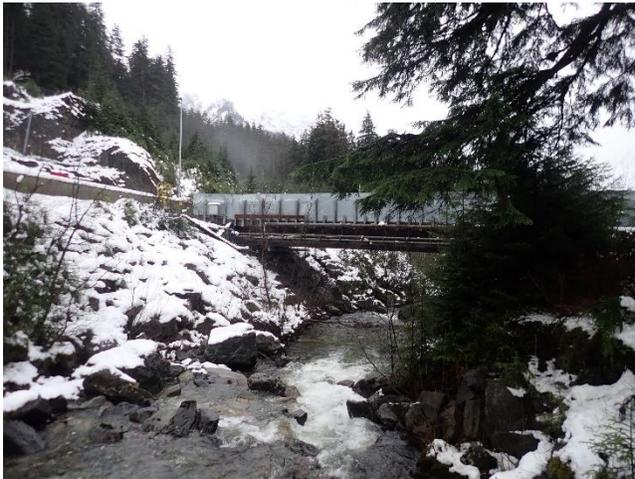
The recorded flow rate for Greens Creek (Photo 1) on 12/11/2019 was 34.5 cubic feet per second (cfs). The 920-area water withdrawal rate from Greens Creek was approximately 0.75-cfs.

**Photo 1. A view of Greens Creek from the weir.**

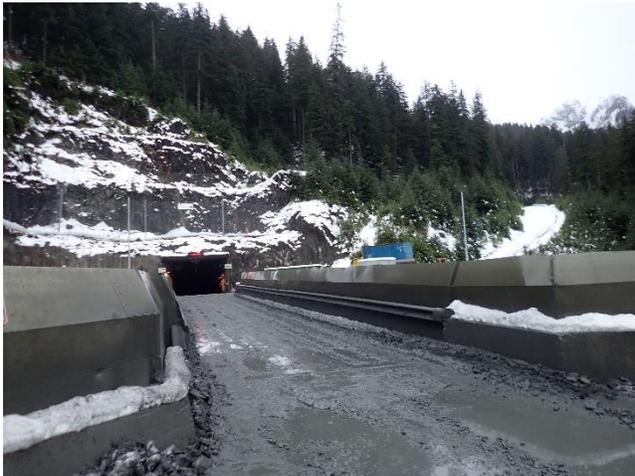
The 920 Bridge's splash guards are preventing sediment splash over from vehicular traffic (Photo 2).

**Photo 2. The 920 bridge.**

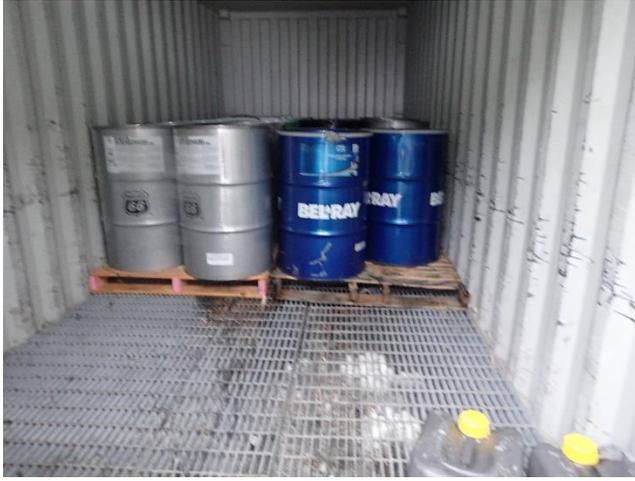
Good housekeeping practices were observed at The 920 warehouse (Appendix 5 BMP Plan page 39). All petroleum/chemicals were properly stored within appropriate secondary containment (Photo 3).

**Photo 3. Petroleum products stored with appropriate secondary containment.**

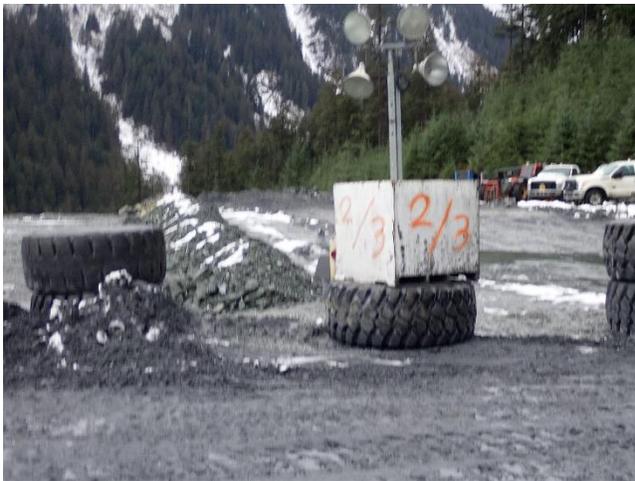
HGCMC continues to store waste rock at this location (Photo 4). Class 1 waste rock is separately staged from Class 2/3 waste rock due to the rock's classification for acid neutralization or acid generation potential (Appendix 01 Integrated Monitoring Plan; § 3.1).

**Photo 4. Site 23, where class 1 and class 2/3 waste rock is to be stored.**

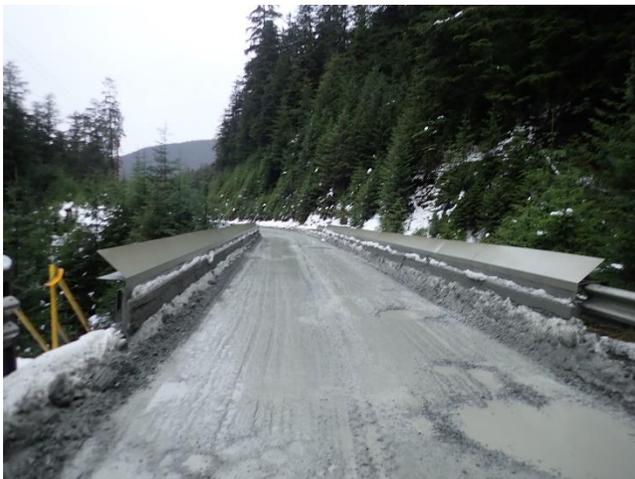
The bridge's splashguards are effectively preventing sediment splashover from vehicular traffic (Photo 5). Surface Operations recently made improvements to the downhill side abutment by installing a steel wall to help prevent soil creeping and future erosion (Photo 6). Geotechnical drilling (Photo 7) will take place once the drilling activities are completed near the 5.4 mile marker B-road. The purpose for the drilling at this location will be to install instrumentation to help study and monitor slope stability.

**Photo 5. The 7.4-mile B-Road bridge (Killer Creek Bridge).**

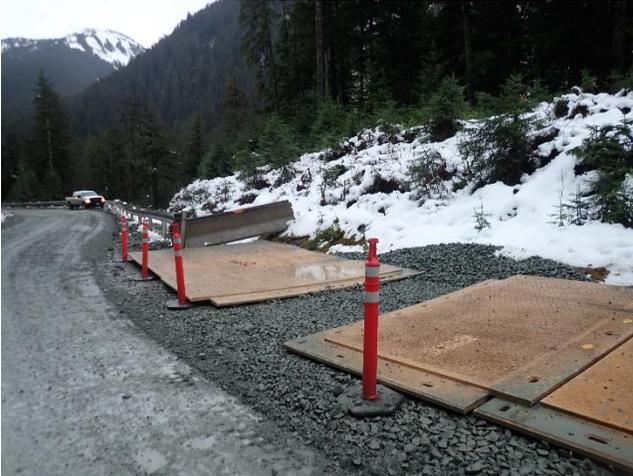
**Photo 6. The location where geotechnical drilling will take place near the 7.4 B-road Bridge.**

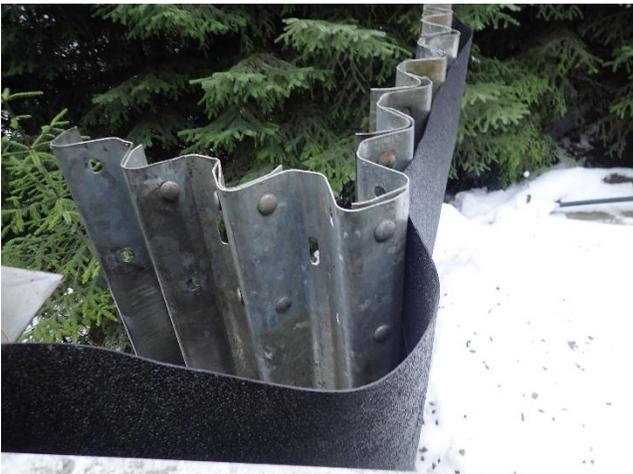
**Photo 7. A steel wall was installed along the abutment to prevent erosion.**

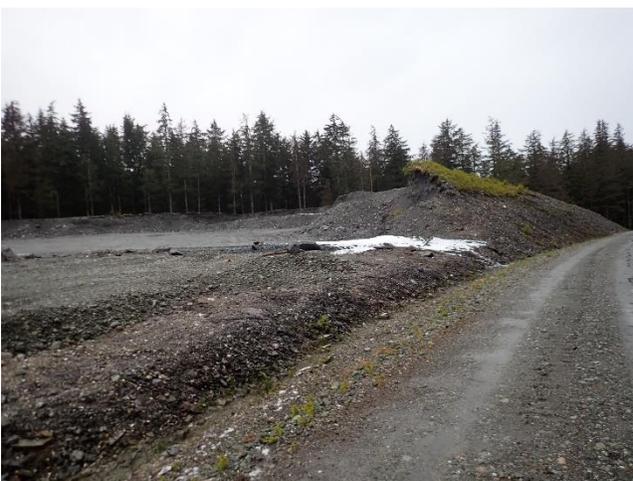
**Photo 8. Site E.**

In 2019, approximately 22,300 cubic yards of waste rock was removed from this location (Photo 8) and disposed of within the TDF.

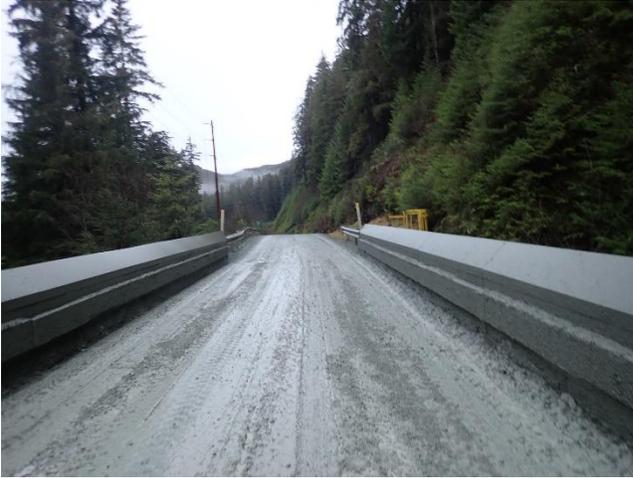
The bridge's splashguards are working as intended by preventing sediment splashover from traffic (Photo 9).

**Photo 9. The 3.4 Mile B-road Bridge (Falls Creek Bridge).**

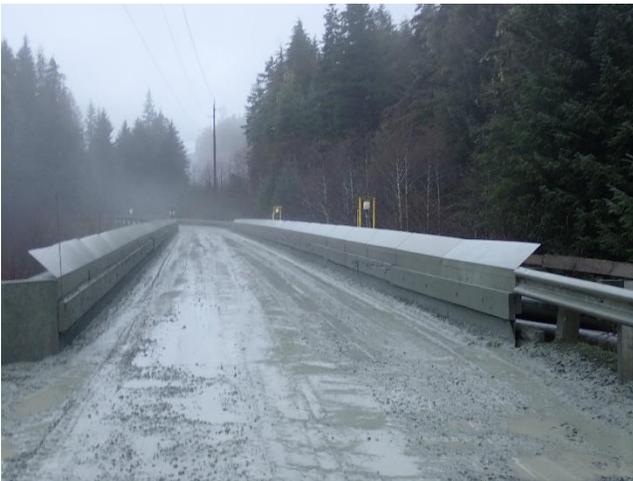
The bridge's splashguards are preventing sediment splashover from vehicular traffic (Photo 10), and the structural BMPs located on the uphill side abutment are functioning as intended. Surface Operations recently made improvements to the standpipe (Photo 11) by drilling small holes to allow the final settling pond to slowly drain down when there is no precipitation. This will also increase the surge capacity of the settling pond during high precipitation events.

**Photo 10. The 3.0 Mile B-road Bridge (Zinc Creek Bridge).**

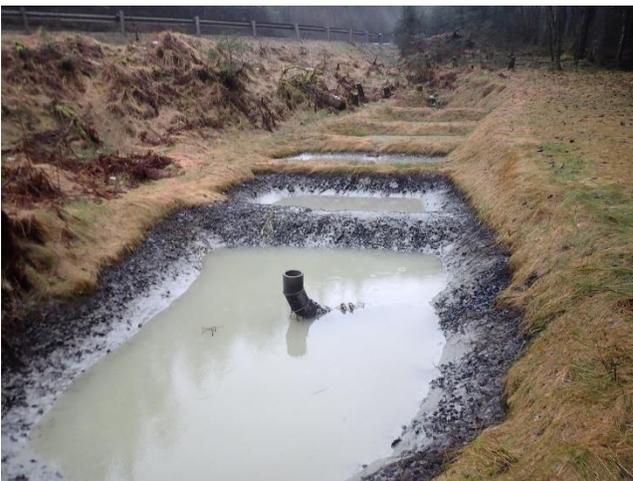
**Photo 11. The series of BMPs for stormwater management near the 3.0-mile maker B road.**

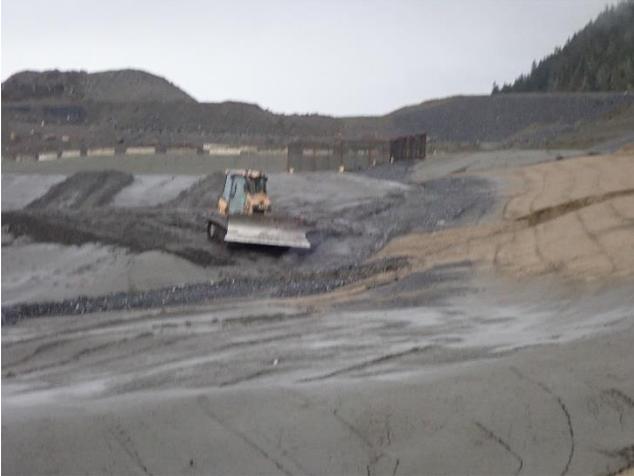
Surface Operations continue to deposit tailings along the eastern ridge of the S3P1 expansion area (Photos 12-13).

**Photo 12. A bulldozer compacting tailings and contouring recently deposited tailings.**

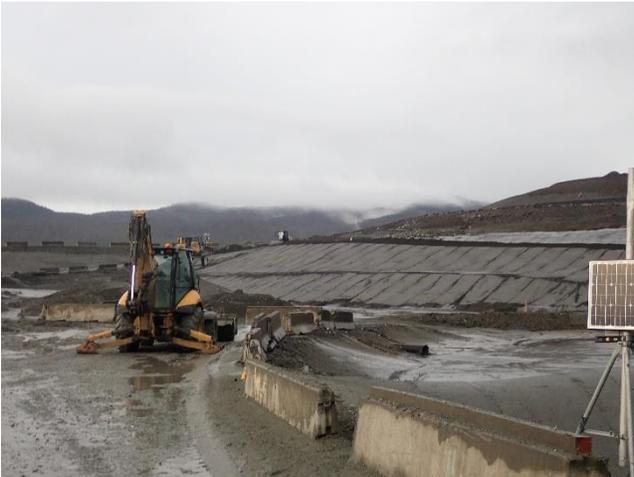
**Photo 13. A view of the S3P1 area.**

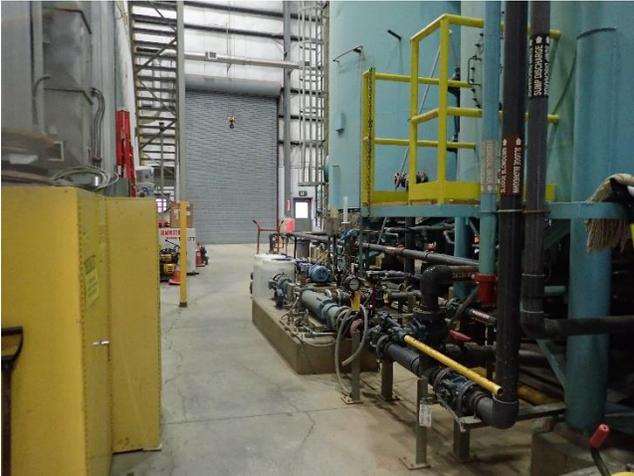
On 12/11/2019, the water treatment plant was treating 1509-gpm. Good housekeeping practices were observed inside the water treatment plant (Photo 14) (Appendix 5 BMP Plan; page 39).

**Photo 14. The TDF water treatment plant.**

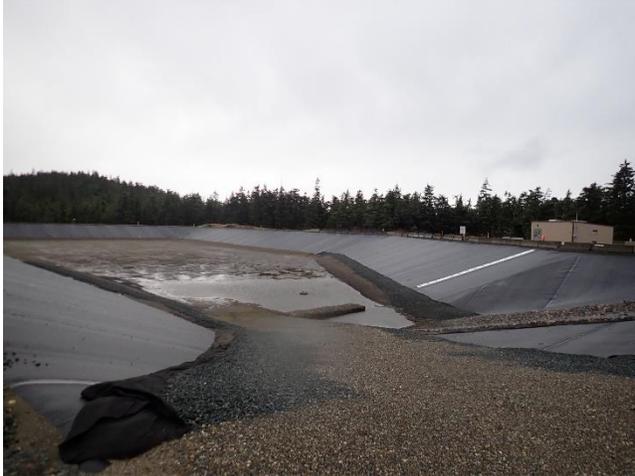
**Photo 15. Pond 10.**

At the time of the inspection, Pond 7 (Photo15) was collecting mine site water. Pond 10 (Photo 16) was collecting direct precipitation.

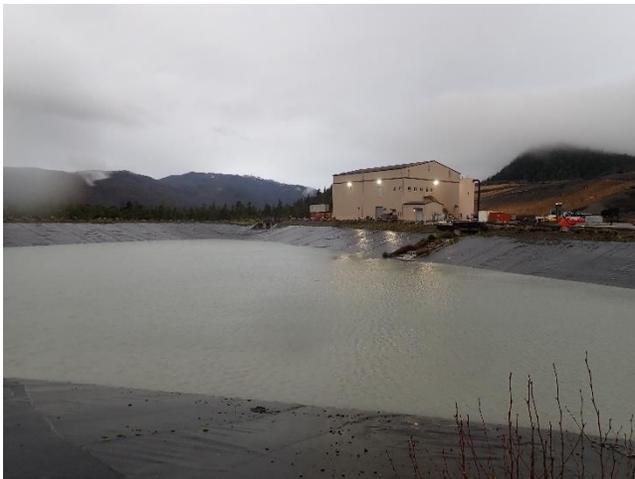
**Photo 16. Pond 7 was receiving direct precipitation and influent mine water.**
