INSPECTION REPORT: GREENS CREEK MINE

Date of Inspection: Thursday February 6, 2020
Date of Report: Tuesday February 25, 2020
USDA Forest Service Inspector: Richard Dudek

Ranger District: Admiralty National Monument, Juneau Ranger District
Weather Conditions: Cloudy with some sun. Temperature: low 30's (°F).

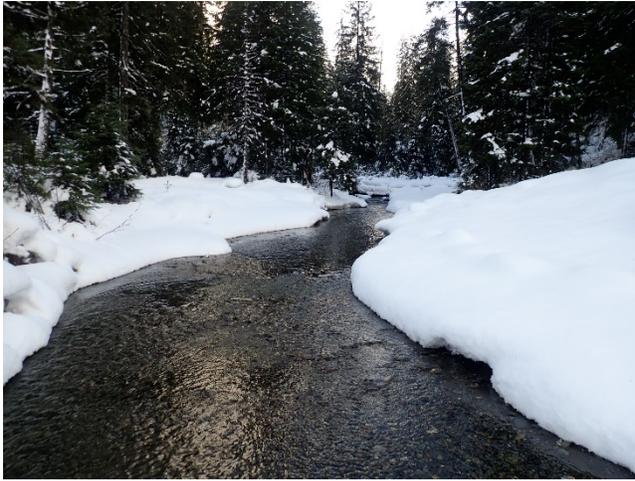
The recorded flow rate for Greens Creek (Photo 1) on 2/6/2019 was 10.3 cubic feet per second (cfs). The 920-area water withdrawal rate from Greens Creek was approximately 1.3-cfs.

Photo 1. Greens Creek.

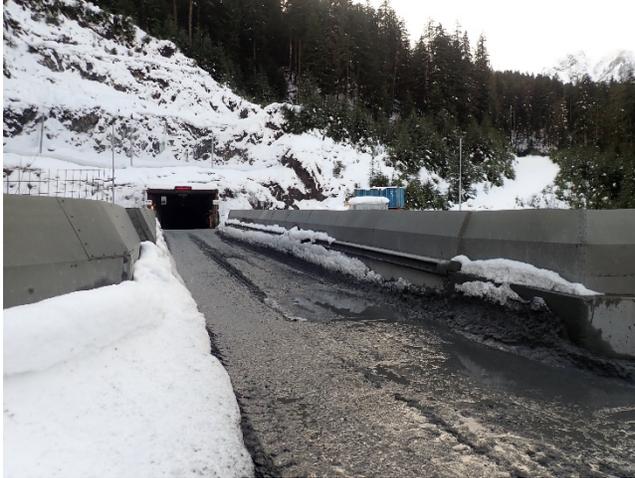
The 920 Bridge's splash guards are preventing sediment splash over from vehicular traffic (Photo 2).

Photo 2. The 920 Bridge.

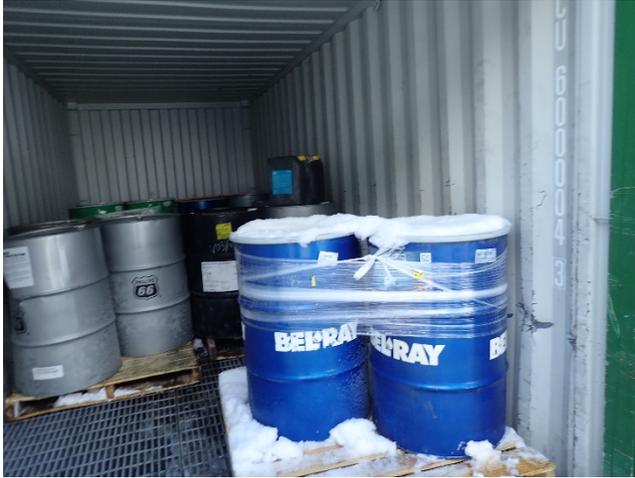
Good housekeeping practices were observed at The 920 warehouse (Appendix 5 BMP Plan page 39). All petroleum/chemicals were properly stored within appropriate secondary containment (Photo 3).

Photo 3. The 920 warehouse storage container.

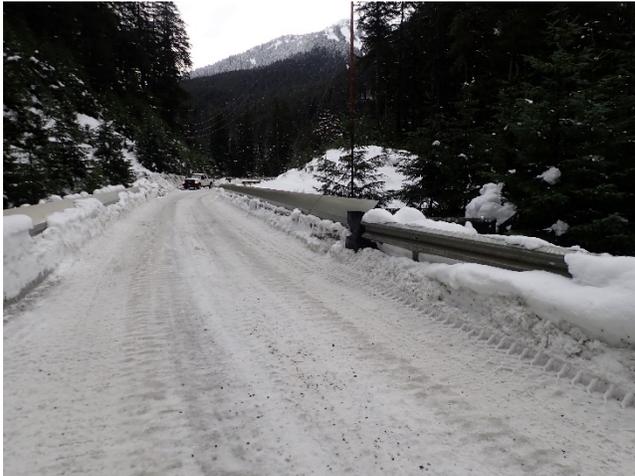
The bridge's splashguards are effectively preventing sediment splashover from vehicular traffic (Photo 4).

Photo 4. The 7.4 Mile B-road Bridge (Killer Creek Bridge).

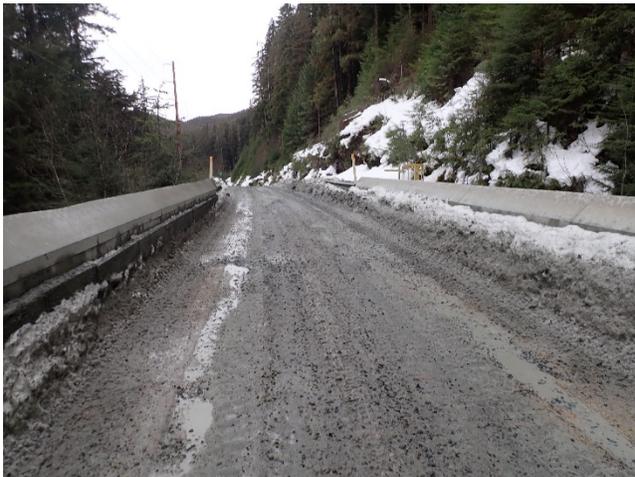
The bridge's splashguards are working as intended by preventing sediment splashover from traffic (Photo 5).

Photo 5. The 3.4 Mile B-road Bridge (Falls Creek Bridge).

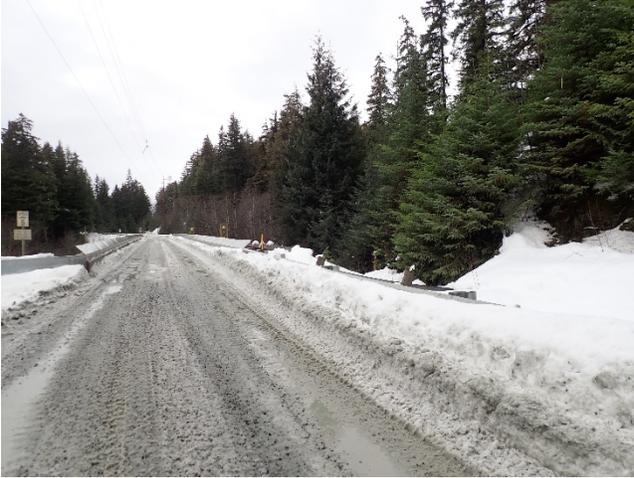
The bridge's splashguards are preventing sediment splashover from vehicular traffic (Photo 6).

Photo 6. The 3.0 Mile B-road Bridge (Zinc Creek Bridge).

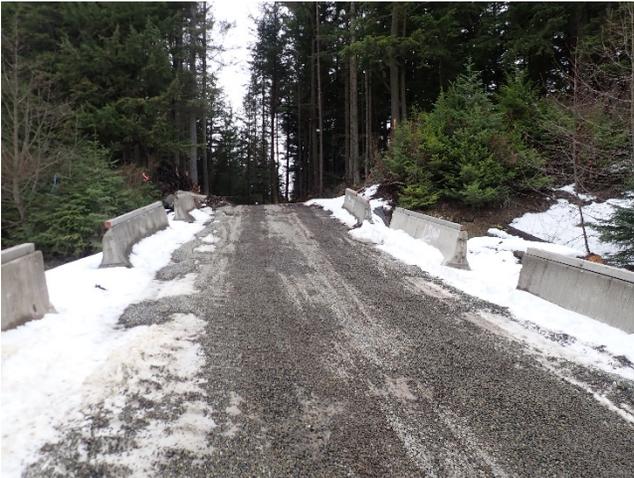
The purpose for the geotechnical drilling at this location is to collect data for a feasibility study on a potential location of a settling pond for the northern TDF area expansion (Photos 7-9).

Photo 7. The entrance ramp for the drill rig used during the geotechnical drilling project.

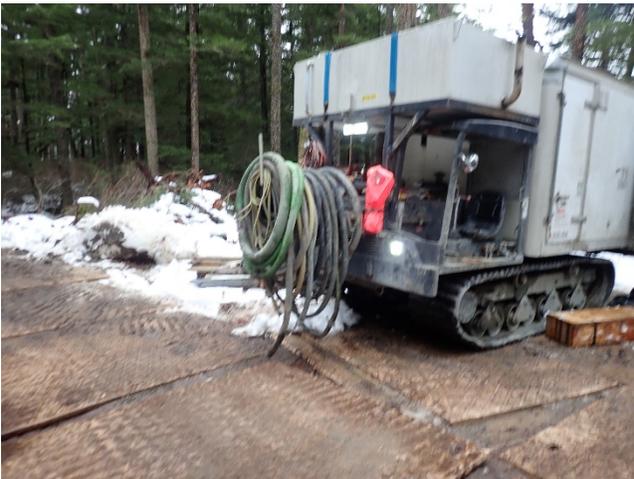
Photo 8. At the time of the site visit, personnel were prepping the drill for a new drilling location.

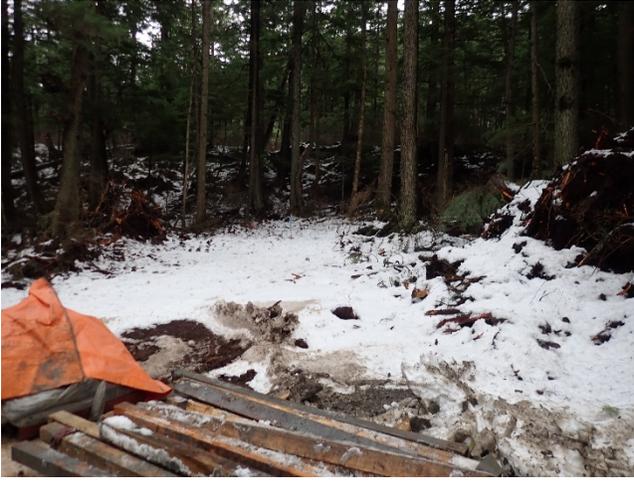
Photo 9. One site where geotechnical drilling was going to take place.

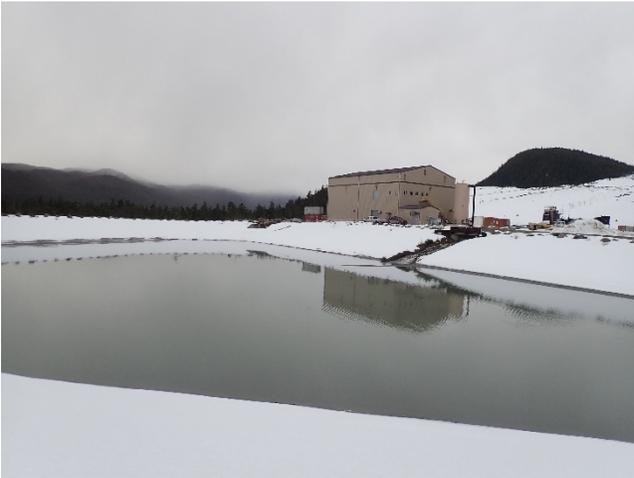
At the time of the inspection, Pond 7 (Photo 10) was collecting mine site water. Pond 10 (Photo 11) was covered in snow and ice.

Photo 10. Pond 7 was receiving influent water from the mine site.

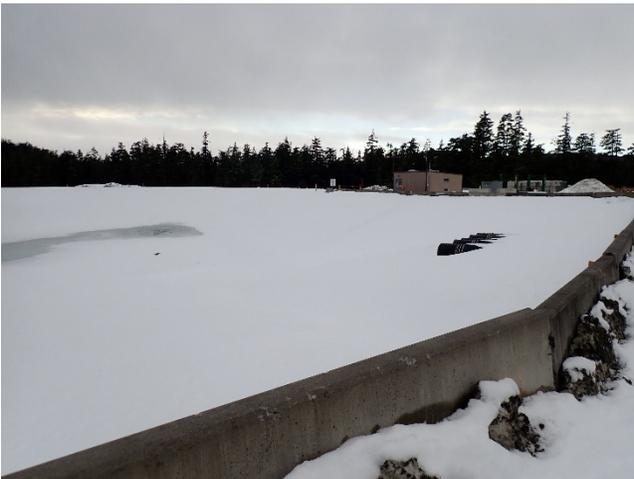
Photo 11. Pond 10 was covered in snow and ice.

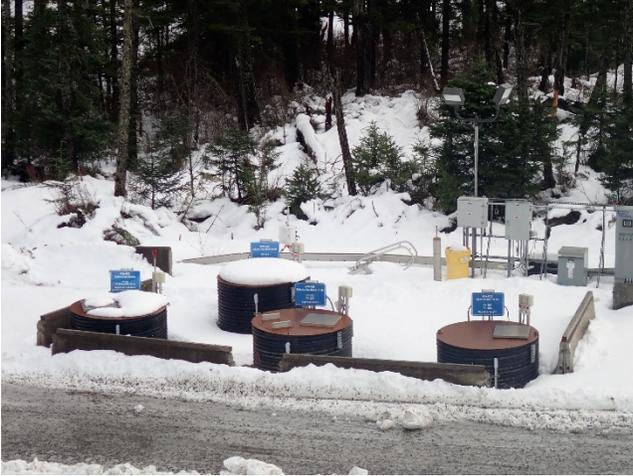
HGCMC recently installed a continuous monitoring system for fugitive dust. The dust monitor is staged by the wet wells that are located to the south of the S3P1 containment area (Photo 12). The data collected will help with future mitigations for fugitive dust control.

Photo 12. A continuous monitoring system for dust is staged behind the wet wells.

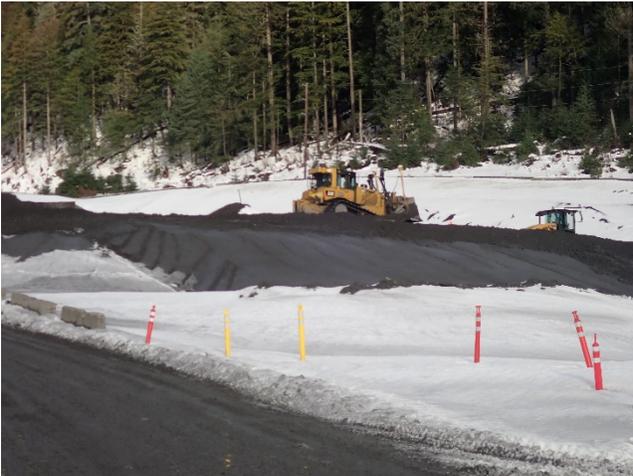
Surface Operations continue to deposit tailings along the eastern ridge of the S3P1 expansion area (Photos 13-14).

Photo 13. Tailings being desposited and compacted in the S3P1 area.

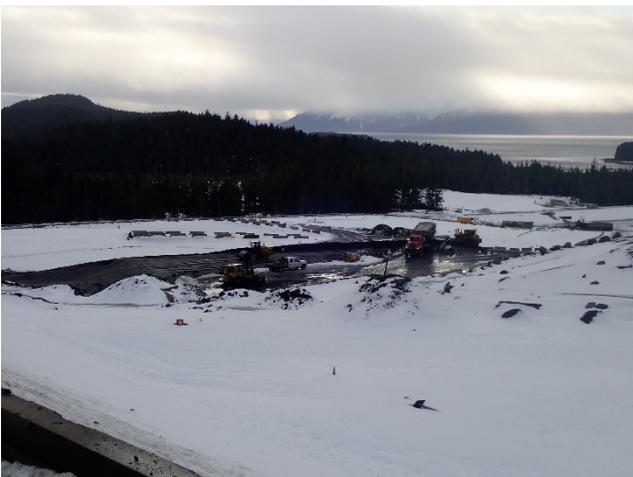
Photo 14. HGCMC is actively placing tailing along the eastern ridge of the S3P1 area.
